Department of Mechanical Engineering

DEVELOPMENT OF CVD COATED CERAMIC MILLING INSERTS FOR MILLING INCONEL 718

A Thesis submitted for the degree of
Doctor of Engineering
In Machining Science

2023

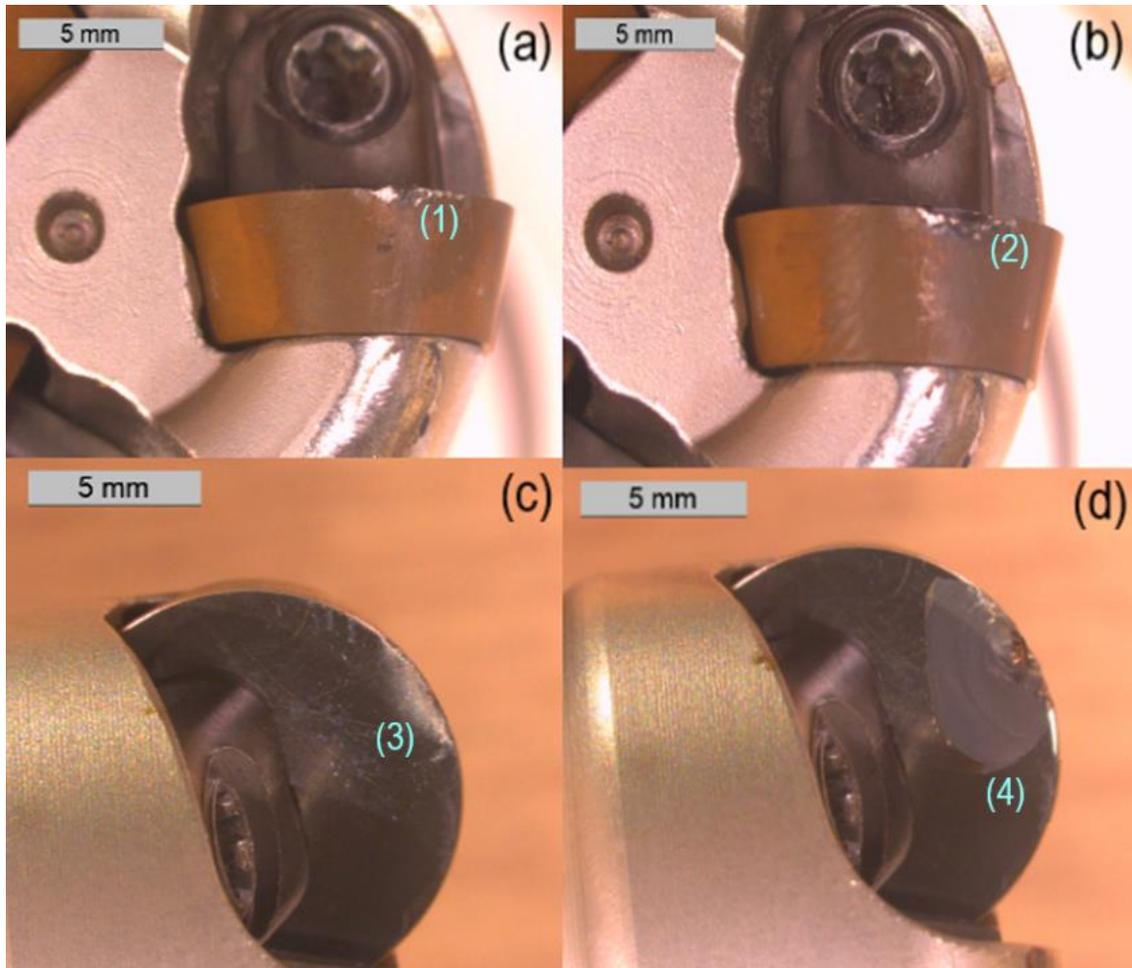
Figure 7.12. 880 m/min-test 17B-Stage-9-10-insert-uncoated-insert-2.1-edge-1.1 (a-b) flank face & Insert-1.1-1.3-edge-1.1 (c-d) rake face. Total material removed after two cuts 22446.7 mm³.

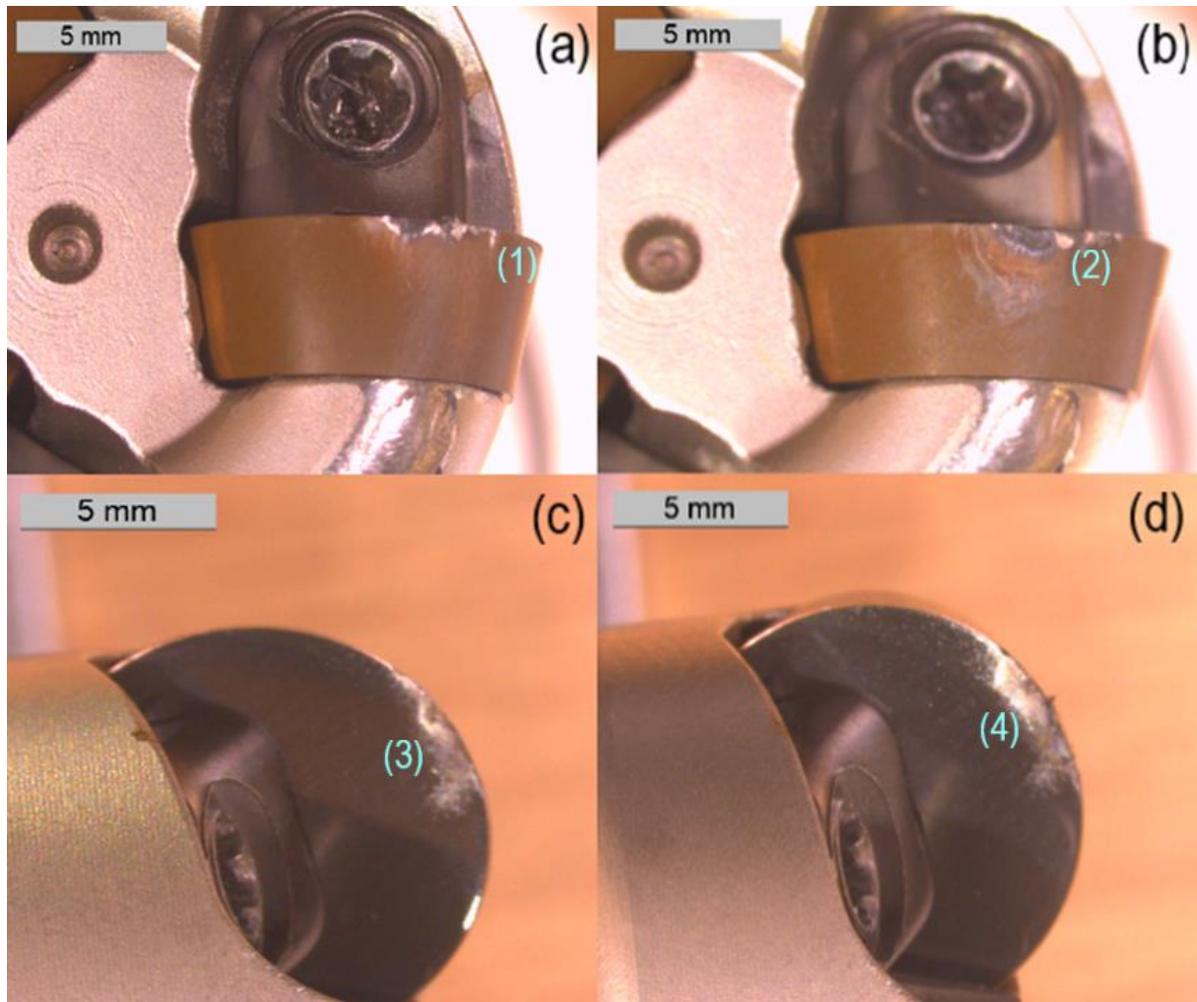
Figure 7.13. 880 m/min-test 17B-Stage-11-12-insert-uncoated-insert-2.1-edge-1.1 (a-b) flank face & Insert-1.1-1.3-edge-1.1 (c-d) rake face. Material removed for this cut 12141 mm³. Total material removed after two cuts 38546.5mm³.

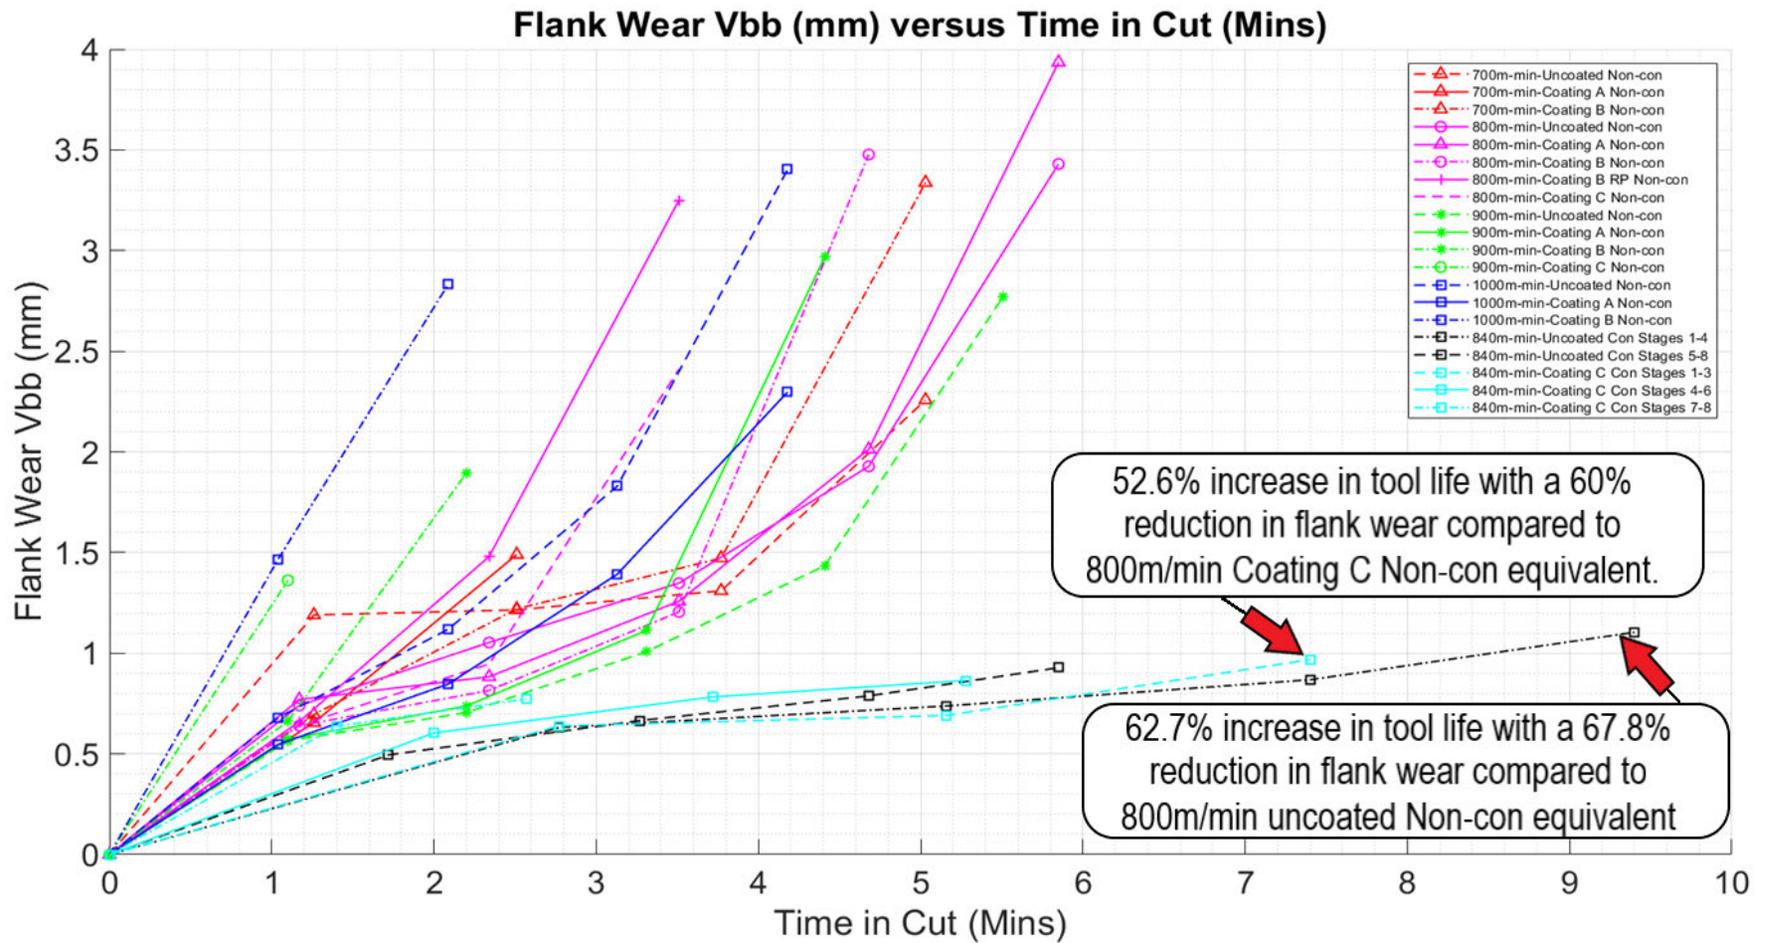
Figure 7.14. 700, 800, 900, 1000 m/min facing ops 1.1-4.5 Uncoated / Coating A / Coating B / Coating B RP / Coating C, 840 m/min continuous spiral ops Stages 1-8 Uncoated / Coating C.

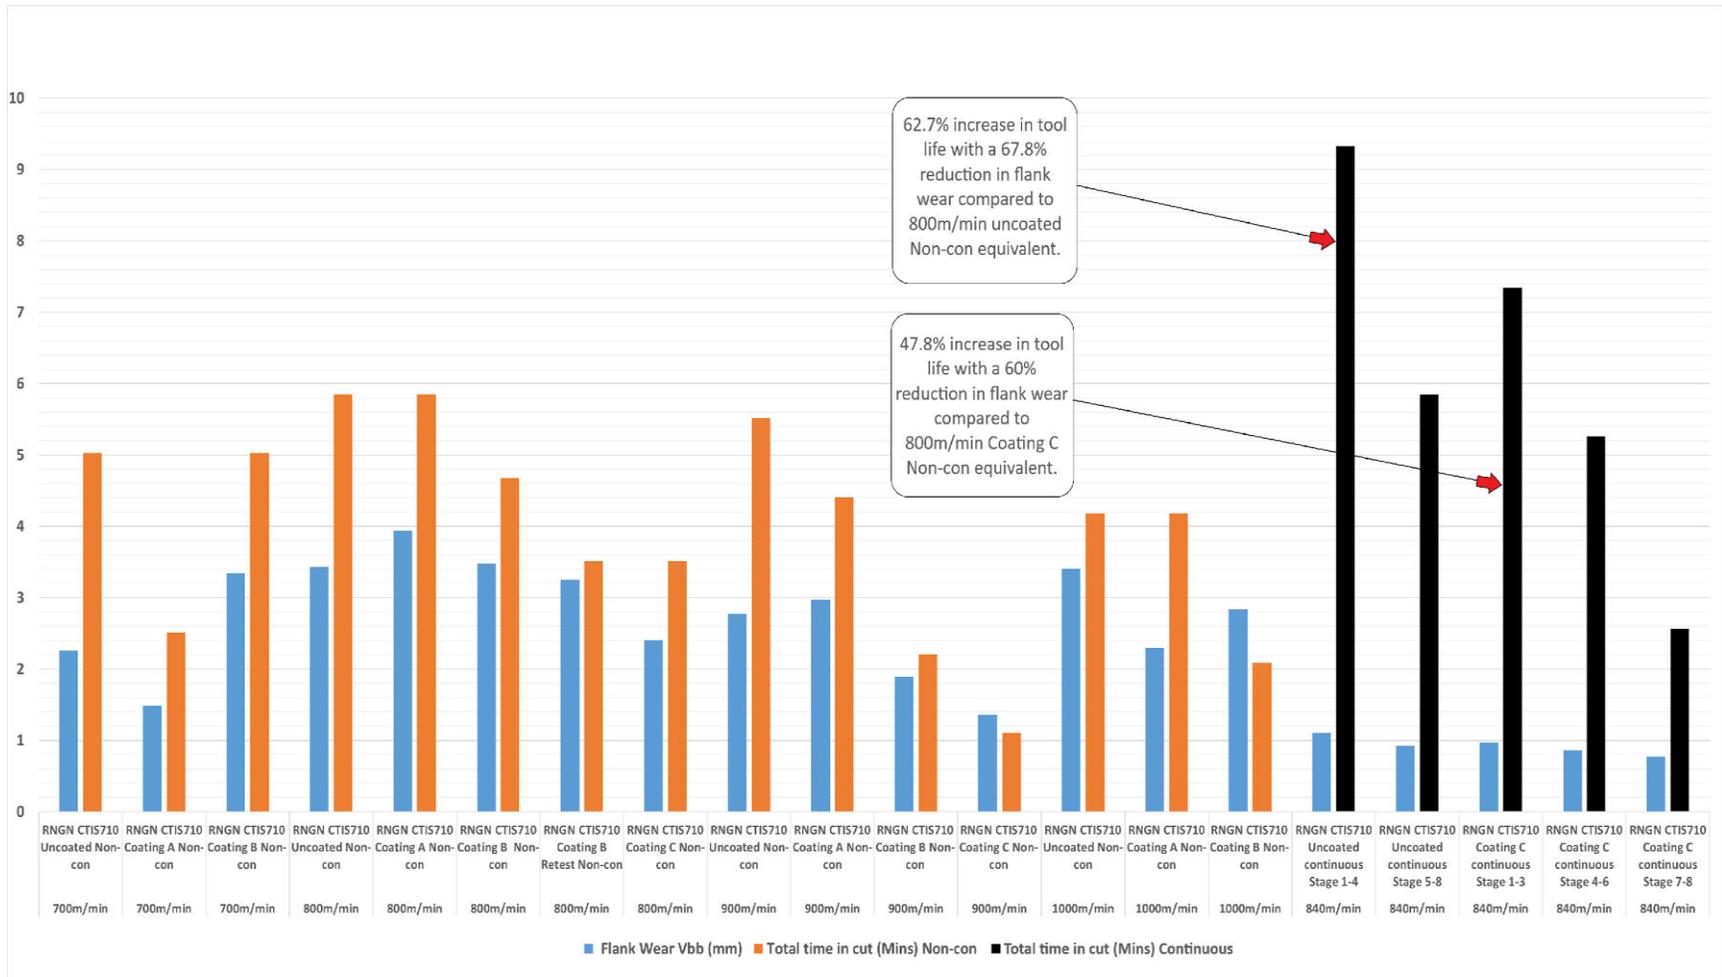
Figure 7.16. Tool life versus flank wear comparison between non-continuous and continuous tool paths.

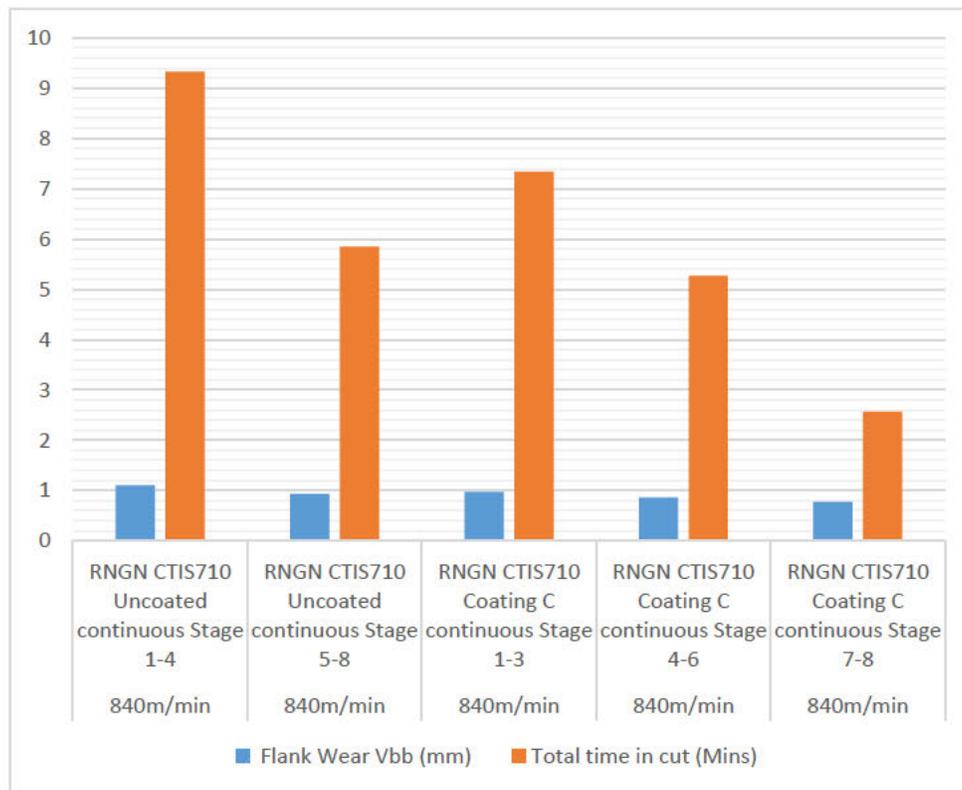
Figure 7.17. Average RNGN insert flank wear (mm) versus time in cut (minutes).

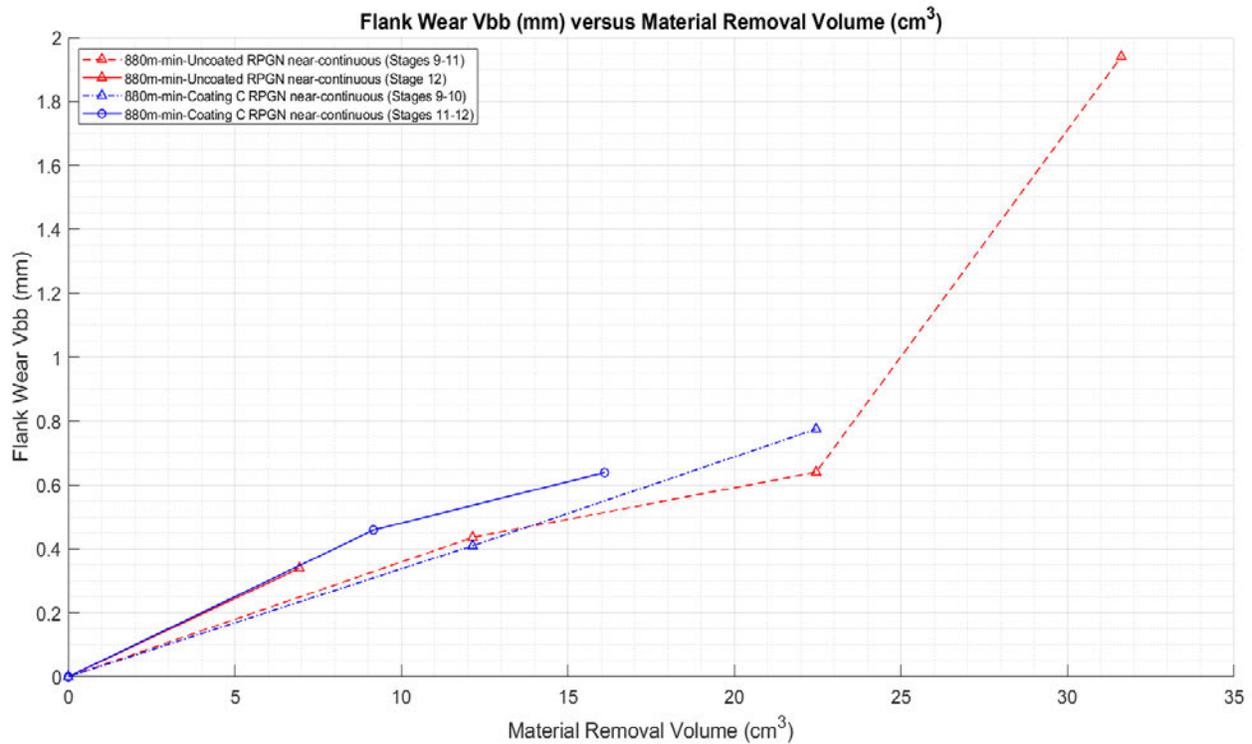
Figure 7.18. 880 m/min near-continuous elliptical spiral ops Stage 9-12 Uncoated / Coating C.

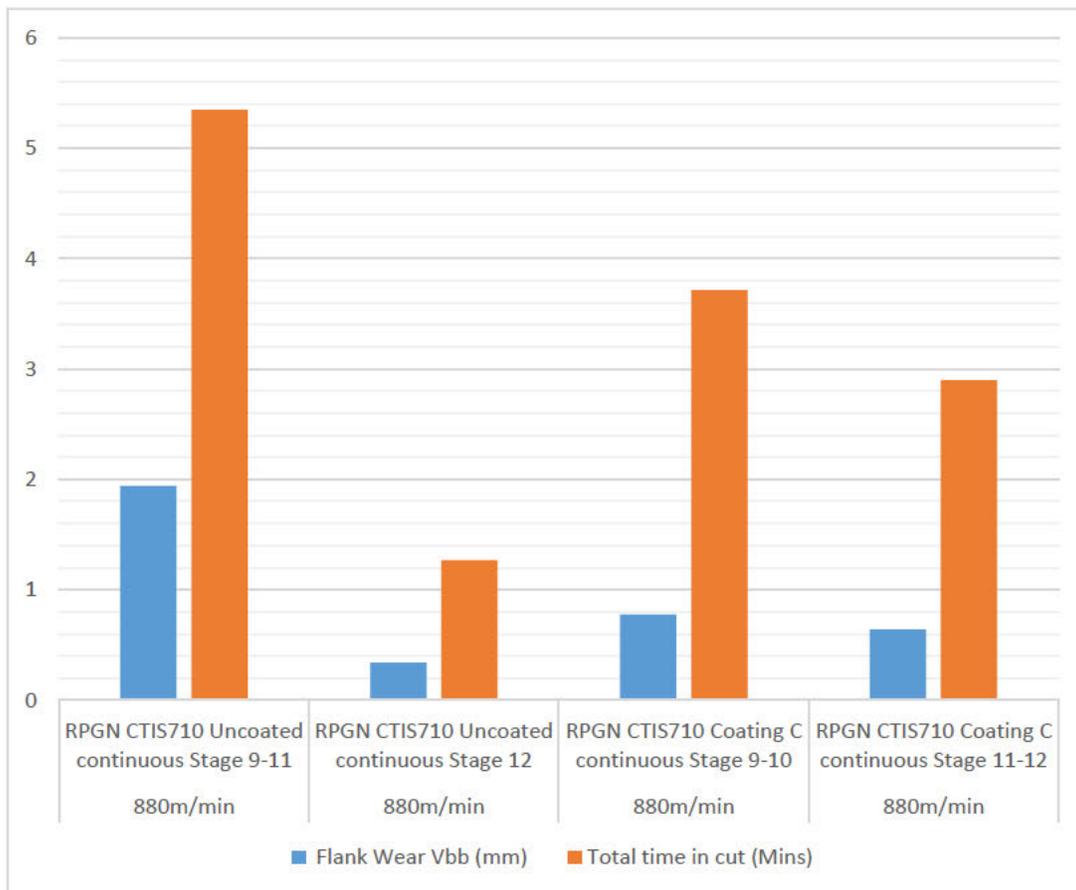
Figure 7.19. Average RPGN insert flank wear (mm) versus time in cut (minutes).
