Investigation of Corrosion Under Insulation (CUI) using microelectrodes

Submitted in accordance with the requirements for the degree of

Doctor of Philosophy

The University of Leeds

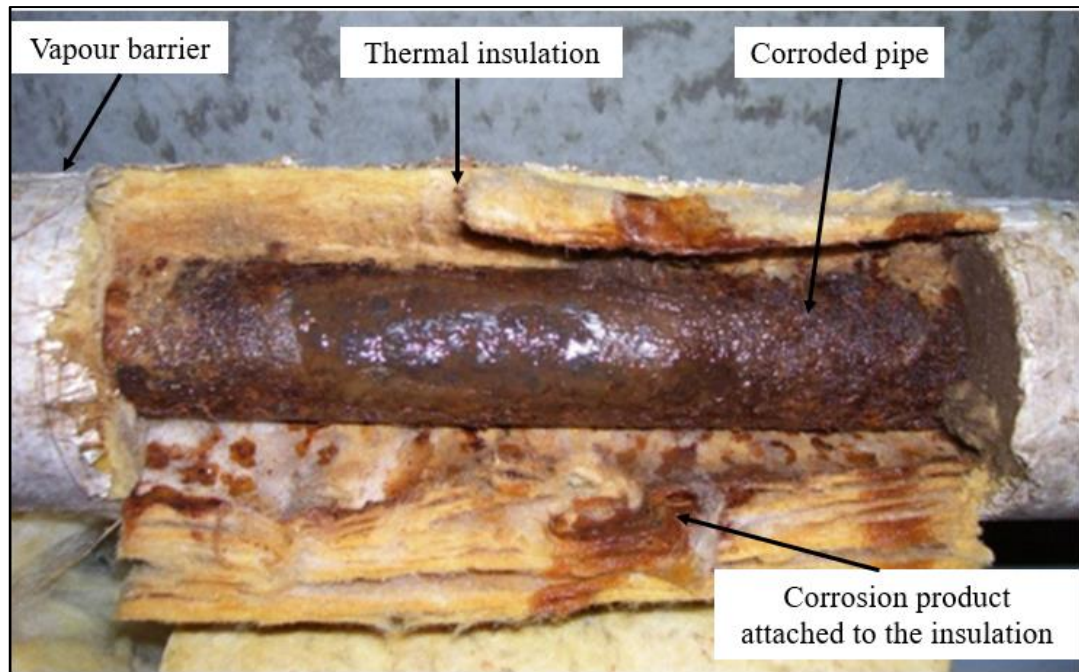
Figure 1-2: Corroded pipe due to Corrosion under insulation (CUI), adapted from [17]

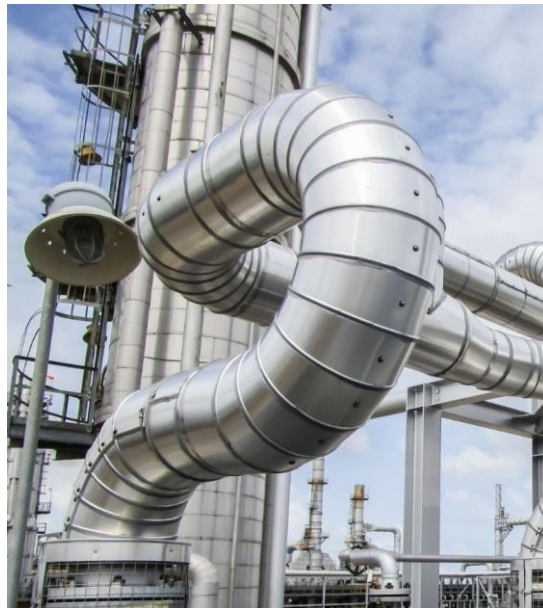
Figure 3-1: Thermally insulated pipe and vessel in an oil refinery [64]

In refineries, thermal insulation plays a critical role in energy saving, process efficiency, and overall operational sustainability. Figure 3-1 depicts a visual representation of thermally insulated pipes and vessels within an oil refinery.

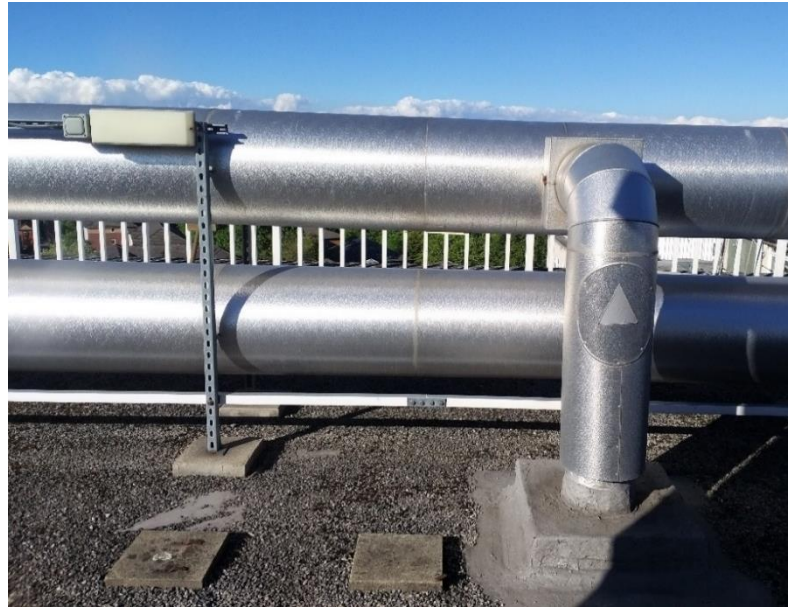
Figure 3-2: Insulated piping system at the University of Leeds

Moreover, insulation exhibits applications that surpass its utilization within the realm of refineries, as it finds relevance across a diverse array of industries and even extends to domestic contexts. This versatility is aptly demonstrated through the depiction in Figure 3-2 where insulated pipes are prominently employed within the

School of Mechanical Engineering at the University of Leeds. This illustration effectively underscores the profound significance of insulation technologies within the landscape of universities.

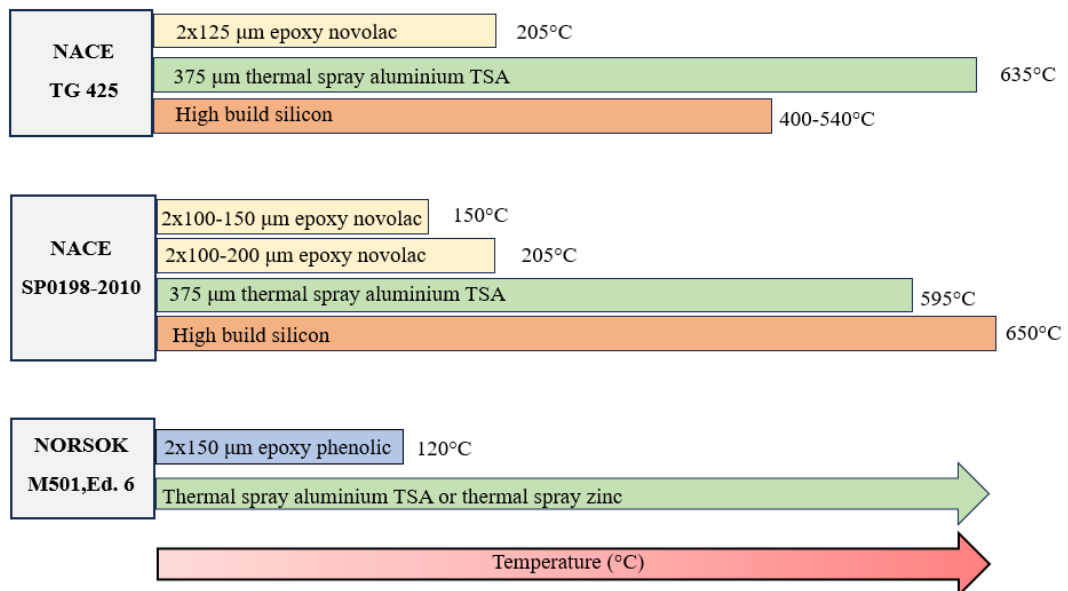
Figure 3-4: Provides an overview of the upper-temperature limits for different coating types (epoxy novolac, TSA, high build silicon and epoxy phenolic as specified by authoritative sources NORSOK M 501, NACE SP0198, and NACE TG 425, adapted from [68]

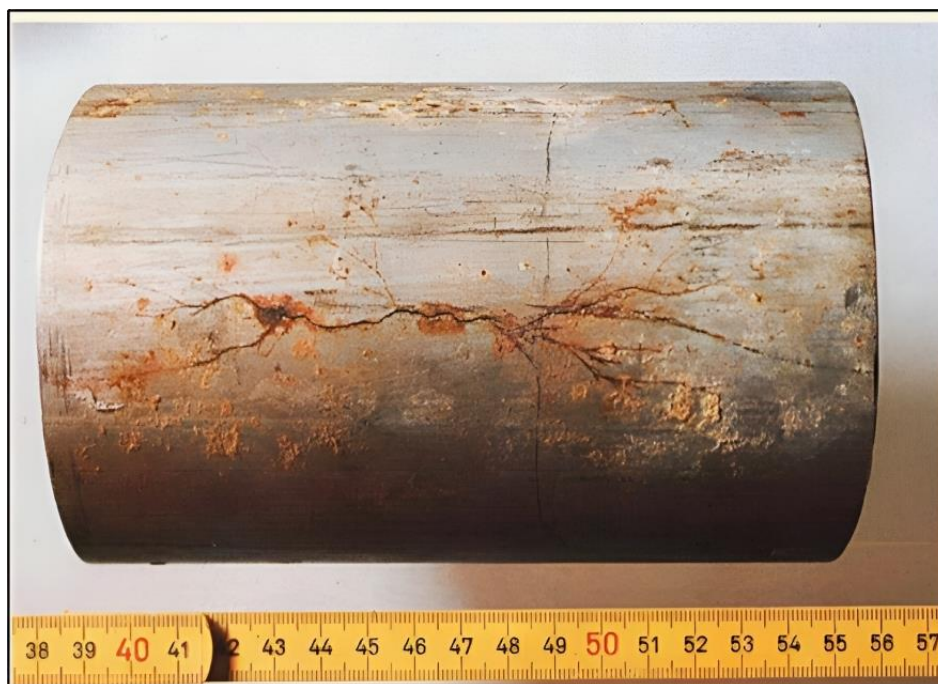
Figure 3-20: An illustration of stress corrosion cracking that took place in type 316 stainless steel that was subjected to thermal insulation in the temperature range of 50 to 60°C. The cracking was initiated by the presence of rinsing water containing 60 mg/kg of chloride, coupled with pre-existing residual stresses [114]
