Three-dimensional behaviour of brickwork masonry arch bridges

Bowen Liu

Submitted in accordance with the requirements for the
degree of Doctor of Philosophy

School of Civil Engineering

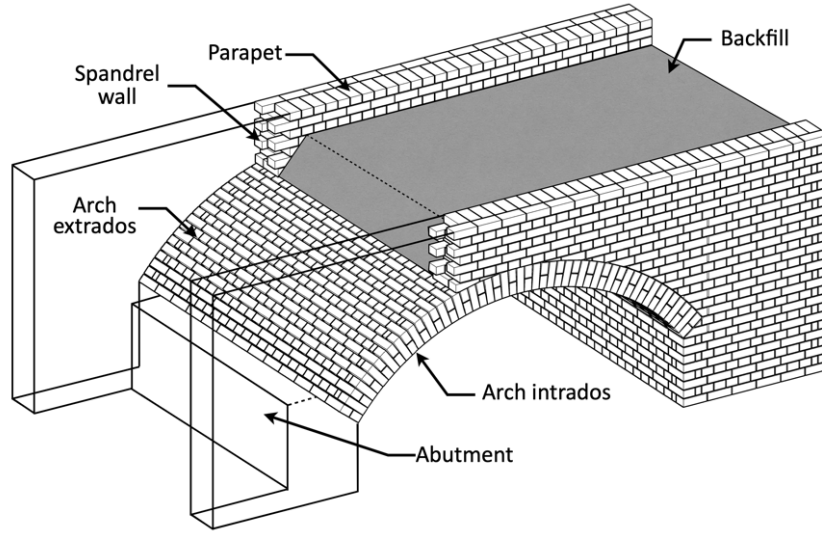
Figure 2.1 Primary elements of a masonry arch bridge.

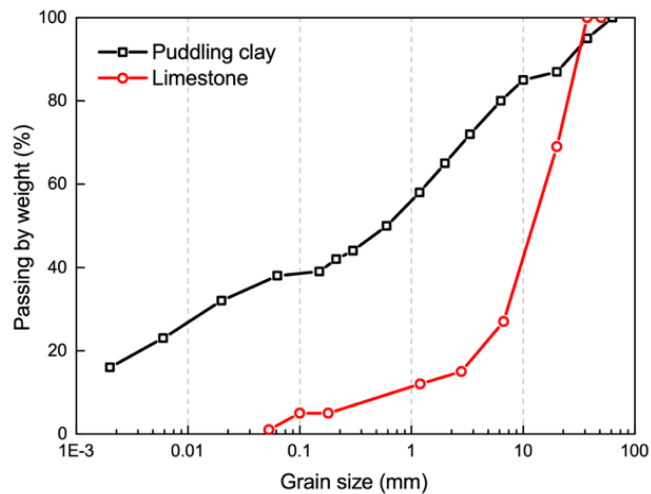
Figure 2.6 Grain-size distribution of the limestone and puddling clay.

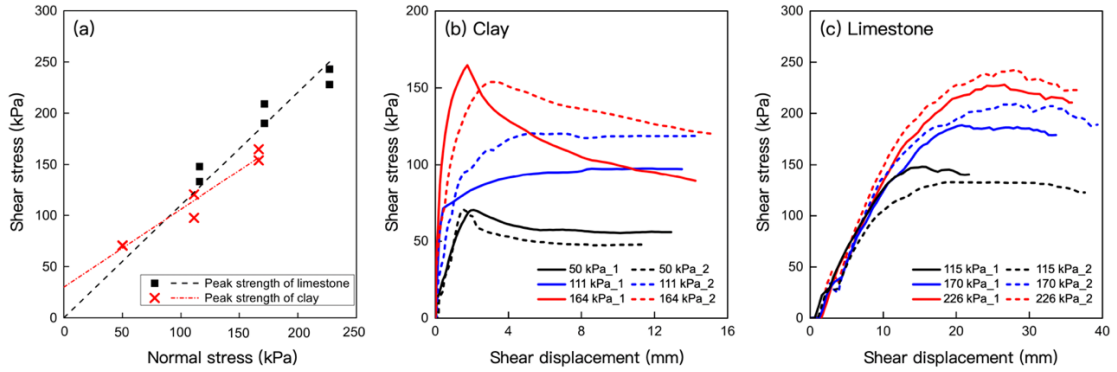
Figure 2.8 Results from direct shear box tests on backfill materials: (a) shear strength envelope for clay and limestone; shear strength versus shear displacement for clay (b) and limestone (c).

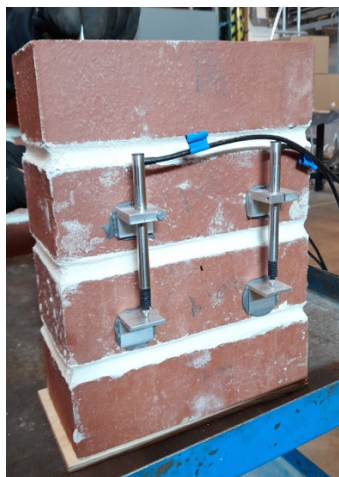
The material properties of masonry units and mortar affect the compressive properties of masonry. A strong unit-to-mortar bond could result in high compressive strength masonry. In the present study, the compressive properties (i.e., compressive strength and elastic modulus) of masonry prisms were determined following the guidelines outlined in the British standard BS EN 1052-1 [70]. Eleven masonry stack bond prisms were constructed and cured under laboratory conditions. Each prism specimen was constructed from four type A dry bricks bonded together with 10 mm thick type O mortar joints. The dimensions of the masonry prism were 102 mm in width, 201 mm in length, and 282 mm in height. During the test, two timber and steel plates with an appropriate thickness were positioned on the top and bottom of the prism to ensure that the compressive stress can be evenly distributed over the bearing area. The compression load was applied at a rate of 0.3 MPa/s under load control. In order to obtain the stress-strain relationship of the masonry prism, the compressive stress applied to the specimen was monitored by a load cell built into the actuator, and the compressive strain was monitored by two LVDTs attached to each of the stretcher faces of the prisms (see Figure 2.9).

Figure 2.9 Compression tests on masonry prisms.

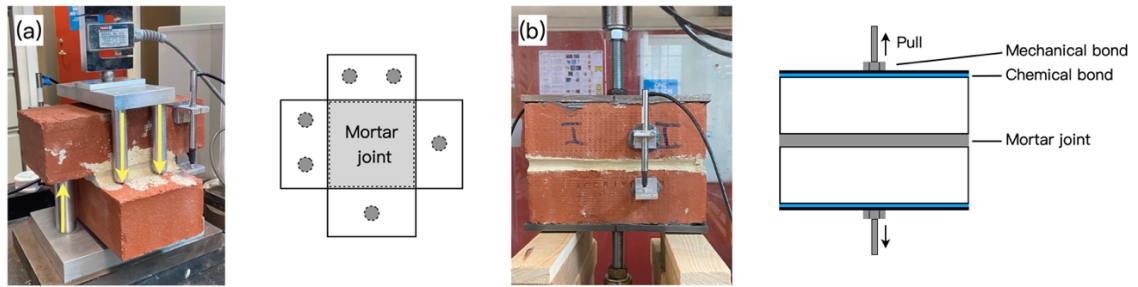
Figure 2.10 Characterisation on the direct tensile bond strength of the unit-to-mortar interface. (a) Cross-couplet tensile test; and (b) full-couplet tensile test.

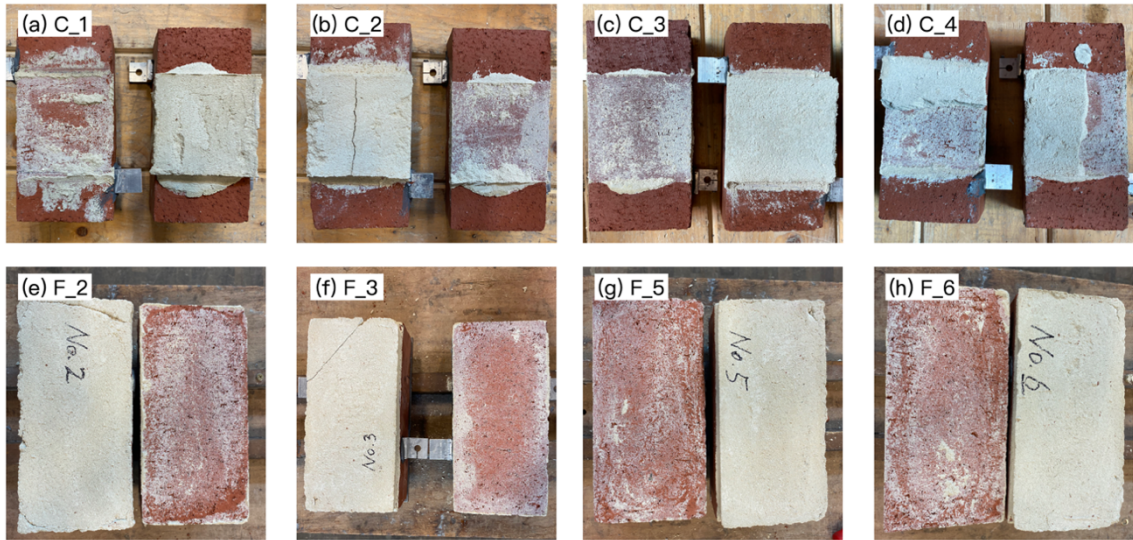
Figure 2.11 Failure modes of brick cross-couplets and full-couplet specimens under tension.

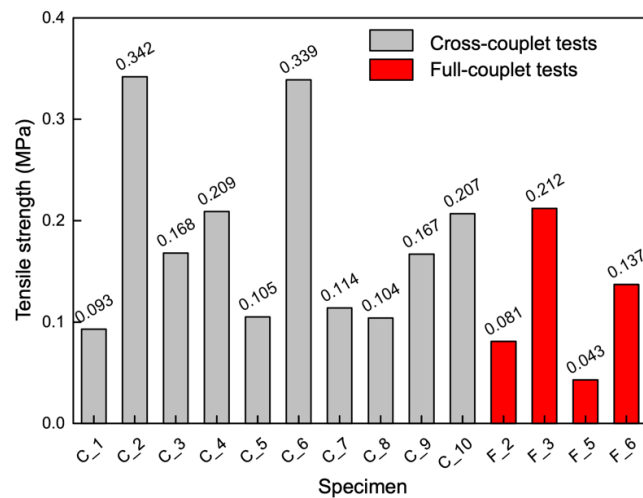
Figure 2.12 Tensile bond strength values.

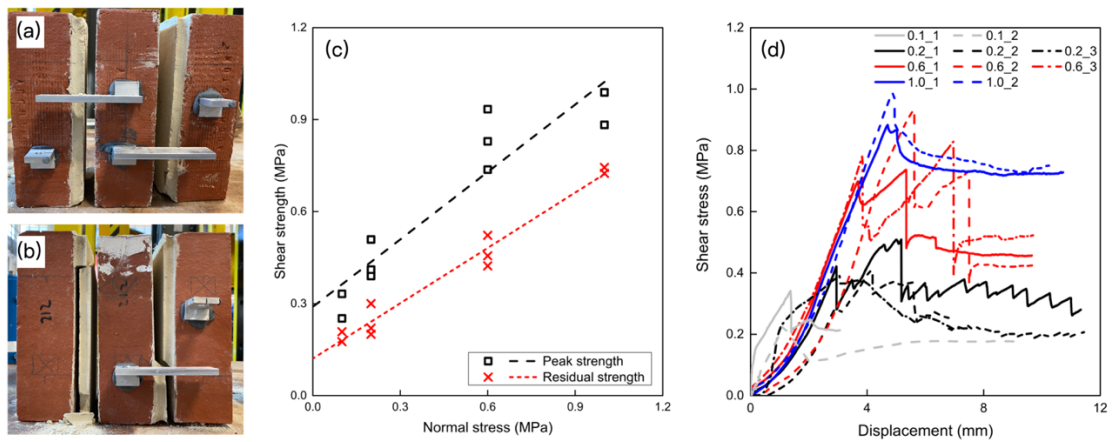
Figure 2.14 Results from masonry triplet shear tests. (a) Failure type 1; (b) failure type 2; (c) relationship between shear strength and pre-compression stress; and (d) shear stress versus vertical displacement curves.

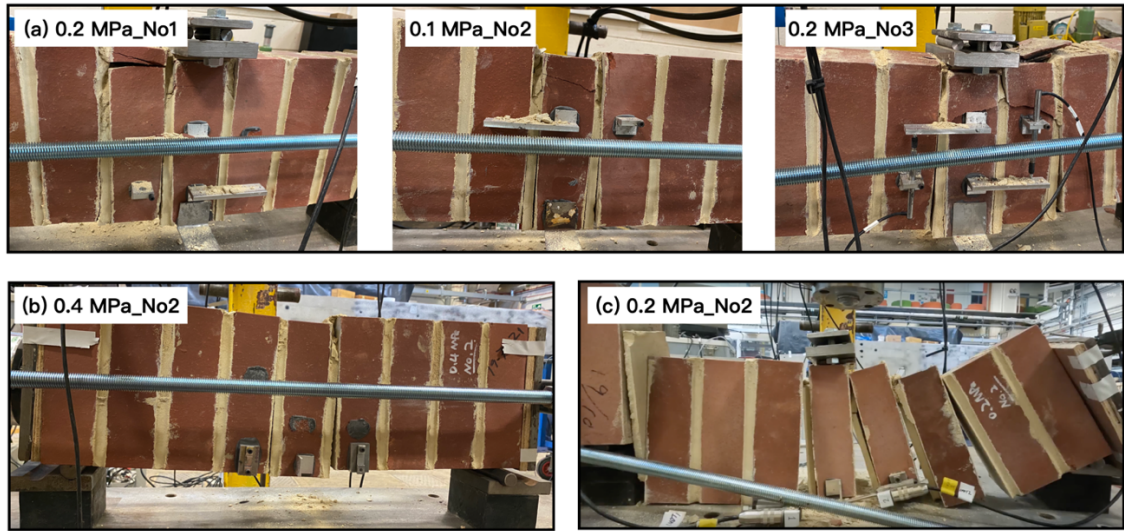
Figure 2.17 Failure modes of masonry flat arches under static loads. (a) Cracking of brick; (b) mortar crushing and shear failure of the specimen; and (c) collapse of the specimen.

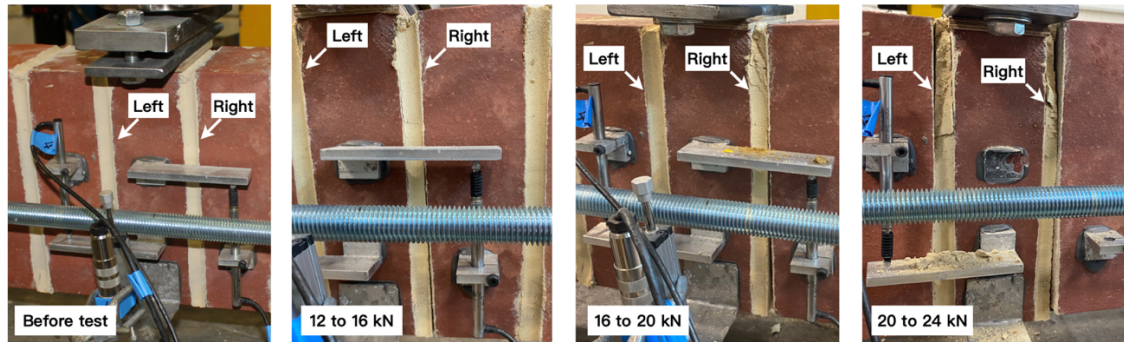
Figure 2.19 Crack propagation in the specimen during the fatigue test.

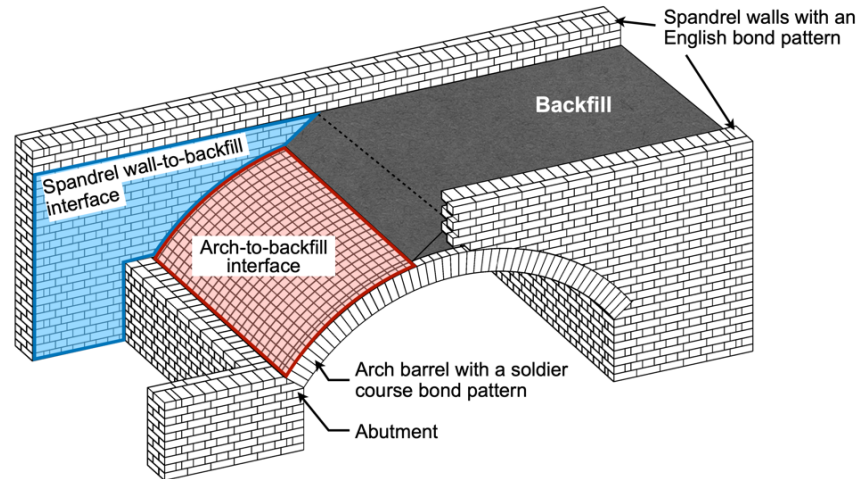
Figure 3.1 Typical brickwork masonry arch bridge showing the spandrel wall-backfill interface and arch-backfill interfaces.

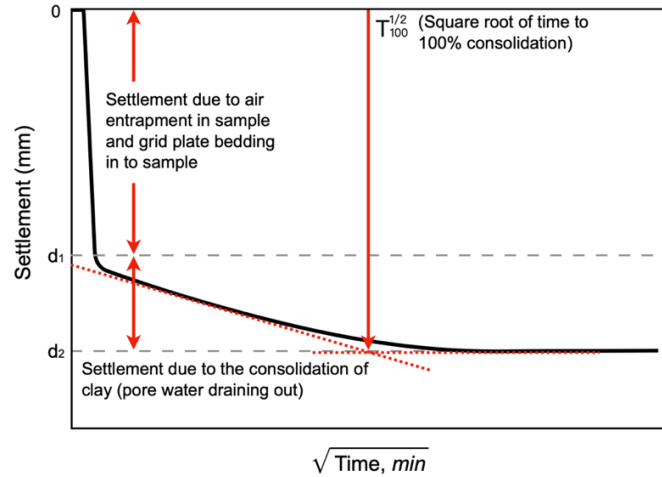
Figure 3.7 Clay consolidation curve under a constant normal stress.

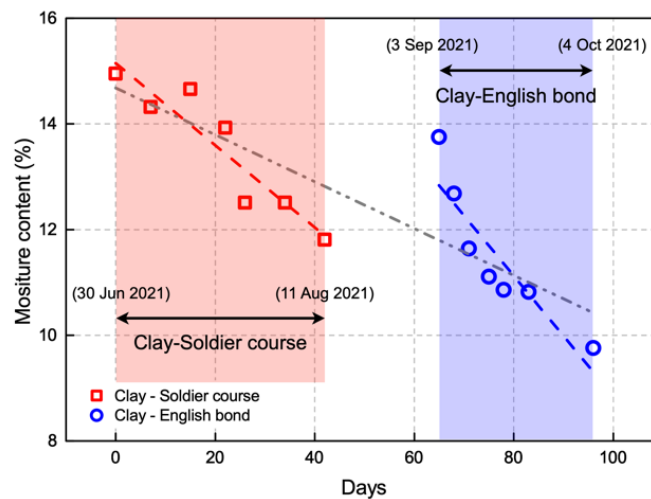
Figure 3.8 Moisture content of clay during the shear tests on masonry-clay interfaces.

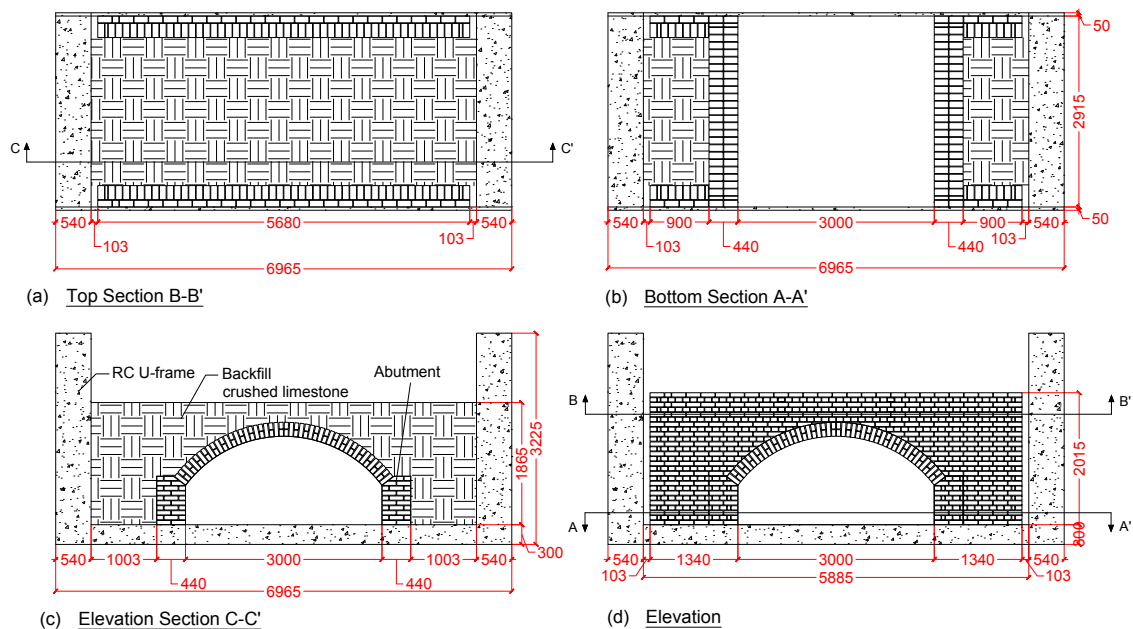
Figure 4.3 Details of the large-scale masonry arch bridge: (a) top view; (b) bottom section A-A'; (c) elevation section C-C'; and (d) elevation (side view) (all dimensions in mm).

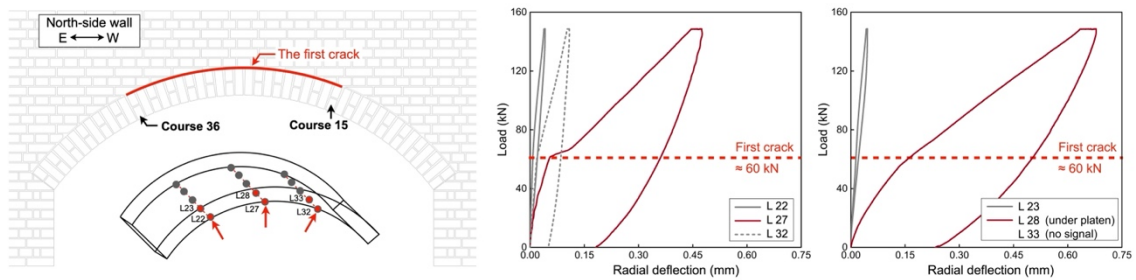
Figure 4.12 The occurrence of the first crack and the corresponding load-deflection curves (T4 at point D).

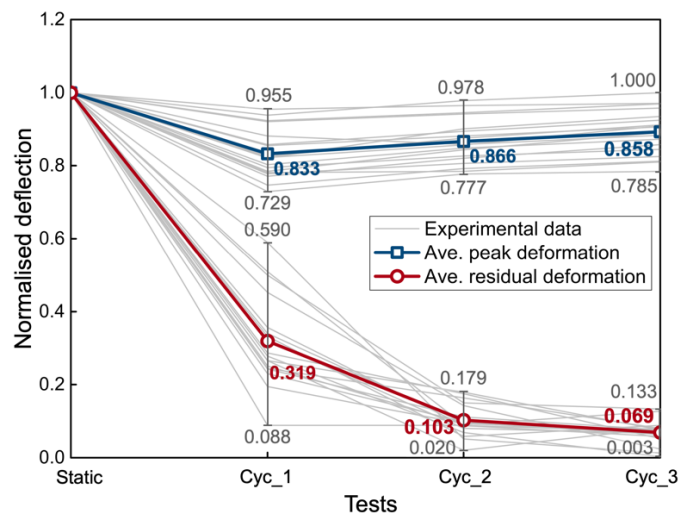
Figure 4.19 Normalized peak and residual deflections of the arch barrel at the location directly under the loading points obtained from the static test and the subsequent three loading cycles.

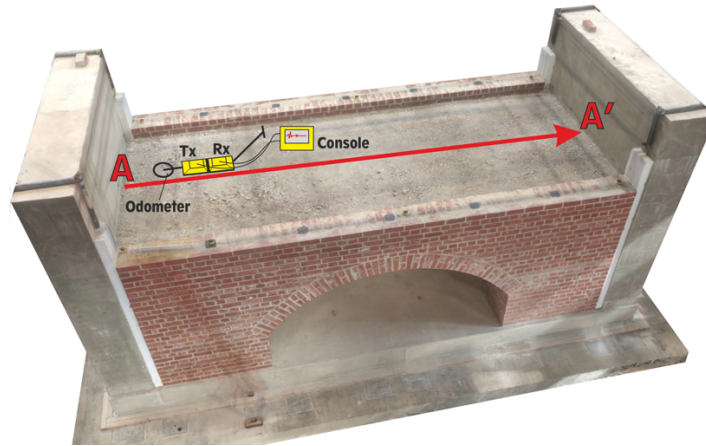
Figure 5.1 Schematic representation of GPR test profile. Sensors&Software equipment is moved along profiles A-A', with 1000 MHz transmitter (Tx) and receiver (Rx) maintained at constant offset in a tow-sled. Data are recorded at a PulseEKKO console, with distances tracked with a calibrated odometer wheel attached to the sled.

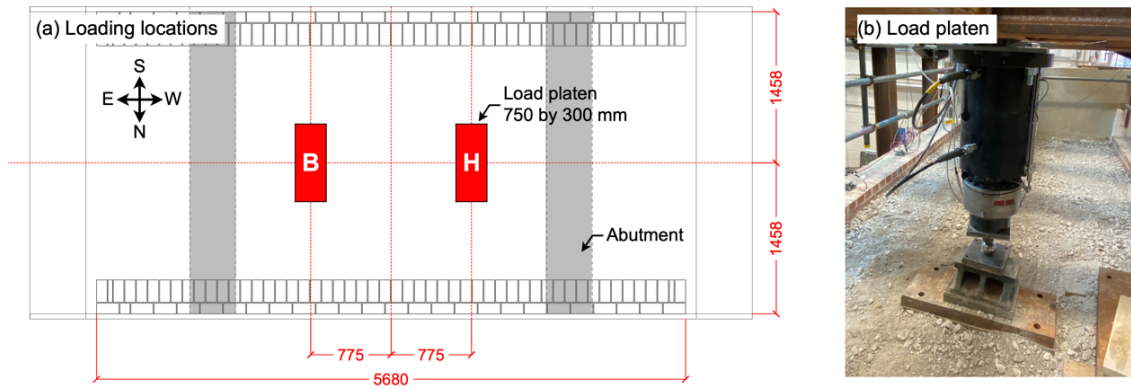
Figure 5.2 Bridge: (a) loading locations; (b) larger load platen used for high- and failure-level load tests (all units in mm).

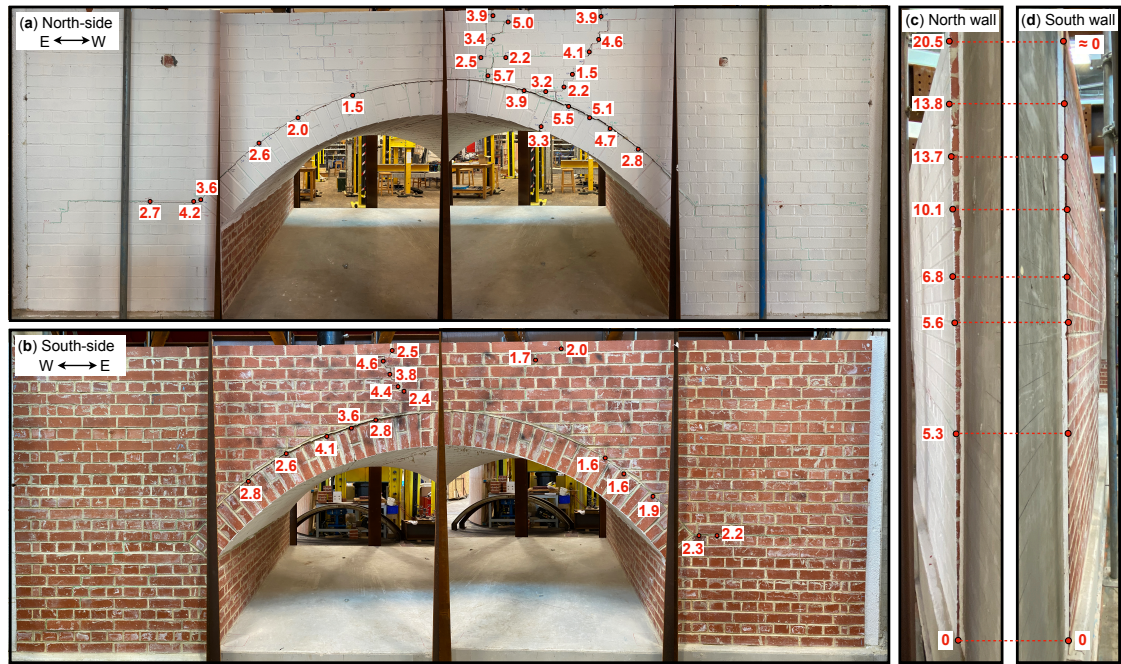
Figure 5.3 Post failure test inspection: (a) width of residual cracks on north-side wall; (b) width of residual cracks on south-side wall; (c) out-of-plane residual deformation of spandrel wall (viewed from the west side) (all units in mm).

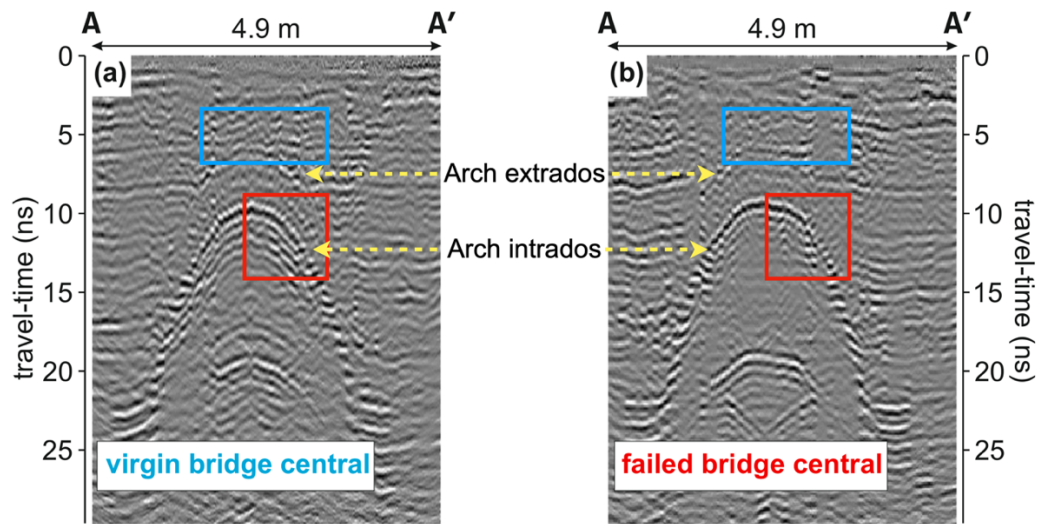
Figure 5.4 Results obtained from GPR testing: (a) longitudinal central profile of the virgin bridge; (b) longitudinal central profile of the bridge after failure.

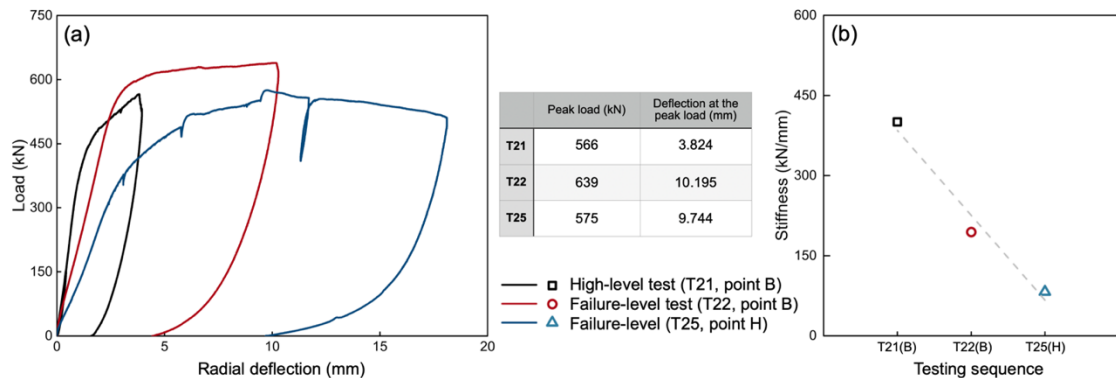
Figure 5.9 Results: (a) load-deflection curve of arch intrados under high- and failure-level tests; (b) stiffness reduction.

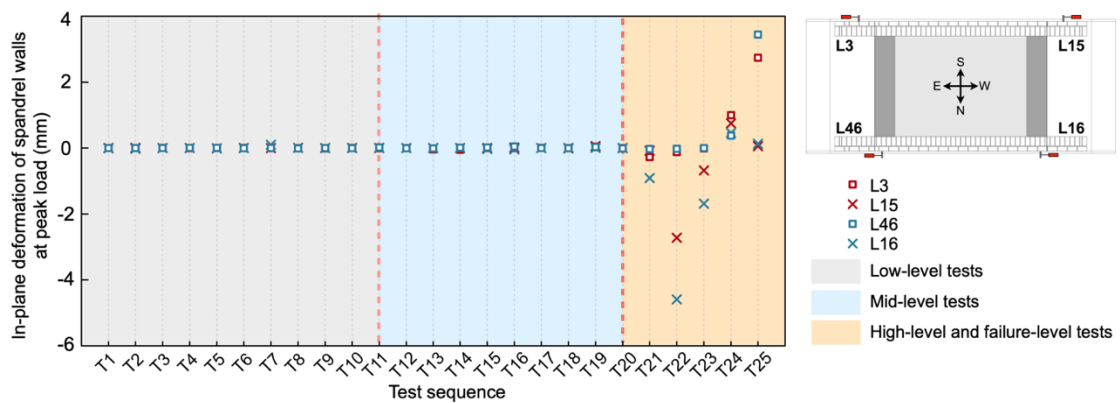
Figure 5.12 Values of in-plane deformation of spandrel walls at the peak load during testing (data obtained from low-level, mid-level, high & failure level tests was respectively highlighted by grey, blue, and yellow windows).

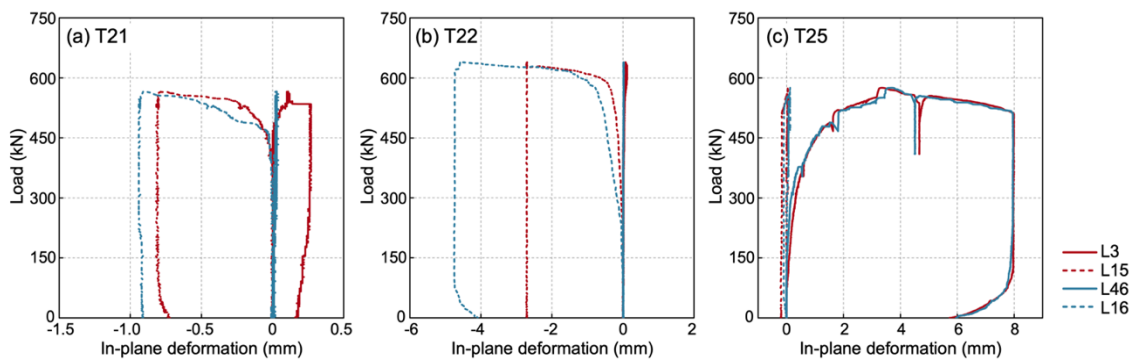
Figure 5.13 Load versus in-plane deformation of the spandrel walls during: (a) T21; (b) T22; (c) T25.

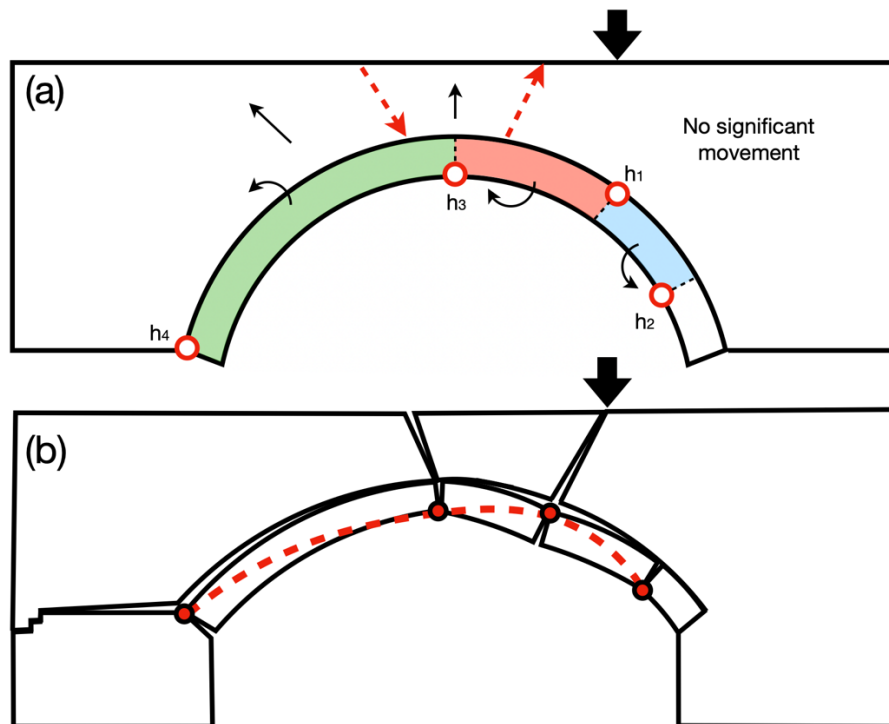
Figure 6.13 (a) Interaction between spandrel wall and the arch barrel in terms of their deformation compatibility; (b) failure mechanism.

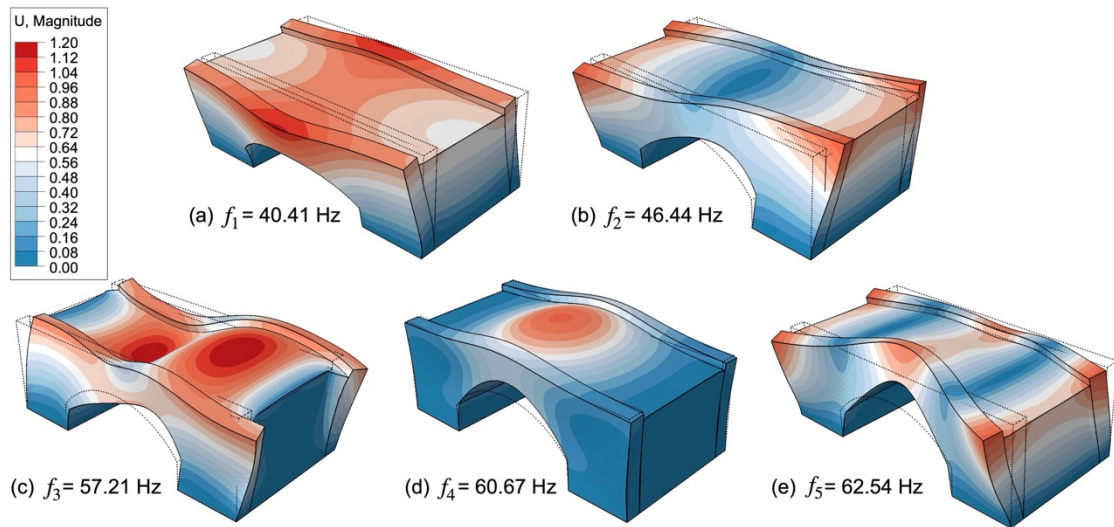
Figure 7.6 Frequencies and mode shapes of the undamaged masonry arch bridge identified from FEM: (a) to (e) show the 1st to the 5th mode, respectively.

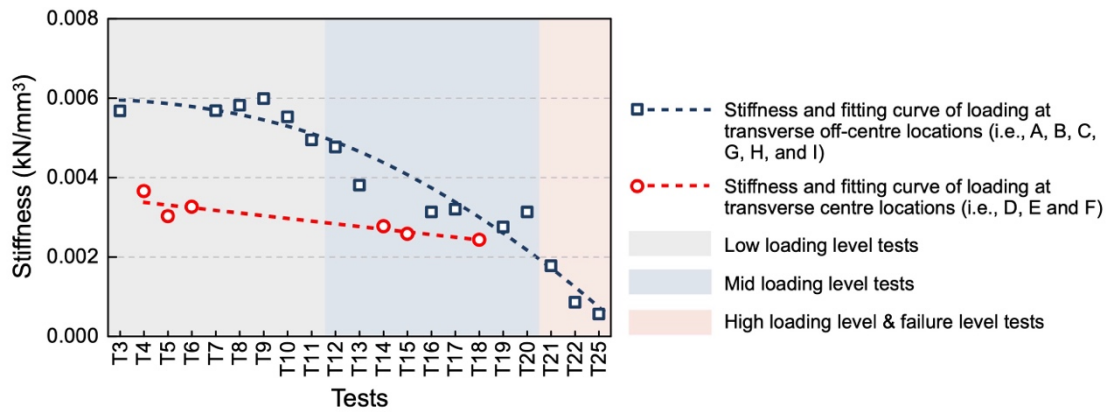
Figure 7.7 Variation in stiffness of the masonry arch bridge along the loading tests (see Figure 7.2 for loading points).

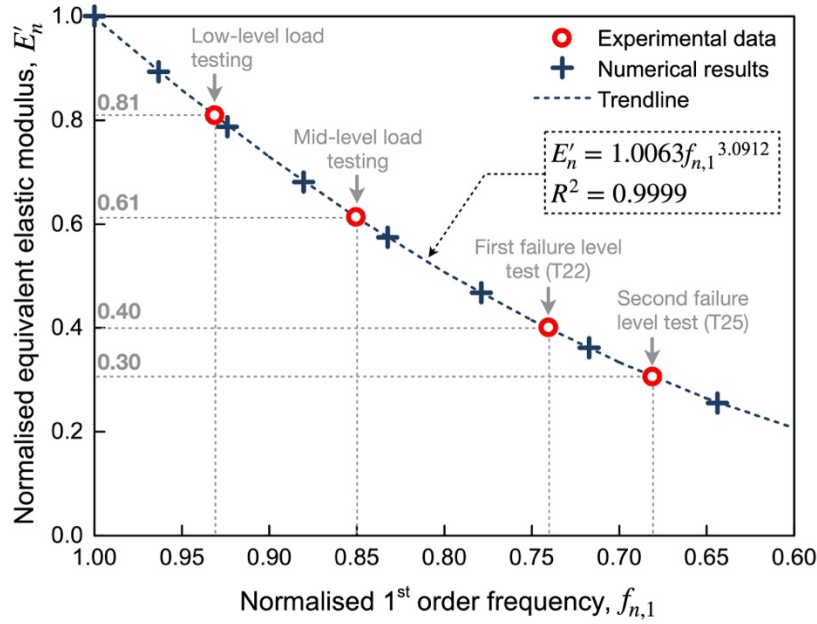
Figure 7.11 Correlation between the normalised equivalent elastic modulus of masonry (E'_n) and the normalised 1st mode frequency ($f_{n,1}$).
