# **The Effect of Corrosion on the Particle Emissions Emitted from Different Brake Rotor Materials**

**By Ishmaeel Ghouri**

**The University of Leeds**

**School of Mechanical Engineering**

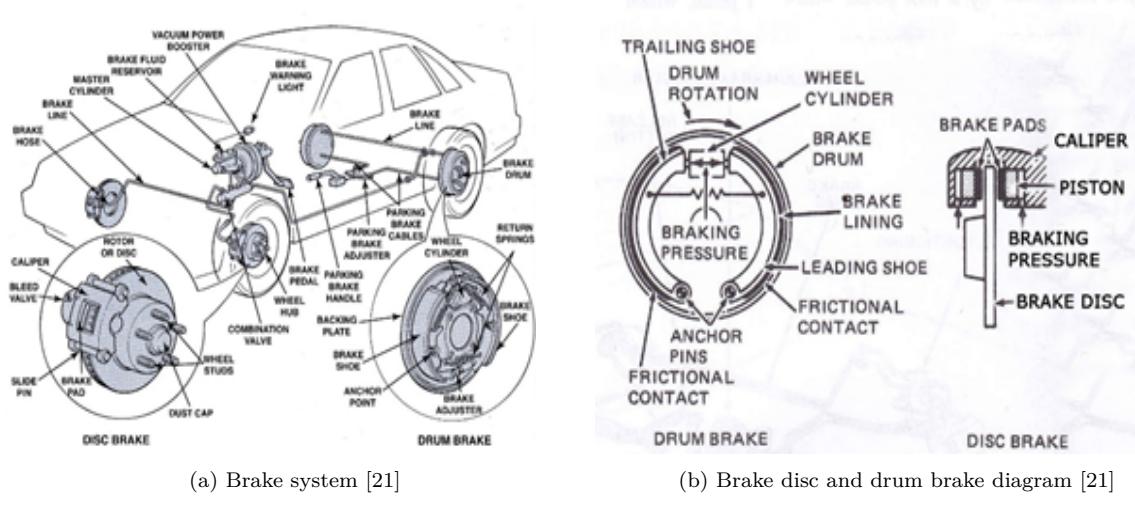
rotating brake disc generates a frictional torque, which is used to slow or stop the vehicle [20]. As shown in Figure 2.1b, the drum brake mechanism uses contact between the brake lining and brake drum rather than between the brake pad and brake disc. Similarly to how the brake pad and disc mechanism work, the brake fluid pushes the brake lining out, resulting in contact between the stationary brake lining and the rotating drum brake, which generates the required frictional torque [21].

Figure 2.1: Brake design

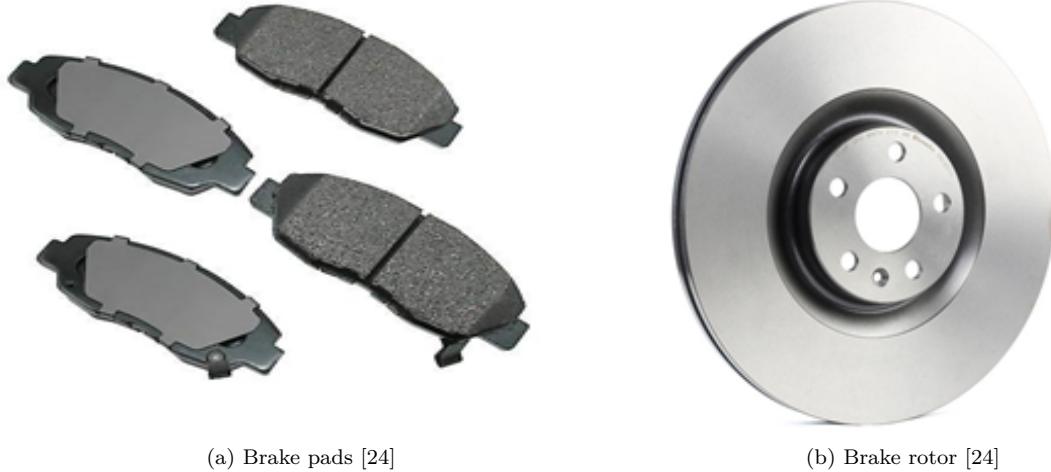
Friction is the resistance to motion during sliding or rolling when one surface moves relative to another surface whilst in contact [22]. The brake pad, Figure 2.2a, is usually made from a steel backing plate with a friction material either bonded or pressed on it [23]. The friction material is what is used to generate friction against the brake rotor, as shown in Figure 2.2b. Therefore, a rough brake pad surface can lead to high levels of friction. However, there is a strong correlation between high levels of friction and high wear rate, which is undesirable [23].

Figure 2.2: Brake friction pair

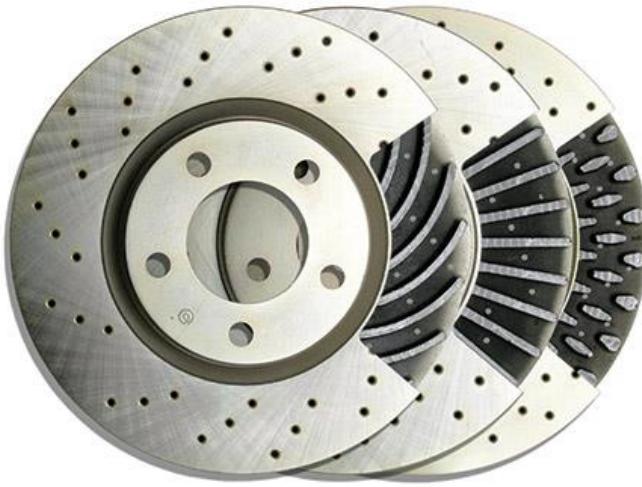
Figure 2.3: Vented disc brake [28]

To increase cooling, vents and vanes are used in a ventilated brake disc, shown in Figure 2.3, to increase surface area, allowing for more airflow to travel through the brake disc compared to a solid brake disc. The extra cooling ability becomes useful, especially when under high load. The geometry and design of the vents in a brake disc can affect the air flow and heat transfer characteristics [27]. Kudal and Chopade. [27] carried out a comparison of a diamond pillar configured vented brake rotor with other arrangements,

namely a straight radial vane, a tapered radial vane and a circular pillar. The diamond pillar rotor gave 26% less mass flow rate than the tapered radial vane, but it performed similarly for heat dissipation. In a comparison with the circular pillar, the diamond pillar dissipated 30% more heat. The reason for the diamond pillar brake rotor having a high heat dissipation despite a low mass flow rate is due to the airflow is more uniform with the diamond pillars, resulting in more symmetrical temperature distribution.

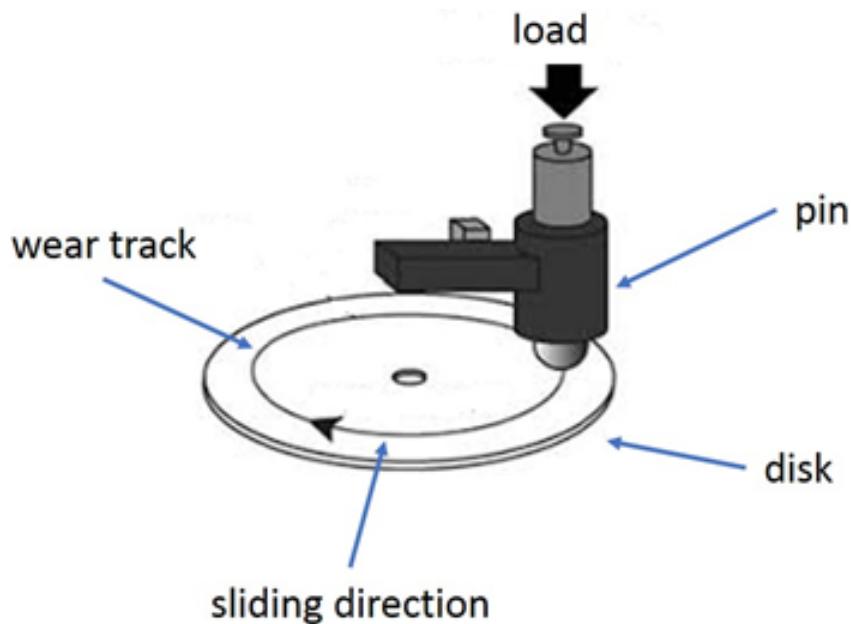
Figure 2.6 below shows an image of a pin-on-disc tribometer. A pin-on-disc tribometer works by the pin being in contact with the surface of a rotating disc. The pin on the tribometer stays stationary, whereas the disc underneath rotates. This rotation and contact between the pin and disc create a sliding motion. Pin-on-disc works similarly to a conventional automotive brake disc system. A load can be applied to the pin to increase or decrease the contact pressure. This is quite like how the brake pressure can be increased or decreased, resulting in an increase or decrease in the braking force. The shape does not necessarily have to be a pin or spherical shape it can be a variety of shapes. The most common shapes are spherical, cylindrical or flat [68].

Figure 2.6: Schematic diagram of pin-on-disc [68]

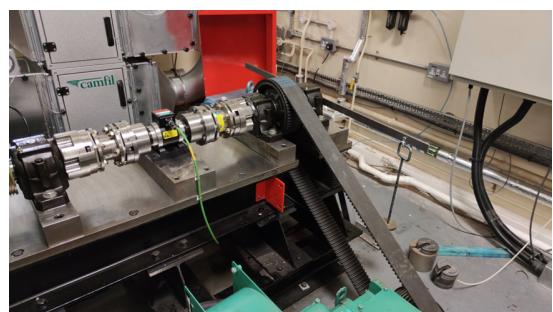
Figure 3.2: UoL brake dynamometer

The UoL brake dynamometer, shown in Figure 3.2a, consists of an inlet duct, an airtight enclosure, an outlet pipe, a Dekati ELPI+, and a 45 kW DC motor (Leroy Somer LSK1604M04 45), capable of turning the brake rotor at speeds up to 1500 rpm. Figure 3.2b provides a side view of the brake dynamometer without the guards, exposing the shaft. As seen in Figure 3.2b, the 45 kW DC motor is connected via a belt to the shaft, which drives the brake disc. Torquemaster TM 23 torque transducer in-line a maximum torque rating of 500 Nm is installed within the shaft to measure the braking torque. The Torquemaster also measures the rotational speed of the shaft.

(b) Side-view of UoL brake dynamometer showing belt drive and torque transducer

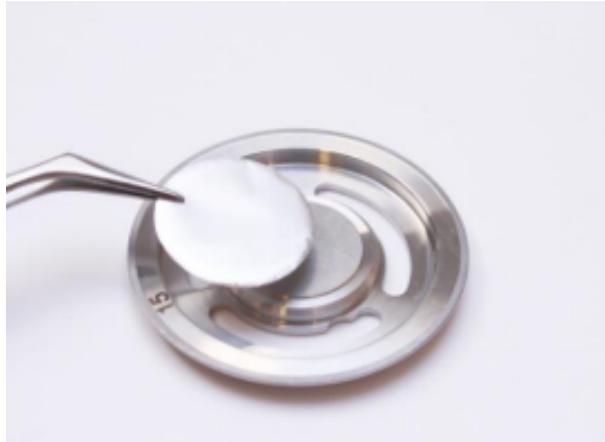
Figure 3.7: Dekati ELPI+ aluminium foil and collection plate [132]

A 25 mm circular hole punch is used to cut collection substrates or foils from household aluminium foil, as shown in Figure 3.7. The Apiezon-L grease is dissolved in toluene solvent to allow for the grease to be spread on the aluminium foils. It is recommended to add the toluene solvent drop by drop to dissolve the Apiezon-L grease until the liquid becomes nearly opaque. Once the Apiezon-L grease has dissolved into an opaque liquid, a clean fine brush is used to spread the grease on the foils. It should be noted that the edges of the foils should be kept clean and free from grease, as this part of the foil will be fixed to the collection plate by the substrate holder ring. Once the foils have been greased, they should be set aside to allow the solvent to evaporate, leaving the grease behind. The preparation and greasing of the foils should be carried out in a fume cupboard with appropriate PPE, as hazardous chemicals are involved.

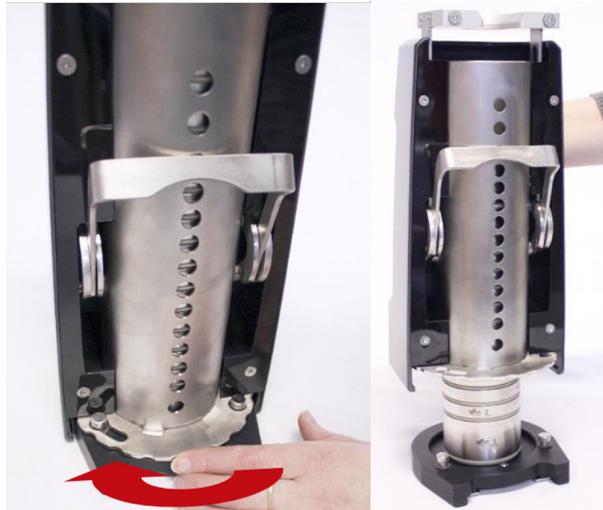
Figure 3.8: Removing the impactor cover [132]

To clean the cascade impactor, it must first be removed from the ELPI+ housing. This involves loosening two impactor tightening screws, disconnecting the zero air pump hose, the charger high voltage, and the trap BNC connectors. The impactor cover, which houses the pre-selector stage containing the corona charger, must also be slid out to expose the cascade impactor. Once the impactor cover is removed, all 15 stages of the cascade impactor are exposed Figure 3.8. Note that stage 15 is only a collection plate. The used foils should then be removed from the impactor collection plates.

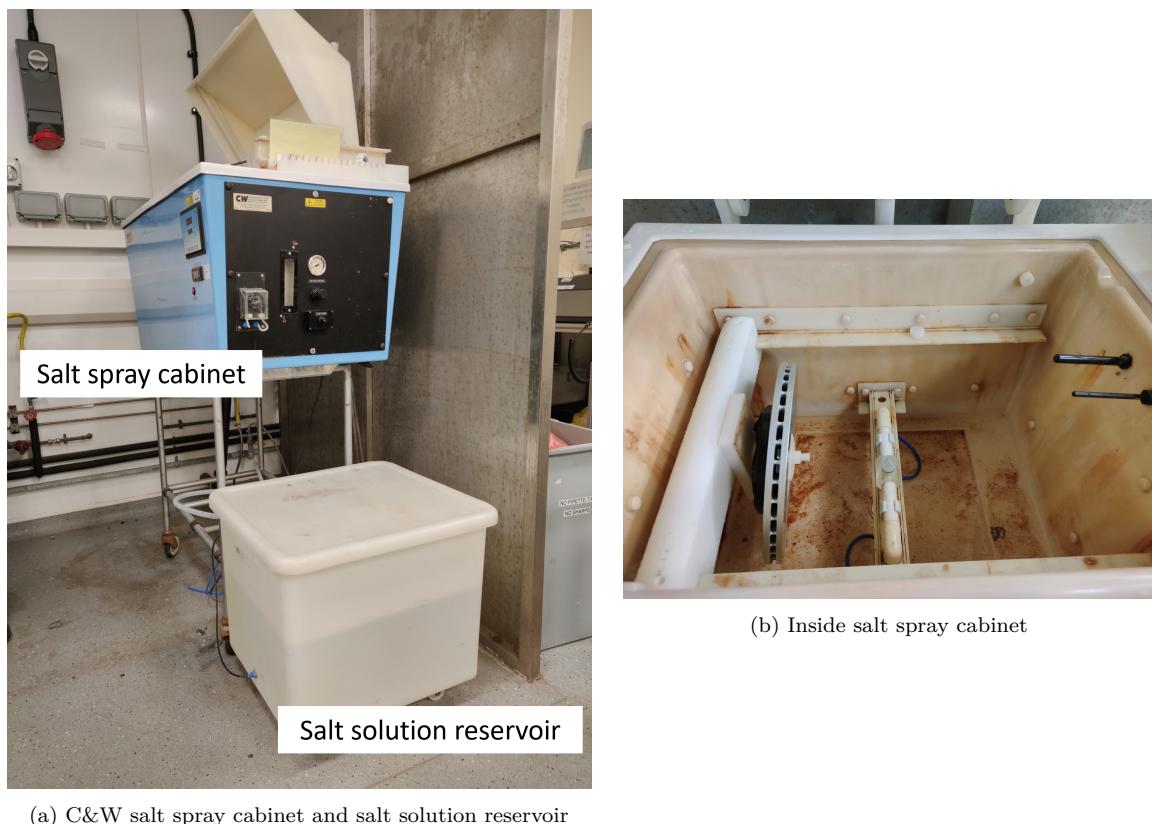
The C&W salt spray cabinet, type SF100, is shown in Figure 3.9. The equipment also contains a 114-litre capacity reservoir, shown in Figure 3.9a, which stores the salt solution. Inside the cabinet, shown in Figure 3.9b is an atomising tower from which the salt solution is sprayed.

Figure 3.9: Salt spray cabinet

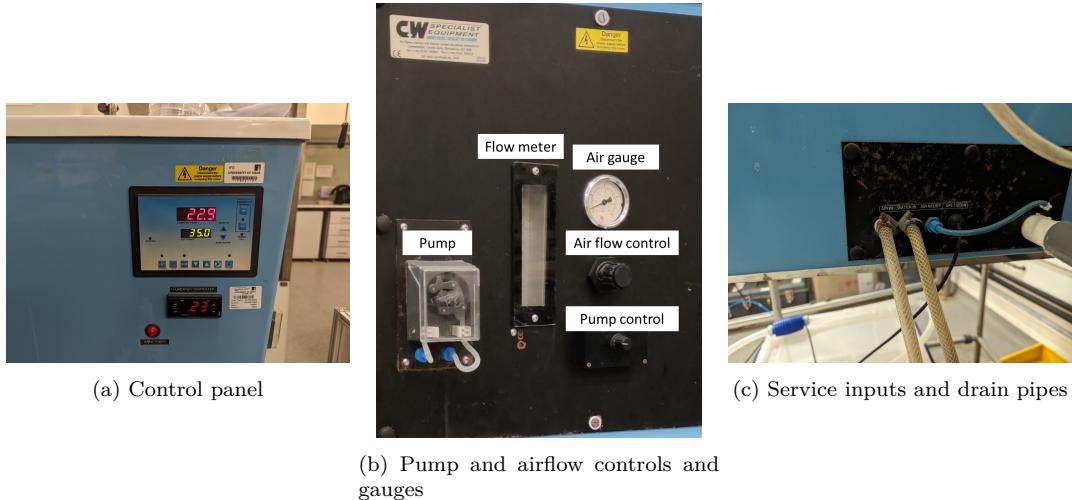
The salt corrosion cabinet is constructed from glass-reinforced plastic in two parts: the outer and inner shells. The blue outer shell, or outer cabinet, houses the control panel, control chassis, humidifier tower, flowmeter, peristaltic pump, pump speed adjuster, and service input panel, as shown in Figure 3.10. The inner cabinet, which sits within the outer cabinet, contains the heater panels.

Figure 3.10: Salt Spray inputs and outputs

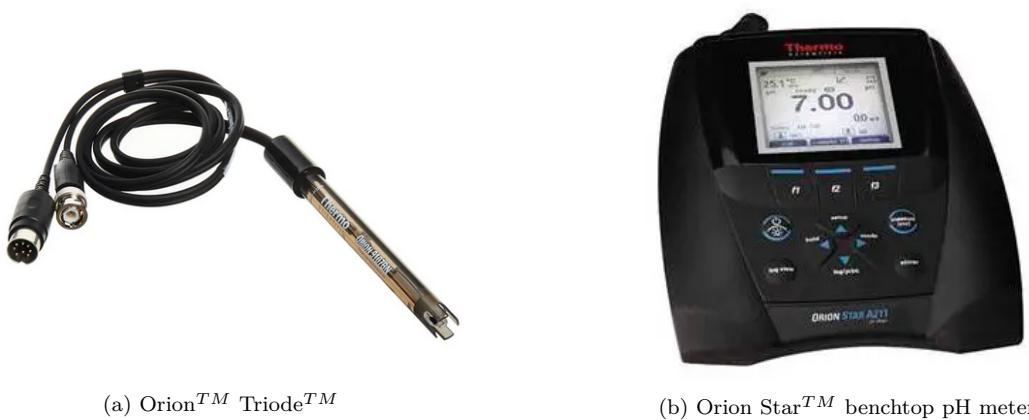
To measure the pH of the solution, the Orion<sup>TM</sup> Triode<sup>TM</sup> 3-in-1 pH probe and Orion Star<sup>TM</sup> benchtop pH meter were used, see Figure 3.11. The Orion<sup>TM</sup> Triode<sup>TM</sup> pH probe is equipped with built-in temperature sensors, enabling pH adjustments based on the solution's temperature to ensure more accurate readings.

Figure 3.11: pH probe and meter

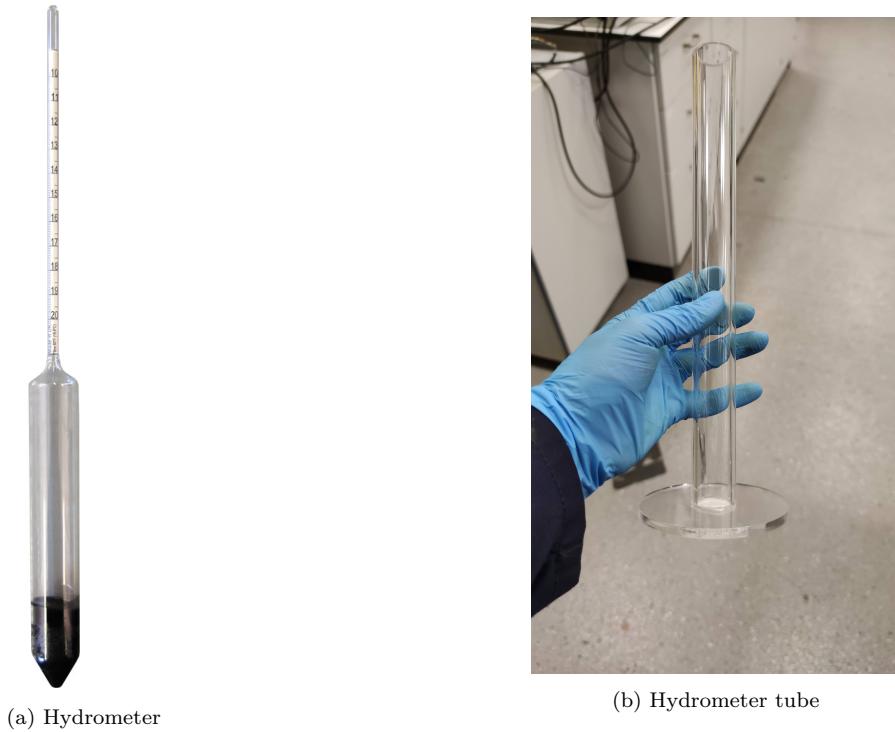
Figure 3.12: Measurement devices for density of salt solution

The density of the salt solution before and after atomization was measured using a hydrometer (Figure 3.12a). One challenge encountered was finding suitable labware compatible with the small volume of collected solution and the length of the hydrometer. To address this issue, custom-made labware (Figure 3.12b) was created.

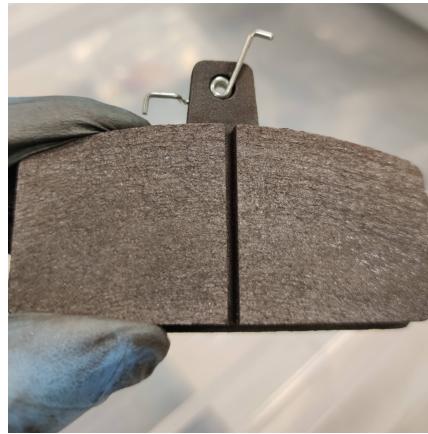
Figure 3.13: Brake pad and rotor used in the GCI study

The available brake calliper used in this project was the prototype brake calliper shown in Figure 3.1. This calliper was designed to house Lancia Delta brake pads, which means the friction material or brake pad is from Lancia Delta. Similar to the GCI rotor, the brake pads are off-the-shelf products. The brake pads, shown in Figure 3.13b, were

(b) MACPO Lancia Delta brake pad

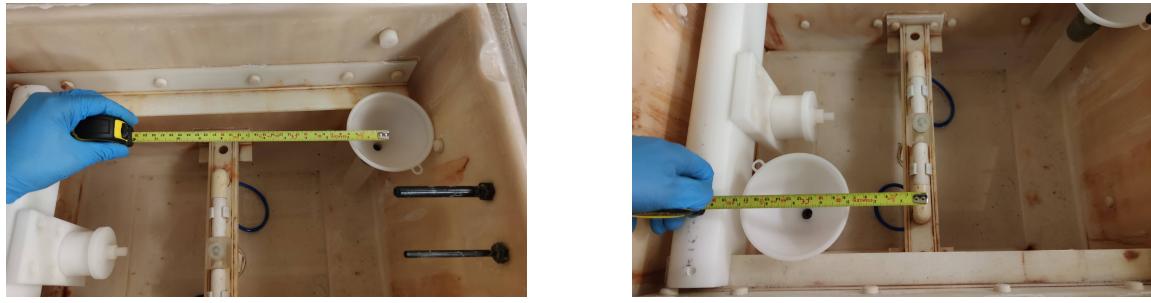
According to ASTM B117, the salt solution in the salt spray chamber must be maintained at a temperature of  $35^\circ\text{C} \pm 2^\circ\text{C}$ . The humidity inside the chamber should be kept at  $95\% \pm 5\%$ , with a spray or collection rate ranging from 1 to 2 mL per hour. Measurement of the collection rate is done using a measuring cylinder attached to a funnel via a rubber bung or stopper. Two such collection devices were positioned inside the salt spray chamber, see Figure 3.17. These devices not only measure the collection rate but also collect the atomized salt solution.

(a) Collection device 1

(b) Collection device 2

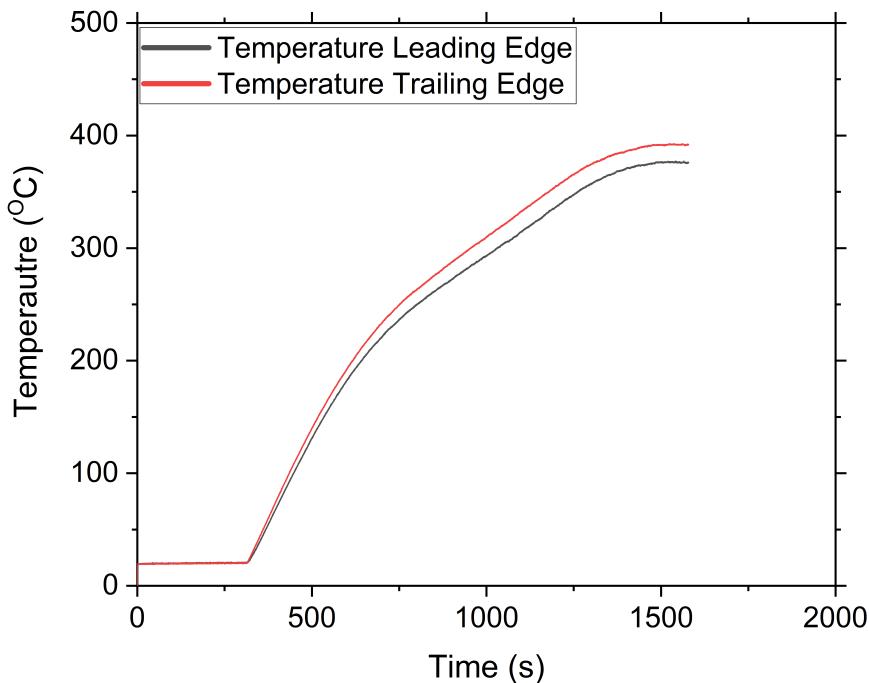
Figure 3.18 illustrates the rubbing thermocouple results from the 15 bar test at 150 rpm. The test was abruptly stopped after 1500 s due to the surface temperature reaching over  $400^{\circ}\text{C}$ . Disc temperatures above  $400^{\circ}\text{C}$  are undesirable, as this goes against the project's objectives of investigating normal (rather than extreme) braking conditions and may be too harsh on the friction couple. Notably, severe degradation of the brake pads was observed after this 15 bar test. Upon inspection, the pads had become denatured or charred [26], [133]. In light of this, the 10 bar brake line pressure was adopted as the highest pressure for all subsequent tests, replacing the previous 15 bar test. However, it was decided to add an intermediate pressure test of 7.5 bar to the test matrix to give the standard test protocol shown in Figure 3.19.

Figure 3.18: Disc surface temperature vs. Time of GCI brake test of 15 bar at 150 rpm

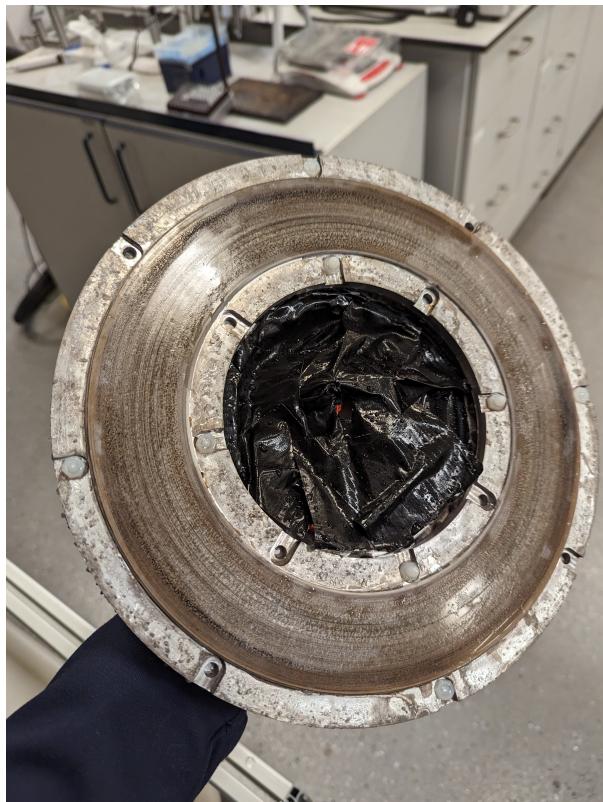
rotor's runout when reattached to the shaft. Additionally, steel screws securing the three-piece rotor assembly were replaced with nylon screws, see Figure 3.20, to prevent corrosion contamination from metallic components.

Figure 3.20: Three-piece rotor with nylon screws and tape for corrosion cabinet

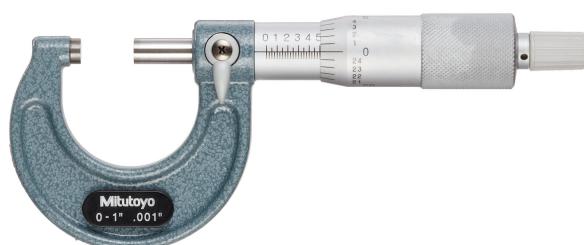
Figure 3.21: Pad wear measurements

In between each test, both mass and thickness loss of the pad material were measured following SAE J2986 standards [138]. The standard specifies using a micrometer with a resolution of 0.01 mm, featuring flat surfaces on both sides contacting the brake pad and equipped with a ratchet mechanism, see Figure 3.21a. Measurements were taken at eight positions starting from the outer diameter top leading edge and proceeding clockwise, with position eight at the inner diameter leading edge. Figure 3.21b illustrates these eight measurement positions on the brake pad. Each measurement position should be at approximately dimension "a" = 5 mm from the edge of the brake pad surface. It should be noted that it was difficult to measure wear on the brake rotor, it was decided that the dimensional wear measurement was excluded.

(a) micrometer

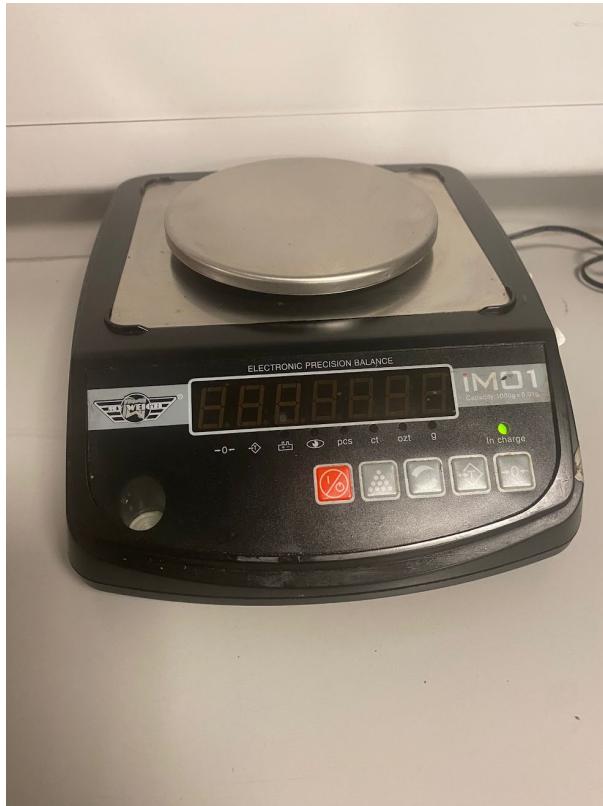
Figure 3.22: My Weigh Precision Balance used to weigh brake pad

For gravimetric measurements, a weighing scale with an accuracy of  $\leq 0.1$  g should be used. The My Weigh Precision Balance, shown in Figure 3.22, has an accuracy of 0.01 g and was employed for the gravimetric measurements of the brake pads.

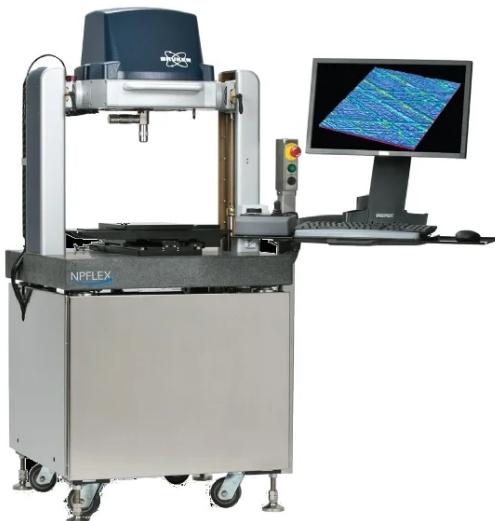
Figure 3.23: Bruker NpFlex

After the 3 tests at the same brake pressure, post-test analysis of the rotors was conducted. Due to the size and weight constraints of the brake rotor, only a limited number of machines and techniques could be employed. Therefore, Bruker NpFlex (see Figure 3.23) was chosen for 3D surface measurements using white light interferometry (WLI) technology. The Bruker NpFlex is sufficiently flexible to accommodate the size and weight of the brake rotor.

Following the last brake test at low, medium, and high brake line pressures, under both uncorroded and corroded conditions, 3D scans were performed using the Bruker Npflex to monitor and assess wear, pits, crevices, and surface roughness on the brake rotor surface.

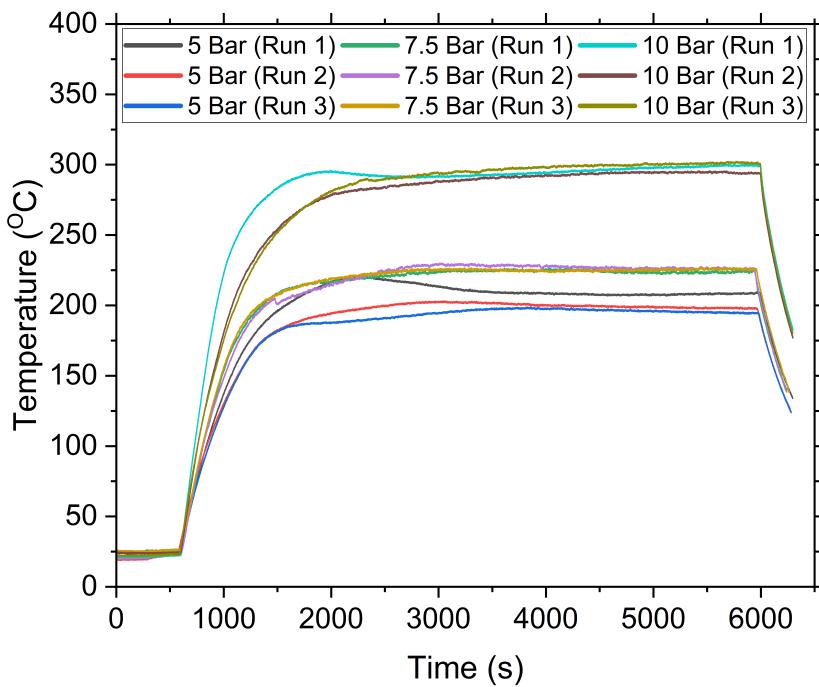
brake pressures at approximately 2000 seconds after the start of the test. The results also show the expected trend: as brake pressure increases, so does the steady-state disc surface temperature. Specifically, 5 bar produced a steady-state disc temperature of around 200°C, 7.5 bar produced approximately 225°C, and 10 bar resulted in a steady-state temperature near 300°C. Overall, the results indicate good repeatability between runs and clear differentiation between the brake pressures.

Figure 4.2: Surface temperature vs. Time for 5, 7.5 and 10 bar brake pressure for the uncorroded test

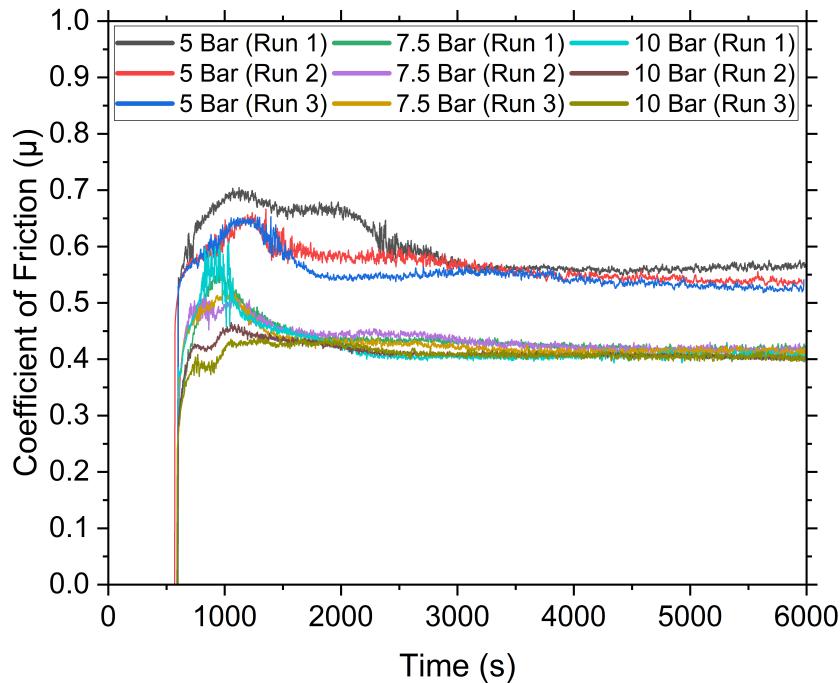
As brake pressure is increased, the steady-state CoF decreases, with 5 bar producing the highest CoF and 10 bar the lowest. This reduction in CoF could be due to the brake not yet fully bedded in for the 5 bar tests. As the protective coating can be seen along with the machine marks from the manufacturer, shown in Figure 4.1, which could be an indication of incomplete bedding-in. This produced a higher than expected CoF due to a not fully developed transfer layer.

Figure 4.3: CoF vs. Time for 5, 7.5 and 10 bar brake pressure for the uncorroded test

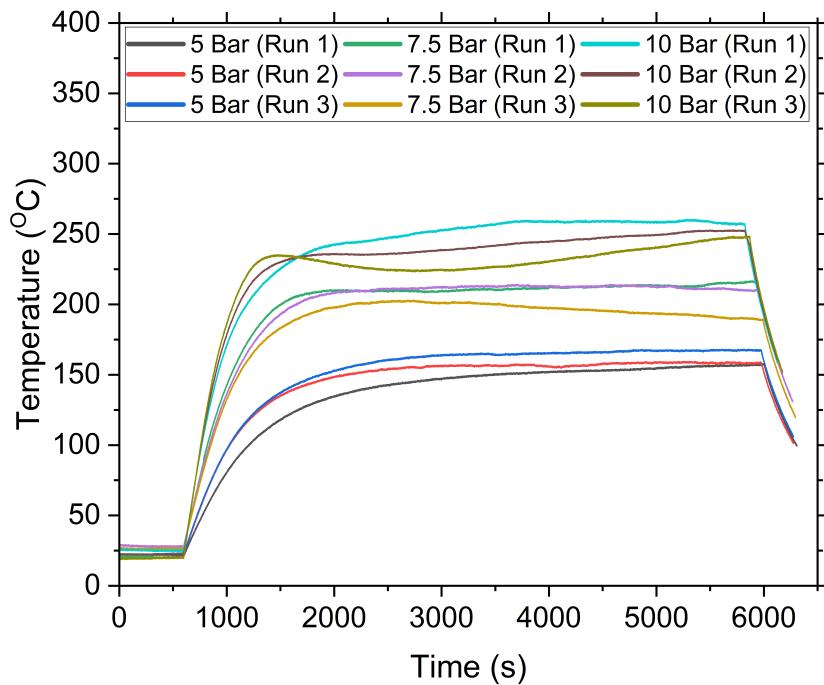
Figure 4.5 shows that by 2000 seconds into the test, the surface temperature of the corroded rotor for all three brake pressures has stabilised, reaching a near steady-state condition for each test. As before the surface temperature increased proportionally with increasing brake pressure. At 5 bar, the temperature stabilised at around 150°C, at 7.5 bar at around 200°C, and 10 bar, the highest temperature measured was approximately 250°C.

Figure 4.5: Surface temperature vs. Time for 5, 7.5 and 10 bar brake pressure for the corroded test

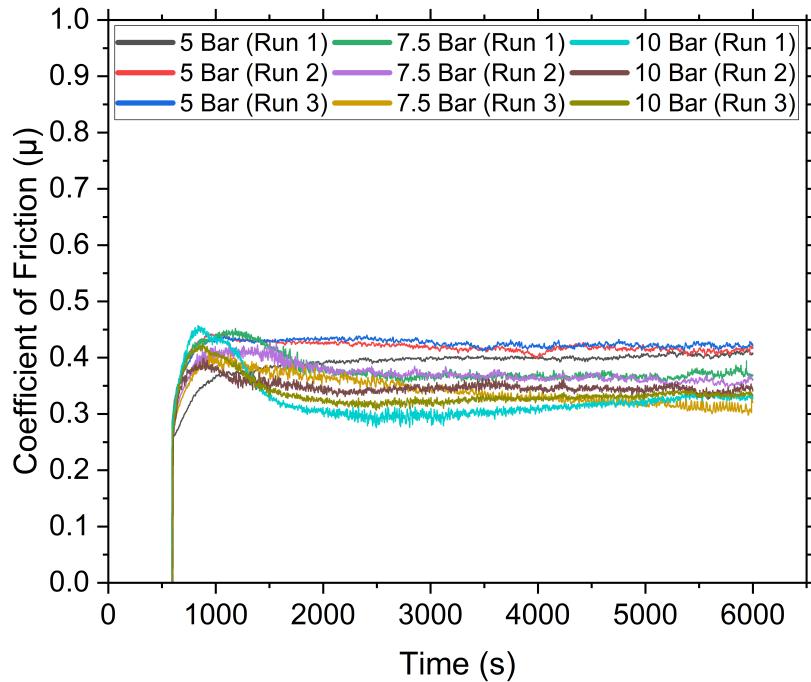
Figure 4.6 presents the CoF results from the corroded GCI rotor for all test runs at each brake line pressure. The lowest pressure of 5 bar produced the highest CoF, followed by the CoF at 7.5 bar, which closely aligned with the CoF values at the highest pressure of 10 bar. Near steady-state friction conditions were achieved for all brake pressures after 2000 seconds. The measured CoF values for the corroded GCI rotor ranged between 0.3 and 0.45.

Figure 4.6: CoF vs. Time for 5, 7.5 and 10 bar brake pressure for the corroded test

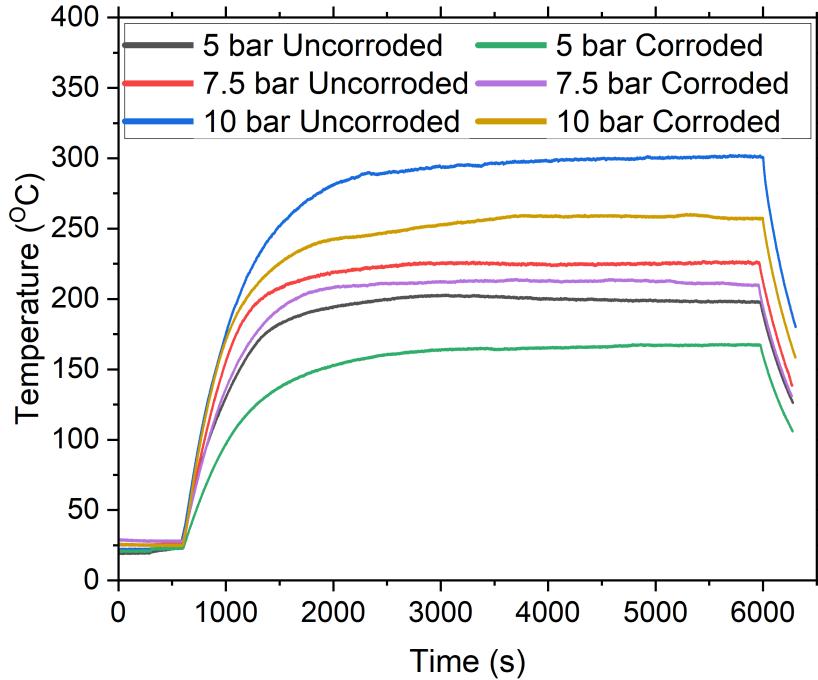
Figure 4.7 illustrates the surface temperature of the uncorroded and corroded GCI brake rotors. The uncorroded rotor displayed a steady-state temperature range between 200°C and just over 300°C, while the corroded rotor exhibited lower steady-state temperatures, ranging between 150°C and 250°C. This may be because the corrosion products remaining on the surface of the corroded rotor produced a greater thermal barrier effect, but also because the CoF (and hence the braking power) was lower than for the uncorroded rotor

Figure 4.7: Uncorroded and corroded rotor Surface temperature vs. Time at 5, 7.5 and 10 bar brake line pressure

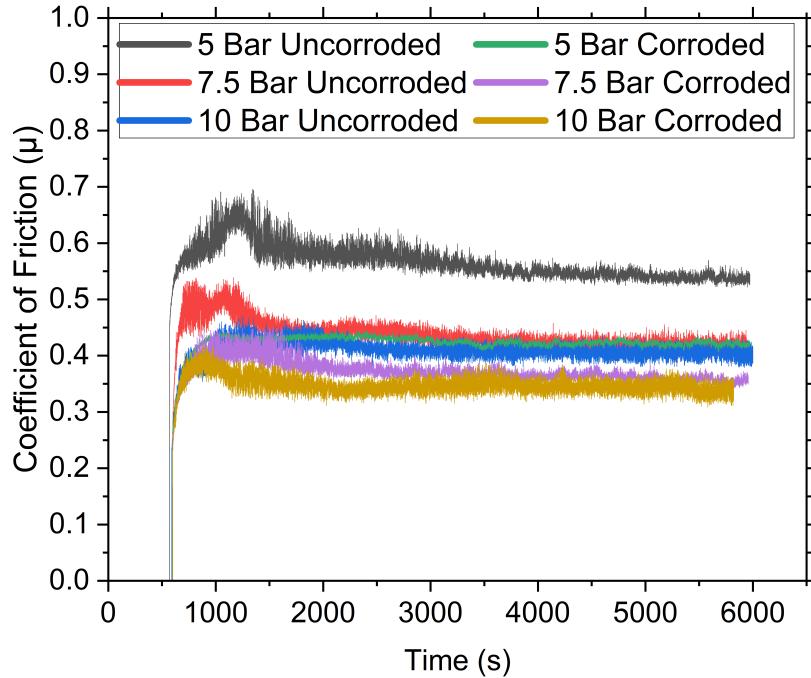
Figure 4.8 compares CoF versus time for both the uncorroded and corroded rotors. It is evident that the corroded rotor did indeed achieve lower steady-state CoF values compared to the uncorroded rotor. Notably, at 5 bar, the corroded rotor exhibited a steady-state CoF of 0.43, whereas the uncorroded rotor produced a steady-state CoF of approximately 0.55. For the 7.5 and 10 bar conditions, similar (although not quite so dramatic) reductions in the steady-state CoF values were seen at pressures of 7.5 and 10 bar.

Figure 4.8: Uncorroded and corroded rotor CoF vs. Time at 5, 7.5 and 10 bar brake line pressure

The surface topography of the corroded brake rotor was examined after the bedding-in procedure, similar to the uncorroded rotor. Figure 4.13 presents the 2D topographic map of the corroded rotor. The image reveals small cavities and pits on the corroded surface, and the uneven topography suggests a reduced real area of contact with the brake pad. This reduced contact area could explain the lower CoF values observed for the corroded rotor, as shown in Figure 4.8, compared to the uncorroded rotor.

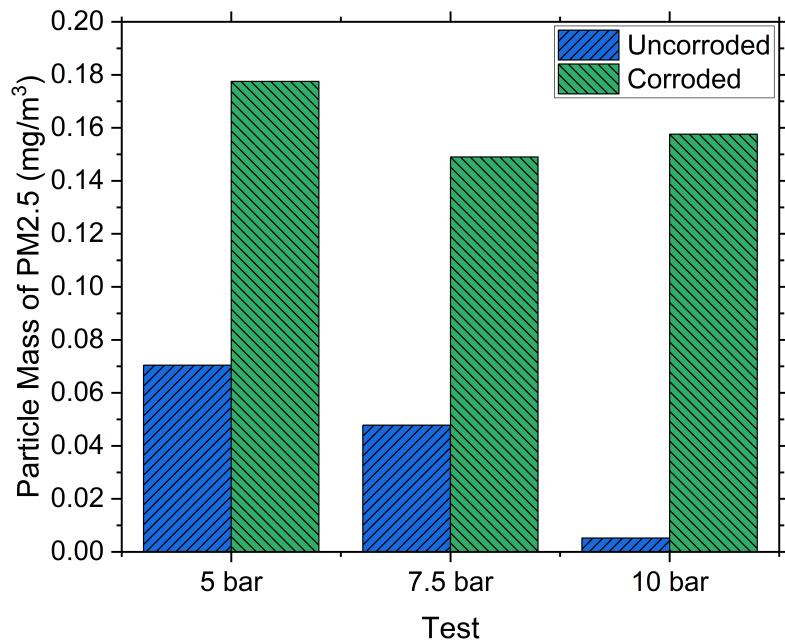
particle mass in the uncorroded tests, followed by 7.5 bar and then 10 bar, which produced a very small amount. Conversely, 10 bar resulted in the highest PM10 particle mass for the corroded disc, followed by 7.5 bar and 5 bar, which had the lowest PM10 particle mass. It is worth noting that, compared with the uncorroded rotor, the differences in both PM2.5 and PM10 particle mass for the corroded disc across the three brake pressures were relatively minor. In contrast, the particle mass emissions for the uncorroded disc decreased significantly with increasing pressure, despite the fact that the braking power is directly proportional to the applied pressure in these constant rotational speed tests, assuming near constant CoF.

Figure 4.9: PM2.5 particle mass of uncorroded and corroded brake rotor at 5, 7.5 and 10 bar

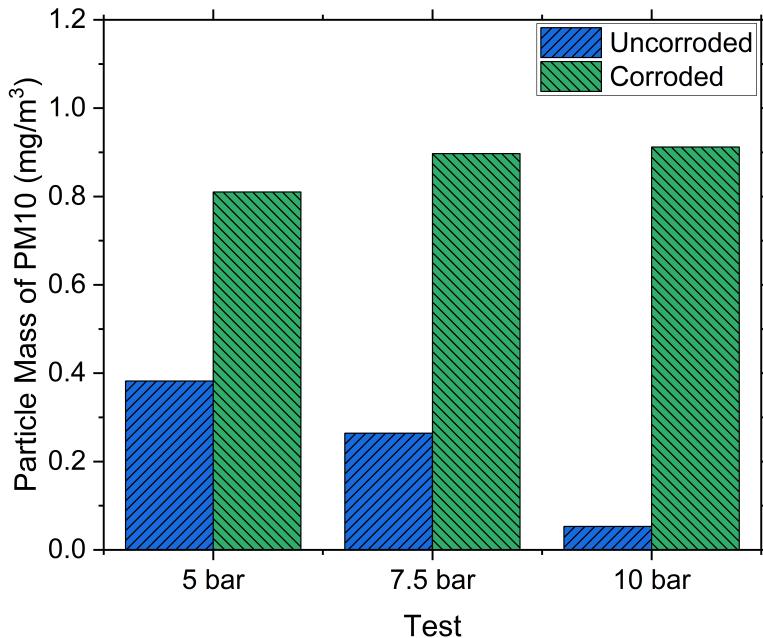
Figure 4.10: PM10 particle mass of uncorroded and corroded brake rotor at 5, 7.5 and 10 bar

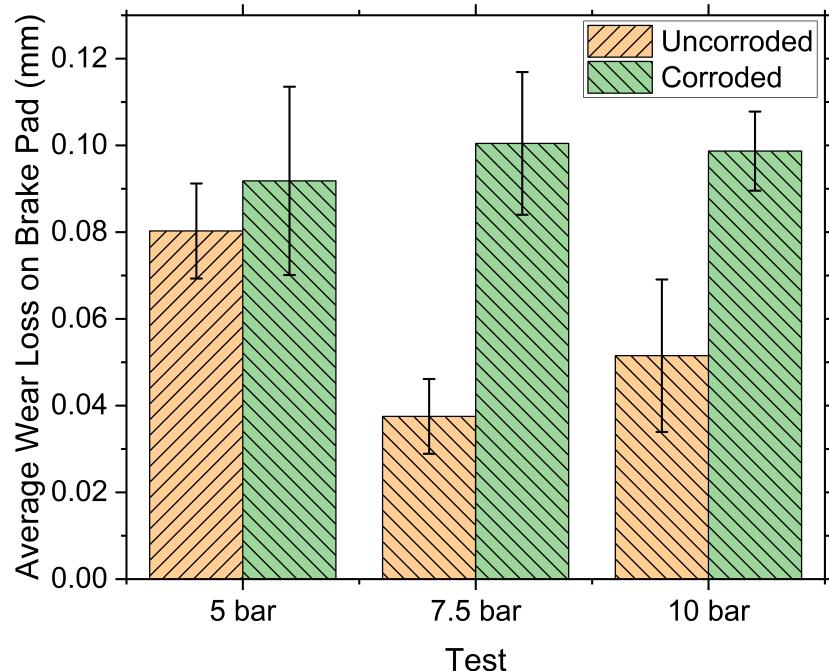
likely not statistically significant, unlike the clear distinctions observed in the uncorroded tests. The consistently higher pad wear in the corroded tests may be more influenced by the rough and uneven surface of the corroded rotor apparent in Figure 4.13 rather than variations in CoF and brake temperature.

Figure 4.11: Dimensional wear of brake pads at 5, 7.5 and 10 bar brake line pressure for uncorroded and corroded rotor

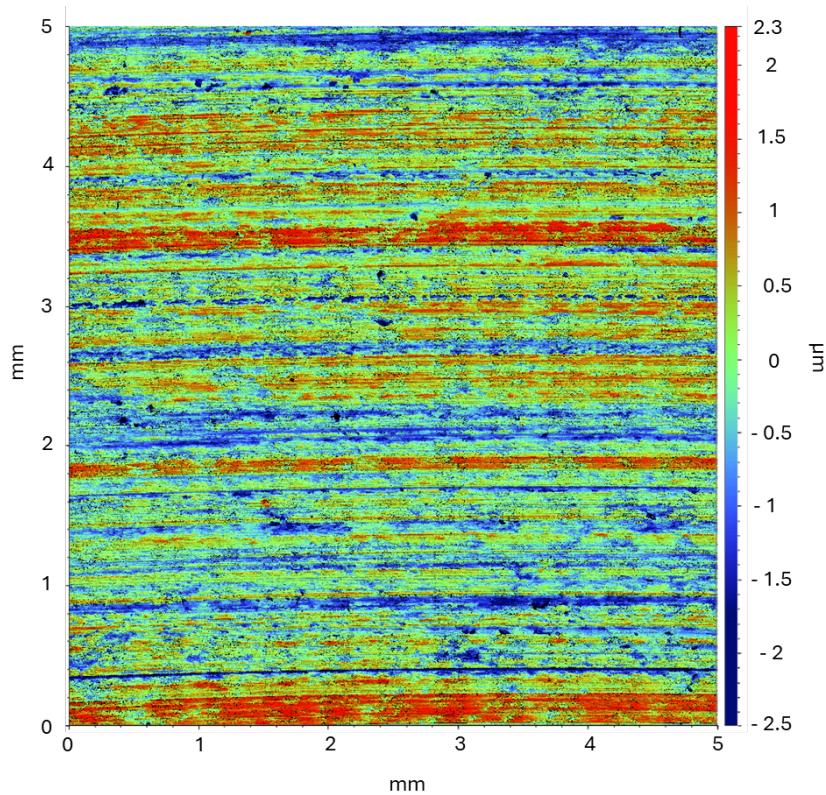
Figure 4.12 displays the 2D topographic map of the uncorroded GCI brake rotor at the end of the uncorroded brake test procedure. The bottom of the scan image it reveals residual machining marks from the manufacturing process. The surface of the rotor appears relatively flat with high and low spots of  $\pm 2.5 \mu\text{m}$ , facilitating a large and uniform contact area between the brake pad and the rotor.

Figure 4.12: Surface topography of uncorroded GCI rotor after the drag brake test procedure

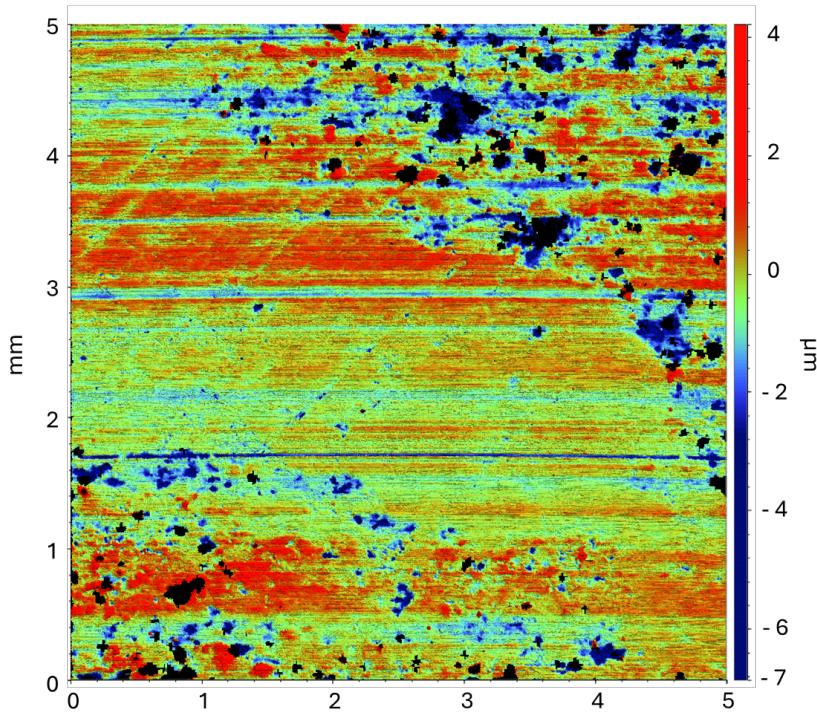
Figure 4.13: Surface topography of corroded GCI rotor after the salt spray treatment and brake bedding-in procedure

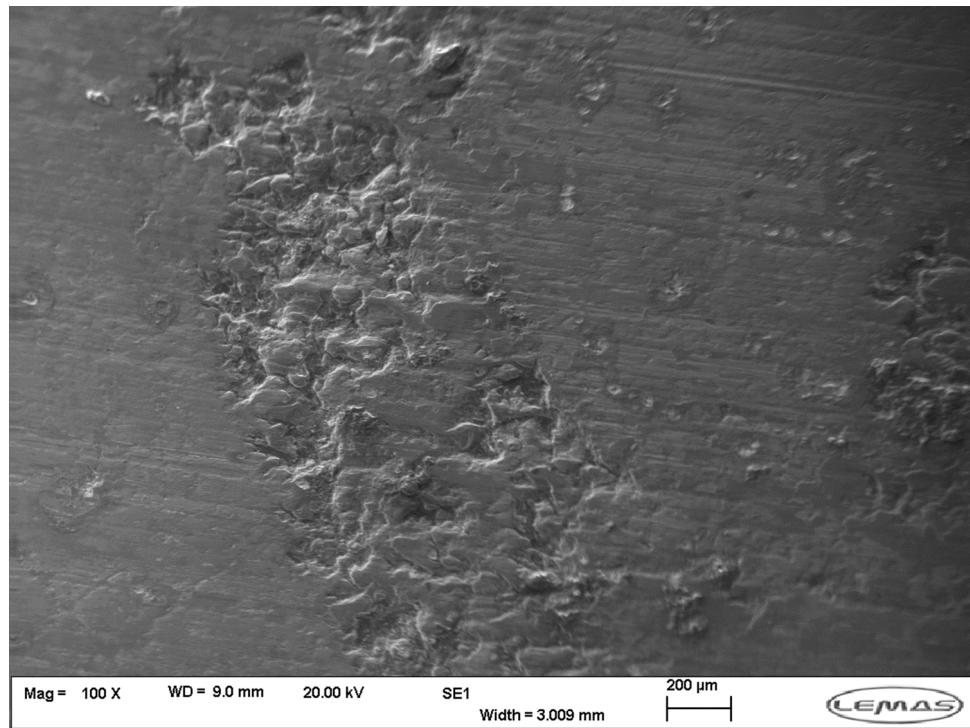
Figure 4.17: SEM image of the damage area on the surface of the GCI brake rotor as a result of corrosion

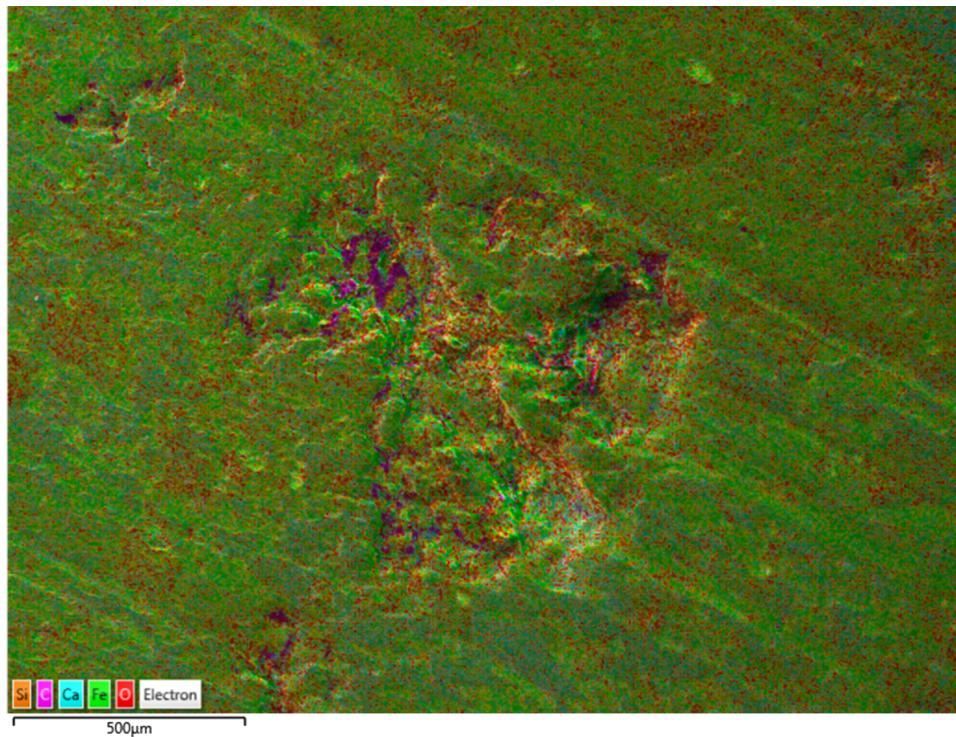
Figure 4.18: Elemental map of the corroded rotor crevices

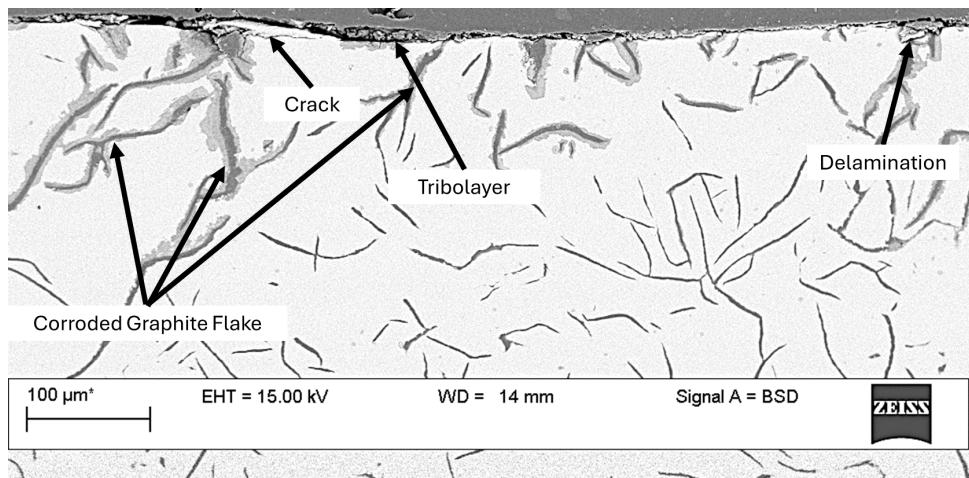
Figure 4.19: Cross section SEM image of corroded GCI brake rotor

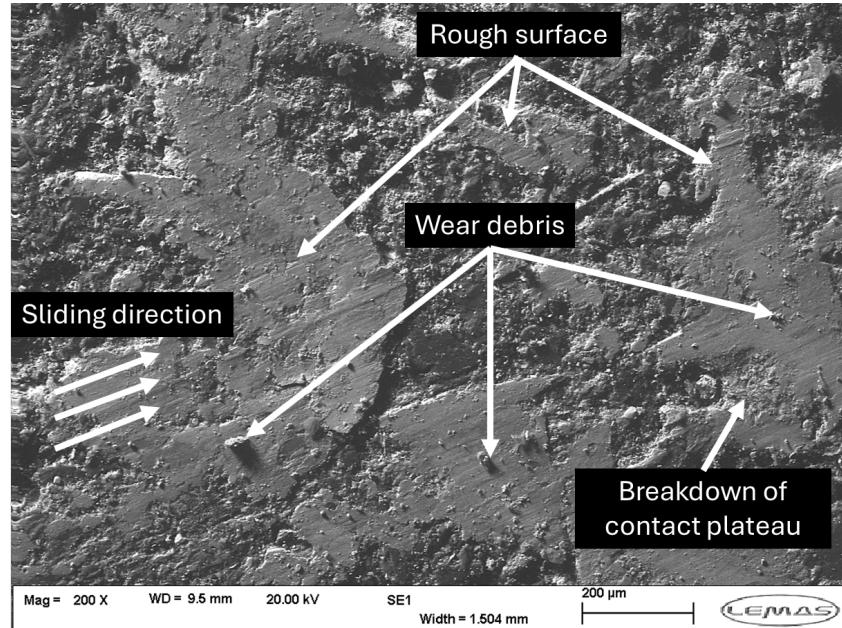
Figure 4.21: SEM image of the surface plateaux and debris found on brake pad tested against corroded GCI

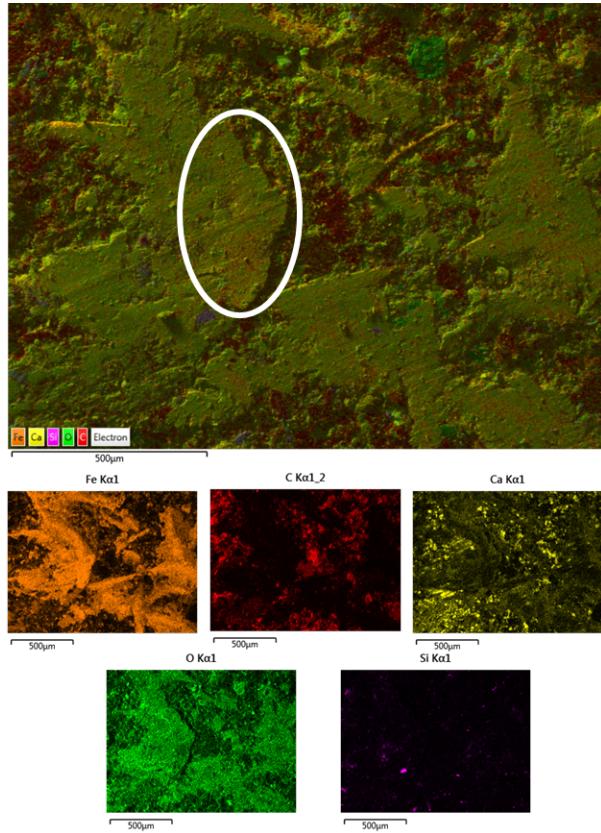
Figure 4.22: Elemental map of contact plateaux on brake pad tested against corroded GCI

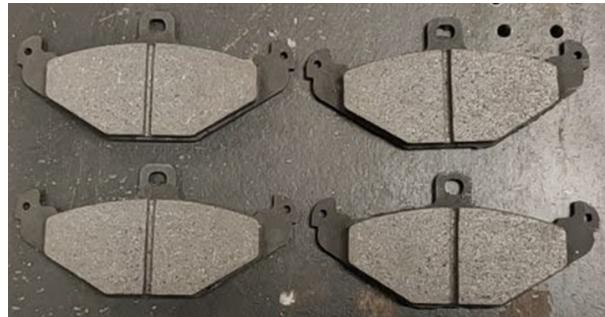
Figure 5.2: Image of Lotus Elise S1 MMC rear brake pads

Figure 5.2 below shows the aftermarket Al-MMC brake pads for the Lotus Elise S1. The brake pad selected is for the rear axle calliper of the Elise. This was done so that the brake pad could fit inside the brake calliper on the UoL brake dynamometer. The content

of the friction material is outlined later in this Chapter.

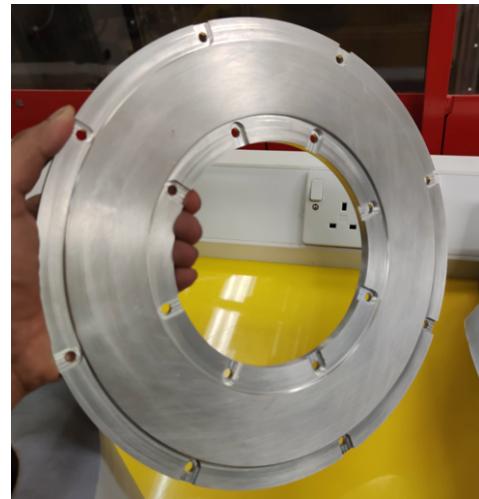
Figure 6.2: Uncoated Al-PEO rotor hub and backplate

The two rubbing surface cheeks of the uncoated Al-PEO rotor are shown in Figure 6.2. These components represent the sections of the Al-PEO brake rotor that underwent PEO treatment. Specifically, the raised area, elevated by 2 mm, corresponds to the brake pad contact region on the rotor. Isolating and PEO treating only the rubbing surfaces is a more efficient approach than coating the whole rotor. This study focused on investigating

(b) Uncoated Al-PEO back-plate
