# **The Effect of Corrosion on the Particle Emissions Emitted from Different Brake Rotor Materials**

**By Ishmaeel Ghouri**

**The University of Leeds**

**School of Mechanical Engineering**

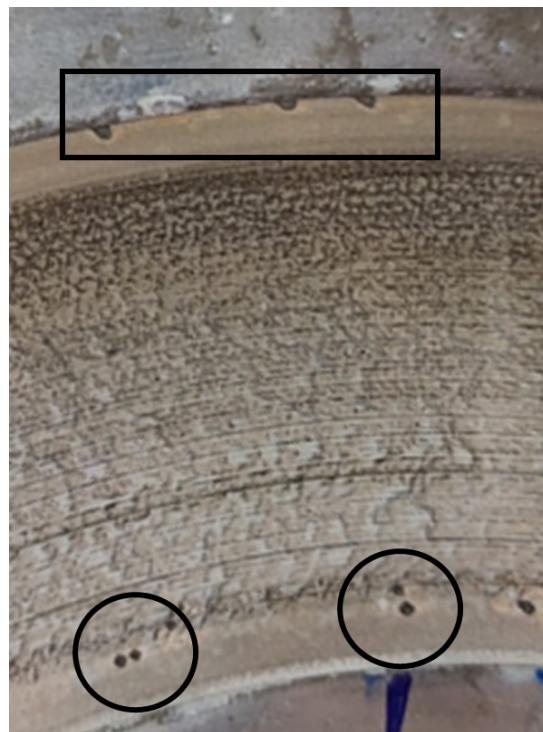
From the photographic image of the Al-PEO friction ring after corrosion, shown in Figure 6.20, chipping of the PEO coating is observed along the top edge of the friction ring. Additionally, spot-like features are present on the bottom edge of the friction ring. Both of these phenomena were only apparent following corrosion of the rotor. It is worth emphasising that the chips and pits are confined to the edges of the friction ring, with no such defects observed on the central rubbing surface.

Figure 6.20: Surface image of corroded PEO coated rotor showing pits on the friction ring

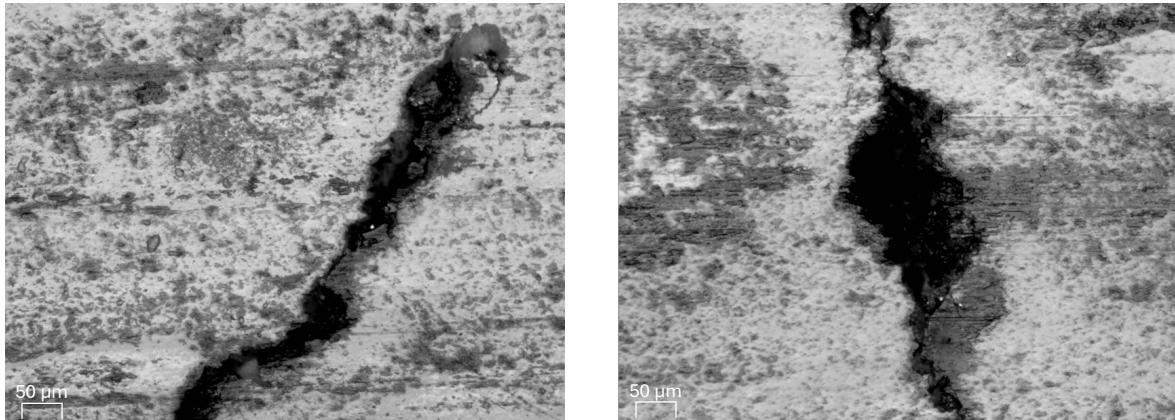
Figure 6.21: Surface cracks observed on the PEO-coated rotor under light microscope

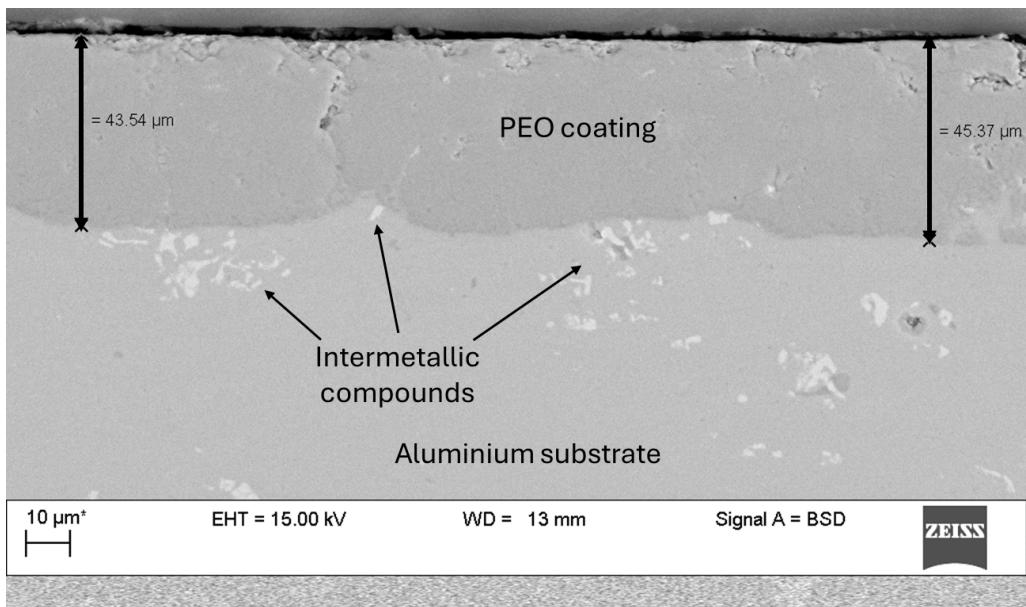
Figure 6.22: SEM image of a cross-section of PEO coating after testing

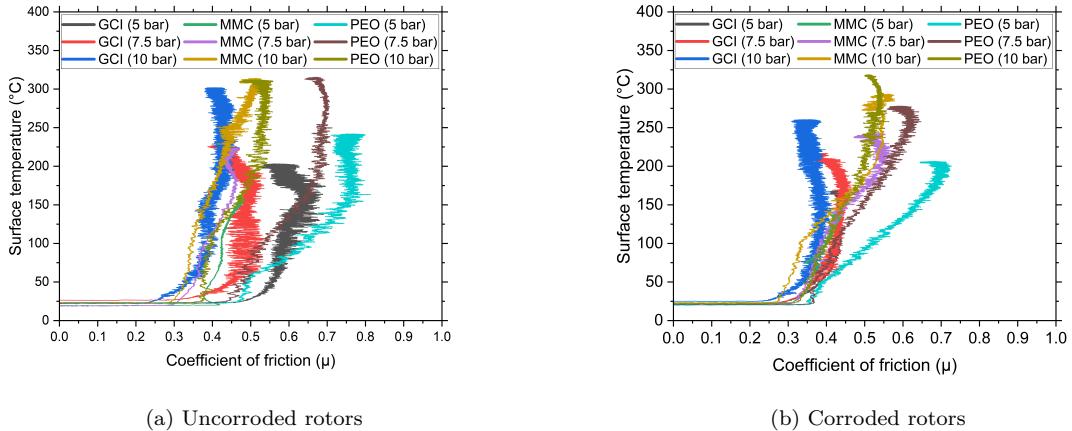
Figure 7.3: Surface temperature vs CoF loss of GCI, Al-MMC and Al-PEO uncorroded and corrosion rotor

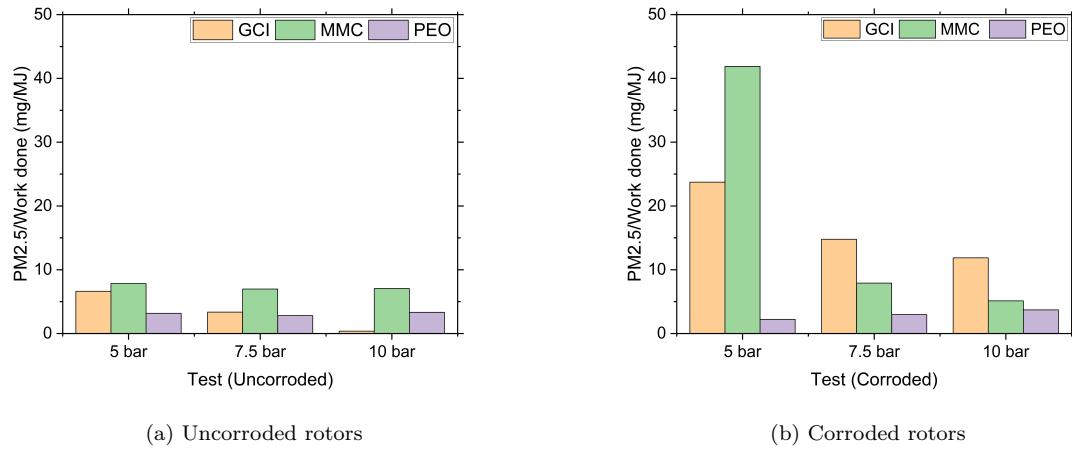
Figure 7.6: PM 2.5 particle emission per unit work done for uncorroded and corroded brake rotor surfaces

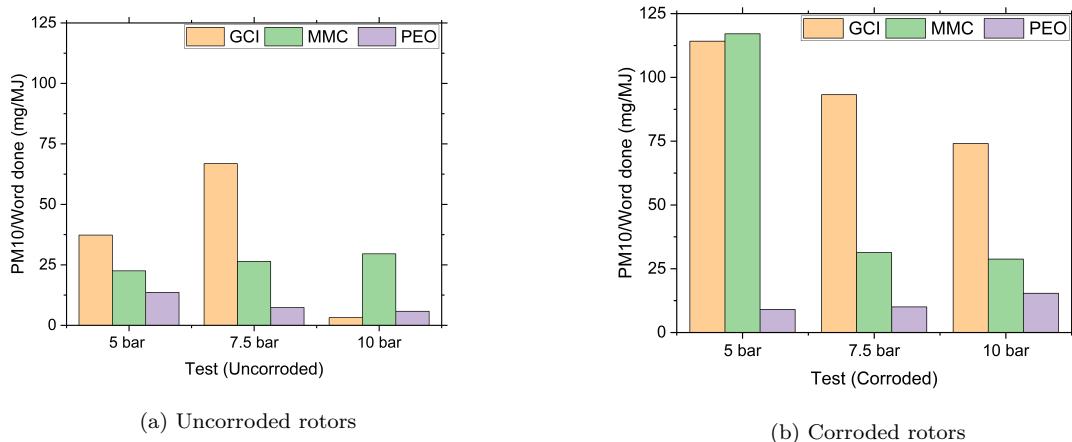
Figure 7.7: PM 10 particle emission per unit work done for uncorroded and corroded brake rotor surfaces

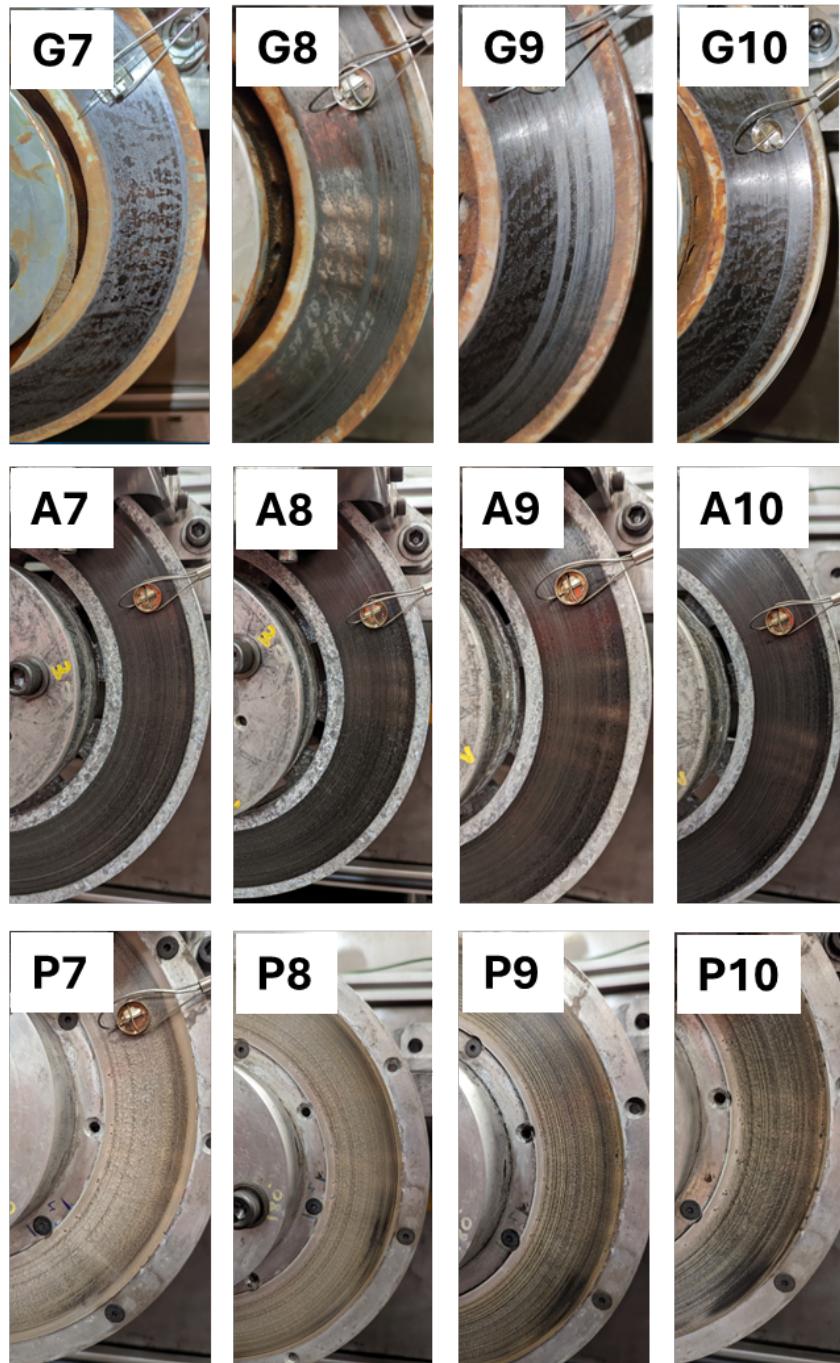
Figure 7.10: Images of corroded GCI, Al-MMC and Al-PEO rotors: 7) after bedding-in, 8) after 5 bar, 9) after 7.5 bar and 10) after 10 bar

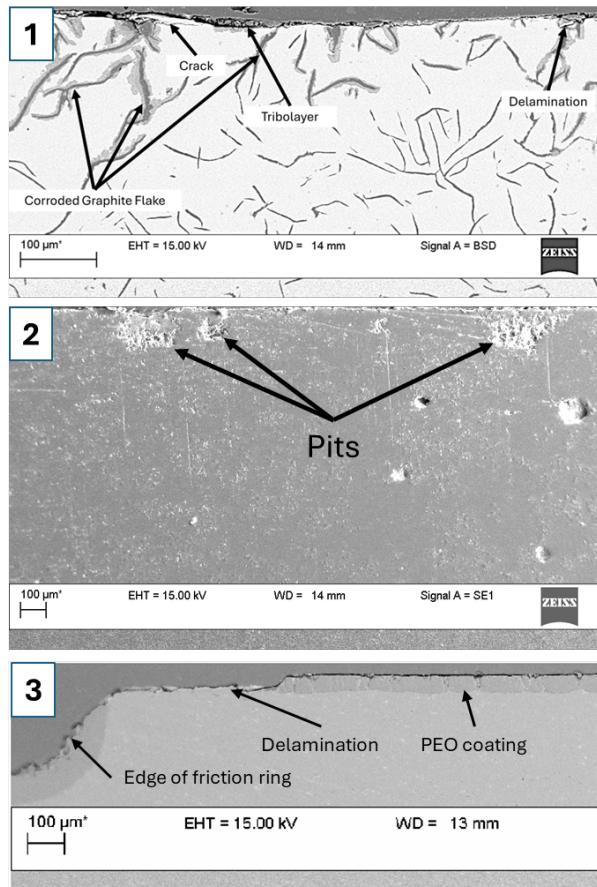
Figure 7.13: SEM images of the cross-section of 1) GCI, 2) Al-MMC and 3) Al-PEO corroded brake rotors after testing
