# Artificial Intelligence Backed Automation for Detecting Cracks in Solar Cells

Sharmarke Hassan  
Doctor of Philosophy

University of York  
School of Physics, Engineering and Technology

November 2025

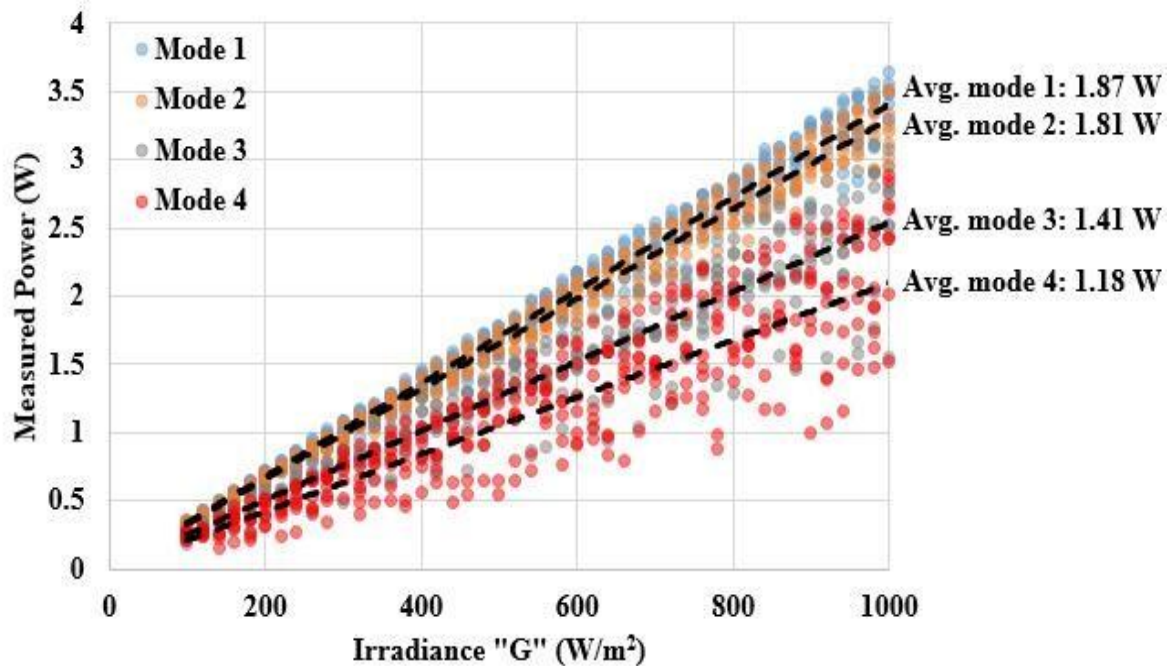
Figure 1. Measured electrical power plotted against PV irradiance for the examined PV cells, illustrating the performance behaviour of the modules under varying illumination conditions [23].

The power loss from PV cells becomes more than 60% when cracks expand in size and complexity according to the classification framework. The data presented in Figure 1 demonstrates that prompt identification and exact classification of defects play a vital role in minimising energy loss.

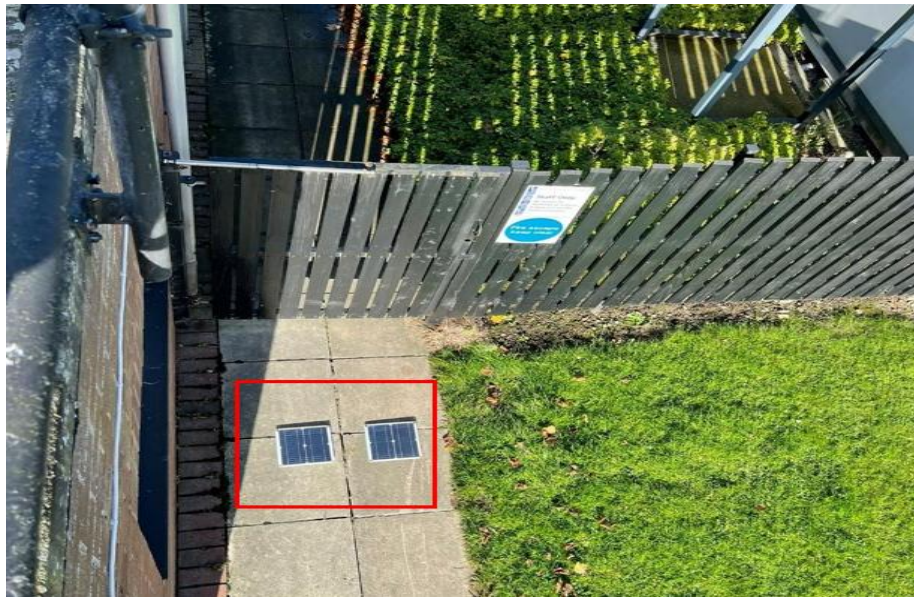
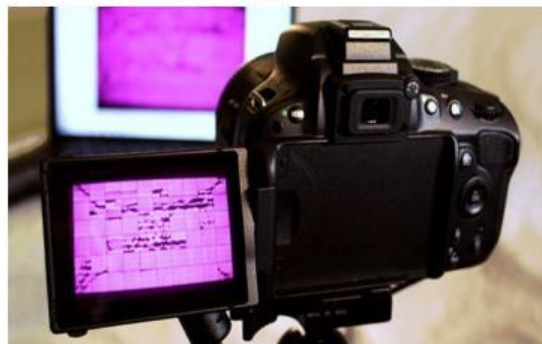
Figure 2. PV modules installed along a public walkway at the University of York. (a) General view of the installed panels; (b) electroluminescence (EL) imaging setup used for inspection [24].

The inability to determine fault locations in PV installations results in substantial delays during inspection procedures [24]. To address this issue, we conducted a pilot study focused on identifying crack formation in PV panels embedded in two PV roads, as illustrated in Figure 2(a).

For this investigation, both electrical performance (I–V and P–V characteristics) and EL imaging of the PV panels were captured under real "road" conditions. The I–V curves were measured using the Seaward PV200 device, with a precision of  $\pm 2\%$ . EL images were obtained using a dedicated EL imaging setup, Figure 2(b), which included a digital camera with a  $6k \times 4k$  resolution and an 18–55 mm zoom lens. The PV panel was connected to a biased power supply and operated under short-circuit conditions to stimulate luminescence in the cells.

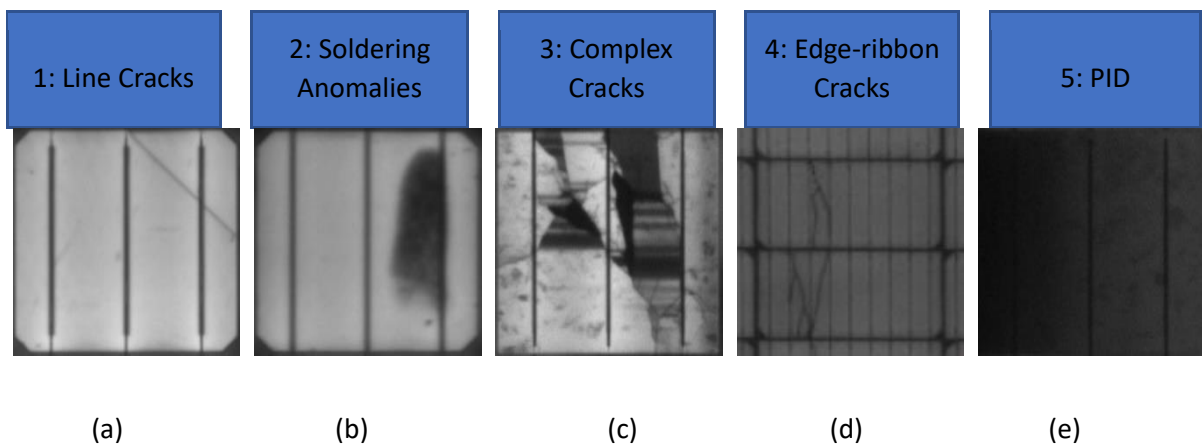
Figure 4. examples of PV defect categories identified in this study: (a) Line cracks; (b) Soldering anomalies; (c) Complex cracks; (d) Edge ribbon cracks; (e) PID [33].

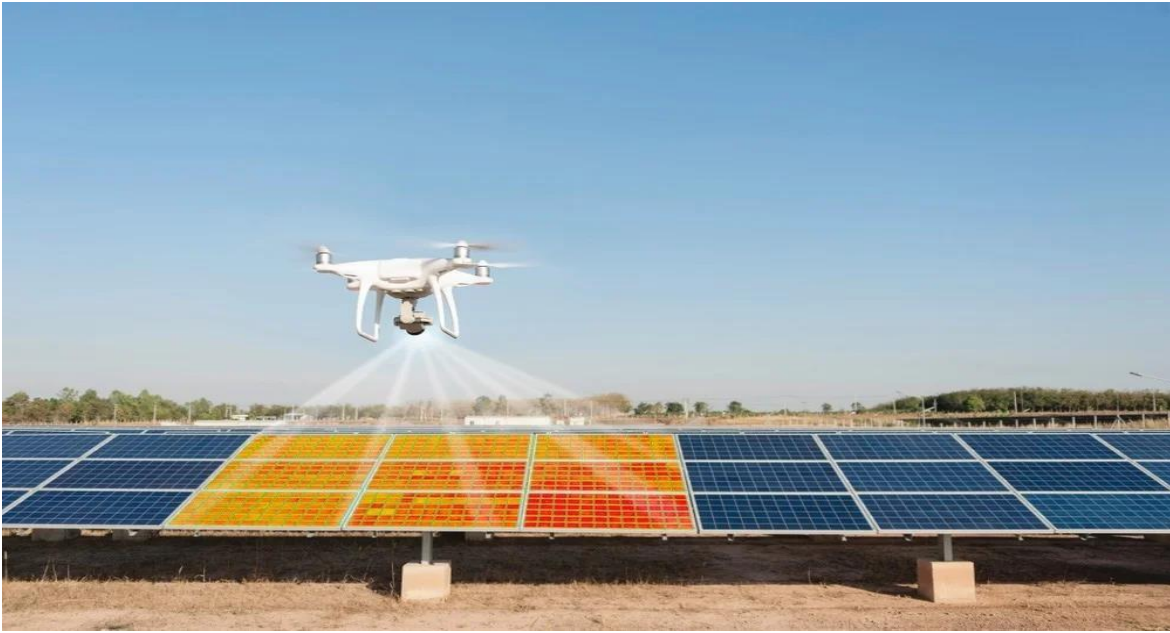
Figure 9. Thermal inspection of PV modules performed using an aerial drone equipped with an infrared camera [64].

This method is widely used for maintenance and quality assurance in large-scale PV systems, detecting defects caused by environmental or mechanical stresses but it is less suited to individual PV cells [62]. However, drone-based thermal imaging is a valuable tool for maintaining large PV installations, offering rapid and accurate defect detection despite challenges with labour and cost [63]. As PV energy grows, this method will remain crucial to ensuring system reliability.

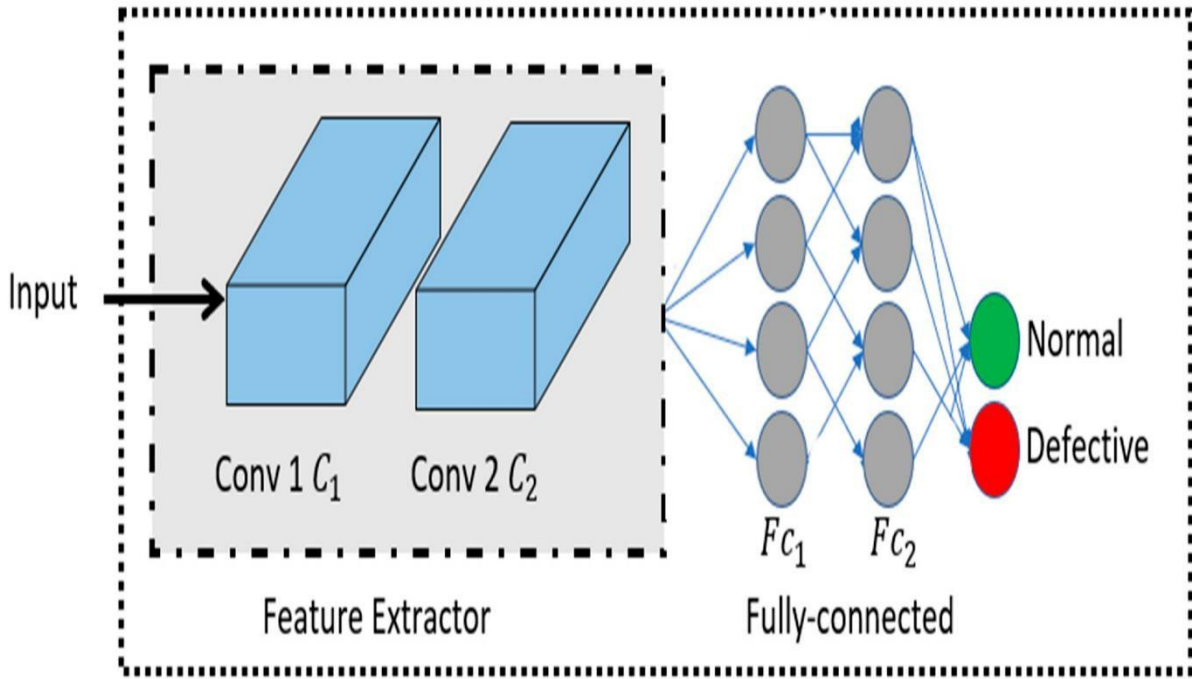
Figure 10. Proposed CNN PV-cracknet architecture [96].

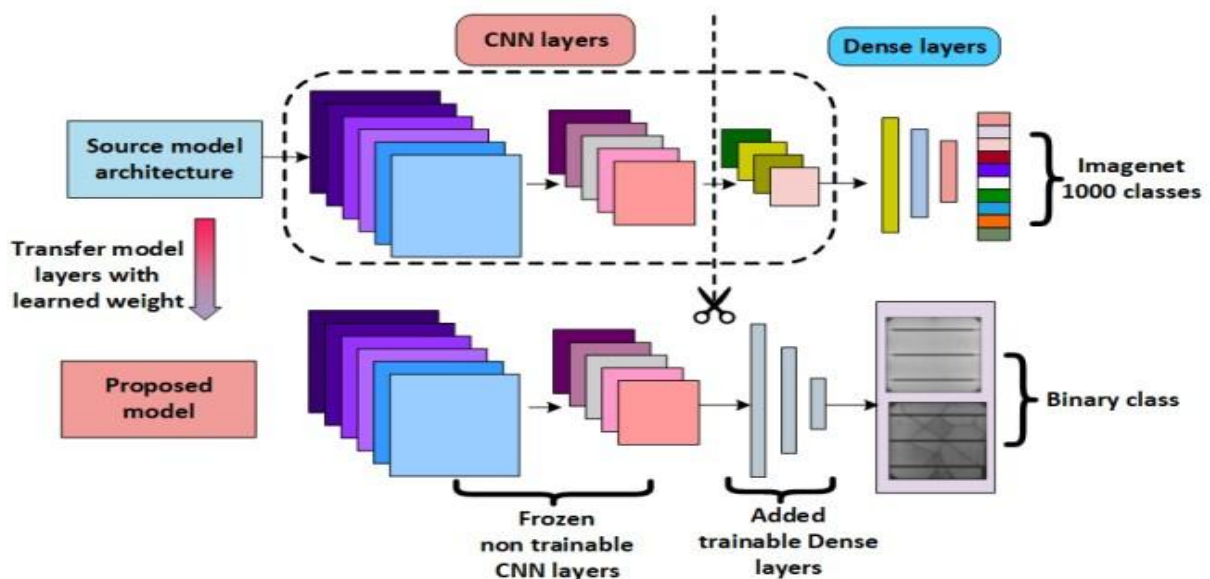
Figure 13. Proposed ensemble learning architecture [99].

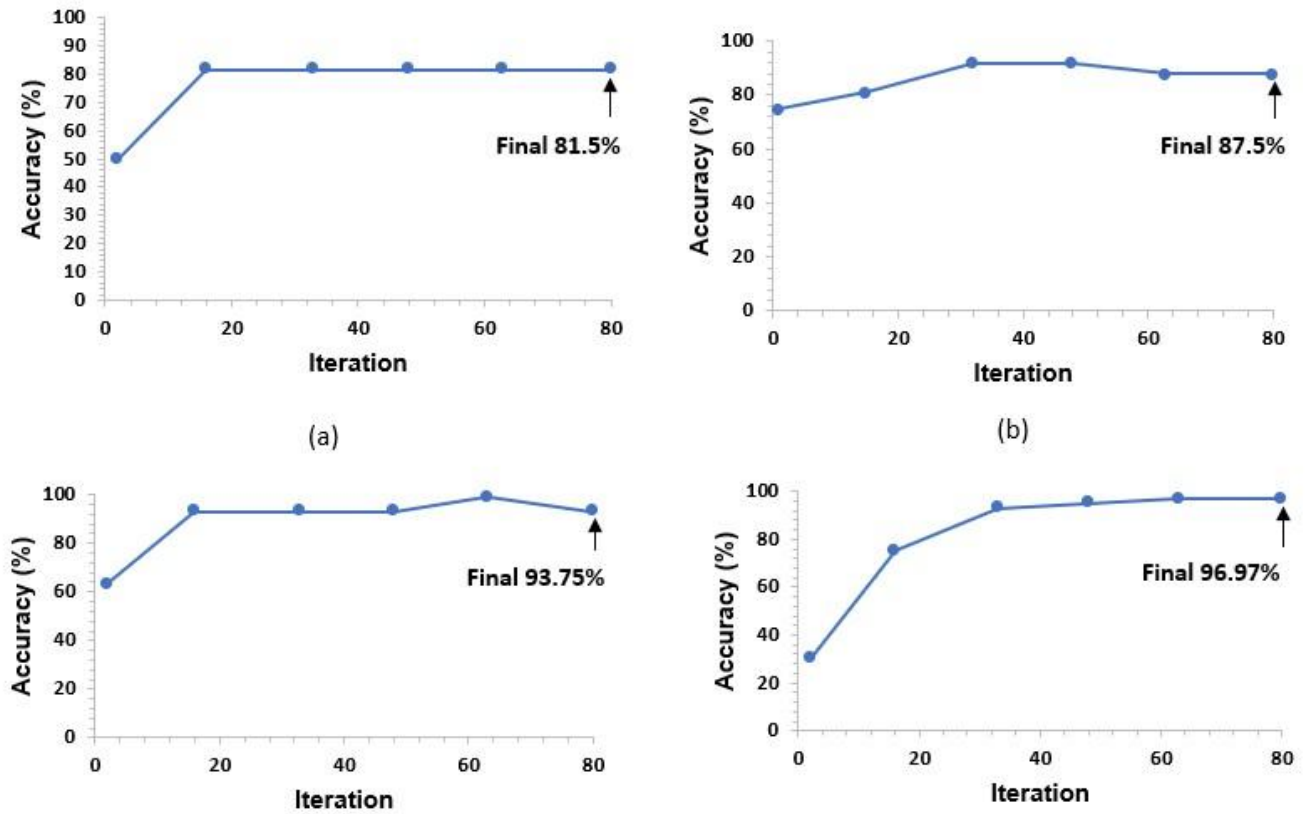
Figure 18. Validation accuracy results of the CNN architectures. (a) Net1, (b) Net2, (c) Net3, (d) Net4 [102].

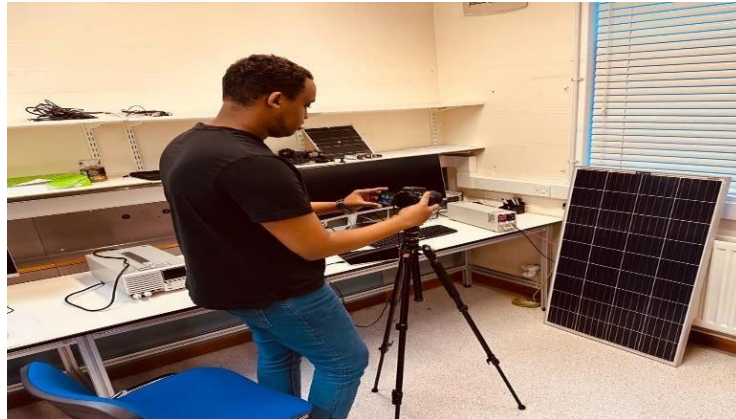
bias current during imaging. An example of the captured EL image is presented in **Figure 28(a)**, while the main components of the Brightspot EL imaging setup are shown in **28(b)**.

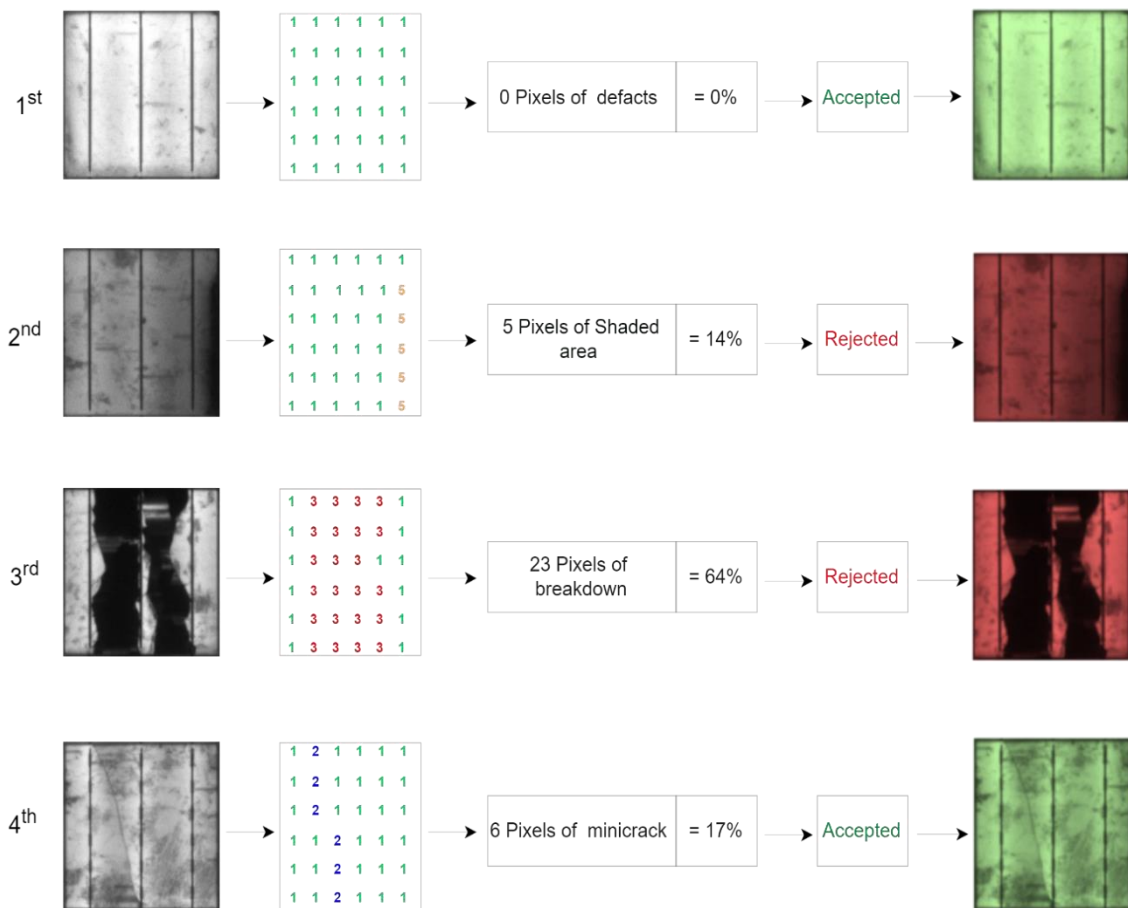
Figure 33. Cell level prediction (Mix of accepted and rejected cases) [110].

The third cell presented multiple defects, and the CNN predicted it as rejected since many of its pixels were classified as defective, leading to the cell being illustrated as red. A fourth cell exhibited a minicrack and in this instance the CNN concluded that the cell was healthy. This outcome was based on the fact that the standard tolerance for minicracks was set at 28 percent, which is considerably higher than the standard used for other defects. As the percentage of defective pixels in this case was only 17 percent, the cell was labelled healthy and shown in green.

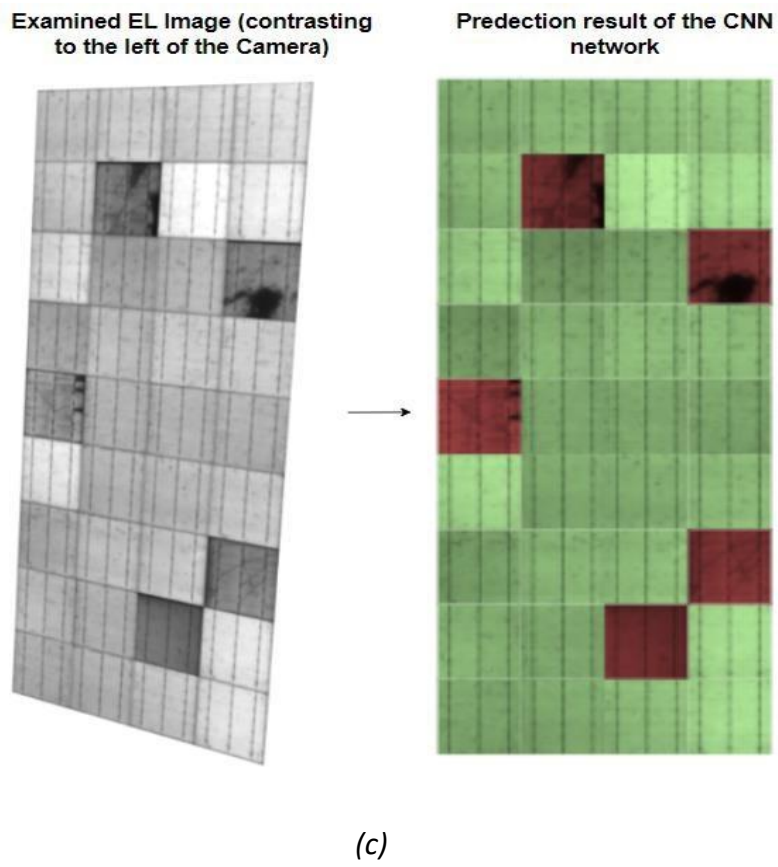
Figure 36. Prediction of PV module condition based on varying imaging angles. (a) Perpendicular to the camera, (b) Contrasting to the right of camera, (c) Contrasting to the left of camera [110].

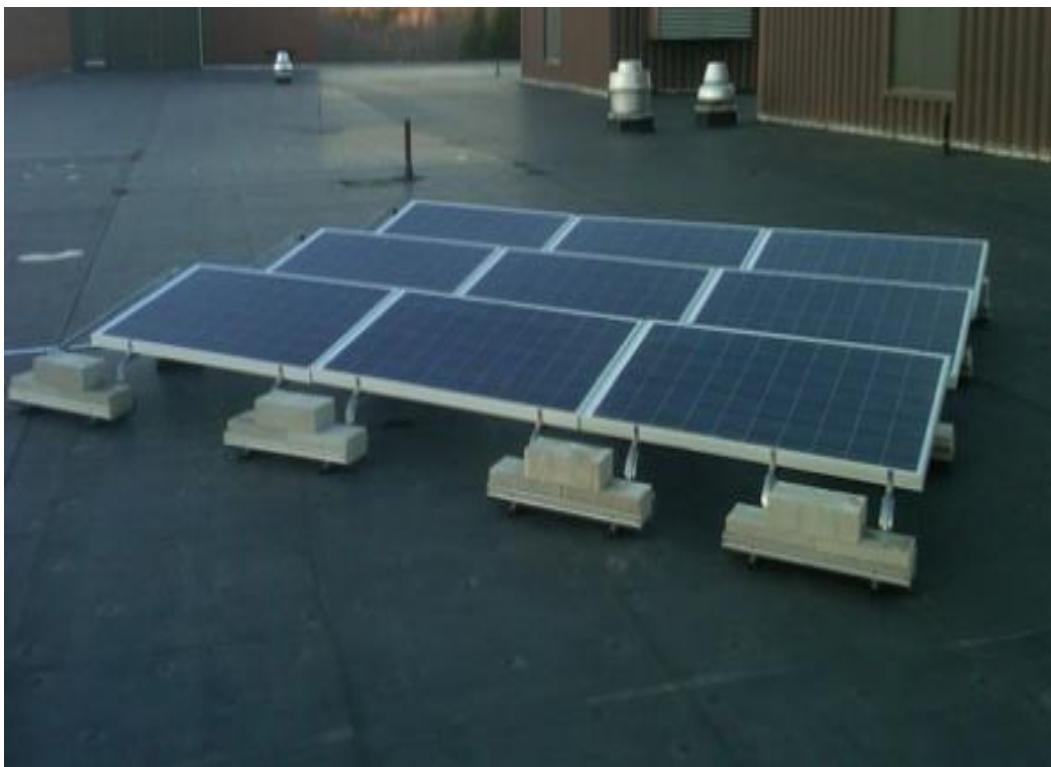
Figure 37. Examined PV system on the site [110].

As shown in Figure 37, the PV string analysed in this case study was composed of nine polycrystalline silicon modules connected in series. The key electrical parameters of this string are presented in the Table 11.

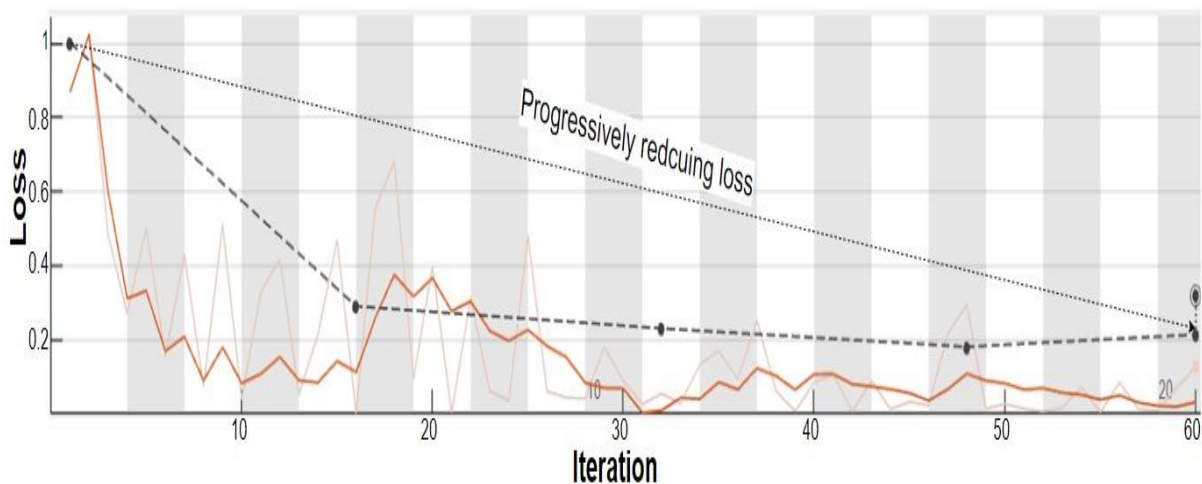
Figure 39. Arch 4 CNN network learning Loss vs learning iterations (epochs) [110]).

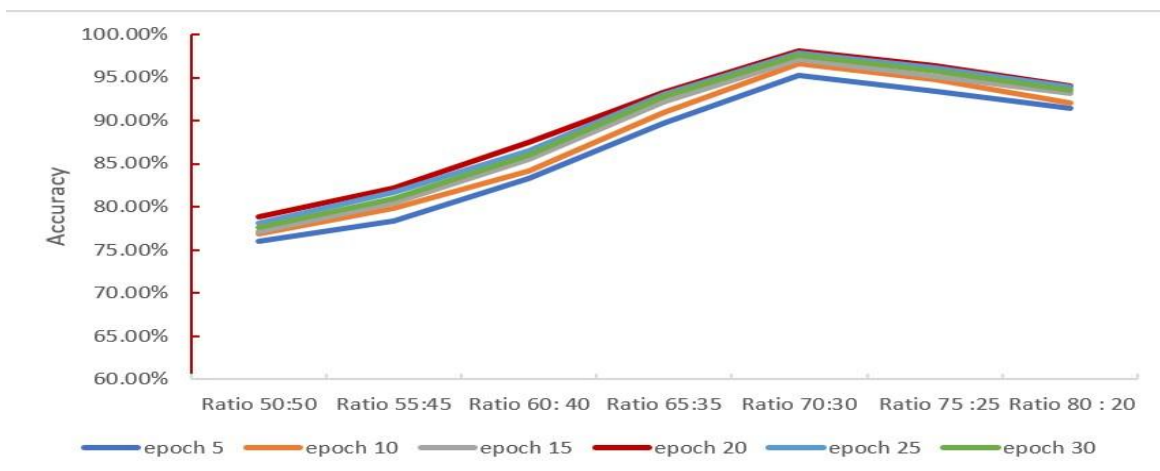
Figure 40. Accuracy sensitivity analysis illustrating the relationship between training epochs and data split ratios [110].
