**An Analysis of Roman Ceramic Building Material from York and  
its Immediate Environs**

**By J. M. McComish**

**MA by Research**

**The University of York**

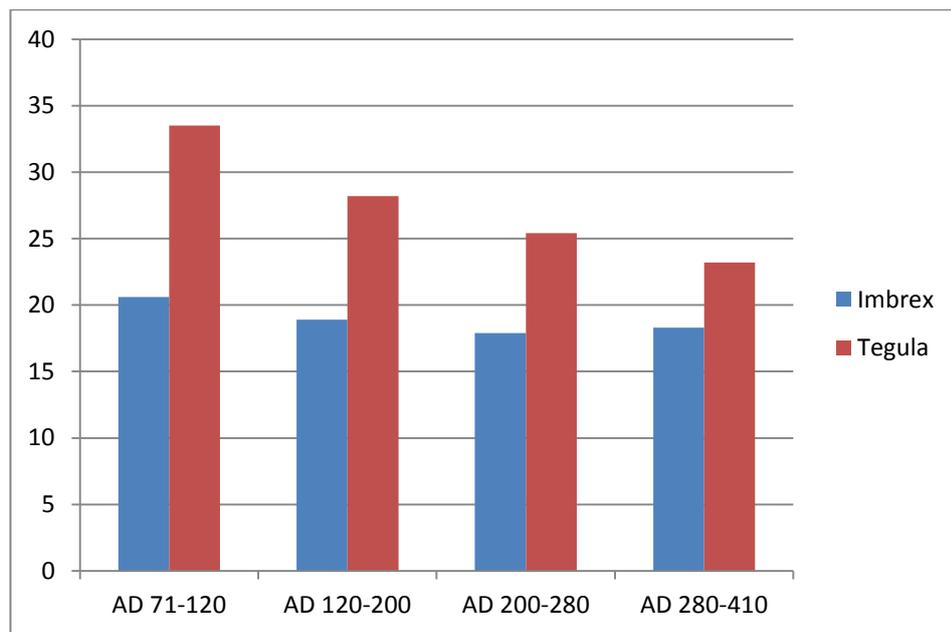
*Figure 4. The average thickness of roofing tile in mm in relation to date, for the sites selected for detailed stratigraphic analysis in Appendices 8-13 (associated data in Tables 35-6).*

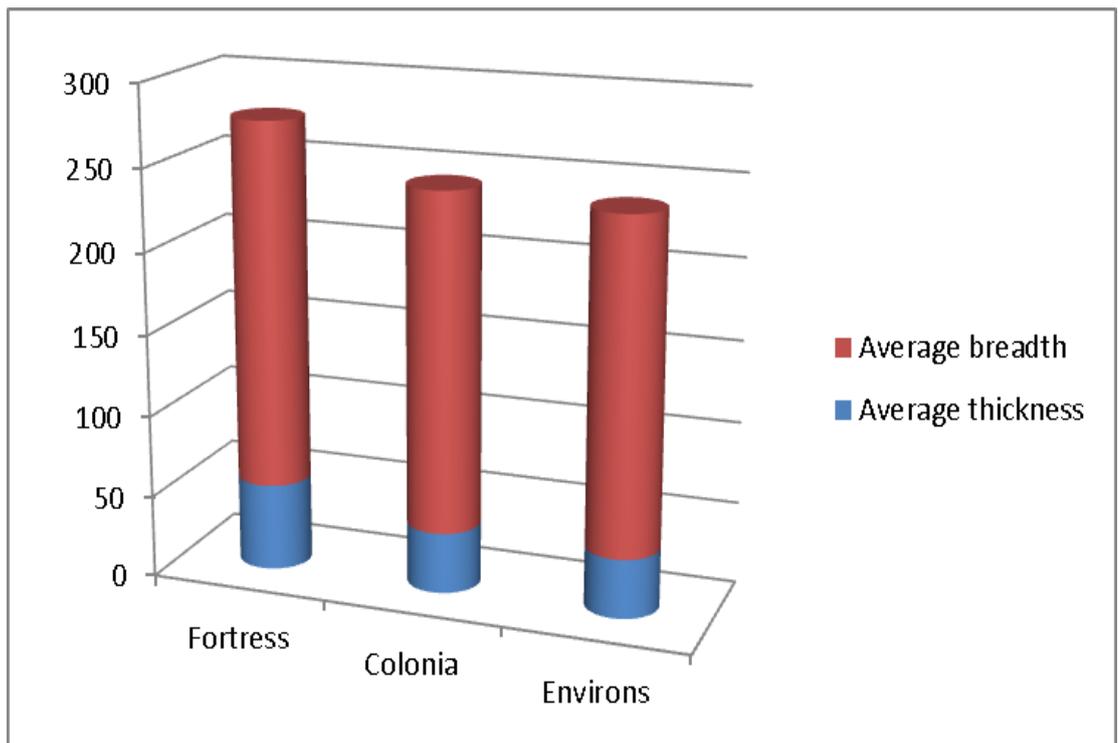
Figure 10. The average breadth and thickness of bessales in mm in relation to zone.

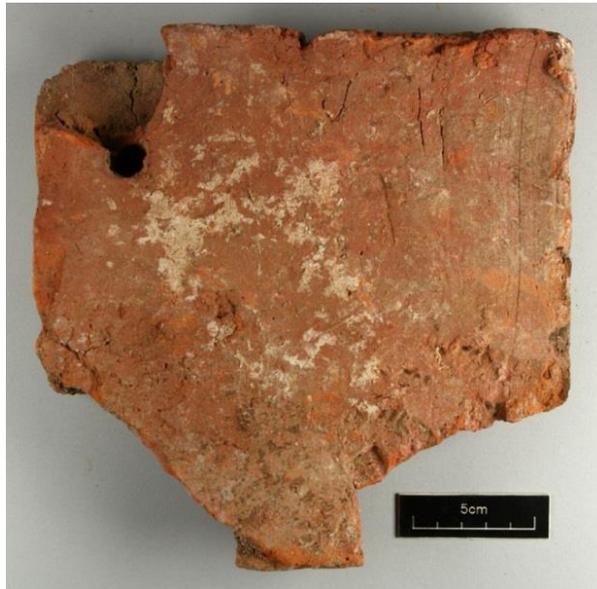
Figure 20. A *bessalis* pierced by a hole, from 1-9 Micklegate, Context 7159, © YAT

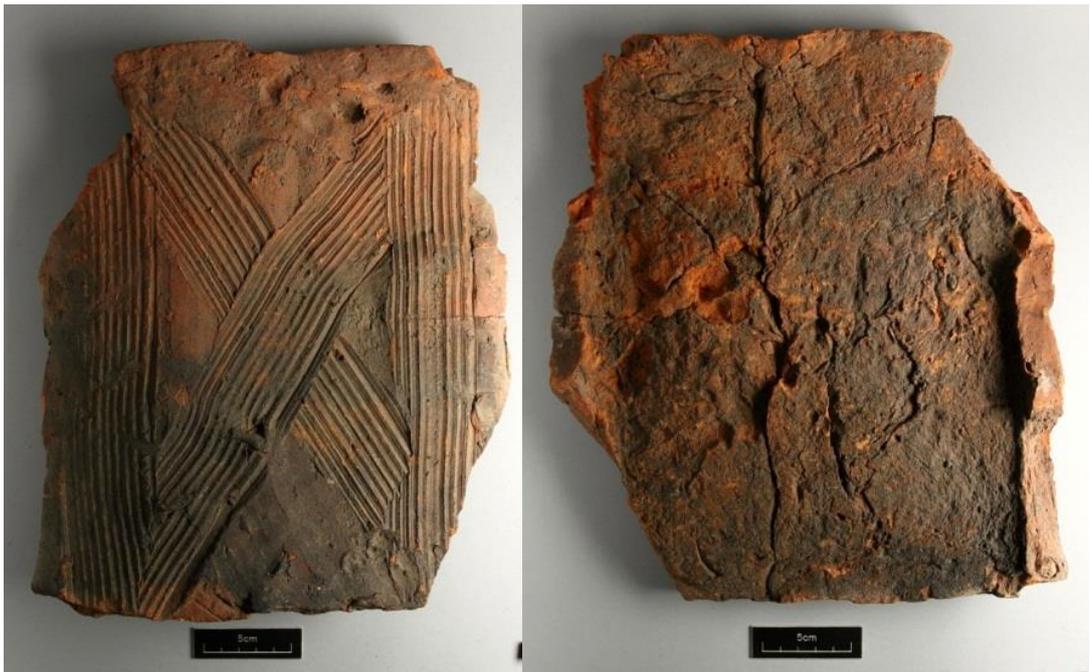
*Figure 25. The exterior and interior surfaces of a combed box flue tile with a complete surviving height and breadth, unstratified from excavations at 21-33 Aldwark, © YAT*

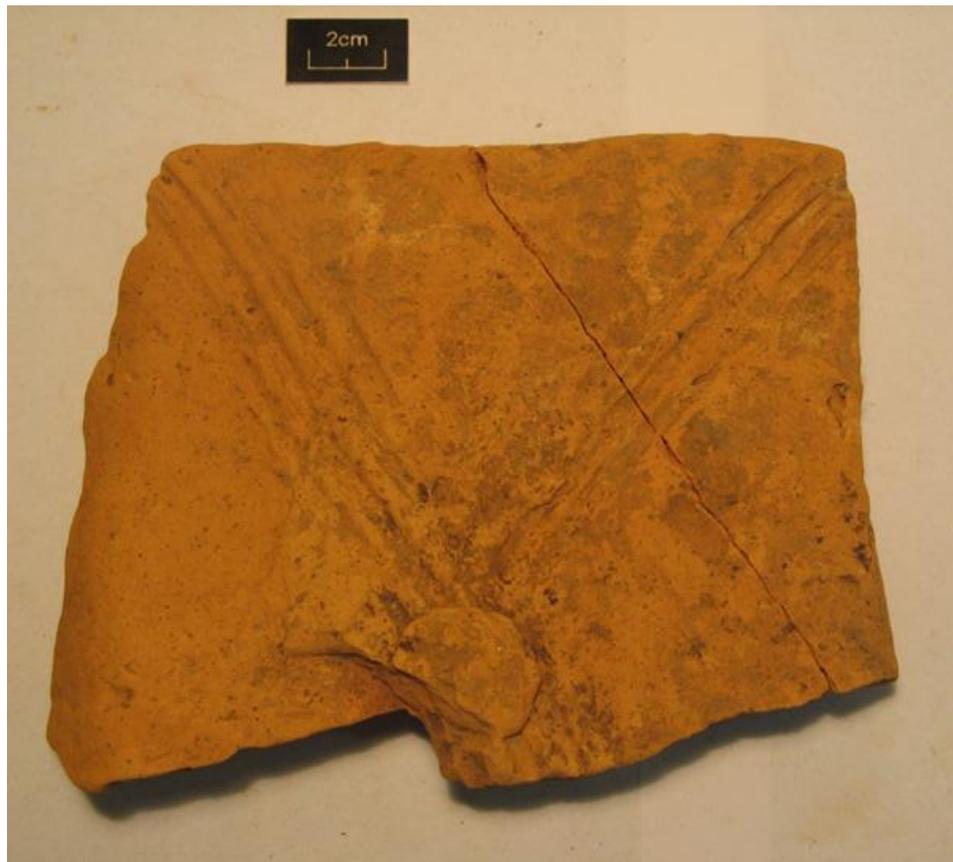
*Figure 28. The exterior surface of a combed box flue tile with a central clay pellet, from Heslington East, Context 1126.*

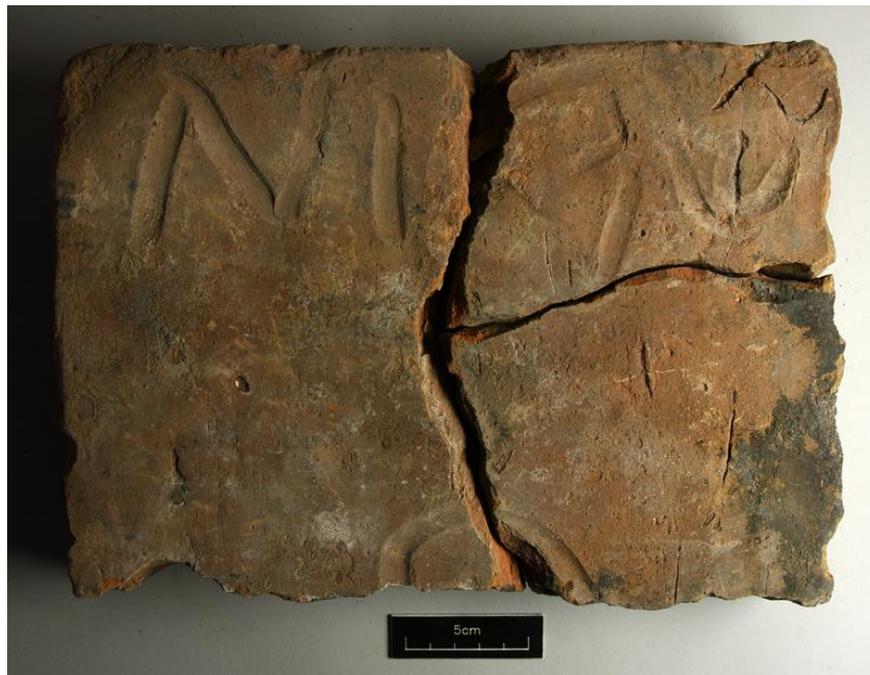
*Figure 37. Lydion with graffito, from 16-22 Coppergate, Context 5248, © YAT*

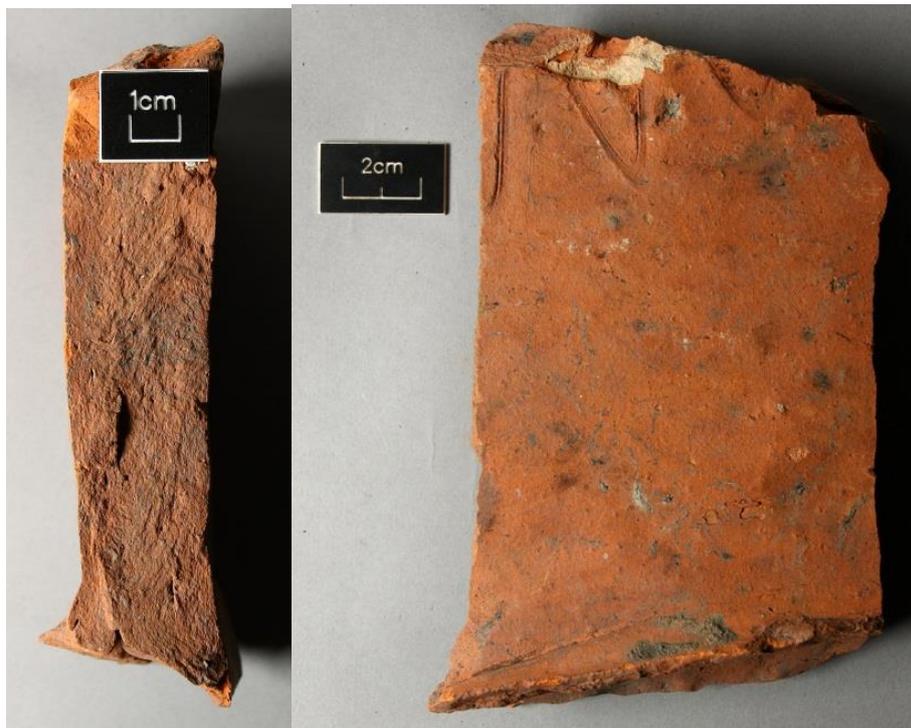
*Figure 41. A tile with unusual edge and graffito in the form of VVV, from the 1-9 Micklegate, Context 2113, © YAT*

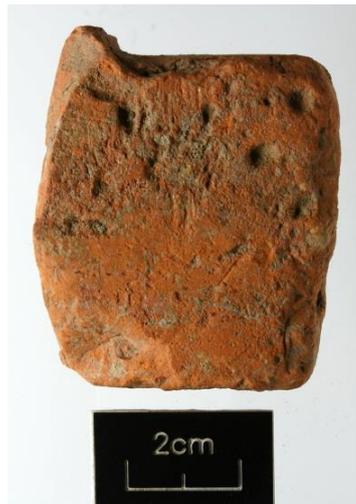
Figure 42. A possible armchair voussoir sherd from 12-18 Swinegate, Context 3614, with the broken off portion being at the left side of the photograph, © YAT

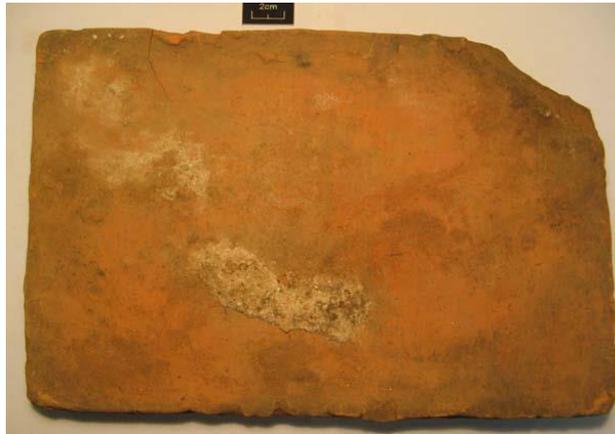
*Figure 43. Rectangular brick of a non-standard size from Heslington East, Context 173*

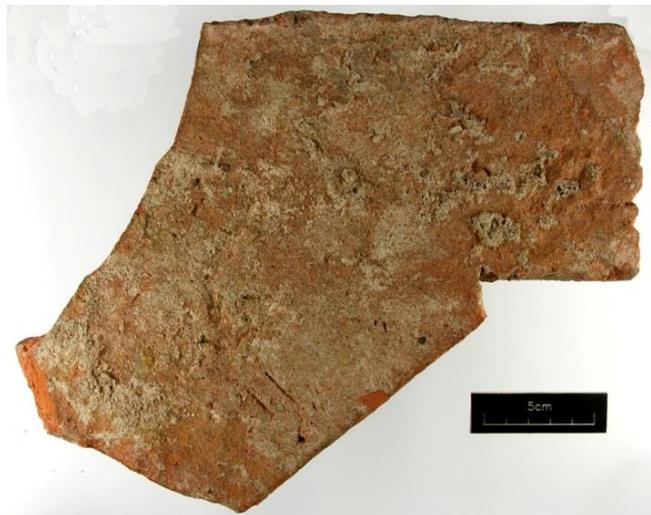
*Figure 45. An 'L' shaped brick from 1-9 Micklegate, Context 7162 with a possible batch number on the surface, © YAT*

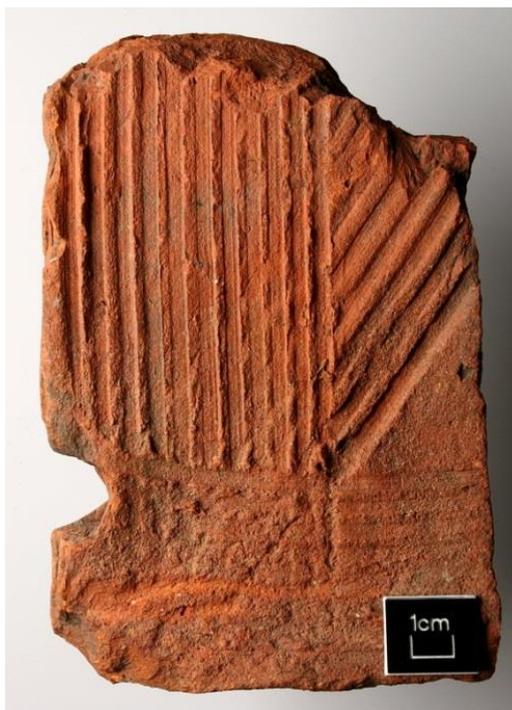
*Figure 46. An unstratified parietalis brick from the YAT collections, © YAT*

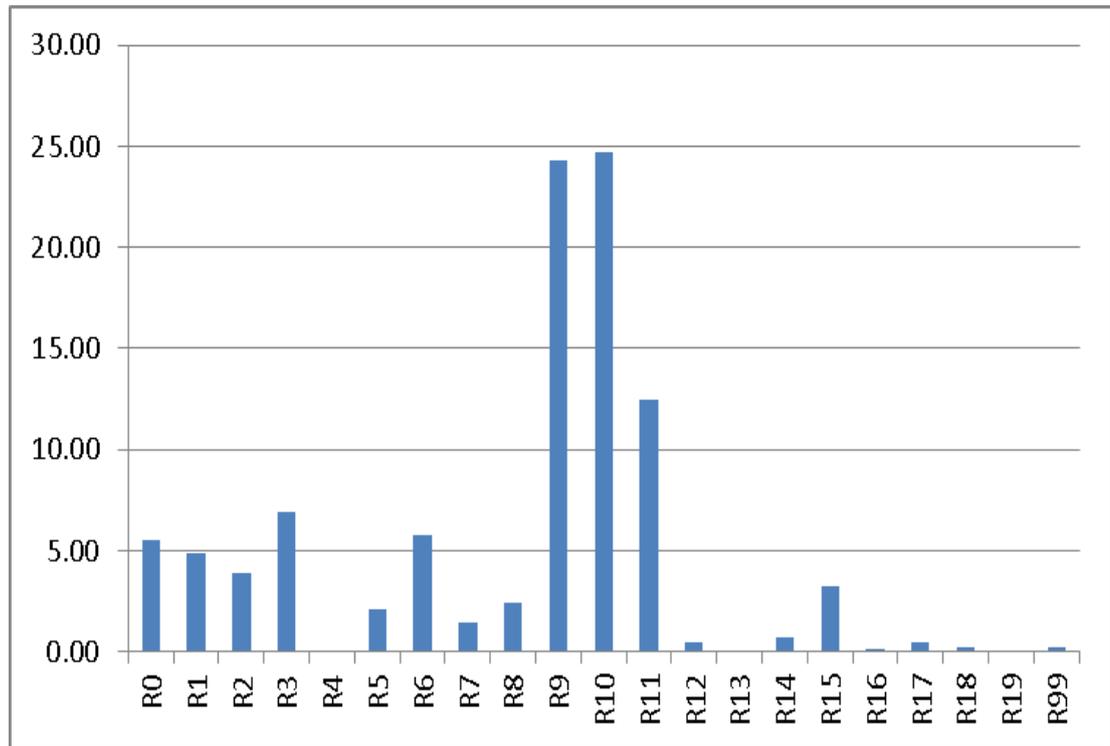
Figure 82. Weight in grams of each fabric as a percentage of the total weight of tile examined

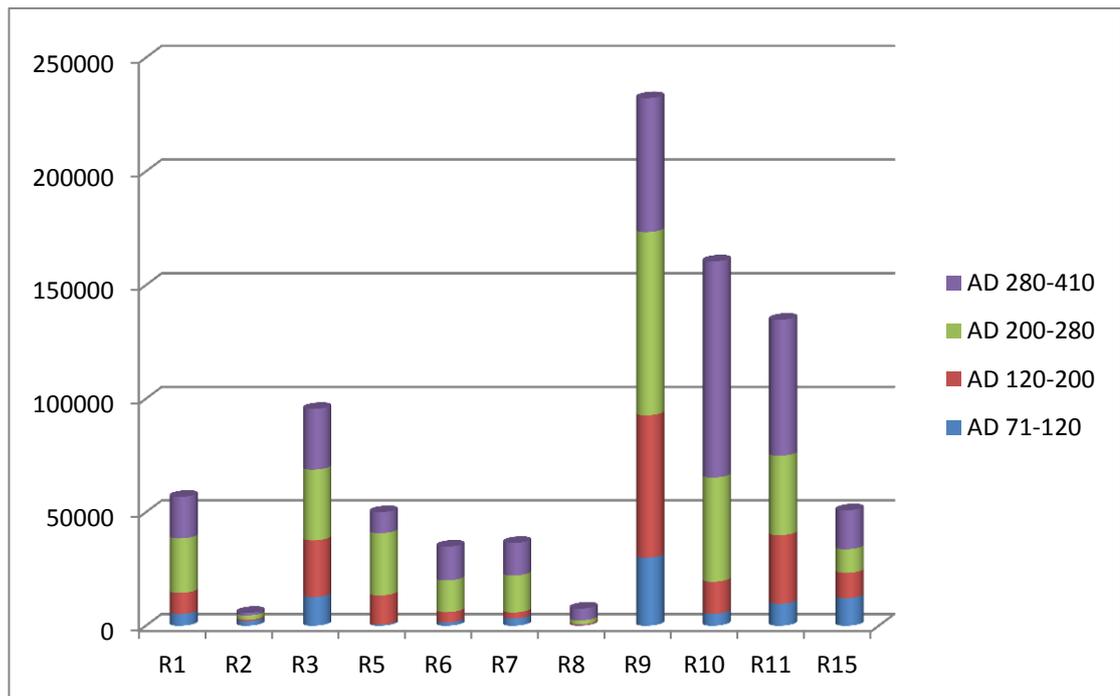
Figure 104. The of fabrics weight in grams in relation to chronological group (for selected excavations)

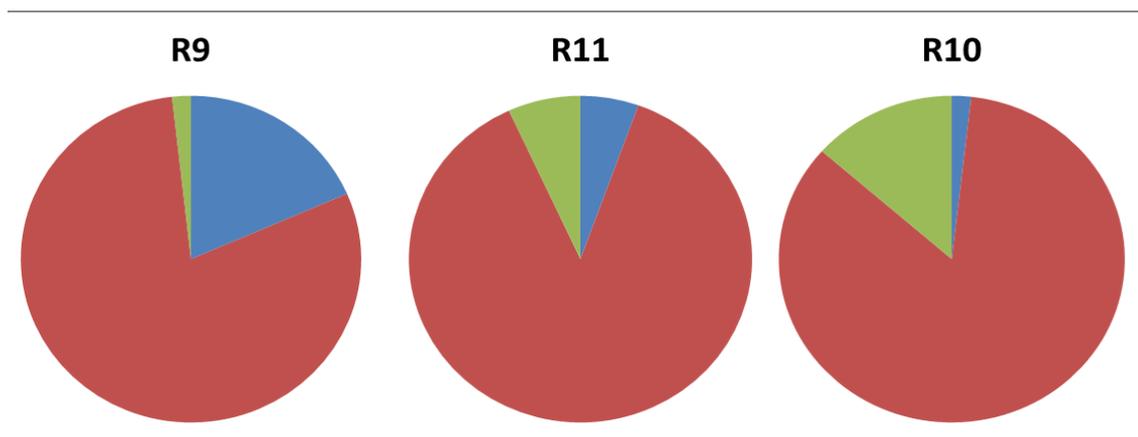
*Figure 105. Fabric in relation to lower cutaway types for fabrics with over seventy examples (blue = cutaway Group A<sup>Warry</sup>, red = cutaway Group B<sup>Warry</sup>, and Green = cutaway Group C<sup>Warry</sup>).*

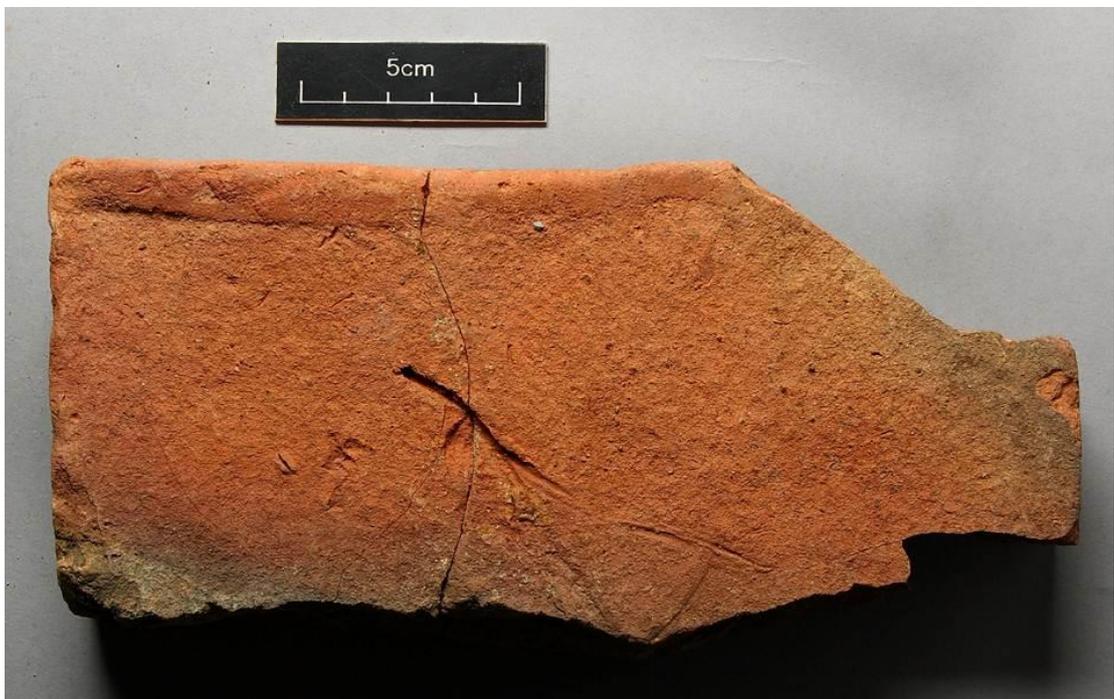
Figure 122. Graffito from George Hudson Street, Context 6071, © YAT
