## Ruins to Re-use: Romano-British Remains in Post-Conquest Literary and Material Culture

Volume Two of Two

Jane-Heloise Nancarrow

A thesis submitted for the degree of Doctor of Philosophy The University of York Centre for Medieval Studies July 2013

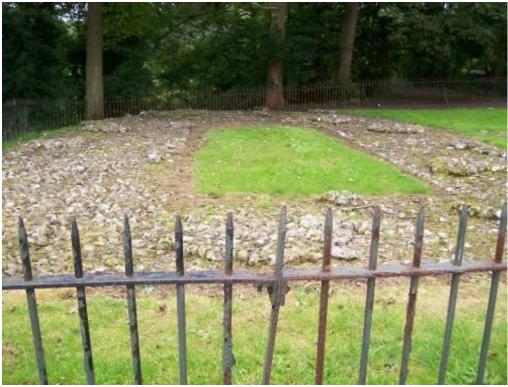
Figure 3: A section of the third-century town wall near the London gate, on the south-east side of Verulamium.

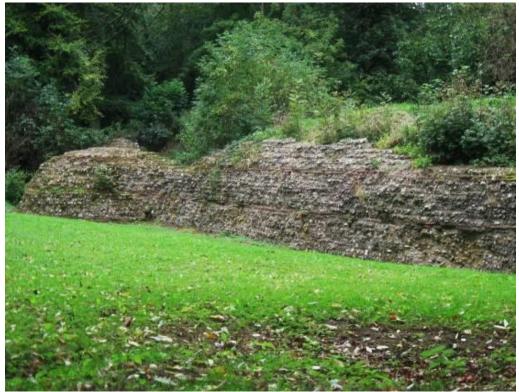
Figure 4: Foundations of the north tower of the London Gate.

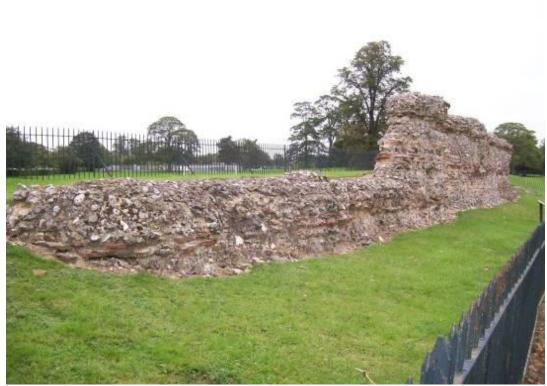
Figure 5: The south corner bastion of the third century wall.

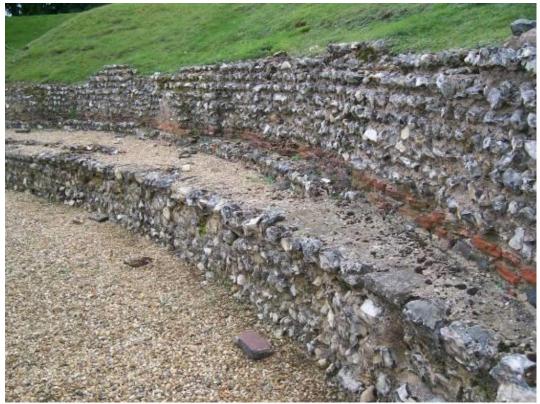
Figure 12: The now excavated Roman theatre from the north-east.

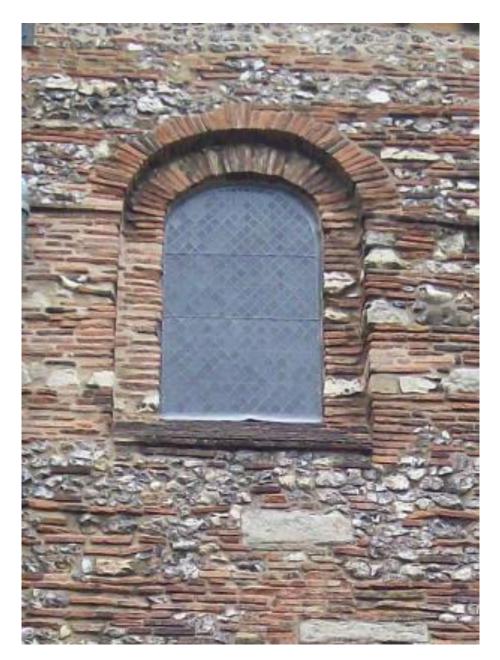
Figure 15: The Norman Abbey, from the North West showing a considerable amount of salvaged Roman material fabric.

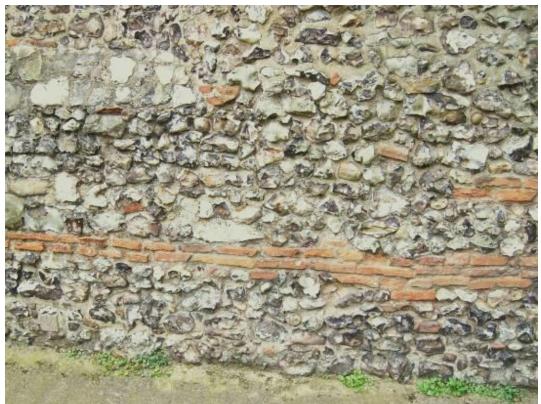
Figure 25: Tile banding on a section of the Roman wall at Verulamium.

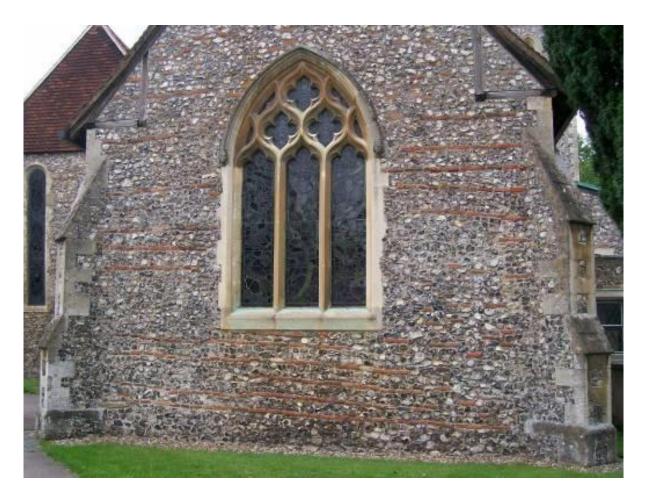
Figure 26: Tile banding on a section of the North wall of the nave of the Abbey.

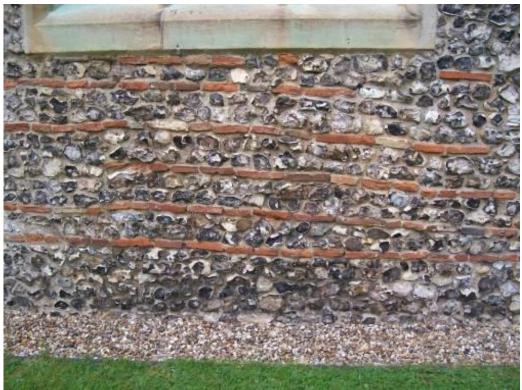
Figure 27: East end of St Michael's Church over the forum site of the Roman town. The tile banding appears entirely decorative.

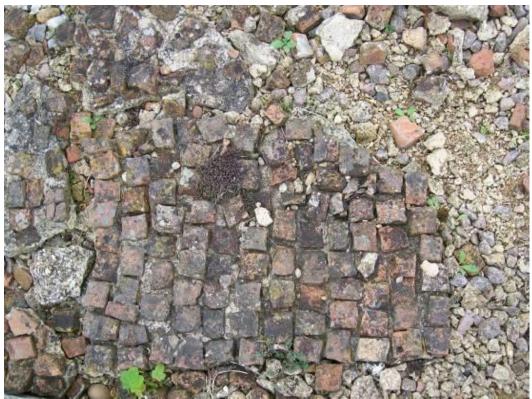
Fragment of Roman mosaic used in building the Norman church (abbey collection on display). Note the white and dark tiles bordered by terracotta tiles on the right edge.

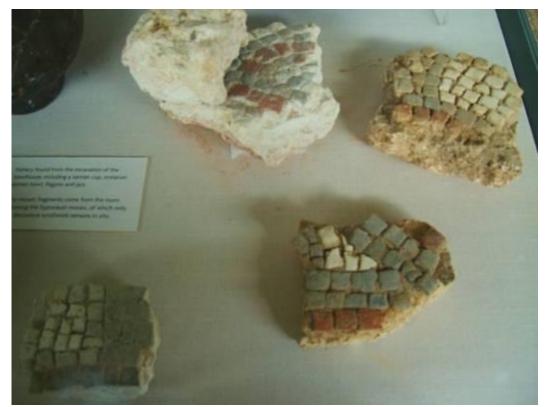
Figure 37: A sample of Roman tile mosaic at the theatre complex at Verulamium.

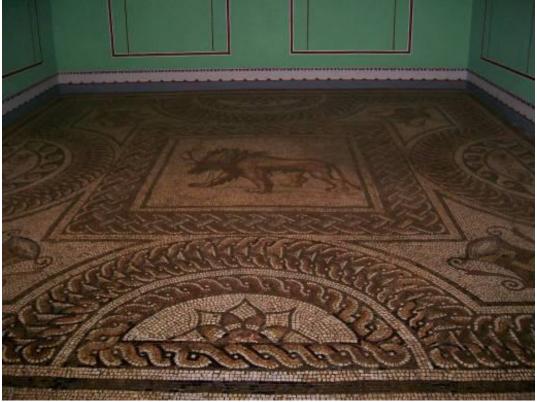
Figure 38: Roman mosaic fragments in the Verulamium museum. Note the similarities with the sample recovered at the abbey.

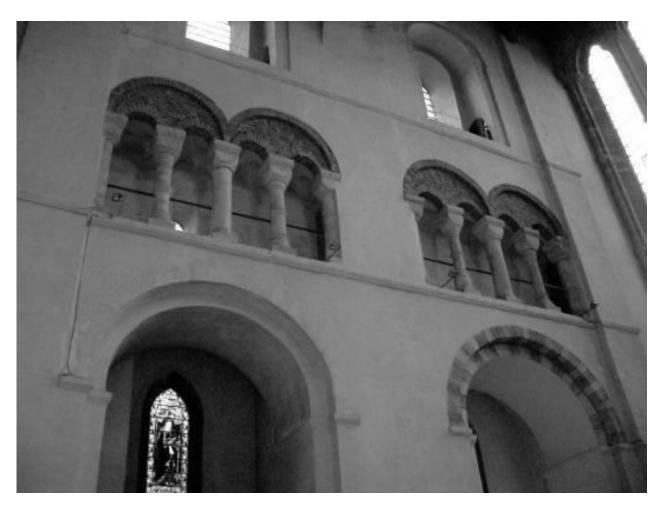
Figure 42: External columns in the Norman tower, possibly of Roman origin. Rosalind Niblett. *Verulamium,* Figure 2.

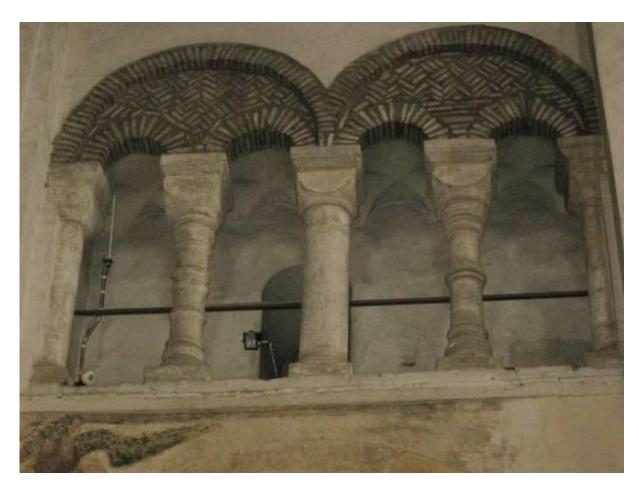
Figure 43: The Anglo-Saxon baluster shafts in the triforium arches of the south transept.

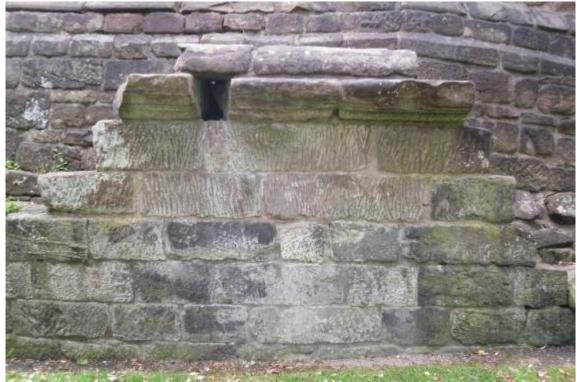
Figure 49:

Section of the Roman wall on the north side of the town (to the east of Northgate) showing the *opus quadratum* construction technique and the elaborate cornice of the fortress wall.

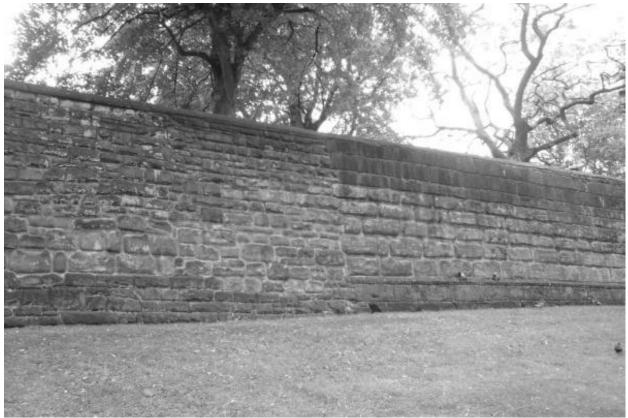
Figure 52: Roman south east corner tower exposed to just above foundation level.

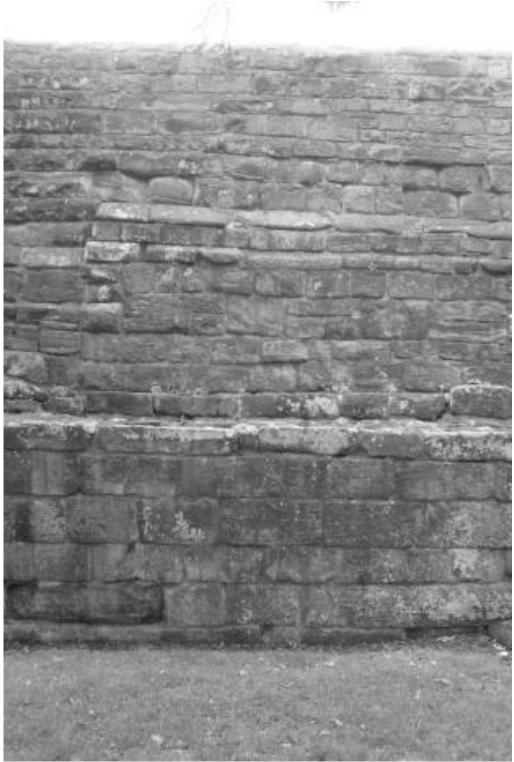
Figure 53: The diverse construction techniques and phases in the Chester city wall.

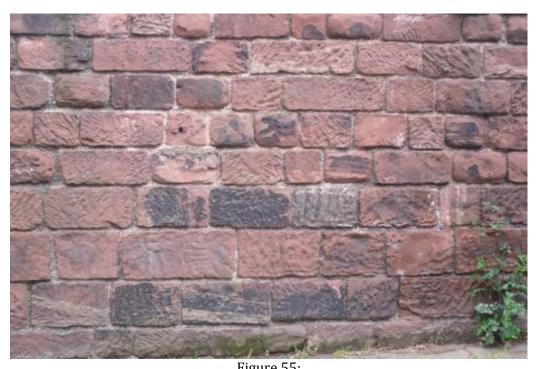
Figure 54: The diverse construction techniques and phases in the Chester city wall.

Figure 54: More construction techniques and phases in the Chester city wall.

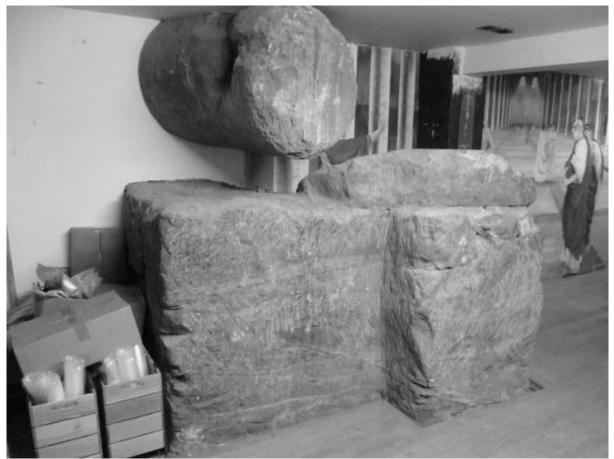
Figure 58: Back wall of the Roman strongroom in the Northern suite of the *principia*, now located in a display room *in situ* at Hamilton Place.

Figure 58: Back wall of the Roman strong room in the northern suite of the *principia*.

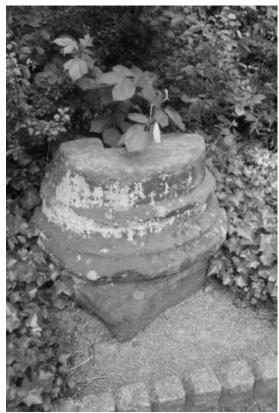
Figure 60: A series of column bases and capitals from excavation of the *principia* on display in Market Square.

Figure 60: A series of column bases and capitals from excavation of the principia.

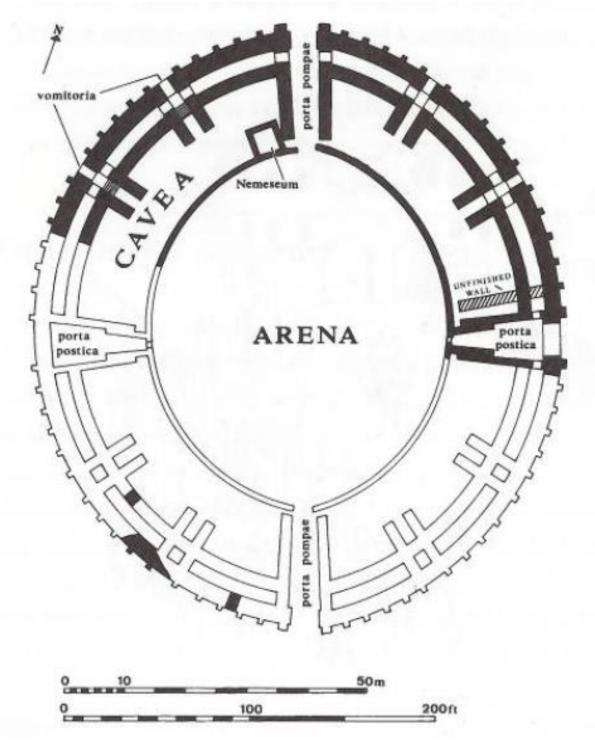
Figure 65: Plan of the Roman amphitheatre in relation to the Norman church of St John's.

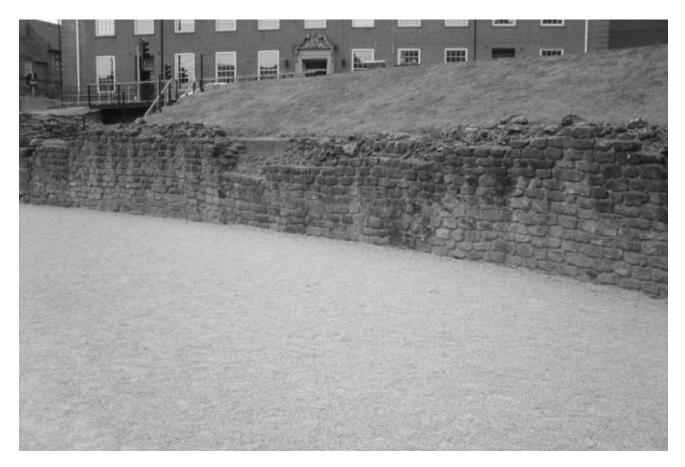
Figure 66: Chester's Roman amphitheatre with the inner and outer walls of the *cavea* marked.

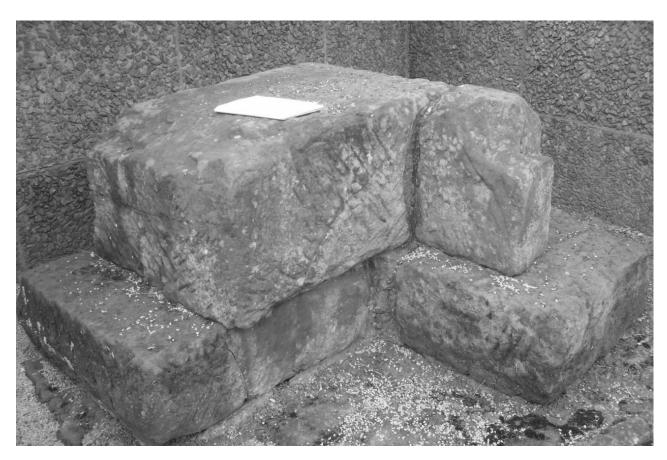
Figure 67: The inner wall or *cavea* of the amphitheatre with the seating bank behind. Note the *cavea* walls do not stand to any substantial height.

Figure 67: The inner wall or *cavea* of the amphitheatre.

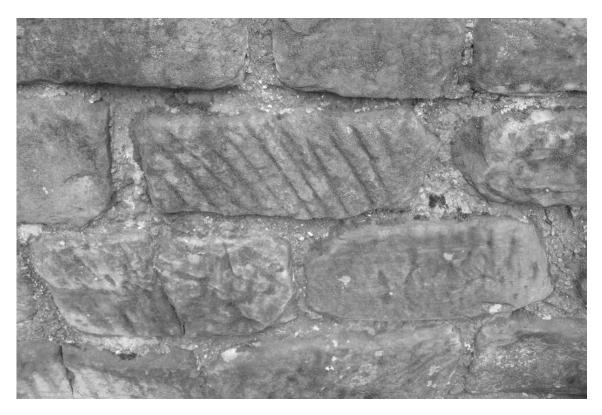
Figure 68: Tooled masonry on large stone blocks inside the north entrance to the amphitheatre. The A4 page rests on top to demonstrate scale.

Figure 68: Tooled masonry on large stone blocks at the amphitheatre.

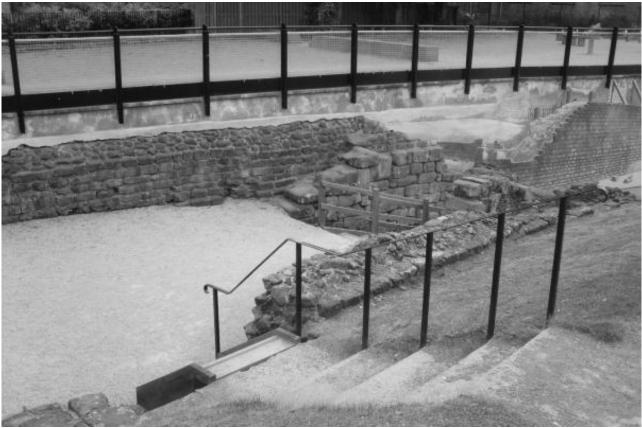
Figure 70: A section of the *cavea* wall, showing the neat finish of the *petit appareil* coursed masonry facing an internal rubble core.

Figure 70: A section of the *cavea* wall, showing *petit appareil* coursing.

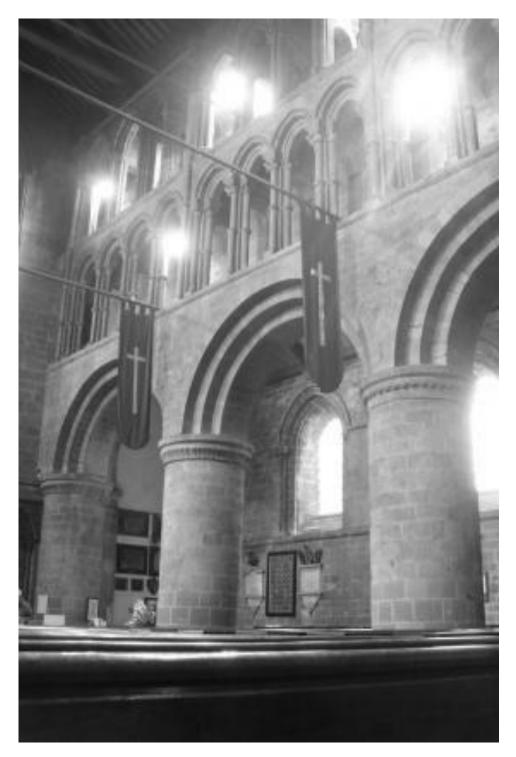
Figure 73: View down the nave towards the crossing of St John's church. Note the blocked eastern end directly after the eastern arch of the crossing. The transept arches form part of the earliest building phase of the church.

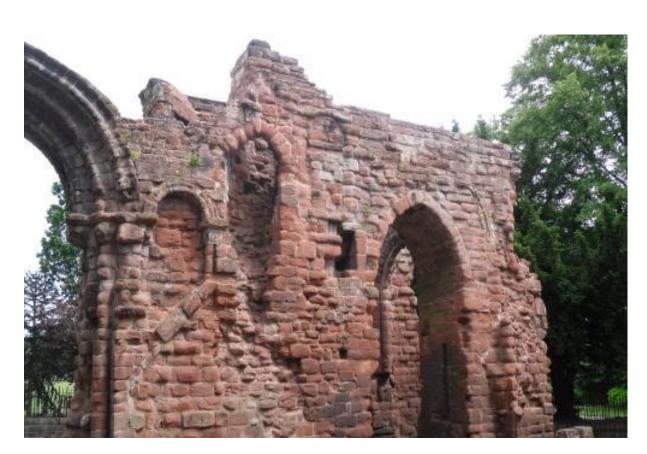
Eastern arm of the church, this view is taken from where the Romanesque apse would have been, looking south. You can see examples of many alterations to the fabric, though the stonework in which this series of arched windows is set corresponds to that in the Romanesque section of the eastern end.

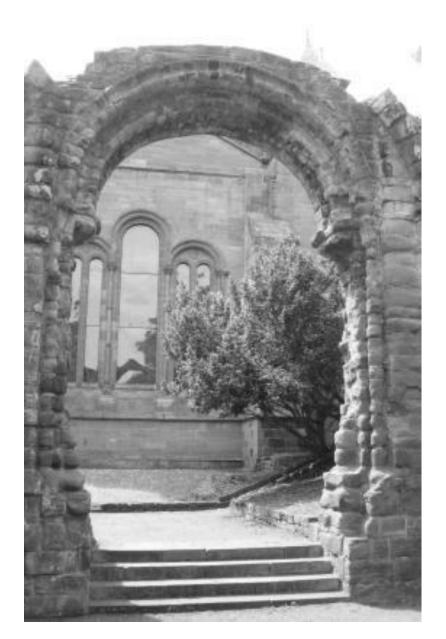
Figure 77:

View of the far east wall demonstrating again the complicated phasing history of the east end of the church. There are evidently some repairs, additions and insertions into this wall, which makes surveying very complicated. Note the curved stairwell entrance in the middle, which Richard Gem proposes dates from the earliest Norman build. The door to the right is a later gothic arch.

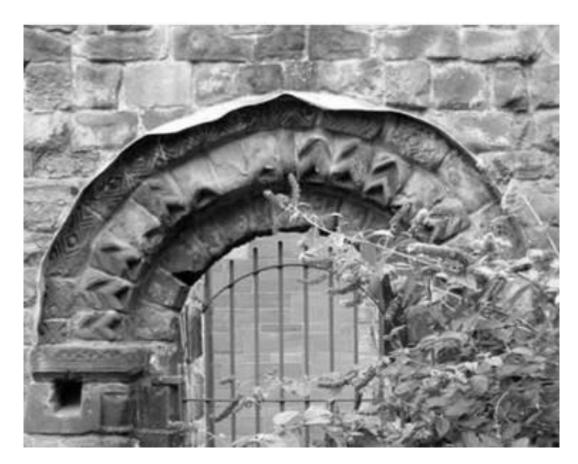
Figure 78: The central Romanesque arch of the east end, with the blocked east end of the current church visible in the background.

Figure 78: The central Romanesque arch of the east end.

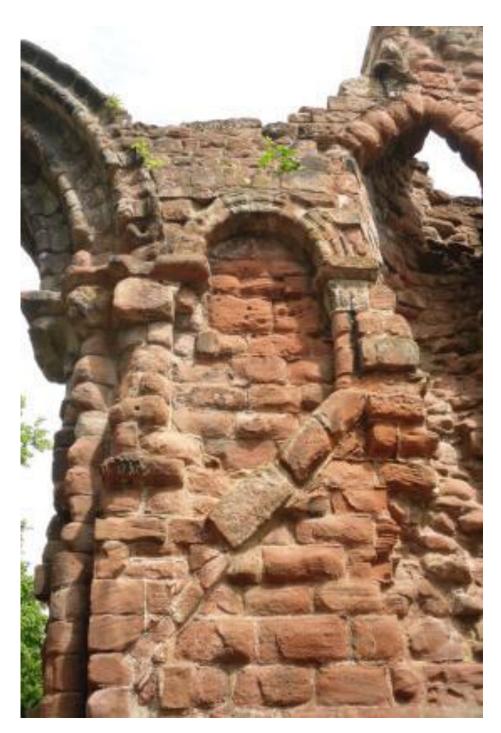
Figure 79: The well-preserved Romanesque window in the first bay of the south aisle of the choir from the outside. Copyright Corpus of Romanesque Sculpture in Britain and Ireland. info-crsbi@kcl.ac.uk.

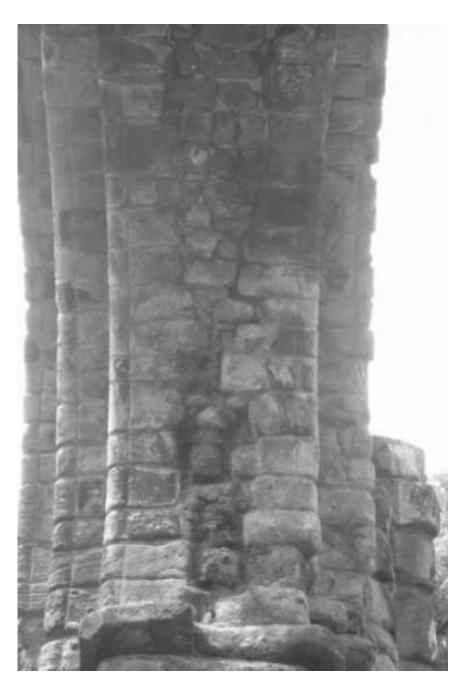
Figure 80: Lewis hole half way up the right hand side of the Romanesque arch and Romanesque blind arcading.

Figure 80: Lewis hole in the Romanesque arch of St John's.

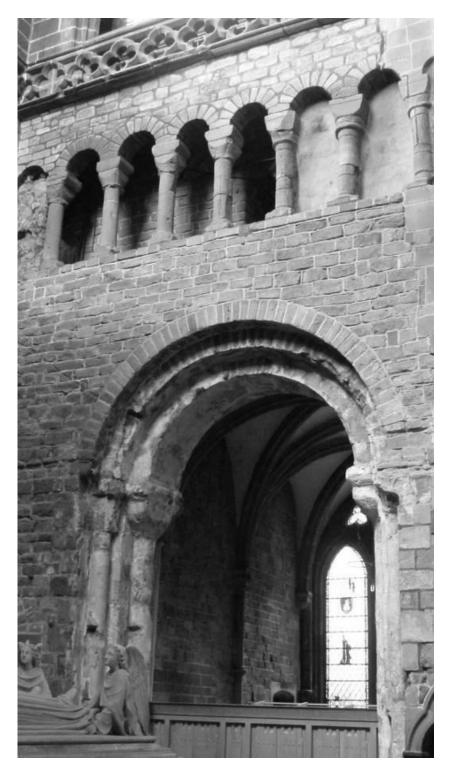
Figure 84: Norman archway leading from the south aisle of the cloister into a blocked entrance in the north transept.

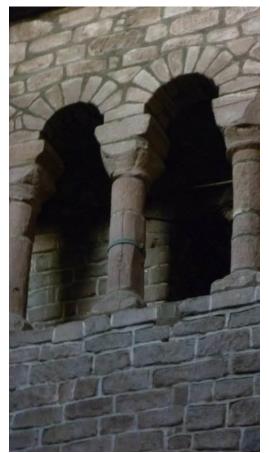
Figure 88: Evidence of plaster on the right hand columns in the arch of the north transept, east wall.

Figure 88: Evidence of plaster on the arch of the north transept.

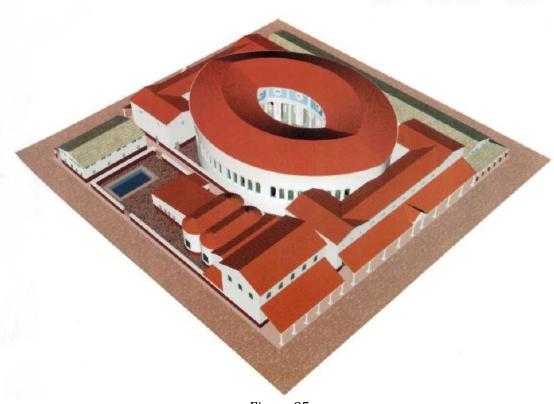
Figure 94: Plan of the Elliptical building at Chester. David Mason, *The Elliptical Building*, p 35.

Figure 94: Plan of the Elliptical building at Chester.

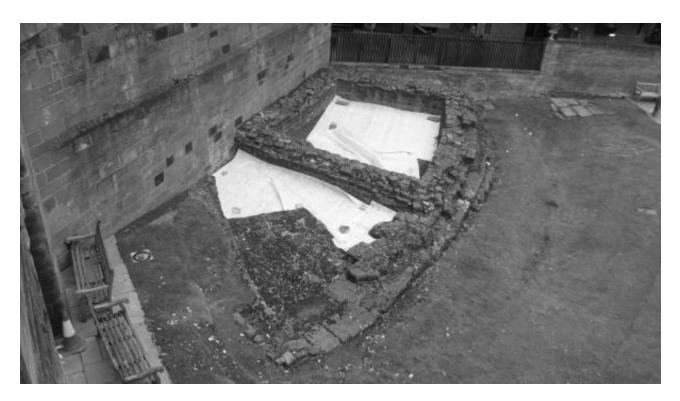
Figure 100: Wall fabric of St Olave's church in Chester. Block size and shape resembles that at St Michael's, most likely salvaged from Roman buildings.

Figure 100: Wall fabric of St Olave's church in Chester.

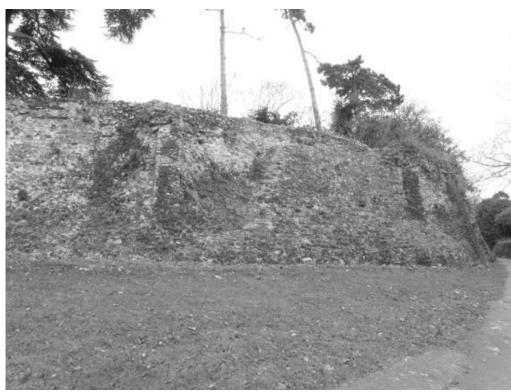
Figure 107:

A section of the Roman wall to the Norman of the Norman keep. There is evidence of several phases of repair, which interrupt the original facing and lines of tile.

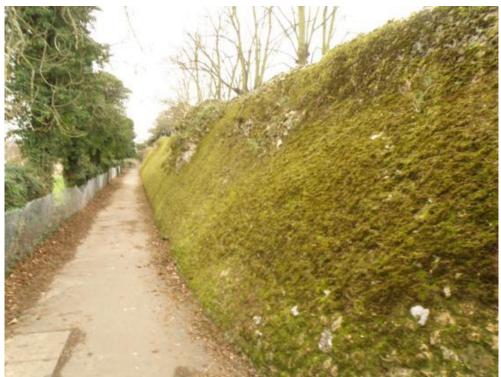
The north-east corner of the town wall. The wall has been completely resurfaced, with buttresses added and Roman decoration removed. This section may have been completely rebuilt.

Figure 108: The north-eastern corner of the town wall.

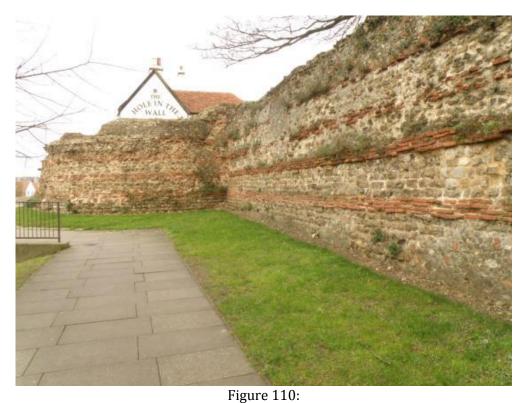
A section of the town wall at the north of Castle Park. This part of the wall may have been robbed of its facing material in order to provide decorative elements for the nearby Norman keep.

Figure 109: A section of the town wall in the north of Castle Park.

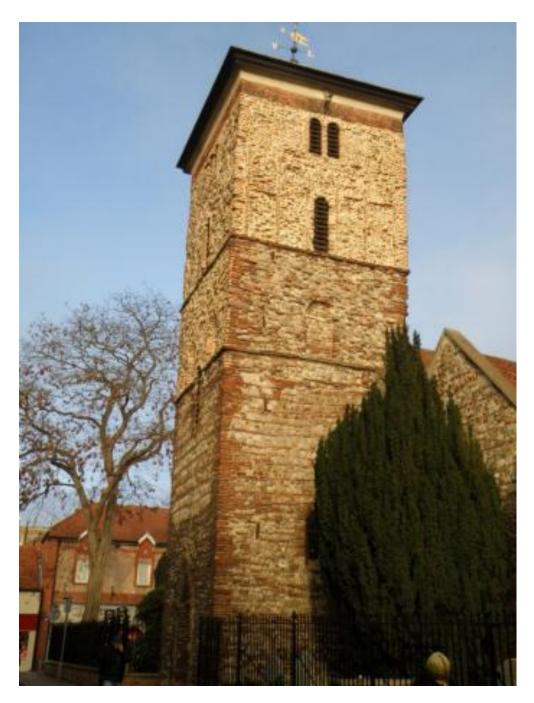
Figure 112: Exterior of St Peter's Colchester, showing extensive re-use of Roman tile and rubble.

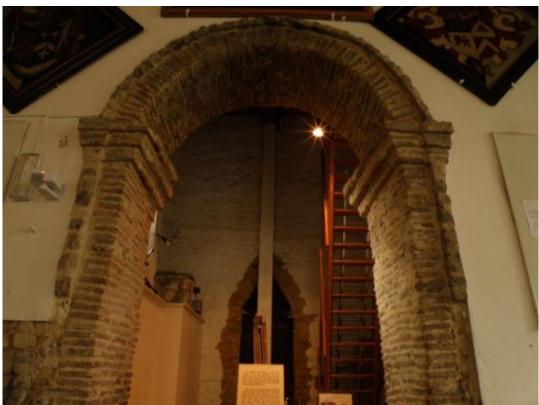
Figure 114: The lower section of the western tower, Holy Trinity, Colchester showing the use of *tegulae* in the quoins of the tower.

Figure 114: The lower section of the western tower, Holy Trinity.

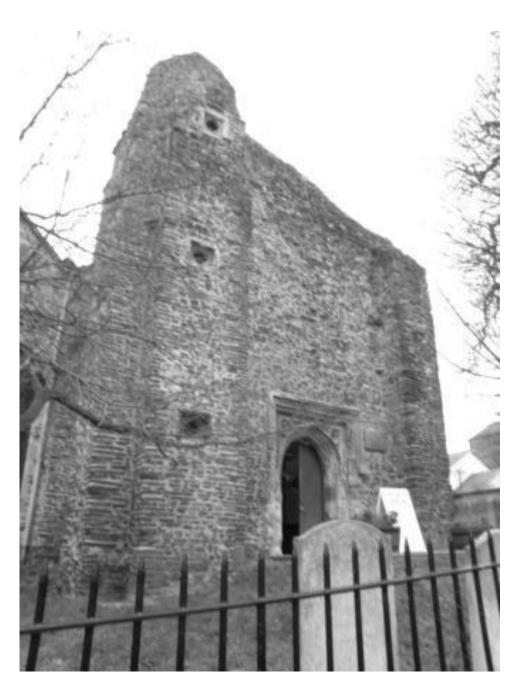
Figure 117: Exterior of All Saints' Colchester, showing extensive re-use of Roman tile and flint rubble.

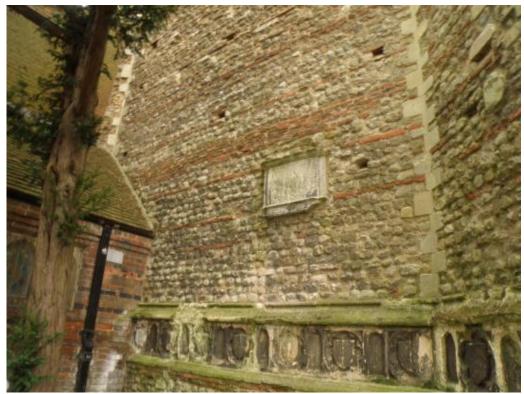
Figure 119 :

The interior of the west tower of St Martin's, showing extensive re-used Roman building material (and general spoliated rubble).

Figure 119: The interior of the west tower of St Martin's.

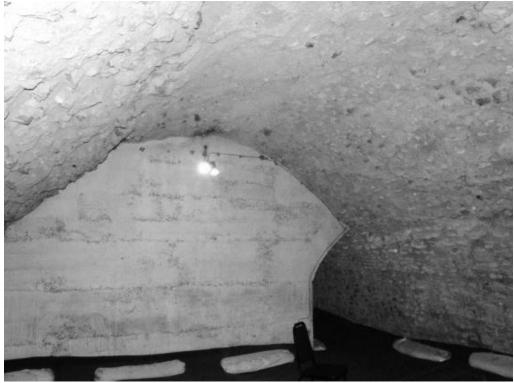
The podium of the Roman temple of Claudius lies underneath Colchester Castle. The walls of the Norman castle clasp the podium completely on three sides. Phillip Crummy, *City of Victory*, p 147.

Figure 122: The podium of the Roman Temple of Claudius.

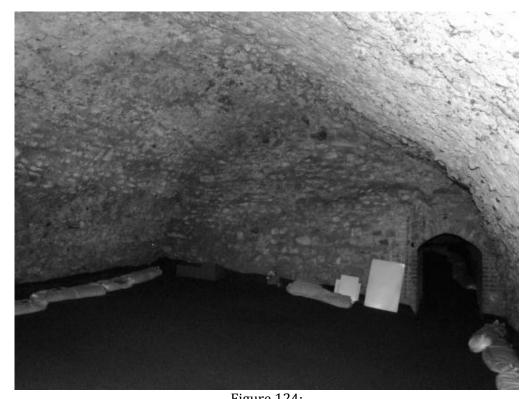
Figure 123: The Roman crypts. The middle west chamber, with modern concrete buttress.

Figure 123: The Roman crypts. The middle-west chamber.

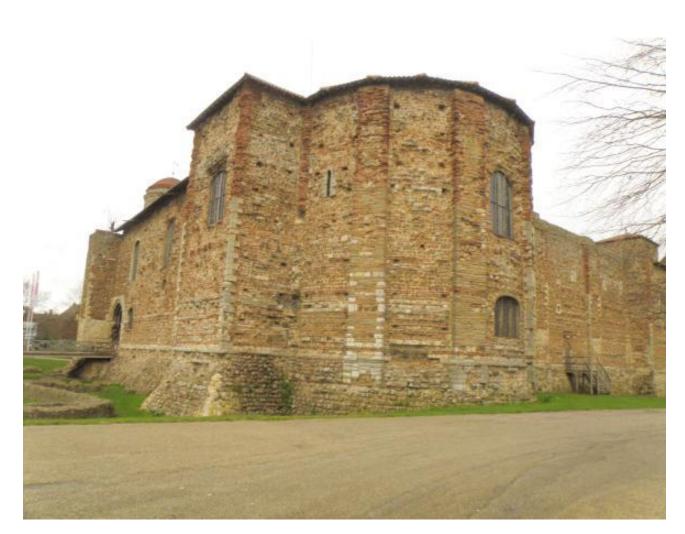
Plan of Colchester Castle showing how the underlying Roman fourth century 'raft' extension affected the upper floors and layout of the chapel. Phillip Crummy, *Aspects of Anglo-Saxon and Norman Colchester*, figure 67.

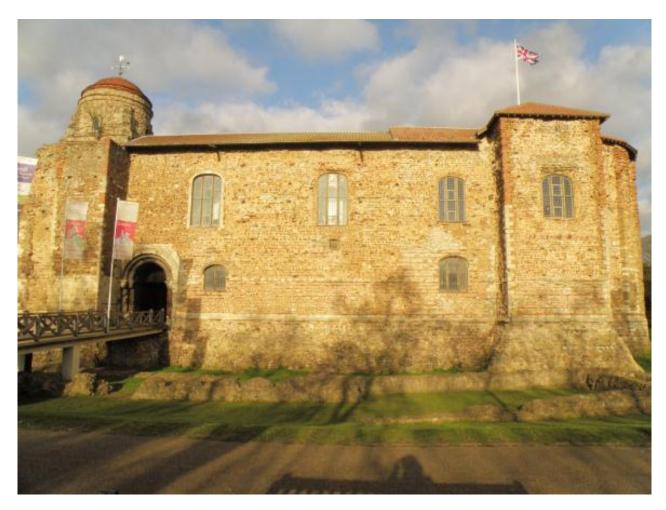
Elevation of Colchester castle showing the original intention, the early castle, the late eleventh-century change of plan and the castle as it was probably built. Phillip Crummy, *City of Victory*, p 147.

Figure 128: Elevation of Colchester castle showing the original intention.

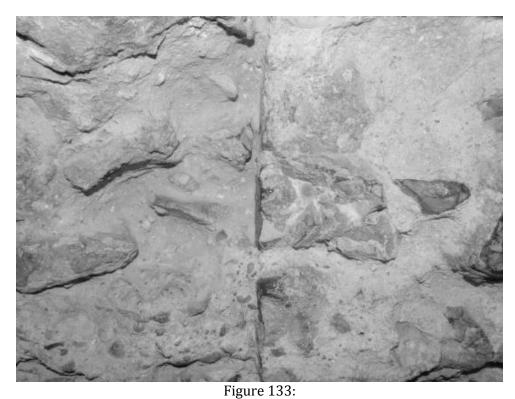
Figure 132:

Cracks appeared in the excavated vaults of Colchester Castle following heavy rains in 1931, directly underneath the main interior wall. This shows that the Normans believed the podium to be, if not solid, then of a sufficiently load-bearing capacity to support large masonry walls. However, they not build the main exterior walls on the podium.

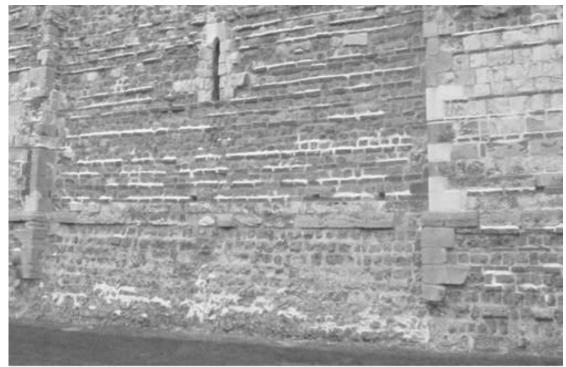
Note that the stone quoins do not extend higher than the first phase of building. This may indicate that this particular supply of Roman stone ran out early in the building of the west wall of the keep.

Figure 135: Stone quoins which do not extend higher than the first phase of building.

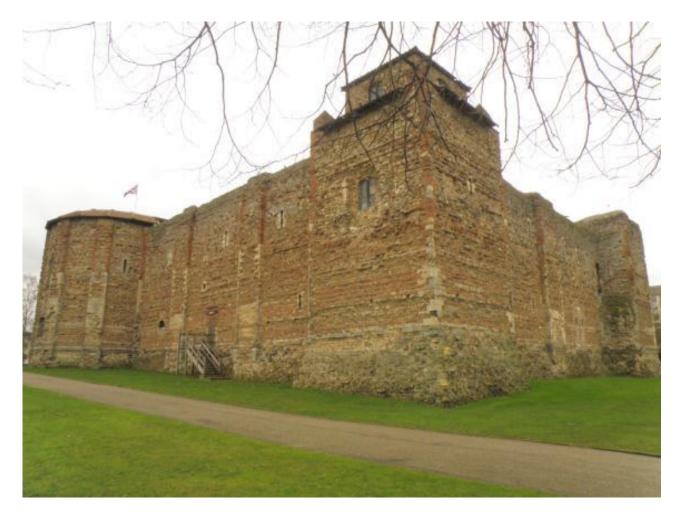
Figure 139:

In some places in the east wall, the tiles are confined to a single layer. This does not match the polychromy found in the nearby Roman walls, where several layers of brick are interspersed with the flint.

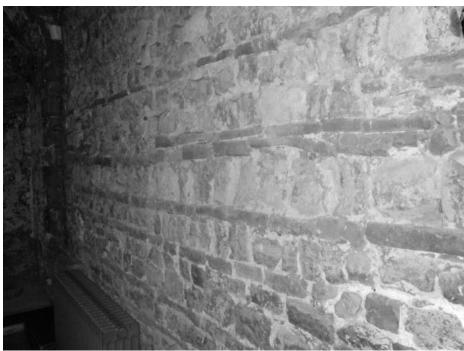
Section of the Roman wall near the Balkerne Gate. The selection and use of *petit appareil* stone interspersed with Roman brick was a decorative technique copied by the Normans.

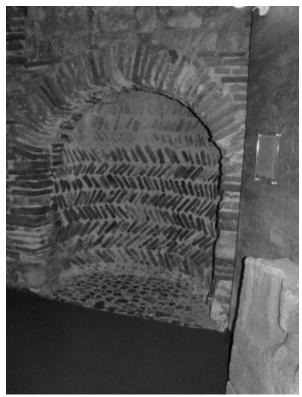
Herringbone decoration made out of Roman bricks adorns the first floor internal wall. It is not known whether this surface was plastered, but the deliberate decoration using the rarer Roman *tegulae* suggests that it wasn't.

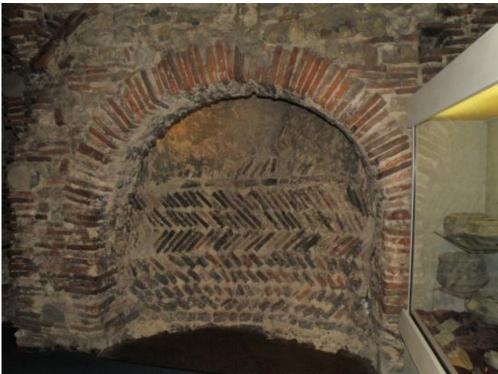
Figure 144: All of the castle's fireplaces, on each floor, were constructed out of Roman tiles arranged in decorative herringbone patterns.

Figure 144: Colchester Castle fireplaces constructed out of Roman tiles.

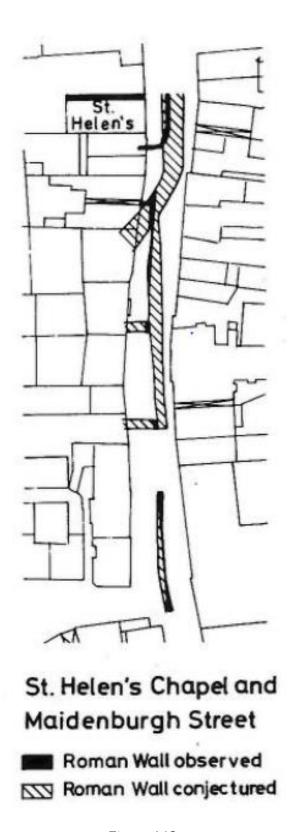
Figure 147: Plan of the Roman theatre of Colchester, with the area of St Helen's and the excavated remains marked in darker shading.

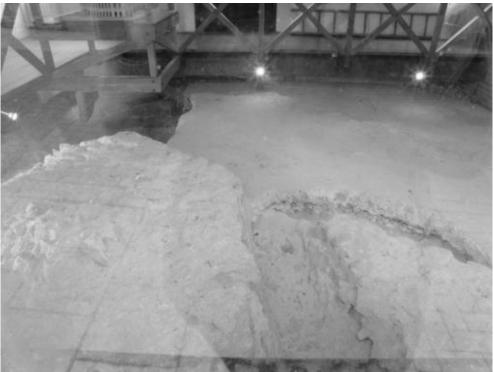
The line of the outer wall of the Roman theatre was built as a dark section of bricks into the surface of Maidenburgh Street. The inner wall of the theatre is underneath St Helen's church, further down the street on the left.

Figure 149: The line of the outer wall of the Roman theatre in Maidenburgh Street.

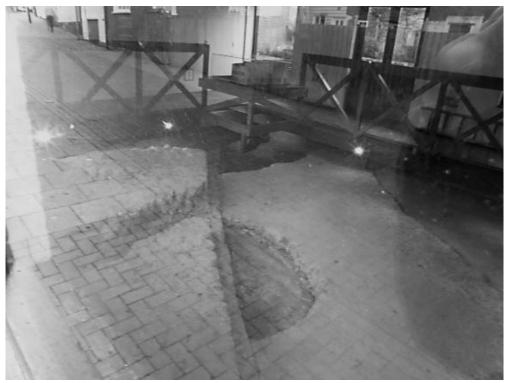
Figure 150:

The Roman theatre of Colchester. Remains of the internal corridor can be seen as the flat surface in the middle ground, the foundation of the outer wall of the theatre is the raised area in the foreground.

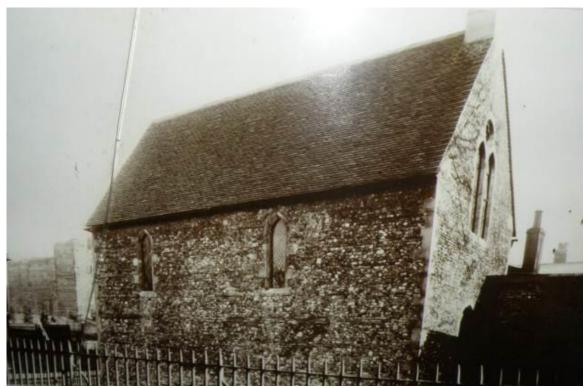
Figure 153: Roman masonry at the lowest levels of the north wall of St Helen's chapel.

Figure 153: Roman masonry at the lowest levels of the north wall of St Helen's chapel. Figure 154: A photograph of St Helen's chapel taken in 1892.

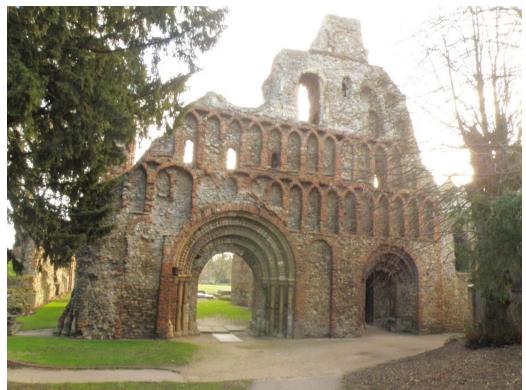
The town wall adjacent to St Botolph's is of a different character to the rest of the Roman walls, suggesting a later date for construction and a possible source of building stone for the twelfth-century monasteries.

Figure 161: The town wall adjacent to St Botolph's was a source of building stone.

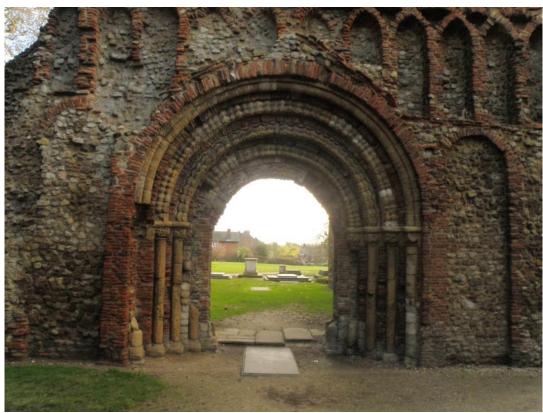
Figure 162: The west front of St Botolph's Colchester. Note the arches, doorways, window frames, and quoins constructed out of recycled Roman tegulae.

Figure 162: The west front of St Botolph's Colchester.

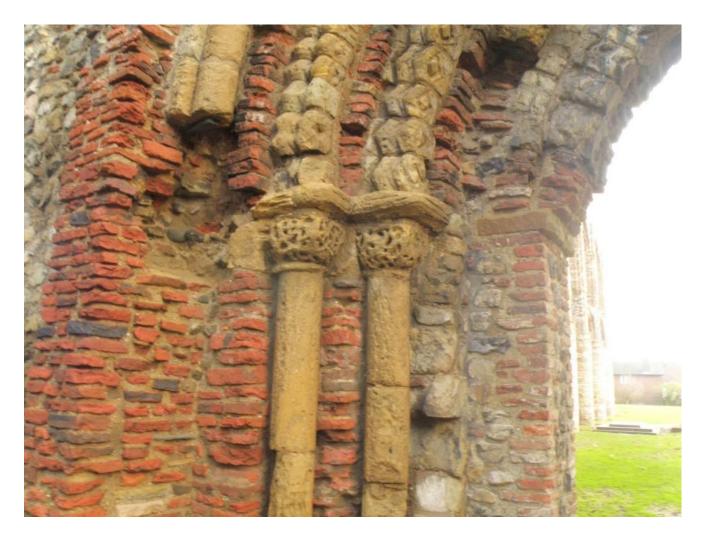
Figure 163: The late-Romanesque central doorway in the west front of St Botolph's, Colchester. The decorative relief is carved Caen stone, interspersed with Roman tegulae.

Figure 163: Caen stone and Roman tegulae in the late-Romanesque west front.

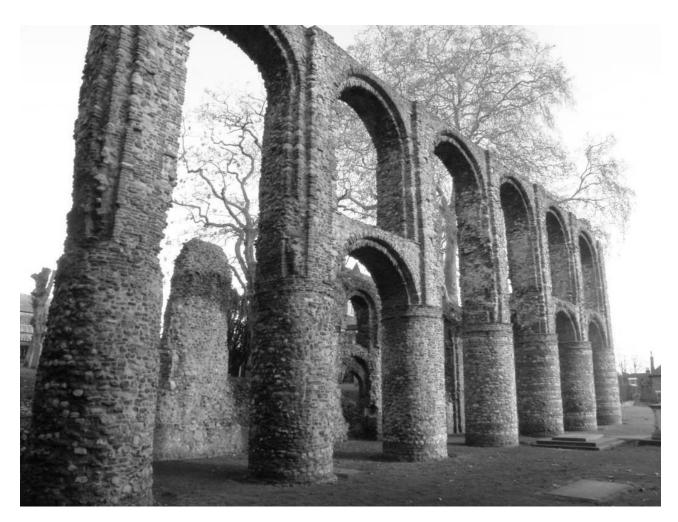
Figure 164: The decorative scheme at St Botolph's may have involved the lime rendering of the exposed Roman brickwork.

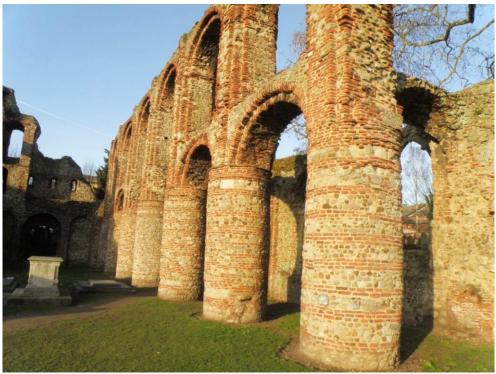
Figure 165: The nave pillars near the west door at St Botolph's show evidence of rubble construction or repair.

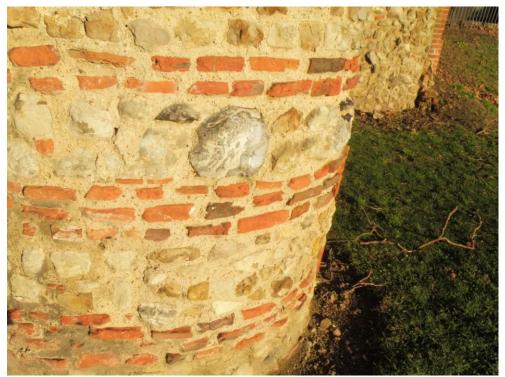
But at the crossing end of the nave, the Romanesque pillars clearly show the rubble and tile polychrome striation reminiscent of Roman buildings.

Figure 166: Romanesque pillars show the polychrome striation of Roman buildings.

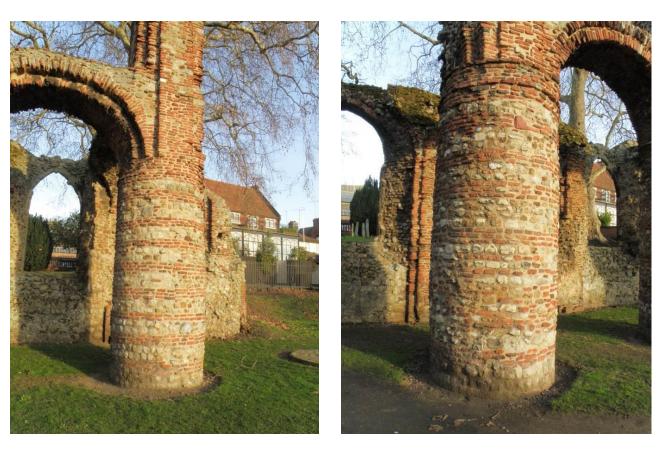
Nave pillars towards the crossing on the north side of St Botolph's show evident polychrome banding. This may have helped keep levels even when building with rubble, but it is difficult to see how this construction technique could be anything other than intended for decorative effect.

Figure 167: Polychrome banding on nave pillars towards the crossing.
