**FRETTING-CREVICE CORROSION OF CEMENTED METAL ON
METAL TOTAL HIP REPLACEMENTS**

Submitted in accordance with the requirements for the degree of
Doctor of Philosophy

The University of Leeds
School of Mechanical Engineering
Leeds, UK

August, 2013

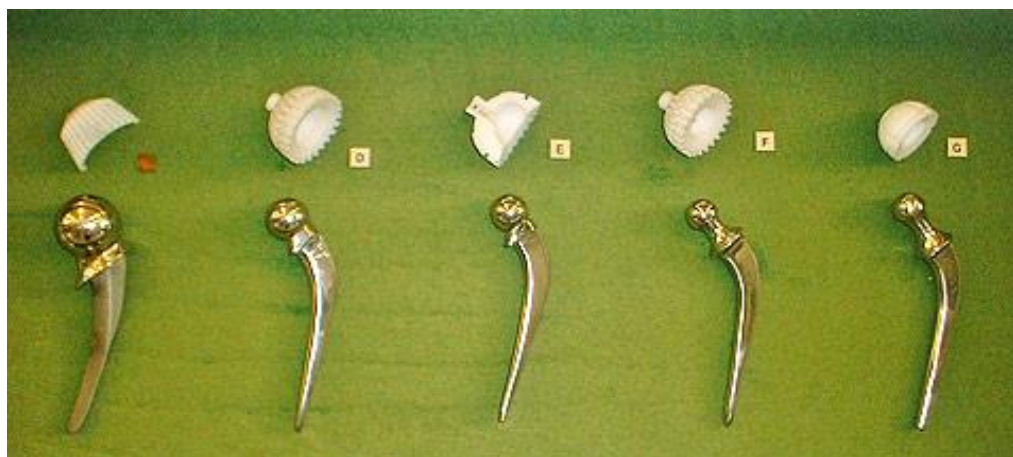
Figure 1-1 - Evolution of the Charnley Low Friction Arthroplasty[1]

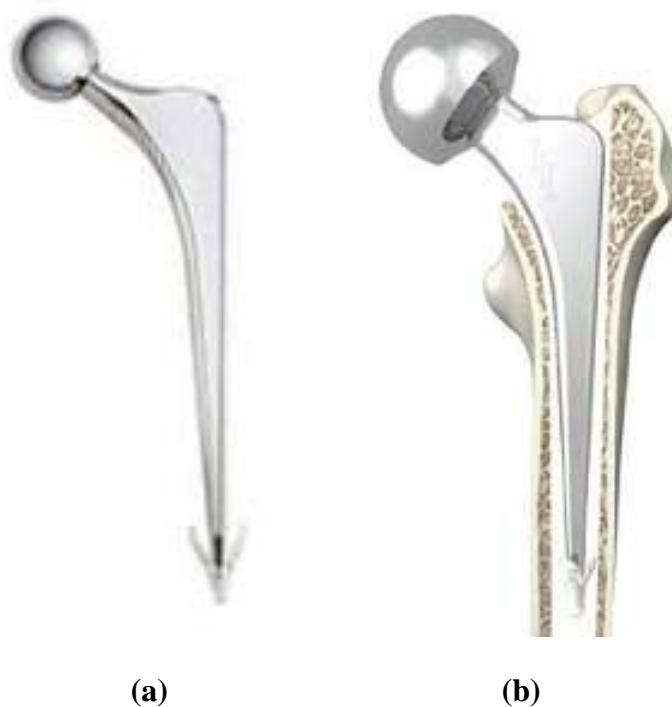
Figure 2-5 – a) Exeter modular femoral stem b) schematical view of a cemented Exeter femoral stem with large diameter head.

During the design process of a THR there are many factors that must be taken into consideration.. Anatomic stems have been available on the orthopaedic market for over 20 years [28-30]. Anatomically designed stems usually consist of a proximal medial lateral flare and a distal section. One of the most popular cemented anatomic stems implanted in the UK today is Exeter V40 (Figure 2-5) [30]. Fowler et al [29] explained that the Exeter was the first polished, collarless, double taper geometry stainless steel hip to be introduced in the early 1970s. Although the results for this stem were good for this time, the design was later adjusted in 1976 due to an increased amount of stem fracture. Advances in materials and processing saw the Exeter stem further evolve, with changes in surface finish and material type being adjusted [31].

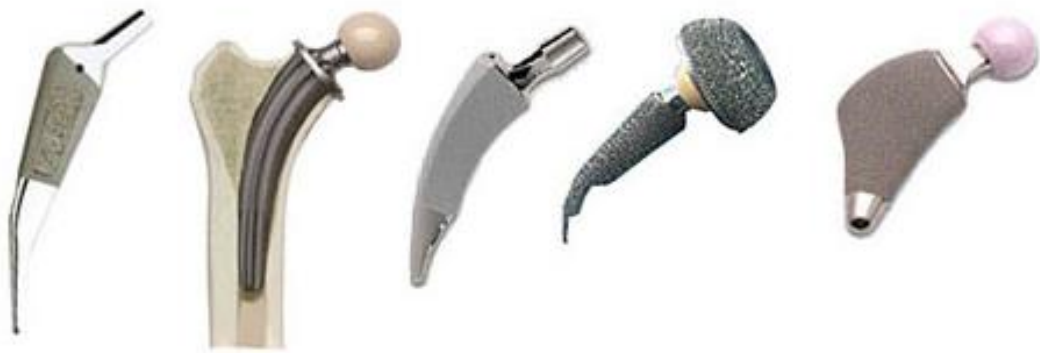
Figure 2-6 - Variety of short stemmed components currently available in the United Kingdom (Image taken from DePuy international promotional material)

Although initial device design has existed since the ninetieth century, an increased demand for THA in young and active patients has seen the development for a new generation of short or stem less THRs (Figure 2-6). There are numerous benefits from a shortened or no distal stem, some of which include; better load distribution in the medial, lateral anterior and posterior walls of the femur, optimum control of axial and torsion stresses, excellent control of calcar and lateral flare, bone stock preservation and an easier surgical procedure. It has been shown that cementless, anatomically designed femoral components can provide satisfactory, early pain relief and function in a more younger and active patient population [32, 33].

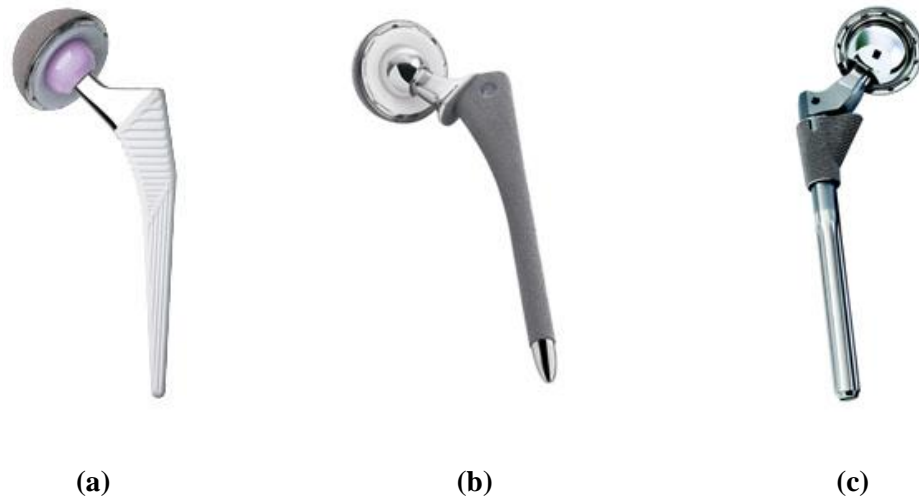
Figure 2-9 - Typical THR (a) Ceramic-on-Polymer (b) Metal-on-Polymer (c) Metal-on-Metal (Image taken from DePuy international promotional material)

Along with different types of materials and fixation methods, there are also numerous bearing materials and combinations that need to be considered during the design of an implant. The common combinations of bearing materials are shown below in Figure 2-9. Although extensive research into the suitability of orthopaedic bearing materials has been conducted, the suitability of MoM bearings still remains controversial. June 2007 saw a MHRA medical device alert issued on the DePuy MoM Bearing followed by another MHRA medical device alert issued for all MoM hip replacements in April 2010. Reports of soft tissue reaction and unexplained hip pain have been associated with MoM THR [51].

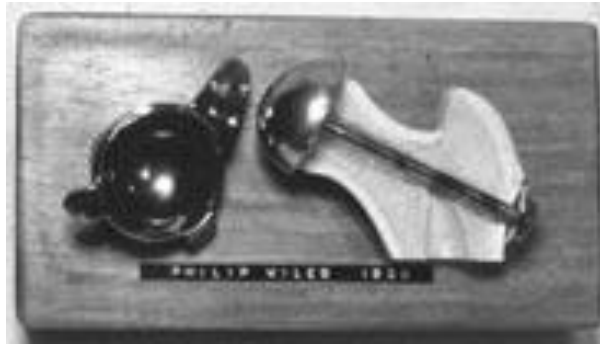
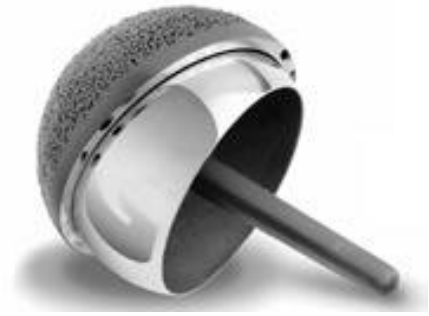
Figure 2-10 – a) Wiles' acetabular cup and resurfacing of the femur. First generation MoM and b) modern MoM hip resurfacing [1]

Metal-on-metal was used in the early stage of THR, although not all old designs were successful. The first generation of MoM THR were designed and developed by Philip Wiles in 1938 [52]. However these implants were largely unsuccessful due to the poor quality of material which was primarily stainless steel, poor manufacture and lack of adequate fixation within the body. However with the introduction of methyl methacrylate bone cement in the 1960s by Sir John Charnley and the development of new materials, the 2nd generation of MoM THR were developed. Weber et al [53] was one of the first to realise that in fact the low wear rates of MoM THRs could be related to a reduction in loosening. Chan et al [54] explains that 2nd generation MoM implants are traditionally manufactured from surgical grade CoCrMo alloys because of their corrosion resistance and hardness. Cobalt based alloys are generally well suited as self-bearing materials. They are known for a certain self-healing capacity, the ability to polish out visible surface scratches with continued wear cycles rather than to experience a progressive deterioration of the surface topography leading to accelerated wear [55].

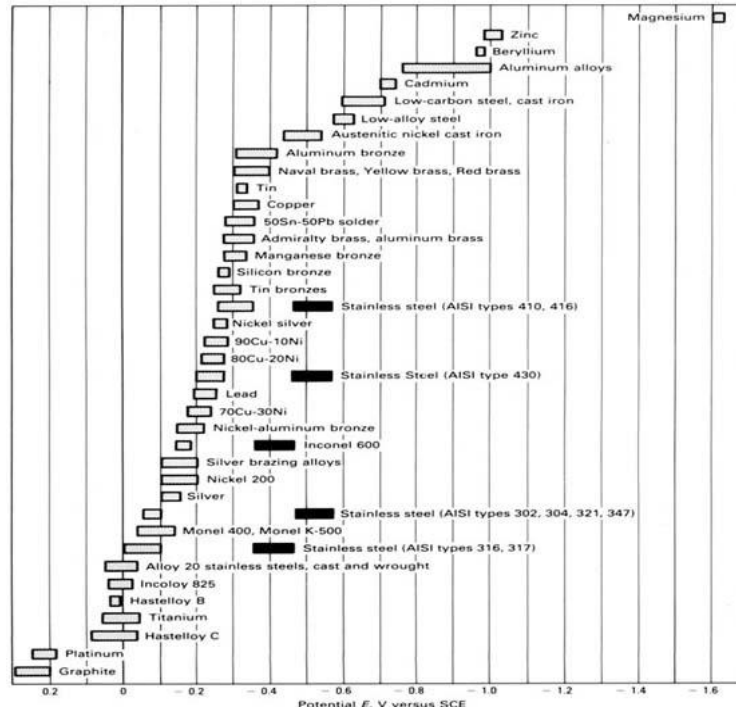
Figure 2-13 - Galvanic series of various metals in salt water according to ASTM G82-98

Galvanic corrosion occurs when a potential difference is established between two electrically connected metals immersed in a corrosive or conductive solution according to Ohm's law. This potential difference results in an electron flow between the metals usually resulting in accelerated corrosion of the more susceptible alloy (anode) and protection of the other alloy (cathode). The tendency of a material to corrode can be predicted from the standard emf electrode potential of the metals and the alloy is ranked according to its tendency to corrode. This is known as the galvanic series. This is typically used to predict which materials will preferentially corrode, with the alloy with the lowest electrode potential becoming the anode in the couple. Galvanic corrosion can be affected by numerous factors such as distance from anode to cathode, anode:cathode area ratio and the environment [79].

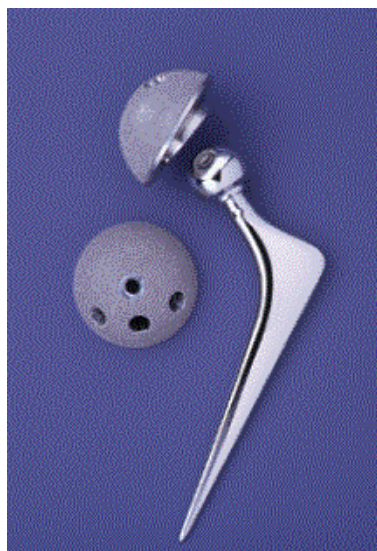
Figure 4-1 - Ulitma TPS™ MoM total hip replacement used in the Norwich cohort

The research work in this thesis was developed around the need to understand a particular failure around Metal-on-Metal Total Hip Replacements. This chapter outlines the particular failure and a review conducted by the candidate of the retrievals. The Ultima TPS™ (DePuy International, Leeds) hip was one of the first second generation Metal-on-Metal hip replacements to be developed and consisted of a collarless, tapered, highly polished wrought low carbon (LC) CoCrMo femoral stem with a 12/14 modular taper. A 28mm MoM articulation was utilised in this cohort consisting of a wrought LC CoCrMo Ultima femoral head and a wrought high carbon (HC) CoCrMo taper lock acetabular insert. A porous coated Ti-6Al-4V Acetabular outer shell with three holes for supplementary fixation was used. Figure 4-1 demonstrates the system that was implanted in the cases presented by Donnell *et al* [4].

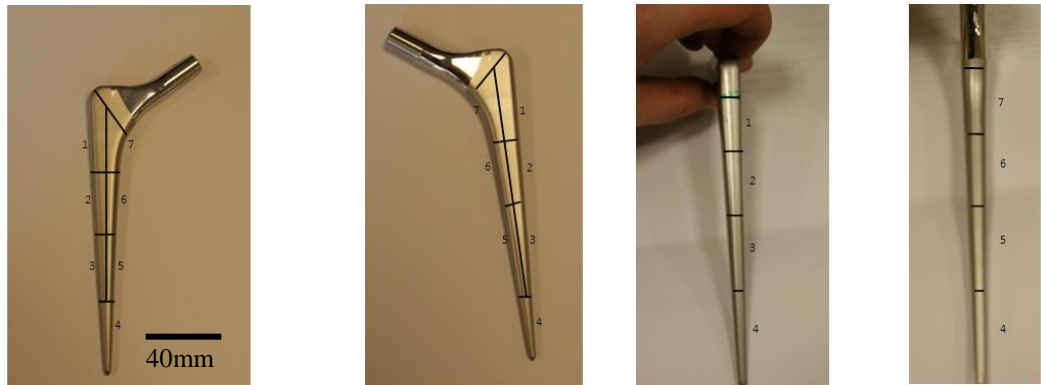
Figure 4-2 - Location and orientation of Gruen zones used to map fretting corrosion in this study

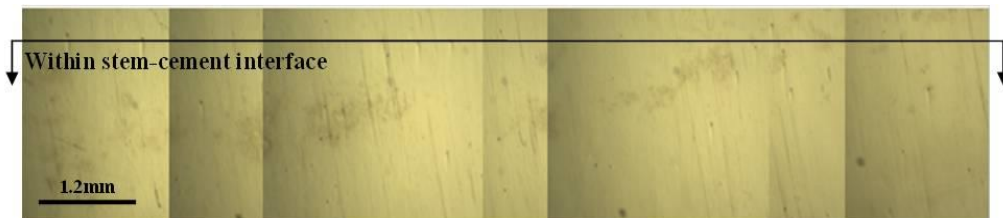
Figure 6-12 – Stem-cement interface of forged polished LC CoCrMo Ulitma TPS stem after 60 days immersion with antibiotic free bone cement

Upon retrieval of the immersed stems, a contrast in localised corrosion could be seen on all of the stem surfaces. Figure 6-12 demonstrates the corrosion profile of a polished femoral stem cemented with non-antibiotic PMMA bone cement. Although surface analysis of polished femoral stems found that localised corrosion

had initiated within the stem-cement crevice after 60 days immersion, the propagation of localised corrosion was not extensive. Light microscope analysis on other areas of the stem demonstrated that localised corrosion had occurred within the stem-cement crevice. Again these areas of localised corrosion were not extensive after 60 days of immersion. Antibiotic bone cement was seen to increase localised corrosion found at the stem-cement interface (Figure 6-13). Surface analysis was also conducted on the vaquasheened immersion tests. After 60 days immersion, femoral stems with an increased surface roughness indicated little to no localised corrosion had taken place within the stem – cement crevice (Figure 6-14).

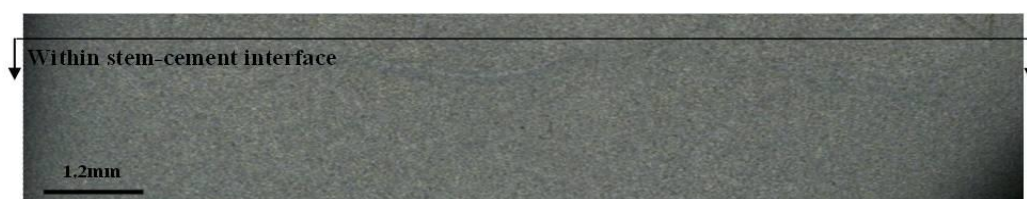
Figure 6-14 - Stem-cement interface of forged vaquasheened LC CoCrMo Ulitma TPS stem after 60 days immersion with antibiotic bone cement

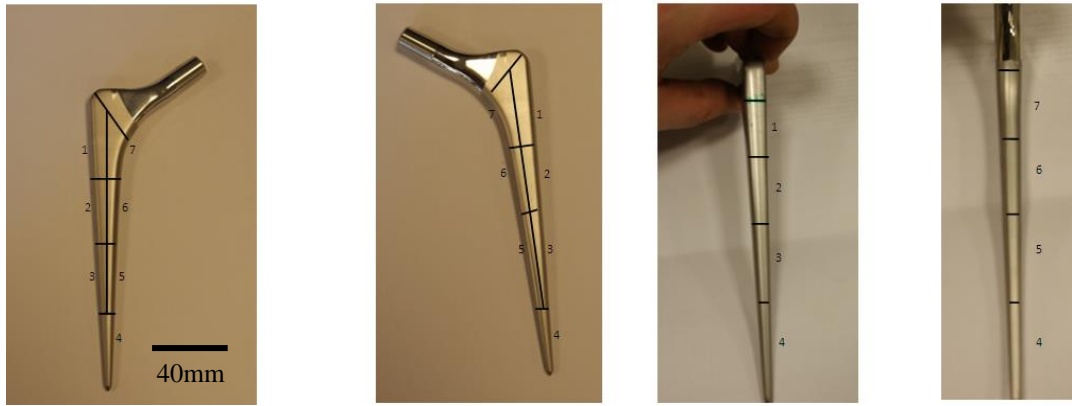
Figure 9-28 - Location and orientation of Gruen zones used to map fretting corrosion

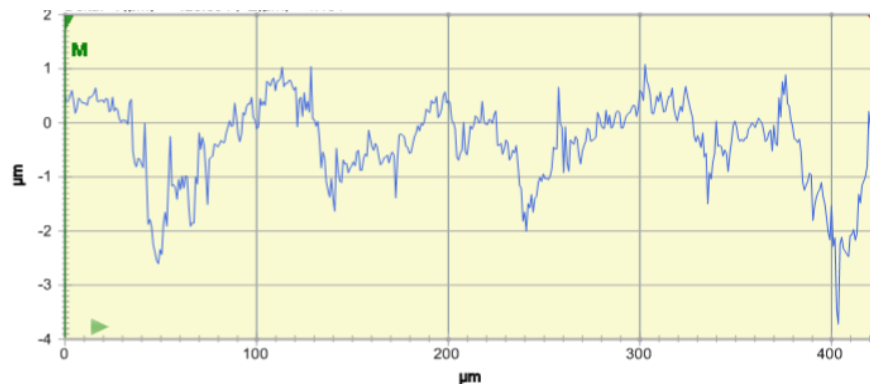
(b)

Figure 9-38 - 2D surface morphology of roughened femoral stems in a) SR1 and b) SR2 regions after 500,000 cycles

Figure 9-37 shows the 3D interferometry results for roughened femoral stems and the adjacent PMMA bone cement when subjected to cyclic loading. Table 9-4 demonstrates the different surfaces values obtained from the analysis. For the metallic femoral stem, S_a and S_q was not seen to differ between worn and unworn regions with analysis demonstrating the same amount of peaks and troughs around the mean plane of analysis. An increase in S_z was seen between the SR1 and SR2. For the SR1, S_z along with S_{sk} measurements demonstrate large surface irregularities in the positive direction suggesting ploughing and plastic deformation of the surface. For surfaces that had not been affected by wear or corrosion (SR2), S_z and S_{sk} measurements suggested the height between the maximum and minimum peak was lower, as well as the surface irregularities skewed in the negative direction when compared to SR 1. Interferometry analysis demonstrated that distal areas unaffected by wear and corrosion displayed similar surface values as virgin surfaces. This can be seen in the 2D line traces presented in Figure 9-38.
