THE INFLUENCE OF CHLORIDE ON THE  
THAUMASITE FORM OF SULFATE ATTACK IN  
MORTARS CONTAINING CALCIUM CARBONATE

A THESIS PRESENTED FOR THE DEGREE OF DOCTOR OF PHILOSOPHY

DEPARTMENT OF CIVIL AND STRUCTURAL ENGINEERING  
CENTRE FOR CEMENT AND CONCRETE  
FACULTY OF ENGINEERING  
THE UNIVERSITY OF SHEFFIELD

AUGUST 2004

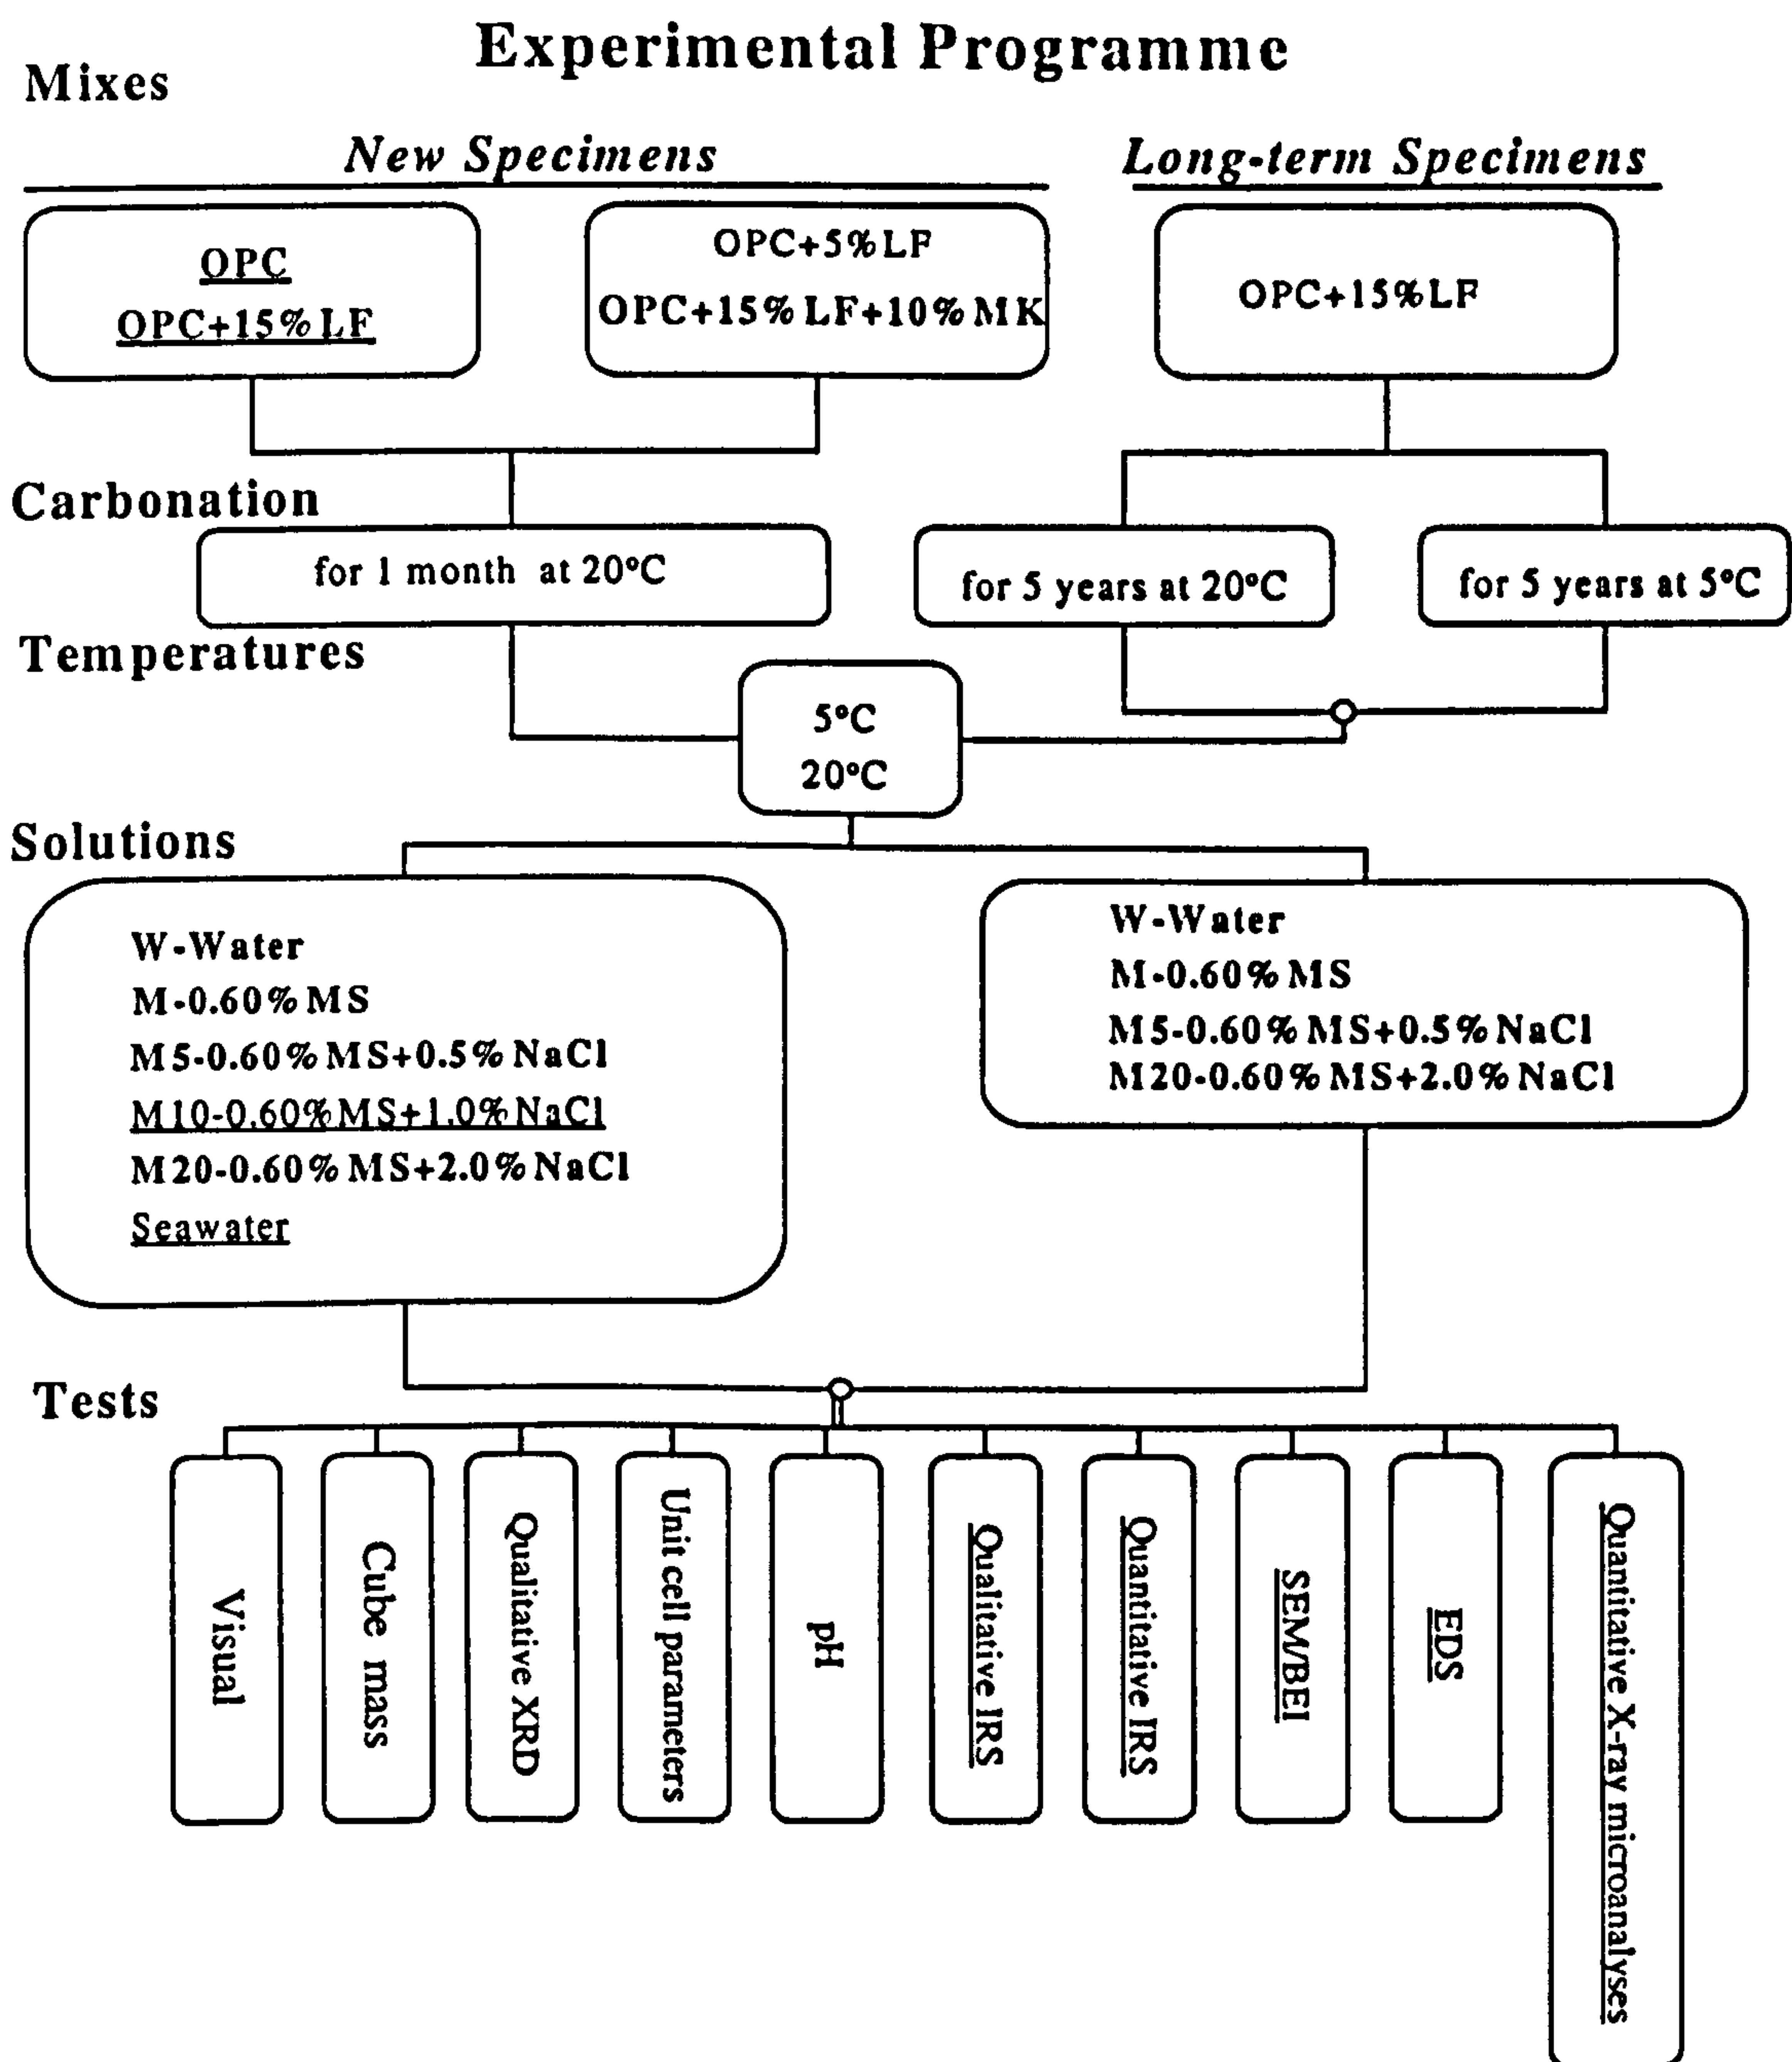
Figure 3.1: Schematic view of the experimental programme. (LF): amount of limestone filler in %; (MK): metakaolin; (MS): magnesium sulfate; (XRD) X-ray diffraction; (IRS): Infrared spectroscopy; (SEM/BEI): scanning electron microscopy/ backscattered electron image; (EDS): energy dispersive x-ray; underlined solutions and tests were applied to the underlined mixes.

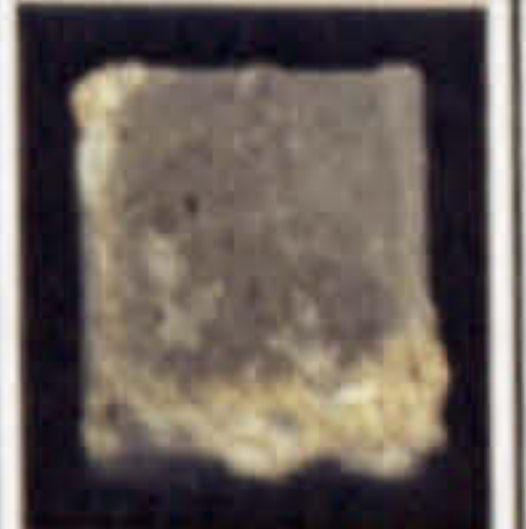
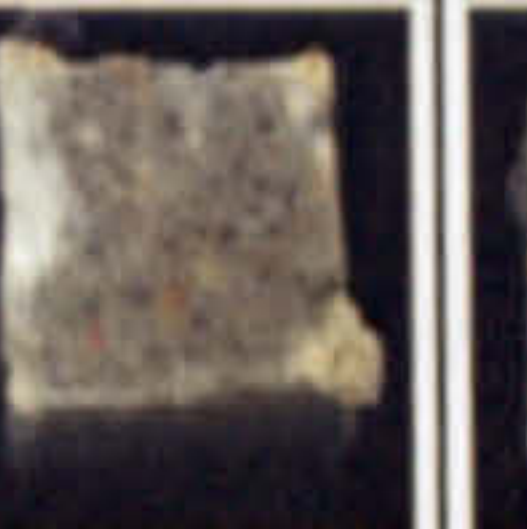
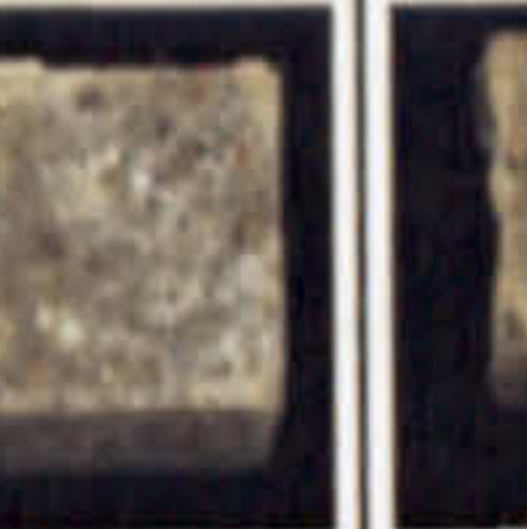
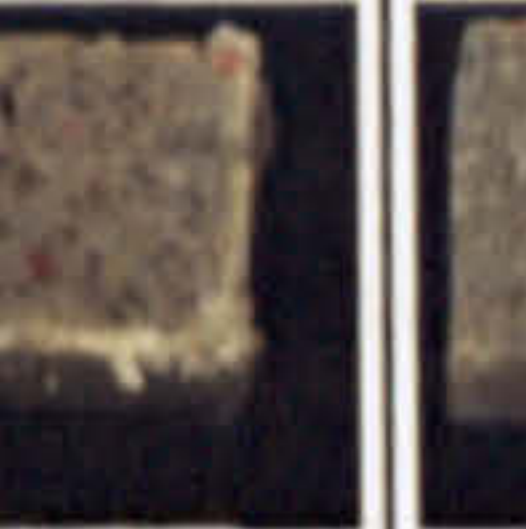
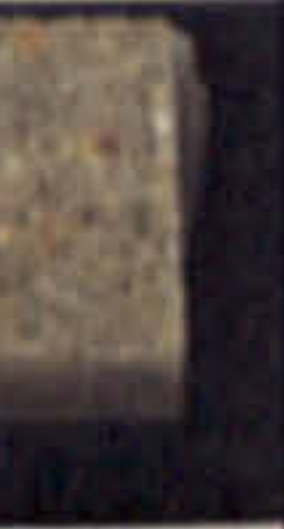
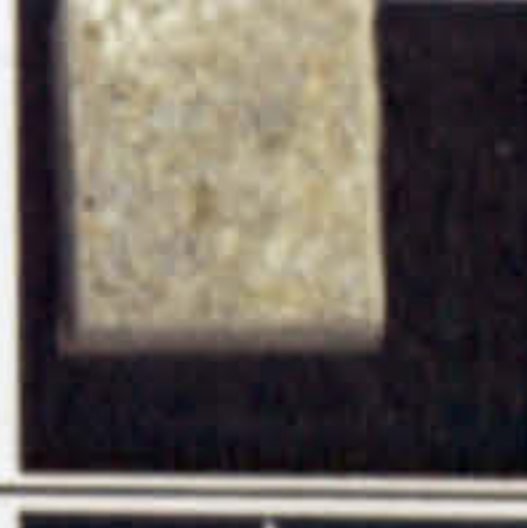
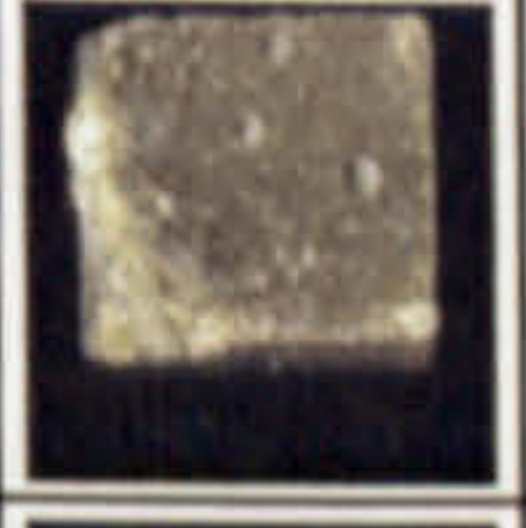
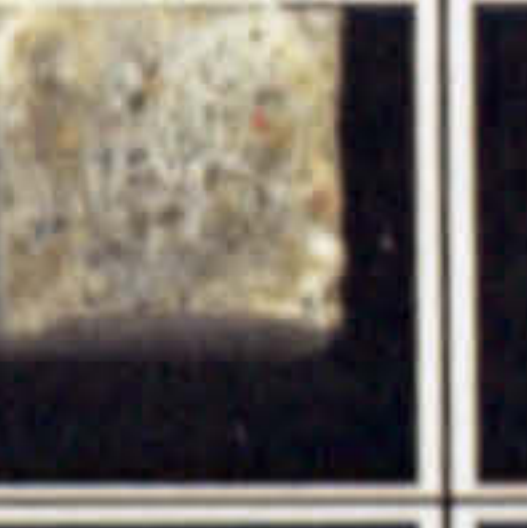
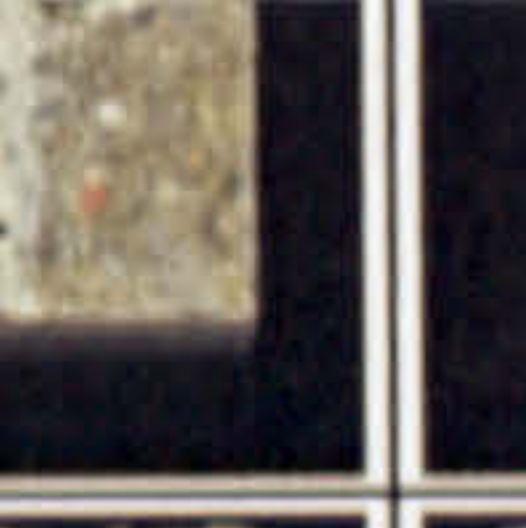
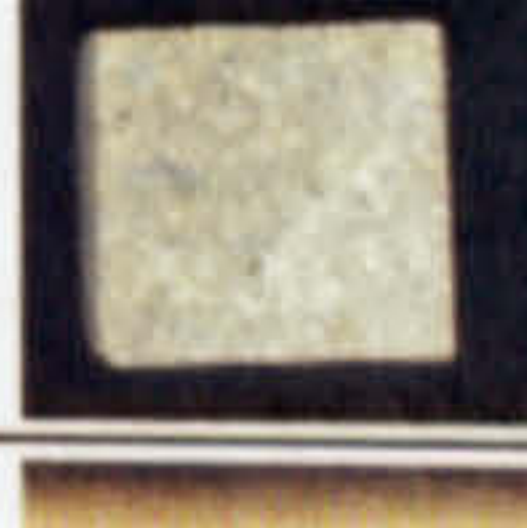
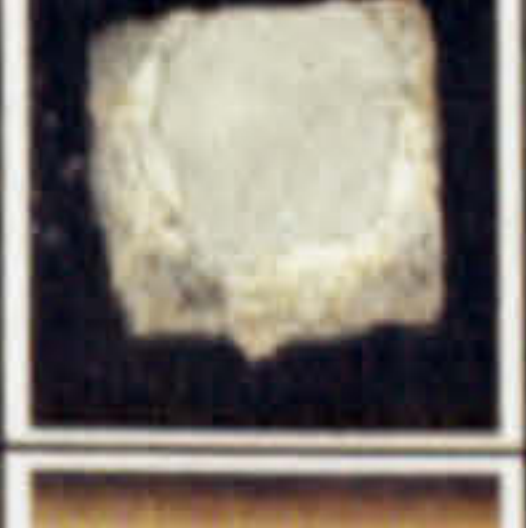
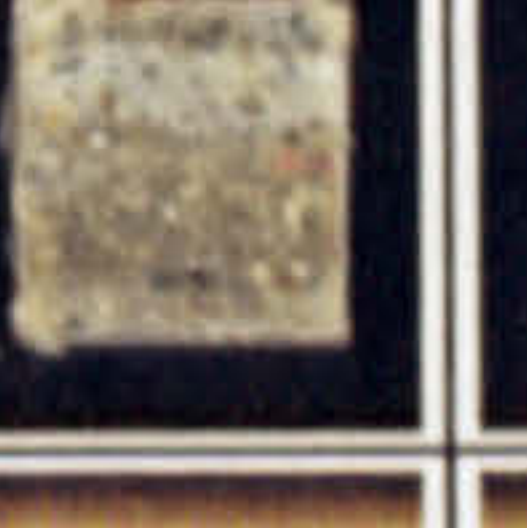
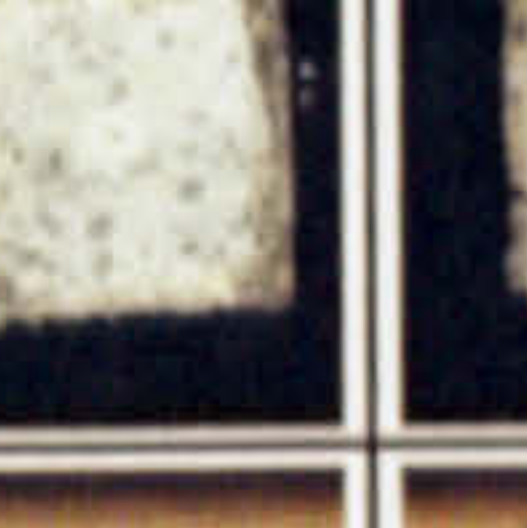
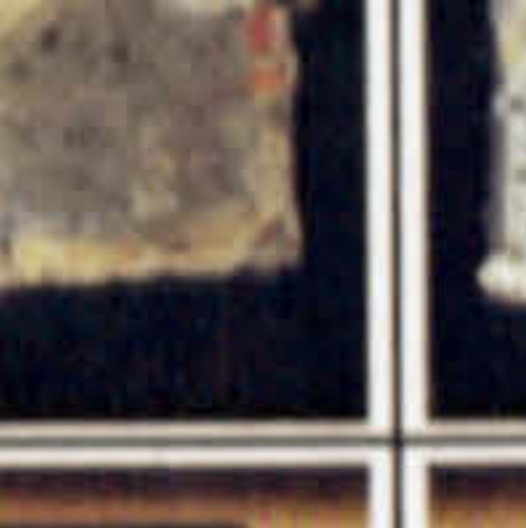
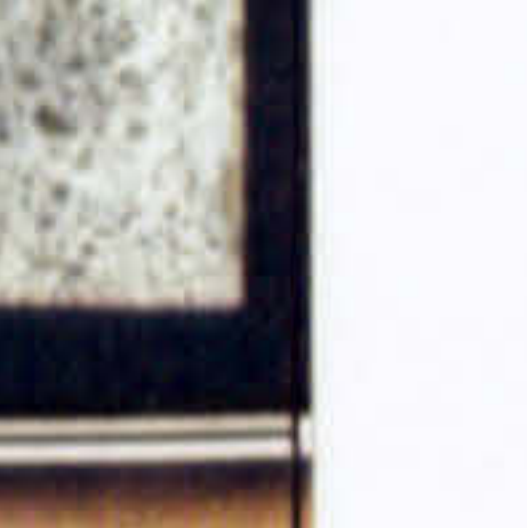
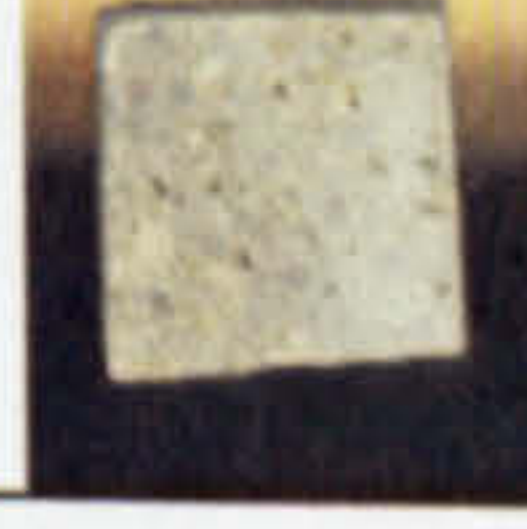
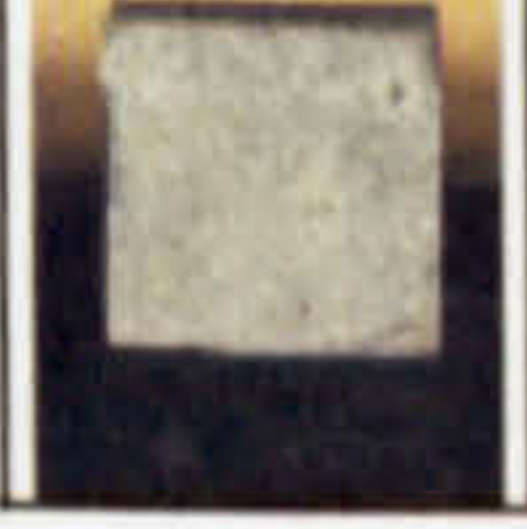
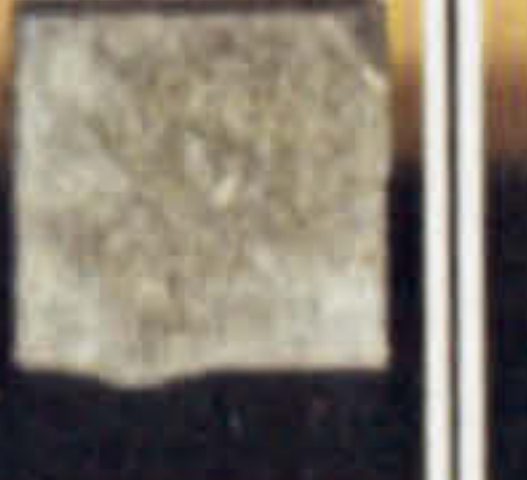
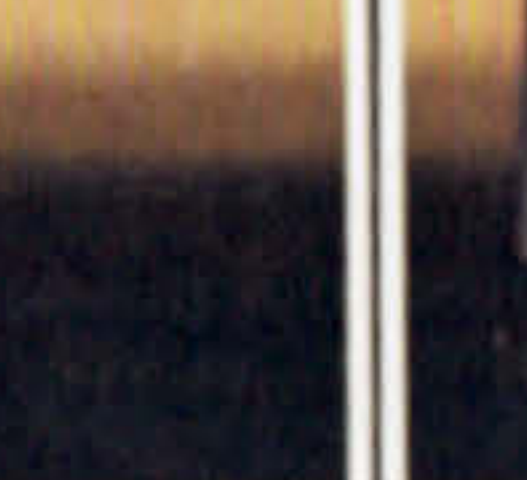
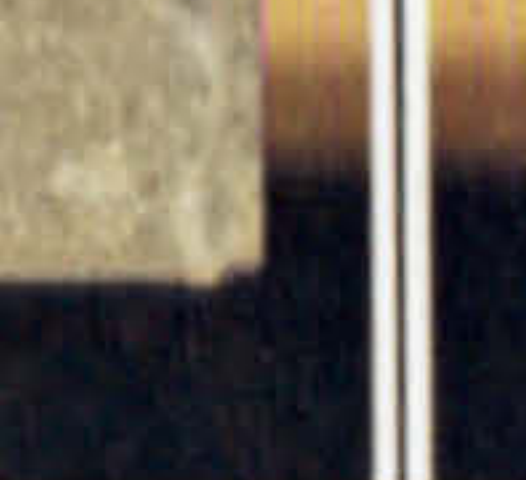
Figure 5.1: Samples after 84 days in different solutions at 5°C.

Figure 5.1 and Figure 5.2 show the visual assessment after 84 days. At this very early age, it is not possible to tell whether chloride plays any role in the attack.

Immersion in synthetic seawater (SEA), did not promote any deterioration in OPC and 15% LF mixes at both 5°C and 20°C. At this age, 15%LF surface colour was whiter than that of OPC in the same solution.

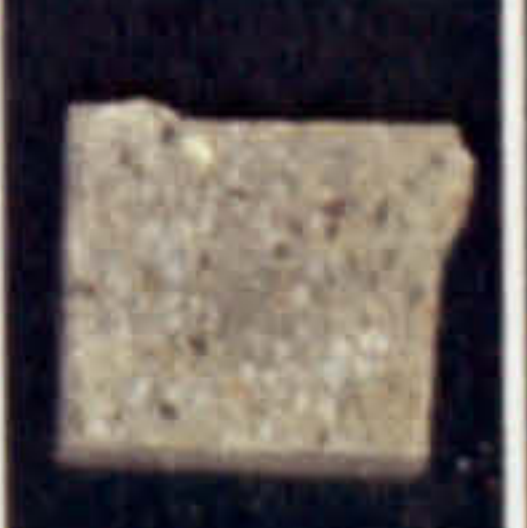
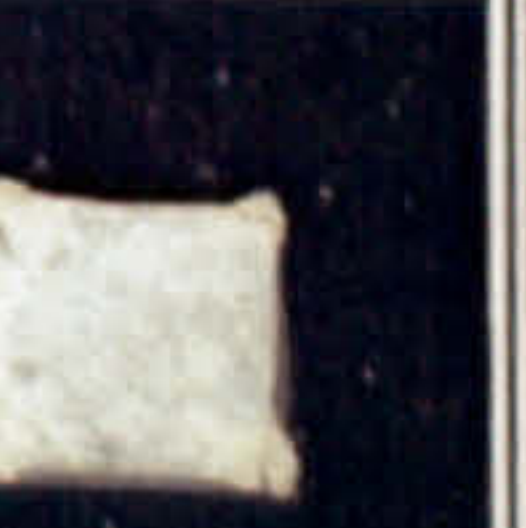
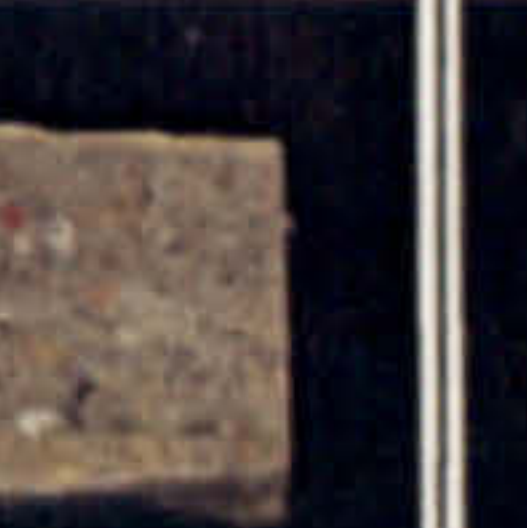
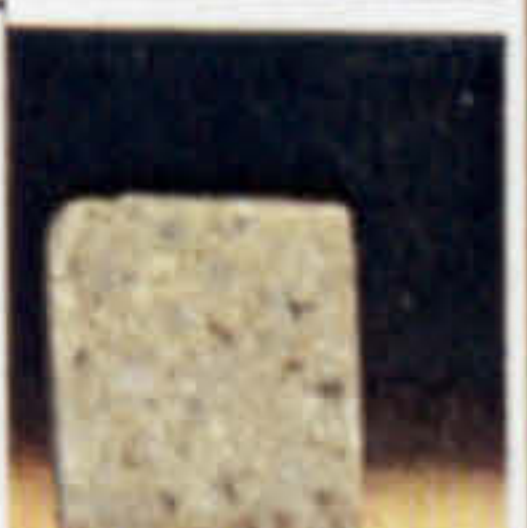
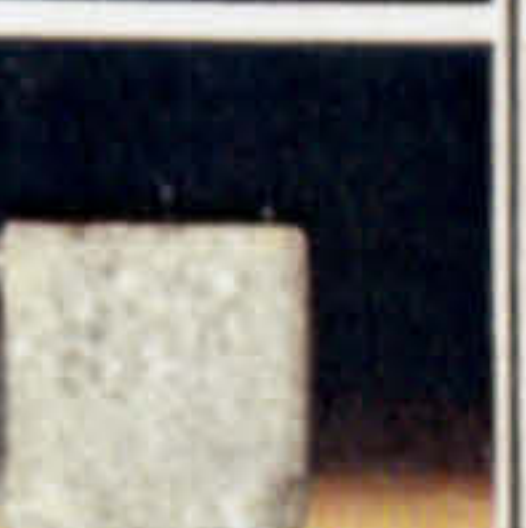
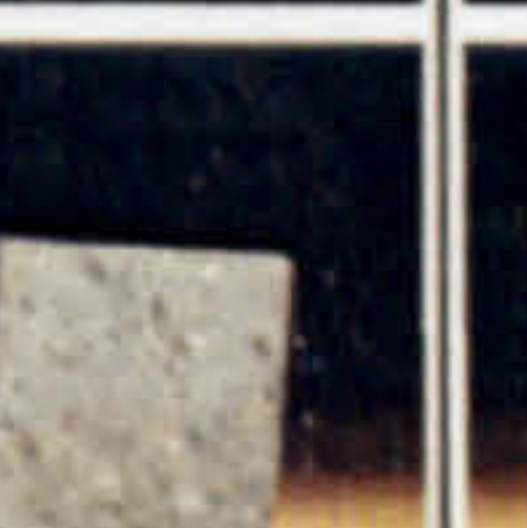
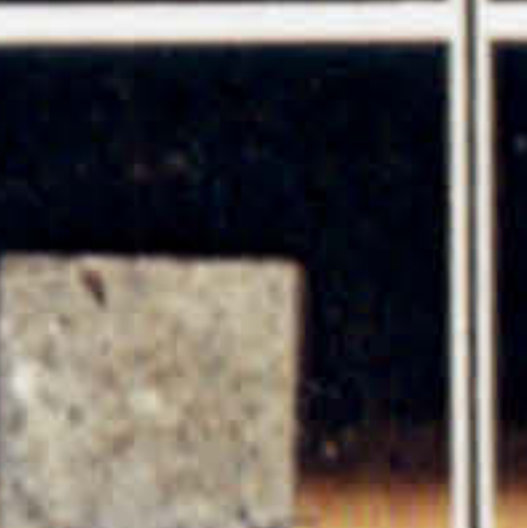
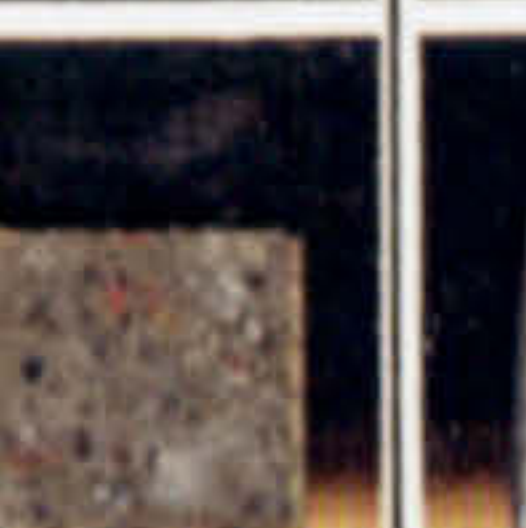
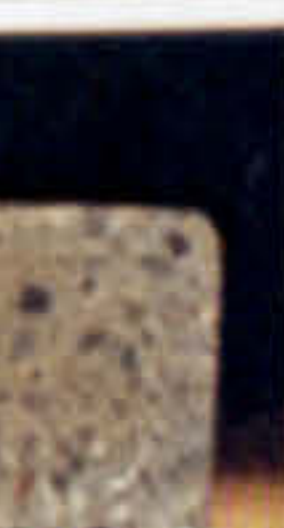
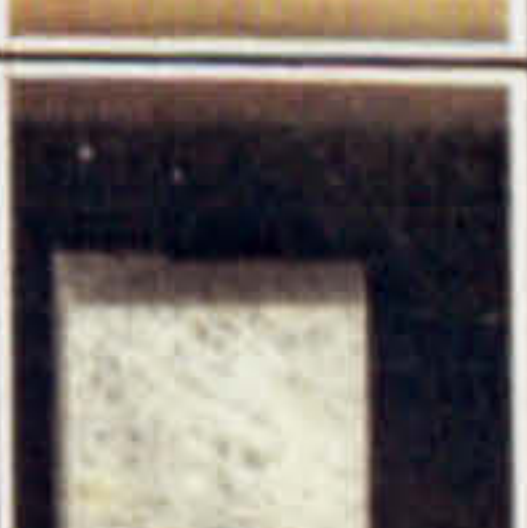
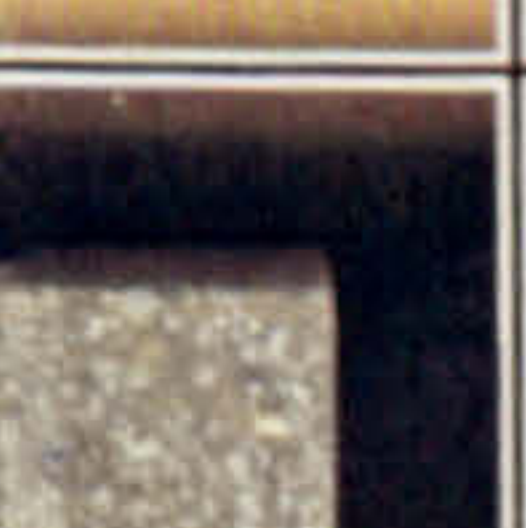
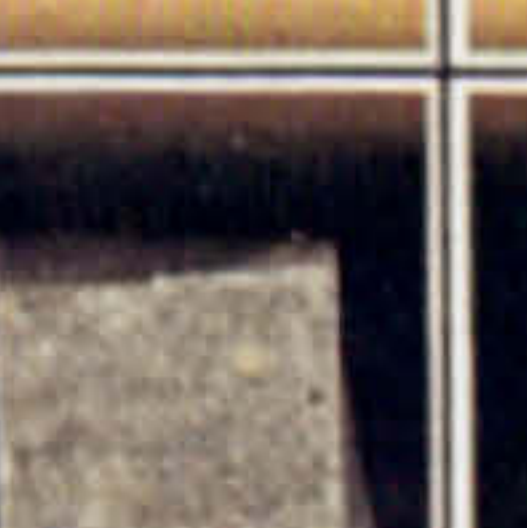
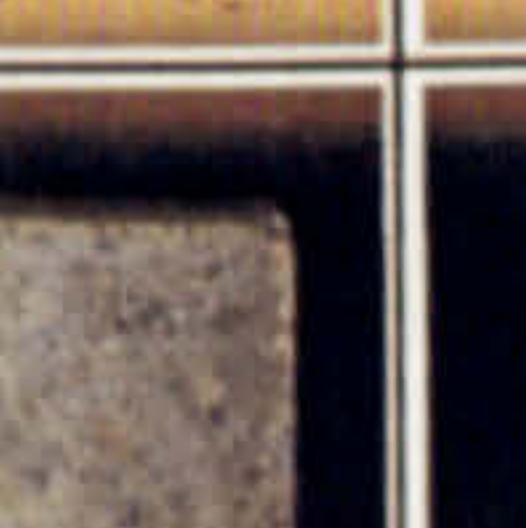
Figure 5.2: Samples after 84 days in different solutions at 20°C.

However, the damage to 15%LF samples immersed in magnesium sulfate and 2.0% chlorides (M20) were similar to that of samples in pure magnesium sulfate (M). Also, samples immersed in sulfate and 0.5%Cl<sup>-</sup> (M5) presented the least damage of all salt solutions, and sulfate plus 1.0%Cl<sup>-</sup> (M10) showed the largest deposit of a white material on the surface of the cubes. The damage was characterised by some spalling and blisters at the edges at 5°C, but not at 20°C. This seems to indicate that the expected mitigation of chloride over sulfate attack may not hold at lower temperature as time progresses.

In OPC samples, deterioration occurred at the edges and corners at both temperatures 5°C and 20°C, but this was slightly more intense at the lower temperature.

Metakolin mortars (MK) did not undergo any superficial signs of damage in any solution or temperature.

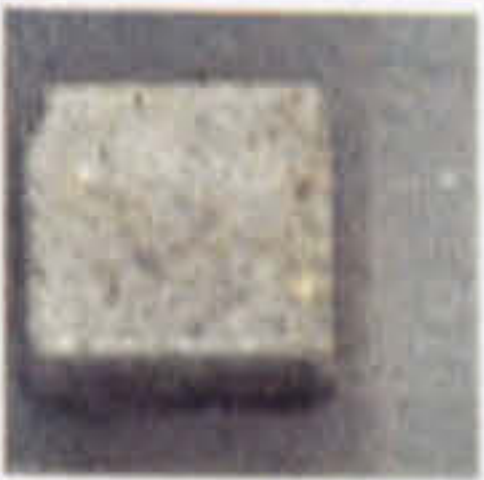
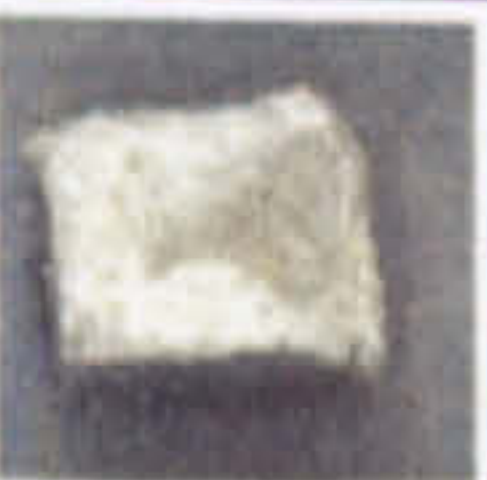
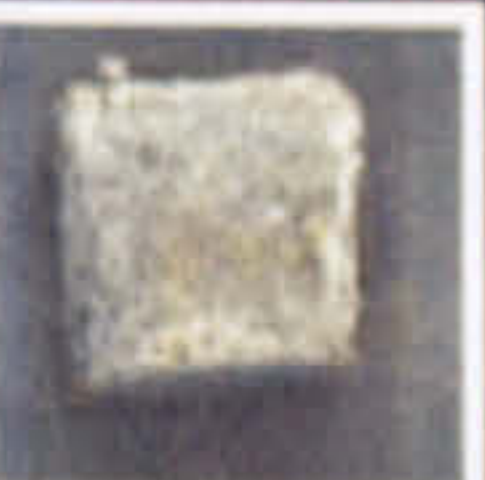
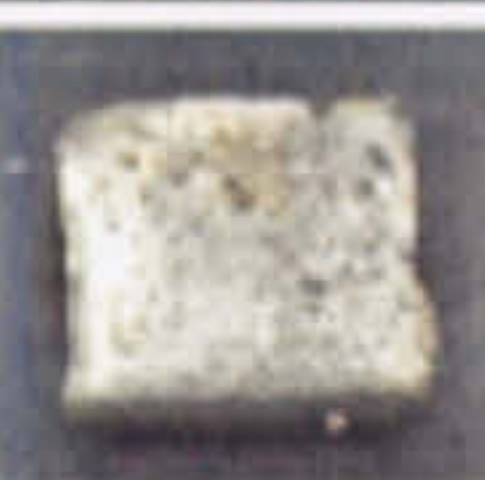
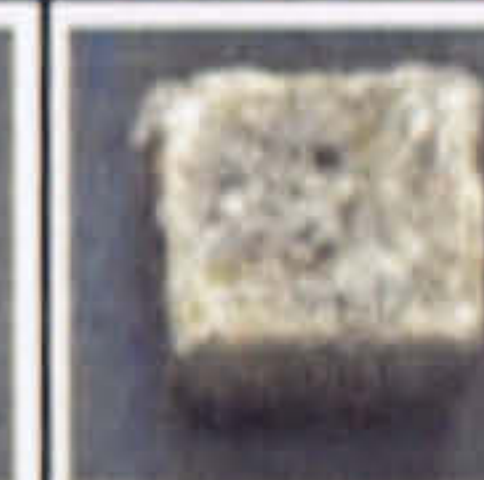
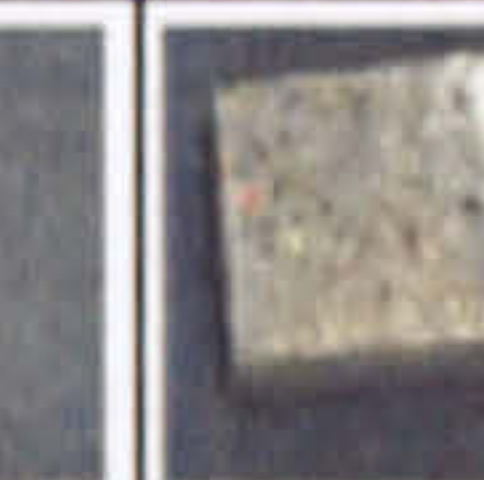
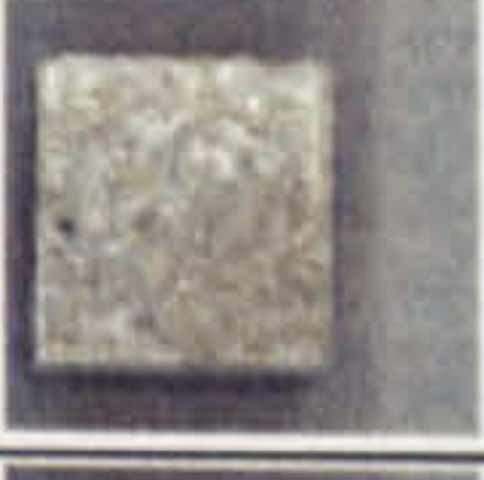
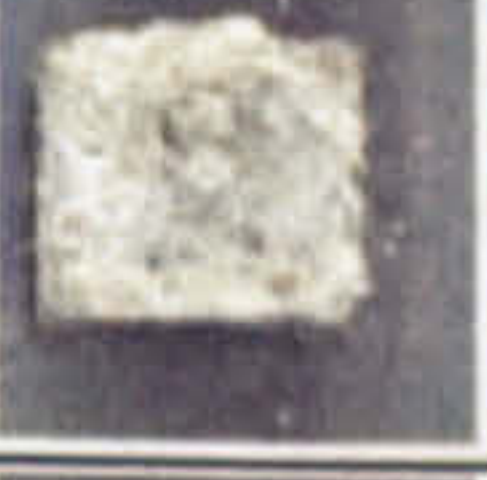
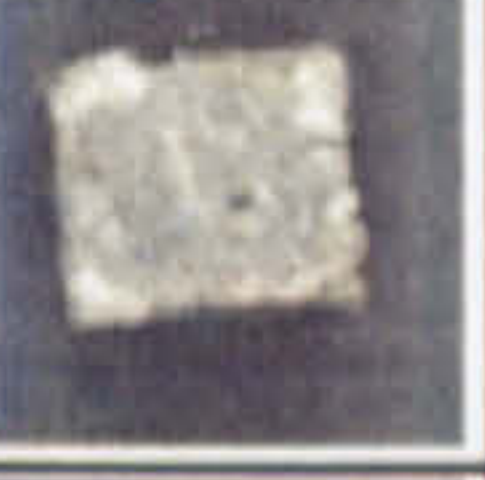
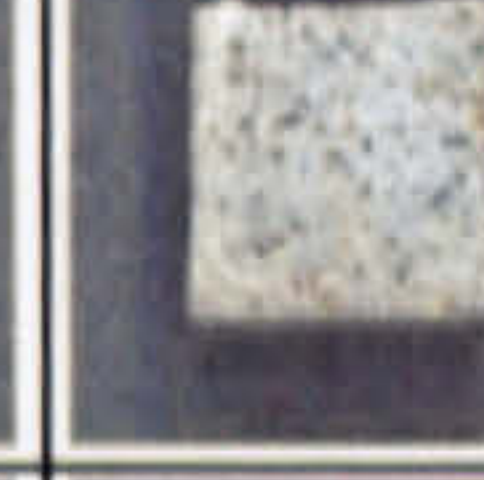
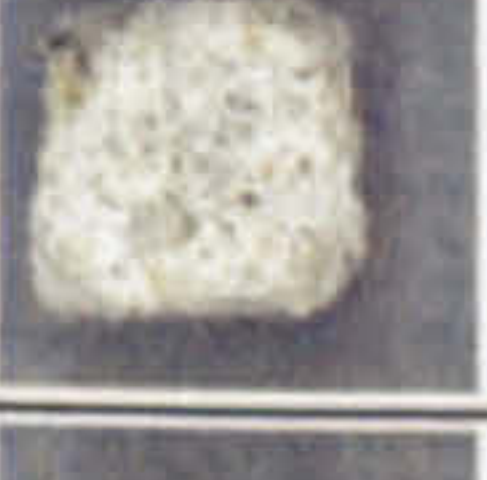
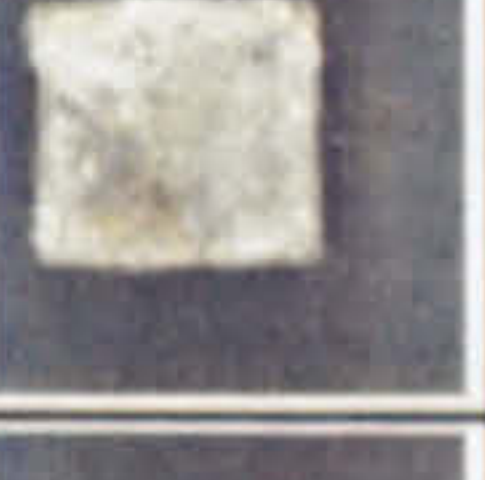
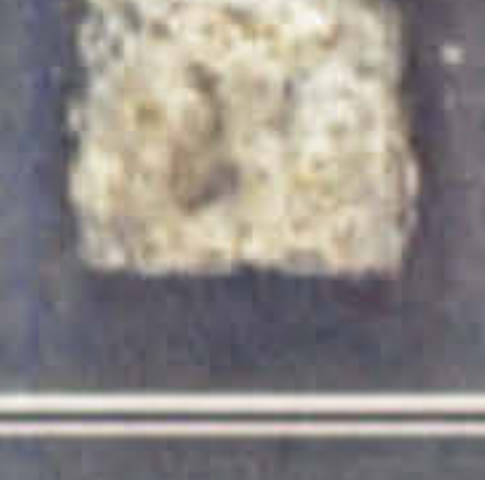
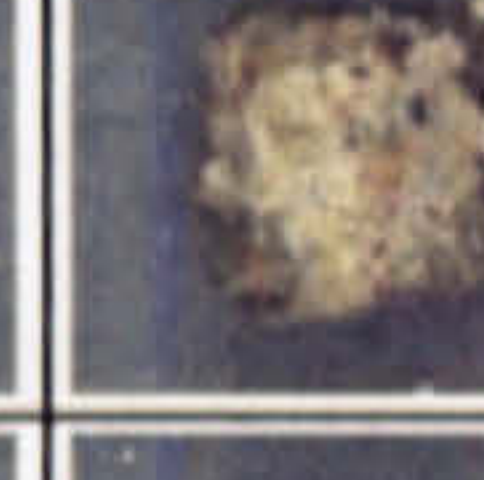
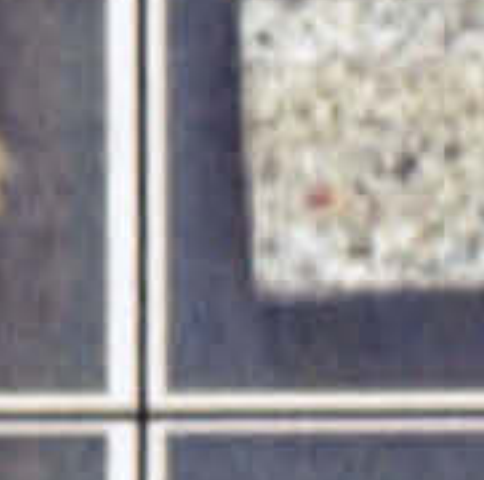
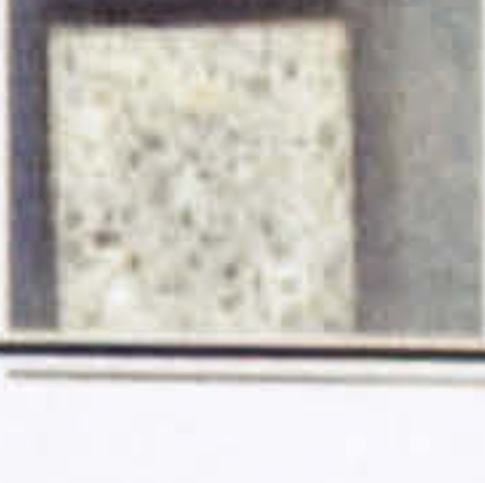
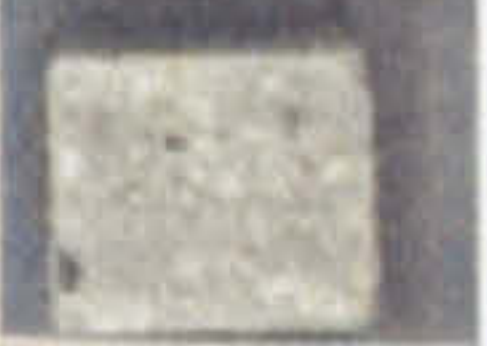
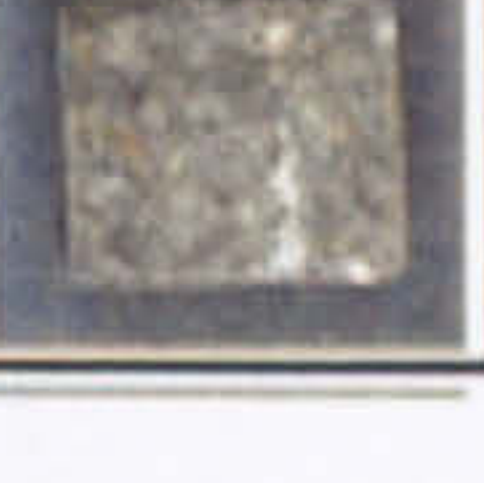
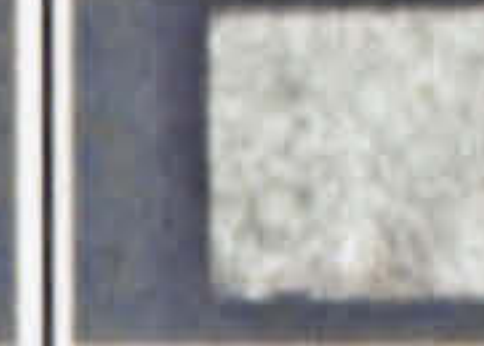
Figure 5.3: Samples after 168 days in different solutions at 5°C.

As time progressed, the different effects of chloride, carbonate and temperature on the damage became more evident, as can be seen in Figures 5.3 and 5.4.

Whereas little sign of deterioration could be detected for samples stored at 20°C, a white mushy deposit covered the surface of 15% LF cubes in salt solutions at 5°C. 15%LF in M5 was virtually unattacked when compared to the damage of 15%LF in M20, 15%LF in M10 and 15%LF in M, which decreased with the level of chloride in solution.

In 5% LF at 5°C, the combined effect of chloride and sulfate is not clearly seen. There was strong deposition of a white and mushy material over the surface of cubes immersed in M solution, which was more prominent than in OPC in M and M5 but less than in M20. The sequence of damage does not follow the same pattern seen in the 15%LF samples at low temperature, since the damage in samples immersed in M is more intense than those in M5 and M20. Again, no significant damage was detected in any solution at 20°C.

A similar trend as seen for 15%LF samples seems to be happening in OPC (0%LF) mixes, but with lesser intensity. White mushy material formed on the surface, and also at the edges of the cubes. 0%LF samples in M5 seem to be less attacked than the other salt solutions. This also seems to be the case at 20°C, where 0%LF samples immersed in M5 are less damaged than those immersed in pure magnesium sulfate (M).

Salt solutions: The combined effect of chloride and sulfate on pH changed with temperature. It can be seen that the pH of the systems immersed at 5°C were mostly higher than 10.5. At later ages, all salt solutions were alkaline (pH>12.0). As far as pH higher than 10.5 is concerned, M5 (0.5%Cl<sup>-</sup>), in which mortar samples were less damaged than in other solutions (Fig. 5.3, 5.5 and 5.18), also maintained pH below this threshold during most of the exposure time.

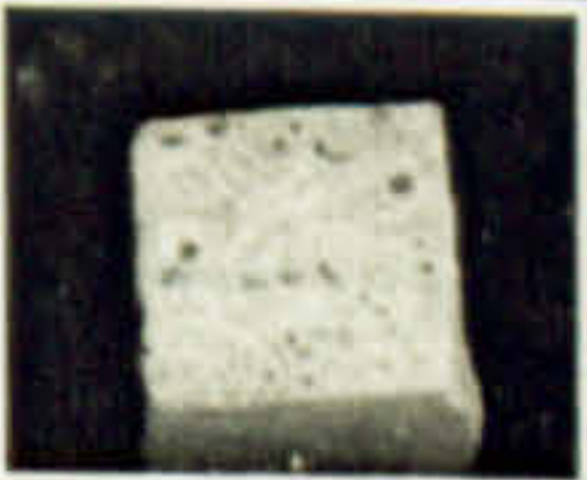
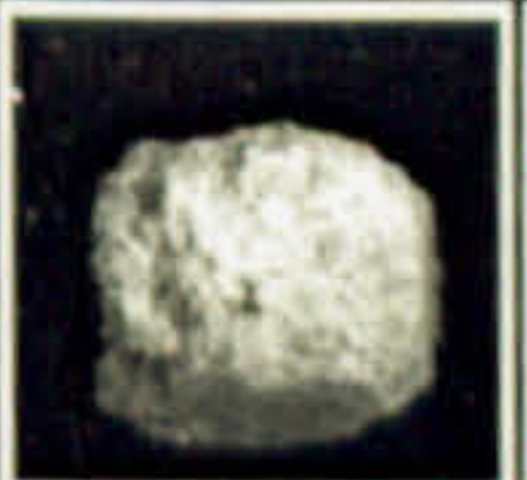
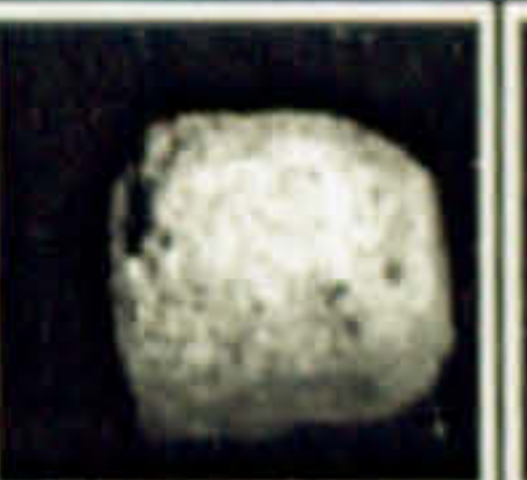
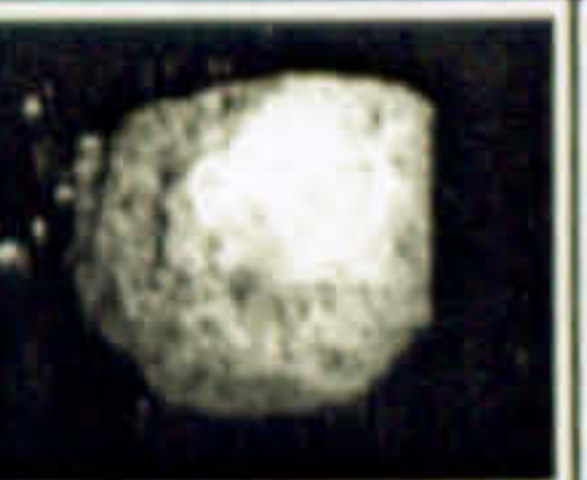
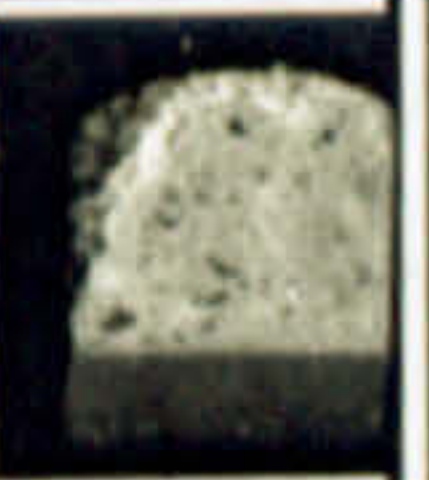
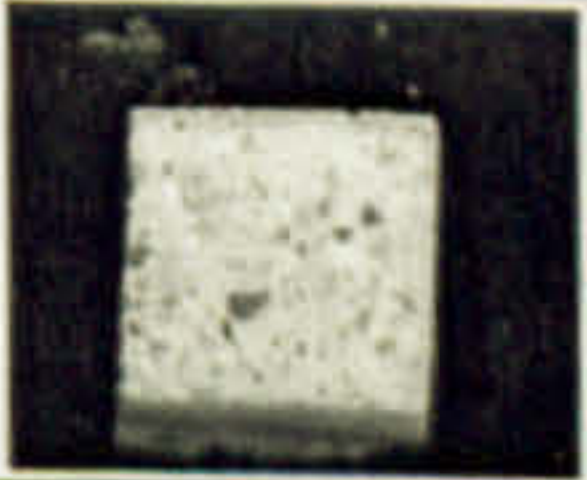
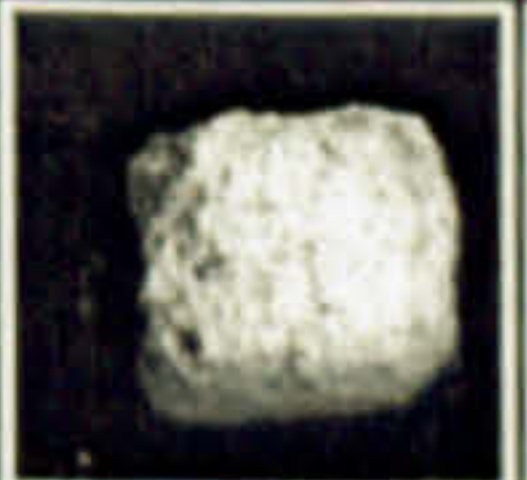
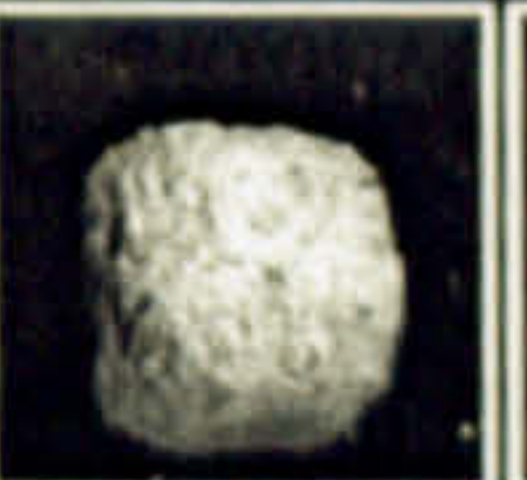
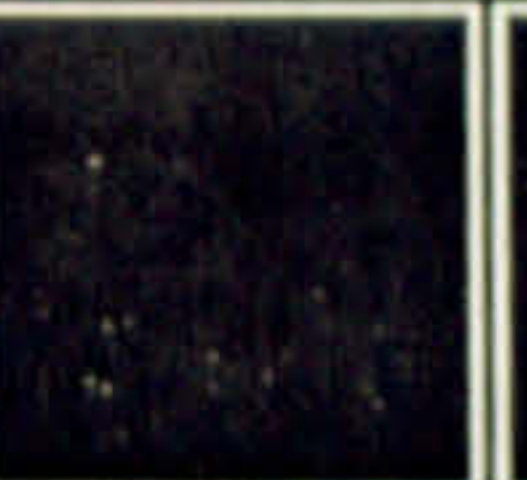
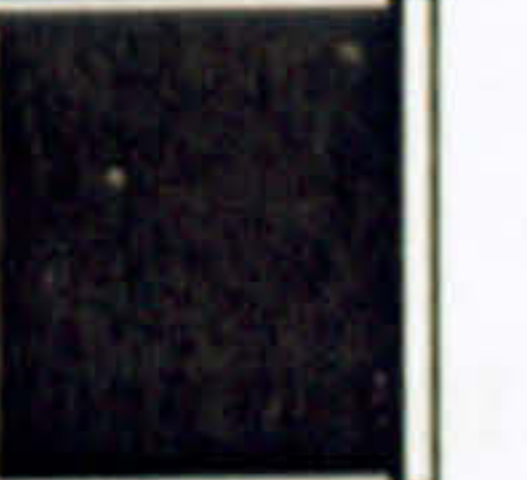
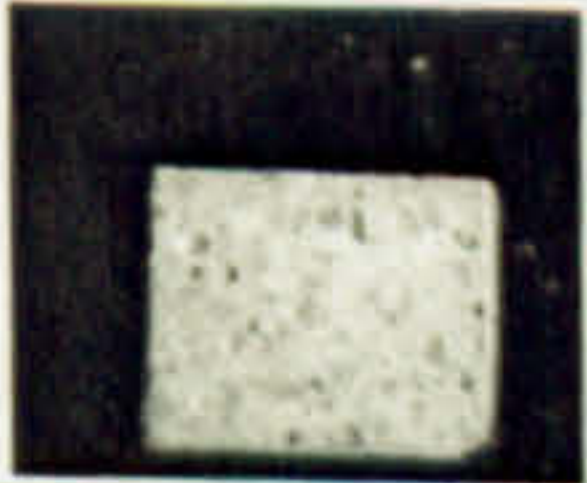
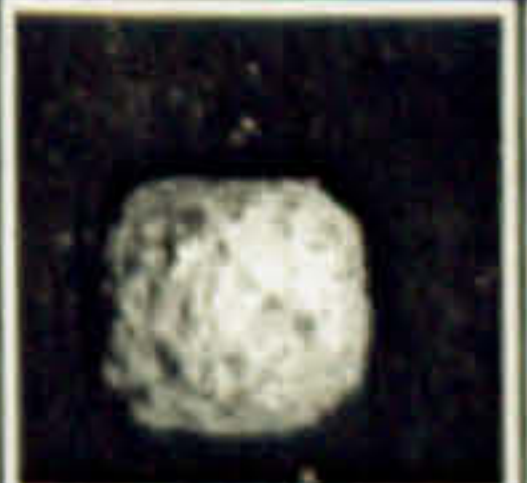
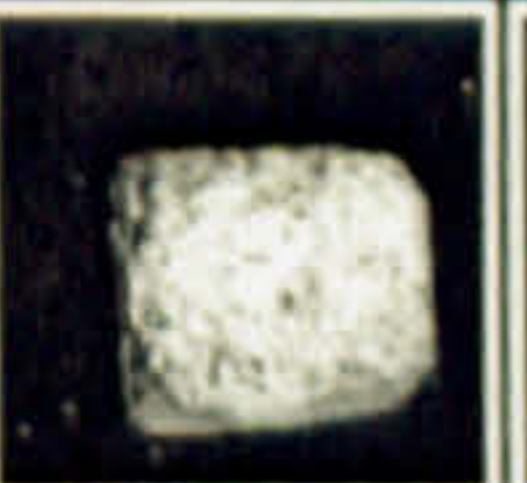
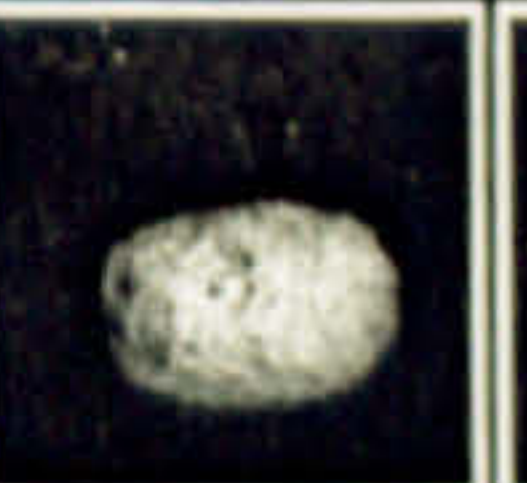
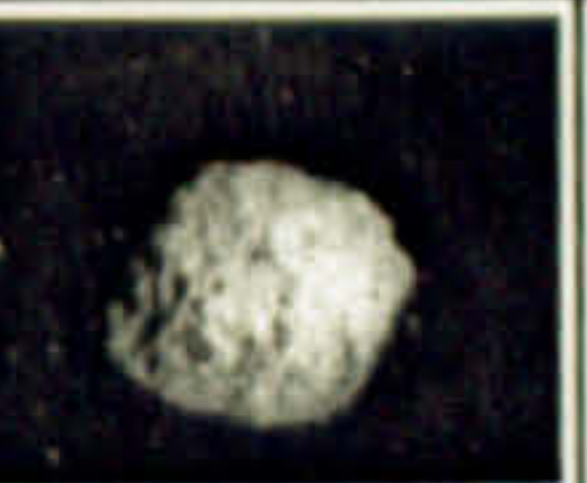
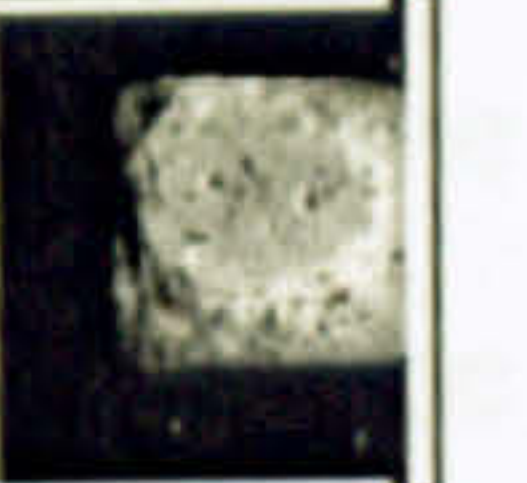
Figure 5.5 and shows the appearance of samples immersed in salt solutions at 5°C.

After longer exposure, the effect of chloride on the sulfate attack became clearer. It was evidently temperature dependent, as seen by both the form and intensity of the damage at the different temperatures.

On the one hand, the attack at 5°C was marked by an overall failure of the cement matrix, which turned into a white mushy material that precipitated in the bottom of the containers. The aggregate of the remaining cubes was totally exposed, and it could be easily removed by hands. There was no resemblance to the original shape as the attacked cubes had turned into round shapes. In this mode of attack, as far as the carbonate content is concerned, the higher the amount of carbonate filler, the more intense the attack, irrespective of the presence of chlorides in solution at 5°C. Indeed, the 15%LF mortar showed the highest degree of attack.

The intensity also varied with the concentration of chlorides in solution. The worst case occurred in samples immersed in the combined solution of sulfates and 1%Cl<sup>-</sup> (M10), followed by 2%Cl<sup>-</sup> (M20), pure sulfate (M), 0.5%Cl<sup>-</sup> (M5) and seawater (SEA). Mortars with 5% LF showed the second highest degree of damage. Again, the combination of chlorides and sulfates seemed to have worsened the attack, although it can be more evident by looking at the overall view of the samples after one year of
