THE INFLUENCE OF CHLORIDE ON THE  
THAUMASITE FORM OF SULFATE ATTACK IN  
MORTARS CONTAINING CALCIUM CARBONATE

A THESIS PRESENTED FOR THE DEGREE OF DOCTOR OF PHILOSOPHY

DEPARTMENT OF CIVIL AND STRUCTURAL ENGINEERING  
CENTRE FOR CEMENT AND CONCRETE  
FACULTY OF ENGINEERING  
THE UNIVERSITY OF SHEFFIELD

AUGUST 2004

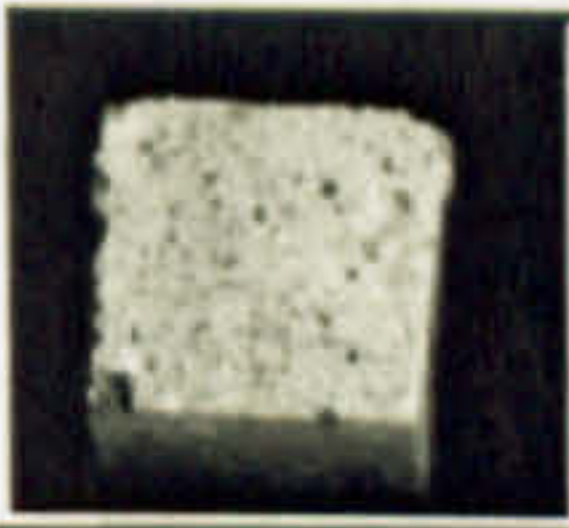
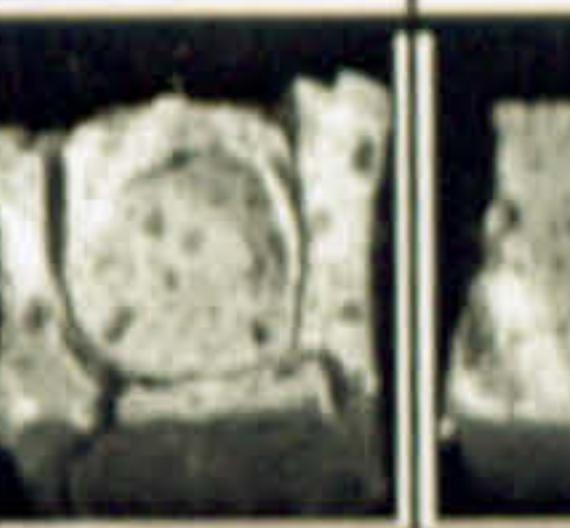
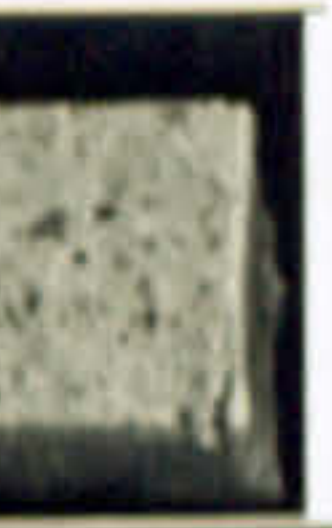
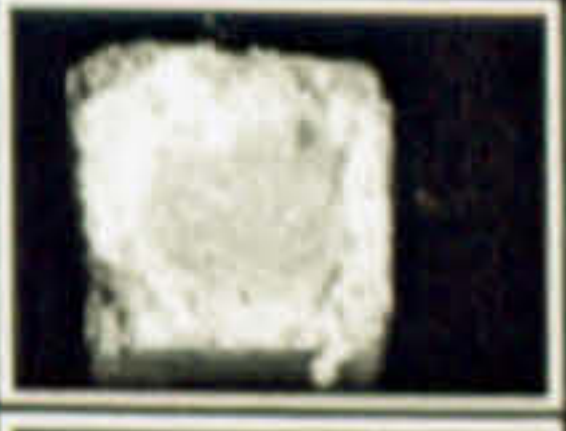
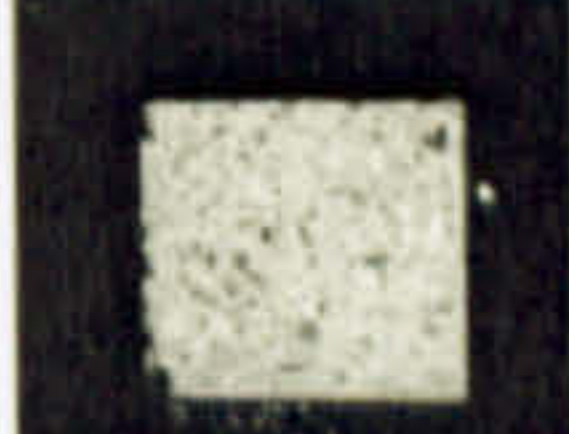
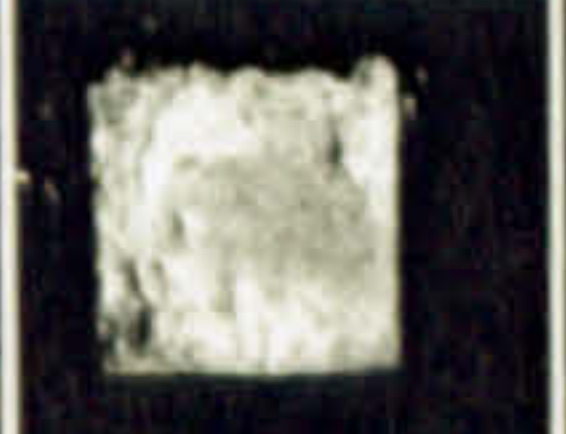
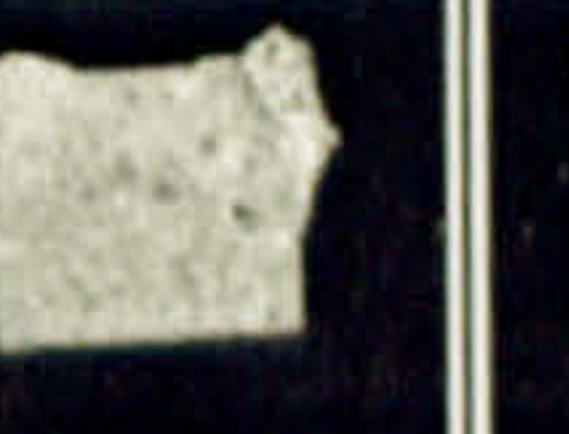
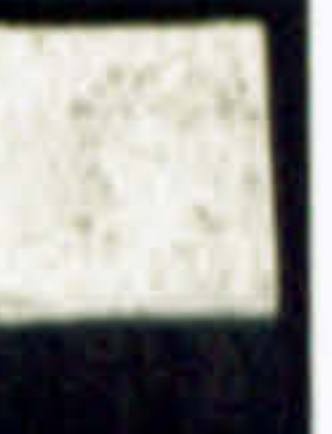
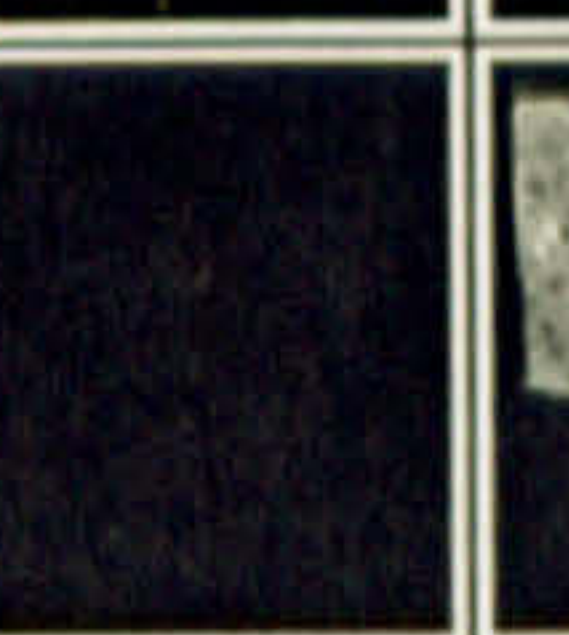
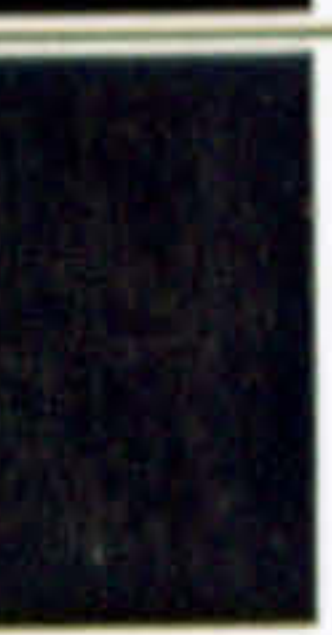
Figure 5.6: Samples after 308 days in different solutions at 20°C.

The performance of samples immersed in the test solutions at 20°C is shown in Figure 5.6.

On the other hand, samples immersed in salt solutions at 20°C showed only superficial damage, marked by some attack at corners and edges. Also, extensive cracks and delamination of the corroded surface developed in OPC in M20, and to a slight extent in both 5%LF and 15%LF in the same solution. The cubes still resembled their original shape, and the intensity of the attack was much less when compared to that at 5°C. Although the corroded material could be removed by hand, the cores still retained some strength. The overall appearance of the corroded material was of flake-like fragments rather than the mush, white was observed at 5°C.

In metakaolin mixes, despite the presence of 15% limestone filler, no thaumasite formed after one year of exposure in the selected salt solutions, but the formation of ettringite and gypsum, did form without expansion or visual signs of damage did occur (Figure 5.6 and 5.10).

- (v) At 20°C, the pH decreased below 10.0 in most solutions with time, except in 0%LF in M20 (2.0%Cl<sup>-</sup>) and seawater, where damage was also detected (Fig 5.6). Also, the pH was around 11.04 in 5%LF immersed in M5, after 385 days, but no signs of deterioration could be identified.

It is important to underline that octahedral silicon has also been identified in several mixes and solutions at 20°C, especially in 0% and 15%LF immersed in pure magnesium and combined with 2.0%Cl<sup>-</sup>. However, the low intensity of Si<sub>500</sub> and the coexistence of AFt, AFm and thaumasite solid solution did not allow a precise interpretation of the data. However, a high intensity of Si<sup>4+</sup> associated in an octahedral coordination with hydroxyls also correlated well with the damage detected in 0%LF immersed in 2.0%Cl<sup>-</sup> (see Fig 5.6 and Fig. 5.9-Chapter 5).

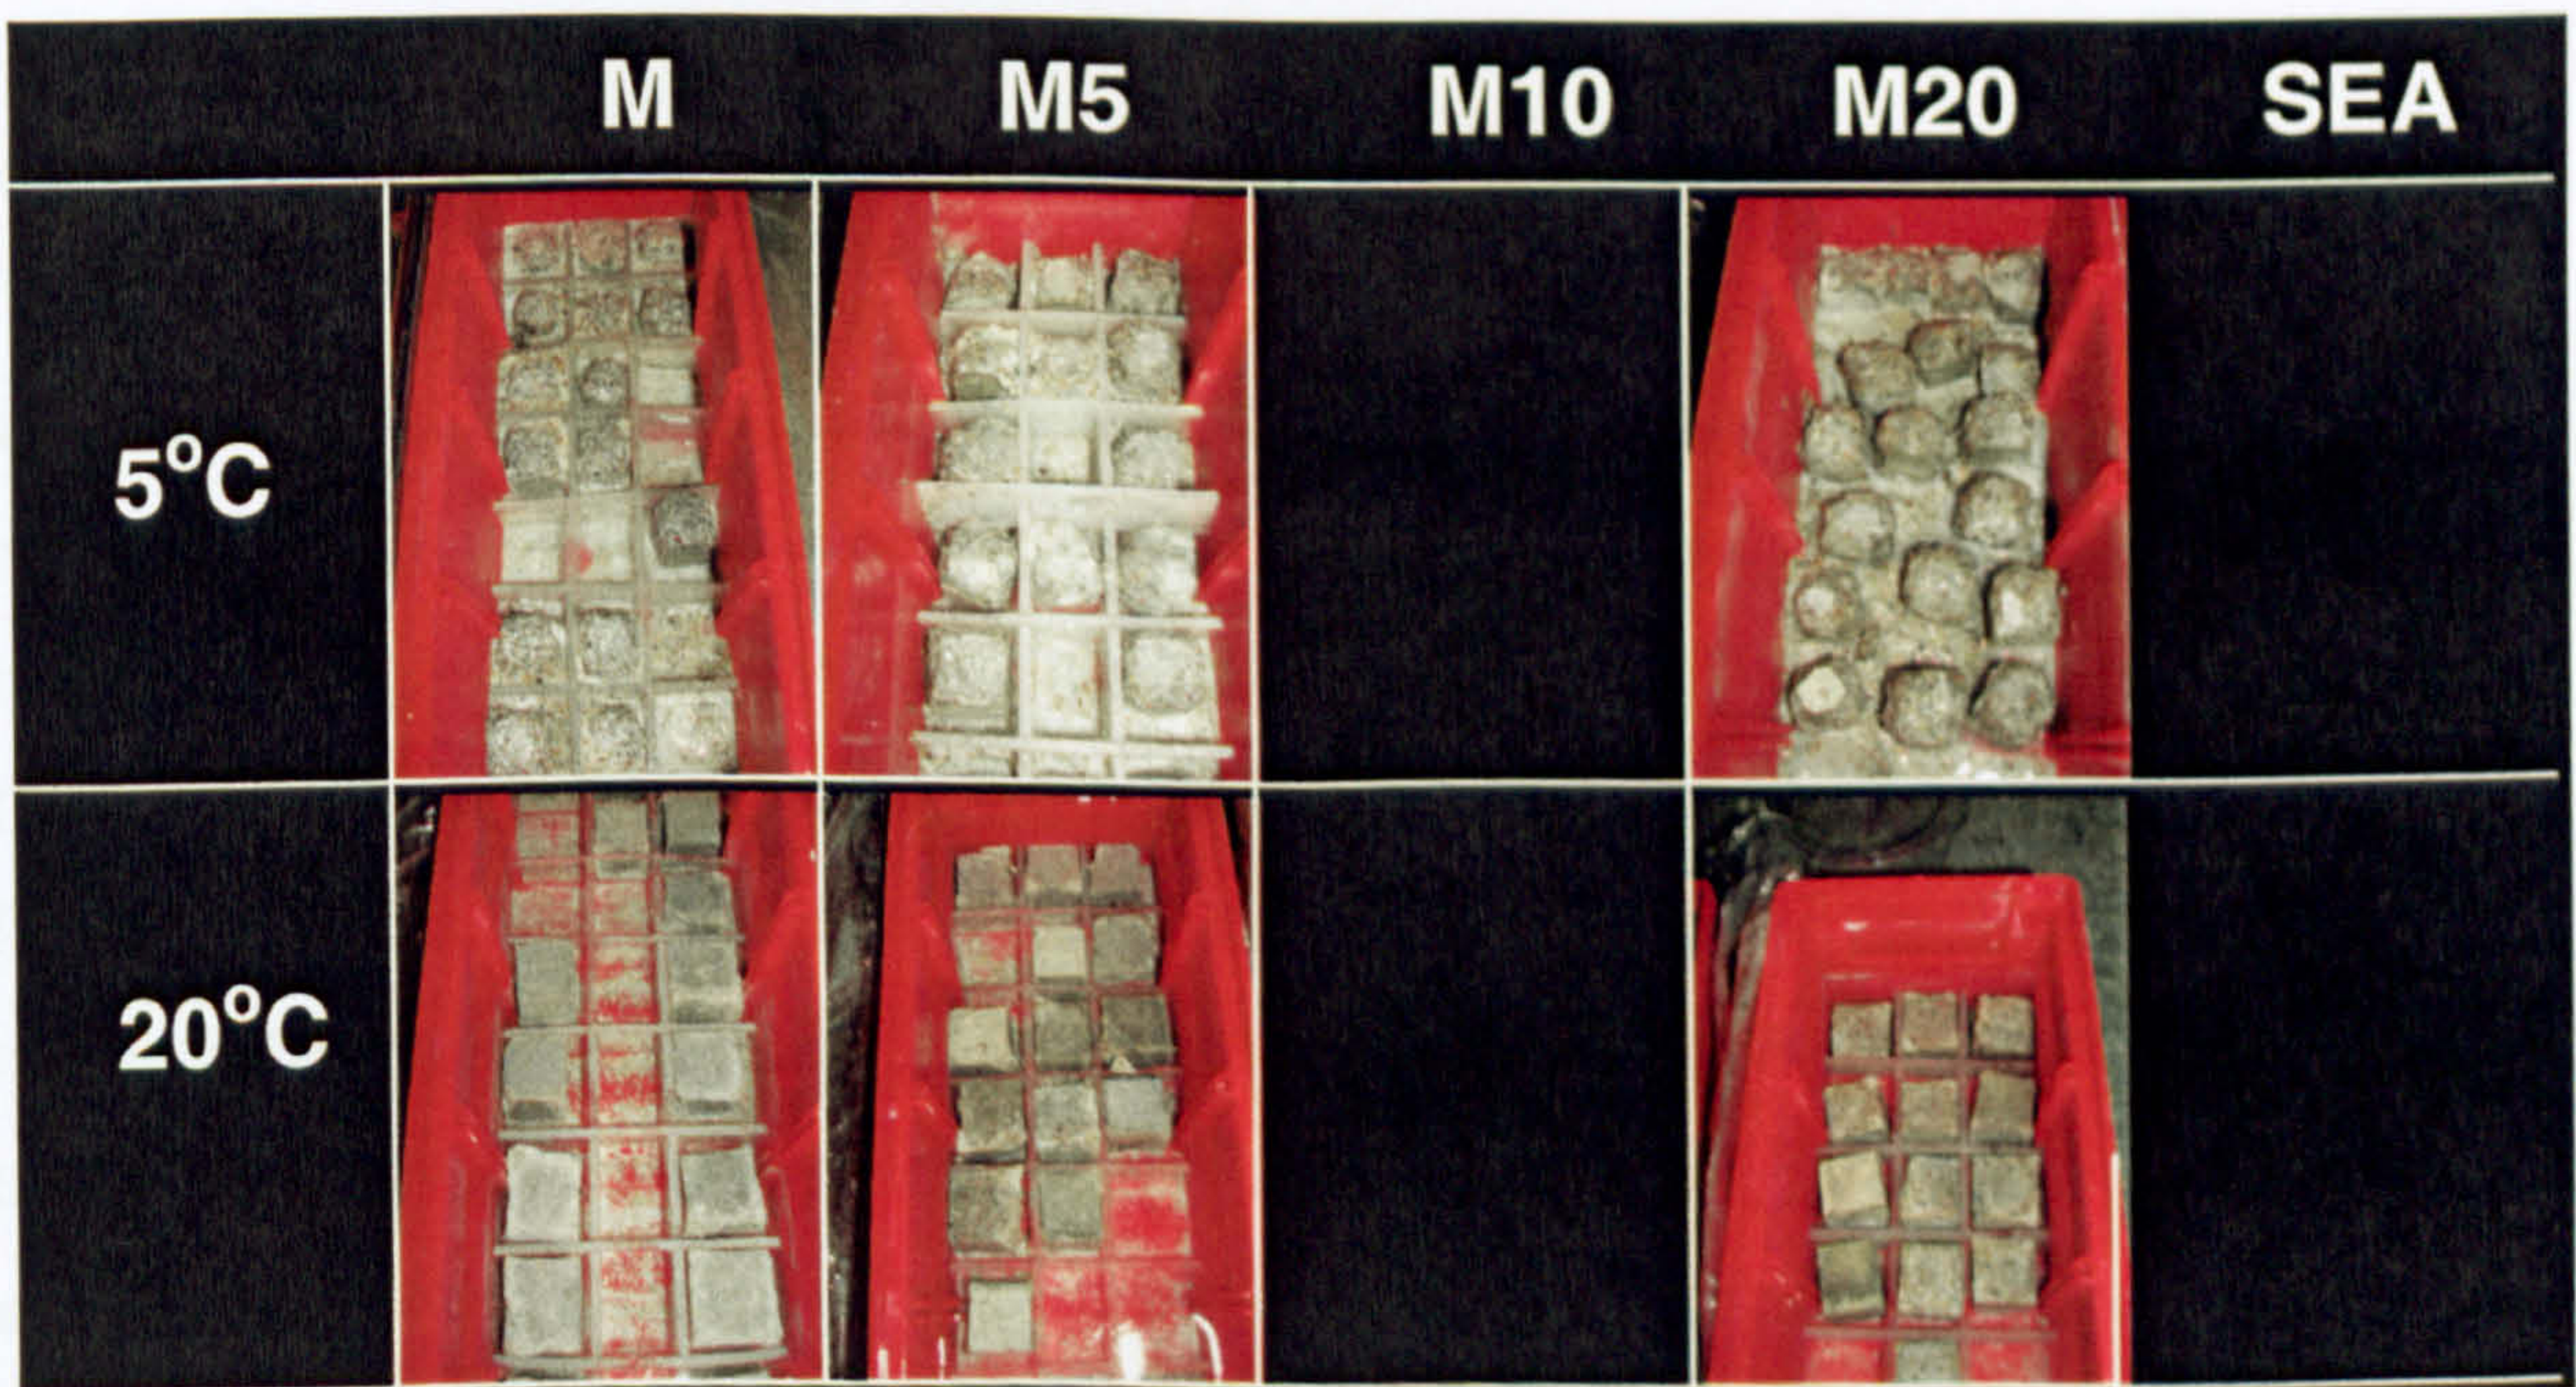
Figure 5.8: General view of 5% LF samples after 53 weeks.

exposure (section D-Figure 5.8). As for OPC without limestone, the attack was less intense than that of 5%LF samples. However, the surface has turned into a white mushy material, which precipitated at the bottom of the containers, as it did not have any binding capacity to remain with the rest of the mortar. Once more, the combined effect of chlorides and sulfate was detrimental, particularly when the performance of the samples was looked at after one year (section D-Figure 5.9).

At 5°C, however, all the OPC mixes with and without limestone filler suffered extensive damage and almost totally disintegrated after 53 weeks. The apparent trend being the higher the carbonate content, the greater the intensity of the attack. At this stage, the corroded material that precipitated at the bottom of the containers was totally mushy. It is still possible to identify the carbonated surfaces that were not attacked in all mixes, although it did not pose any protection to the core but could easily be detached from the bulk sample by hand. These carbonated surfaces were very often broken in flake-like pieces in advanced stages of deterioration. In most cases, these surfaces were confined between precipitated mushy material and directly in contact with the wall of the container. Such cubes were turned upside down in the Figures 5.7 to 5.9 for a better appreciation of this description at the time when those photographs were taken.

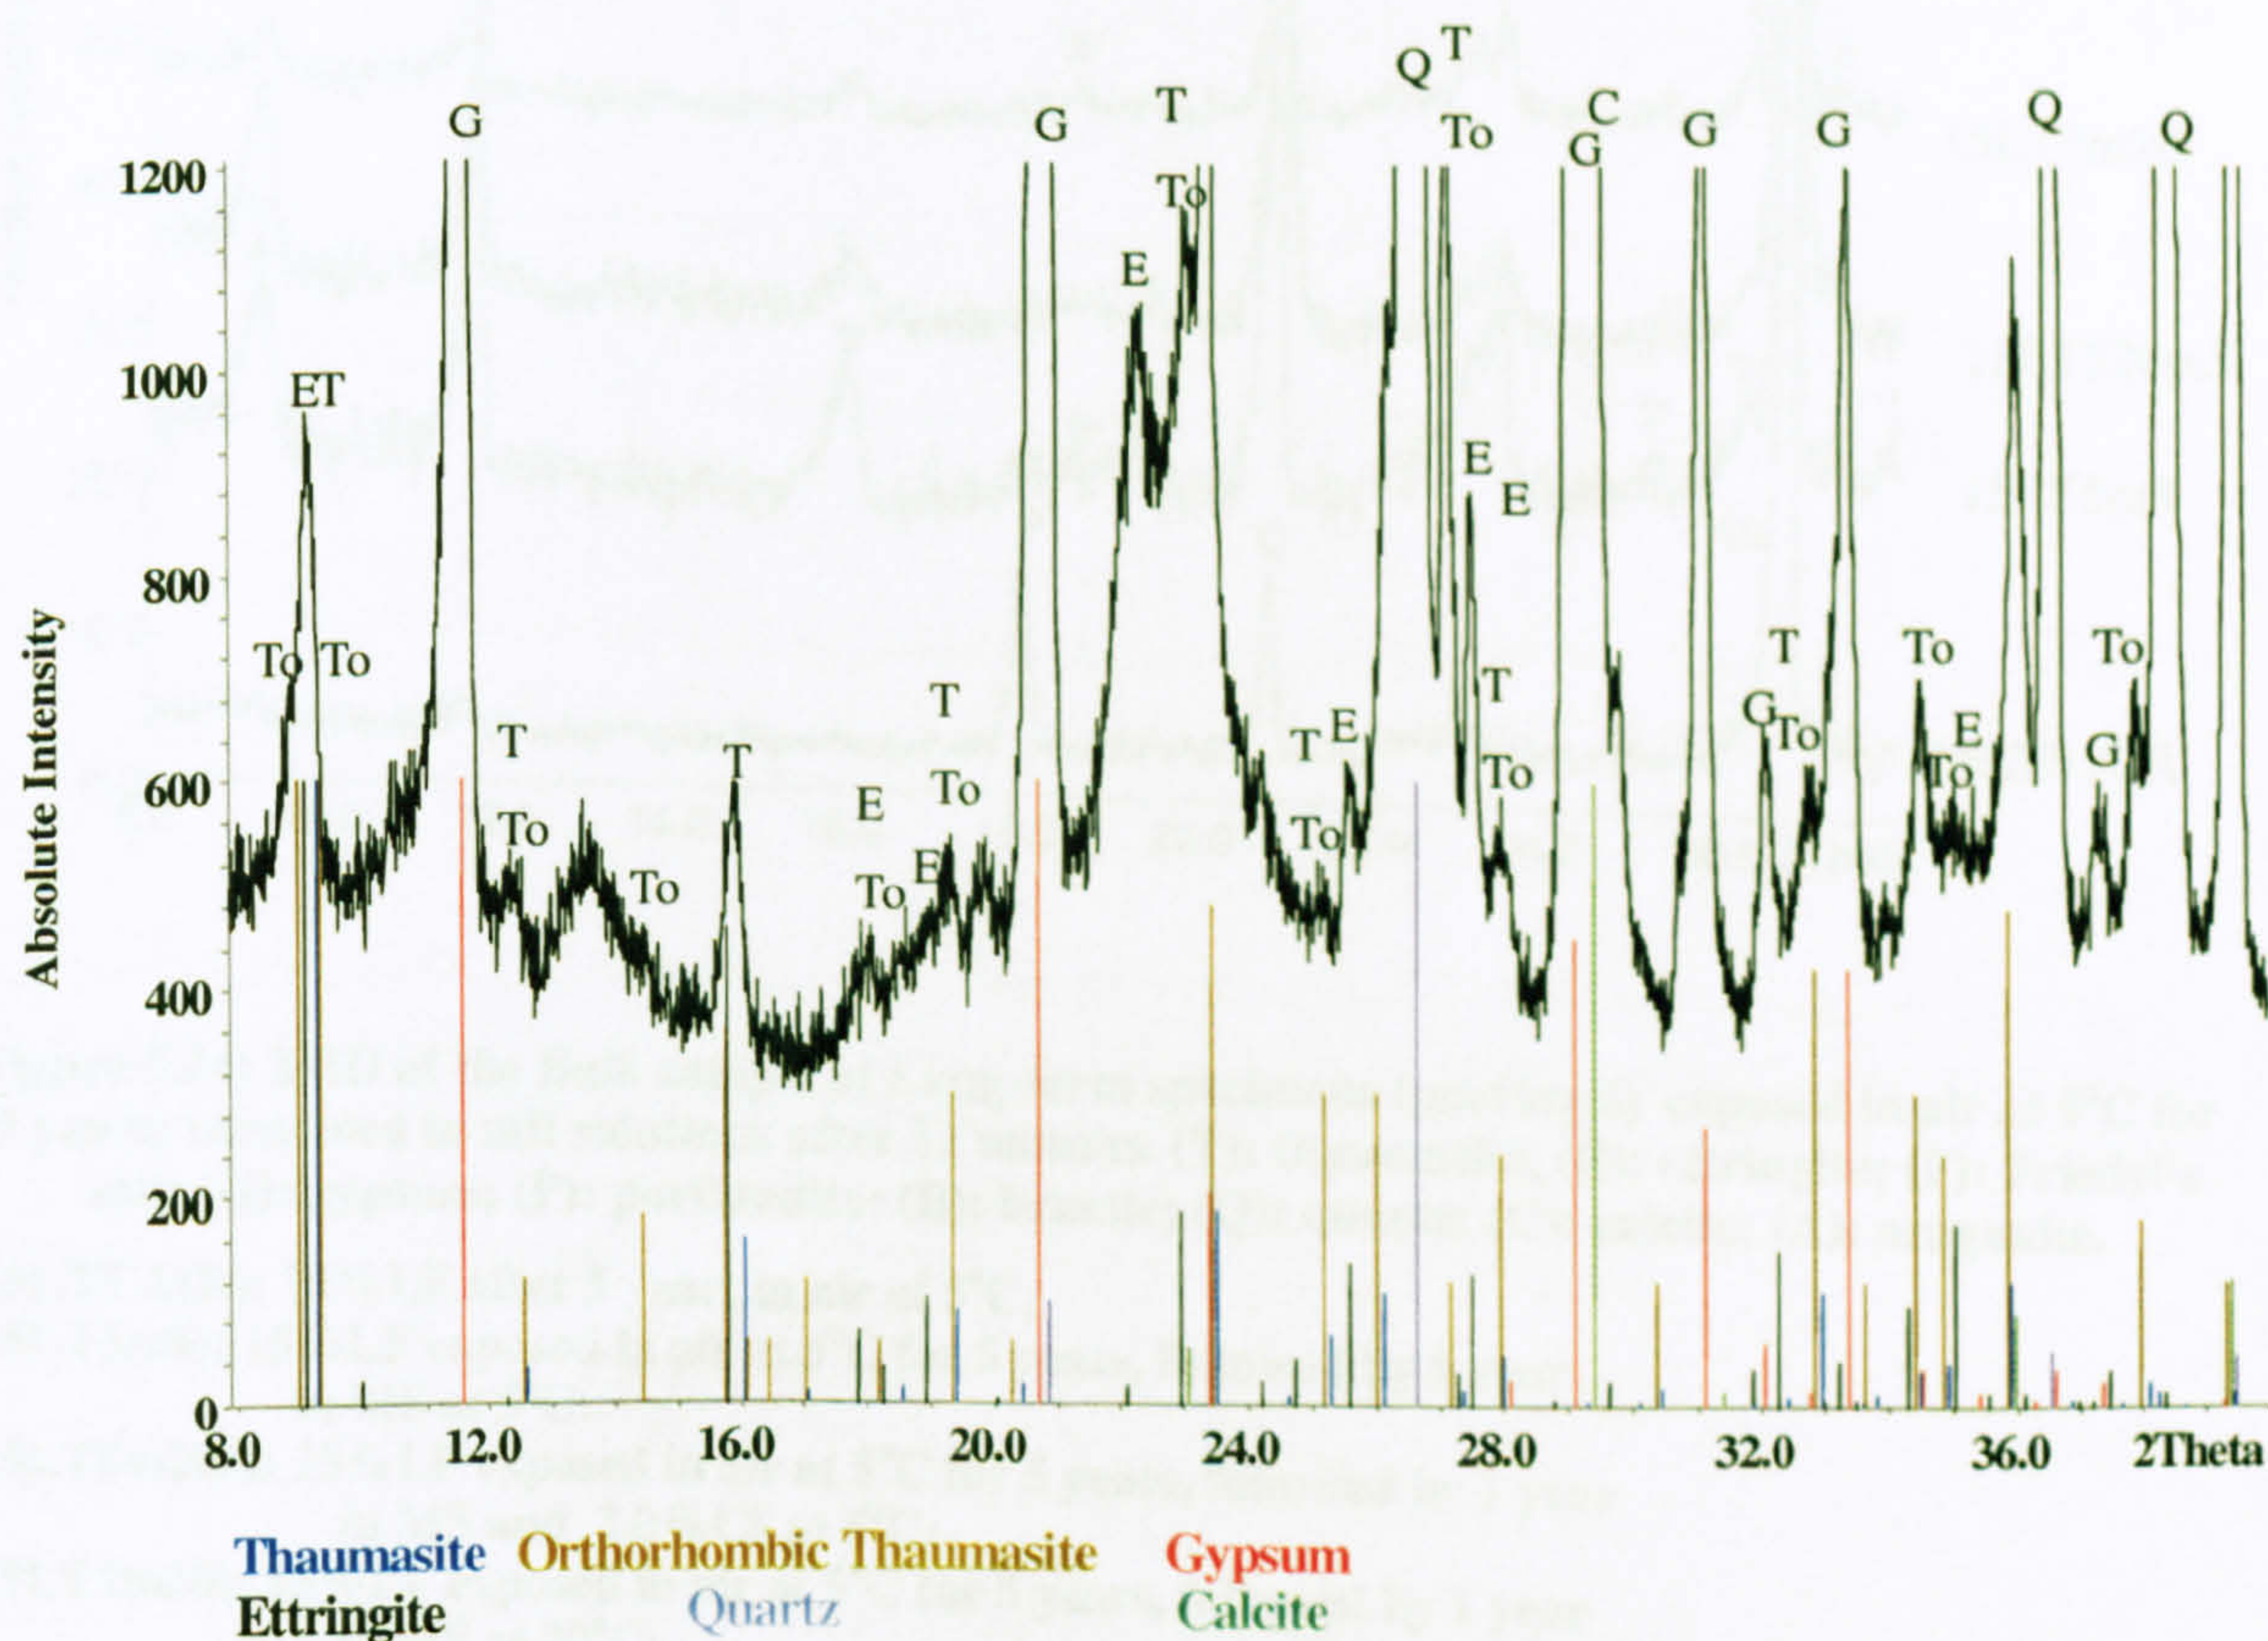
Figure 5.23: MK after 73 weeks in magnesium sulfate at 5°C: (To): orthorhombic thaumasite, (T) thaumasite, (E) ettringite, (G) gypsum; (Q) quartz and (C) calcite.

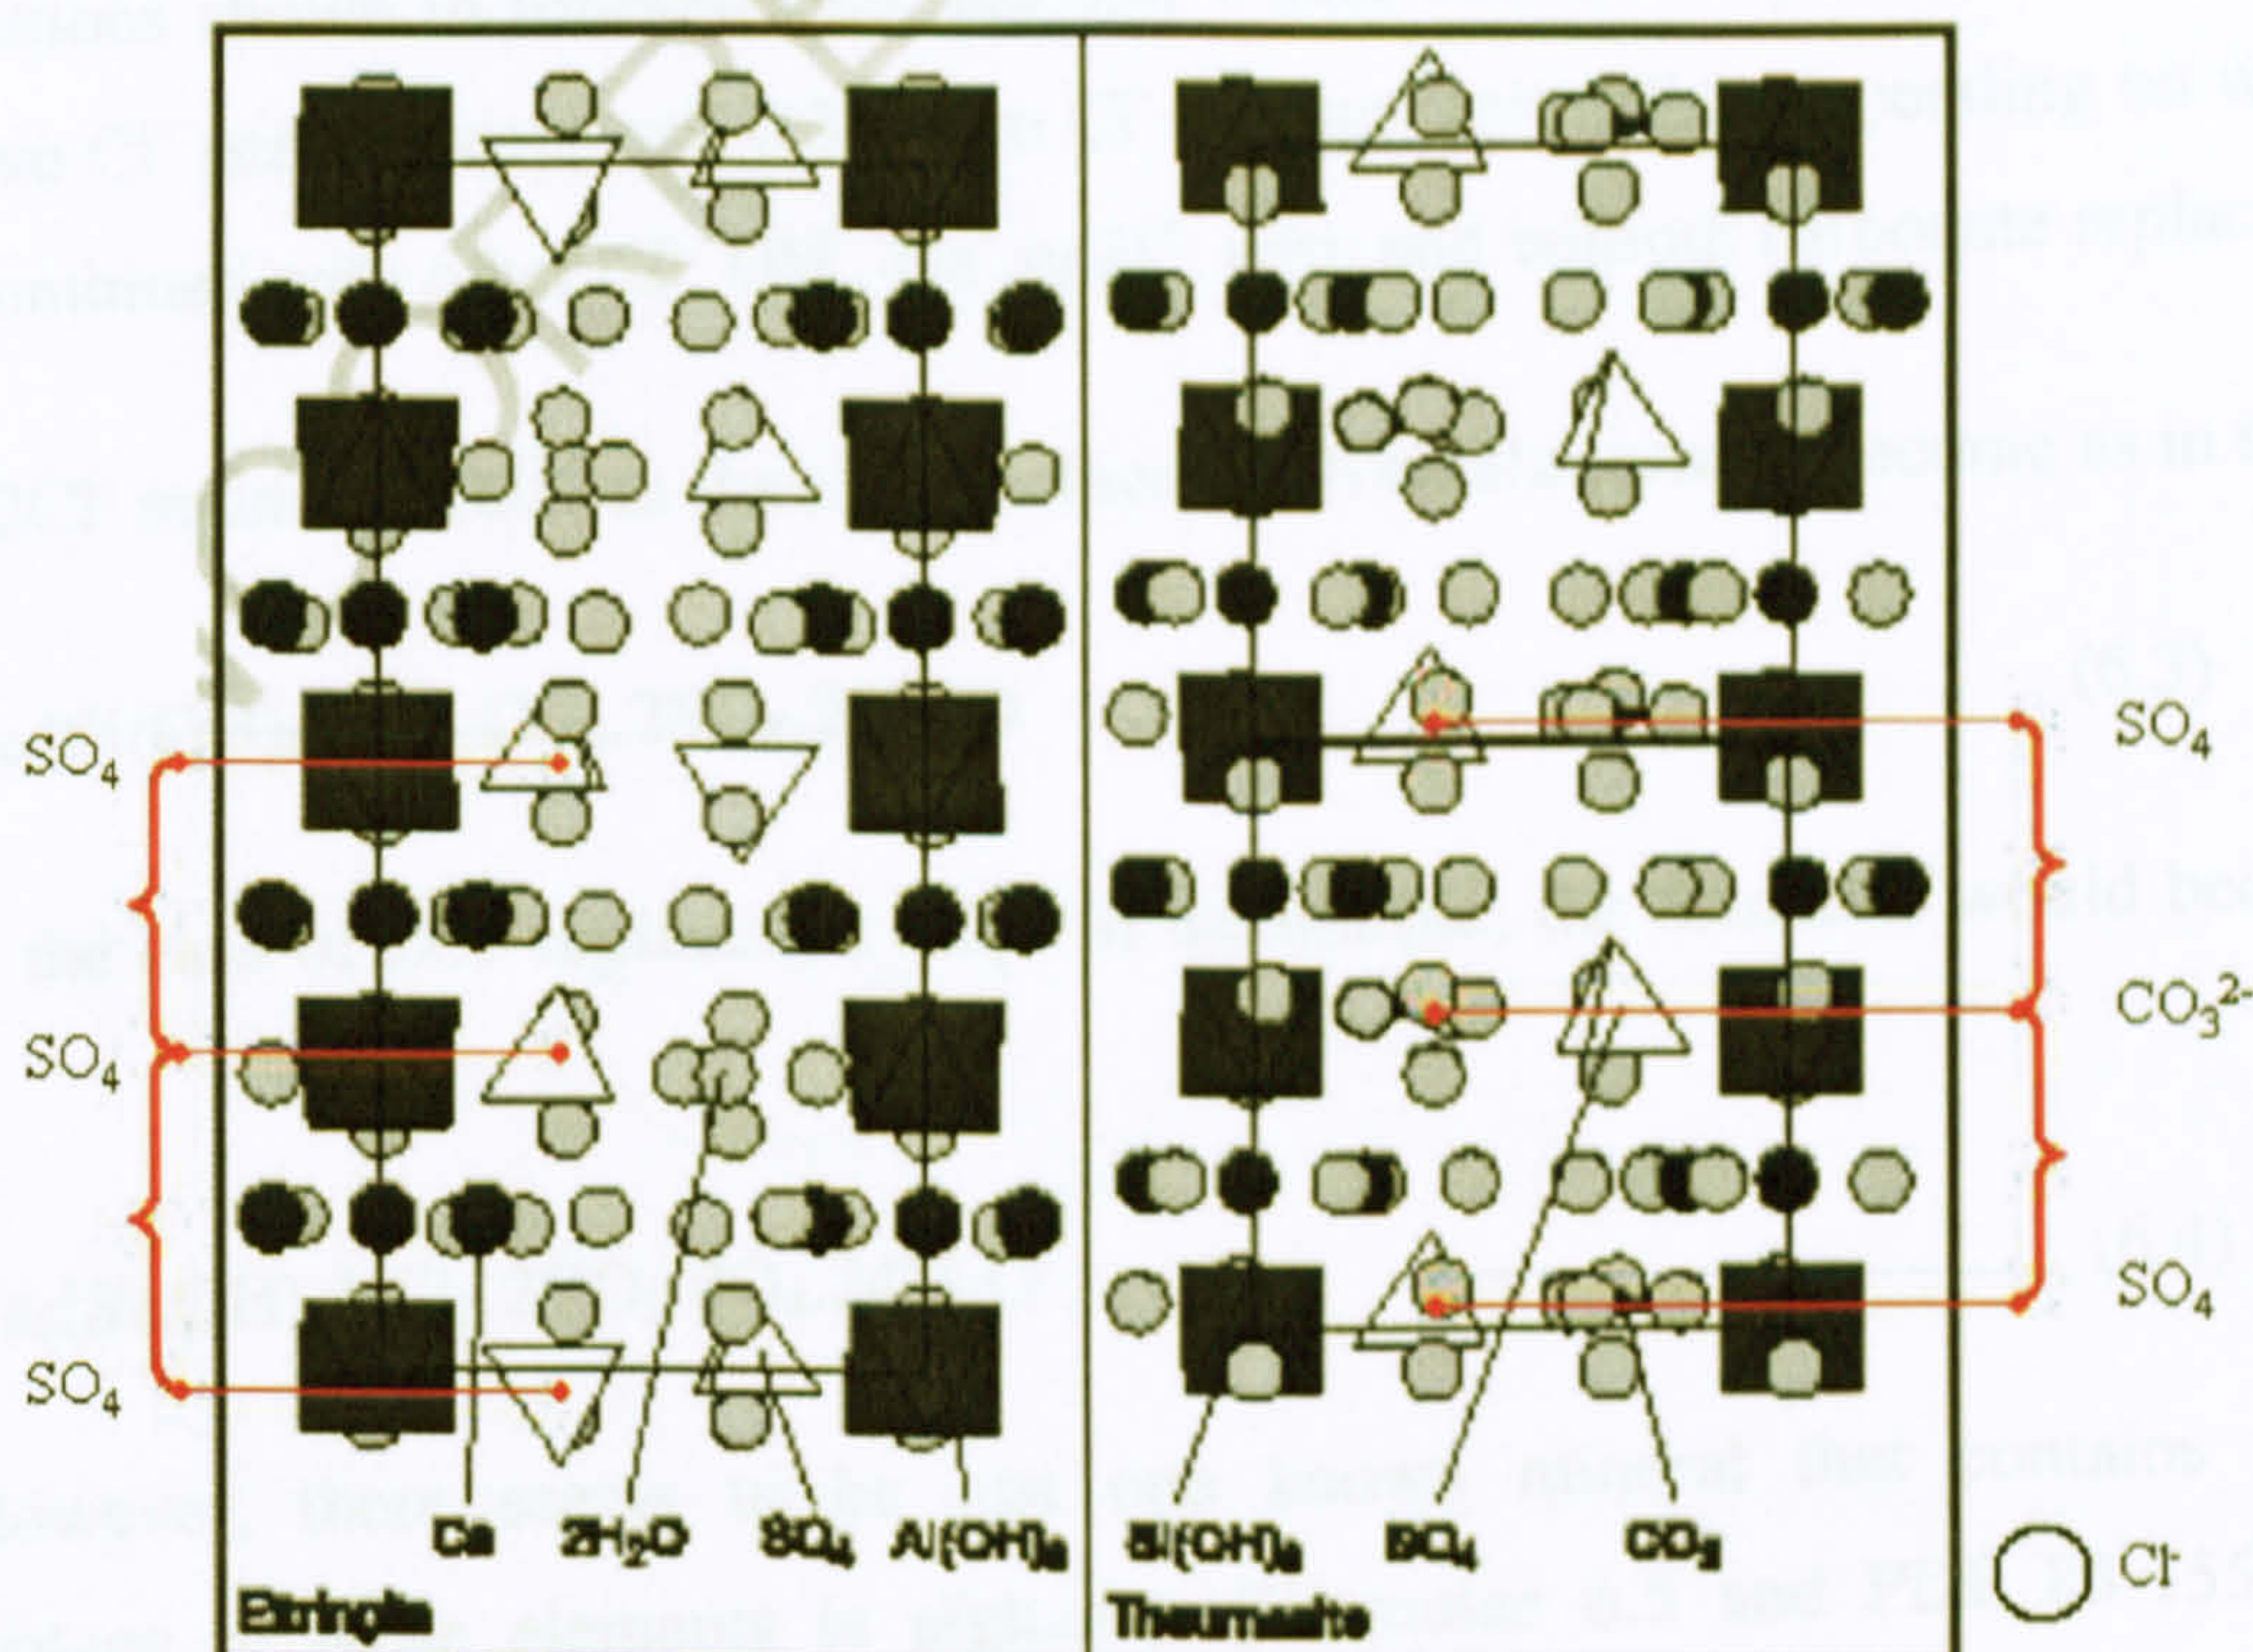
Figure 6.24: Crystal structure of ettringite and thaumasite projection  $c$ -dimension vertical  $[110]$ , as shown in Torres et al. [18].

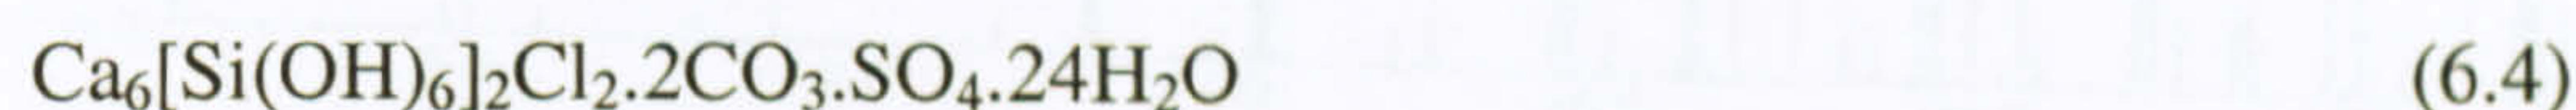
In the case of 2Cl<sup>-</sup> replacing 1 SO<sub>4</sub><sup>2-</sup> in thaumasite, the formulae would become as in 6.4:

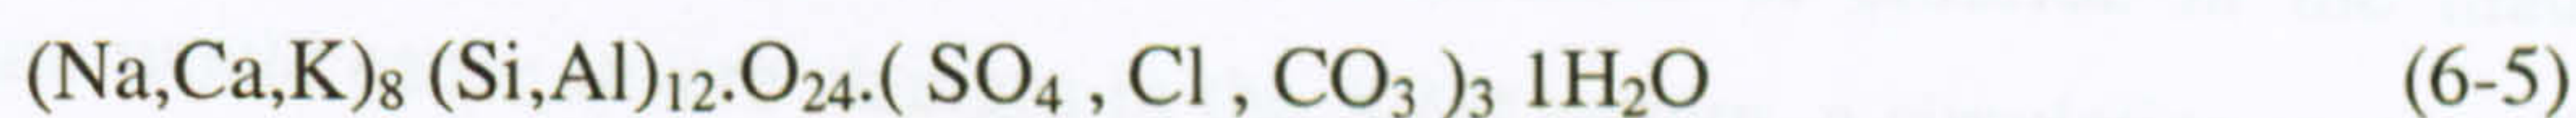
However, there seems to be just one known mineral that contains such an assemblage of these elements is afghanite (Formulae 6.5 and PDF 85-1557). This mineral is found to be hexagonal but its symmetry has been reported as being ettringite type (P31c) or thaumasite type (P63mc), by Ballirano et al. [153] and Rastsvetaeva et al. [154], depending on the concentration of those elements. Although its lattice parameters are  $a=12.80 \text{ \AA}$  and  $c=21.41 \text{ \AA}$ , which is close to that of  $c$  for ettringite ( $21.415 \text{ \AA}$ ), its composition greatly differs from that of thaumasite, ettringite or Friedel's salt.

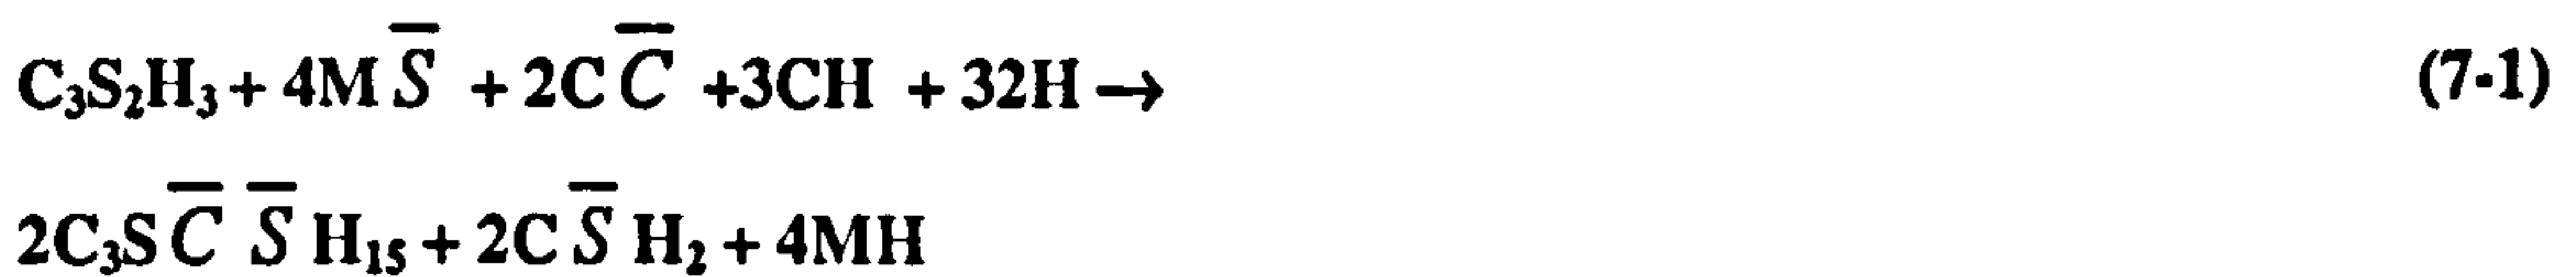
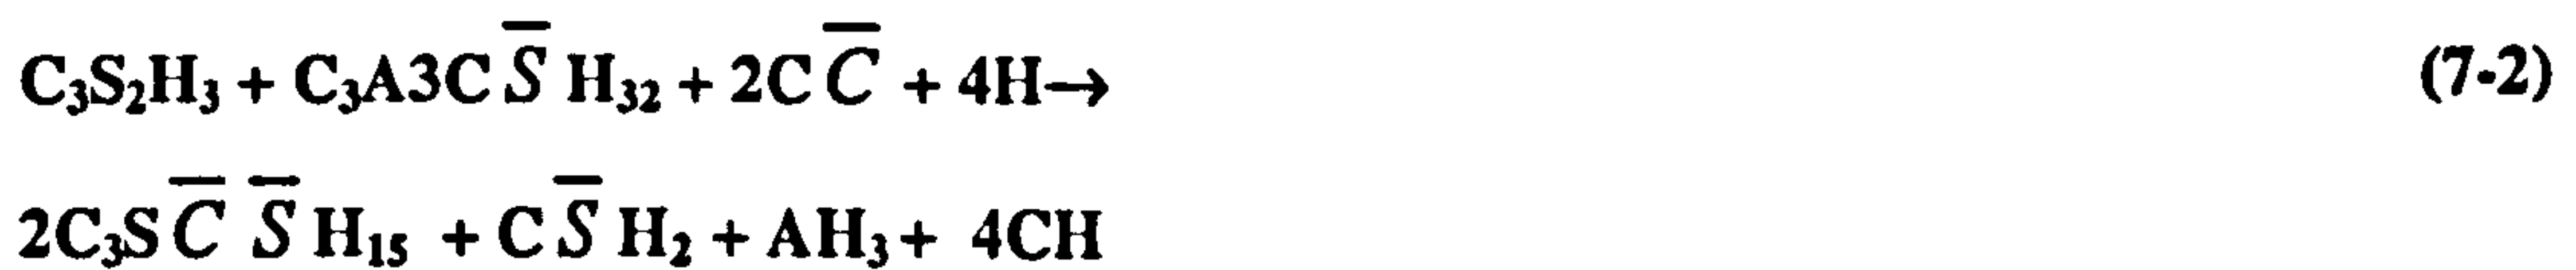
There can be several possibilities for thaumasite formation in Portland cement matrixes, which vary according to the cations of the dissolved sulfate, silicate and carbonate species and also in thaumasite formation. Several reaction paths are proposed, in which thaumasite is formed through the congruent dissolution of CSH in the presence of gypsum and portlandite [11, 84]. Although not very likely to be in equilibrium with sulfates, portlandite is sometimes presented as a reaction product [10]. The dissolution of ettringite is also reported to participate in the formation of thaumasite, in what is called the 'woodfordite' route [84]. In this later case, it still not clear whether ettringite would either offer a nucleation site for thaumasite or it undergoes a substitutional ion exchange resulting in thaumasite. The last topochemical mechanism is believed to be unlikely as the ettringite/thaumasite solid solution series involves some discontinuity [9, 62]. Both mechanisms can be as described in equation 7.1 [11] and equation 7.2 [10, 84]
