# **Thaumasite Sulfate Attack in Cement Mortars Exposed to Sulfate and Chloride and Implications to Rebar Corrosion**

A thesis submitted for the degree of Doctor of Philosophy in the Faculty of Engineering of the University of Sheffield

THE UNIVERSITY OF SHEFFIELD  
DEPARTMENT OF CIVIL AND STRUCTURAL ENGINEERING

**July 2014**

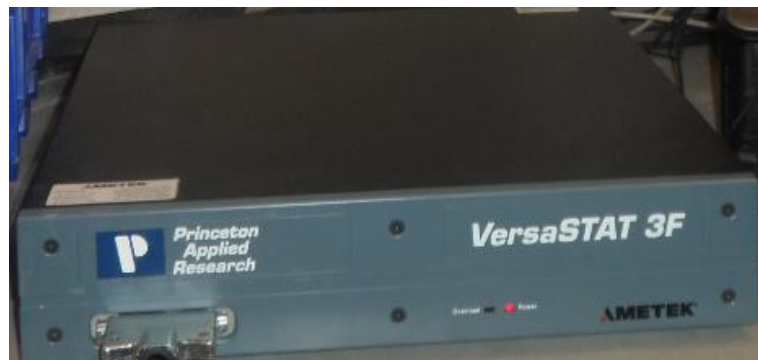
**Figure 3.7.** Corrosion equipment.

In this study, the electrochemical measurements was made using the equipment shown in Figure 3.7, which is a VersaSTAT 3F potentiostat model, manufactured by Princeton Applied Research. A carbon rod placed outside the specimen was used as a counter electrode, while a saturated calomel electrode used as the reference electrode. The polarization resistance ( $R_p$ ) determinations were performed at a scan rate of 0.167 mV/s over a range of  $\pm 10$  mV. A computer program, VersaStudio model, developed by EG&G Princeton Applied Research, was used for applying the potential scan, analysing the data, and calculating the polarization resistance ( $R_p$ ), corrosion current ( $I_{\text{corr}}$ ) Parameters. Figure 3.8 is a schematic diagram for these measurements. LPR measurements were repeated on selective specimens in order to examine the accuracy of the test. Since, the purpose of the tests in this study was to provide comparative data rather than absolute values of the parameters, no corrections were made to the results, which may result in overestimated values.

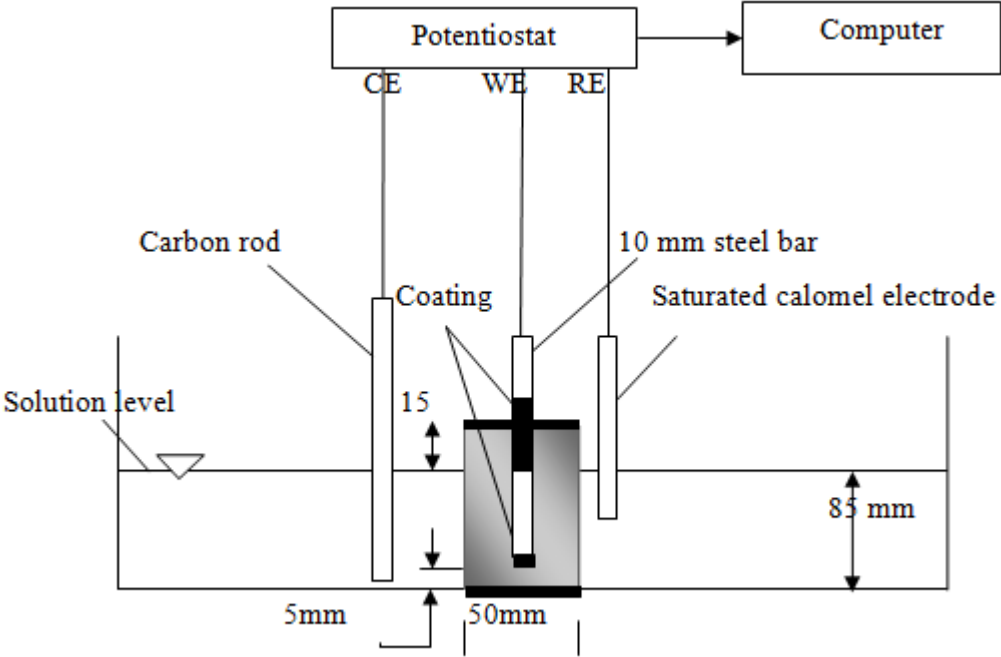
**Figure 3.8.** Set up of corrosion measurements by LPR.

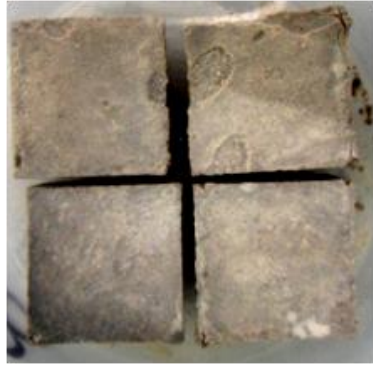
**Figure 4.1.** 20mm mortar cubes of CEMI-LF mortar stored for 74 days in SC5 at 5°C.

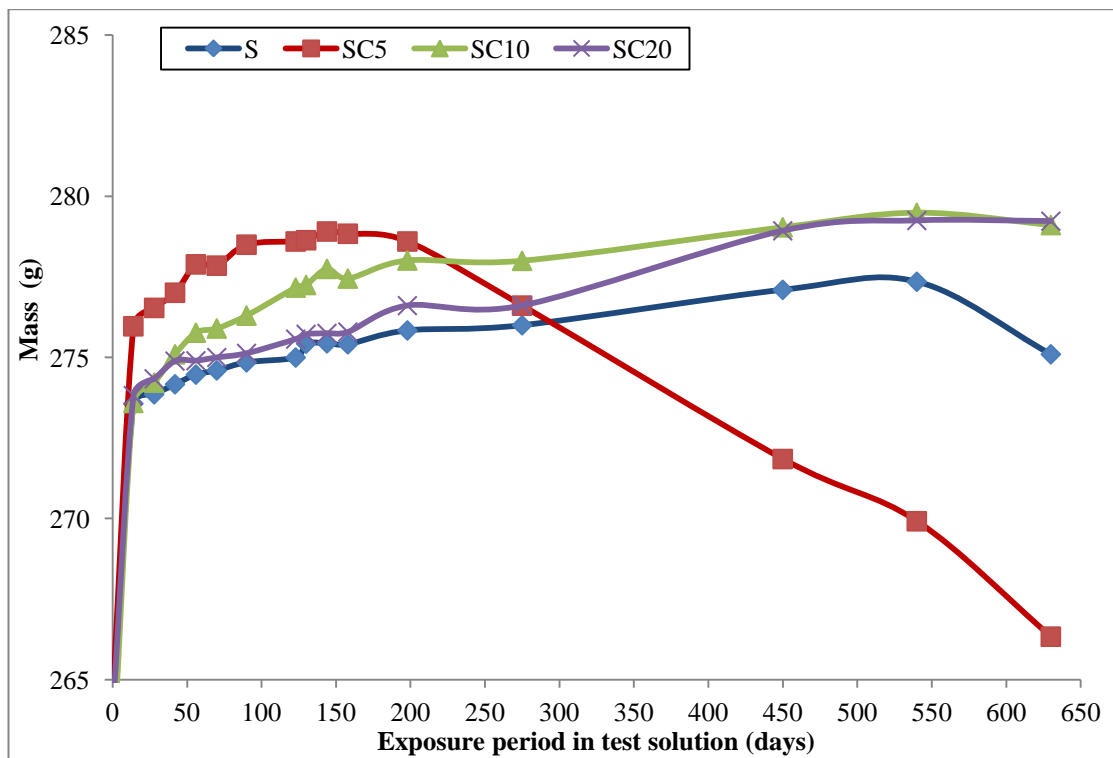
**Figure 4.11.** Mass changes for CEMI mortar cubes stored 630 days at 5°C.

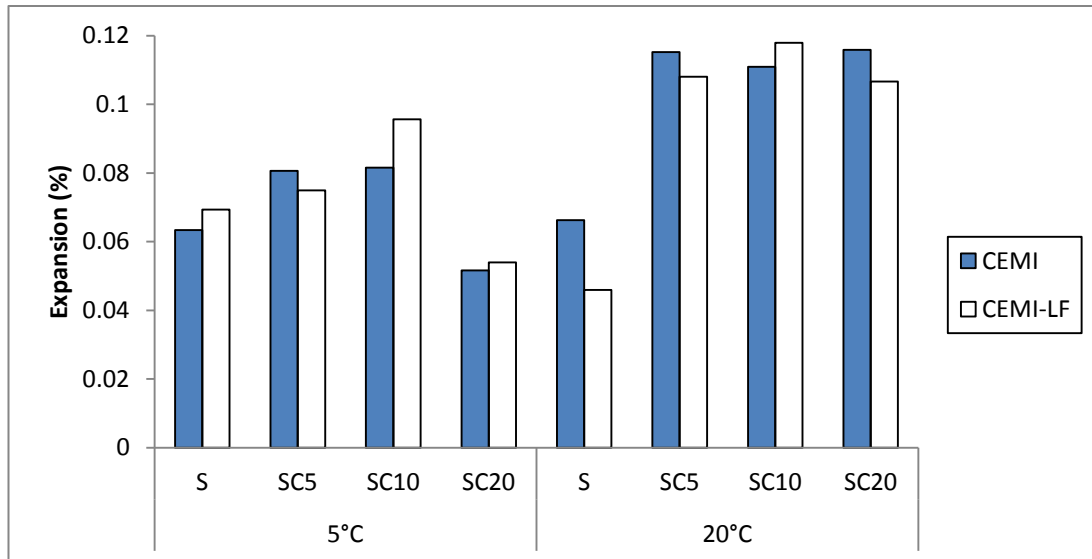
**Figure 4.19.** Length change variations for CEMI and CEMI-LF mortars stored for 630 days at 5 and 20°C.

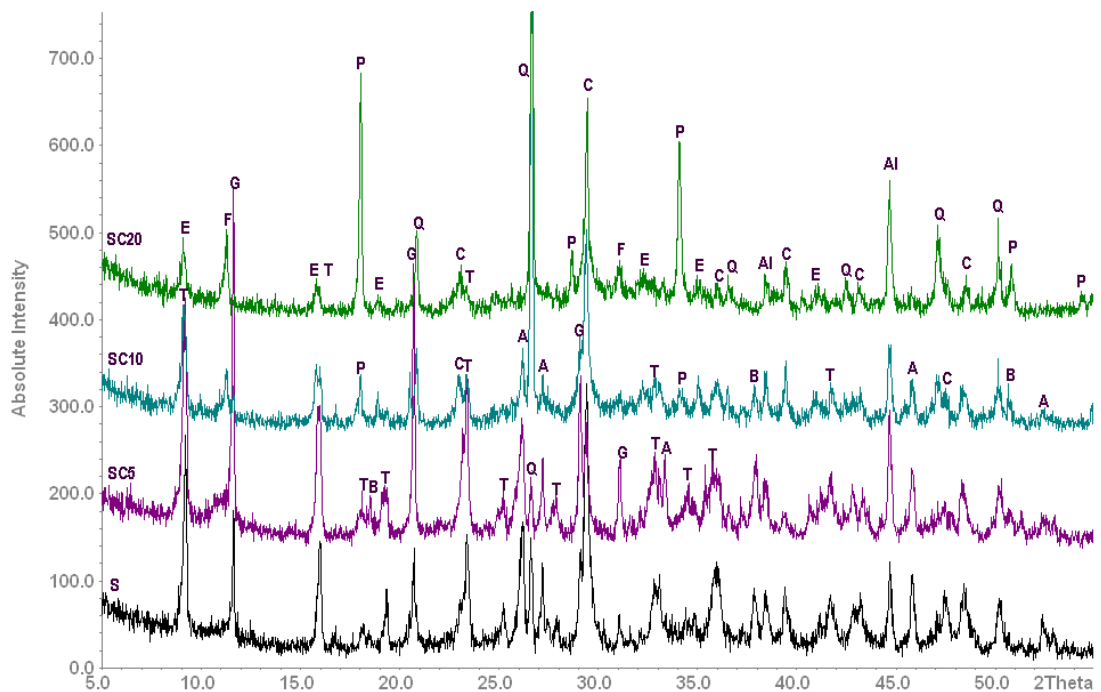
**Figure 4.20.** XRD patterns of CEMI samples stored for 630 days at 5°C.

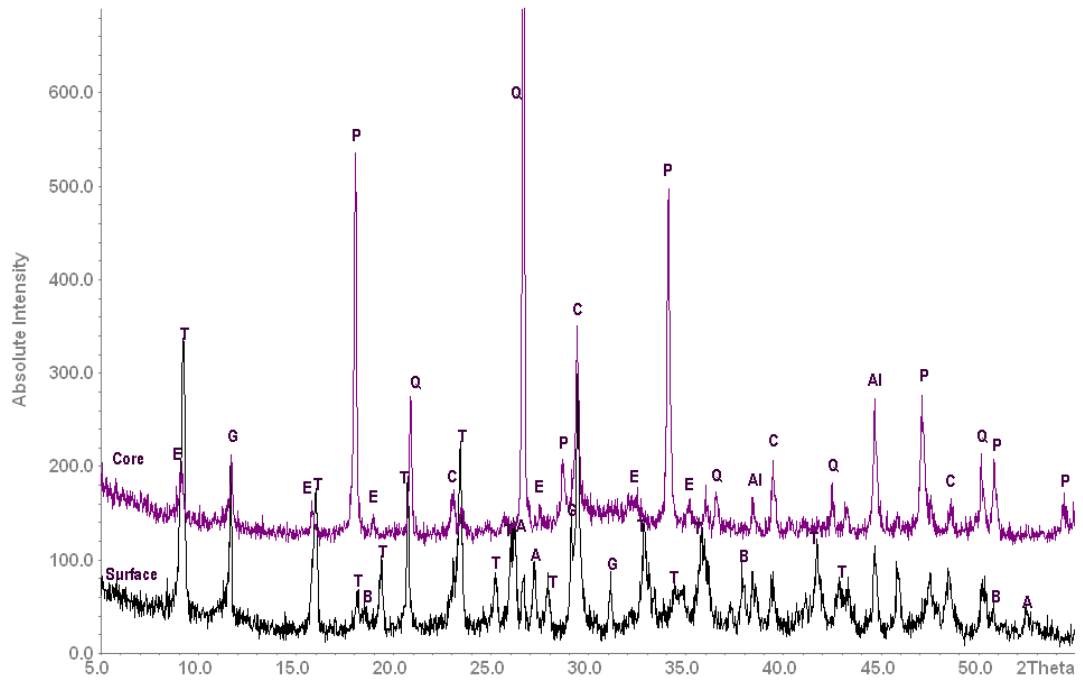
**Figure 4.24.** XRD patterns for degraded surface and sound core samples for CEMI-LF specimens stored 630 days in sulfate only solution at 5°C.

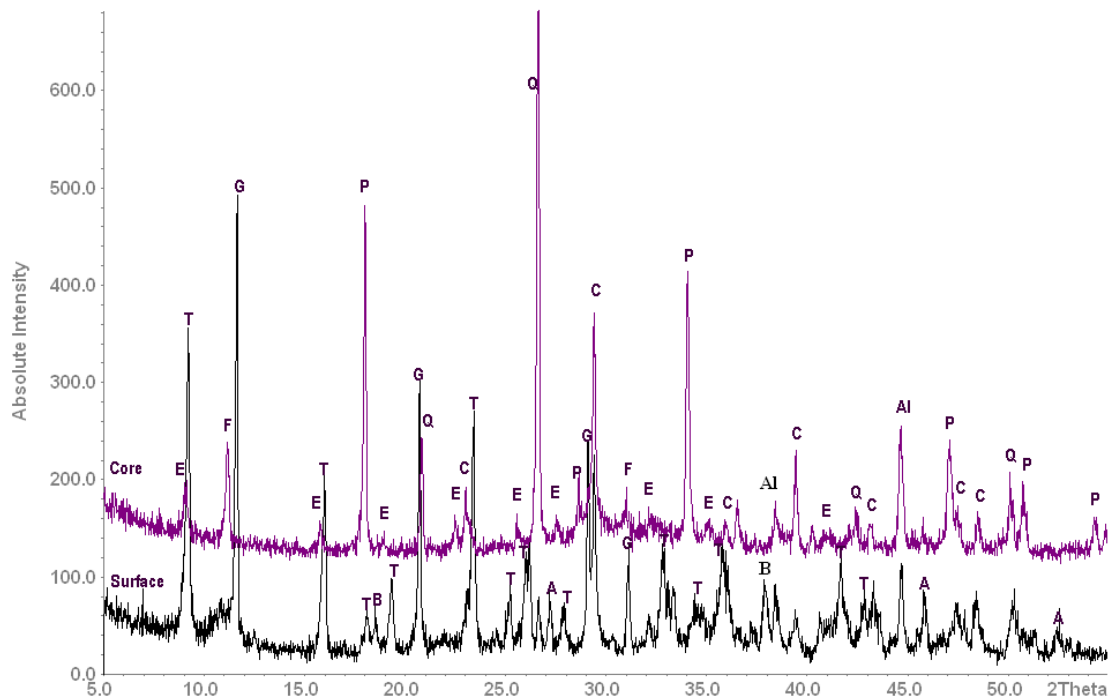
**Figure 4.25.** XRD patterns for degraded surface and sound core samples for CEMI-LF specimens stored 630 days in SC5 at 5°C.

In case of SC5 and SC20 (Figure 4.25 and 4.26) core samples, it can be seen that no gypsum and almost similar peak intensities for ettringite were detected and instead of gypsum, moderate peak intensities for Friedel's salt were present in SC5 and SC20 core samples. This indicates that penetration of chloride into the mortars was more rapid than for sulfate. All results indicate that the core of CEMI-LF mortars, which showed extensive surface degradation, remained intact within this period of exposure. This may explain why these mortars showed negligible expansion.

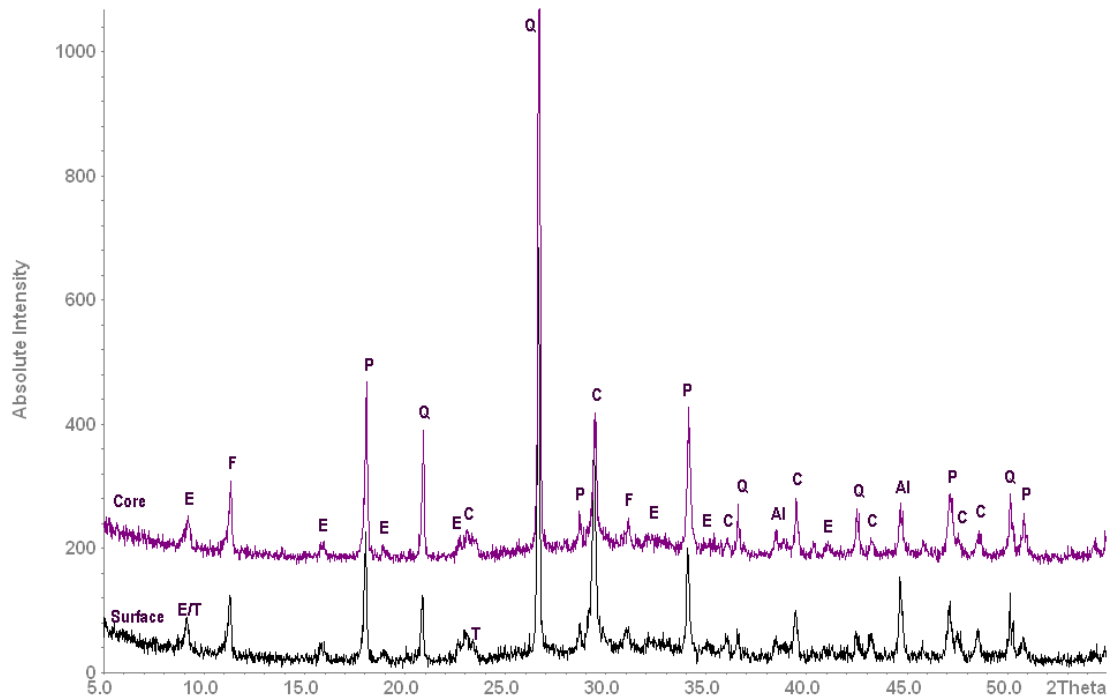
**Figure 4.26.** XRD patterns for sound surface and core samples for CEMI-LF specimens stored 630 days in SC20 at 5°C.

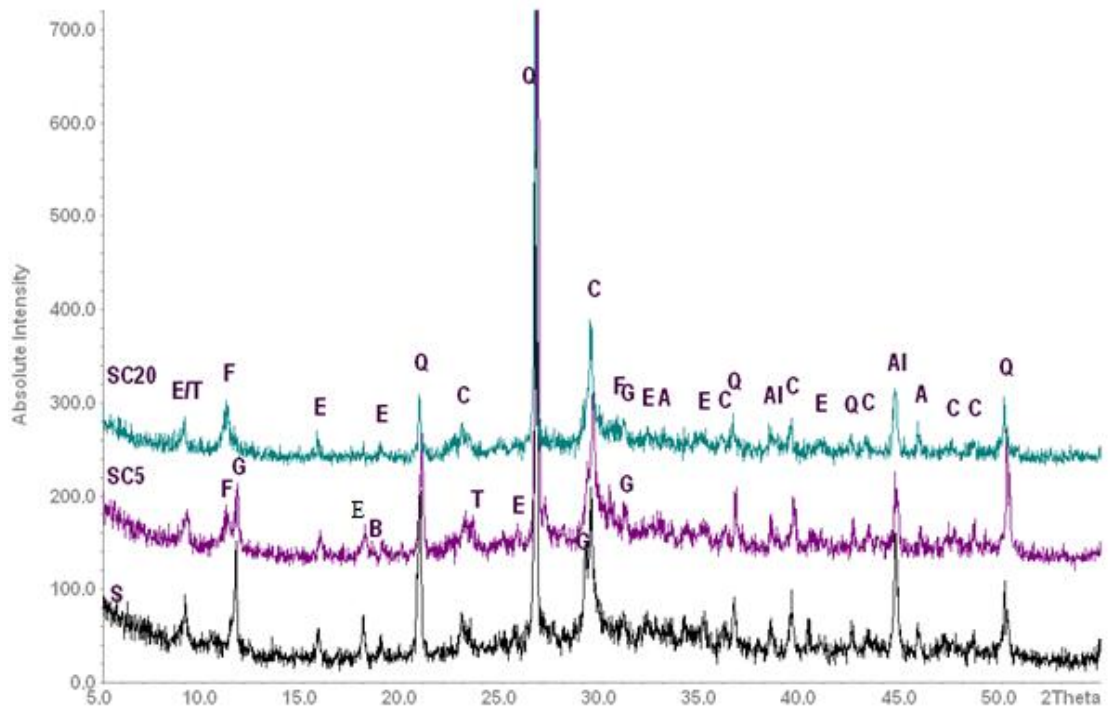
**Figure 4.29.** XRD patterns for CEMI-GGBS samples stored for 630 days at 5°C.

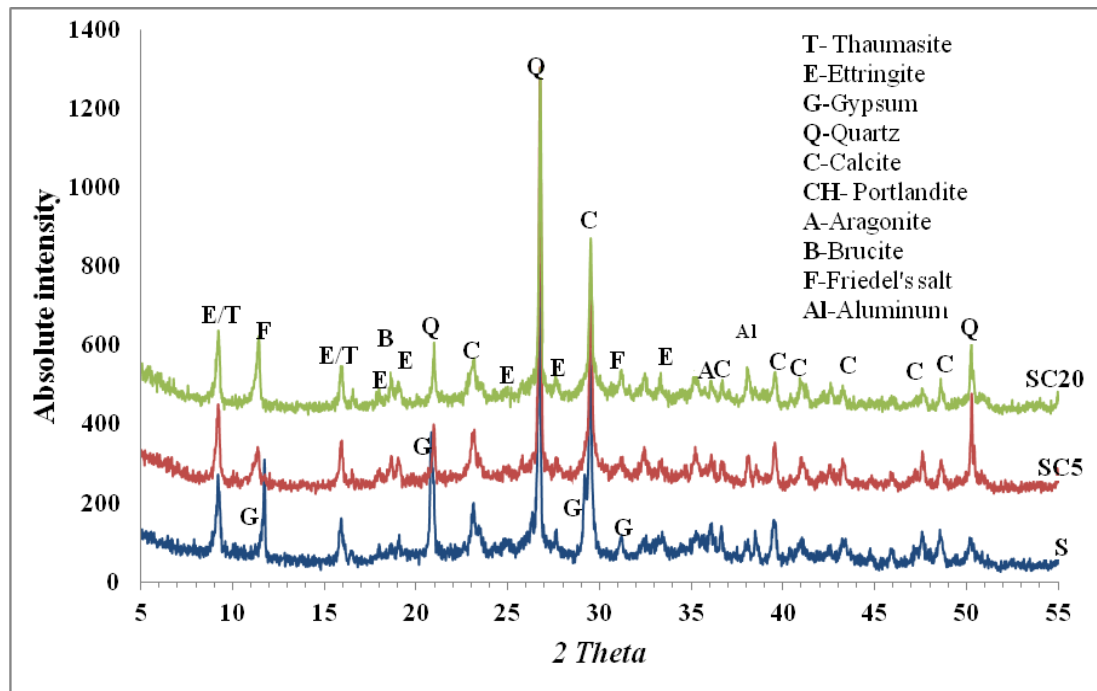
**Figure 4.31.** XRD patterns for CEMI-PFA samples stored for 180 days at 5°C.

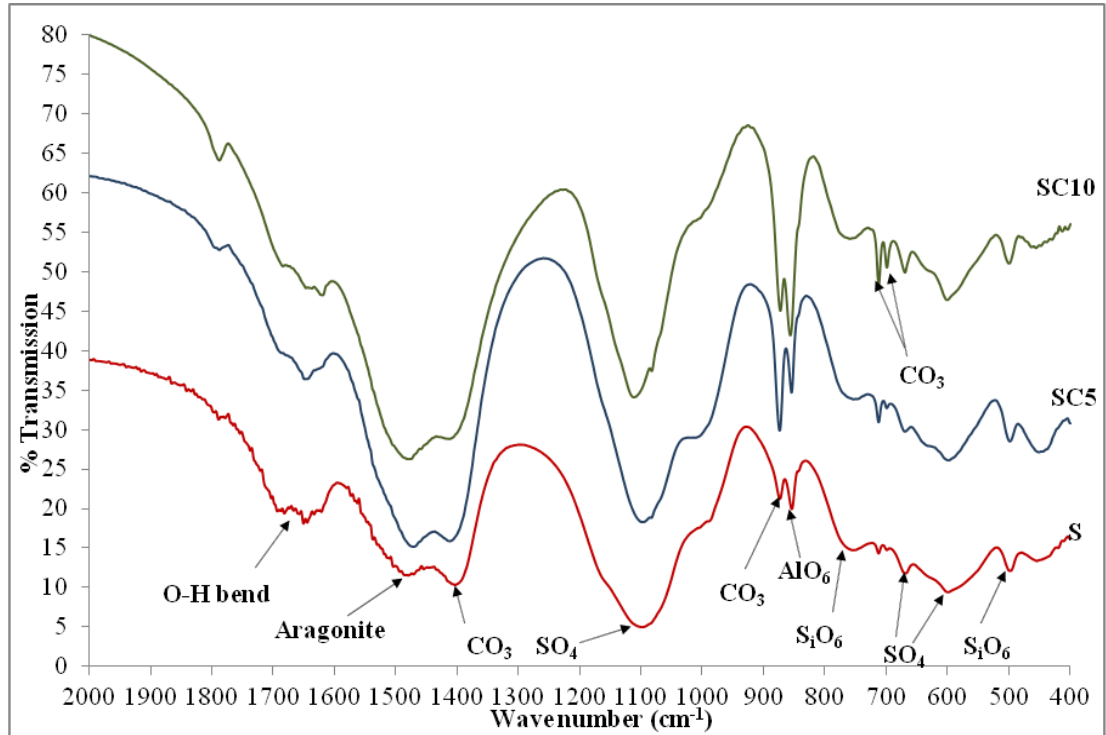
Figure 4.33. Infrared spectra for CEMI degraded samples at 5°C.

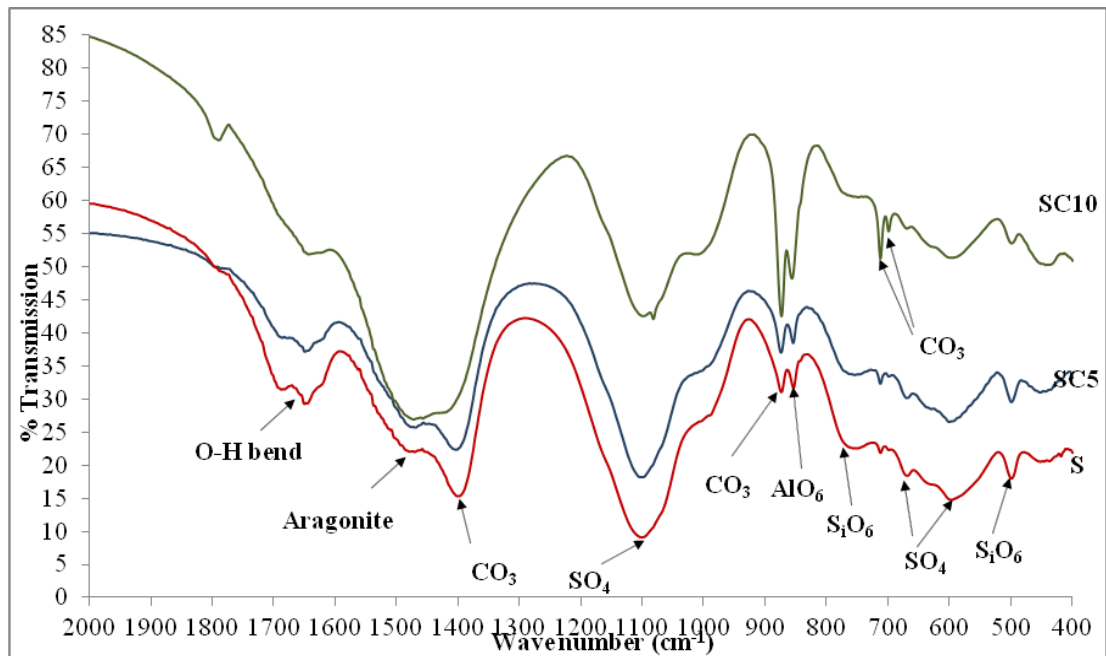
Figure 4.34. Infrared spectra for CEMI-LF degraded samples stored at 5°C.

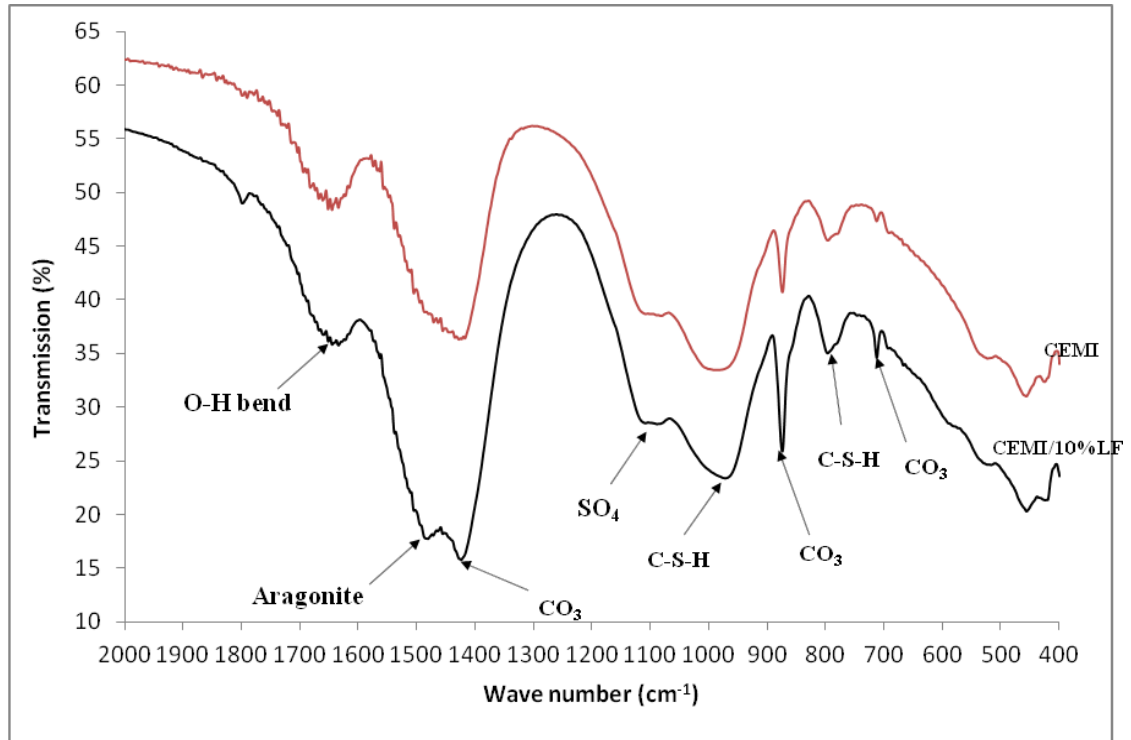
**Figure 4.35.** Infrared spectra for CEMI and CEMI-LF surface samples stored in SC20 at 5°C.

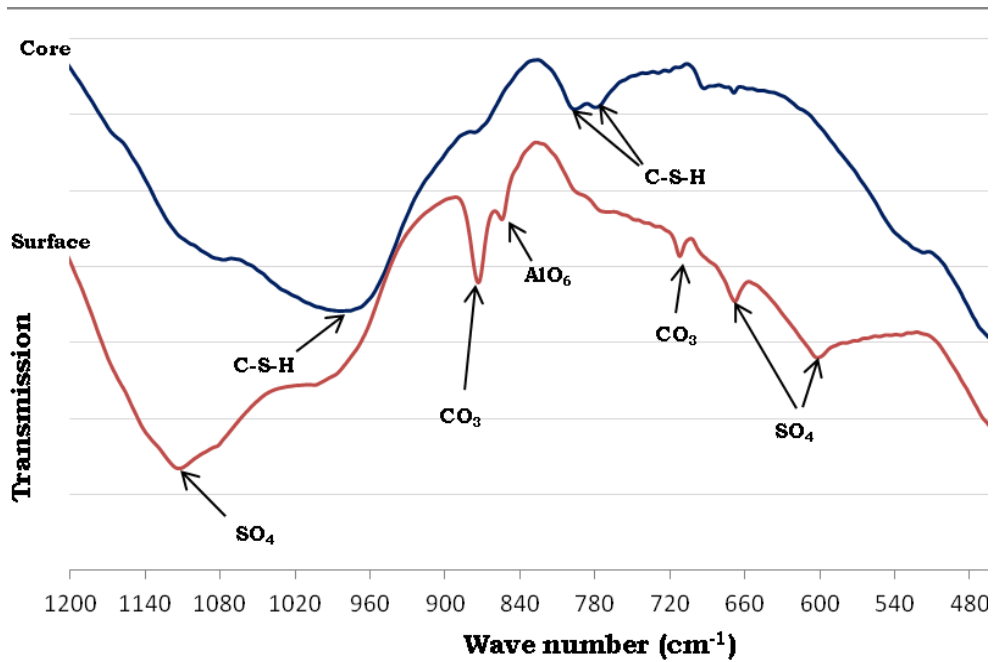
**Figure 4.37.** IR spectra for CEMI-PFA sample stored 180 days in sulfate only solution at 5°C.

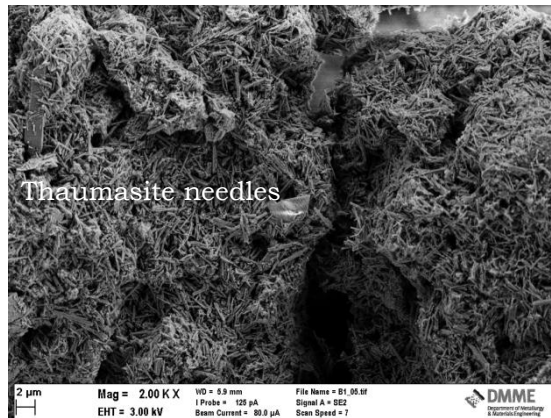
**Figure 4.40.** Morphology of degraded surface of CEMI-LF mortar stored 360 days in sulfate only solution at 5°C.

Fracture samples collected from surfaces of CEMI-LF mortars stored for 360 days in S, SC5 and SC10 solutions at 5°C shown in Figure 4.40 to 4.42 show prismatic fine needle shaped crystals < 0.5 μm in thick and up to 10 μm long as the dominant product. EDX analysis shown in Figure 4.43, indicates that as these crystals consisted mainly of calcium, sulfur, oxygen, aluminium, silicon as well as a small amount of carbon, they are a thaumasite-ettringite solid solution series as reported by Torres et al. (2004).

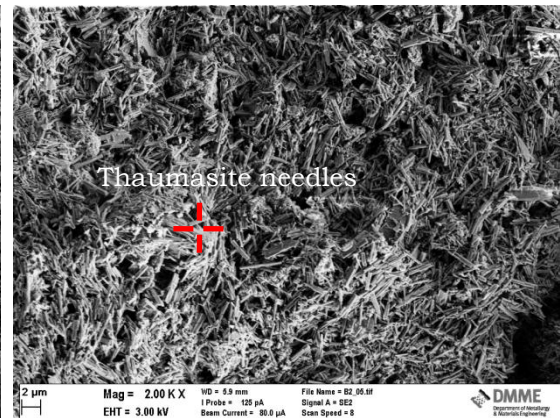
**Figure 4.41.** Morphology of degraded surface of CEMI-LF mortar stored 360 days in SC5 at 5°C.

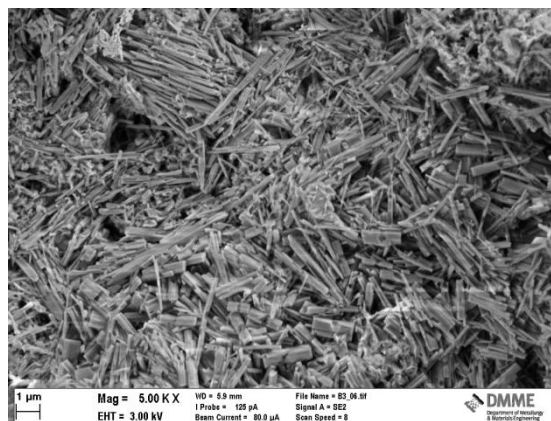
**Figure 4.42.** Morphology of degraded surface of CEMI-LF mortar stored 360 days in SC10 at 5°C.

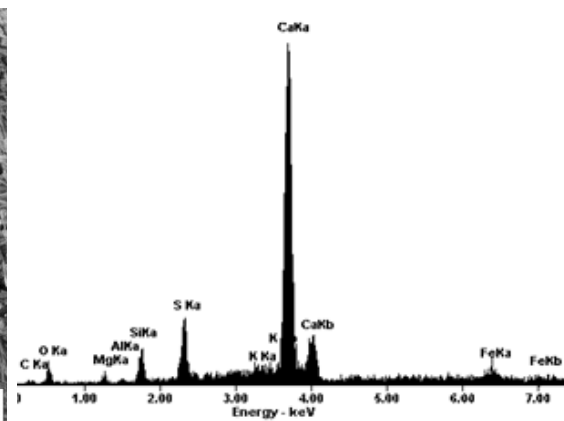
Figure 4.43. EDX of the needles (thaumasite-ettringite solid solution) in Figure 4.41.

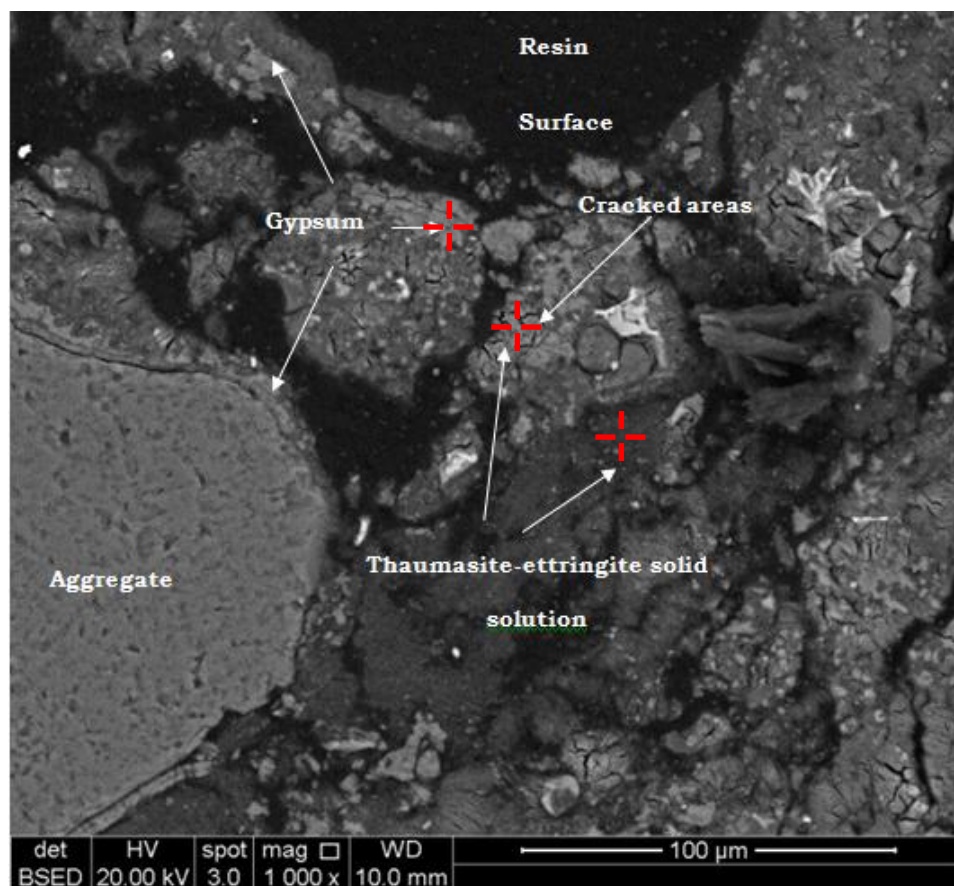
**Figure 4.44.** SEM image of CEMI sample stored 450 days in sulfate only solution.

It was also observed in Figure 4.44 that both cracked and dark areas were surrounded by secondary gypsum as EDX analysis in Figure 4.47 indicates. Gypsum may have formed at an early stage and then acted as a major source of sulfate for thaumasite formation, as reported by Schmidt et al. (2008) and Hartshorn et al. (1999) who noted that thaumasite formation is often accompanied by formation of secondary gypsum when magnesium sulfate was present. Further discussion of this issue is presented in Chapter 6.

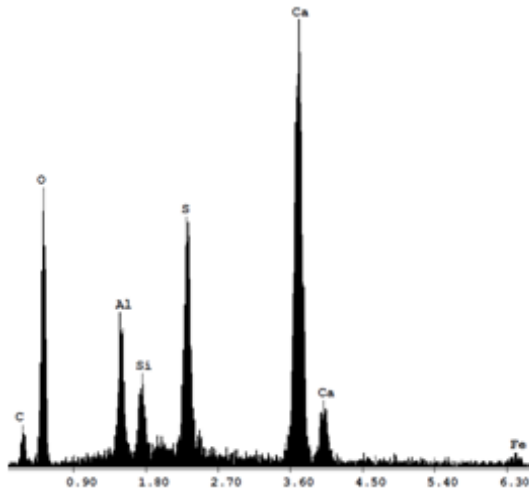
**Figure 4.45.** EDX of cracked light grey area (with Al:Si >1) in Figure 4.44.

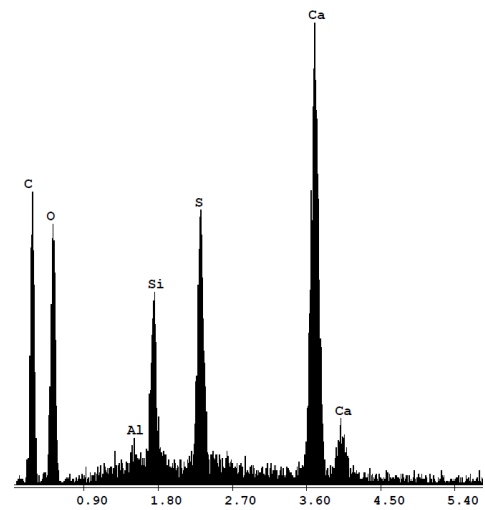
**Figure 4.46.** EDX of dark grey area (with Al: Si <1) in Figure 4.44.

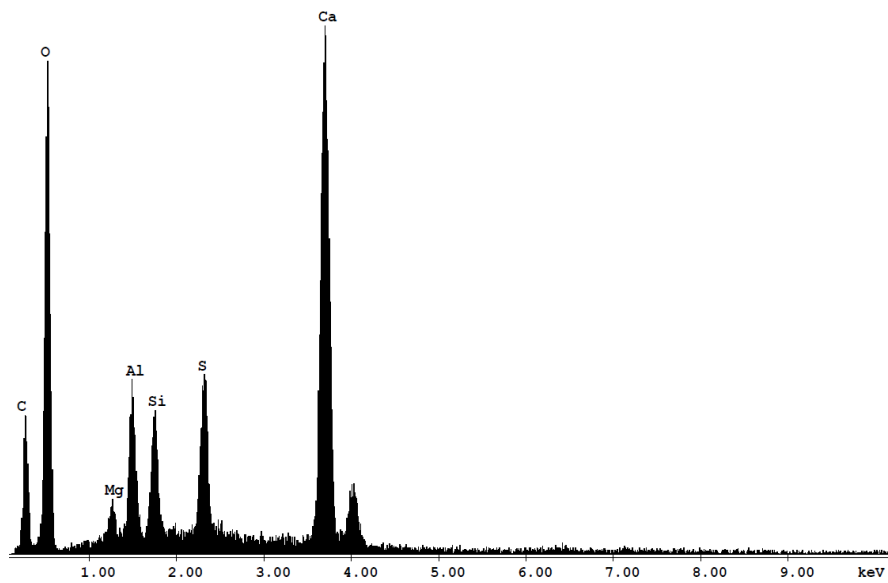
**Figure 4.49.** EDX of point shown in Figure 4.48

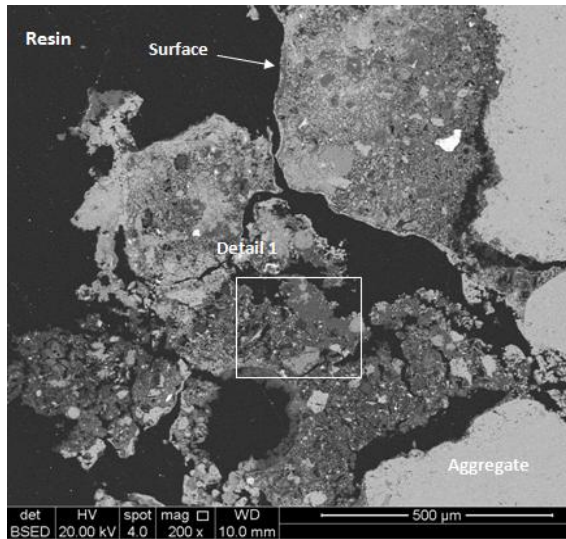
**Figure 4.50.** SEM image of CEMI-LF sample stored for 450 days in SC5.

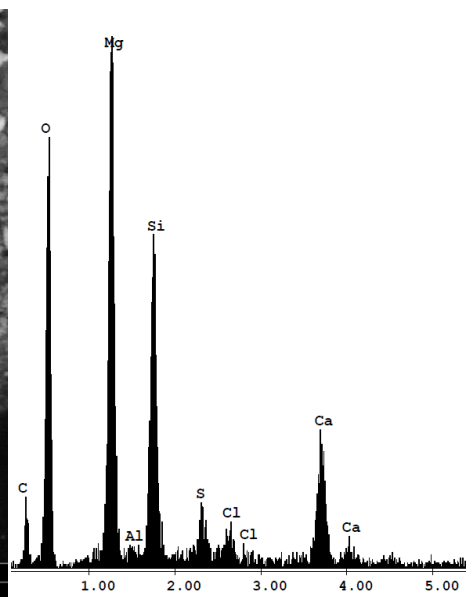
**Figure 4.57.** EDX of (Mg-C-S-H) in Figure 4.55.

The dark area (Figure 4.55) of the CEMI sample consists of high magnesium and low calcium, as indicated by EDX shown in Figure 4.57; which indicates that the C-S-H was decalcified.

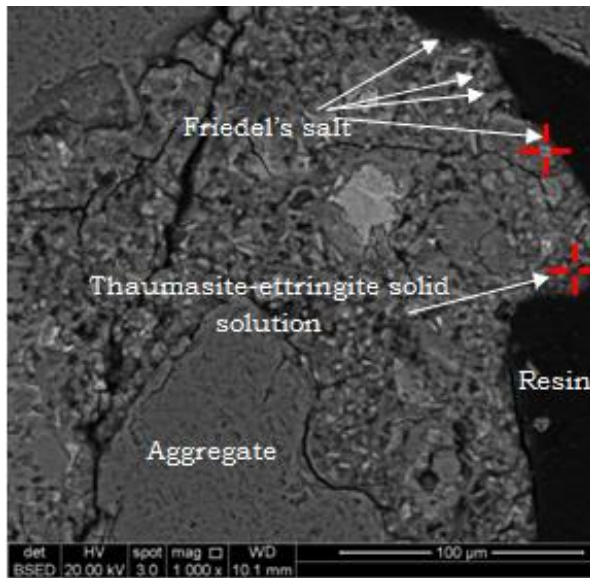
**Figure 4.58.** SEM image of CEMI sample stored 450 days in SC10.

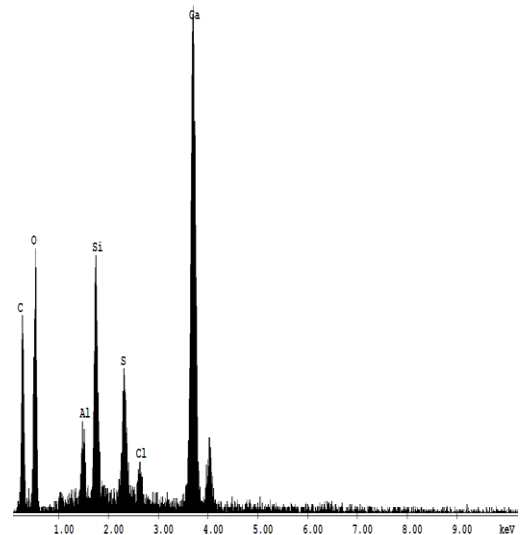
**Figure 4.62.** EDX for the point in Figure 4.61.

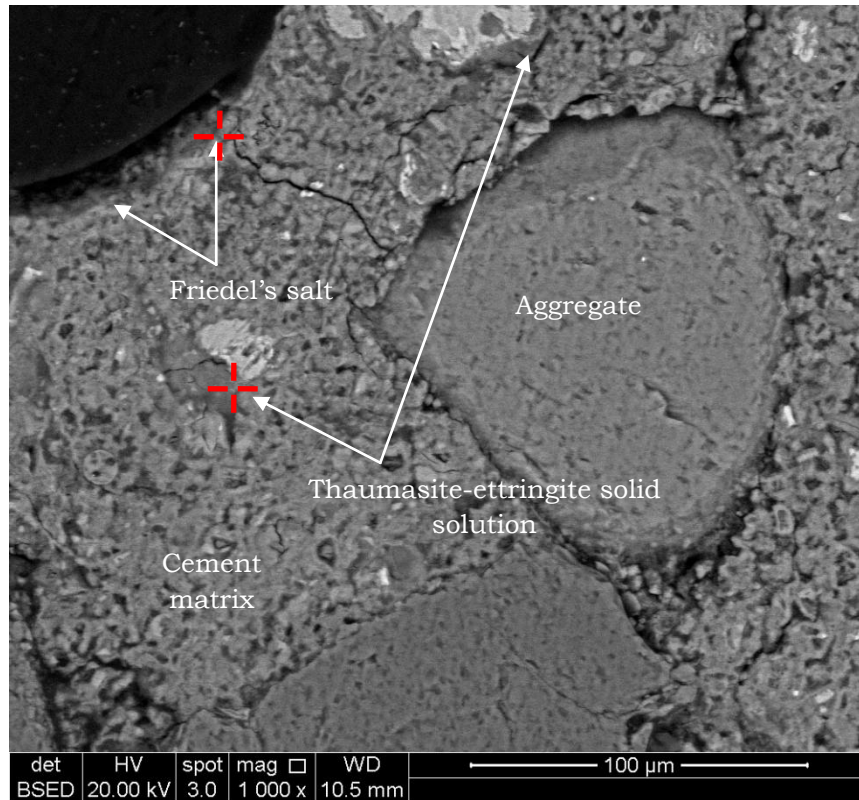
**Figure 4.63.** SEM image of CEMI sample stored 450 days in SC20.

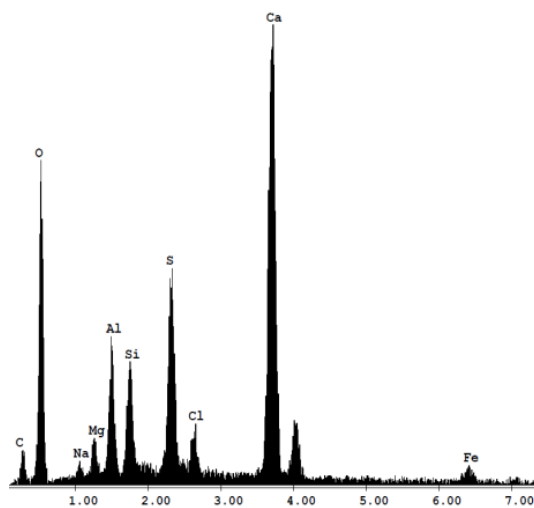
**Figure 4.67.** EDX of cracked material in Figure 4.66.

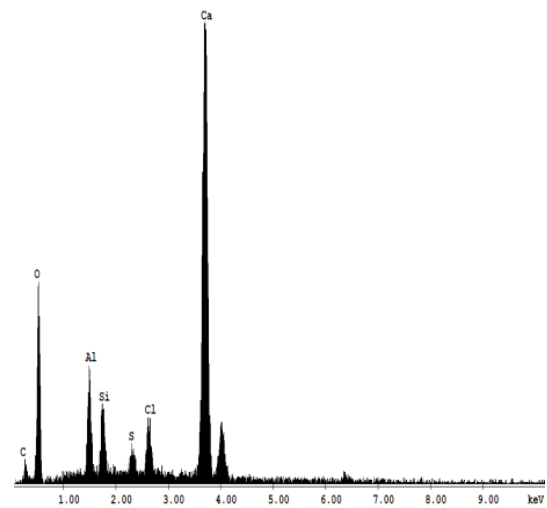
**Figure 4.68.** EDX of Friedel's salt in Figure 4.66.

Friedel's salt which is a non-expansive product, was determined by EDX shown in Figure 4.65 and 4.68. As mentioned above, it is possible that at high chloride concentration, the amount of Friedel's salt produced could present a physical barrier impeding ingress of chemical specie and it may also result in limiting the availability of aluminates phases free to engage in degrading sulfate bearing products. It was reported (Irassar et al., 2005) in a study conducted to investigate the effect of C<sub>3</sub>A content of cement on thaumasite formation, that cement with zero C<sub>3</sub>A, such as SRPC and containing limestone filler showed no thaumasite formation.

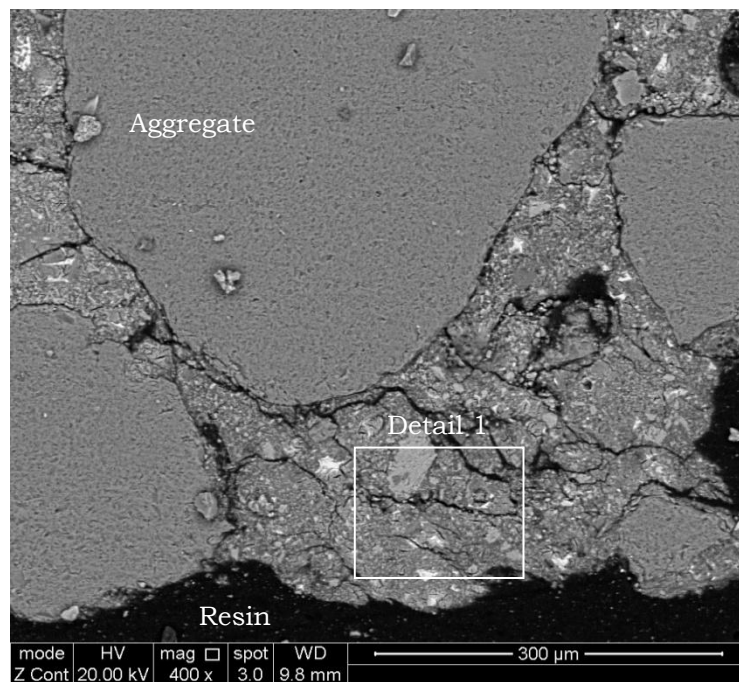
**Figure 4.69.** SEM image of CEMI-LF sample stored 630 days in sulfate only solution at 20°C.

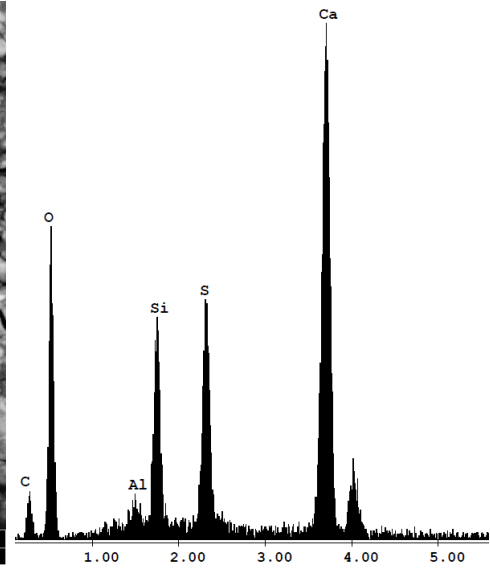
**Figure 4.71.** EDX of cracked material in Figure 4.70.

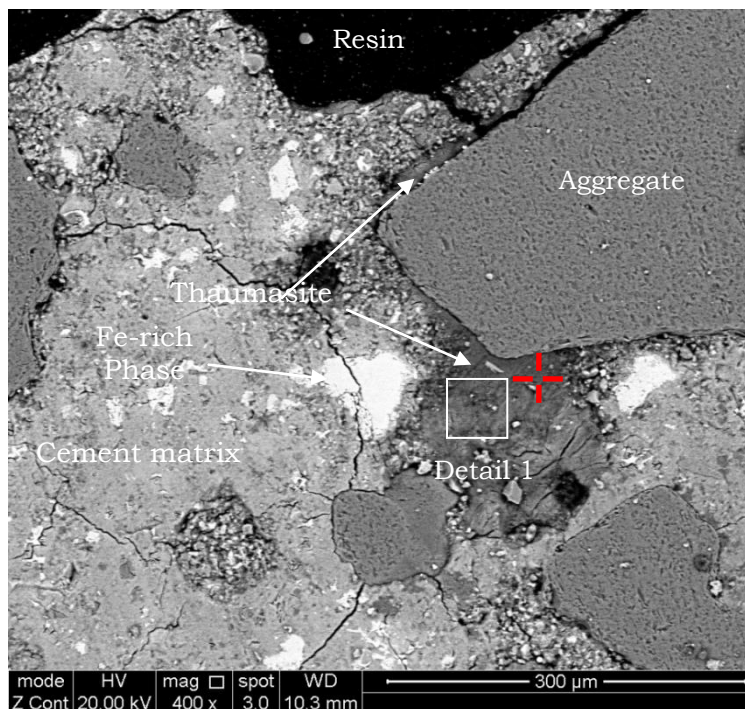
**Figure 4.72.** SEM image of degraded CEMI-LF sample stored in 630 days in SC5 at 20°C.

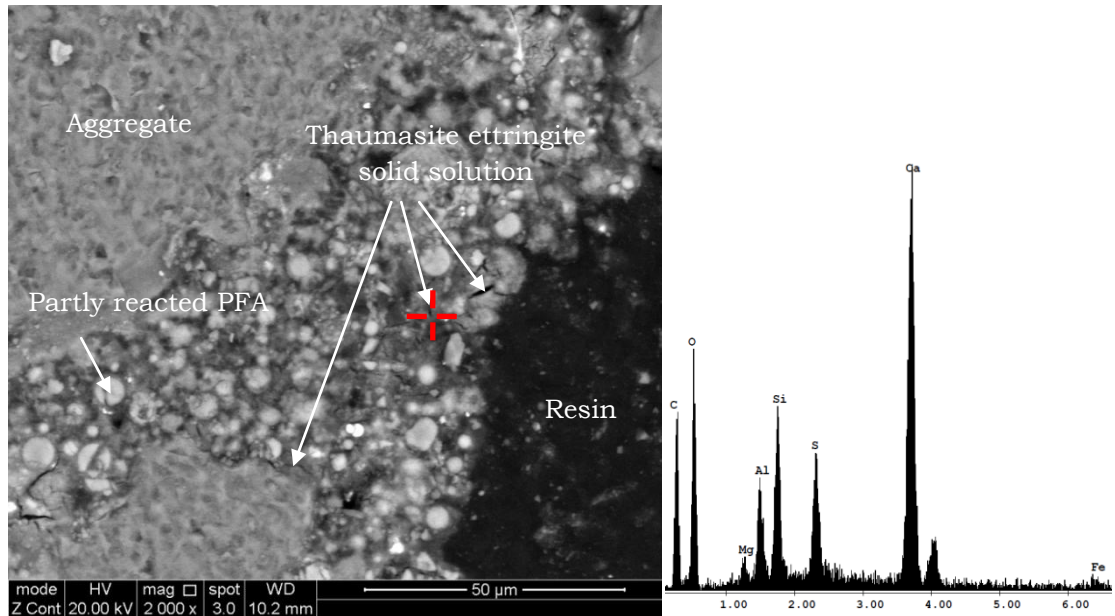
**Figure 4.77.** SEM image of CEMI-PFA sample stored 630 days in sulfate only solution at 5°C.

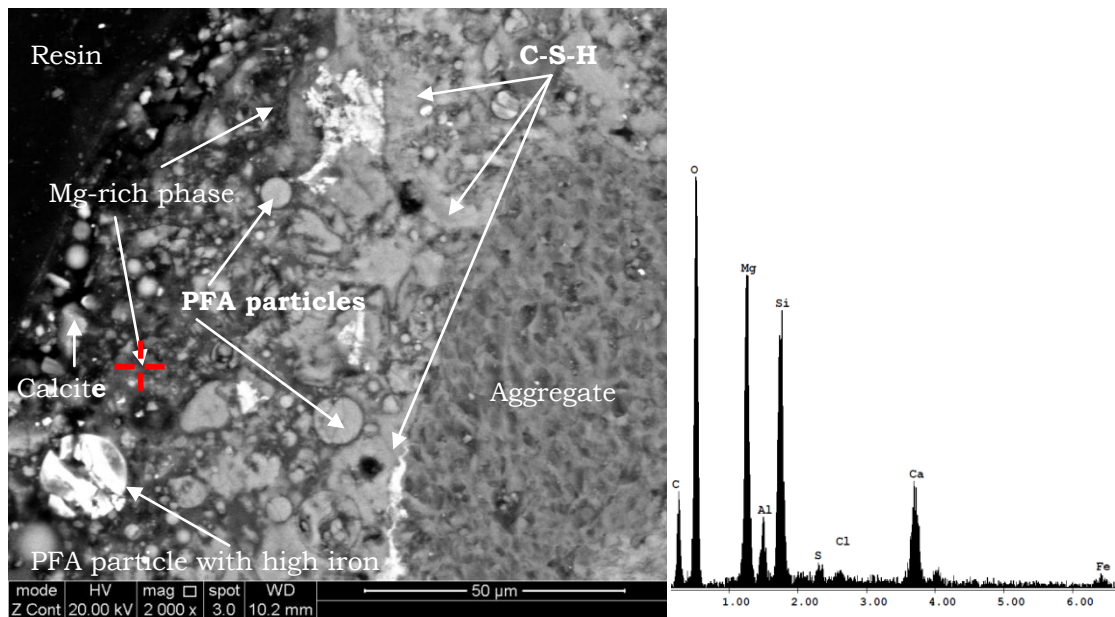
**Figure 4.79.** SEM image of CEMI-PFA sample stored 630 days in SC5 at 5°C.

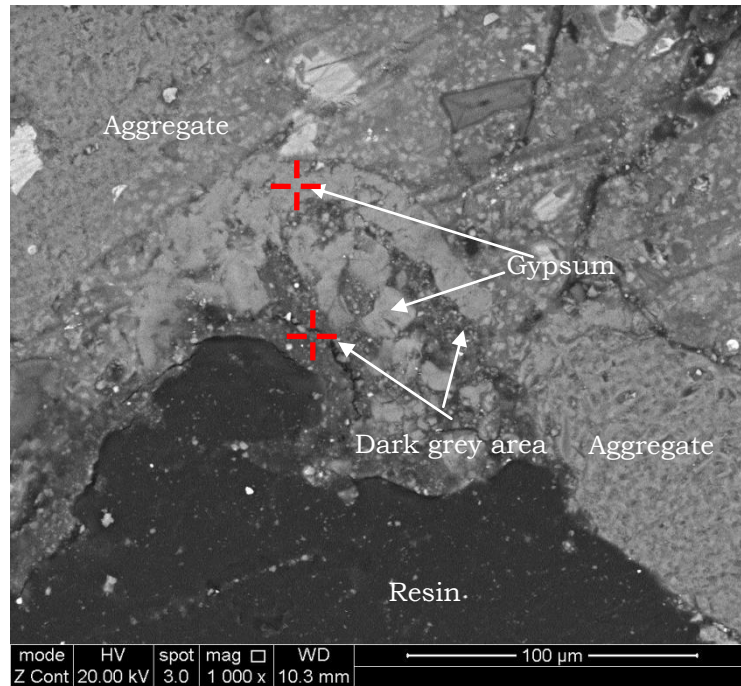
**Figure 4.83.** SEM image of CEMI-GGBS sample stored 630 days in sulfate only solution at 5°C.

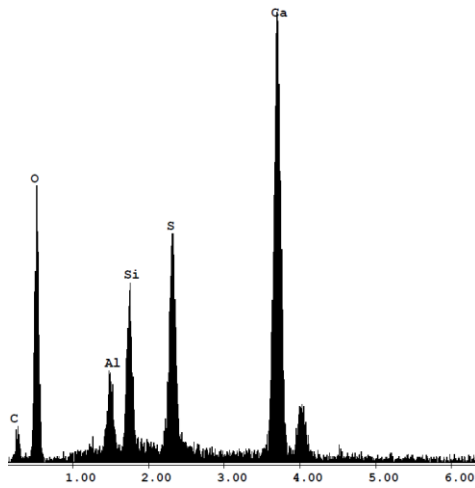
**Figure 4.87.** EDX of 1 (Cracked area) in Figure 4.86.

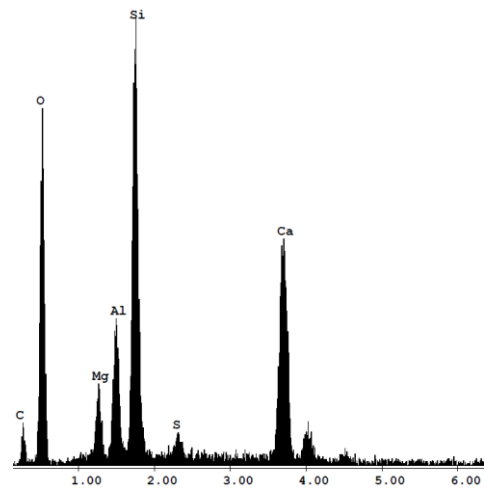
**Figure 4.88.** EDX of 2 (C-S-H) gel with Ca/Si = 0.5 in Figure 4.86.

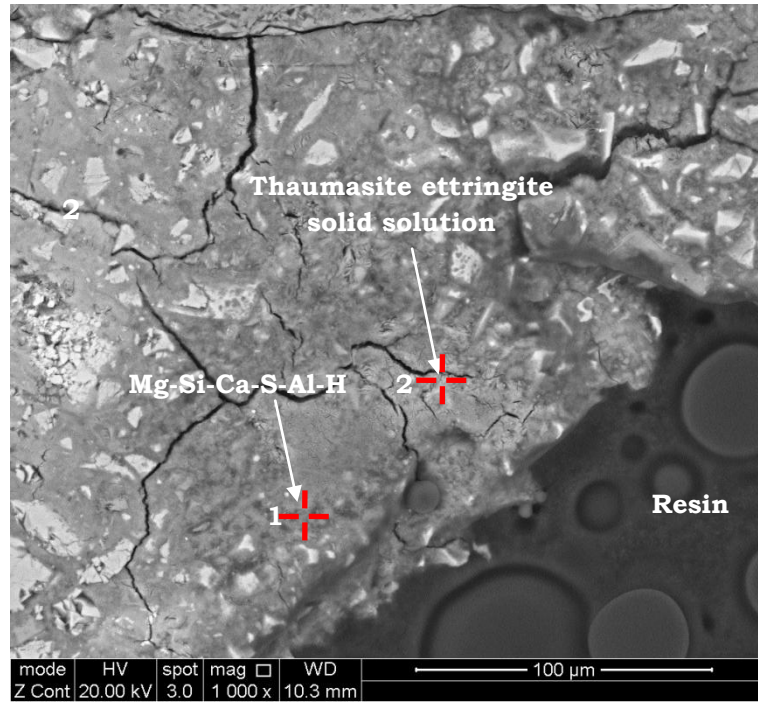
Figure 4.92. SEM of CEMI-GGBS sample stored 180 days in sulfate only at 5°C.

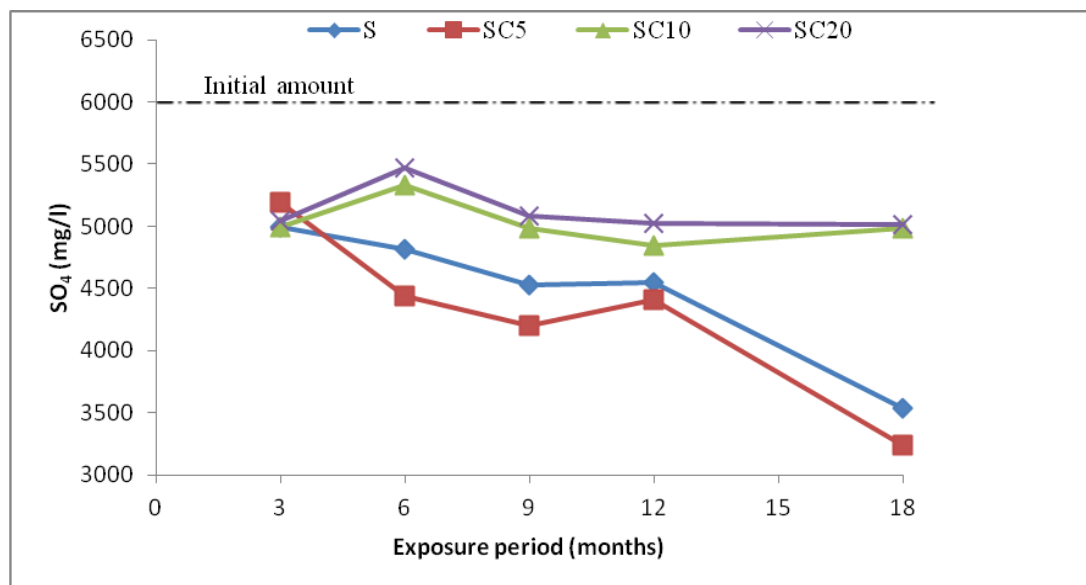
**Figure 4.98.** Variation of sulfate ion in test solutions at 5°C.

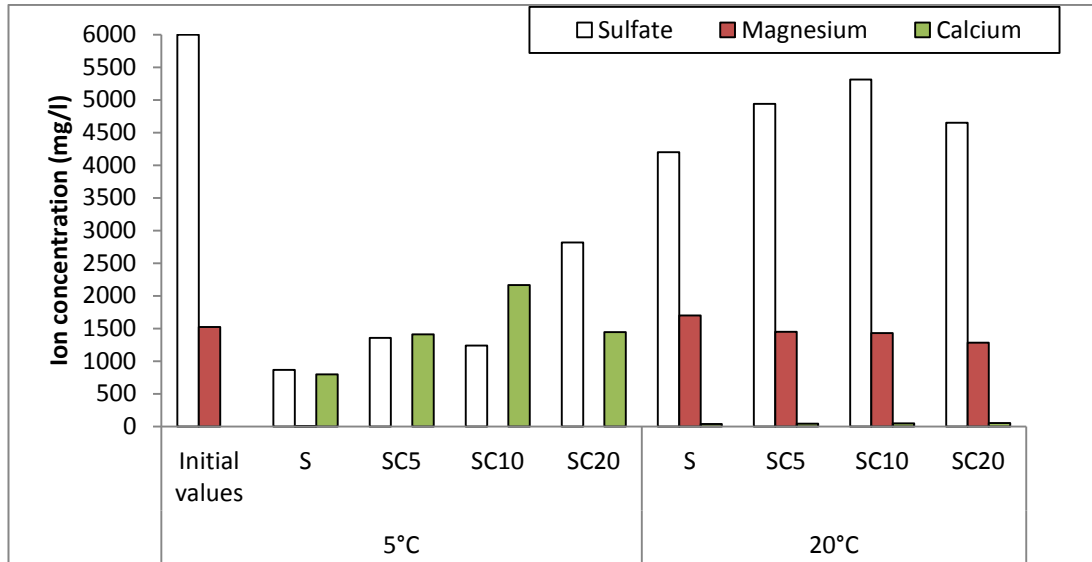
**Figure 4.106.** Concentration of sulfate, magnesium and calcium in CEMI solutions after 180 days at 5 and 20°C.
