# **Thaumasite Sulfate Attack in Cement Mortars Exposed to Sulfate and Chloride and Implications to Rebar Corrosion**

A thesis submitted for the degree of Doctor of Philosophy in the Faculty of Engineering of the University of Sheffield

THE UNIVERSITY OF SHEFFIELD  
DEPARTMENT OF CIVIL AND STRUCTURAL ENGINEERING

**July 2014**

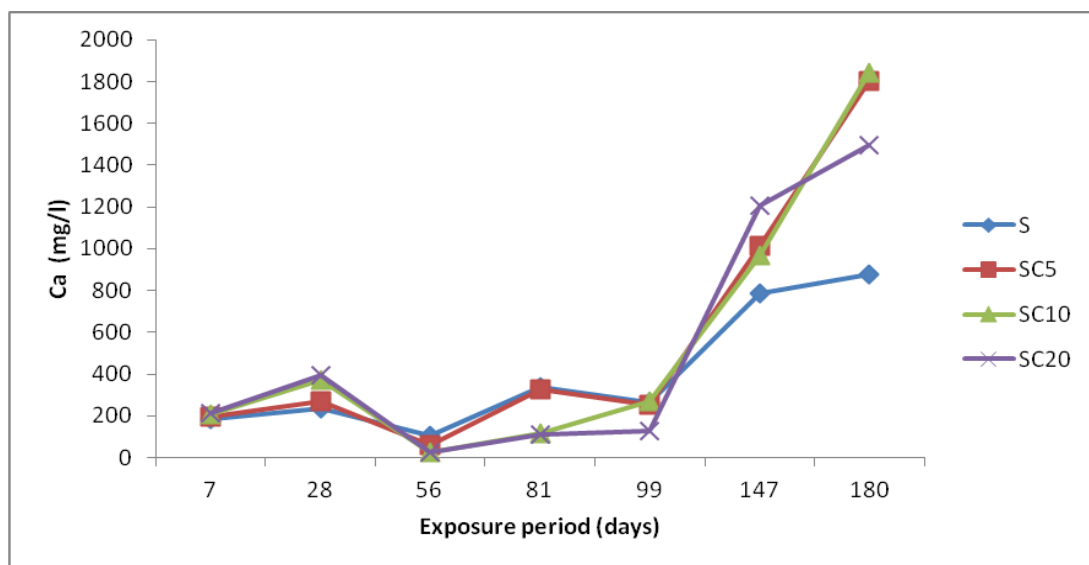
**Figure 4.107.** Variation of calcium level in CEMI-LF solutions stored 180 days at 5°C.

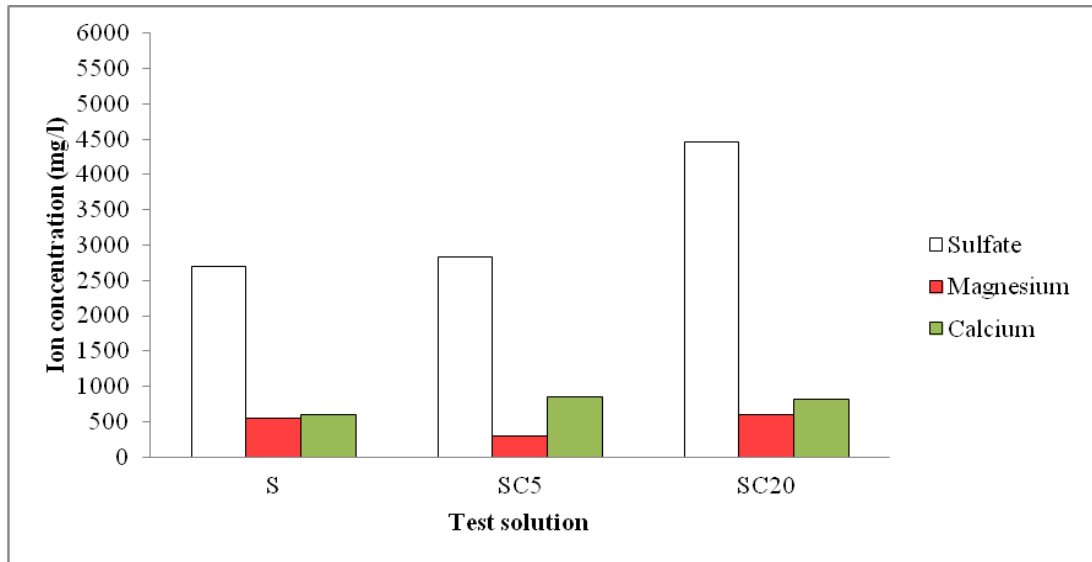
**Figure 4.111.** Variation of sulfate, magnesium and calcium ions in CEMI-GGBS solutions after 180 days at 5°C.

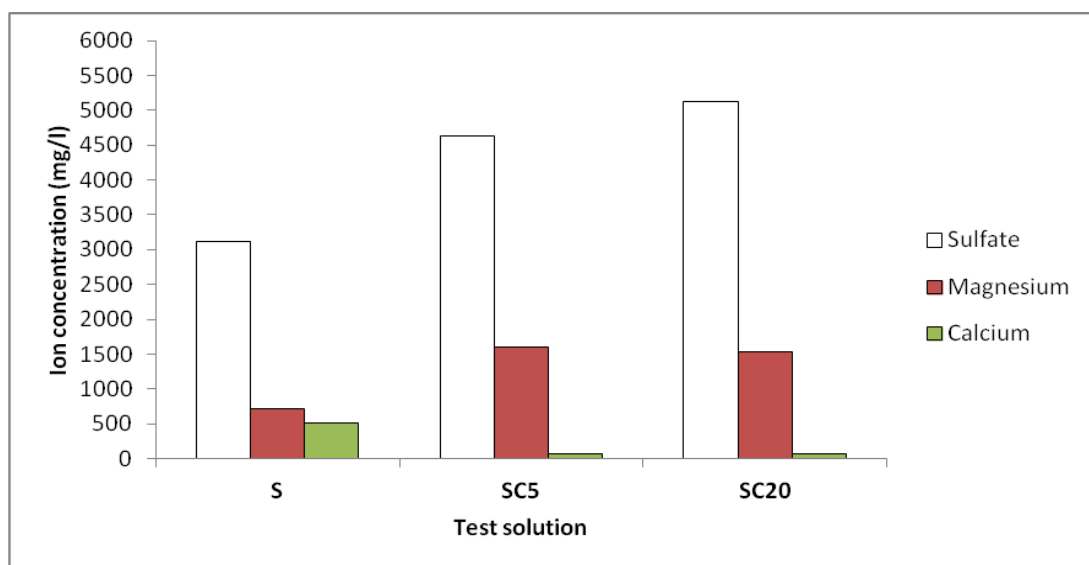
**Figure 4.113.** Variation of sulfate, magnesium and calcium ions in CEMI-PFA solutions after 180 days at 5°C.

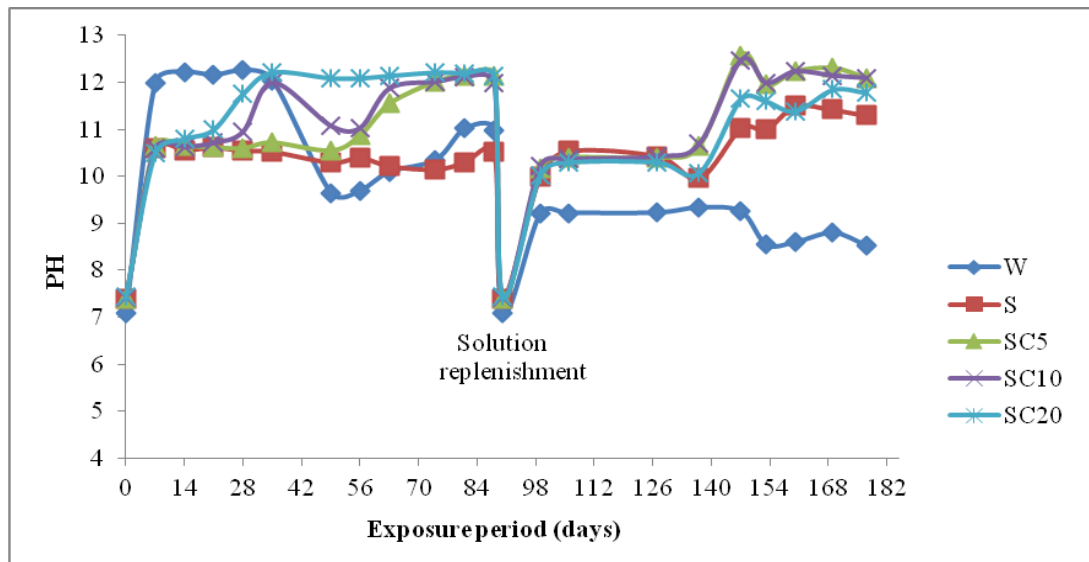
**Figure 4.115.** pH change in CEMI-LF stored for 180 days at 5°C.

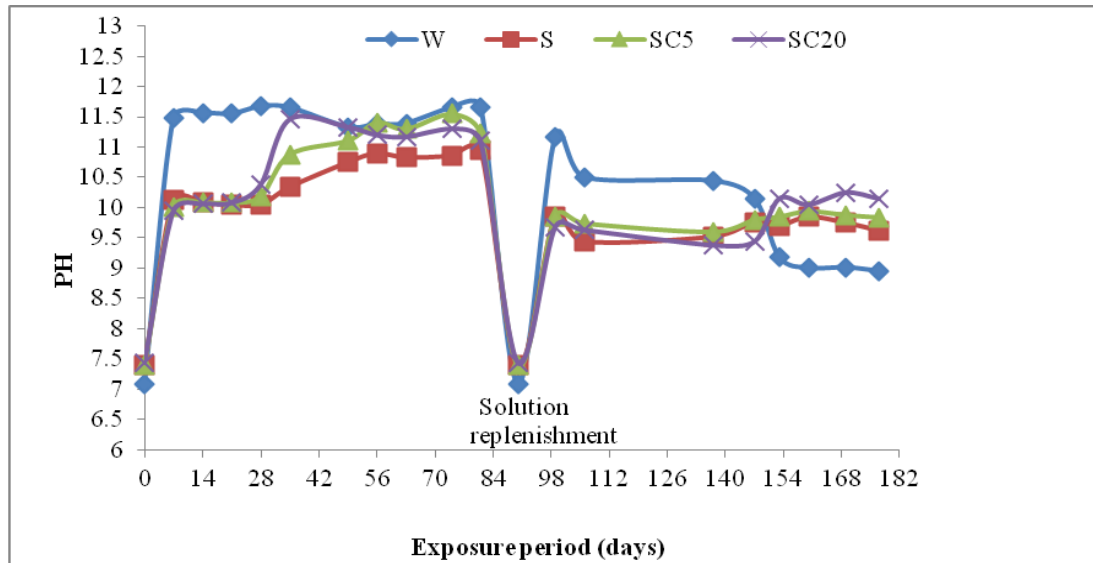
**Figure 4.117.** pH change in CEMI-GGBS solutions stored for 180 days at 5°C.

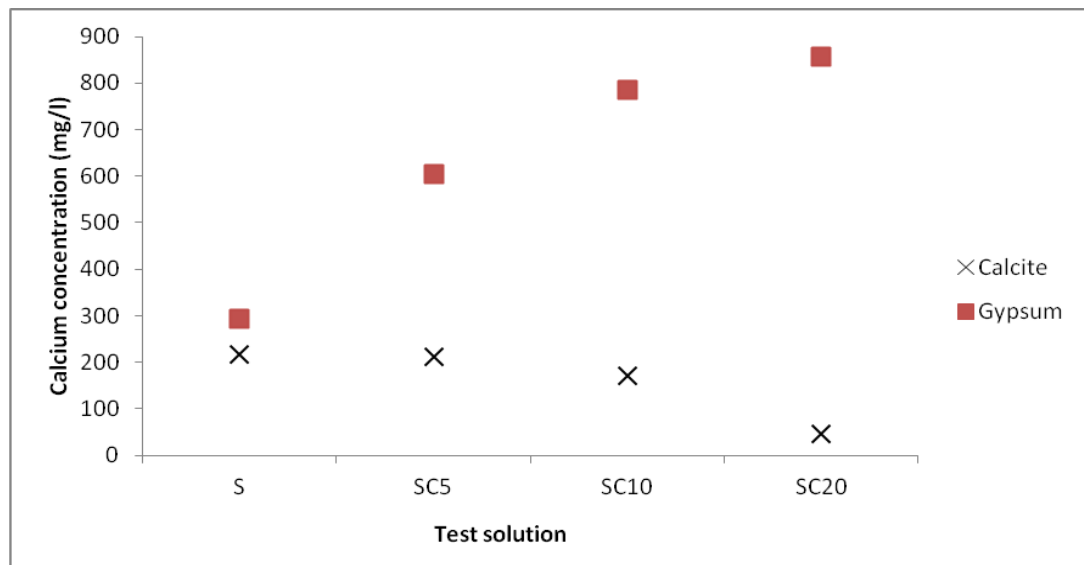
**Figure 4.121.** Calcium ion levels of  $\text{CaCO}_3\text{-NaCl-MgSO}_4\text{-H}_2\text{O-CO}_2$  and  $\text{CaSO}_4\text{-NaCl-MgSO}_4\text{-H}_2\text{O-CO}_2$  schemes at 5°C.

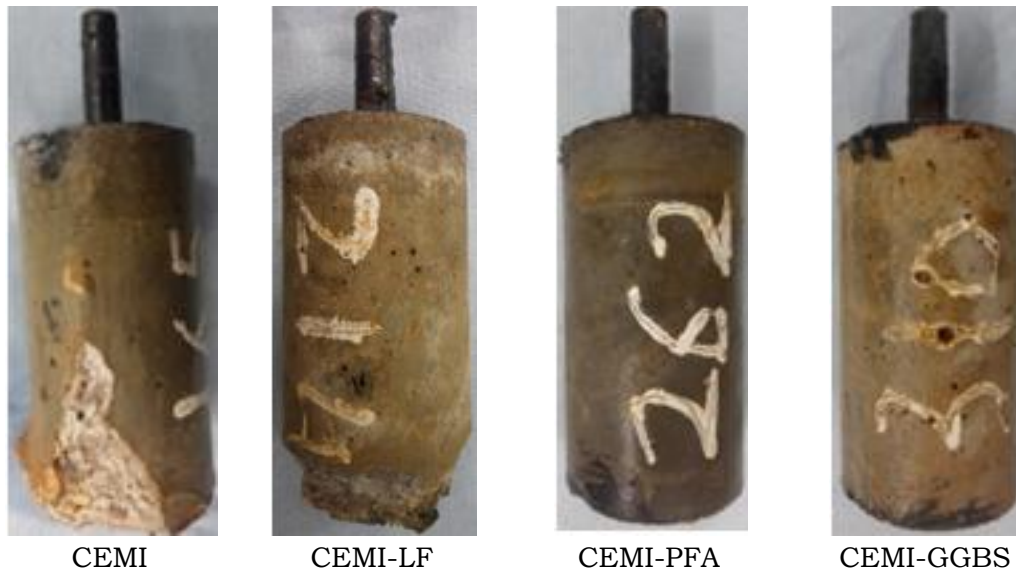
**Figure 5.1.** Mortar specimens stored for 900 days in SC5 at 5°C.

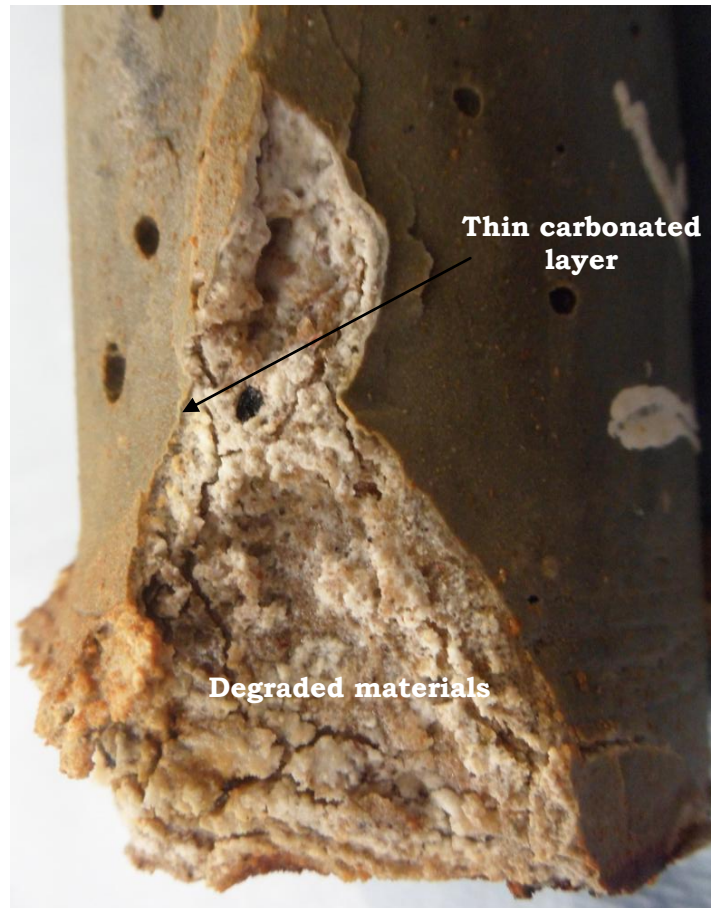
**Figure 5.5.** Degraded part of CEMI mortar at 5°C shown in **Figure 5.1**.

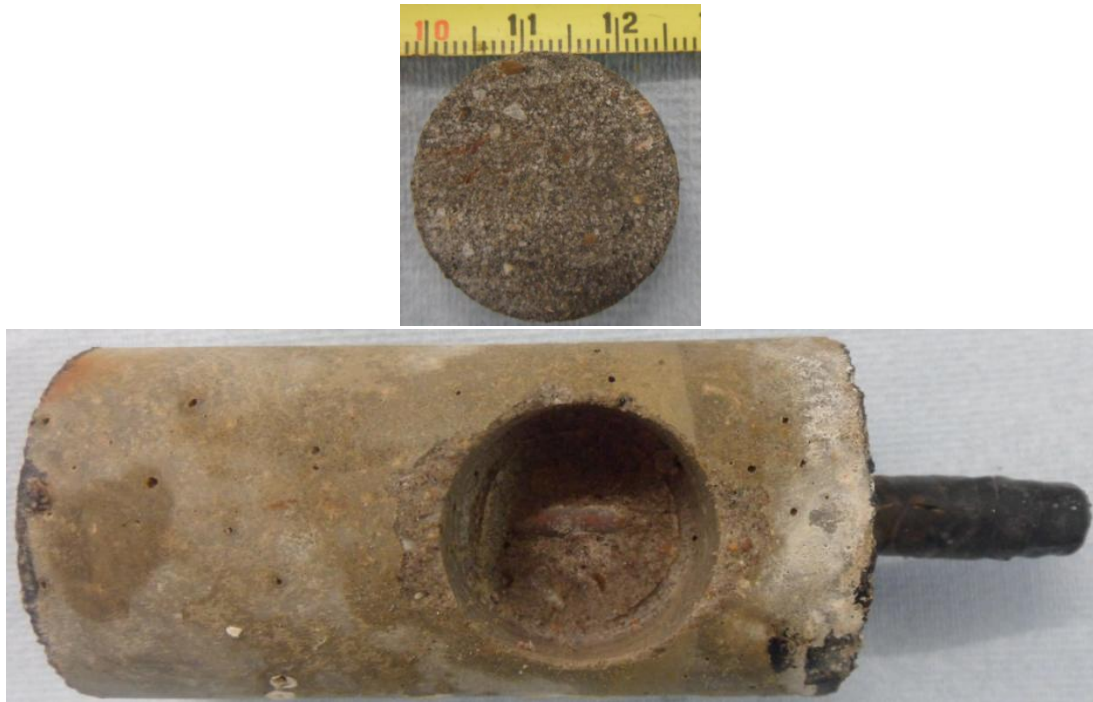
**Figure 5.6.** Drilled core for permeability test after 900 days of exposure.

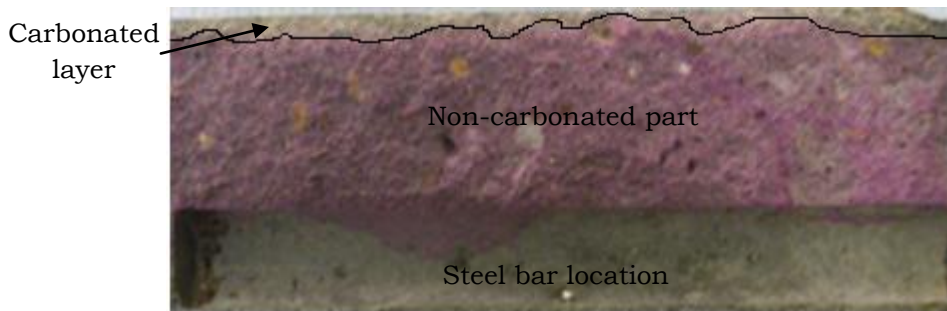
**Figure 5.10.** Typical treated mortar by phenolphthalein solution.

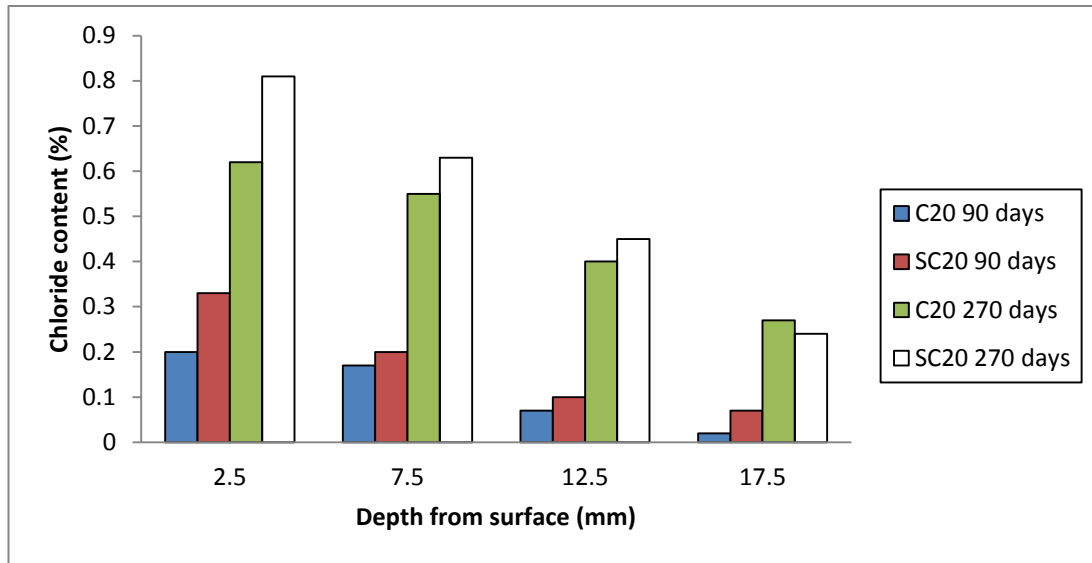
**Figure 5.11.** Chloride contents for CEMI mortars stored 90 and 270 days at 5°C.

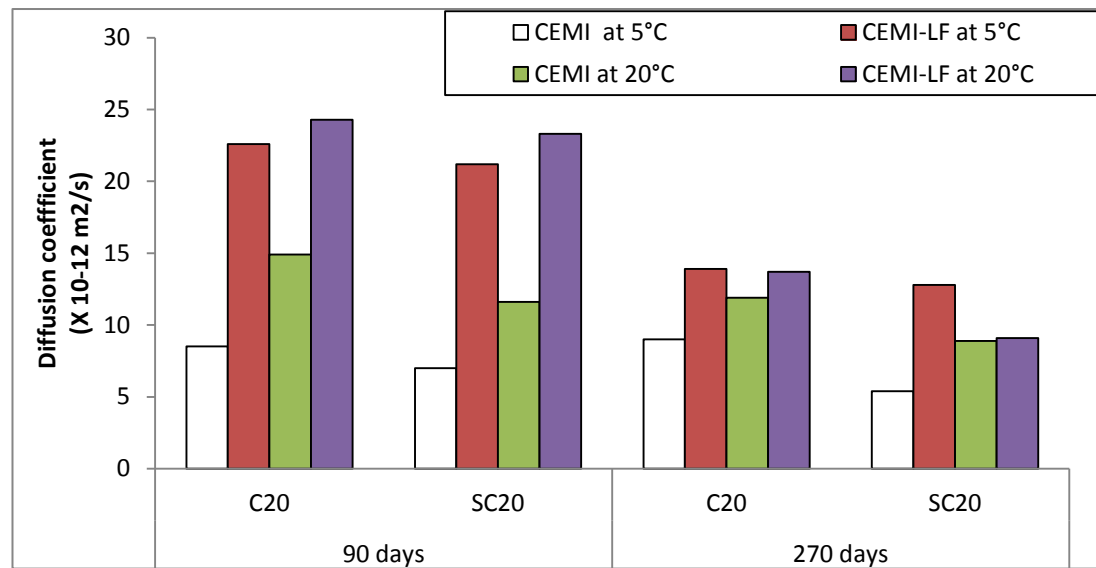
**Figure 5.21.** Chloride diffusion coefficient for CEMI and CEMI-LF mortars stored 90 and 270 days in chloride only (C20) and composite sulfate and 2.0% chloride (SC20) solutions at 5 and 20°C.

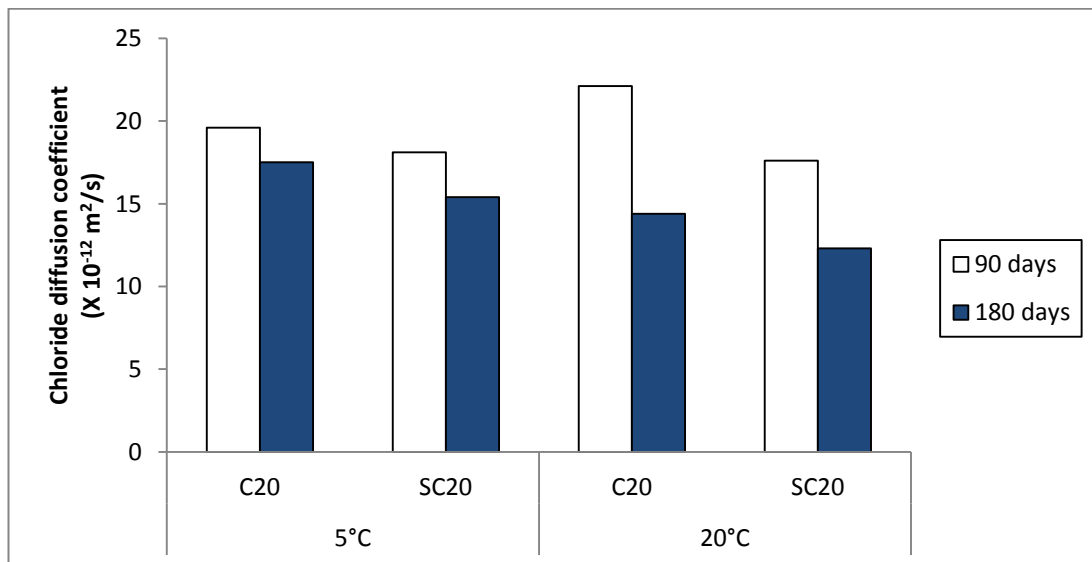
**Figure 5.22.** Chloride diffusion coefficient for CEMI-PFA mortars stored for 90 and 180 days in chloride only (C20) and composite sulfate and 2.0% chloride (SC20) solutions at 5 and 20°C.

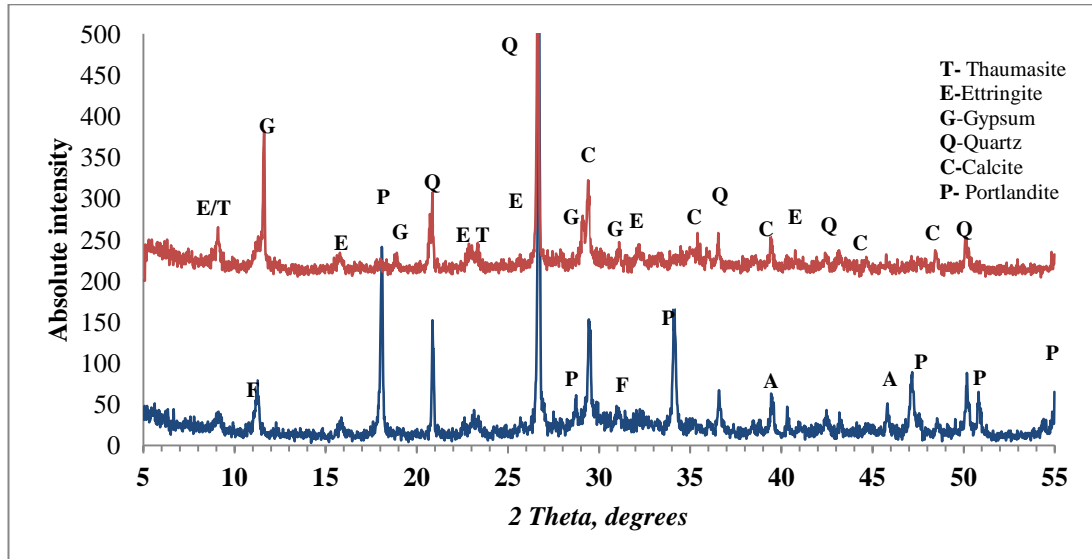
**Figure 5.24.** XRD pattern for CEMI-LF interface samples stored in SC5 at 5°C (Top, red) and 20°C (Bottom, blue).

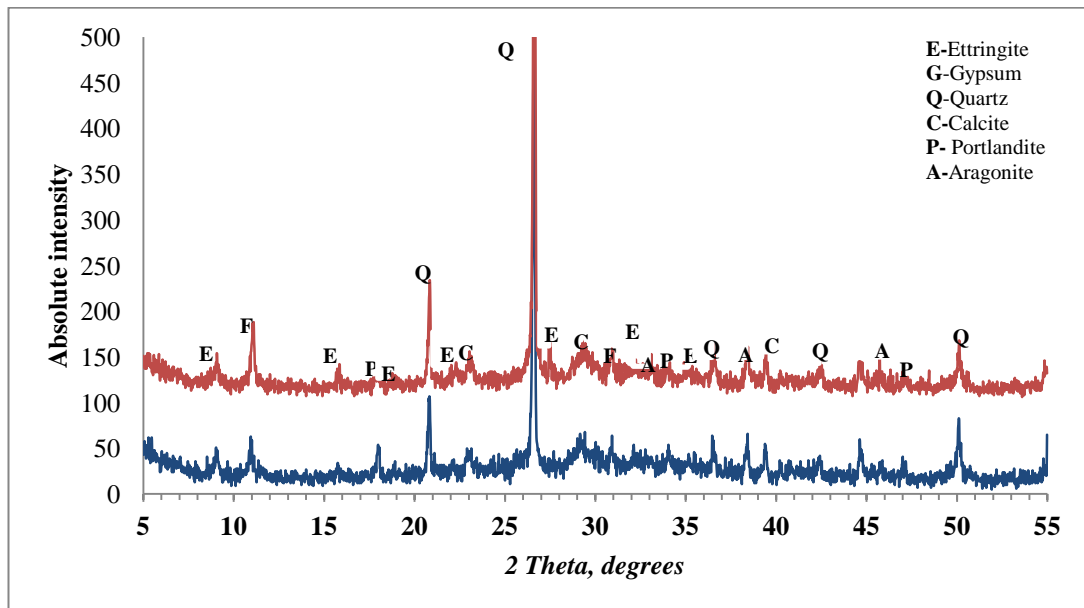
**Figure 5.25.** XRD pattern for CEMI-PFA interface samples stored in SC5 at 5 °C (Top) and 20°C (Bottom).

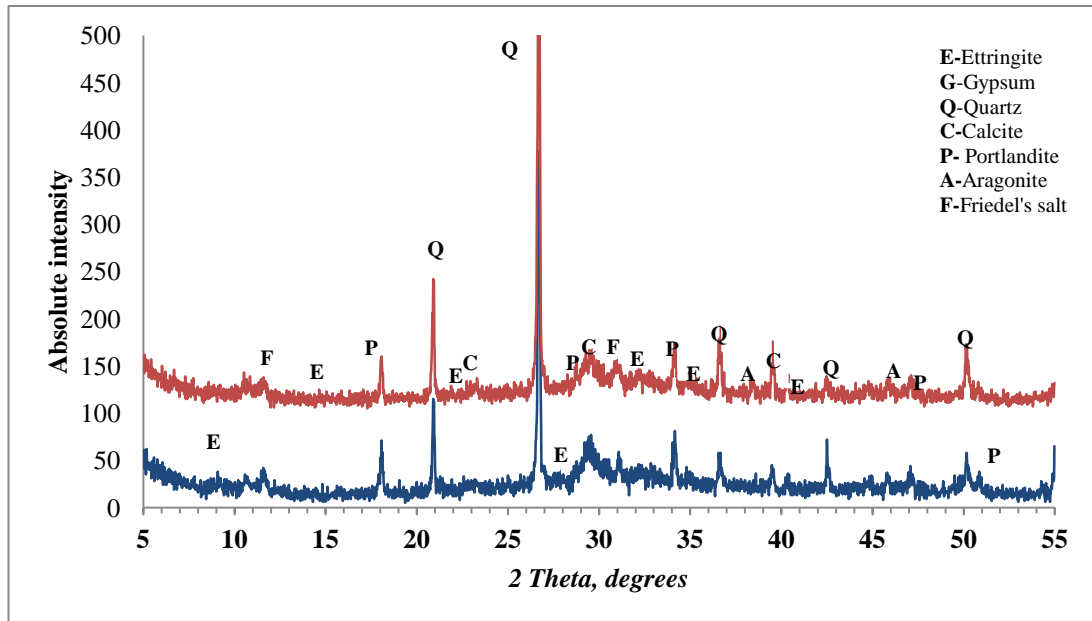
**Figure 5.26.** XRD patterns for CEMI-GGBS interface samples stored in SC5 at 5 °C (Top) and 20 °C (Bottom).

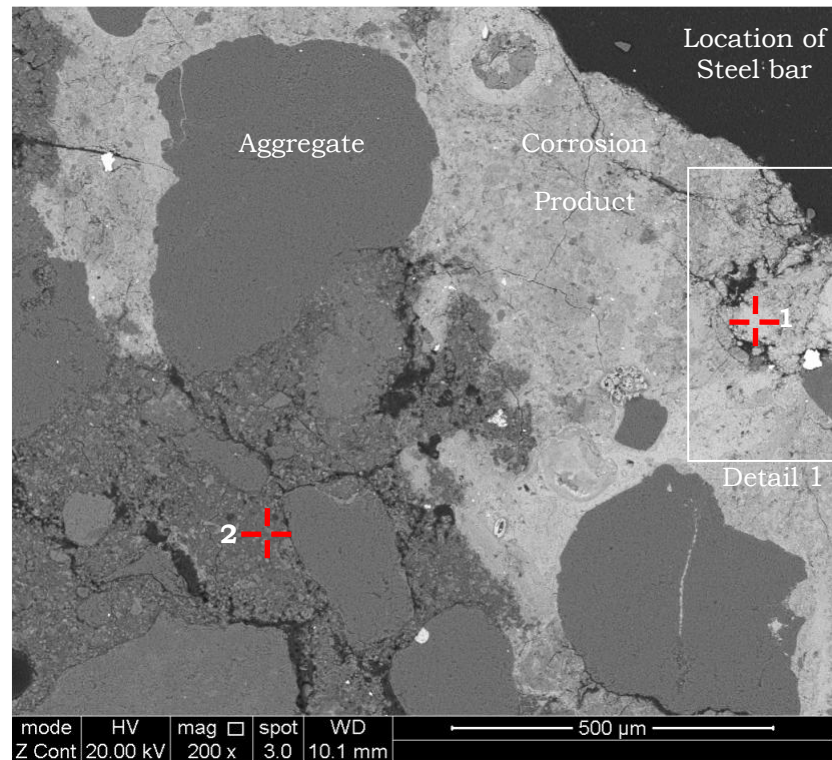
**Figure 5.27.** SEM image for SC5 steel-mortar interface sample stored 900 days at 5°C.

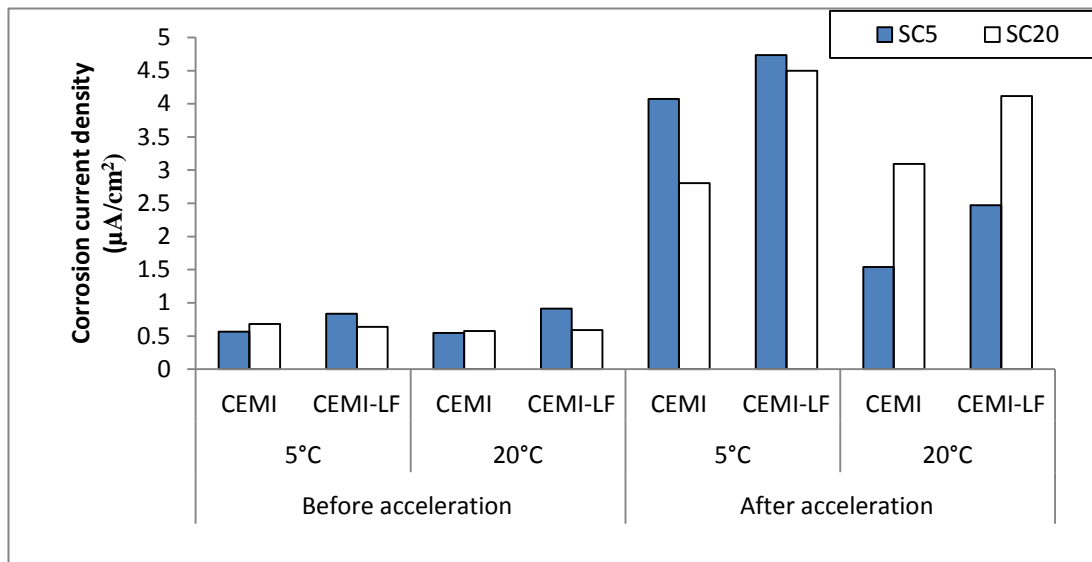
**Figure 5.32.** Variations in corrosion current densities for steel rebars in CEMI and CEMI-LF mortars stored in SC5 and SC20 at 5 and 20°C.

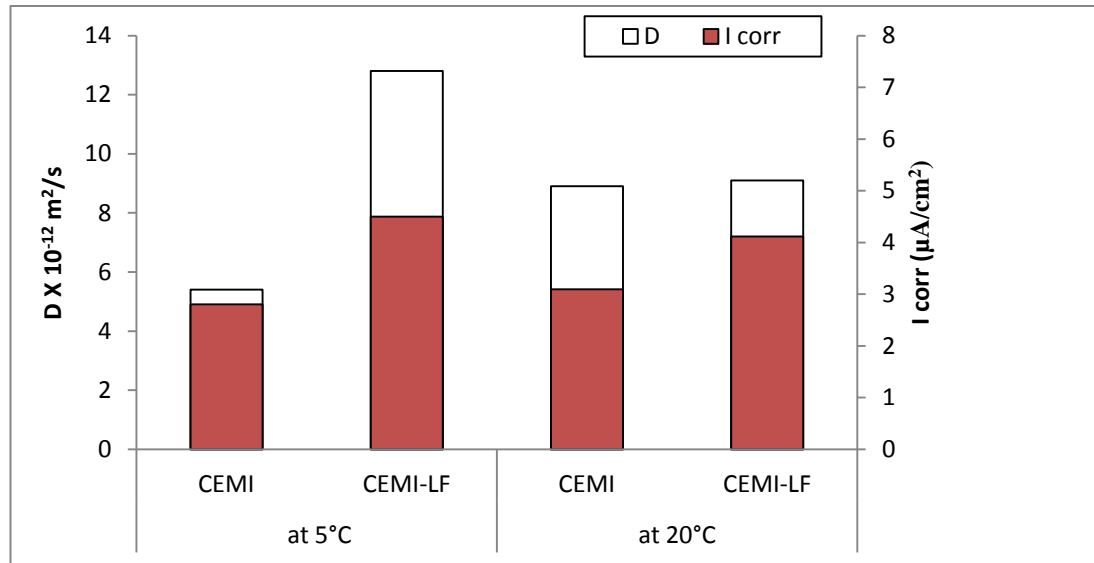
**Figure 5.33.** Corrosion current density ( $I_{corr}$ ) vs. diffusion coefficient (D) for CEMI and CEMI-LF specimens stored in SC20 at 5 and 20°C (Diffusion was calculated after 270 days of exposure, whereas corrosion was measured after 900 days).

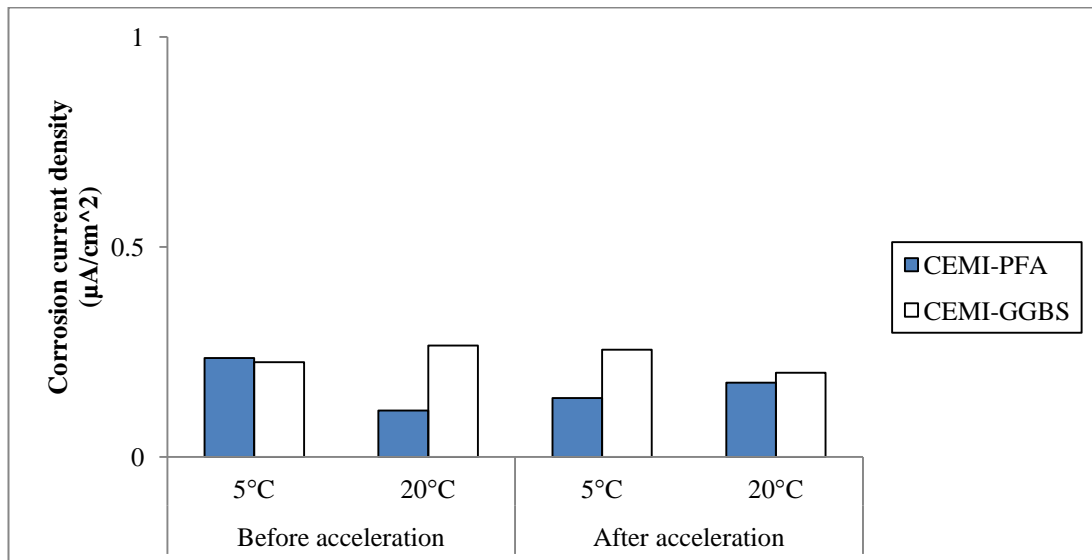
**Figure 5.34.** Variations of corrosion current densities for steel rebars in CEMI-PFA and CEMI-GGBS mortars stored in SC5 at 5 and 20°C.

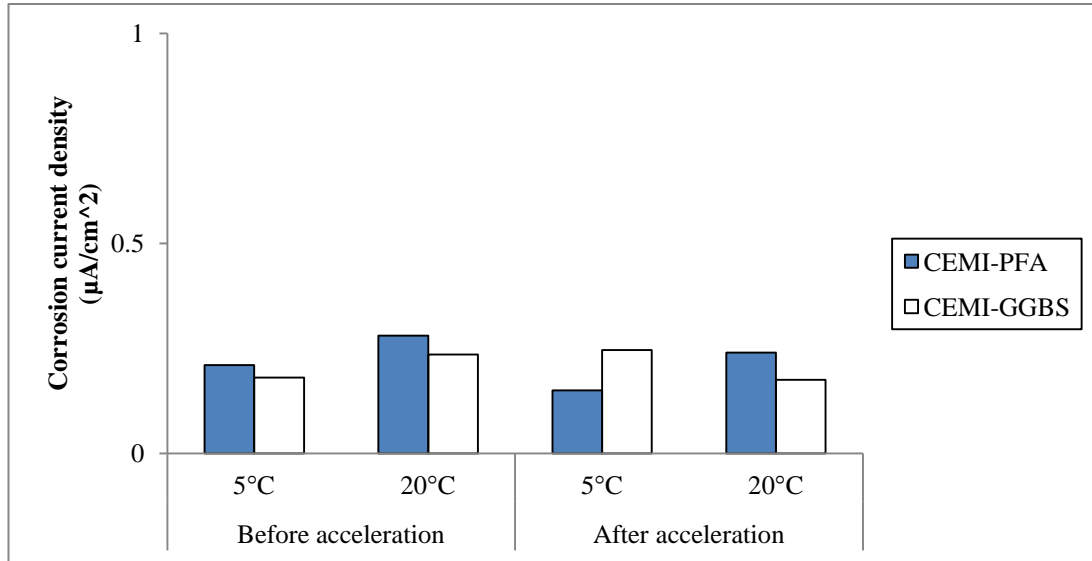
**Figure 5.35.** Variations of corrosion current densities for steel rebars in CEMI-PFA and CEMI-GGBS mortars stored in SC20 at 5 and 20°C.

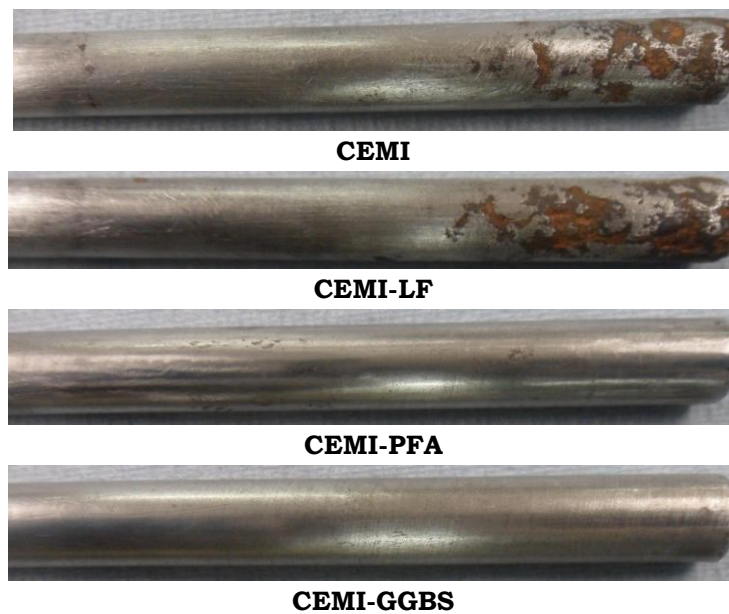
**Figure 5.36.** Surface of steel bars in mortar specimens stored 900 days in SC5 at 5°C.

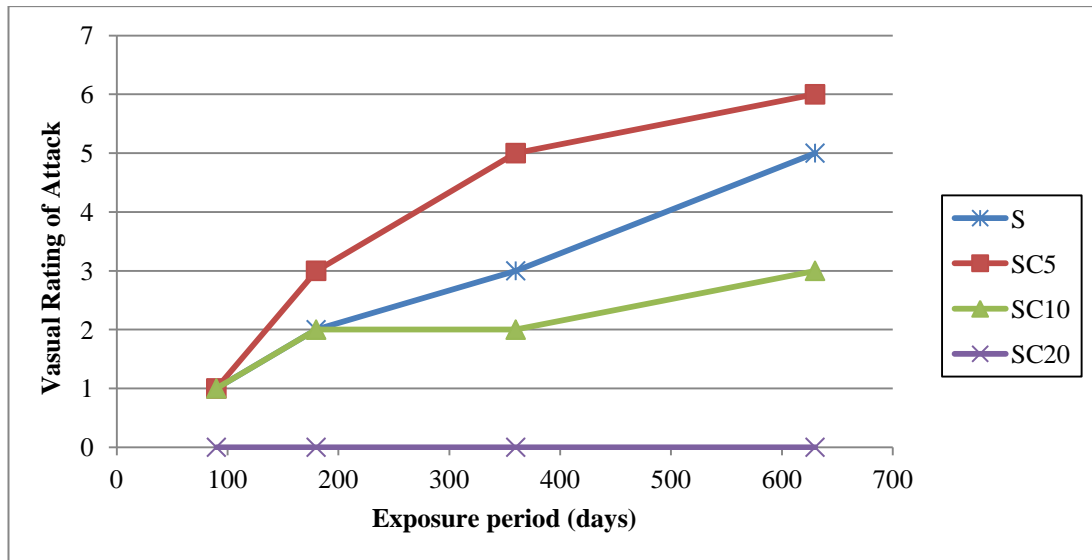
**Figure 6.1.** Evaluation of damage degree as indicated by visual appearance of mortar specimens. [0= No visible damage, 1= minor cracking to corners and edges, 2= moderate damage at corners and edges, 3= severe attack at corners, 4= cracking and spalling, 5= swelling of surfaces, and 6=extensive cracking and swelling].

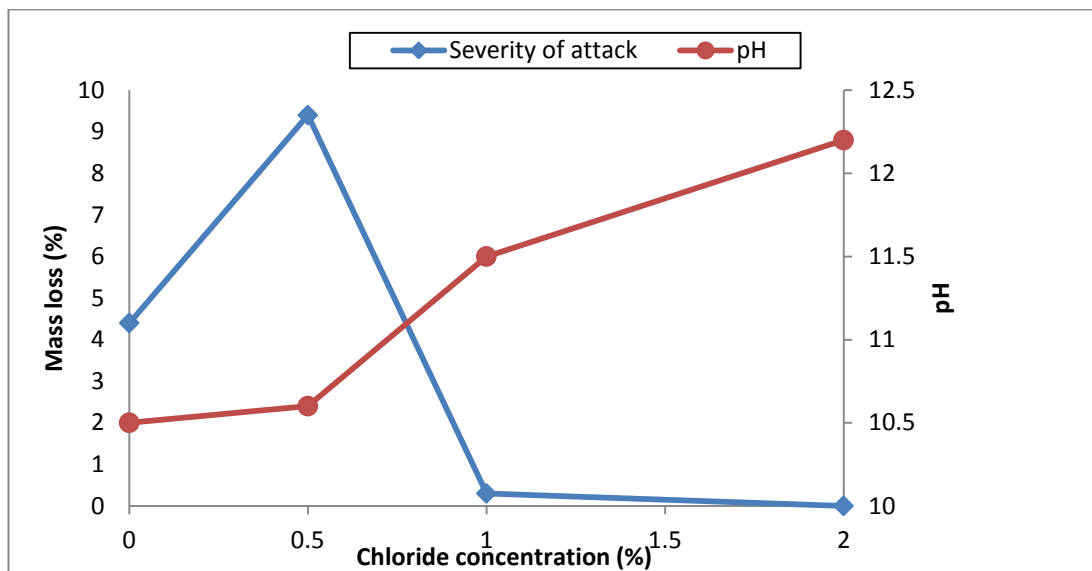
**Figure 6.2.** Effect of chloride level on initial pH change and later severity of TSA of CEMI-LF stored 630 days in solutions at 5°C.

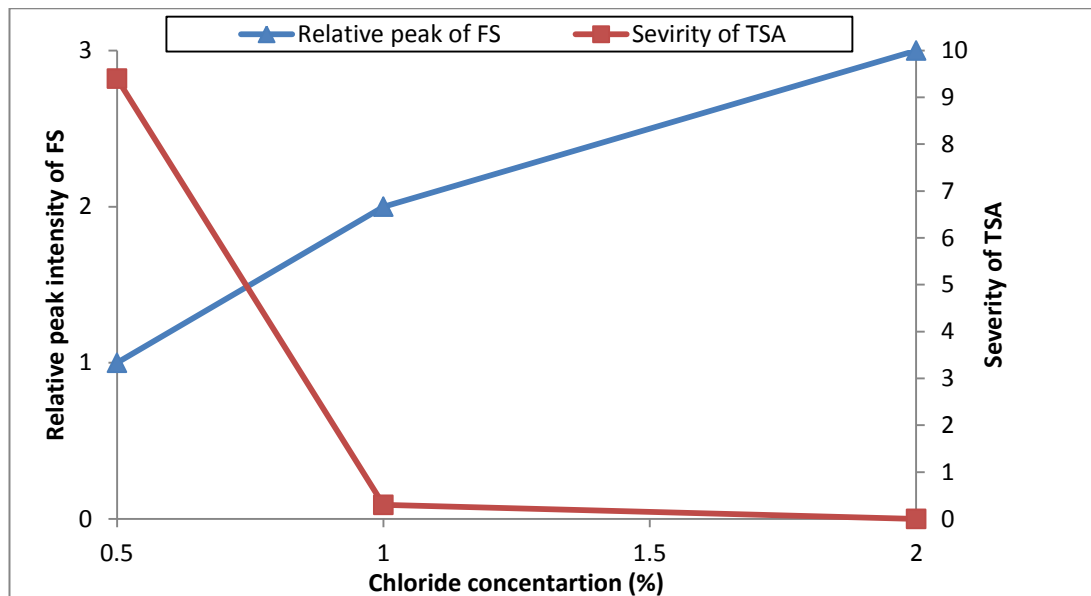
**Figure 6.6.** Severity of TSA (By mass loss) and relative peak height of Friedel's salt (FS) in surface materials for CEMI-LF mortars stored 630 days at 5°C. (Scale of relative peak intensity for FS: 1= low or absence; 2=moderate; and 3= high).

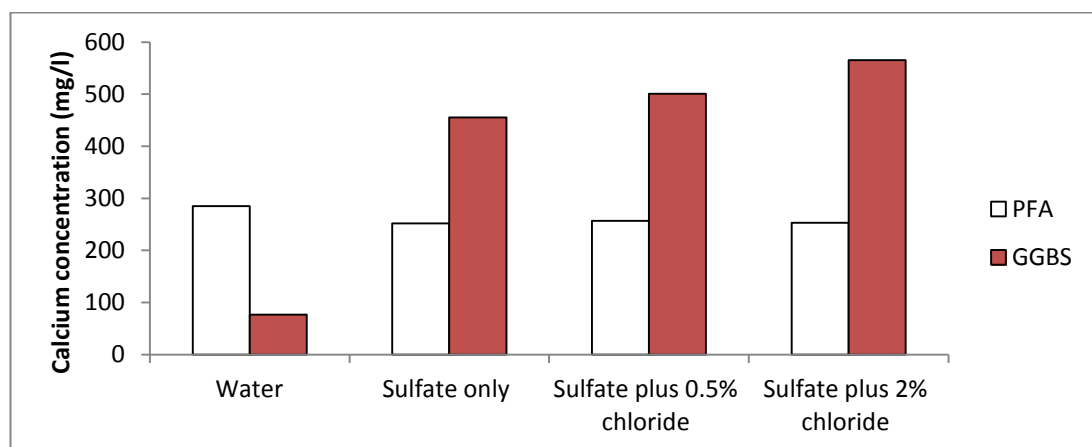
**Figure 6.7.** Calcium concentration in different solutions after 7 days exposure at 5°C.
