Risk-Based Corrosion and Biofouling Management for Tidal Stream Devices

This thesis is submitted in accordance with the requirements for the
degree of Doctor of Philosophy

July 2014

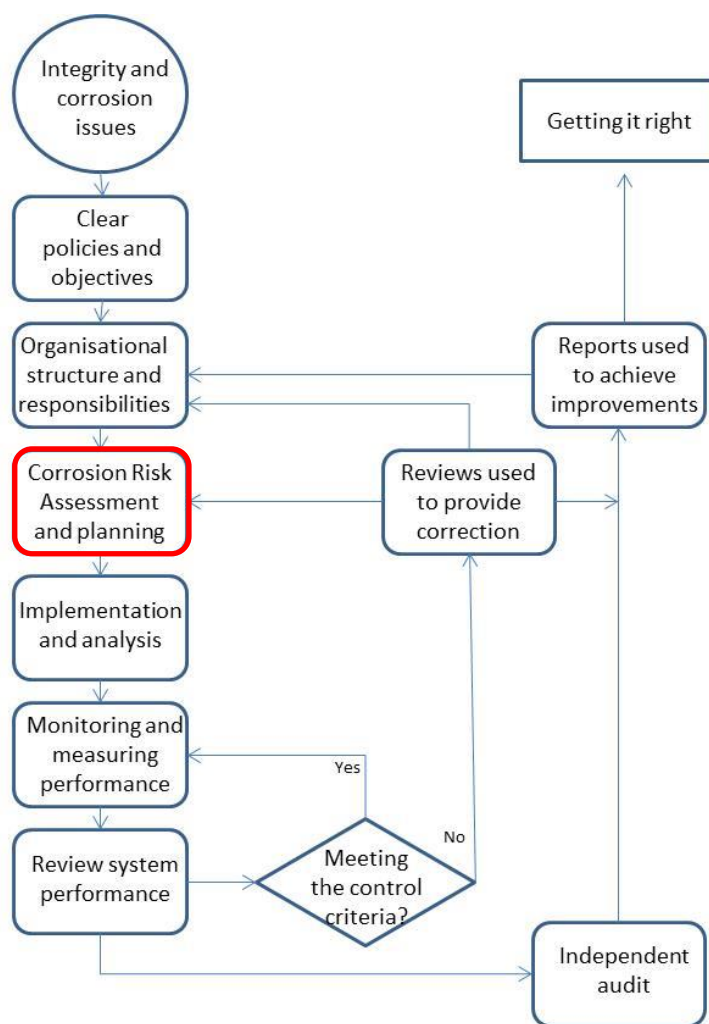
Figure 2.1. Framework for a successful Corrosion Management System (Energy Institute, 2008)

A structured framework, such as that defined in the Energy Institute Guidance for Corrosion Management in Oil and Gas Production and Processing (Energy Institute, 2008) can be used as a basis for developing risk based management. Although the guidance is aimed at oil and gas production and processing, the generality of the framework makes it suitable for application to other applications in similar environments. The framework is outlined Figure 2.1 (Energy Institute, 2008).

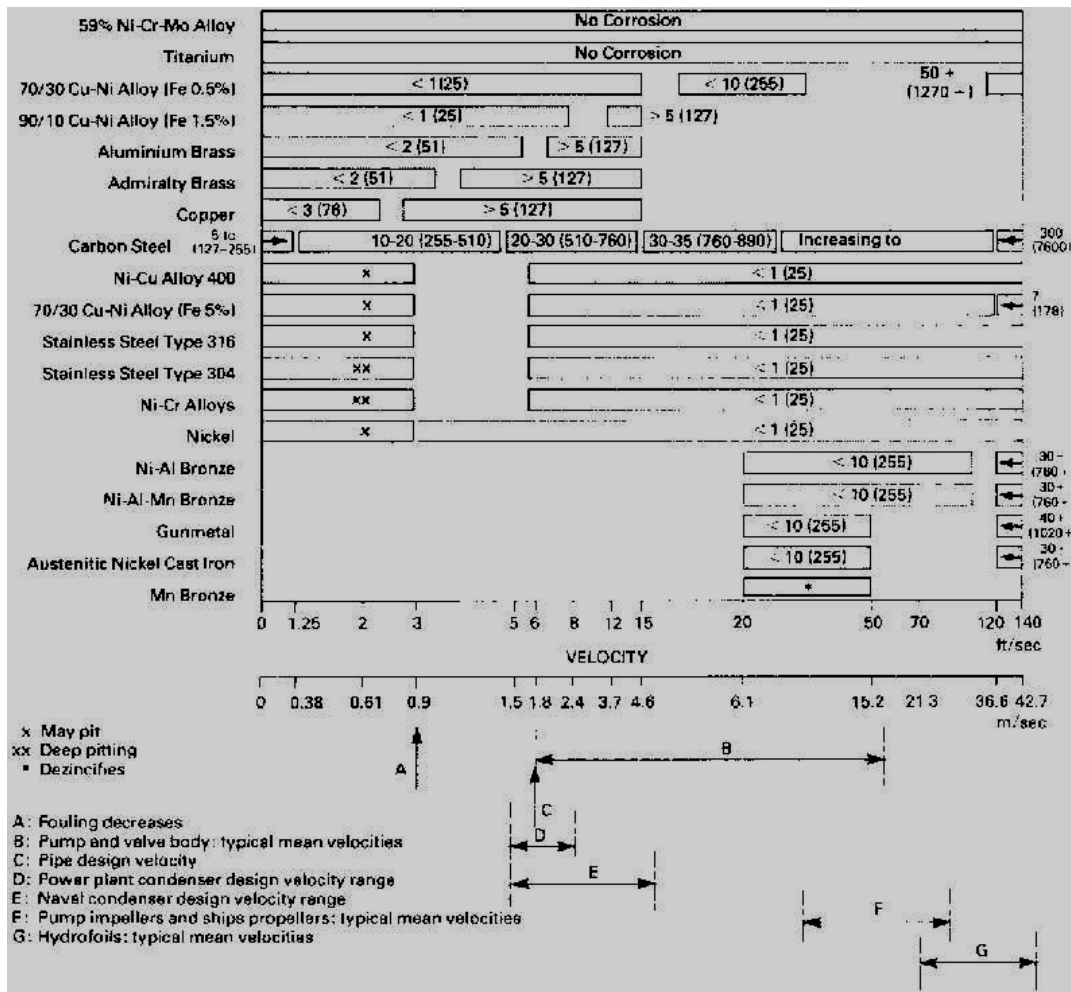
Figure 3.3. Potential corrosion rates of different alloys in flowing seawater. Corrosion rates are shown on the bars, given in units/hr and microns/yr in brackets (Copper Development Association, 1982)

The effect of fluid flow on corrosion can be defined by mass transfer and wall shear stress parameters contacting the solid surface (Efird, 2000). Under flowing conditions, different metals and alloys react in different ways, depending on the type of flow (laminar, turbulent) and the velocity (Wood et al., 1990). The mechanism of failure due to flow requires an understanding of the material, surface structure/roughness and the fluid dynamics of the water in which it is placed (turbulence; one-phase; two-phase; multiphase flow; entrained solid particle concentration and the direction of the flow relative to the material) (Schmitt and Bakalli, 2010; Baboian, 2005; Silverman, 2003). For example, the corrosion of copper increases rapidly above a water velocity of 2 ms^{-1} , with only a low, even rate of corrosion below 1 ms^{-1} . Efird and Anderson (1975) examined corrosion rates over a 14 year period and found varying corrosion rates for 70Cu-30Ni alloy under different flow regimes. The increasing corrosion rates with increasing flow was due to a mechanical stripping of the protective film formed on the surface of the metal. Another study, carried out using jet impingement testing to study the effect of mass transfer and wall shear stress on flow accelerated corrosion (Efird, 2000), showed that corrosion was directly related to the degree of jet impingement testing. Mathematical models have been established for flow induced corrosion in carbon steels, although this work has tended to focus on high velocity seawater (up to 18 ms^{-1} linear velocity) (Jingjun Liu. et al., 2008; Jingjun Liu. et al., 2005). Syrett and Wing (1980) found the flow effect to be related to the electrochemical stability of the film formed as opposed to its mechanical stability.

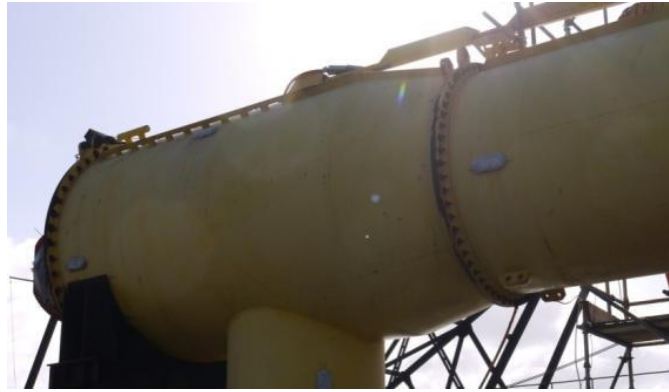
Figure 4.18. Paint flaking around flanges on Nacelle

Paint was observed to be flaking off around the external flanges on the nacelle (Figure 4.18) and also on the join between the nacelle and blade hub (Figure 4.19). This will lead to localised corrosion of the exposed metal surface where this becomes anodic relative to the rest of the coated metal.

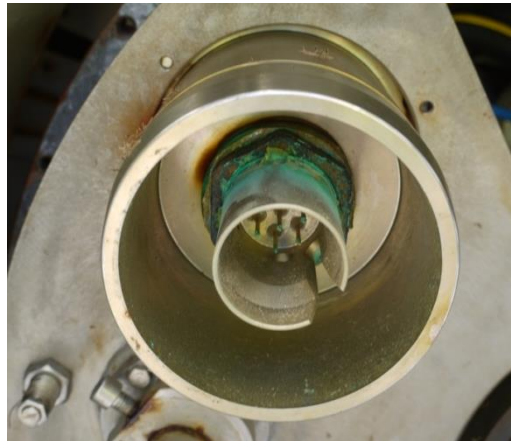
Figure 4.28. ADCP connector location on stab mechanism. Severe corrosion observed on the connector pins and around the base of the connector at the nut fixing

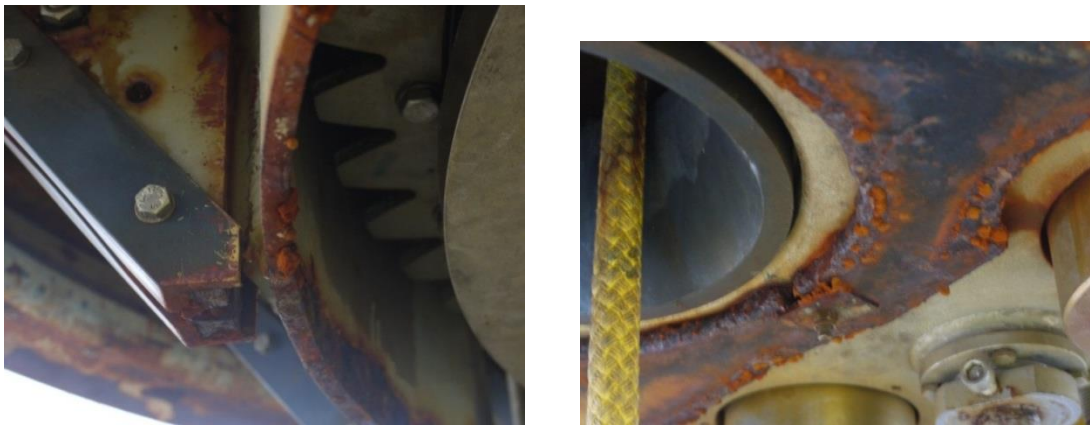
Figure 4.40 (a) and (b). Build-up of corrosion product in skirt

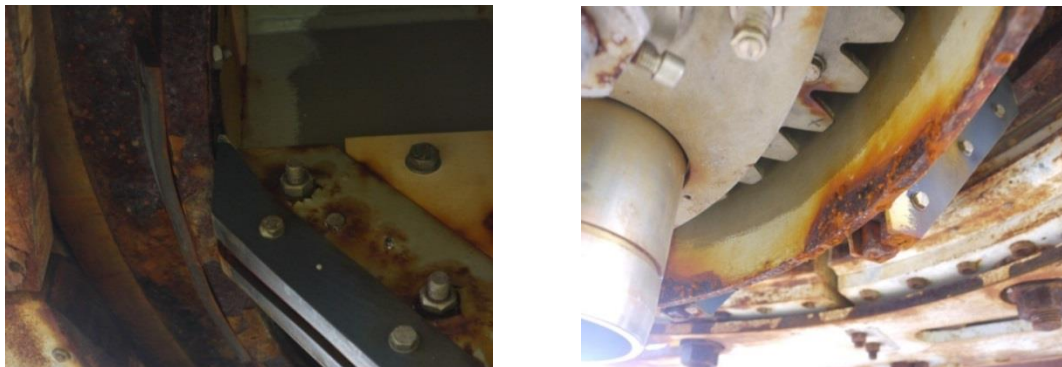
Figure 4.41 (a) and (b). Corrosion in skirt area and blistering of protective paint around fixings

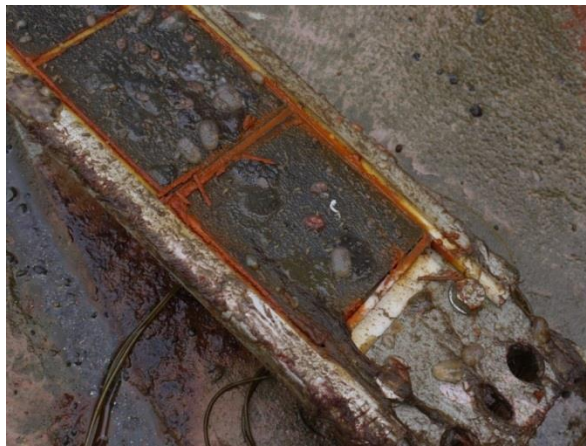
Figure 5.7. Corrosion and biofouling observed on panel A

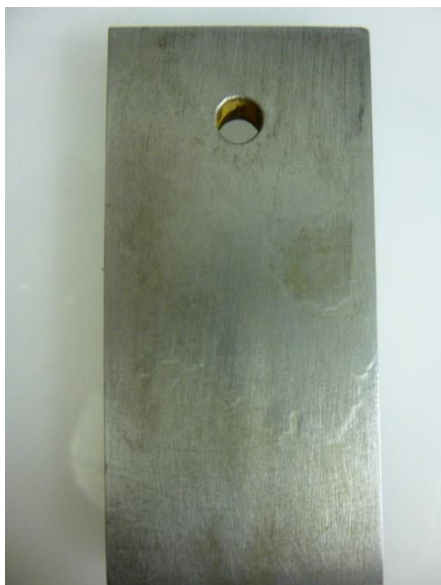
Figure 8.2 Surface damage on carbon steel coupon 1

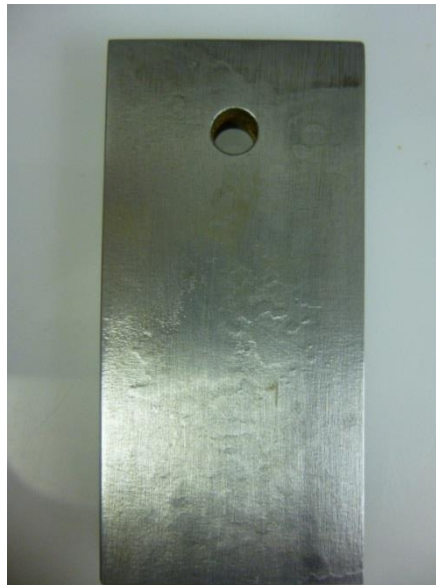
Figure 8.3 Surface damage on carbon steel coupon 2

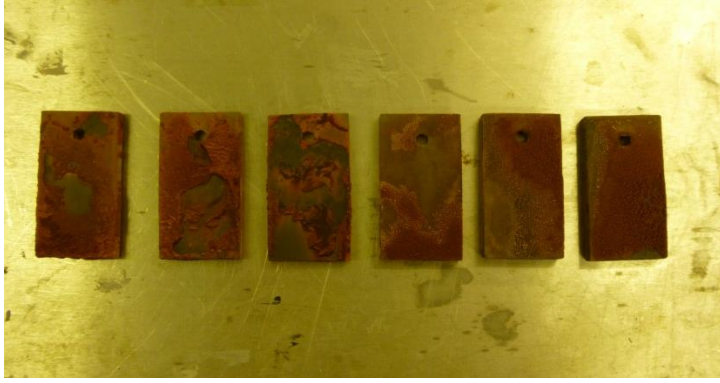
Figure 8.4. SG Iron 400-18 coupons on removal after 500 hours. Coupons 1-3 (reading from the left) were subject to high flow while 4-6 were subject to low flow

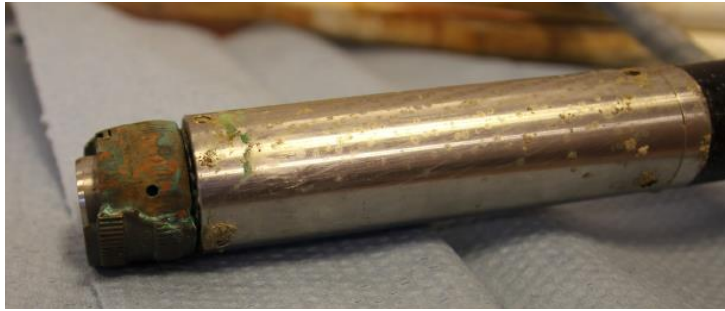
Figure 9.5. Close-up of corrosion of coupling collar

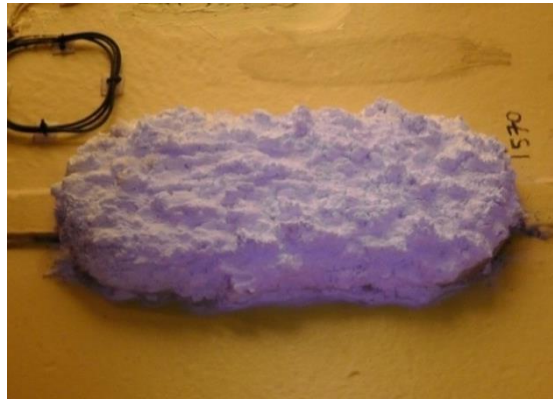
Figure 9.6. Typical skirt anode

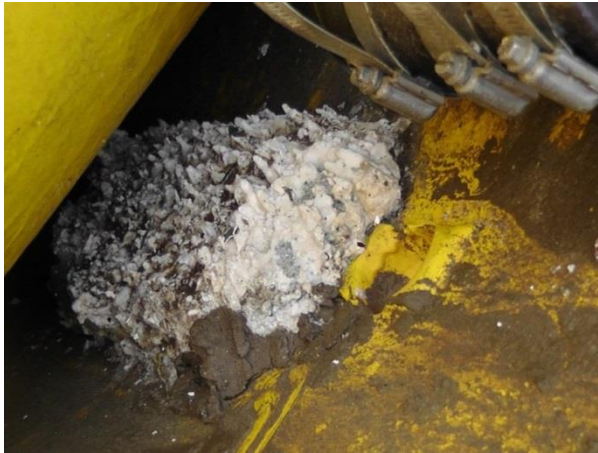
Figure 9.8. Thruster housing anode
