# The Role of Hydrothermal Degradation in the Wear Behaviour of Zirconia

Submitted for the Degree of Doctor of Philosophy

**Leili Shirkhan**

The University of Sheffield

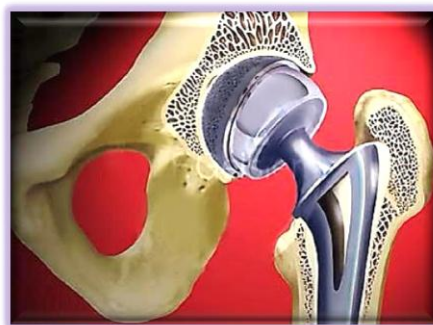
**Figure2.1: Hip joint implants [8].**

Total hip replacement (THR) is a major operation to replace a damaged hip with an artificial part to improve the mobility of patients suffering from a wide range of hip joint diseases. In this operation real joint performance is mimicked using an acetabulum cup fixed inside the pelvis, and the ball component is inserted inside the femur bone, Figure 2.1.

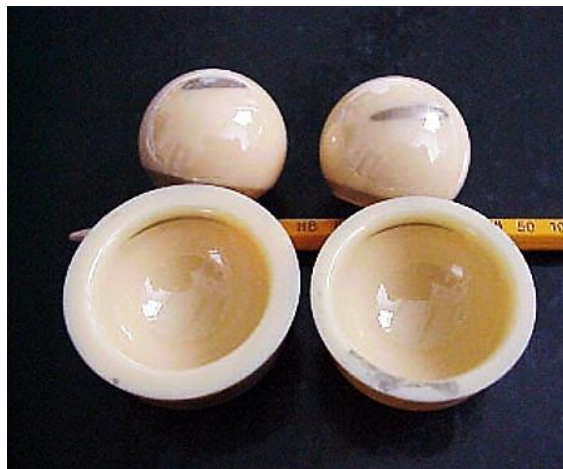
Figure 2.4: Stripe wear region on ceramic head and cup [16].

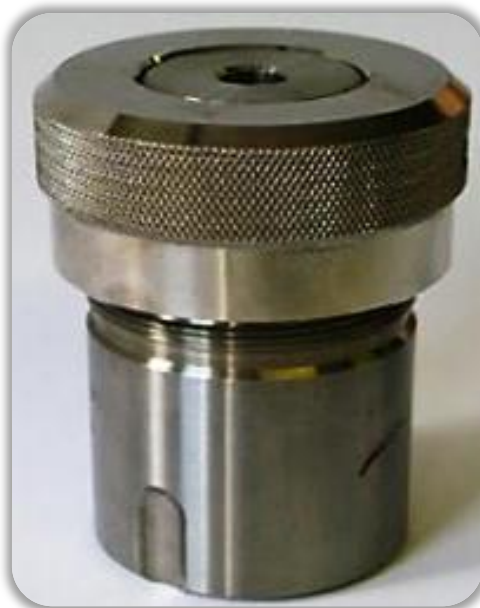
Fig 3.1: Sealed Teflon lined general-purpose vessel

Hydrothermal degradation was simulated by placing specimens in 2 ml of distilled water within a conventional sealed Teflon lined general purpose vessel (Parr Instruments Co., USA), Figure 3.1. The vessel was heated at a rate of 3 °C/min to 134 °C and held at that temperature for periods of 6 , 12 and 24 hours then cooled down to room temperature. The extent of degradation was examined using different microscopy techniques.

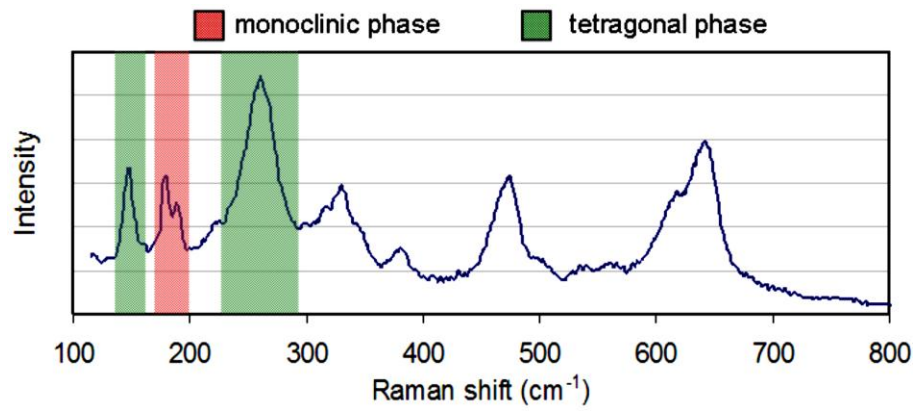
Figure 3.2: Typical Raman spectra of a 3Y-TZP specimen containing a mixture of monoclinic and tetragonal phases [65].

A Raman Spectrometer (LabRam HR, Joriba Jobin Yvon, France) with a 532 nm line of a He-Ne laser was used to obtain the Raman spectrum of aged specimens. Spectra were recorded from 100-900  $\text{cm}^{-1}$  on accumulation of 5 seconds per point. Point analysis and surface mapping were both used, and the latter was found to be a more useful technique to study transformation. The monoclinic phase is characteristically double peaked as shown in Fig. 3.2 [66].

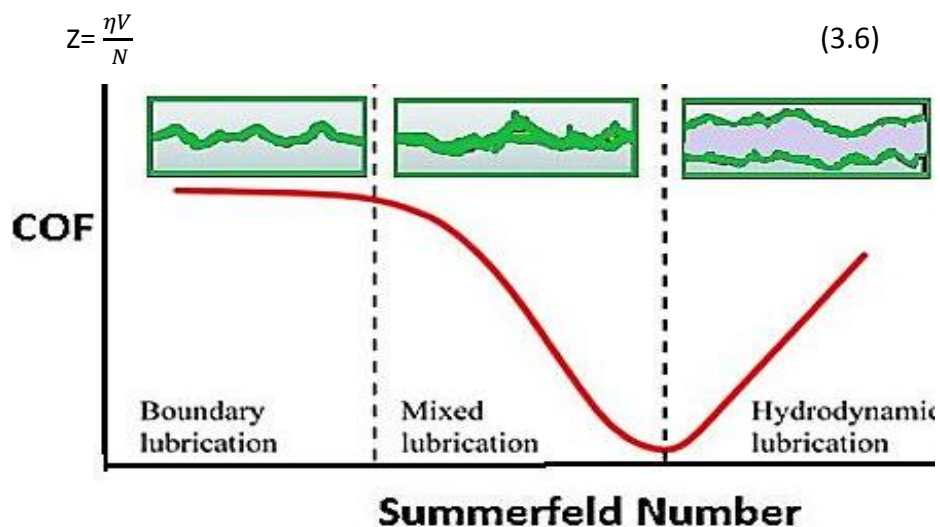
Fig 3.4: Stribeck curve and lubricant regime

The lubricant regime of each sample was identified using a Stribeck Curve in which Sommerfeld Number is plotted against COF. The Sommerfeld number, equation (3.6) [68], is applied to study the wear performance of two rubbing surfaces in dynamic state, in the presence of a lubricant and relates speed ( $V$ ), viscosity ( $\eta$ ) and load ( $N$ ).

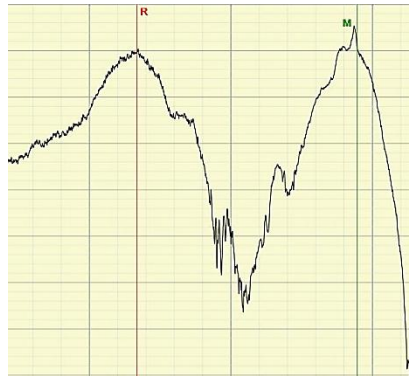
The cross-sectional profile of the wear tracks was measured by using a surface profilometer, Dektak 150 (Veeco Instruments, US). The Profilometer is a straightforward contact quantitative measuring technique. Due to the hard nature of the surface the stylus load was set as 3 *mg* and scan length was varied in different wear regions in accordance with wear scar width. The scan durations were set to 50 s Hills & Valleys profile type. Levelling up the acquired graph gave the lost area of the worn scar.

**Figure 3.5: Volume lost was measured by tribometer of AZ surface worn under 4N load in water after 24 hours sliding with 0.02 m/s speed.**

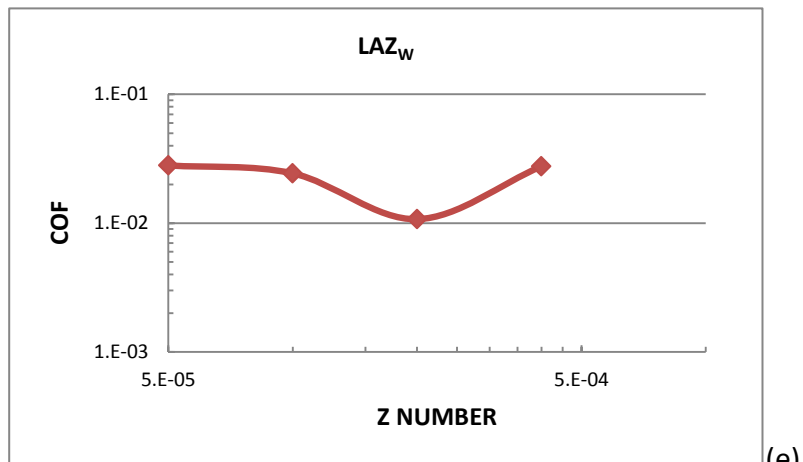
Fig 4.22: The Stribeck curve for (a) Z, (b)AZ, (c)LAZ,(d) DZ, (e)DAZ and (f) DLAZ samples lubricated with ultra-pure water(W) under 4, 2, 1 and 0.5N load. D represents degraded specimens.

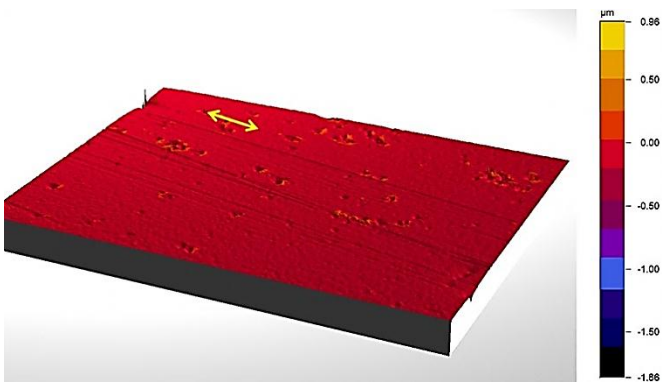
Figure 4.29 shows the worn surface of the AZ sample tested under 0.5N load. It exhibited parallel grooves along the sliding direction that appeared to be associated with third body abrasion.

Fig 4.29: AZ sample worn in water under 0.5 N at 0.02 m/s

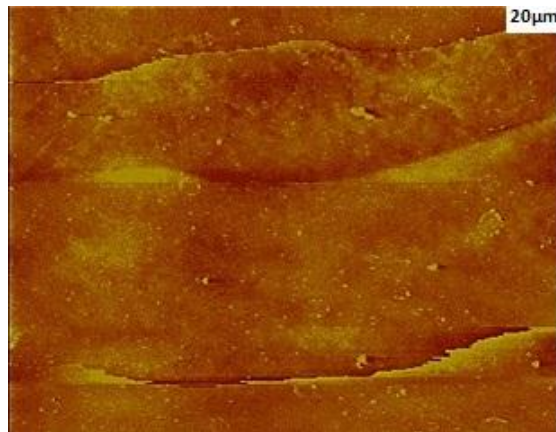
AFM imaging was employed to provide higher resolution information of the wear zone. Wear damage intensity is not uniform across the wear scar, but Figure 4.43 of Z sample under 1N load in water evidences surface modification during the wear process. The significant appearance of lubricant layer existence on top of the surface this layer considerably modified its surface. Figure 4.44 is a lateral force microscopy image of the specimen shown in Figure 4.43 evidencing grain boundary recesses which were not detected in normal contact mode AFM imaging. The amplitude image of this sample shows ripples of compacted layer on the worn region with 5μm wavelength, Figure 4.45.

Fig 4.45: AFM amplitude image of Z sample worn under 1N in water at 0.02 m/s

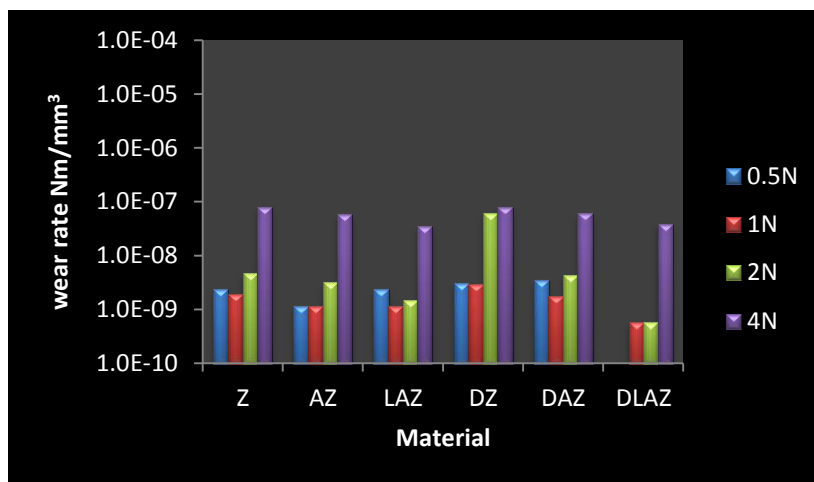
Fig 4.60: Specific wear rates for the reciprocating wear tests of all the material against high purity alumina ball lubricated with bovine serum, showing the effect of materials.
