# **Conservation and Reconstruction at the Palace of Minos at Knossos**

Volume 1

Submitted for the degree of  
Doctor of Philosophy in Architecture

University of York  
October 1998

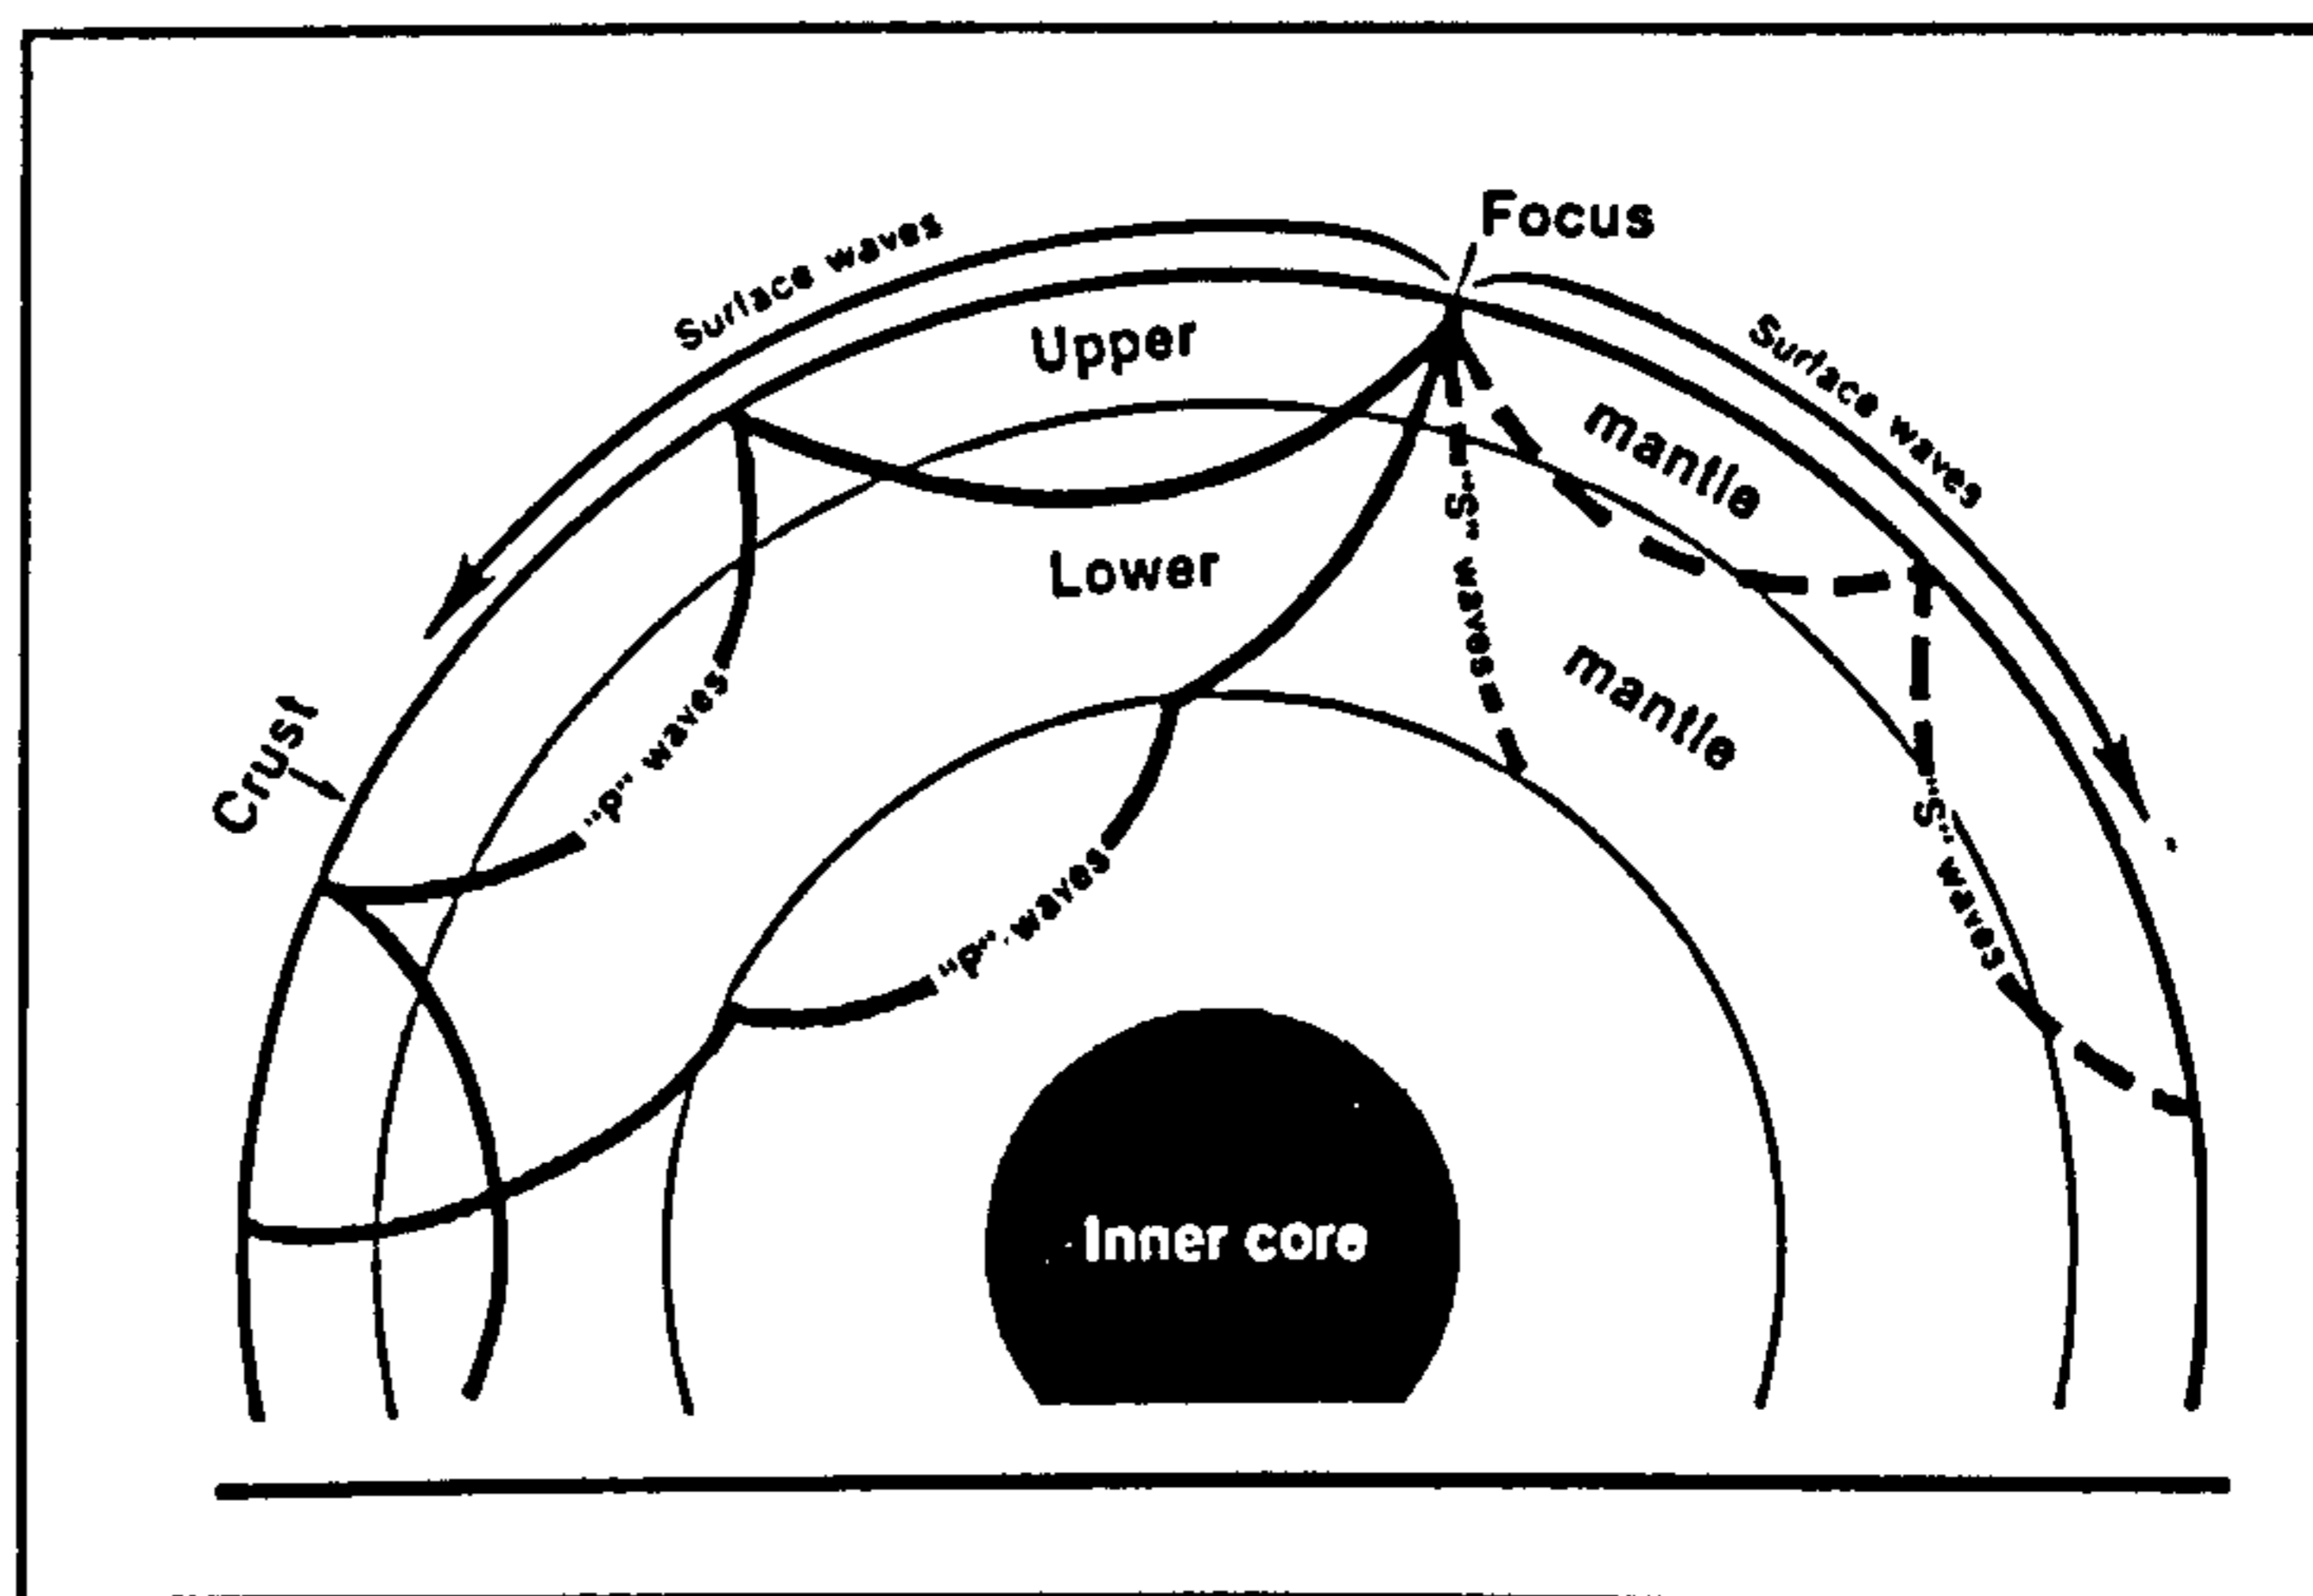
Figure 23 Propagation of P and S-waves through the earth.

crust surface. They shake tall buildings.<sup>125</sup> Furthermore, close to the earthquake's epicentre and at tectonic faults the upper surface of the earth might be deformed causing parts of buildings to slip to a lower level, to buckle or to be twisted in their ground plan.<sup>126</sup>
