Misconnection Project Plan

For the initial trial, four outfalls along the tongue gutter water course located in Parsons Cross, Sheffield were chosen. Initial tests at the outfalls had shown there were misconnections somewhere in these systems.

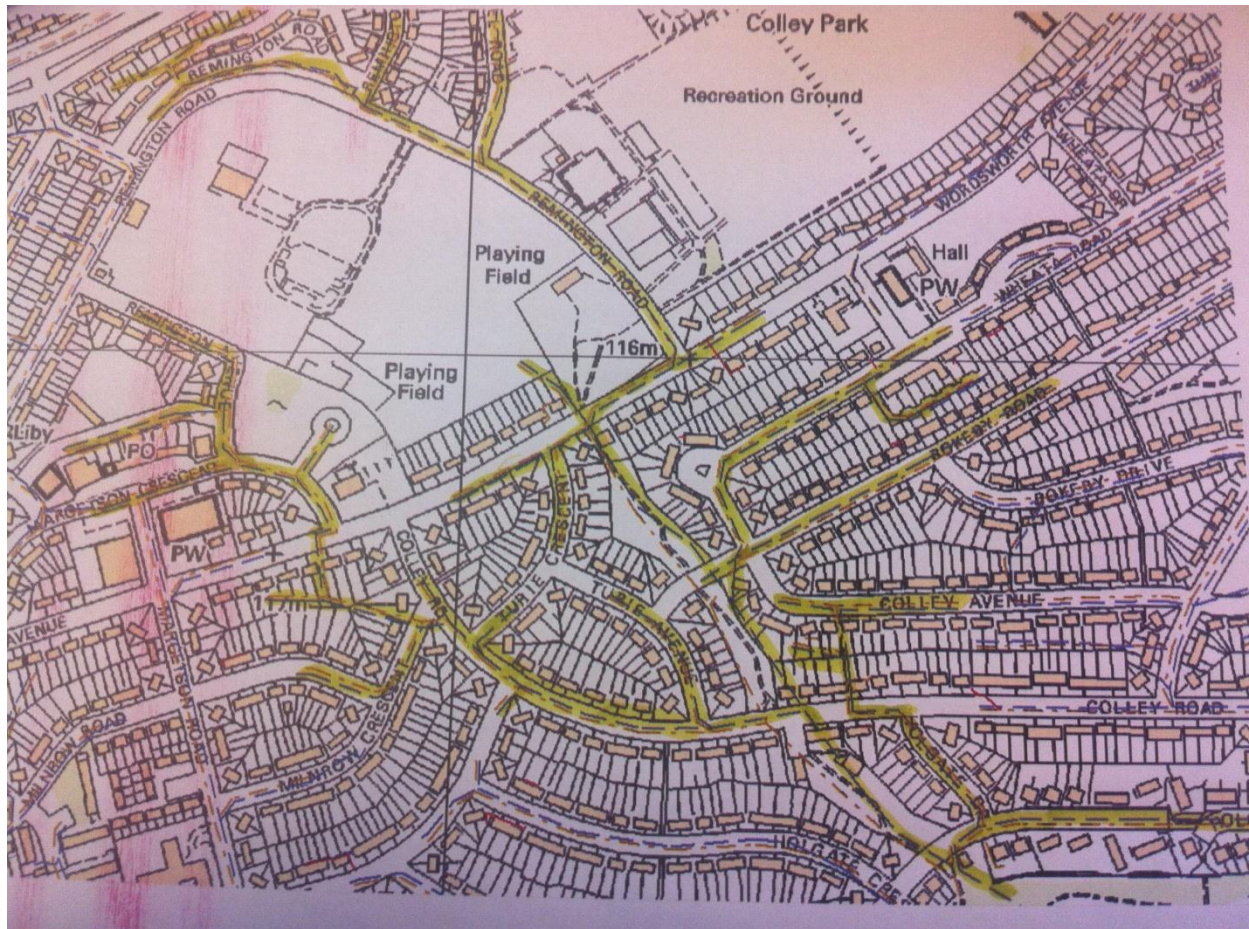
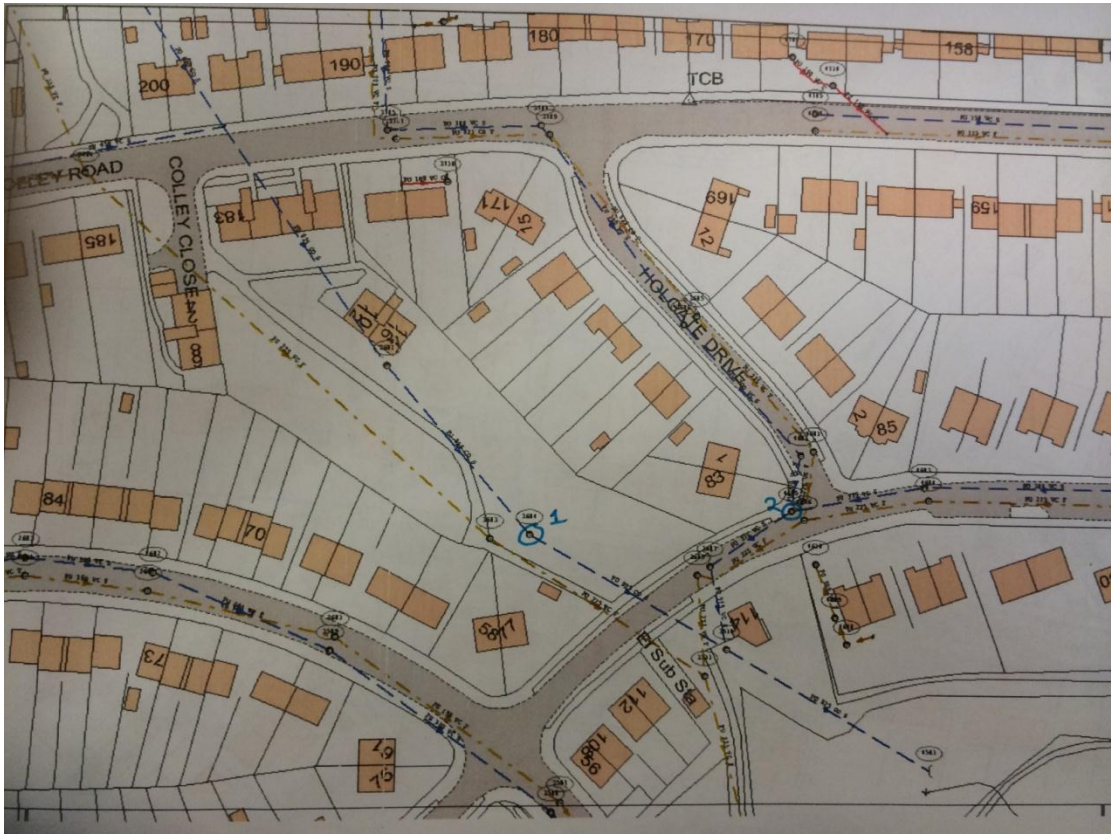
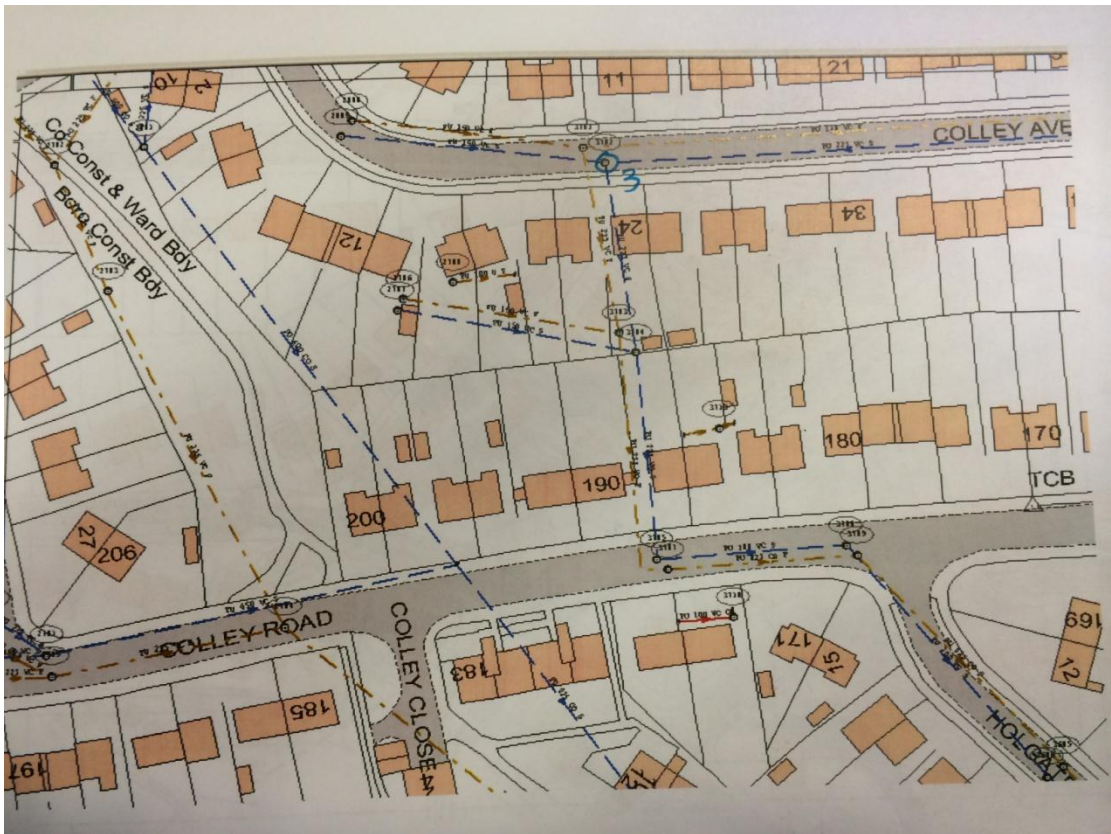
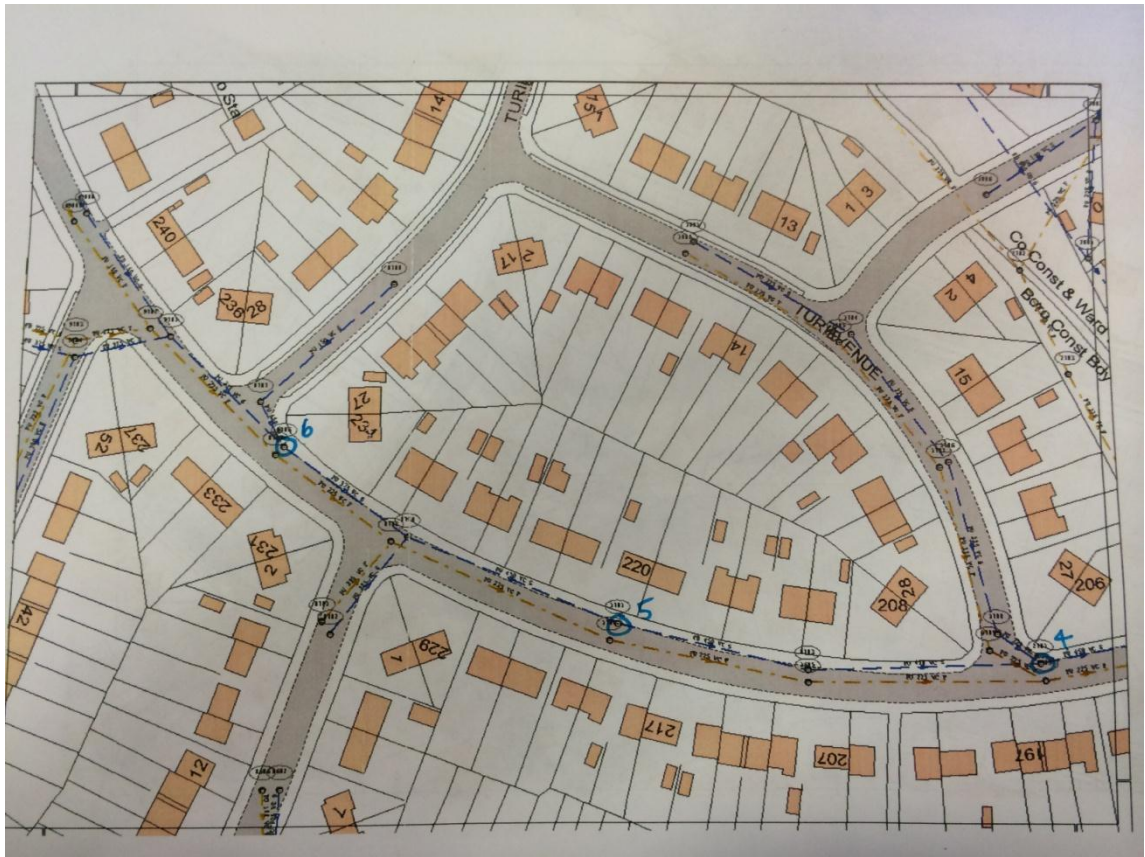
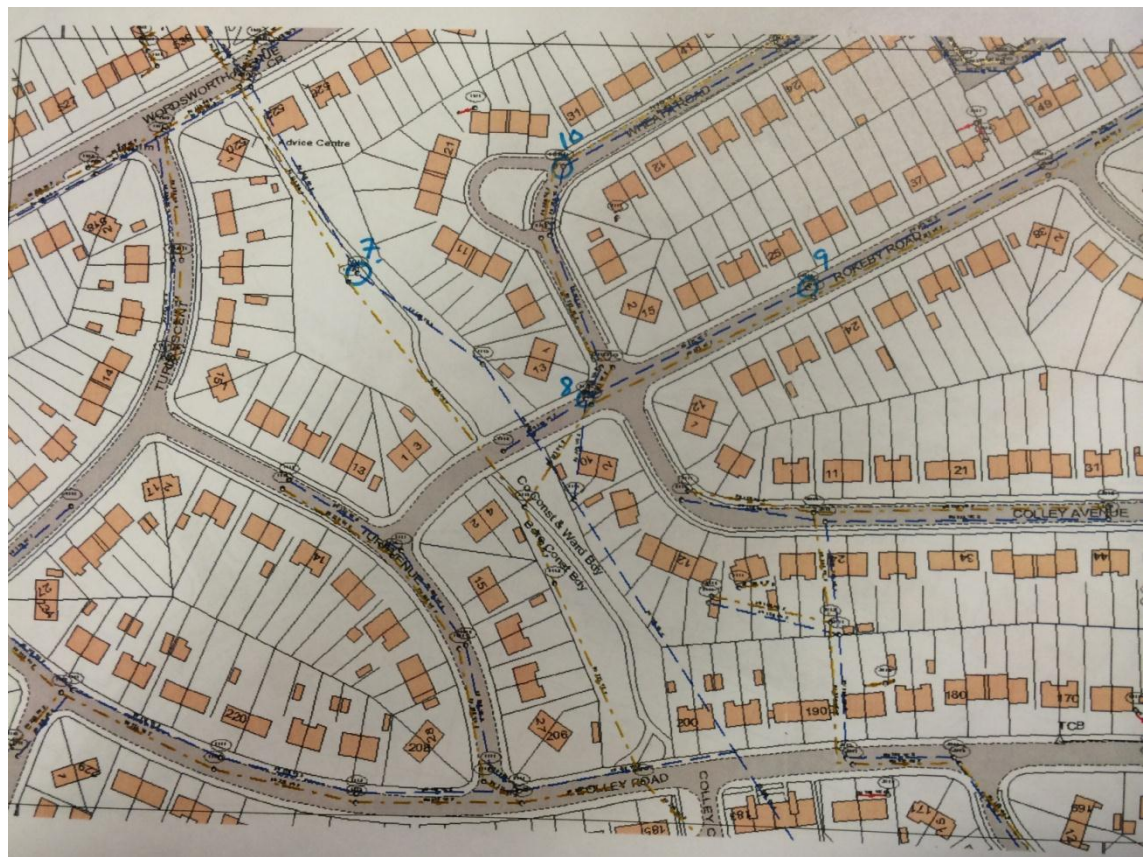
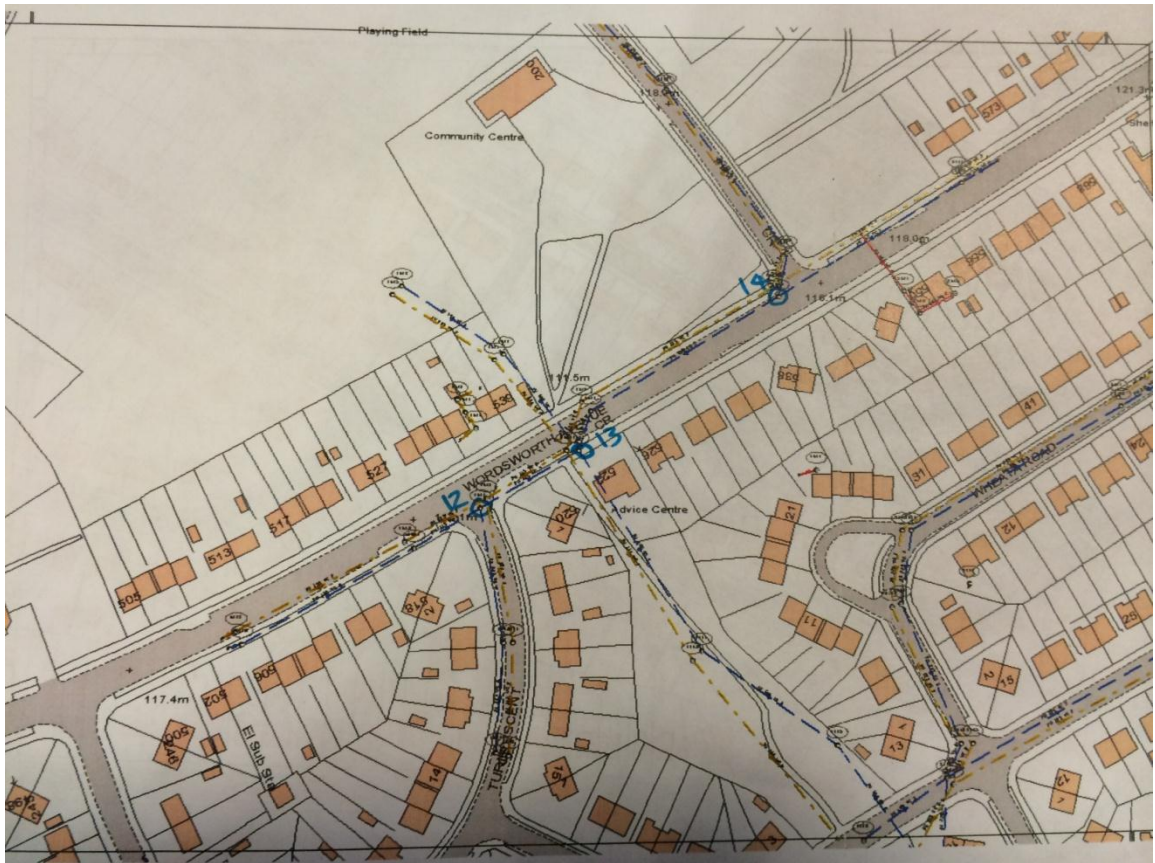
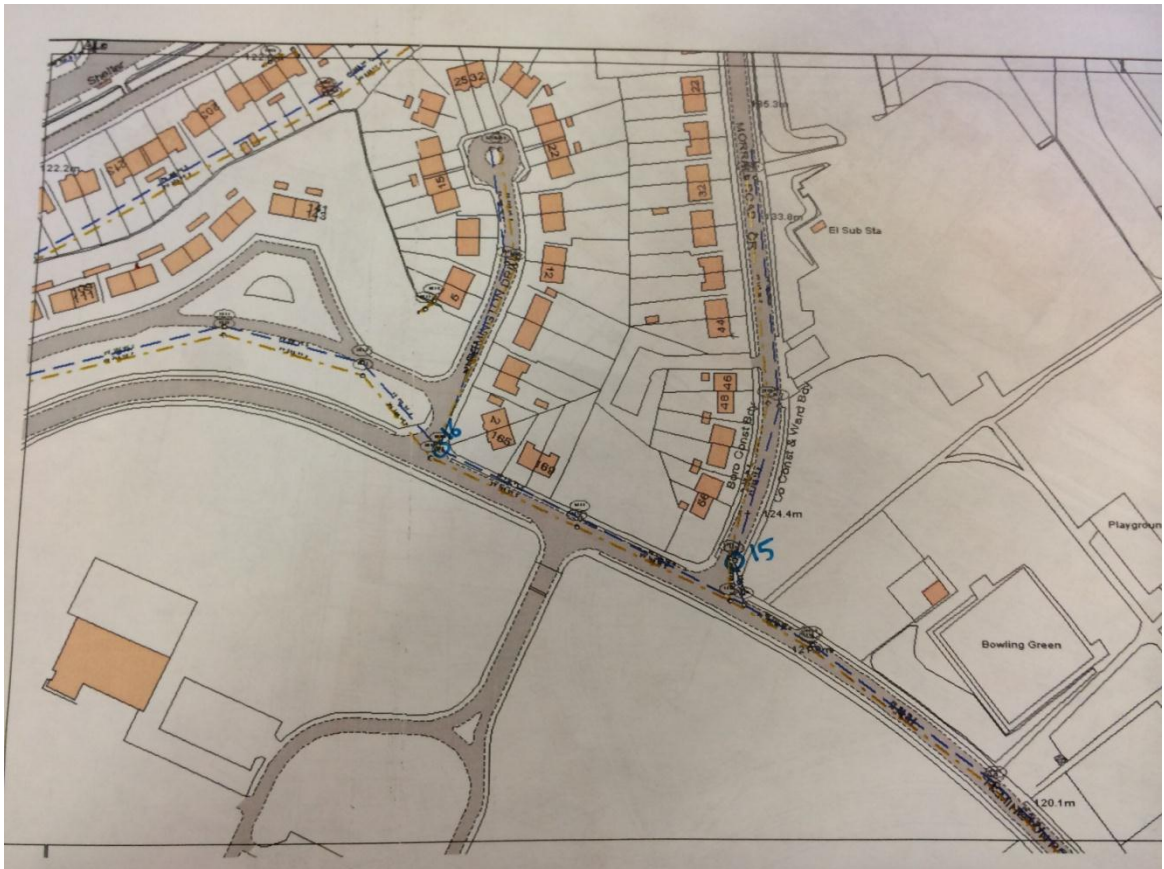
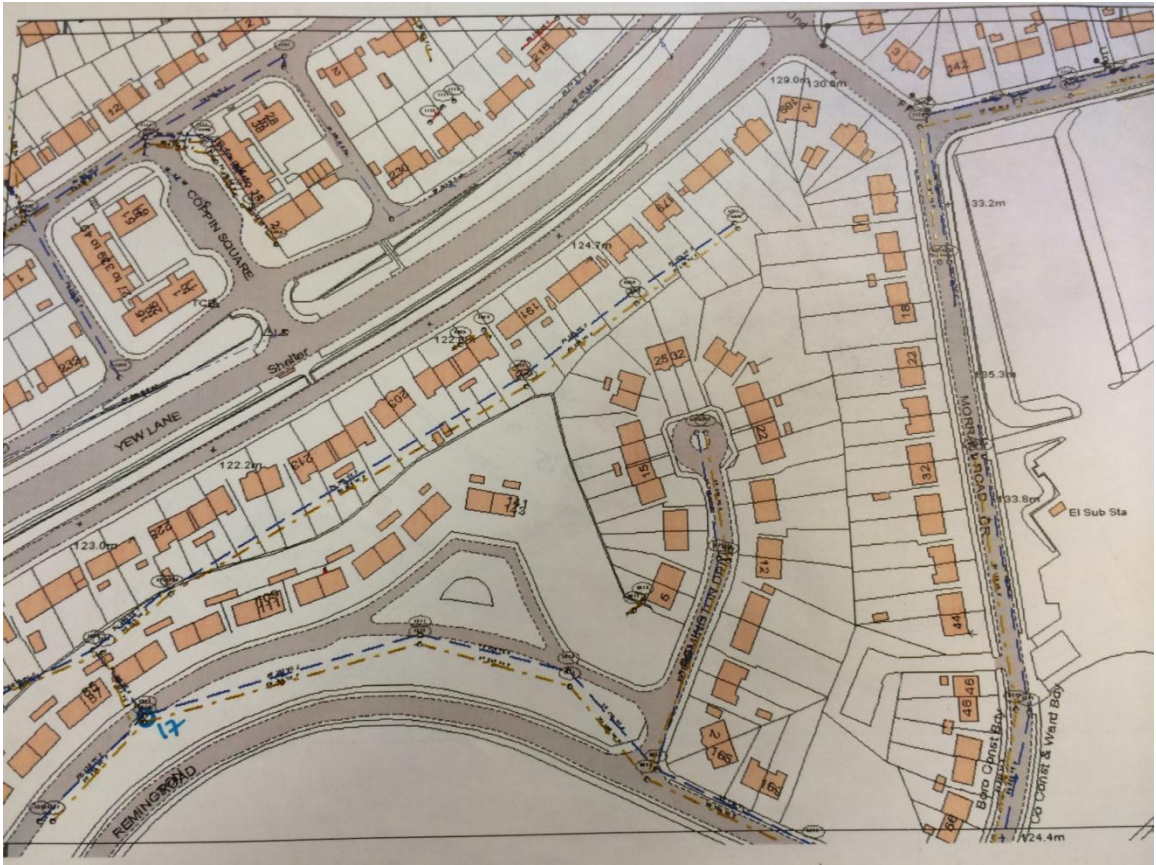
Outfall 3 is a very big system, servicing a large part of the Parsons Cross estate. The outfall itself is situated just off Colgate Road. Again initial tests indicated a misconnection in this system and after a visual survey of the outfall it was clear that there was more than one misconnection in this system.

Using the locations obtained from this detection method several inspections were carried out at the chosen areas. From outfall 3, two misconnections were found, both on Turie Avenue. One misconnection was a soil stack and the other was a sink connection to the storm water gulley. A note was left at both properties with details of what the problems are. From outfall 2, two misconnections were also found, both on Milnrow Crescent. Both misconnections were sink and washing machines connected to surface water gulleys. The customers at these properties were both informed and stated they would get these rectified as it was a very job to resolve.
