The Archaeology and Conservation
of the
East Front of York Minster

Volume 2 of 2
Figures, Drawings and Appendices

Alexander B Holton

University of York

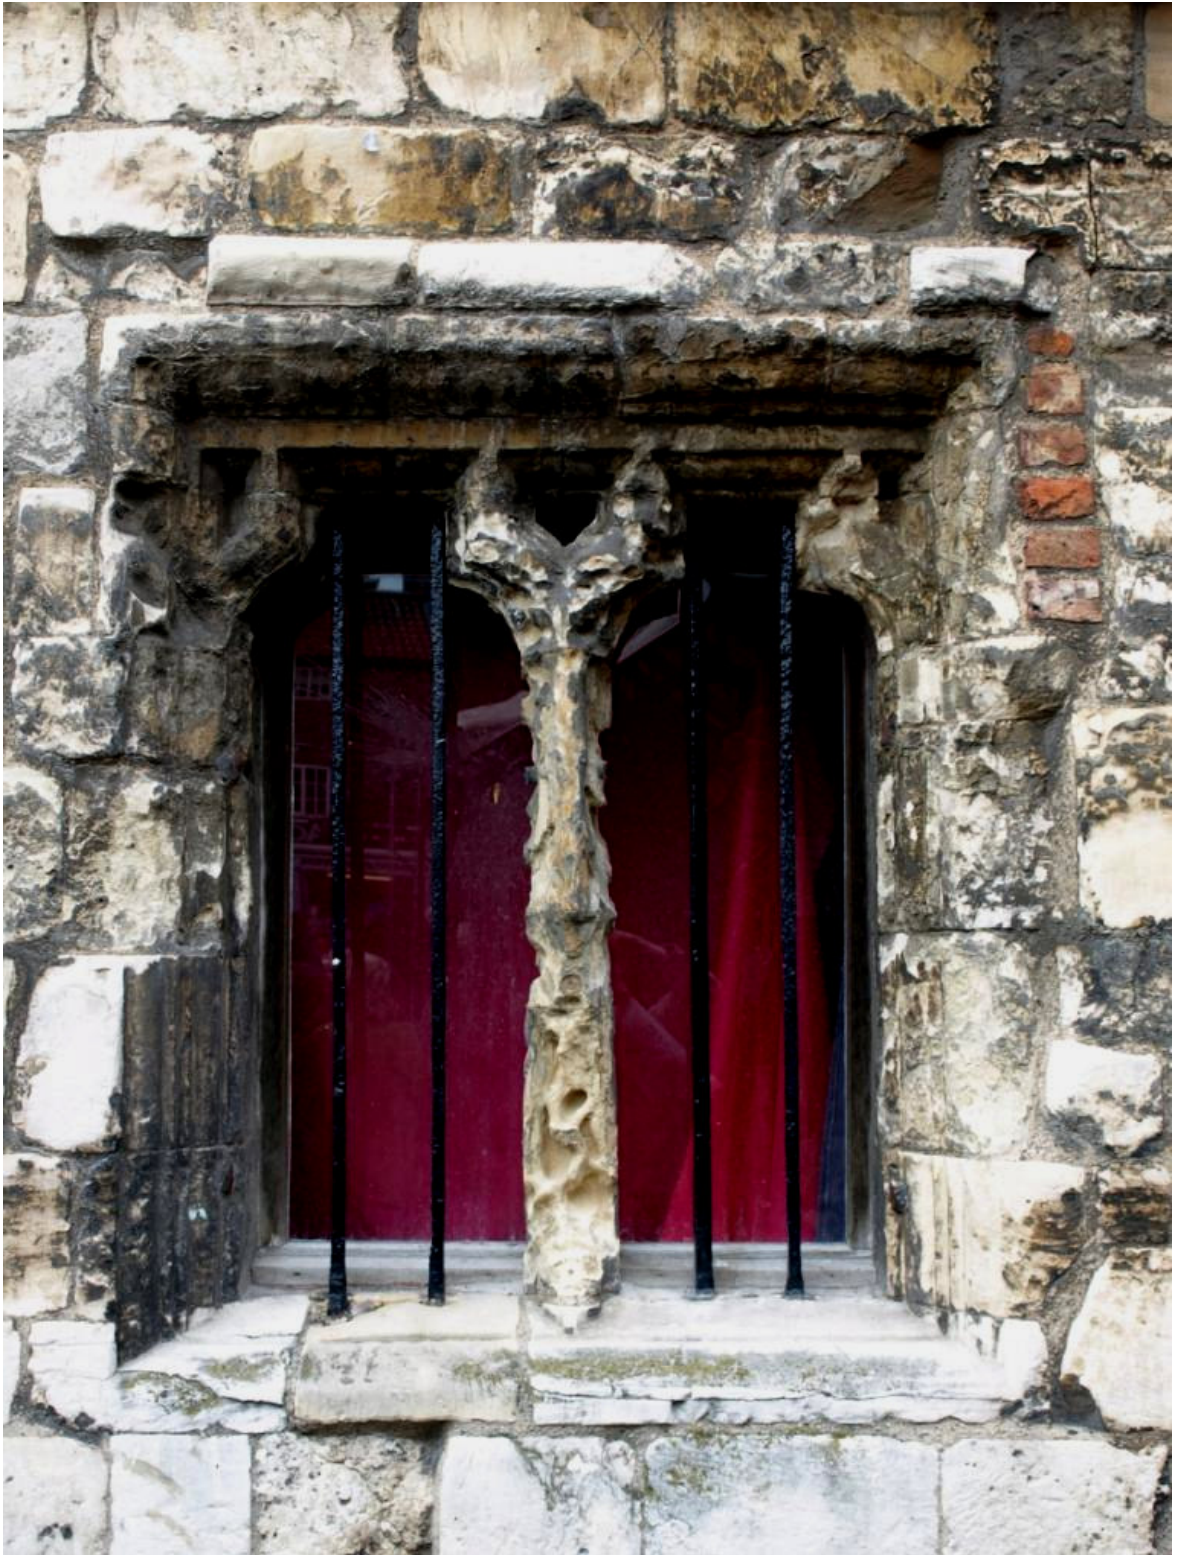
Figure 4: Example of advanced sheltered decay of magnesian limestone, Newmarket, York

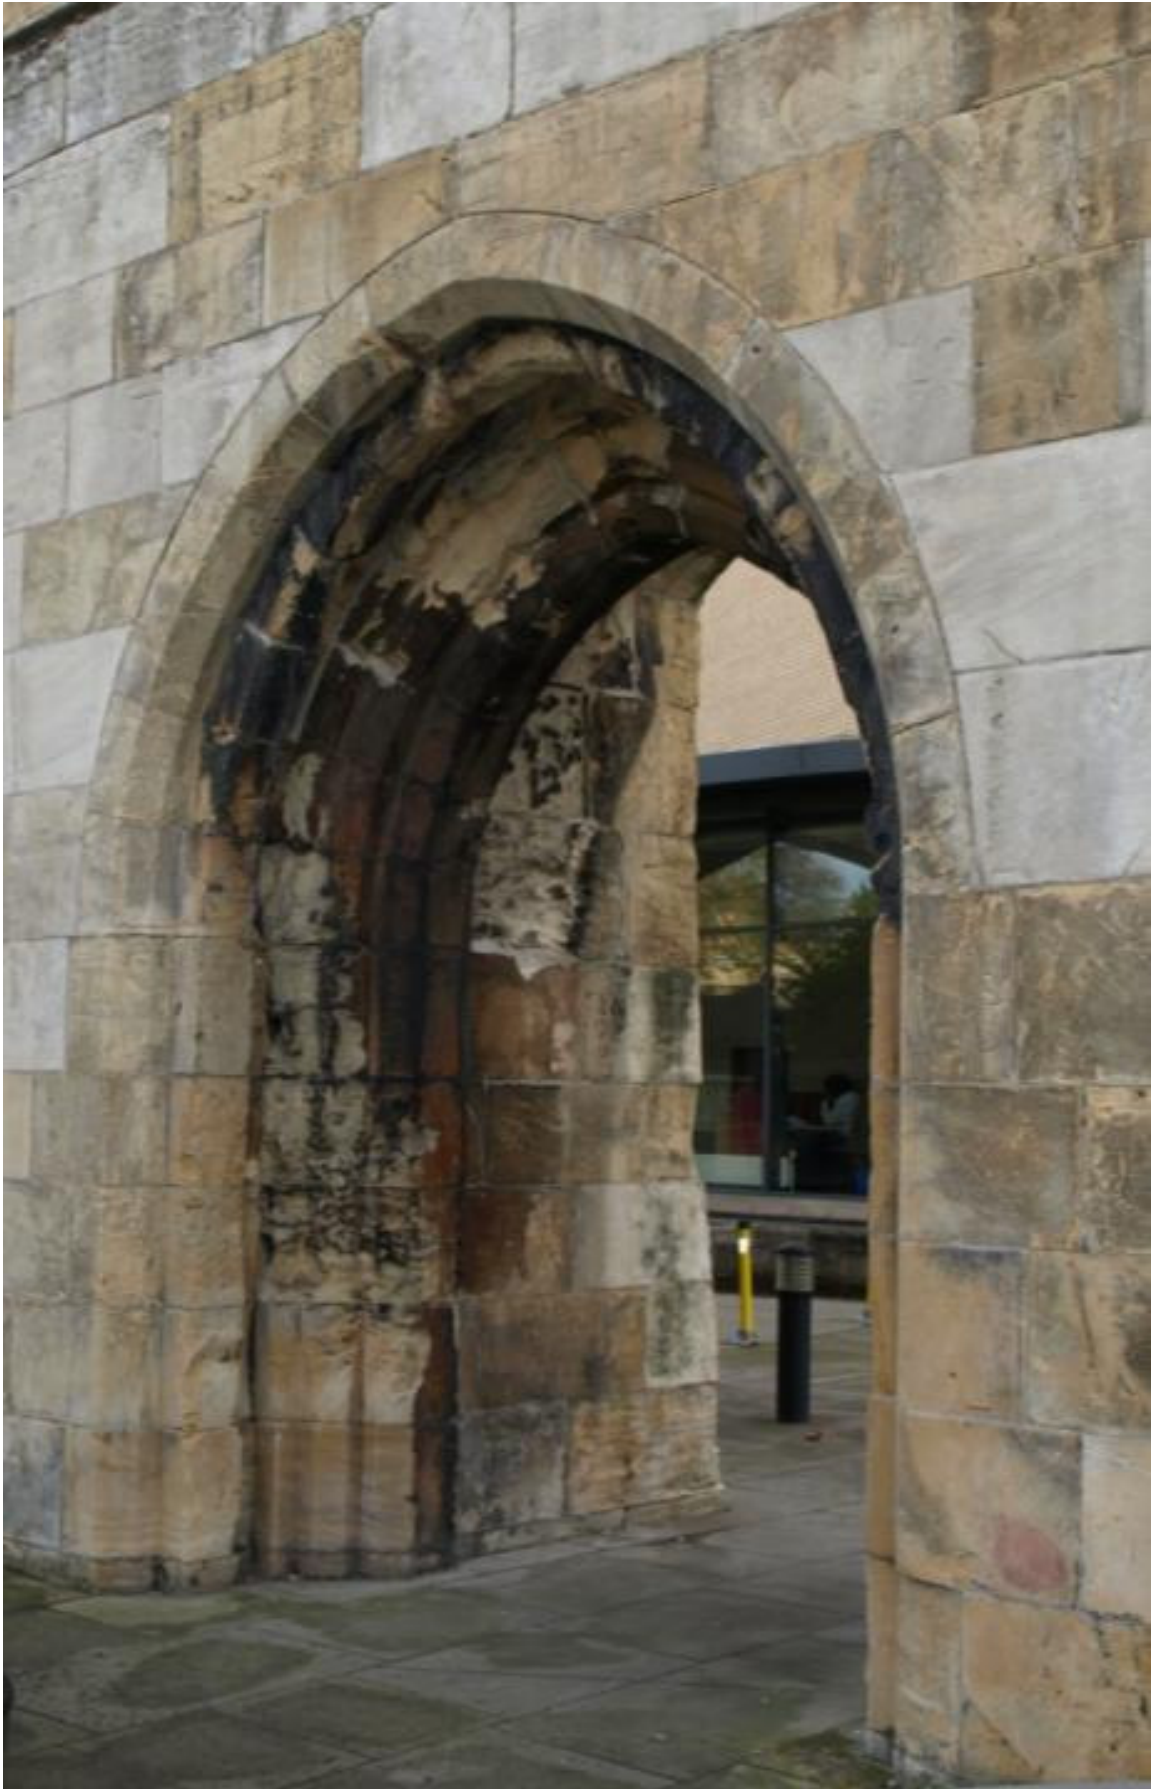
Figure 5: Example of sheltered decay of magnesian limestone, the City Walls, York

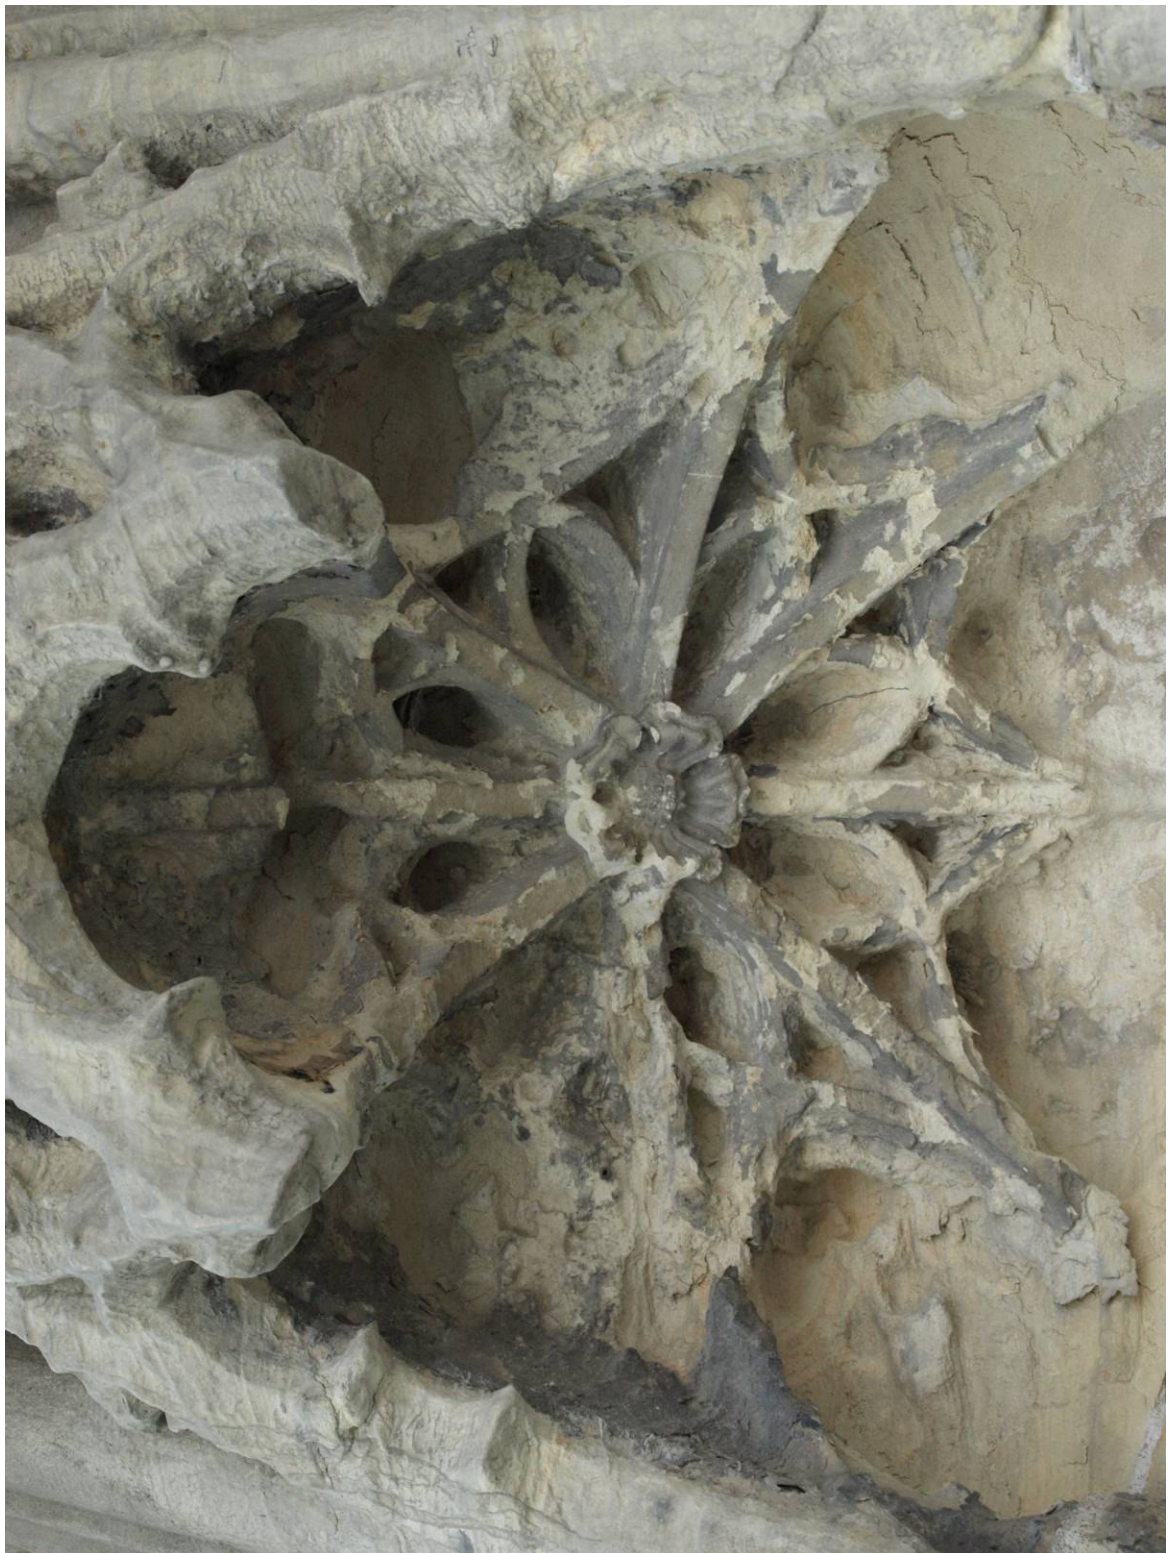
Figure 6: Example of sheltered decay at York Minster, nineteenth-century niche-head of south buttress, East Front (landscape)

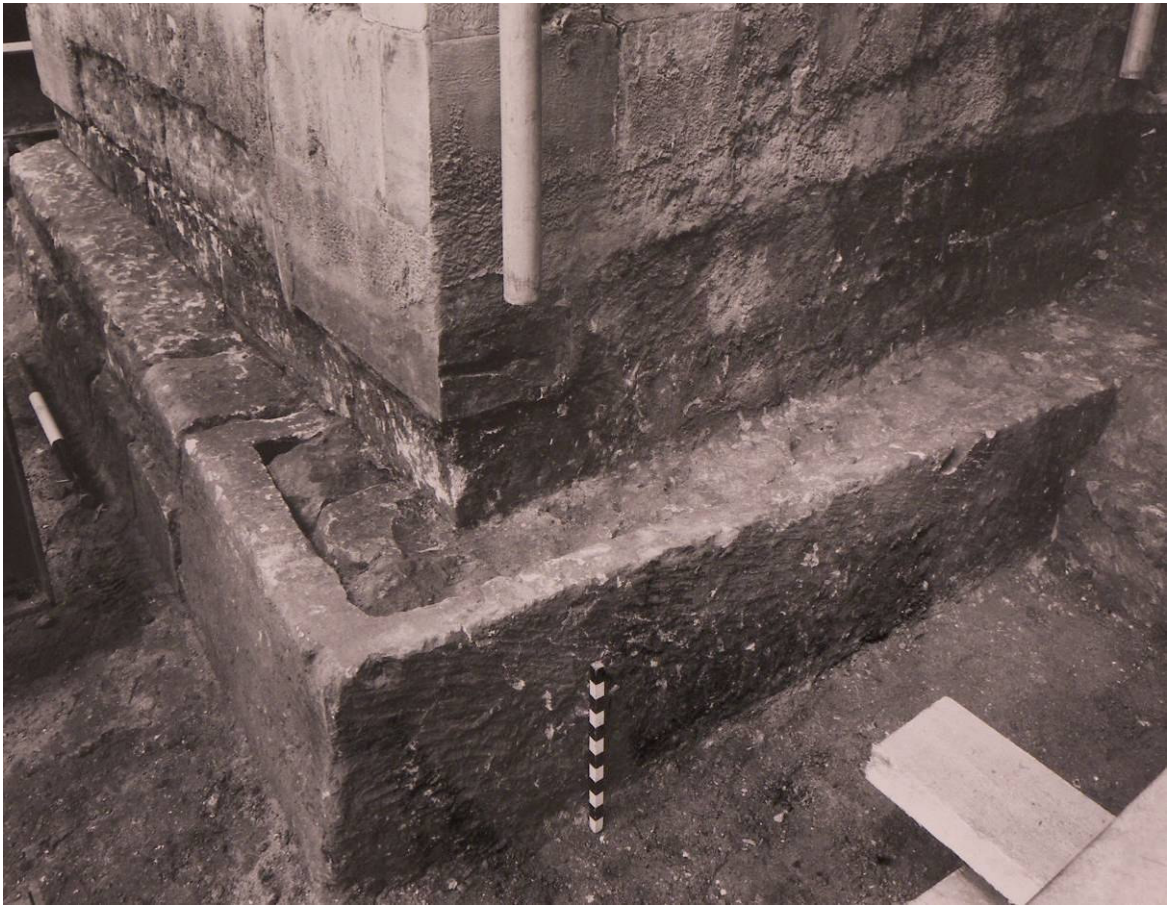
Figure 160: Foundations of first buttress west of south-east turret, 1969 (YML/YMEX/6481)

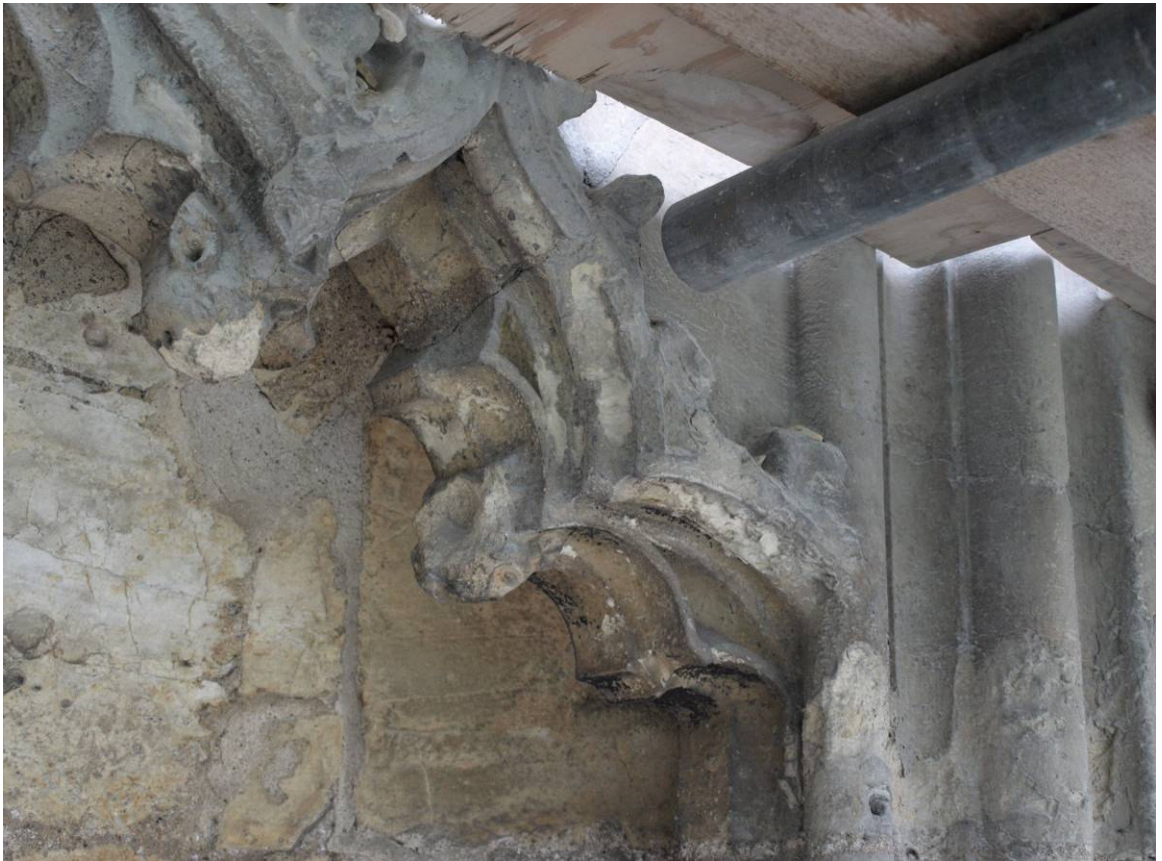
Figure 186: East Front, detail of canopy in south buttress showing previous surface repair and decaying carvings, Level A

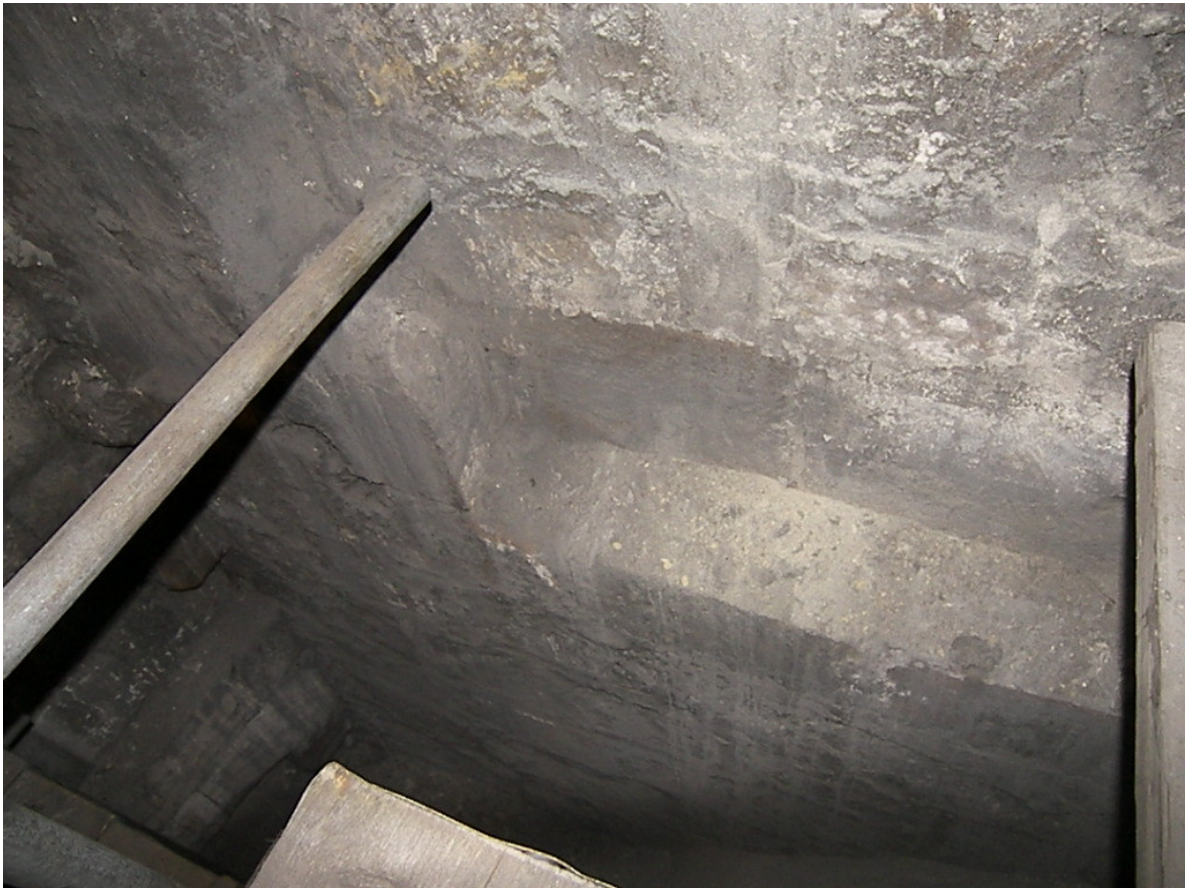
Figure 239: Thoresby's east end, south-aisle roof space looking to rear of East Front and off-setting in aisle wall

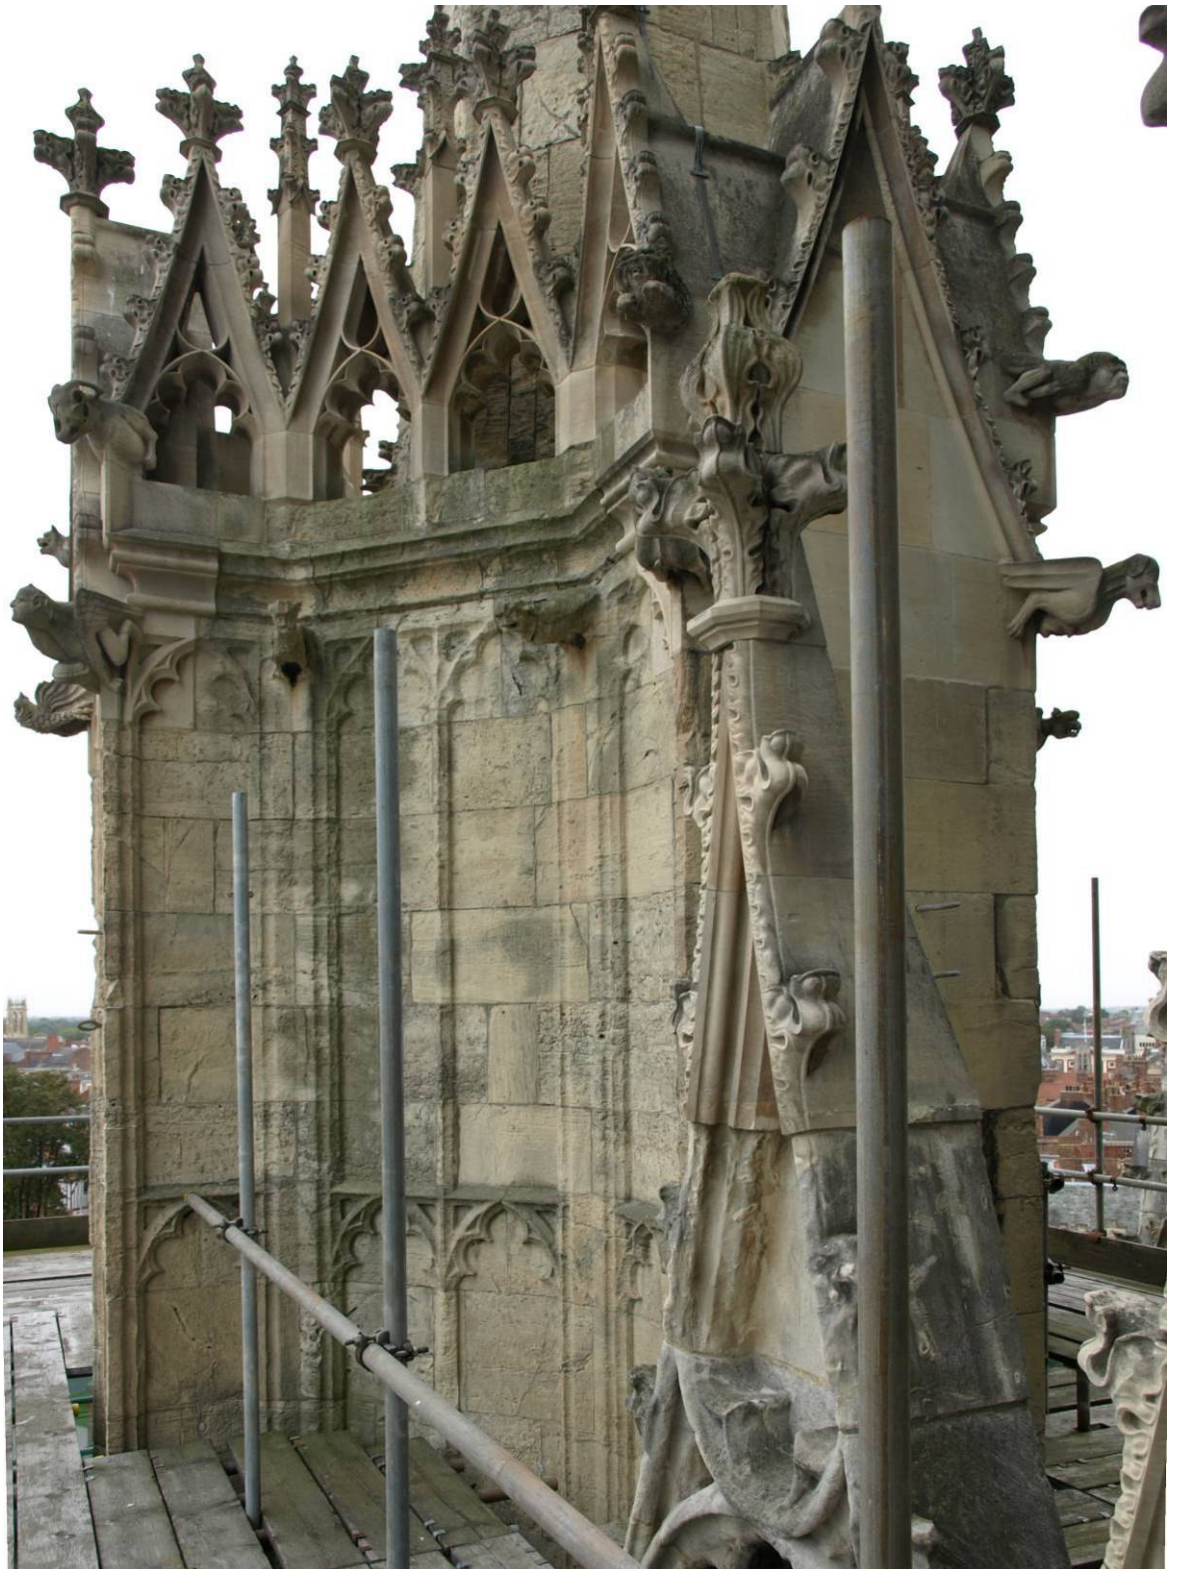
Figure 240: East Front, south-east turret, upper masonry, Level D

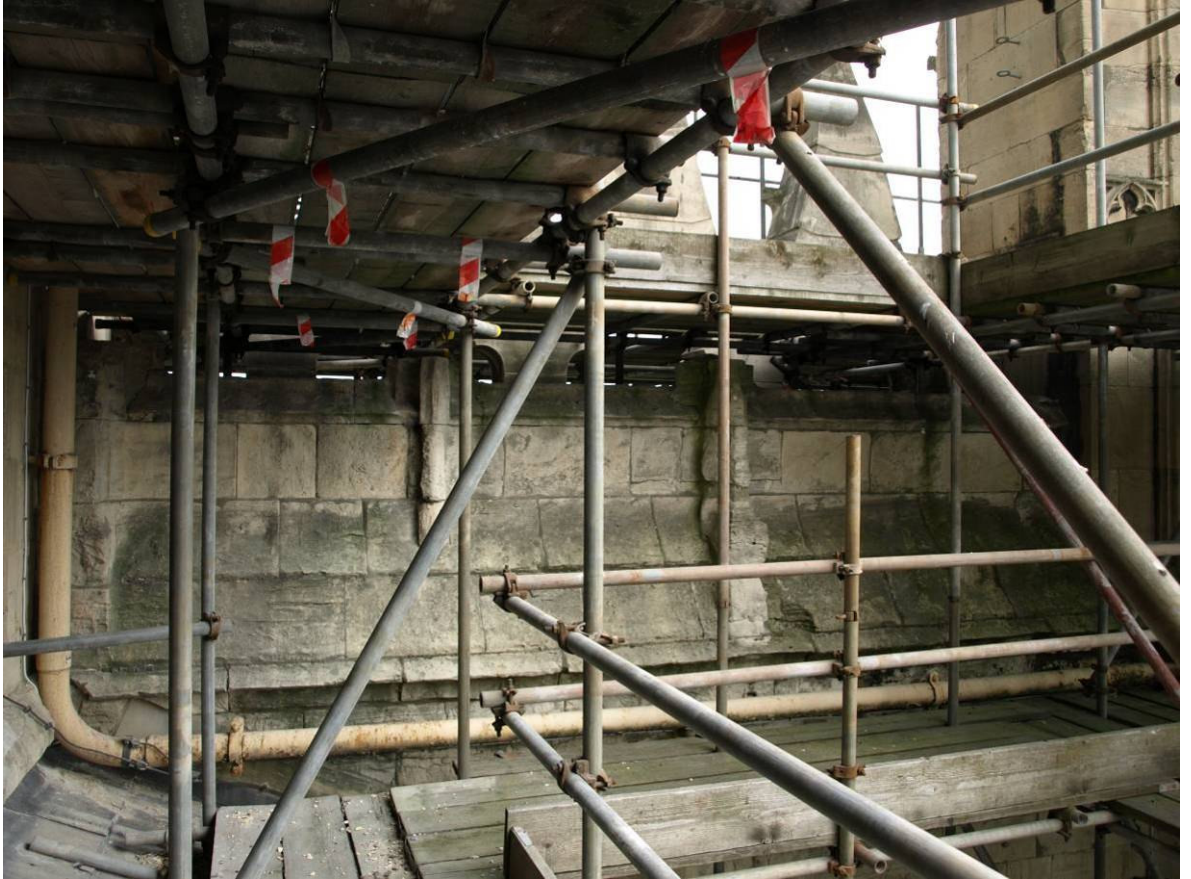
Figure 242: East Front above south-aisle roof, disused stoolings to rear of parapet, Level D

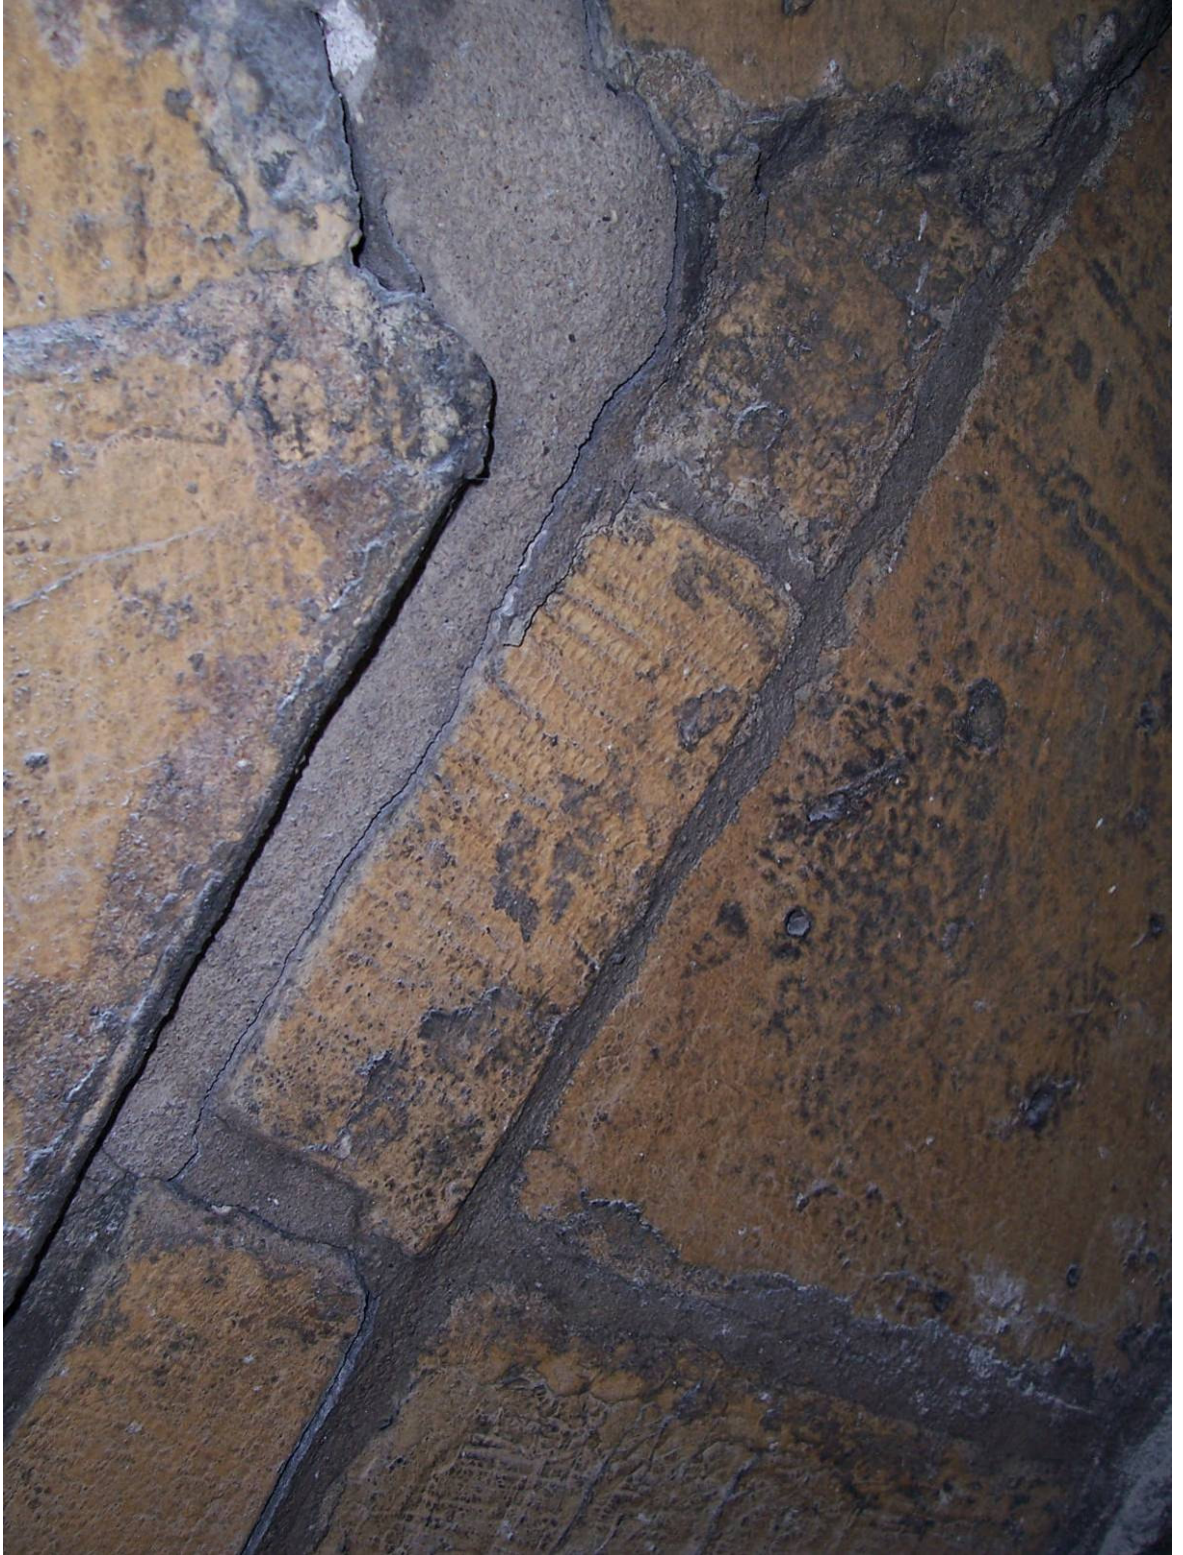
Figure 253: Thoresby's east end, easternmost bay, ?medieval infill to separated masonry with later 1950s cement patching

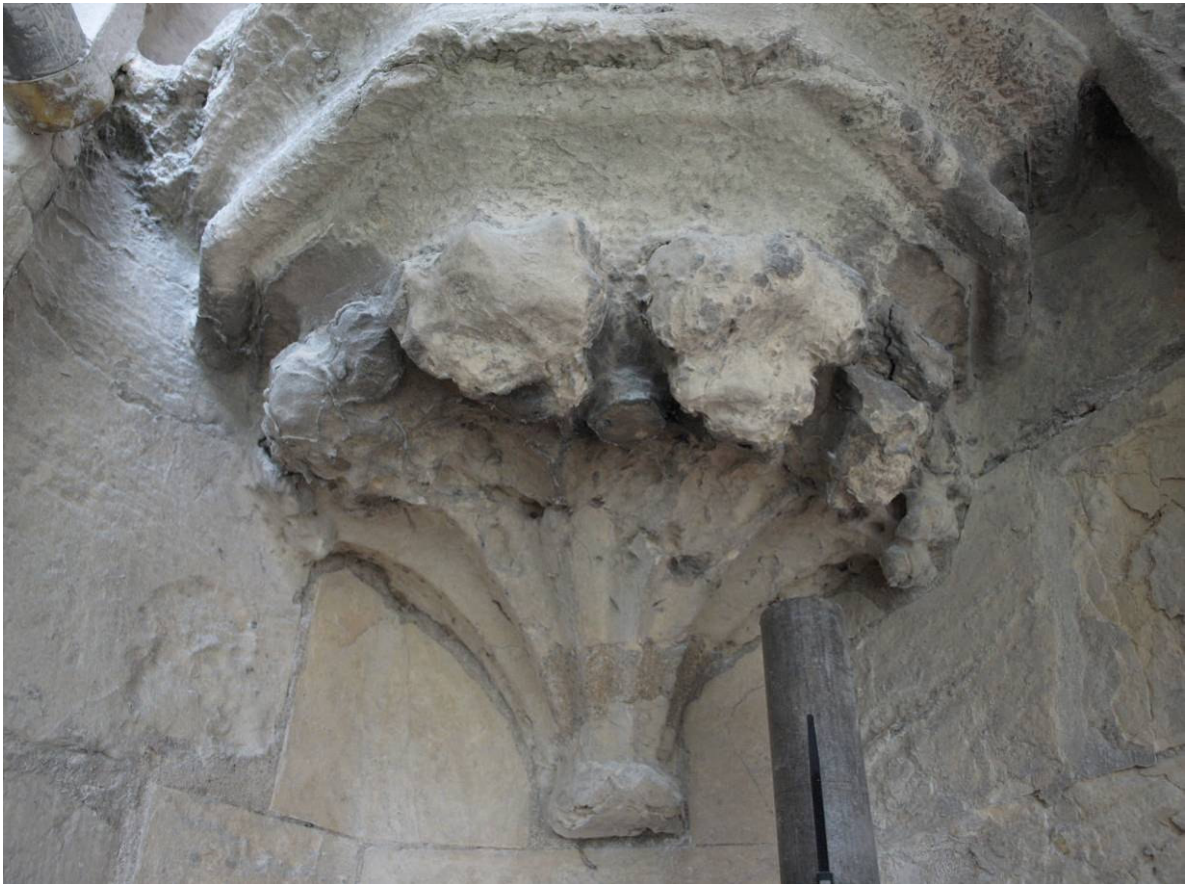
Figure 270: East Front, fourteenth-century niche-pedestal with later repairs, south side of Great East Window, Level D

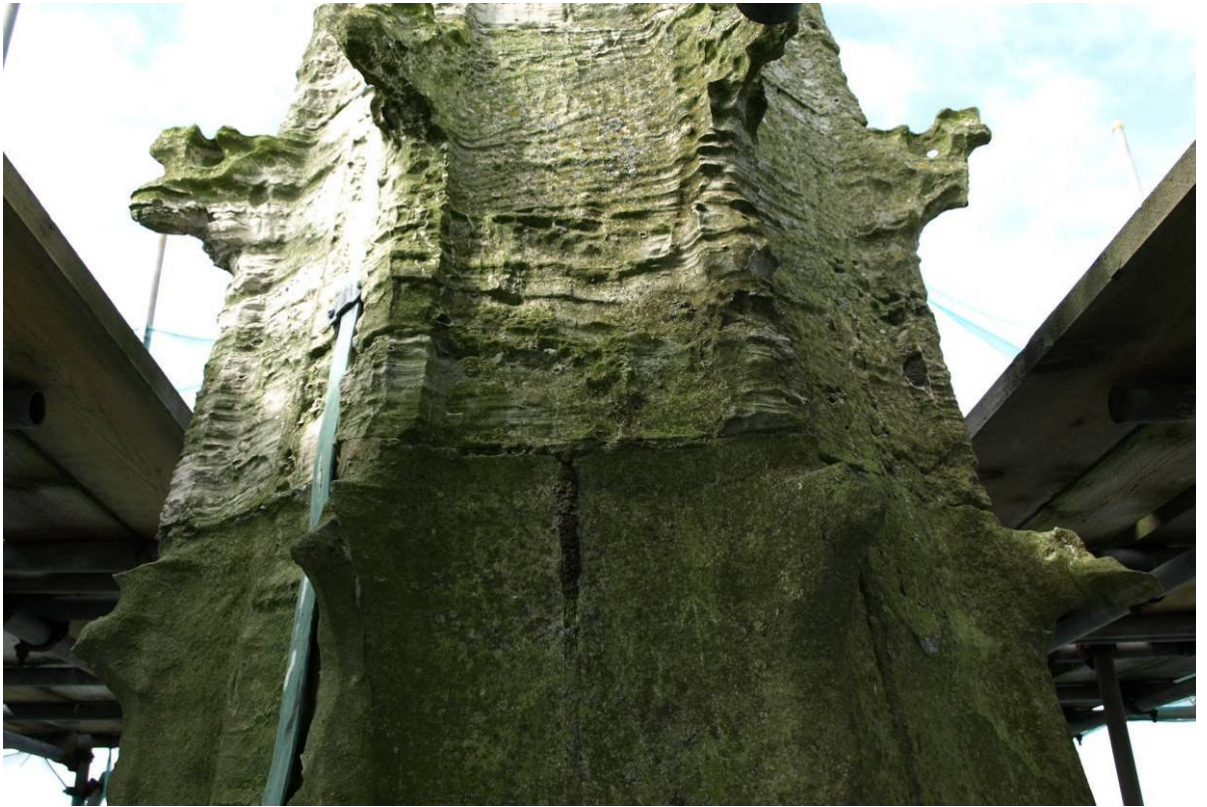
Figure 281: East Front, south-buttress spirelet, Level I, showing differentiation between nineteenth and eighteenth-century stone types and stages in crocket weathering

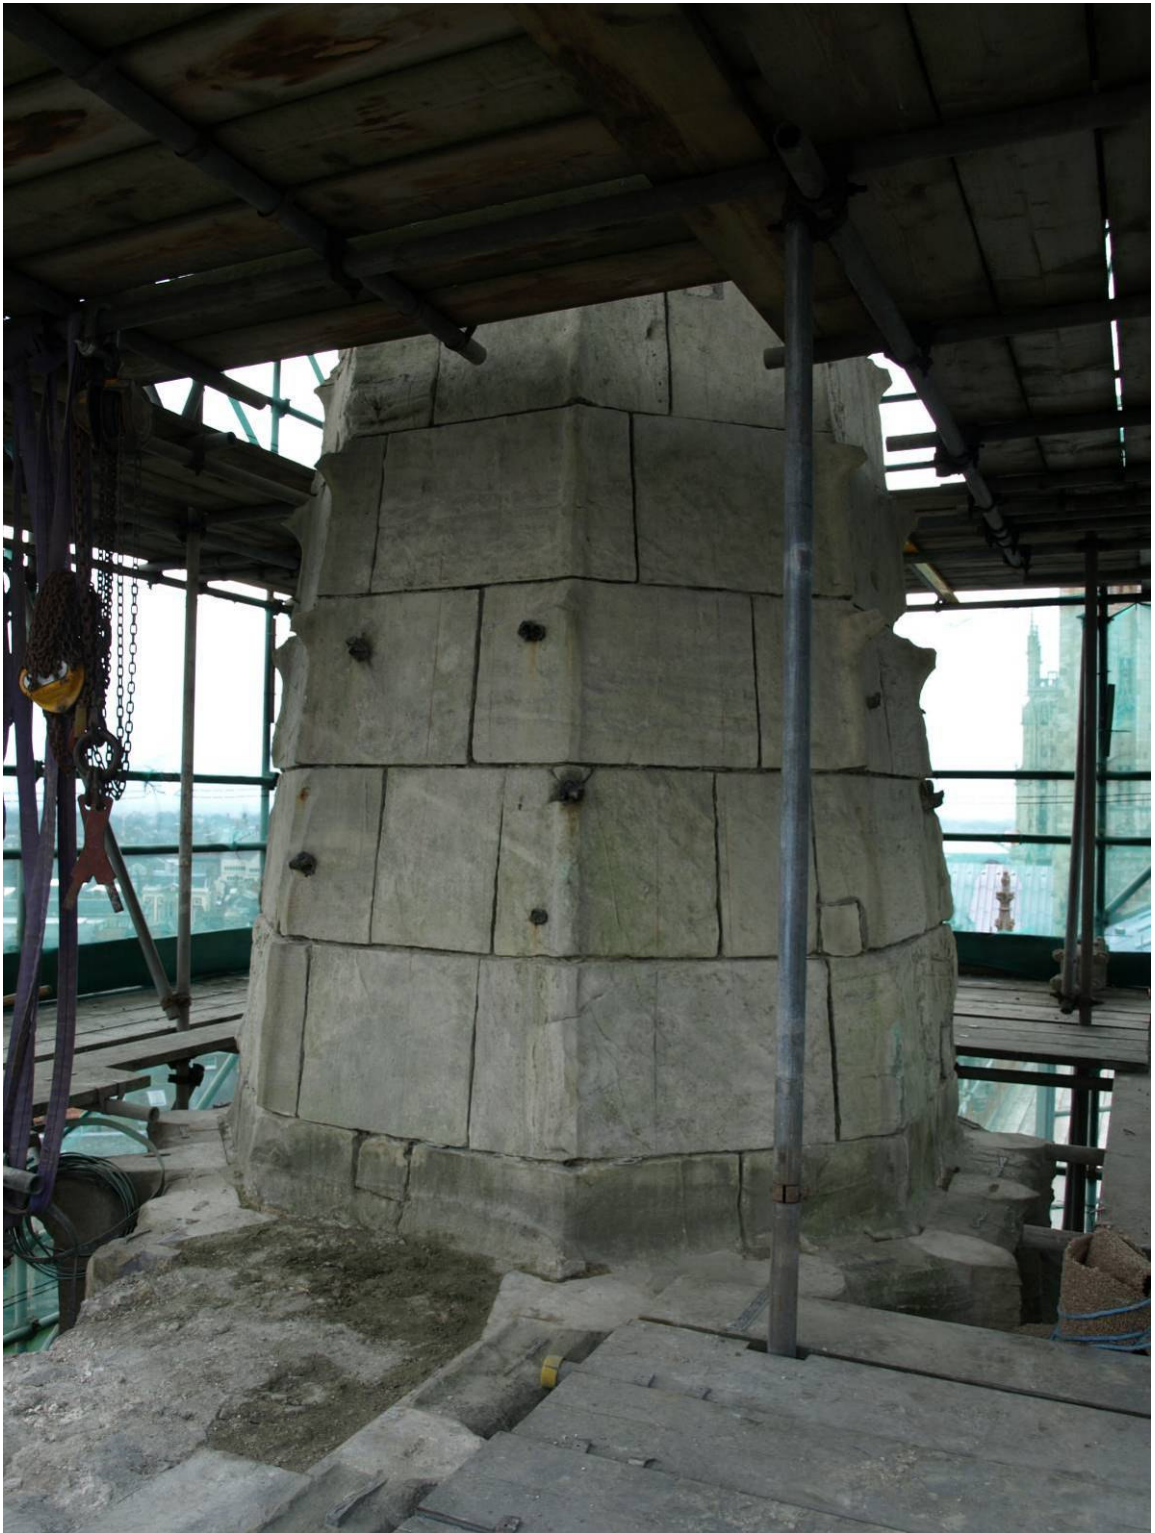
Figure 282: East Front, Levels H and I of south buttress during dismantling showing eighteenth-century spirelet upon medieval broach stones

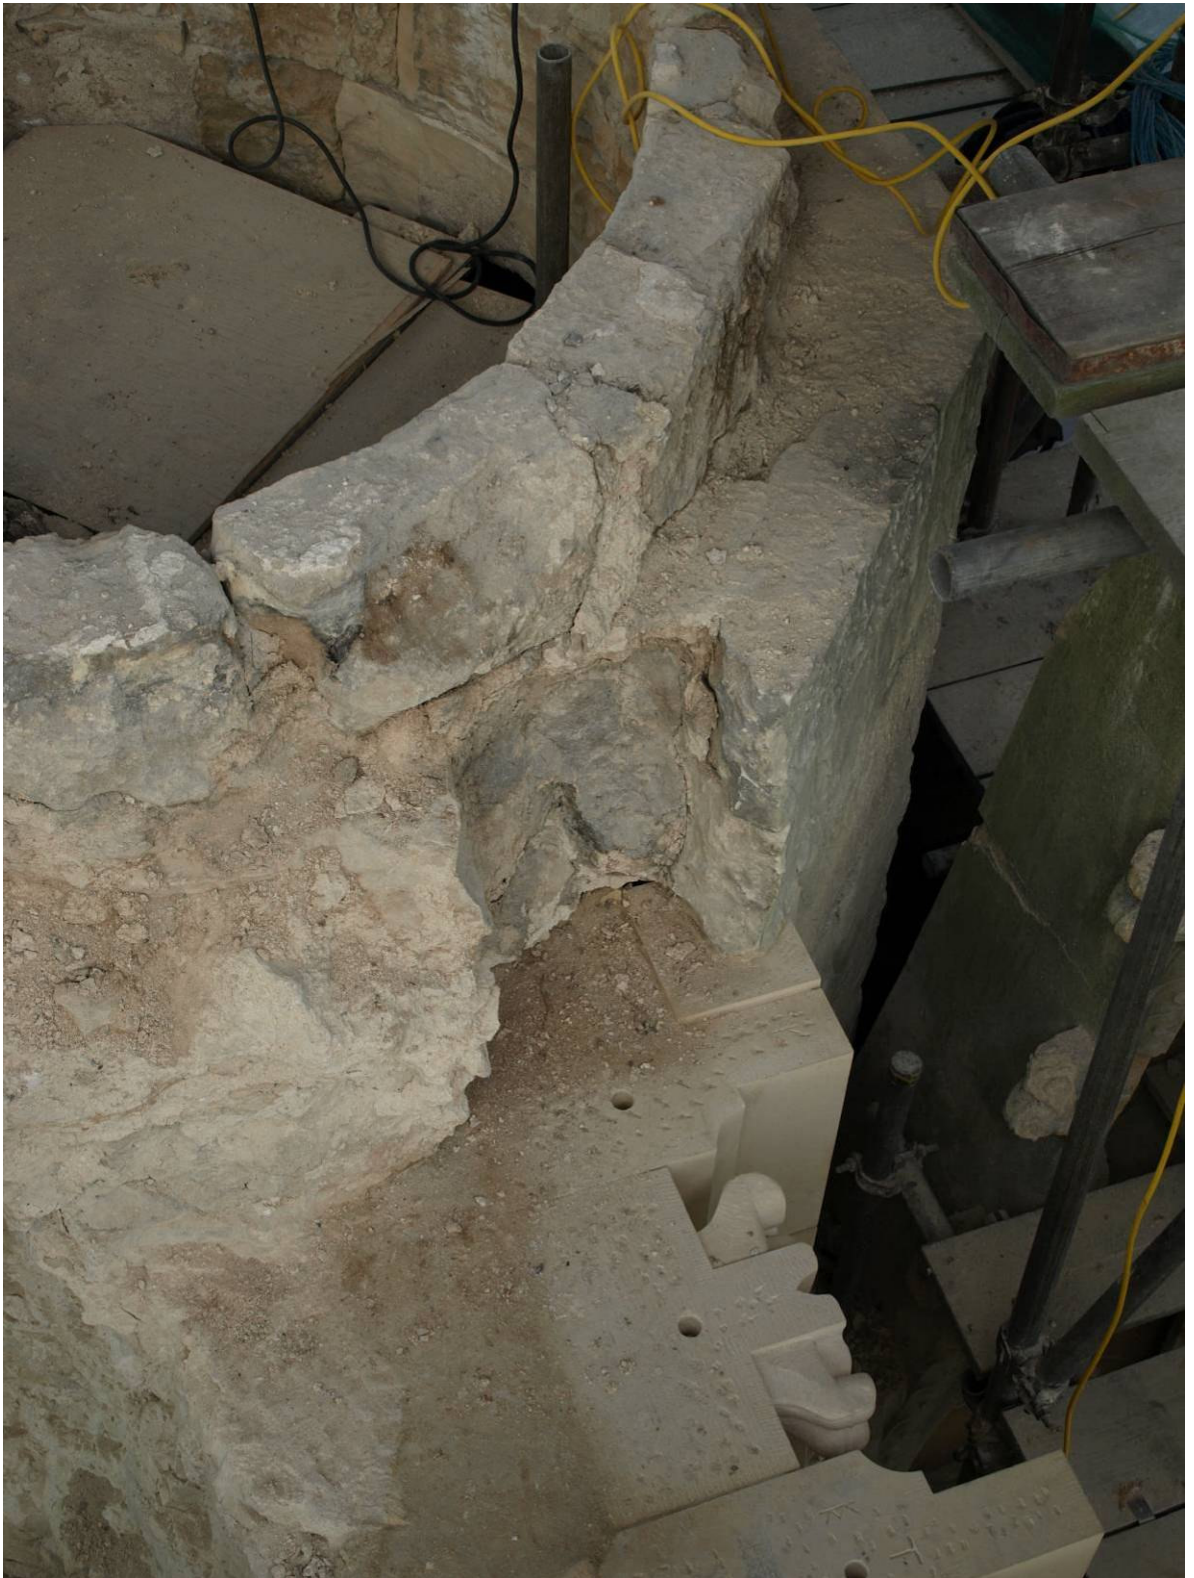
Figure 283: East Front, Level H of south buttress during rebuilding showing medieval broach on inner skin with re-clad exterior

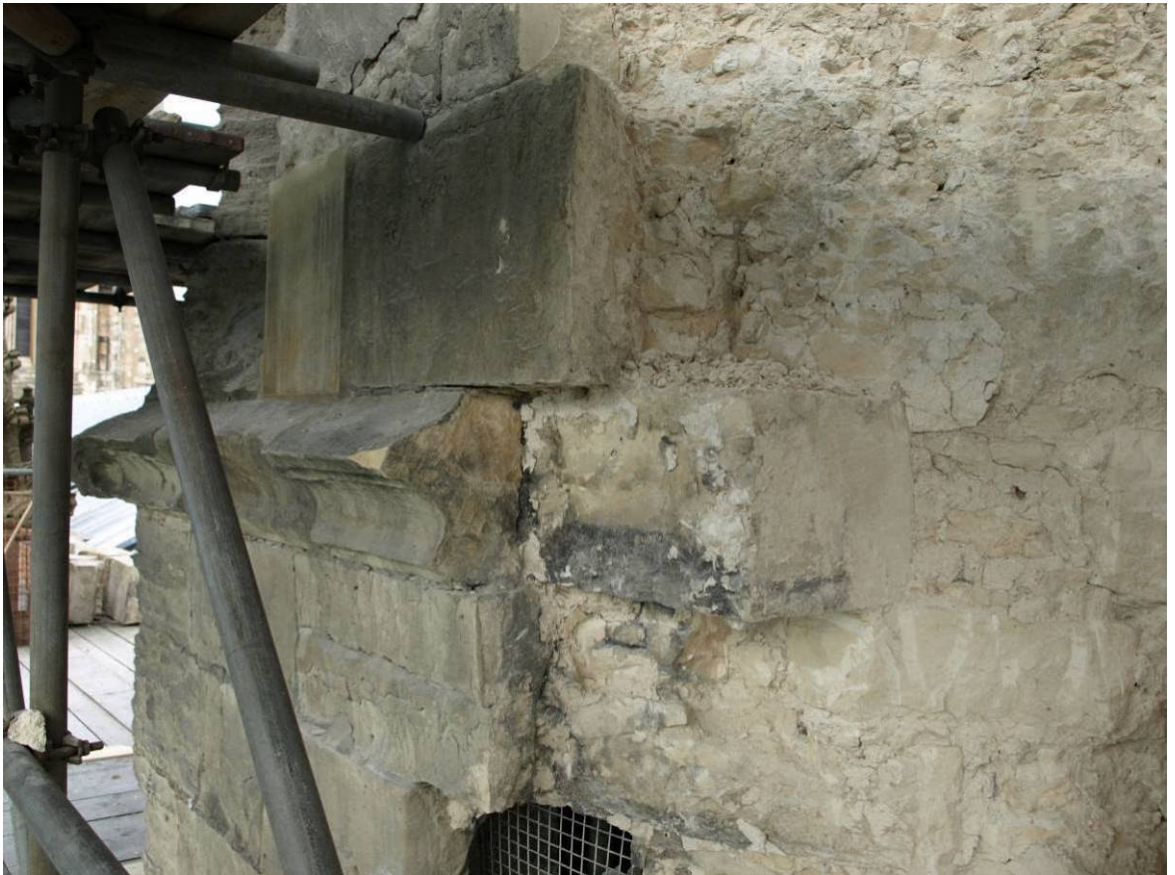
Figure 284: East Front, south buttress-turret Level G during dismantling showing indented nineteenth-century stringcourse

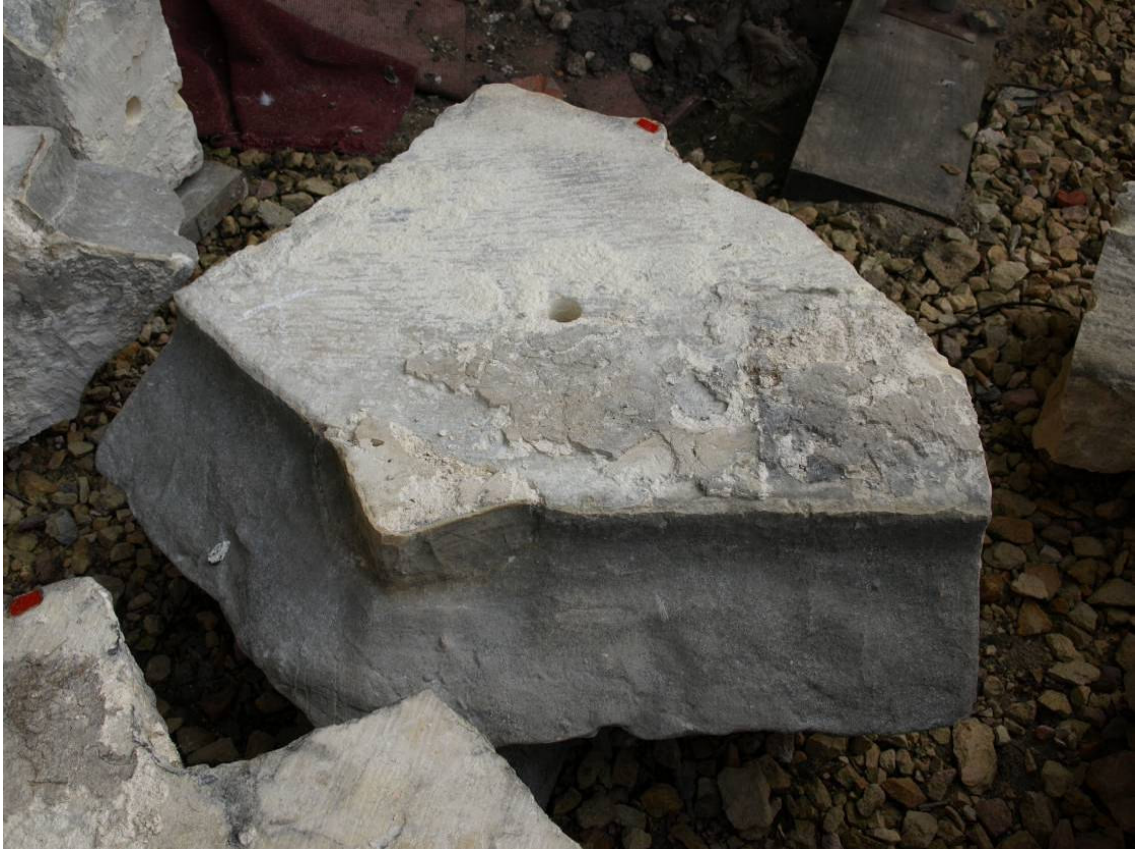
Figure 287: Removed stringcourse stone from beneath south-buttress corona, showing indented stooling

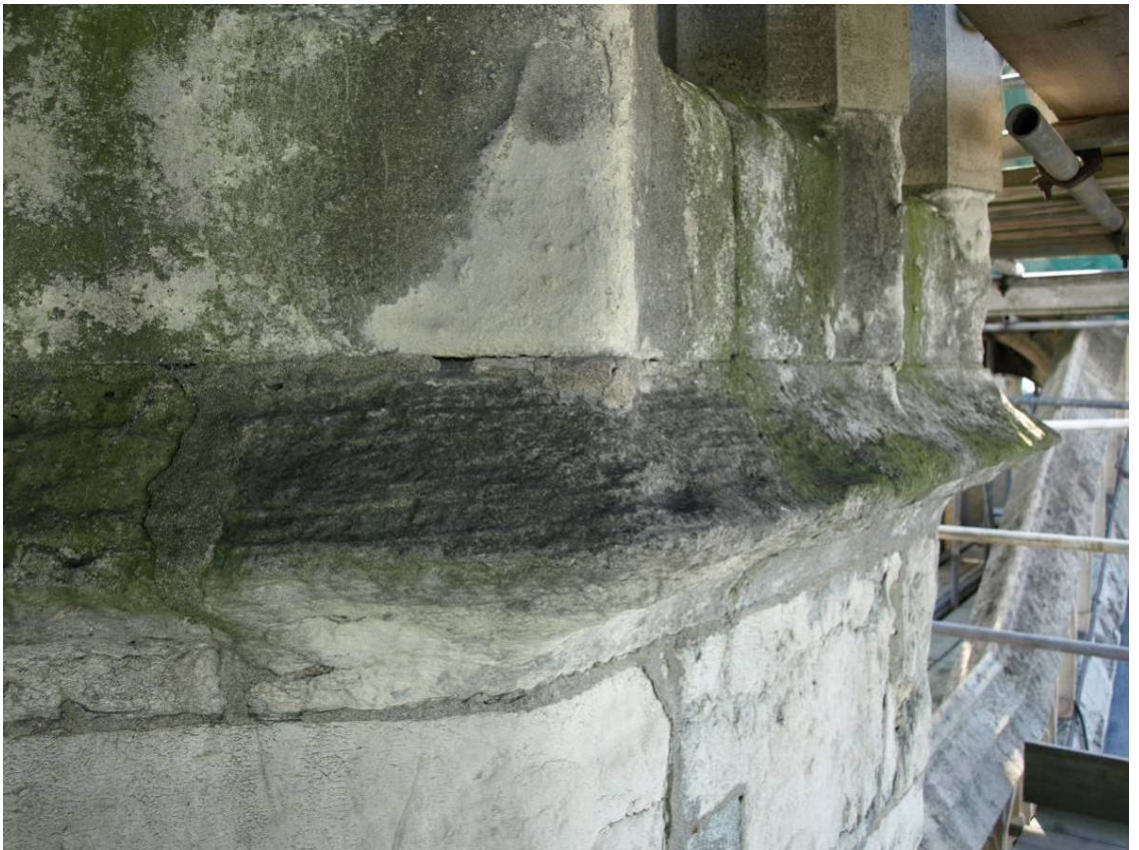
Figure 288: East Front, west face of north buttress showing introduced stooling beneath corona
