The Archaeology and Conservation
of the
East Front of York Minster

Volume 2 of 2
Figures, Drawings and Appendices

Alexander B Holton

University of York

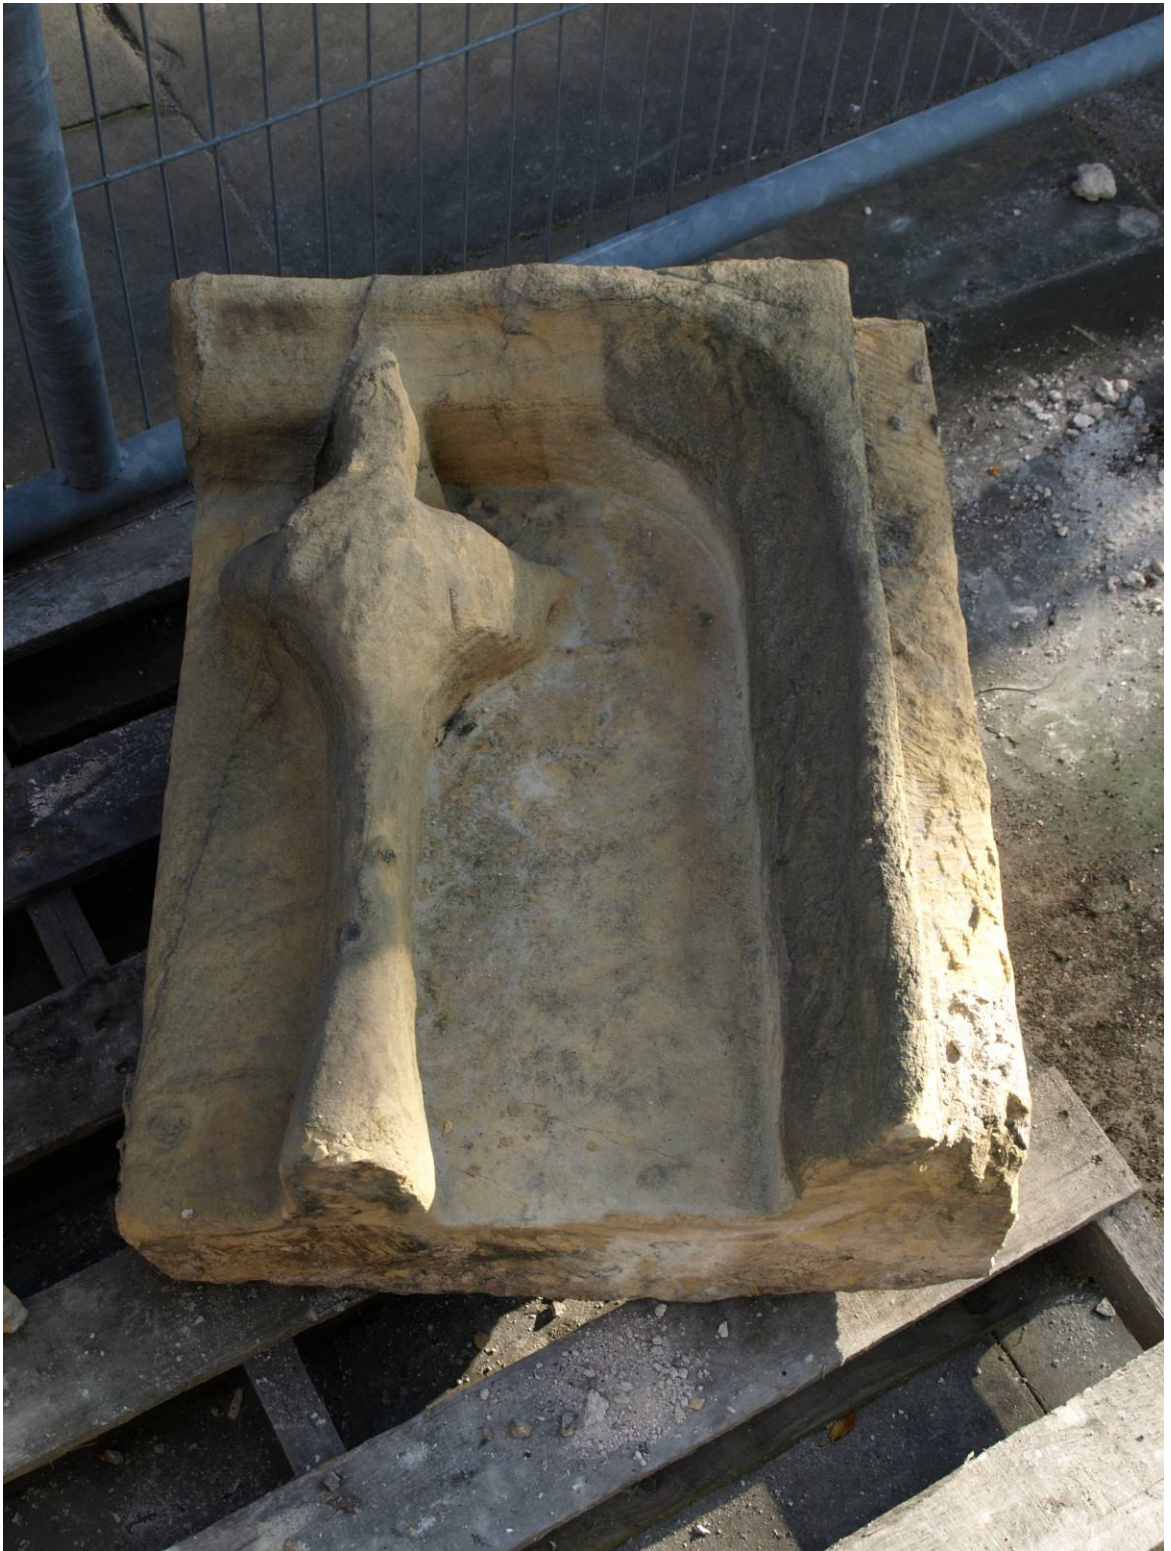
Figure 295: Removed nineteenth-century indent from south buttress, Level F, illustrating shallow depth of replacement stone

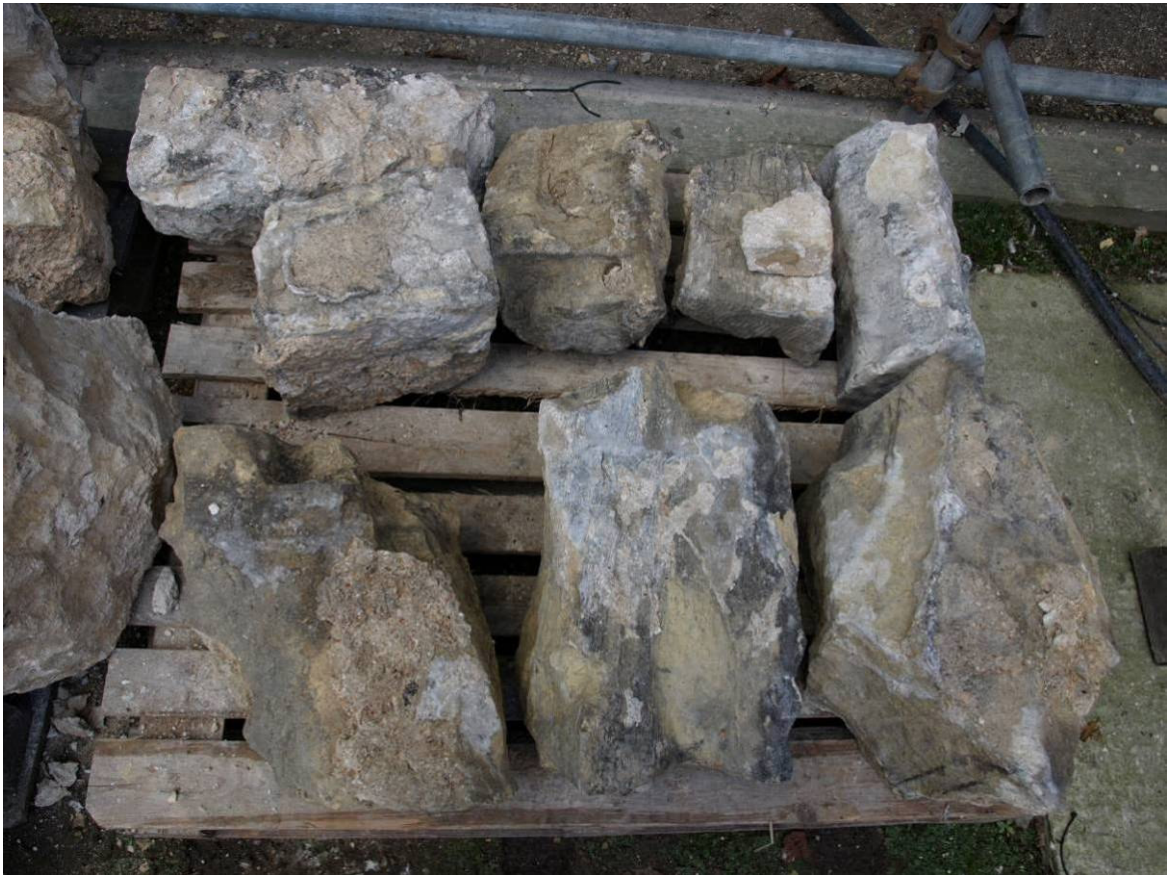
Figure 297: Re-used fragments of previous corona (?eighteenth century) found within core of upper courses of south buttress, Level F

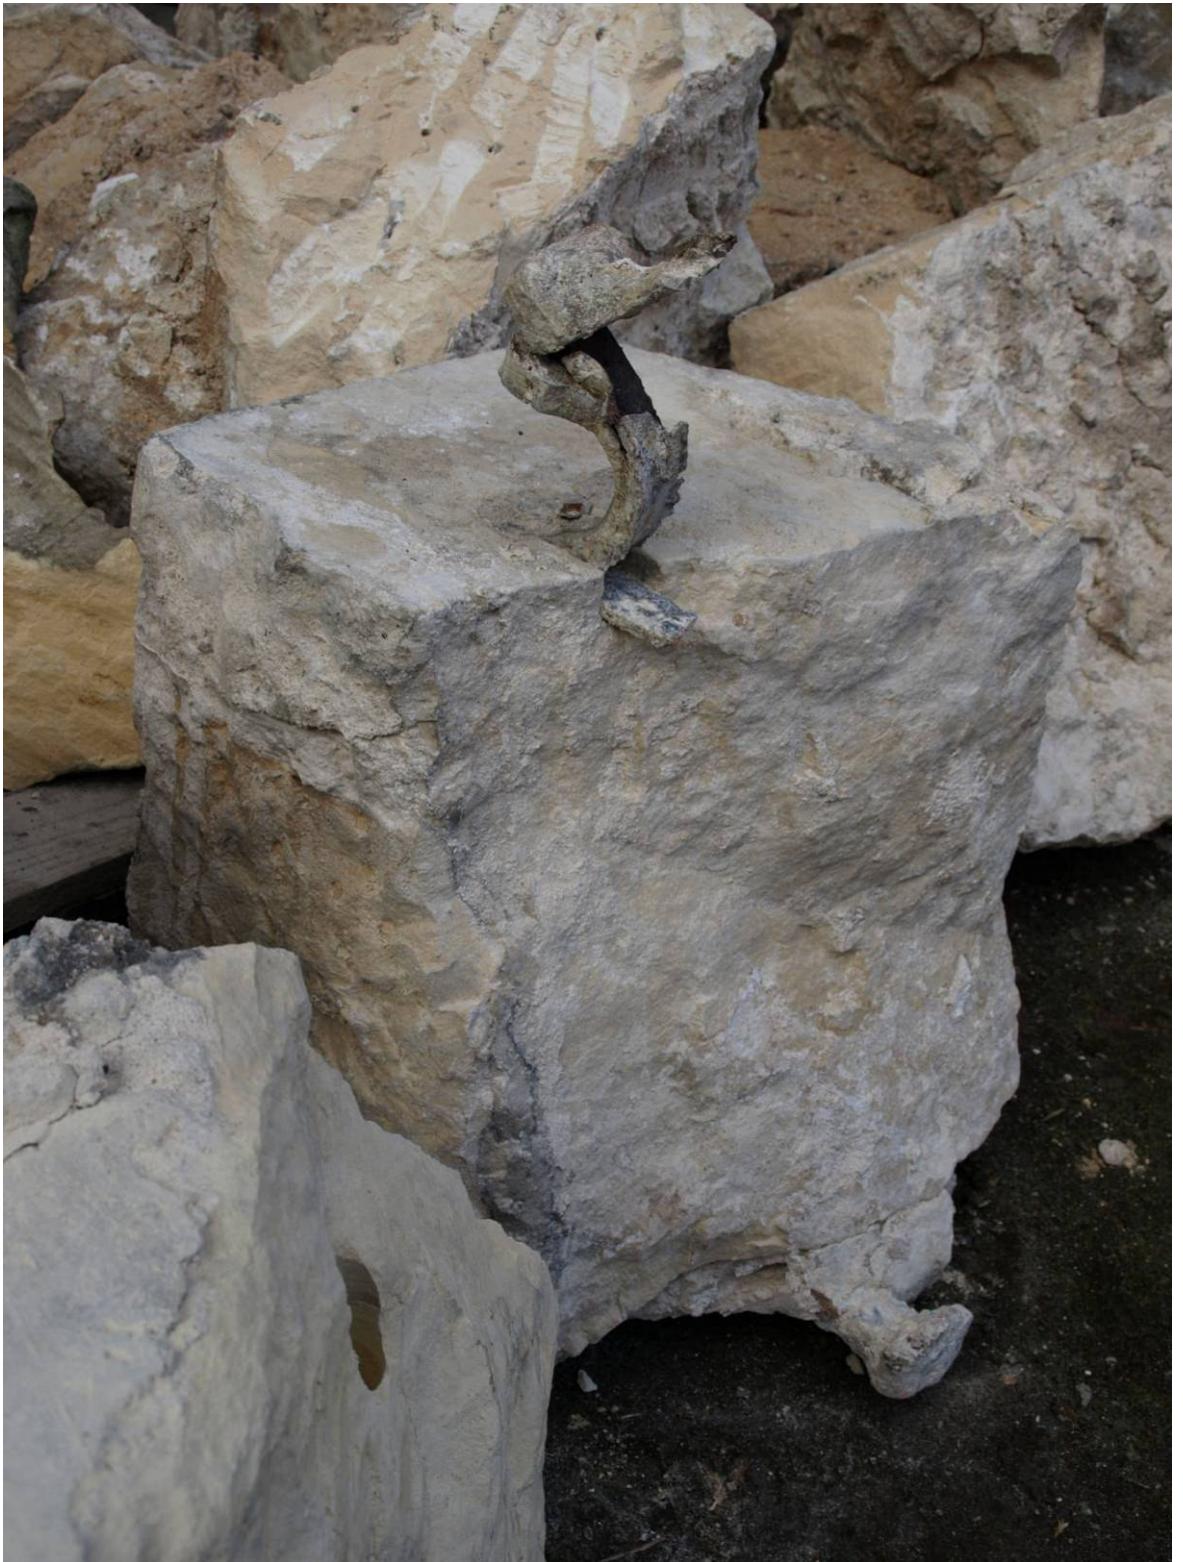
Figure 298: Removed medieval core-work from south-buttress Level F showing iron cramp used to secure later cladding

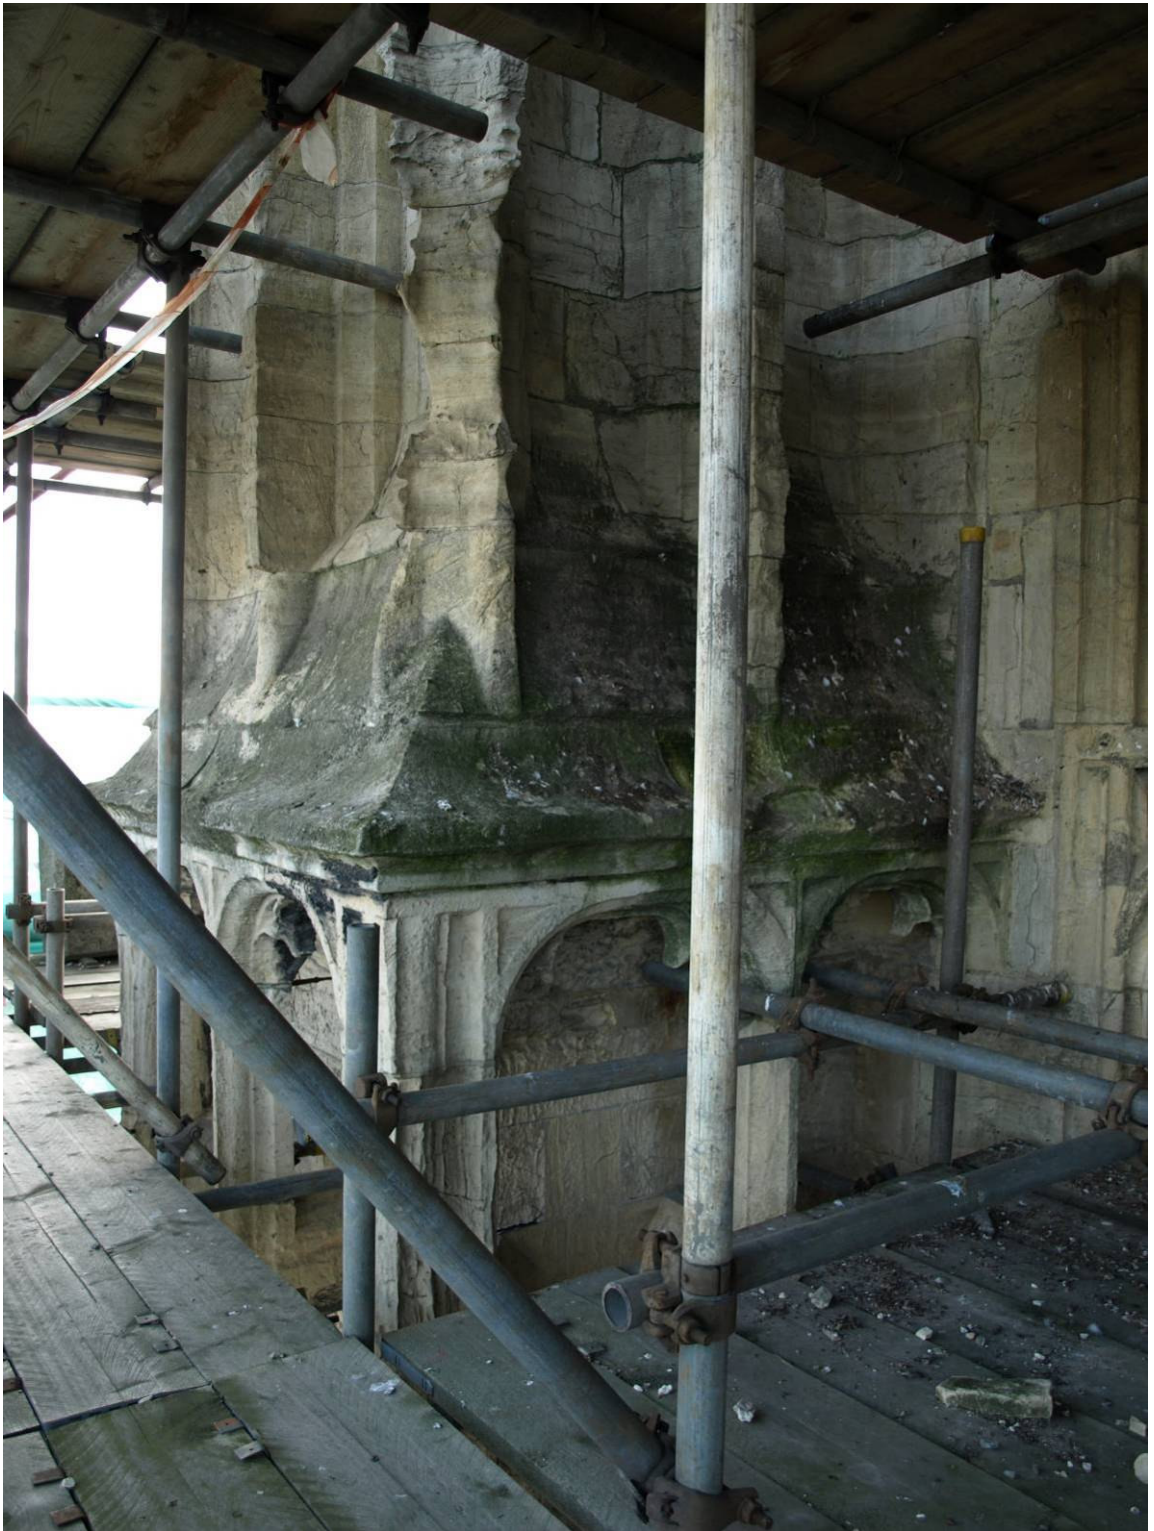
Figure 299: East Front, south buttress before repair, Levels E-F, north-east side

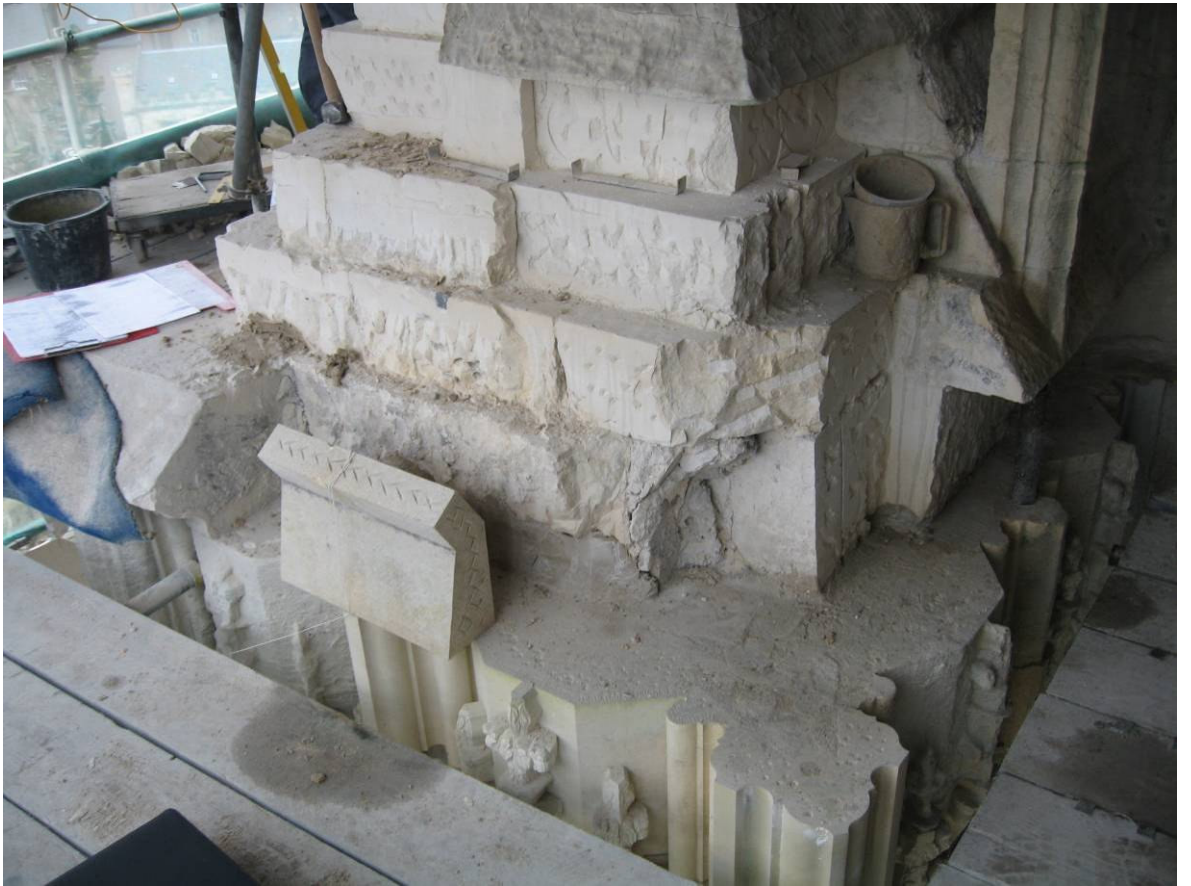
Figure 302: East Front, south buttress, Level E during repair (east and north faces) (Andrew Arrol)

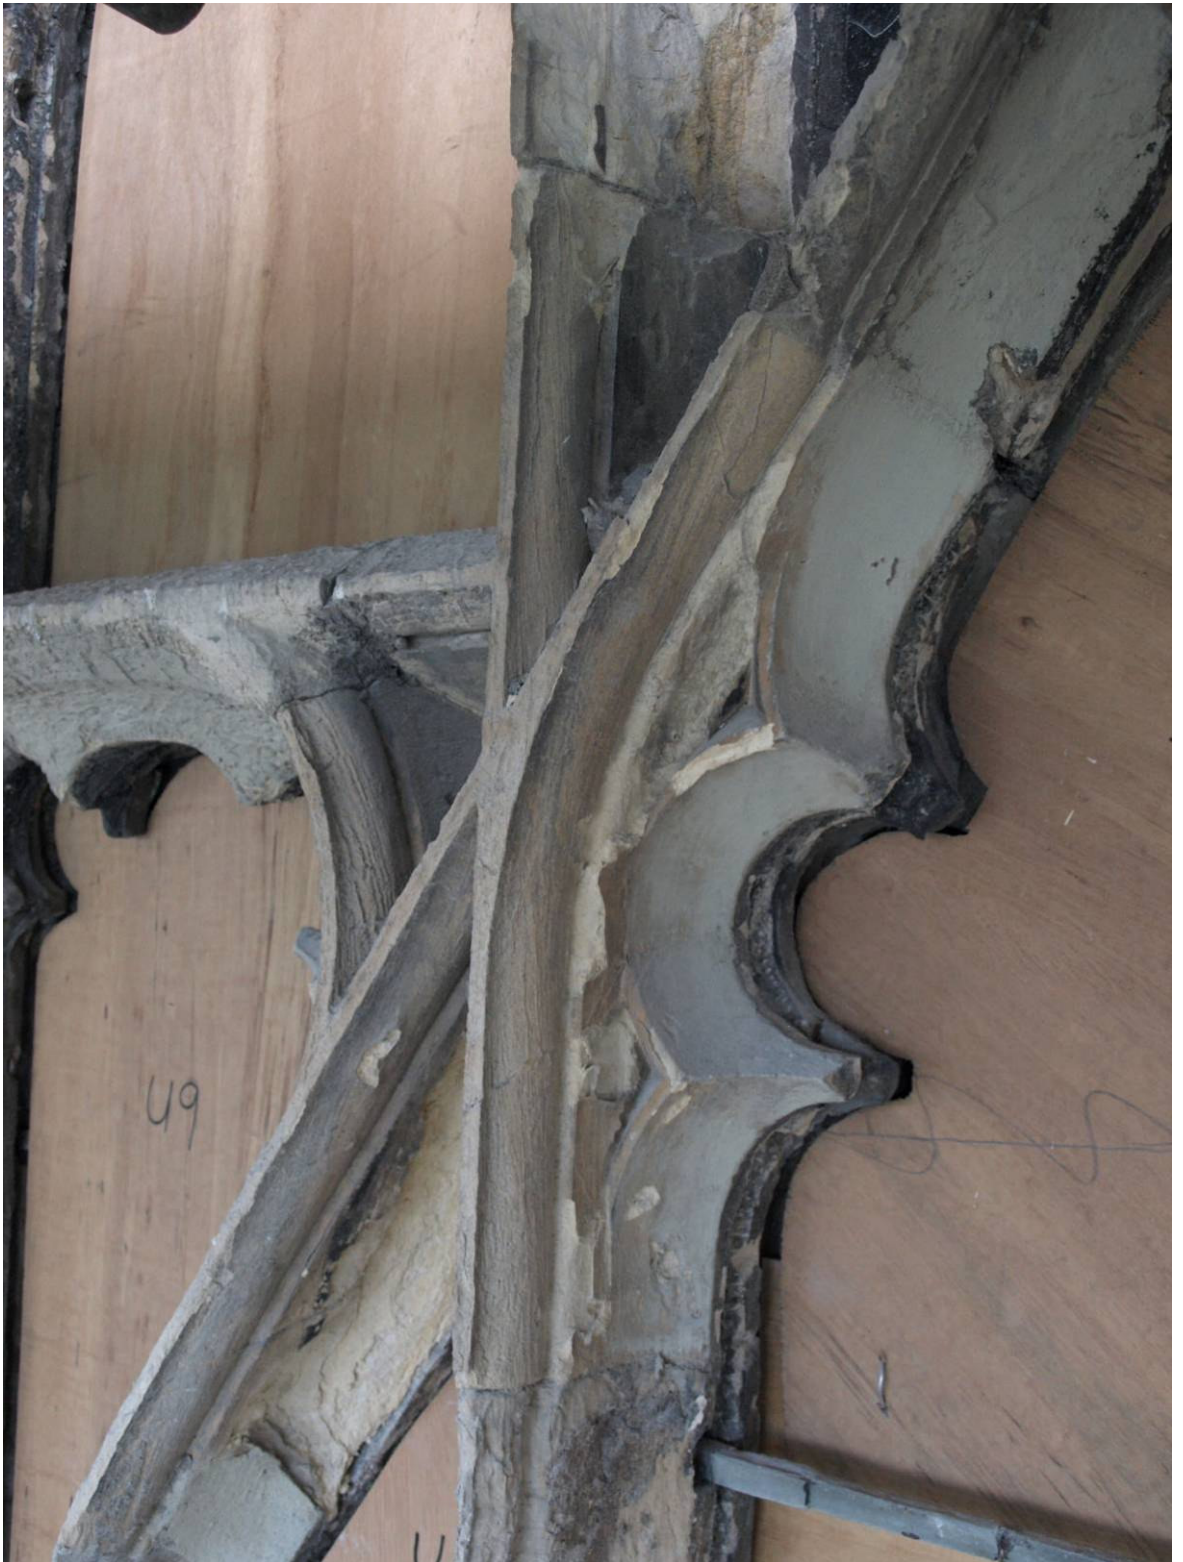
Figure 310: Great East Window exterior, tracery detail showing 1820s insert

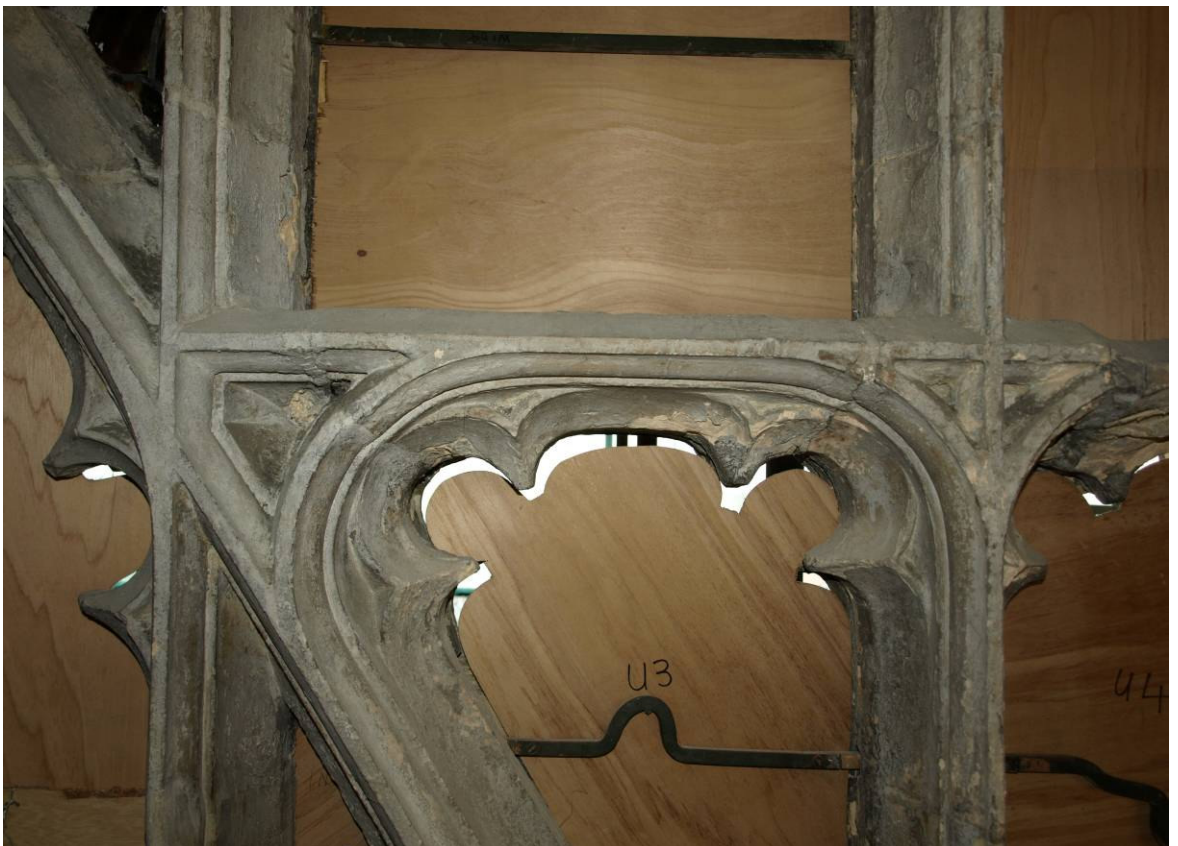
Figure 312: Great East Window interior, detail showing removal of medieval foliage during 1820s, plus 1970s limewash

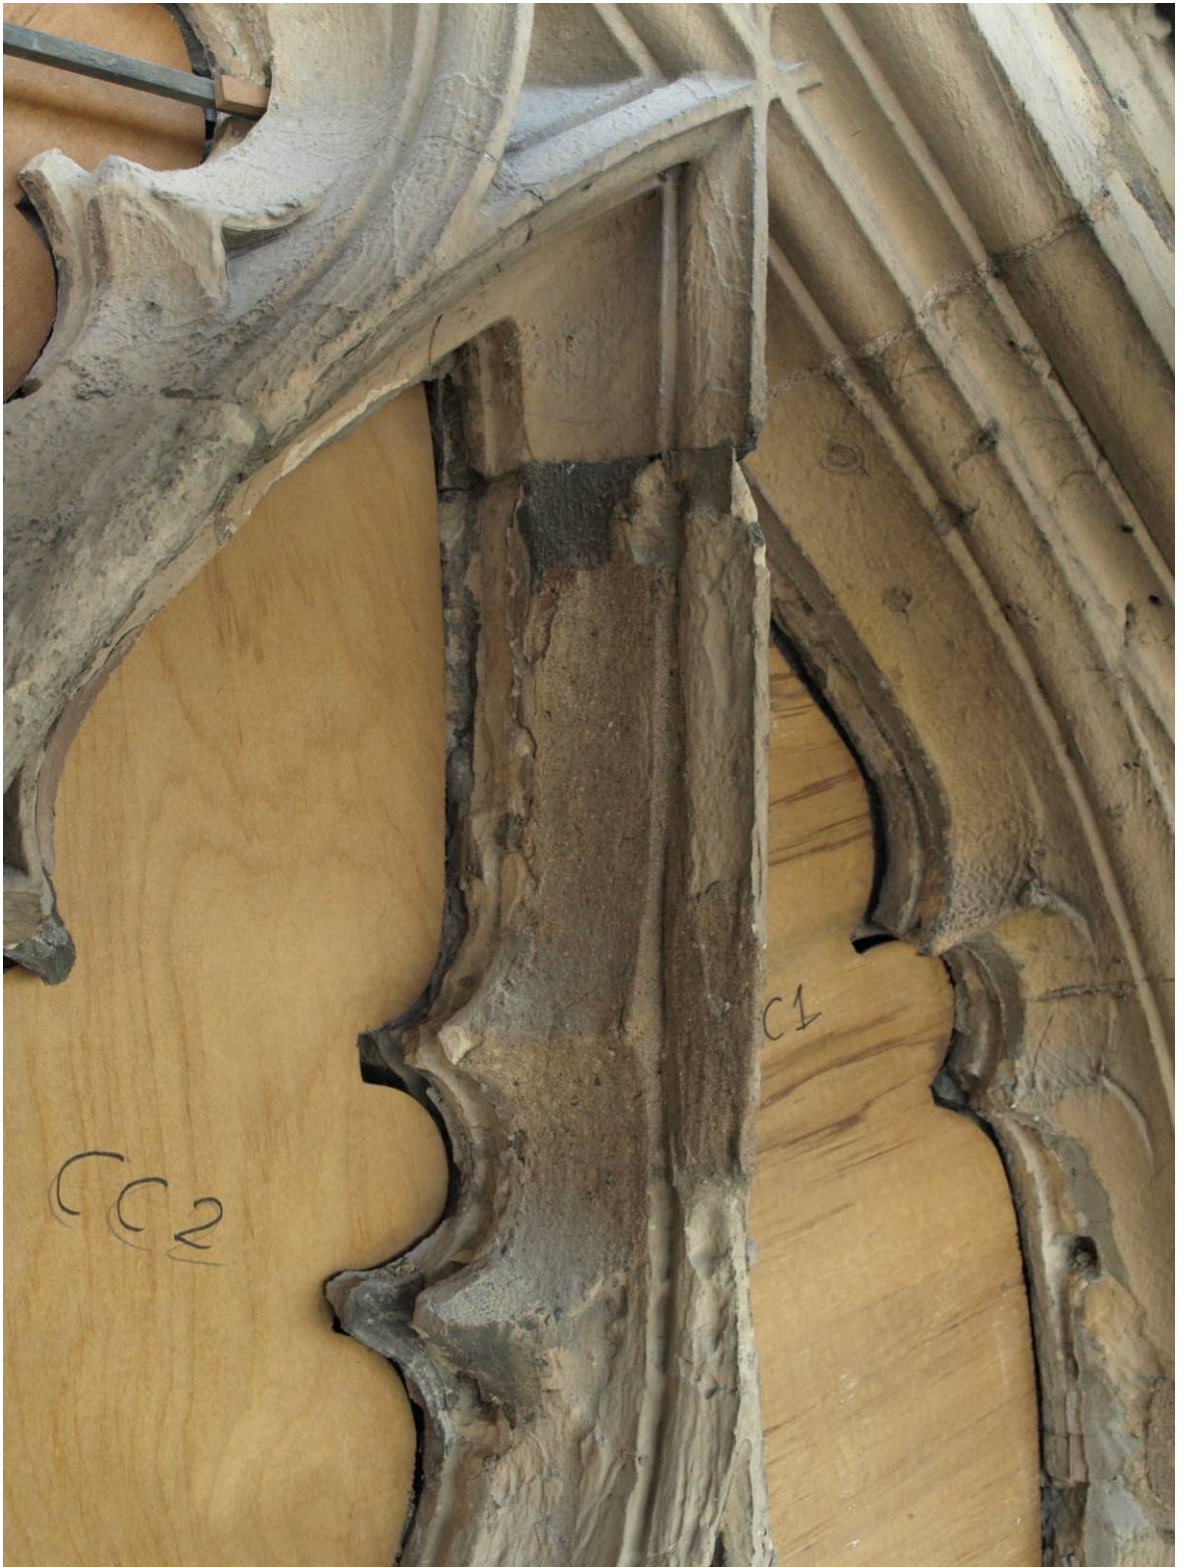
Figure 320: East Front, Great East Window exterior, detail of previous lime-based repairs

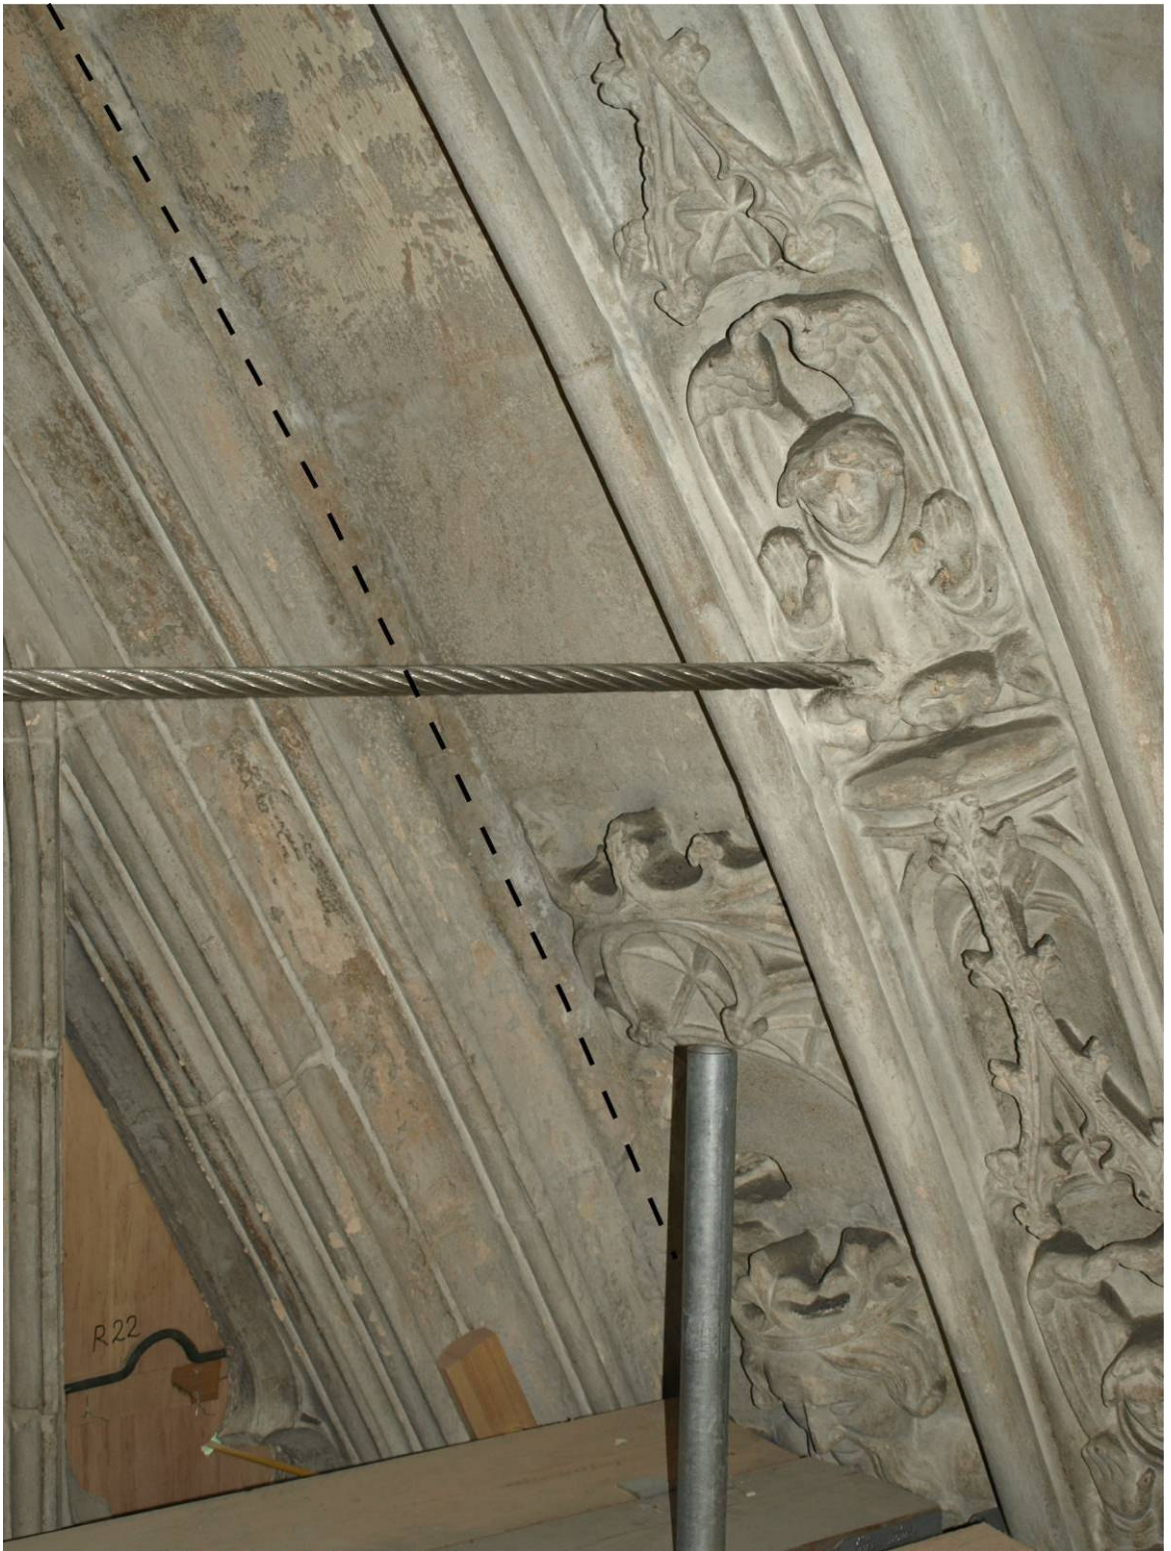
Figure 338: Great East Window interior, south side of arch showing relationship between interior and exterior masonry; dashed line marks mortar infill

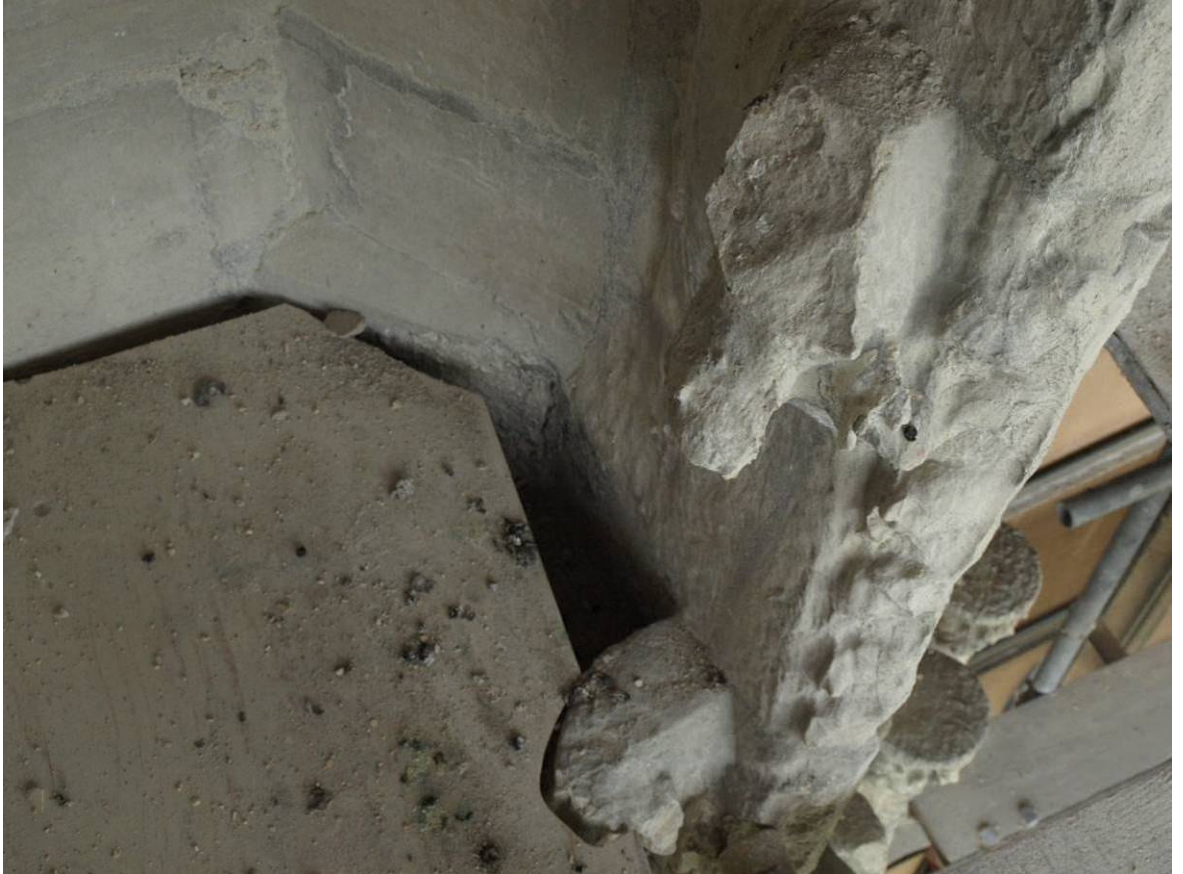
Figure 339: East Front, Great East Window exterior, off-set punched masonry, south side of arch

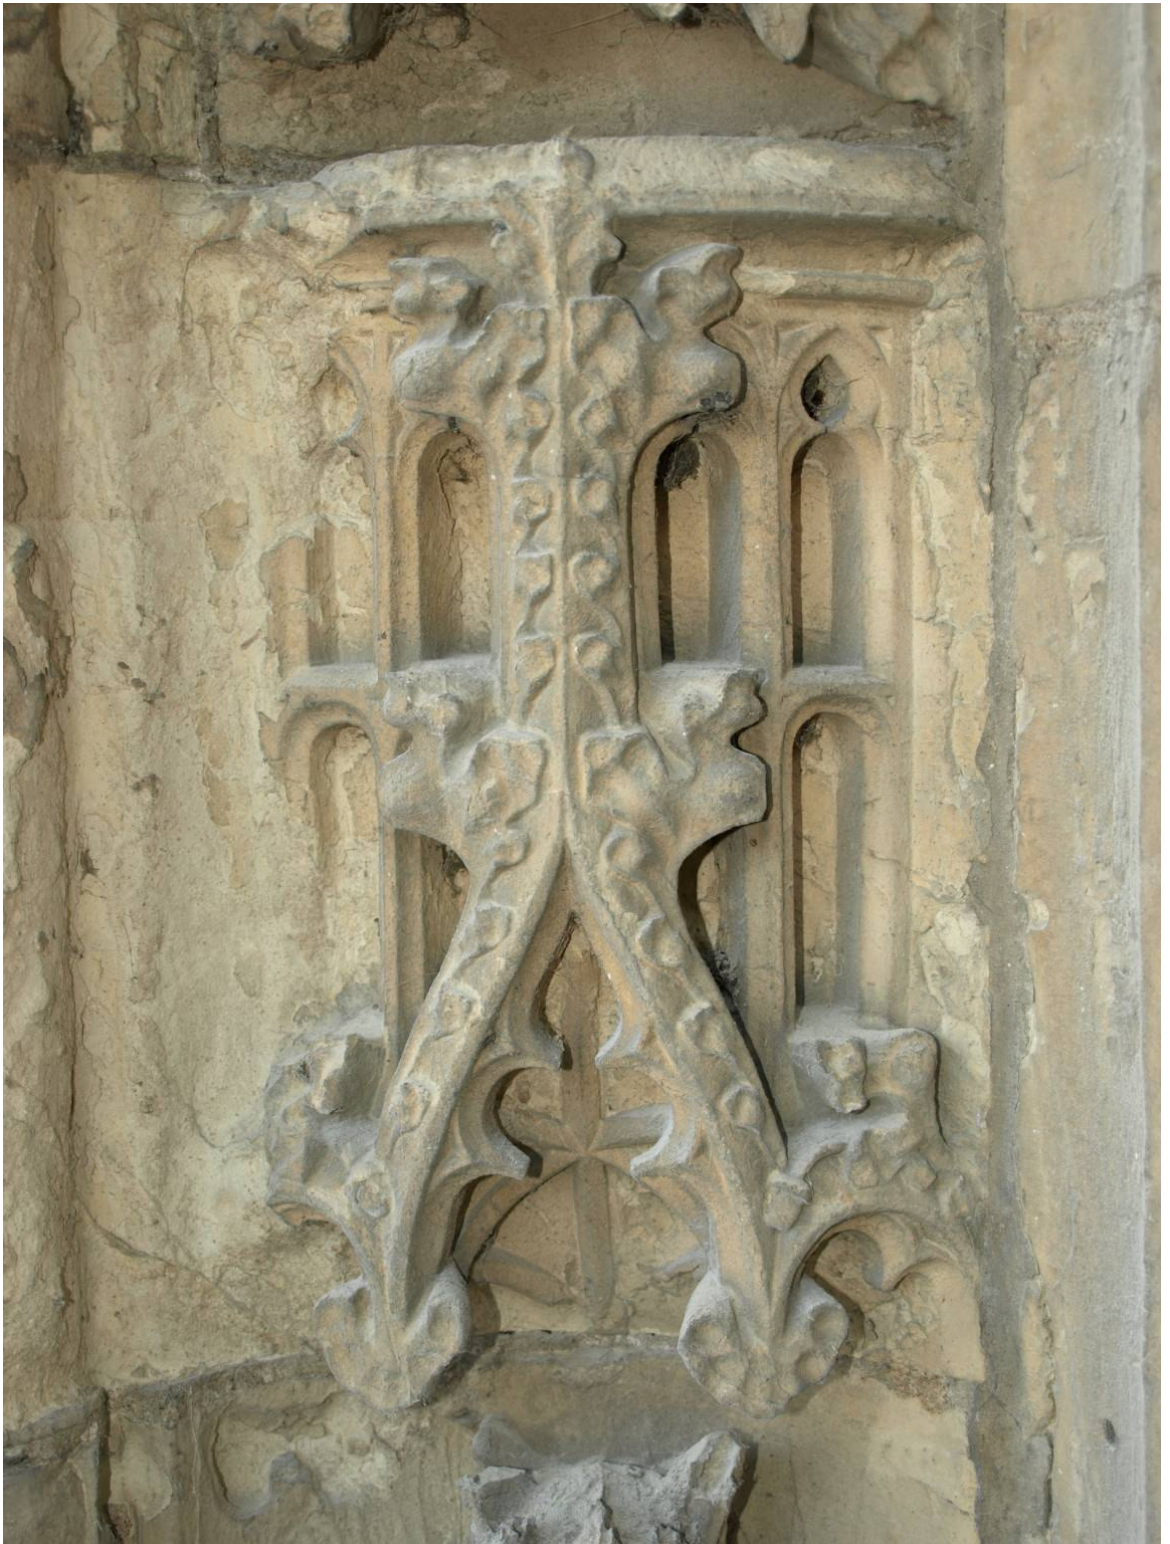
Figure 365: Voussoir b29, nineteenth-century replacement canopy

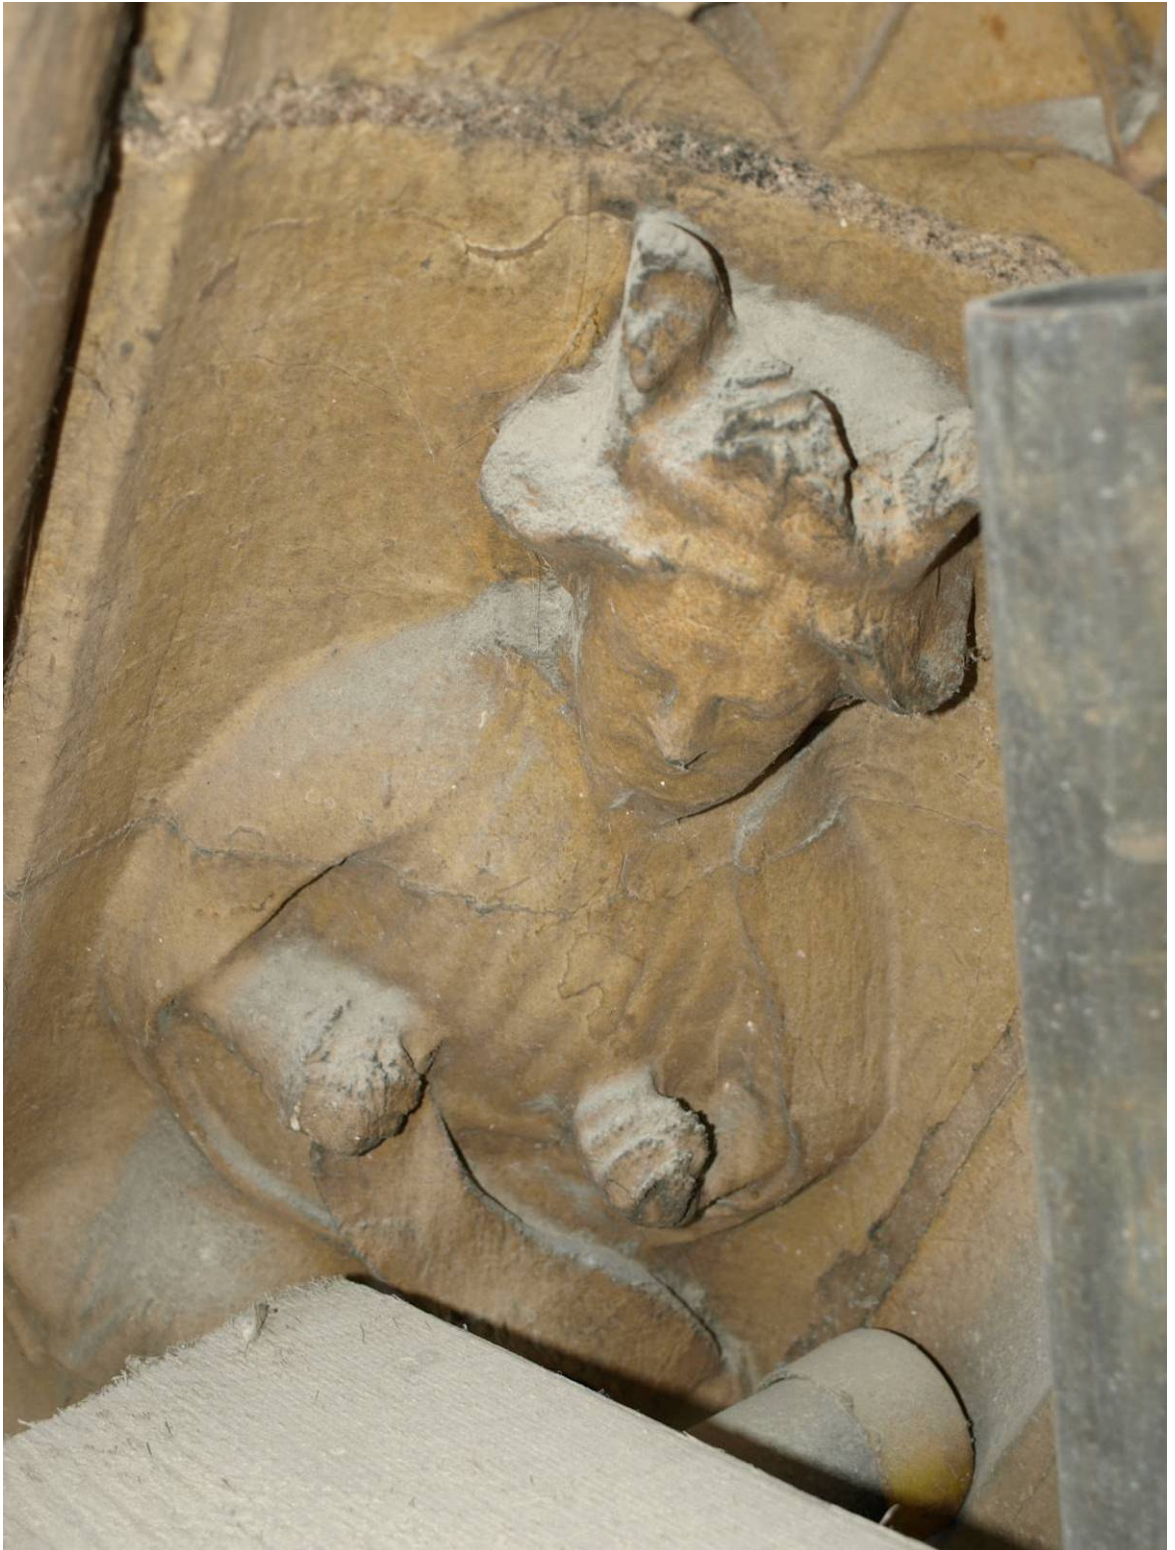
Figure 367: Voussoir b39, showing typical brown staining indicative of previous treatments with linseed oil

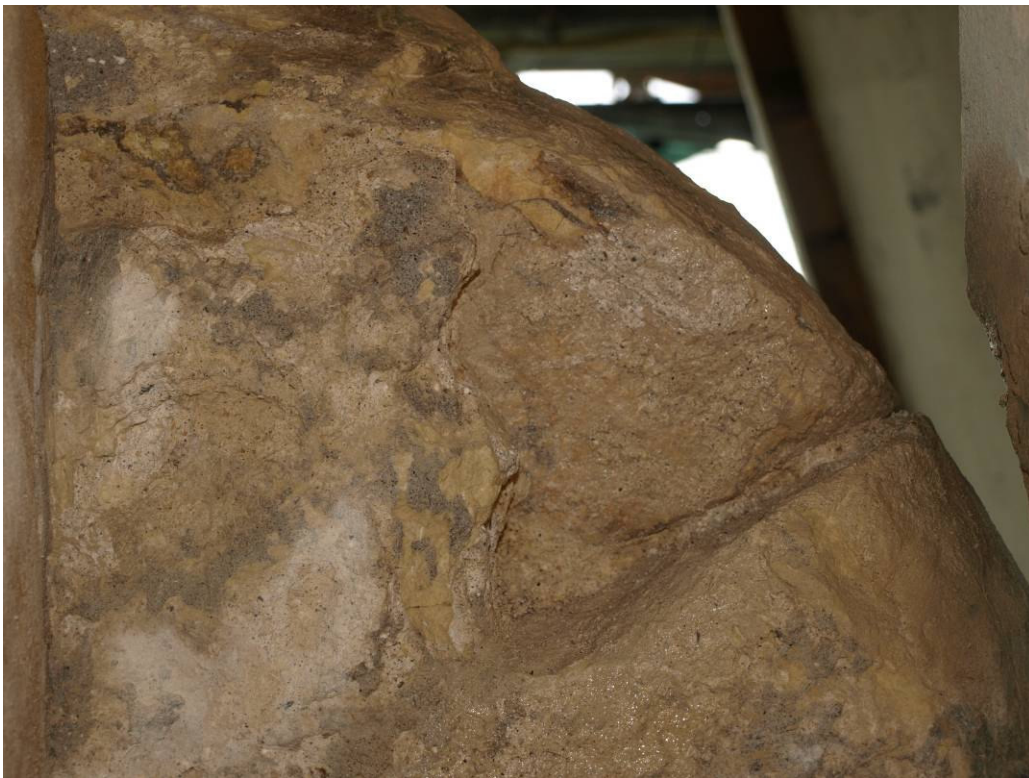
Figure 388: Seated figure, view through rear face of parapet to right-hand shoulder of statue with re-adhered fragments of upper section

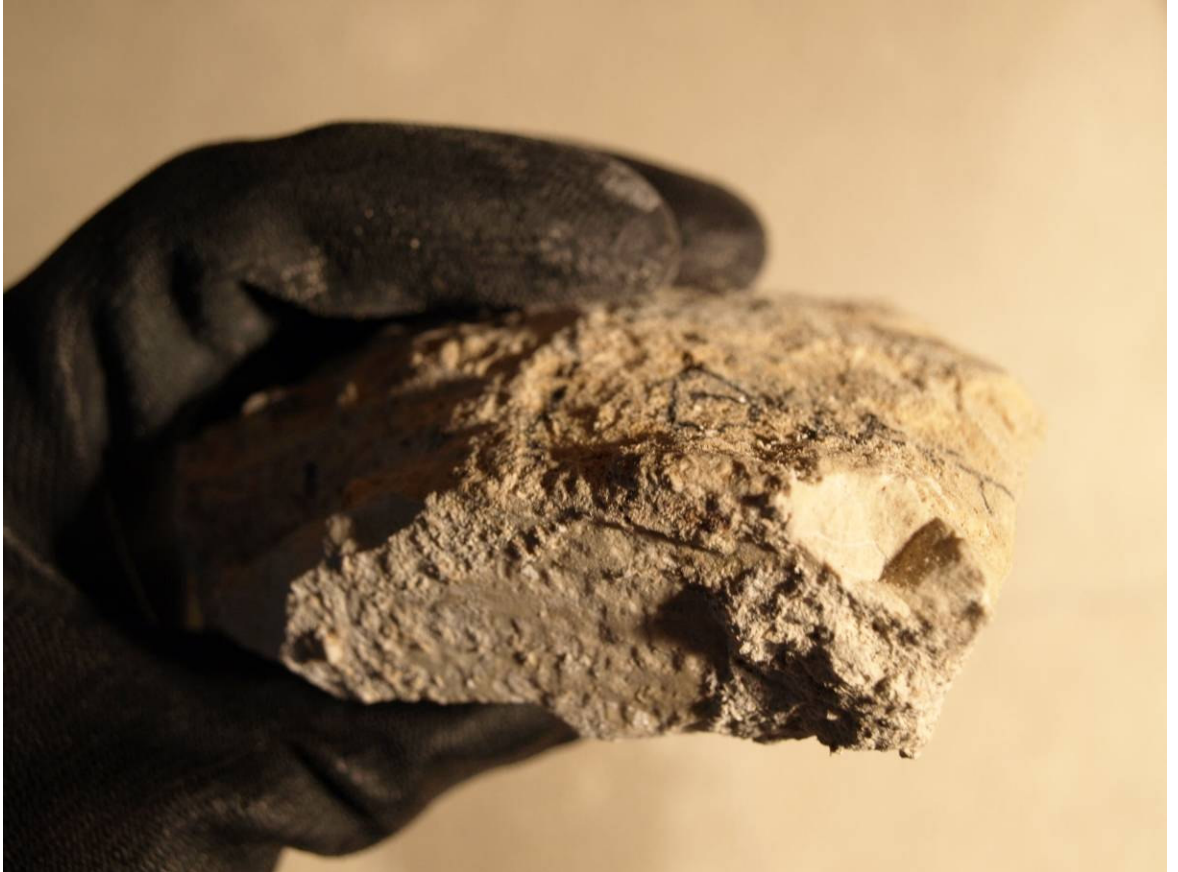
Figure 389: Seated figure, view through rear face of parapet to right-hand shoulder of statue with detached fragment removed to reveal calcite fault. Note white repointing mortar over re-fixing mortar

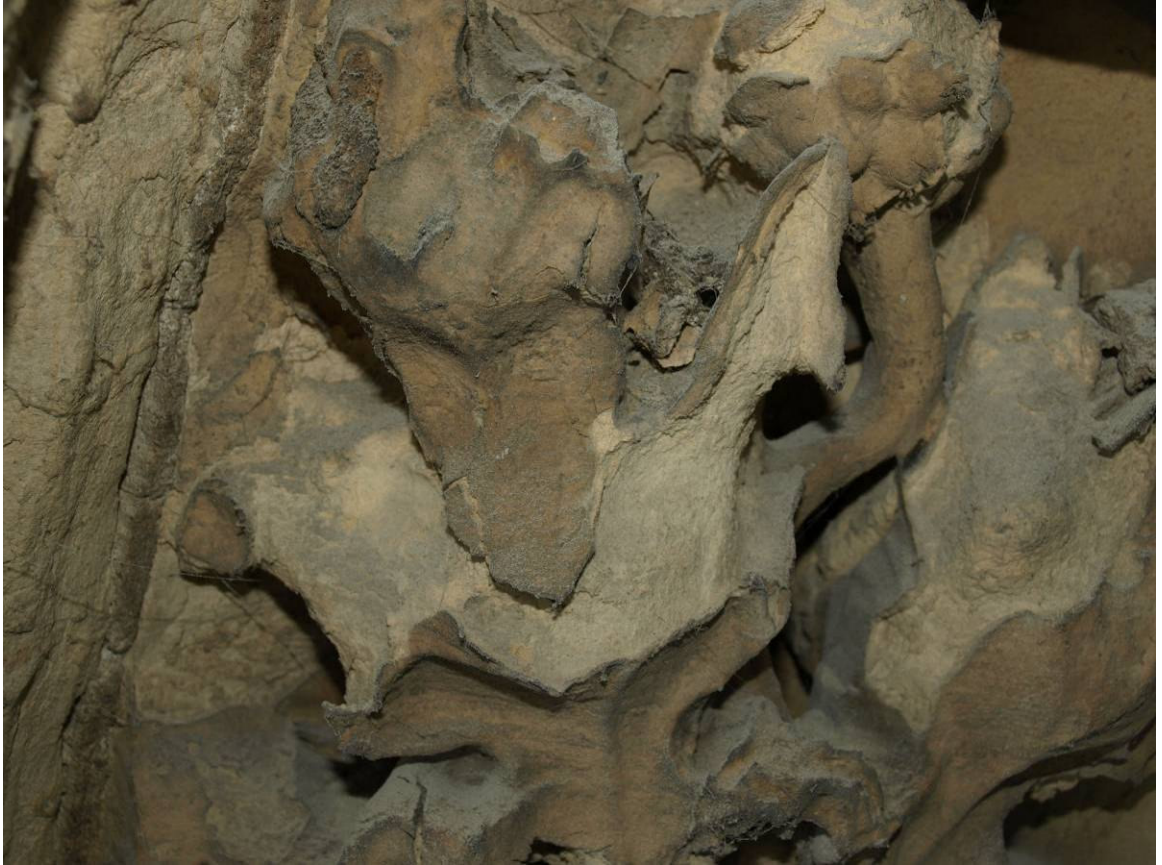
Figure 431: Great East Window, exterior voussoirs, detail of decay

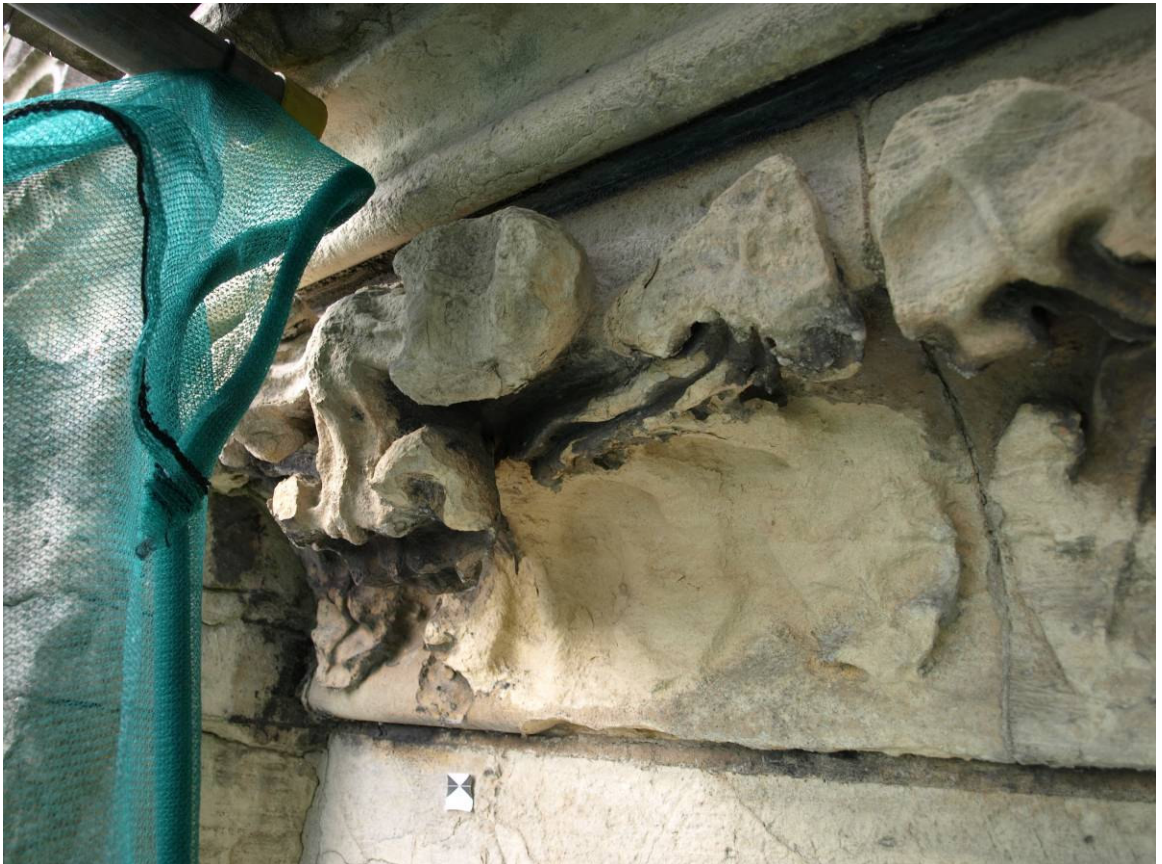
Figure 432: South-clerestory cornice, example of cavitation upon stones previously treated with linseed oil
