The Archaeology and Conservation
of the
East Front of York Minster

Volume 2 of 2
Figures, Drawings and Appendices

Alexander B Holton

University of York

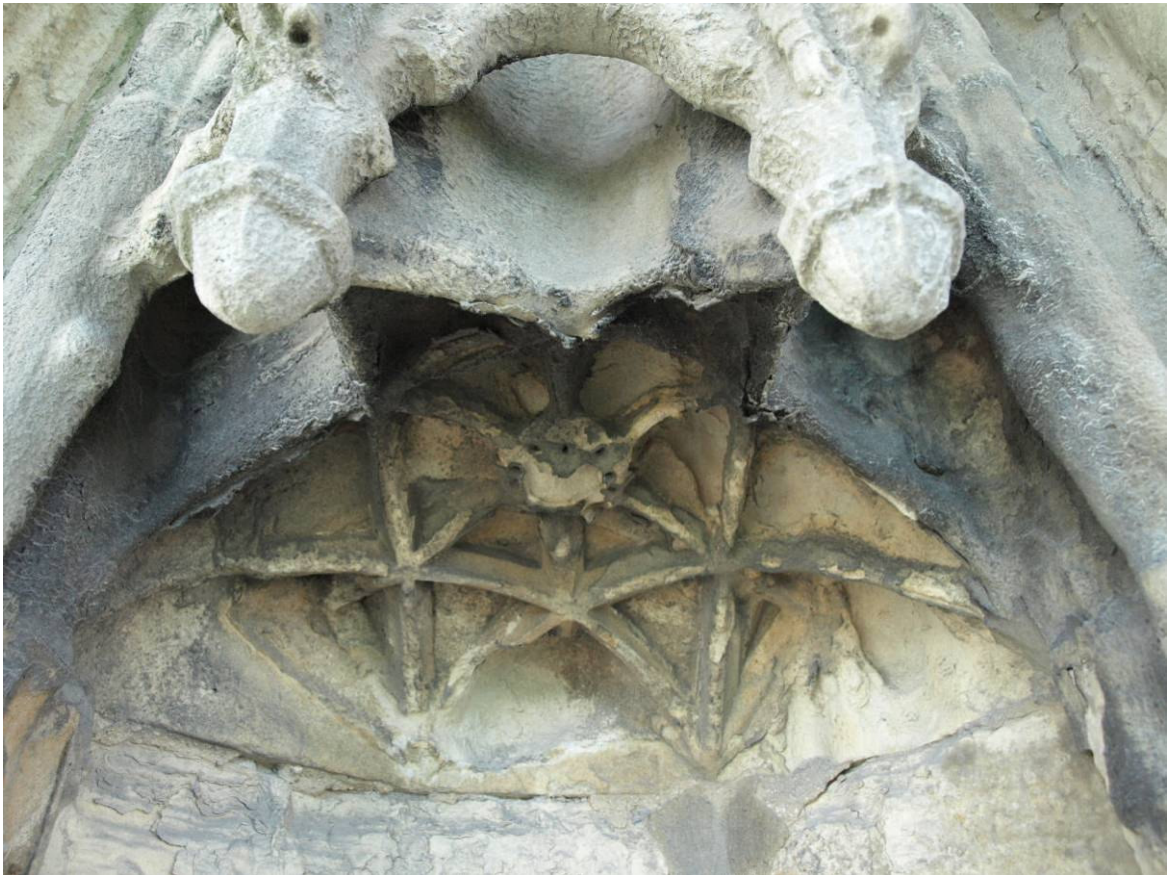
Figure 433: East Front, example of decay upon underside of canopy, north buttress

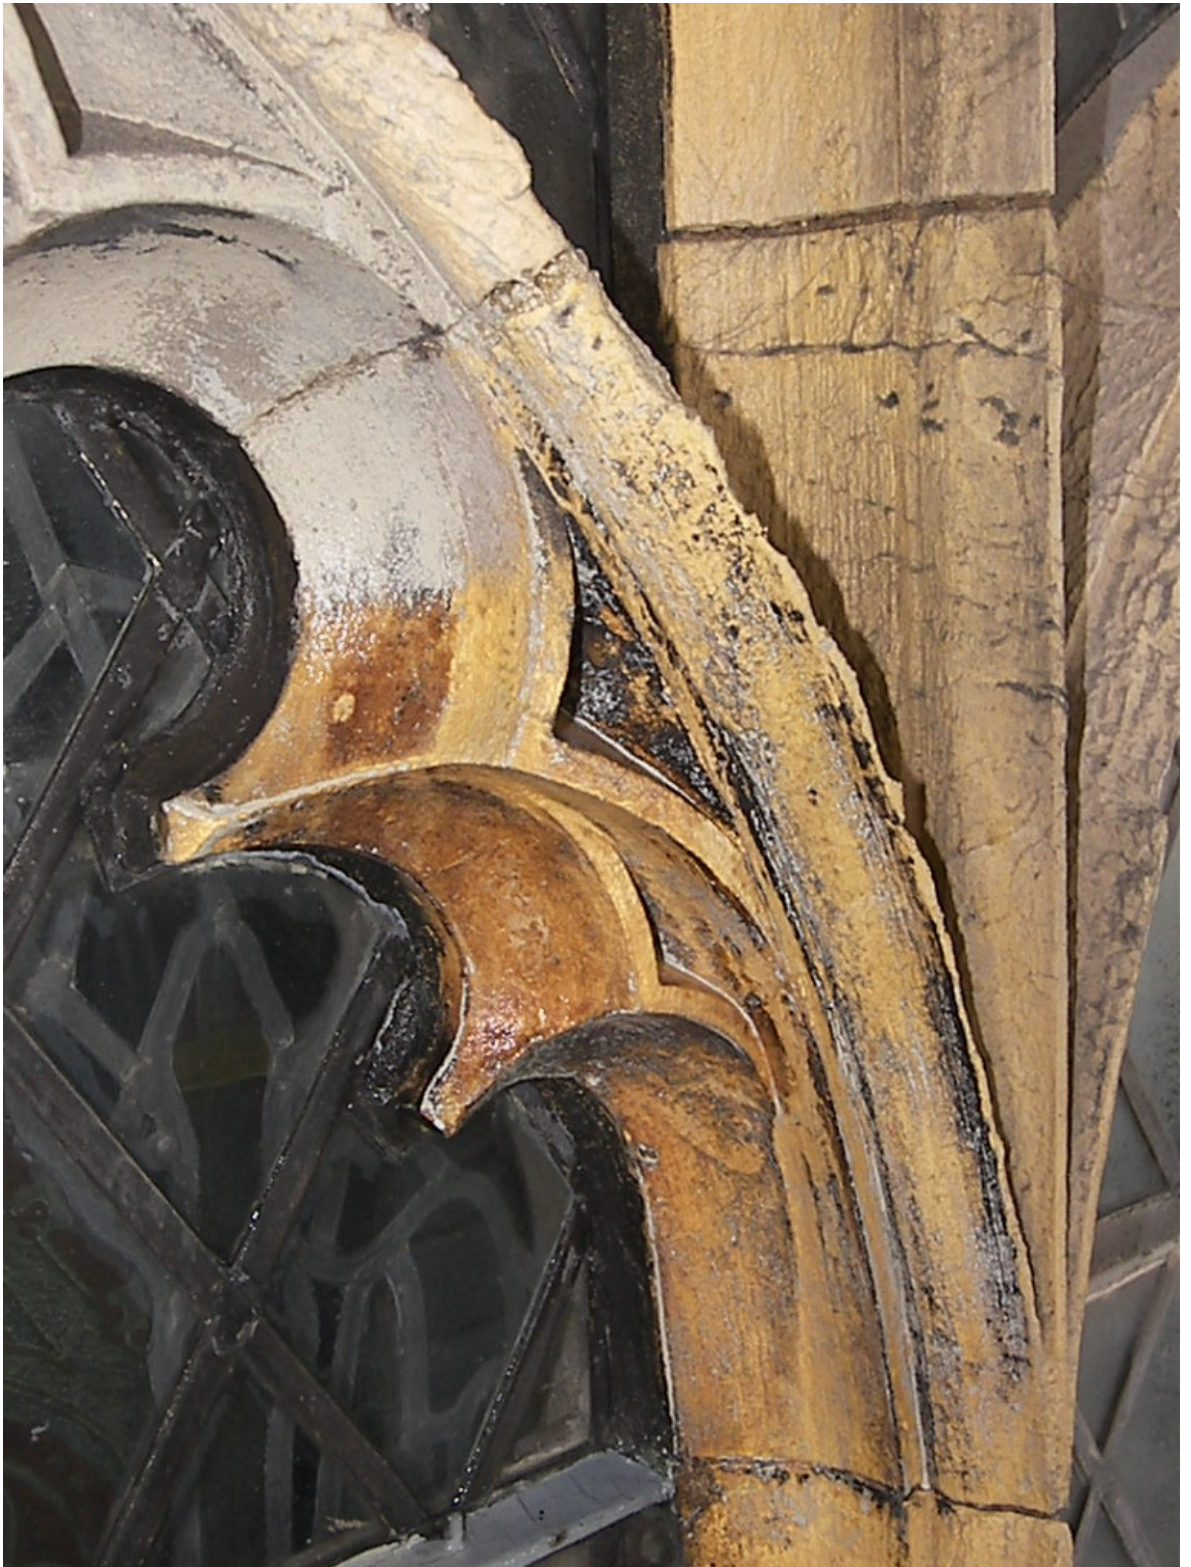
Figure 437: Great East Window, exterior mullions and transom masonry after cleaning trials. Note removal of 1960s paint but retention of historic patination

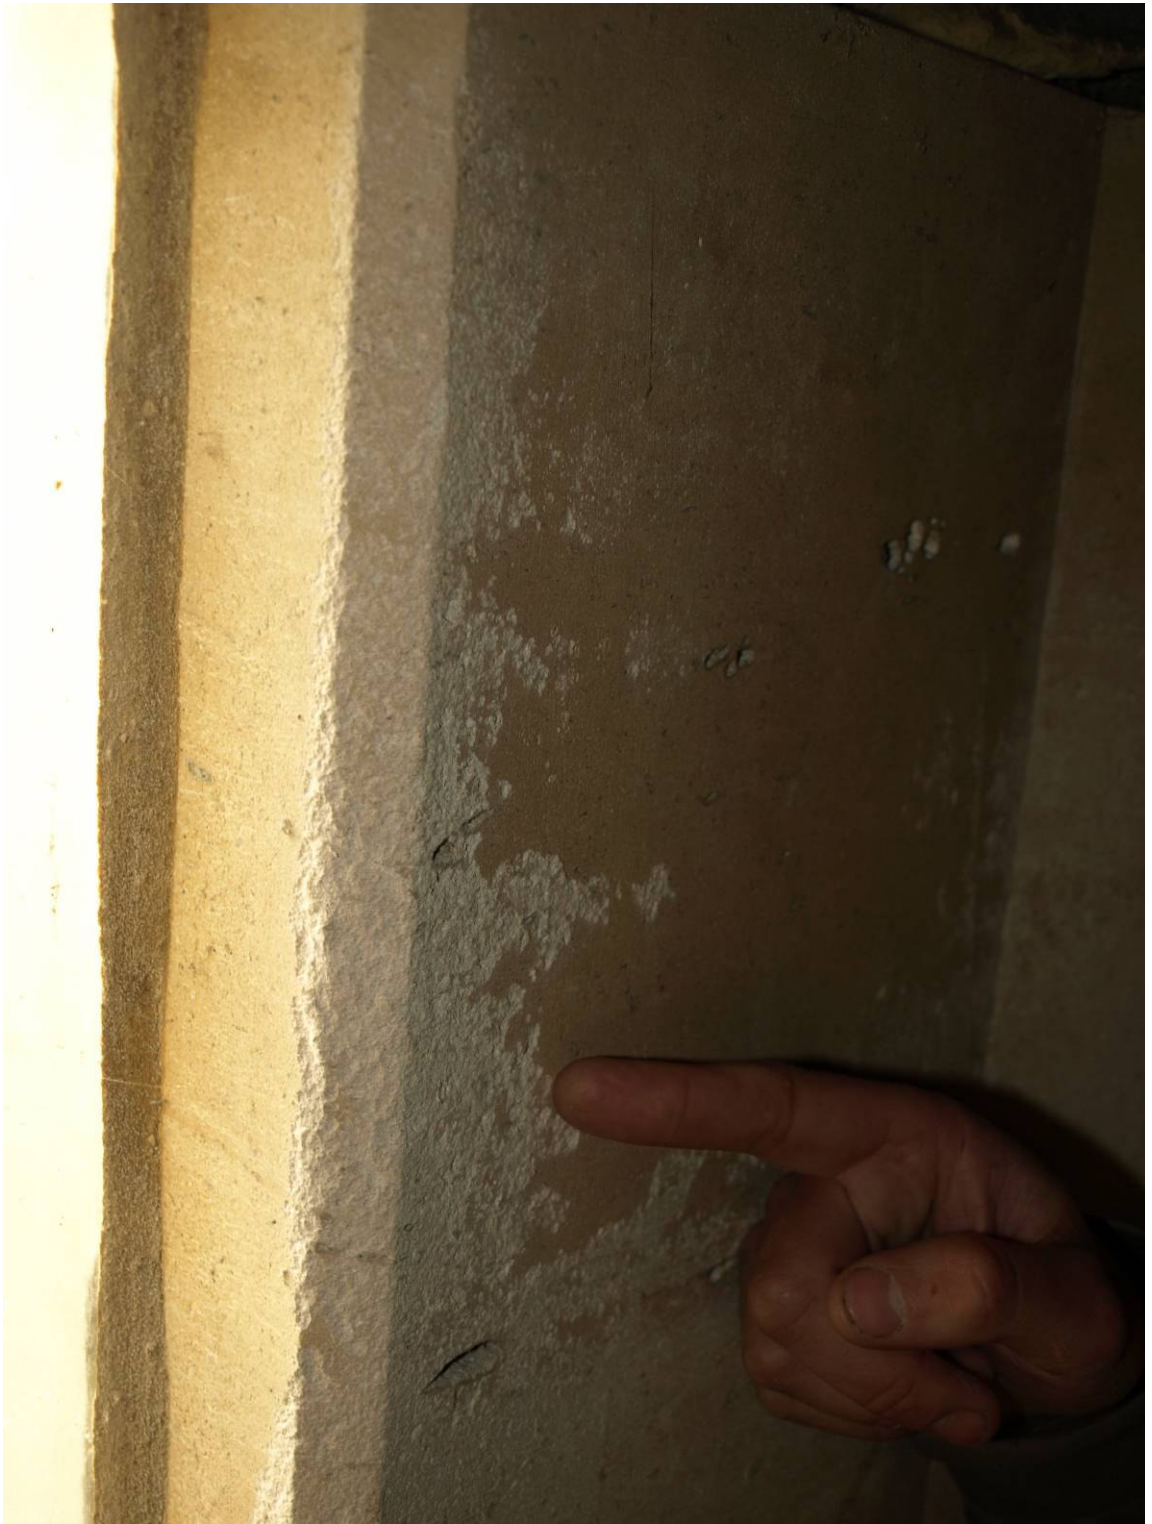
Figure 438: Surface decay of new magnesian limestone indents, Howden Minster Chapter House

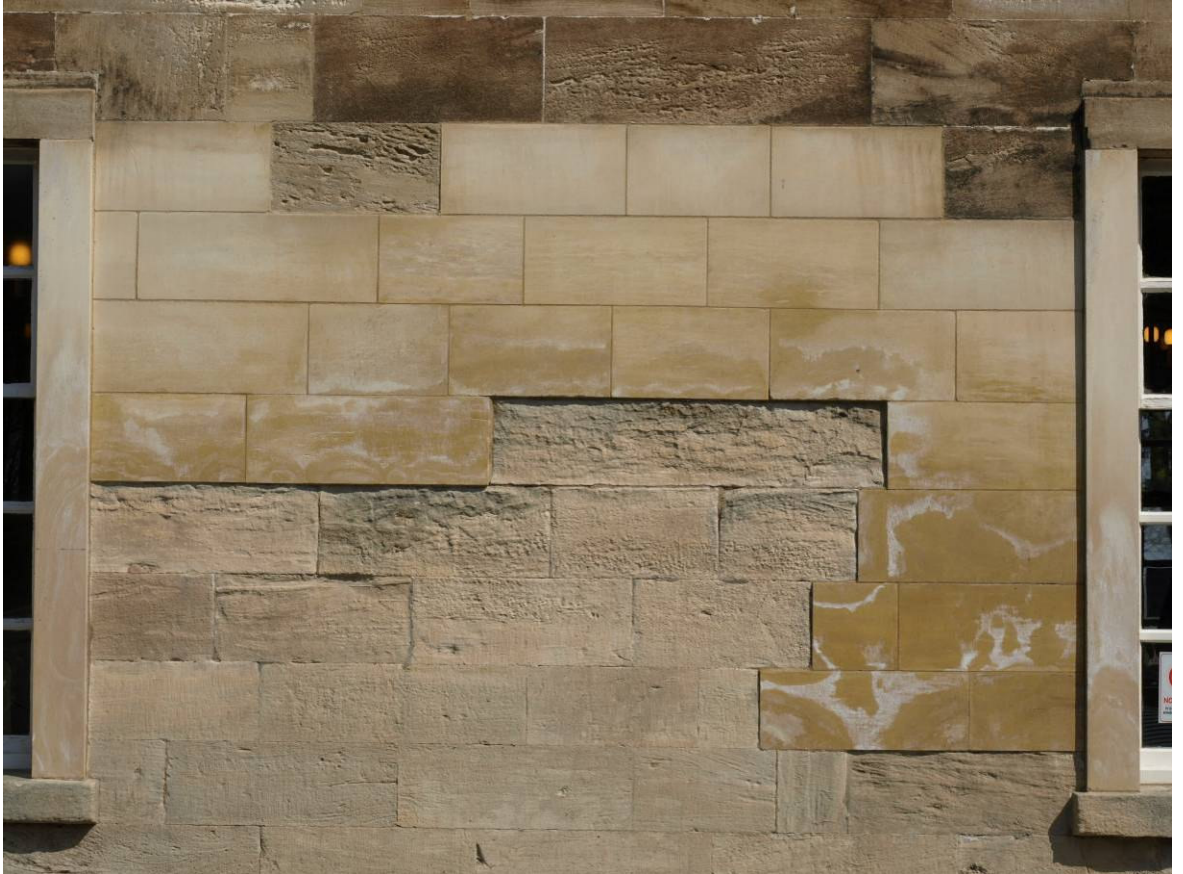
Figure 439: Cusworth Hall, South Yorkshire. Detail of salt damage to new magnesian-limestone masonry

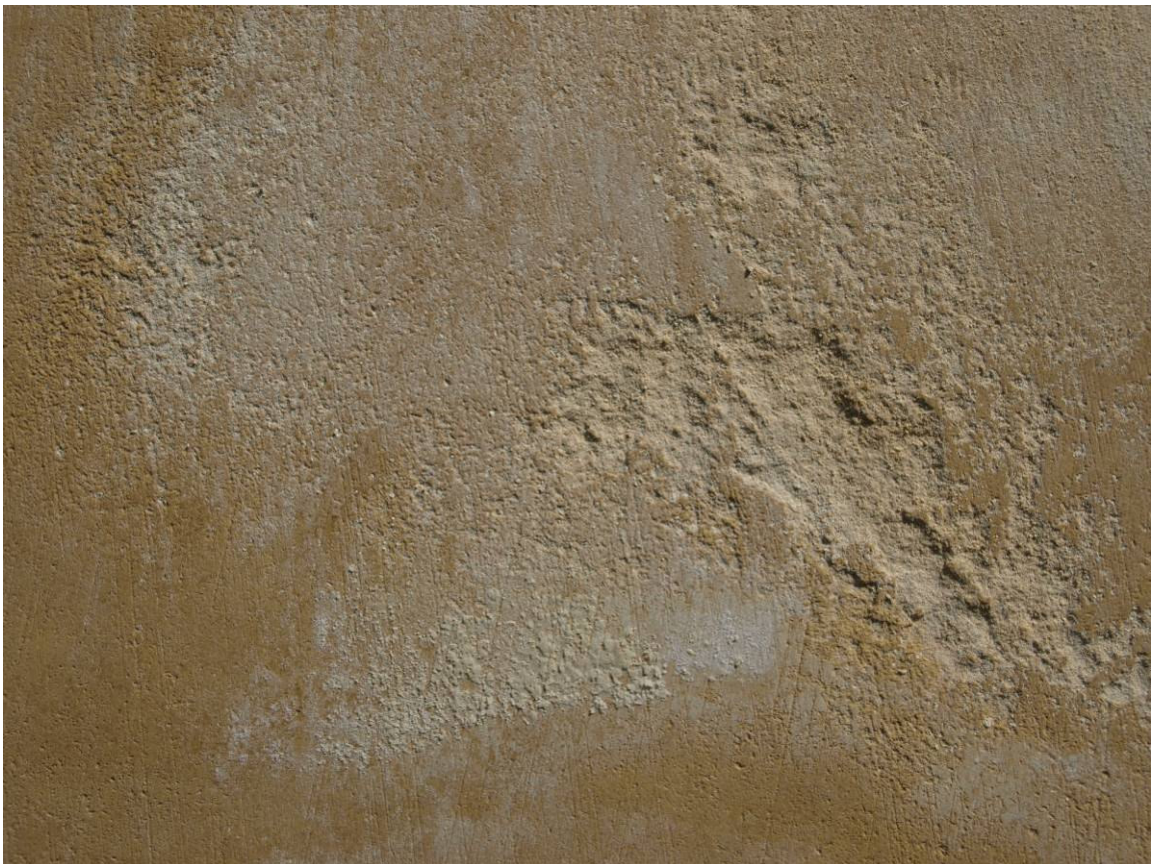
Figure 440: Cusworth Hall, detail of surface decay to new magnesian-limestone masonry

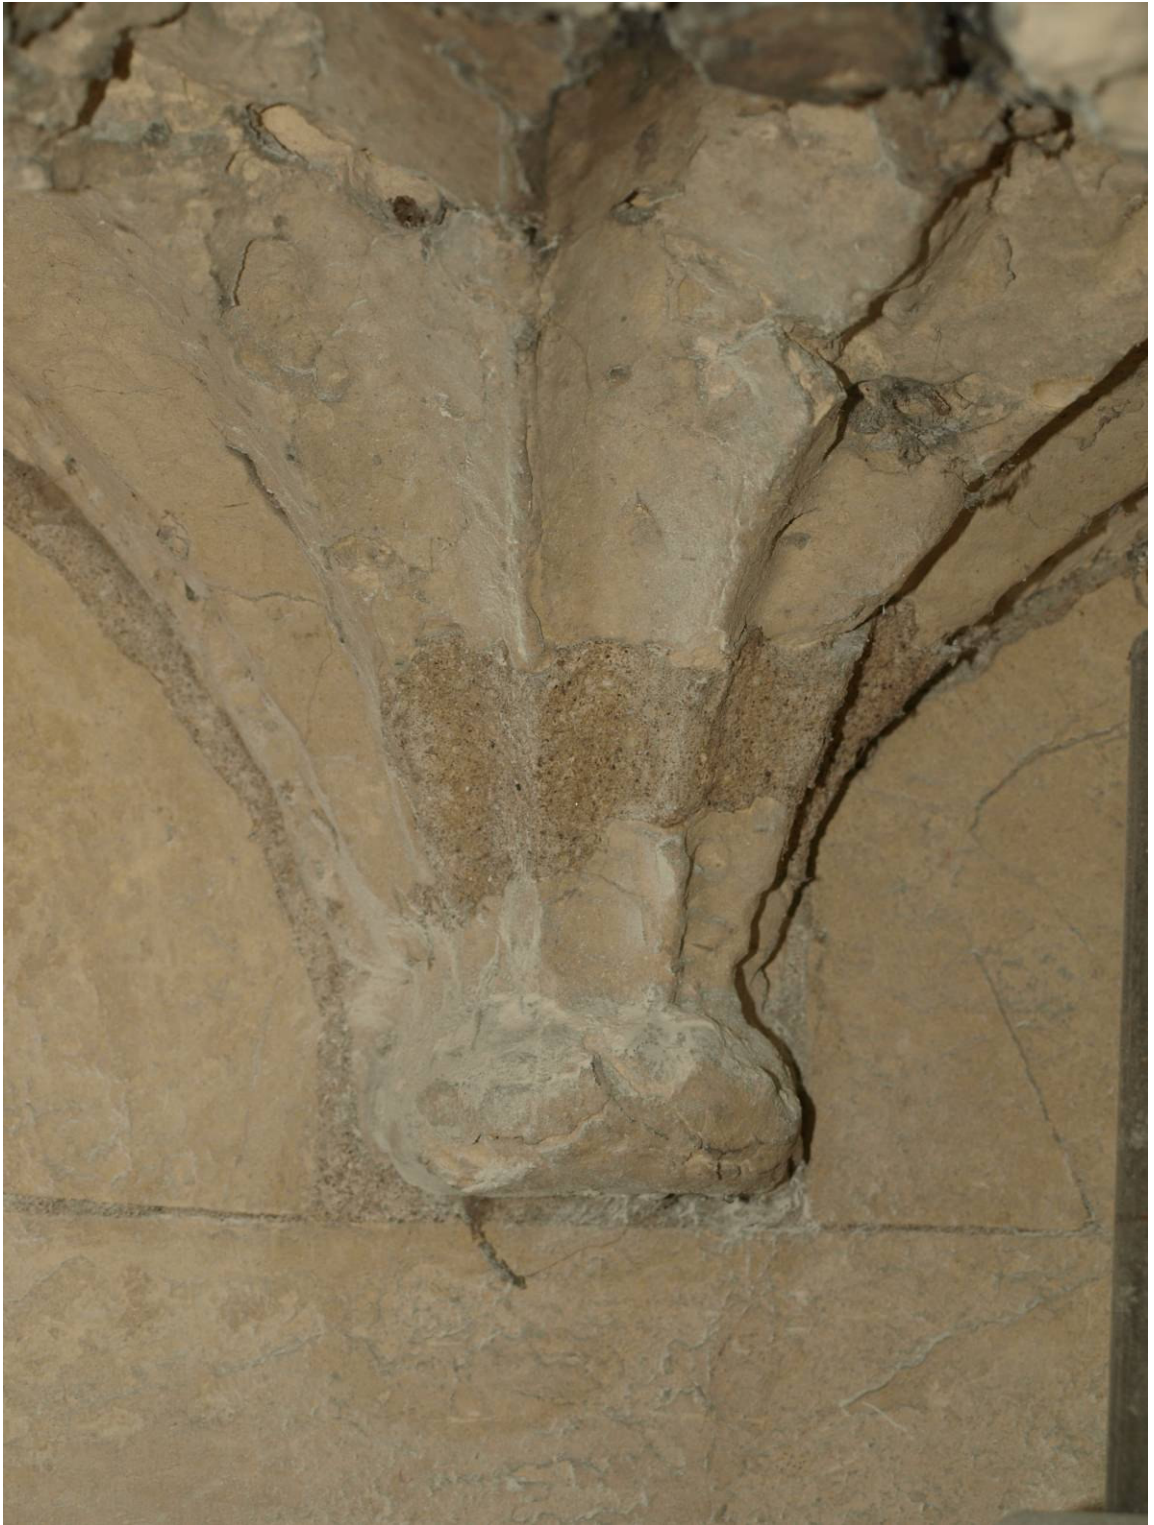
Figure 446: East Front, central vessel, historic lime-mortar repair

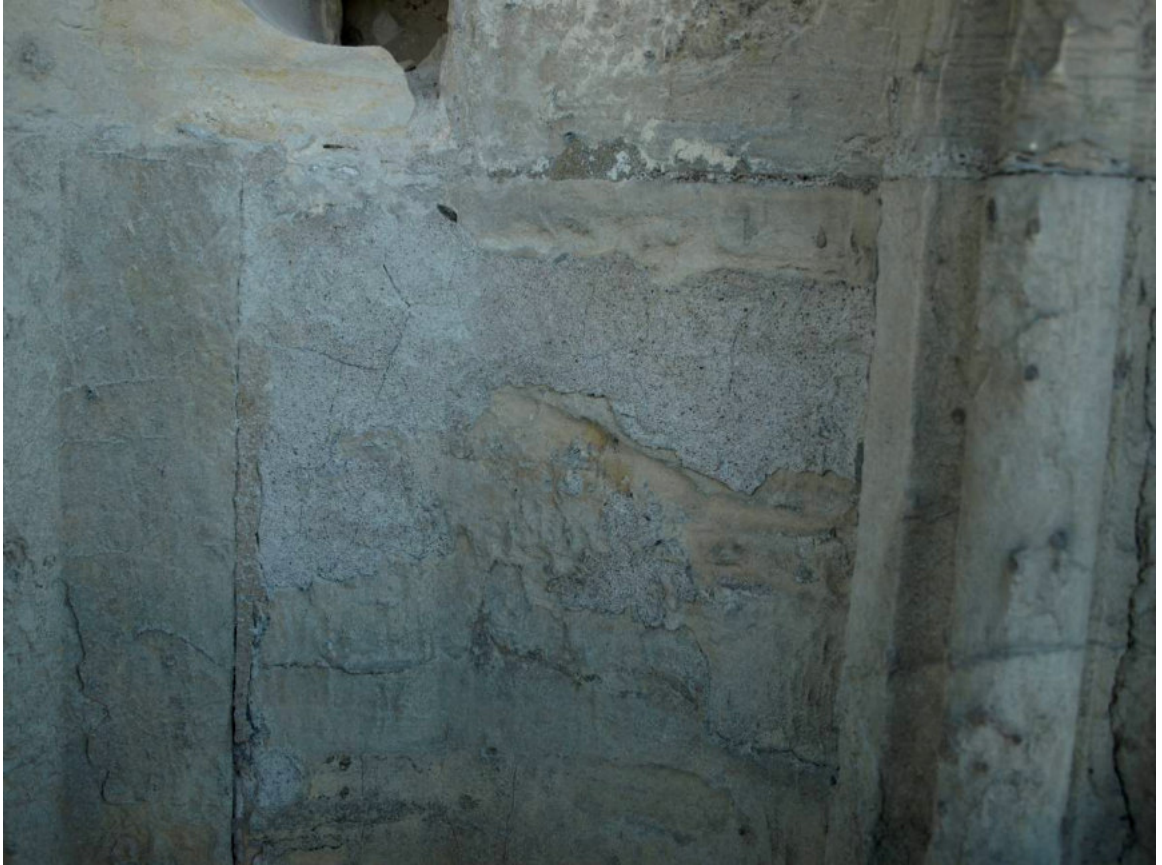
Figure 447: East Front, south buttress, historic lime-mortar repair

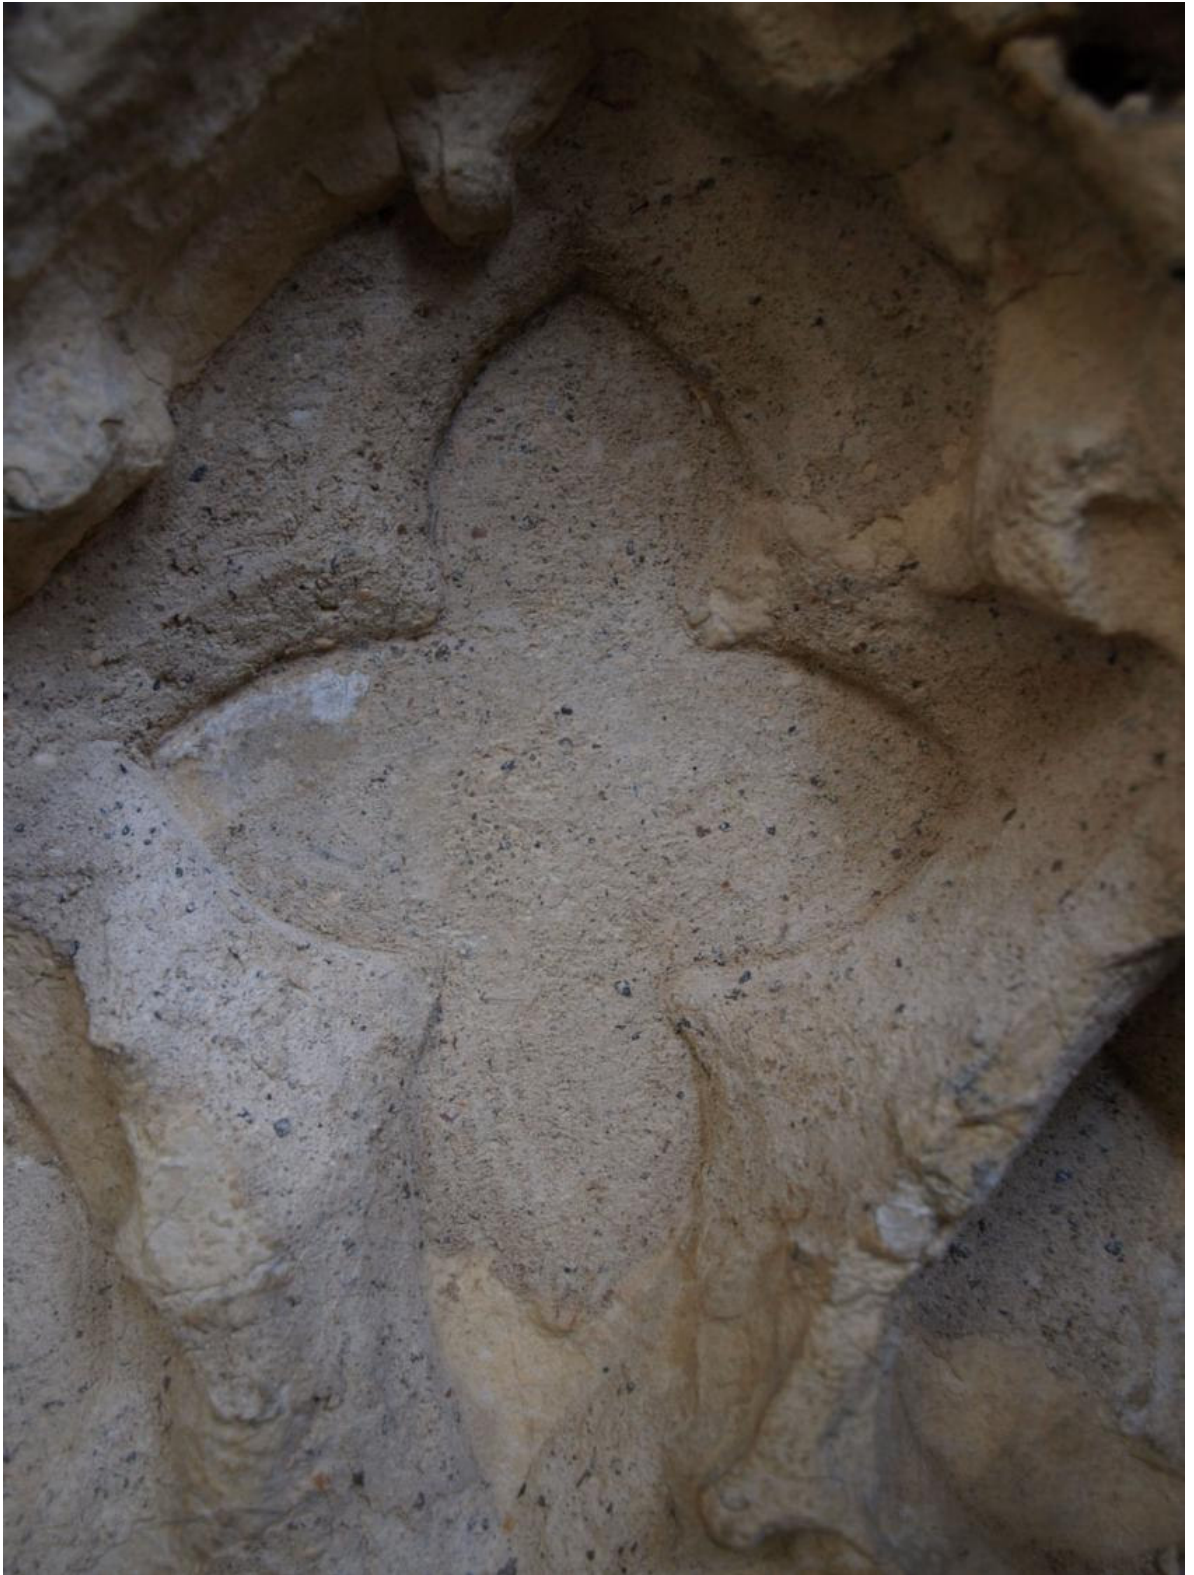
Figure 450: Howden Minster Chapter House, detail of trial conservation with coarse lime mortar

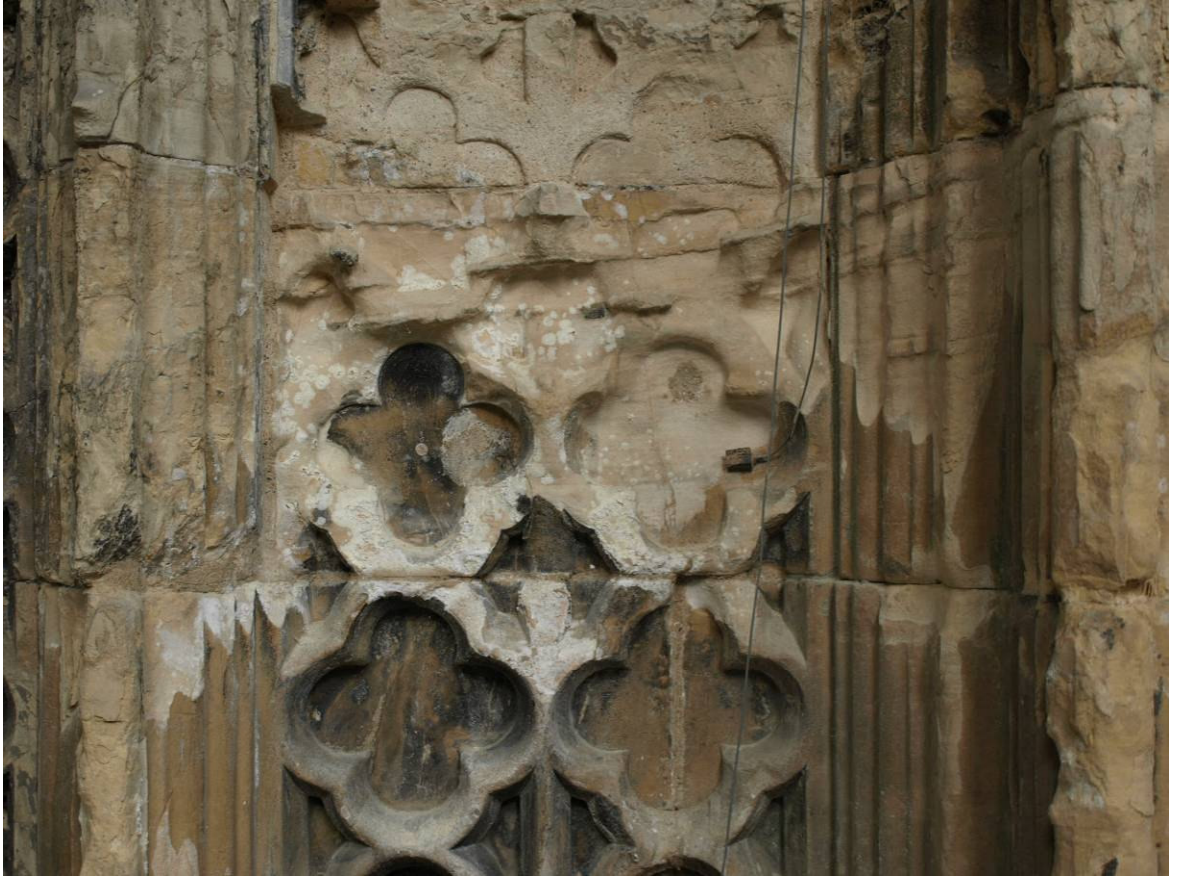
Figure 451: Howden Minster Chapter House, enhanced salt development adjacent to magnesium-lime pointing, June 2010

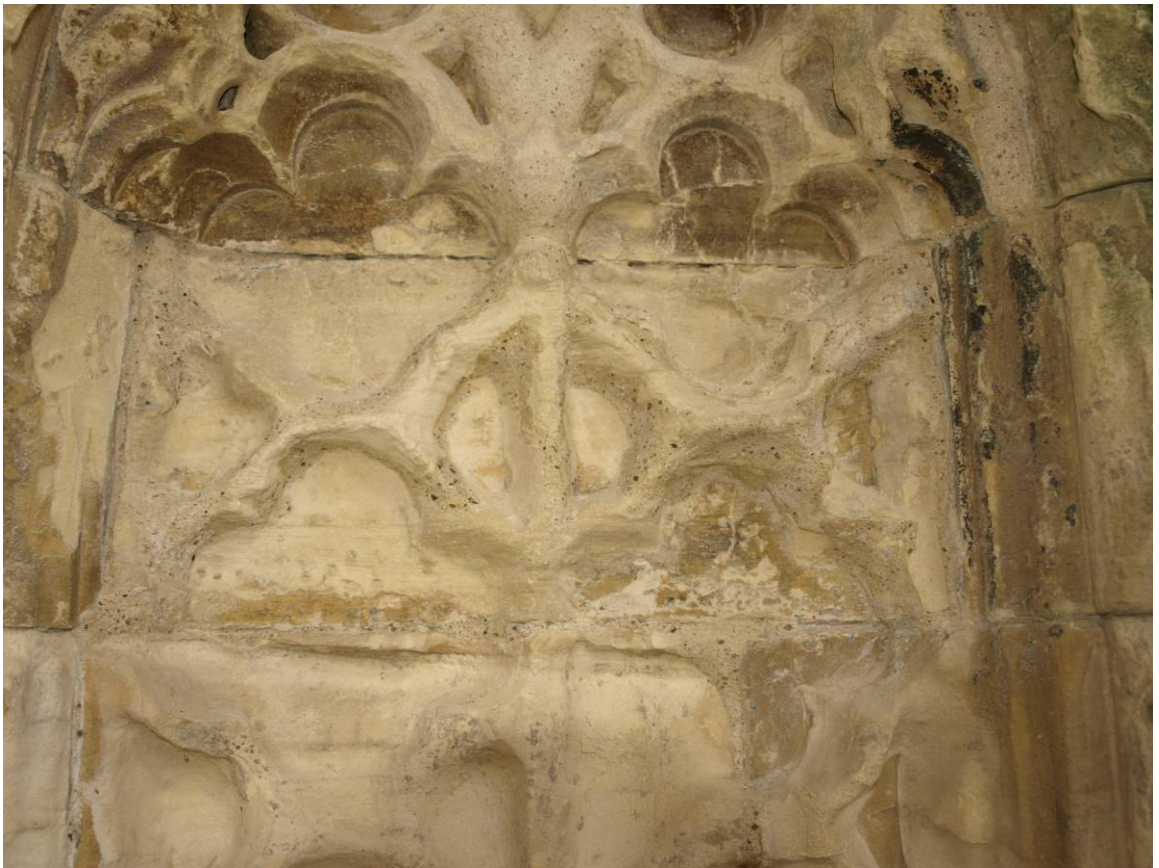
Figure 452: Howden Minster Chapter House, deteriorating NHL2 mortar repairs, June 2010

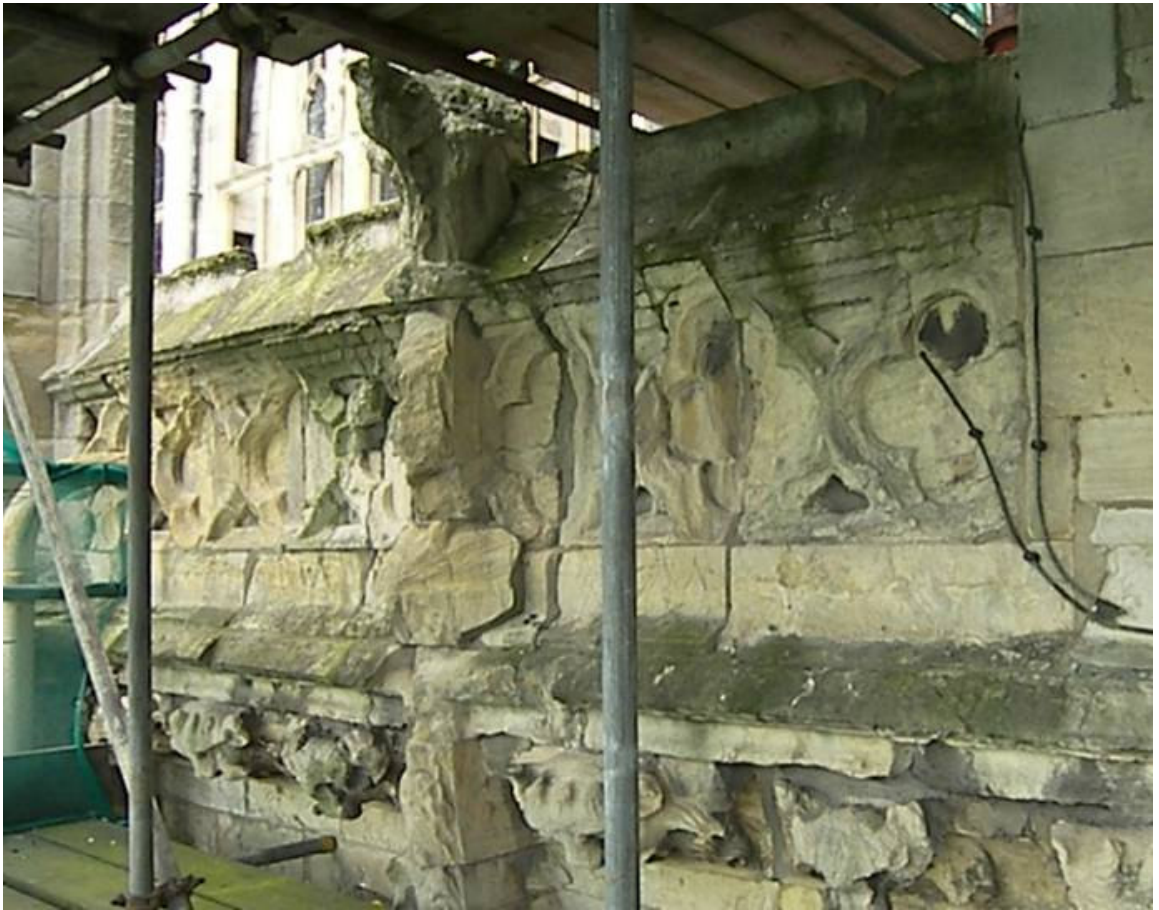
Figure 453: York Minster, aisle parapet, easternmost bay before surface treatment trials, July 2007

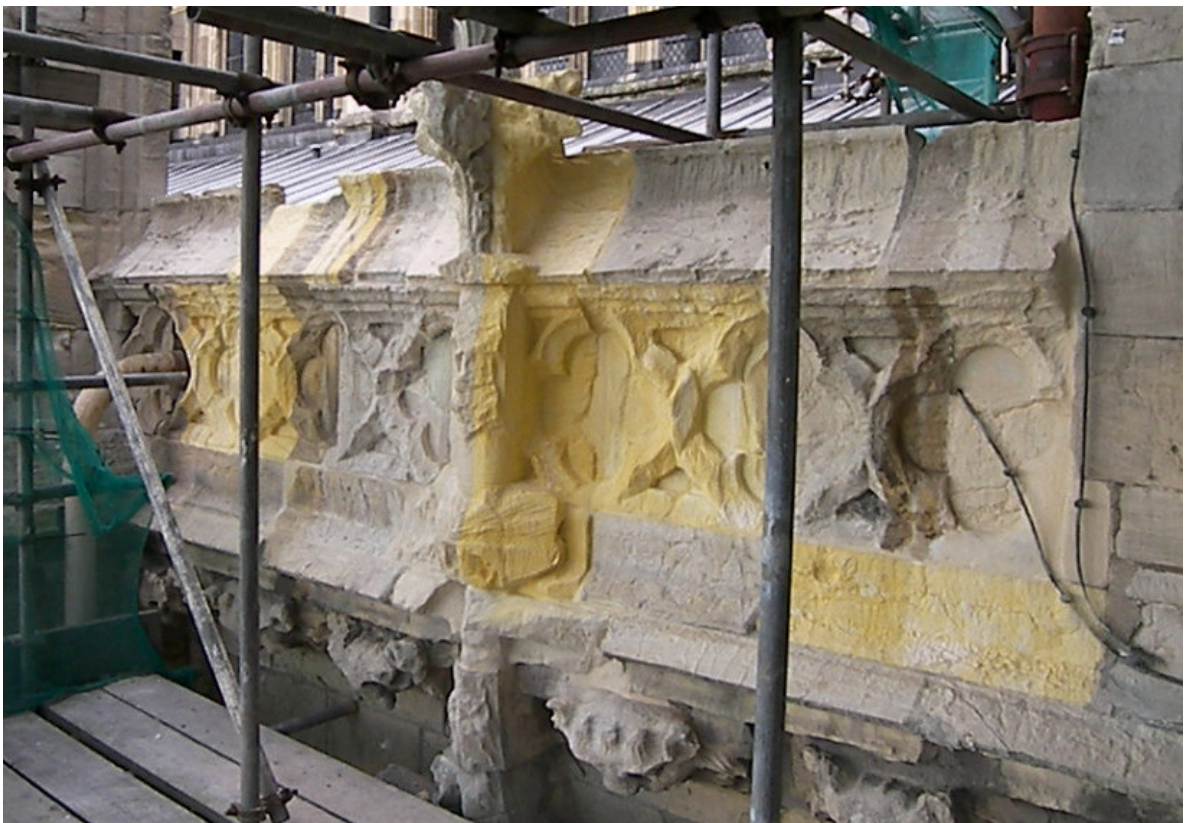
Figure 454: York Minster, south-aisle parapet, easternmost bay after mortar consolidation and application of surface treatments, July 2007

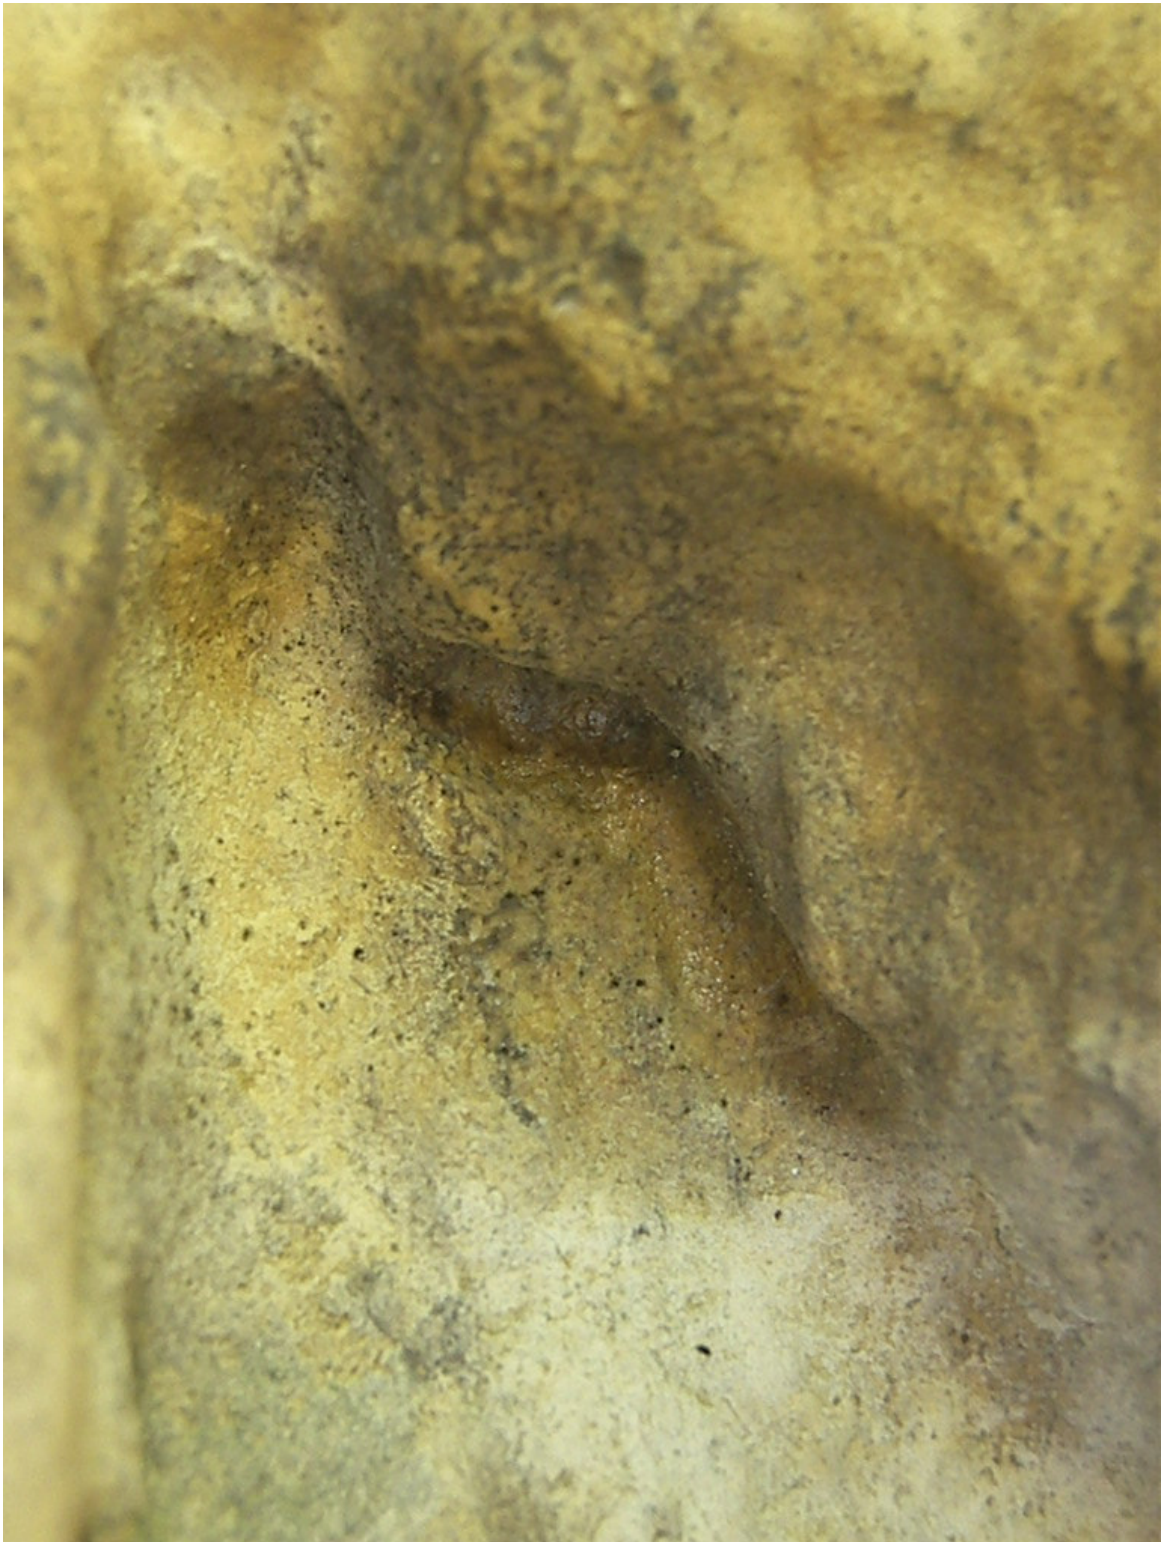
Figure 458: Example of effect of linseed oil, south-aisle parapet trial area, January 2008

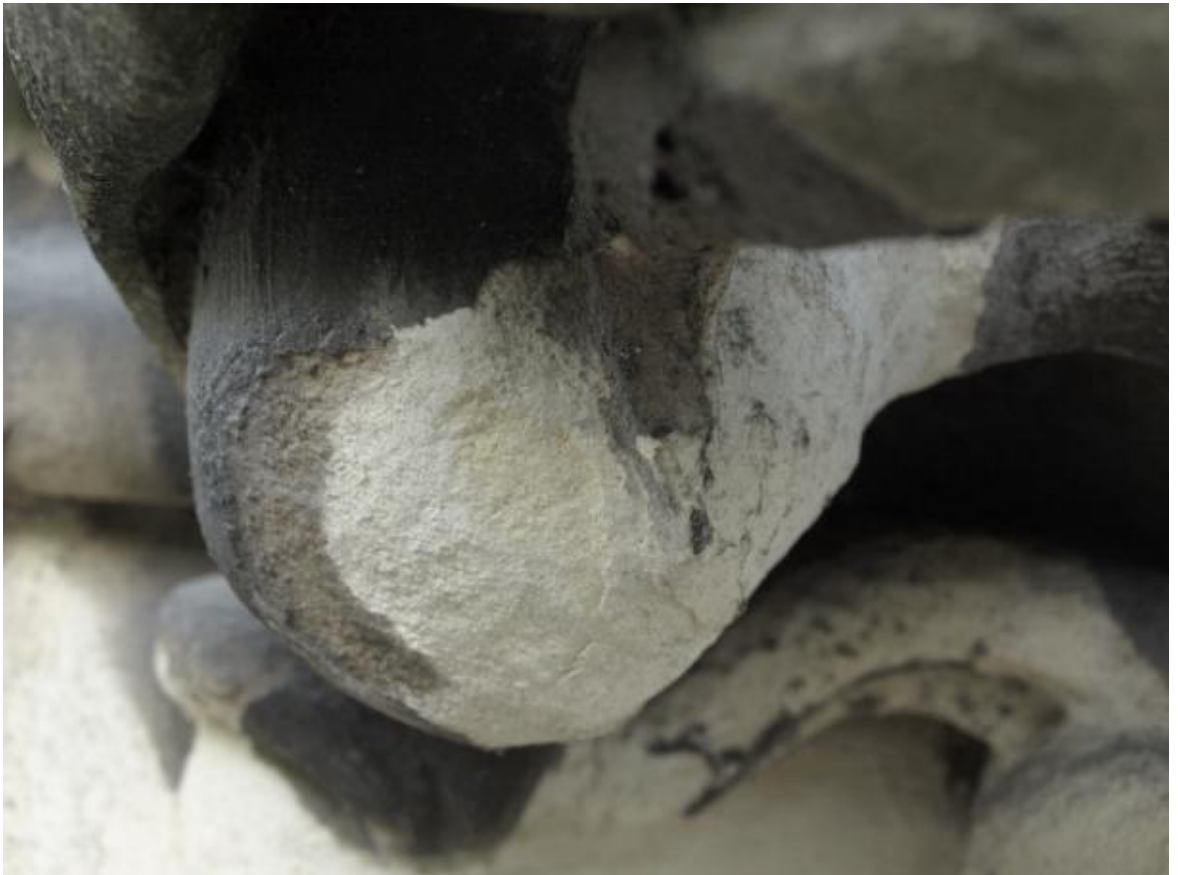
Figure 460: East Front, north-butress grotesque, detail of decay

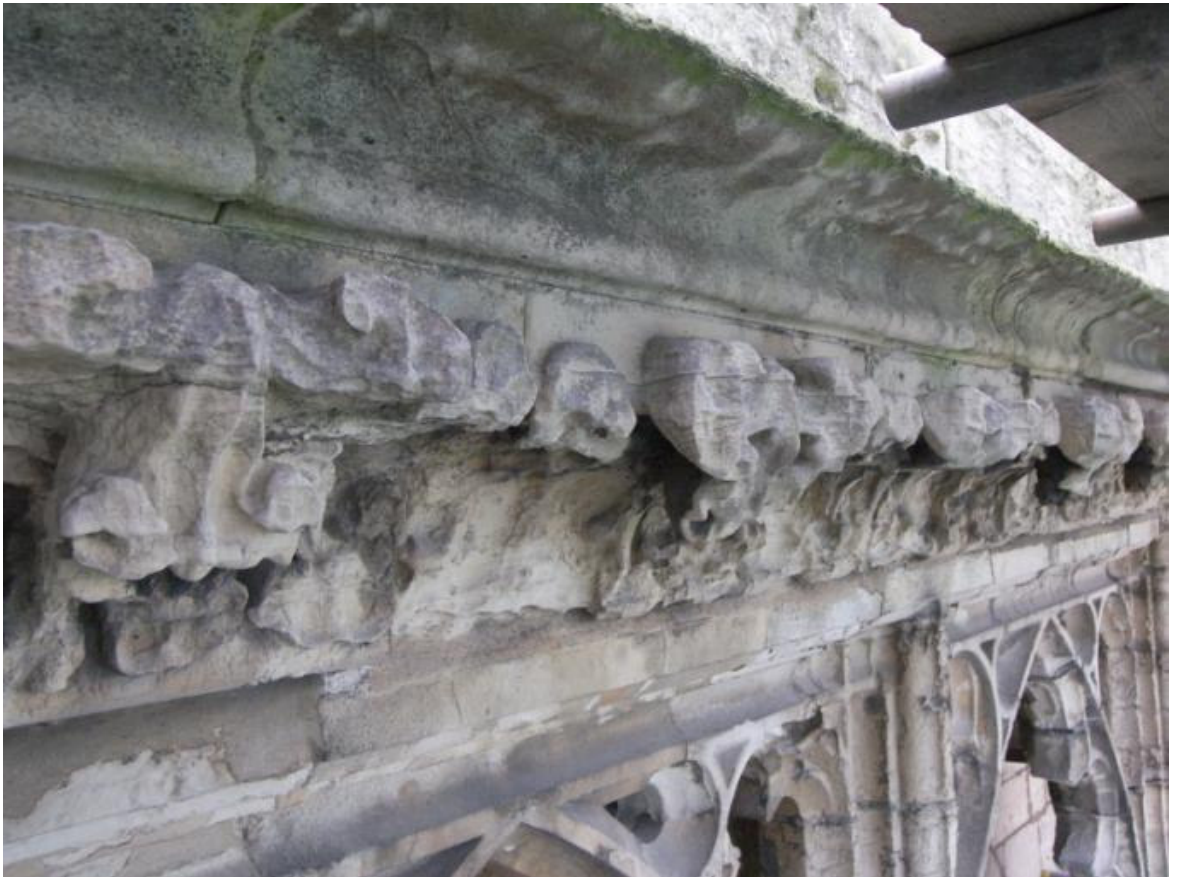
Figure 462: North-clerestory cornice bay 2 before renewal

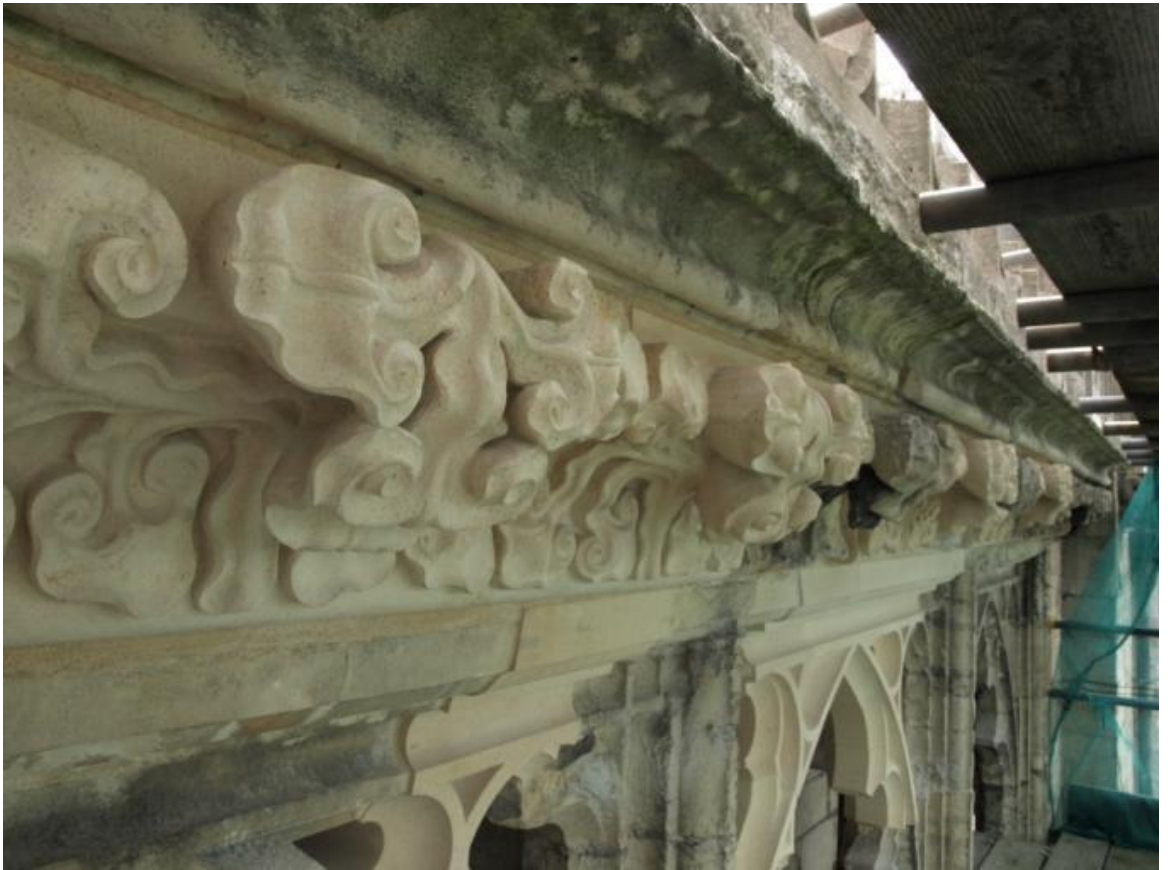
Figure 464: North-clerestory cornice bay 2 after renewal, 2008
