Construction Materials Consultants Ltd.

CERTIFICATE OF ANALYSIS OF MORTAR SAMPLES FOR DETERMINATION OF MIX COMPOSITION & BINDER TYPE

Project Reference	:	North Yorkshire Moors – This Exploited Land of Iron
Sample Location	:	Rosedale East Stone Kilns
Sample Description	:	RESK1A – Typical Vault Brickwork, Kiln 1 Vault 4 RESK1B – Typical Vault Brickwork, Kiln 4 Vault 13 RESK2 – Rear Retaining, Wall kiln 4 RESK3 – Front Wall/Facing, kiln 4, Bedding mortar
Date Received	:	12 th March 2019
CMC Sample Ref	:	SR 2706-S1A = RESK1A – Kiln 4, Vault 4, Brick mortar SR 2706-S1B = RESK1B – Kiln 4, Vault 13, Brick mortar SR 2706-S2 = RESK2 – Kiln 4, Rear Retaining Wall SR 2706-S3 = RESK3 – Kiln 4 Front Wall/Facing
Date Analysed	:	5 th April to 20 th May 2019
Method of Test	:	Determination of binder type by X-Ray Diffraction analysis. Mix composition by acid digestion with grading analysis of recovered aggregate, and thin section examination.

Rosedale East Stone Kilns

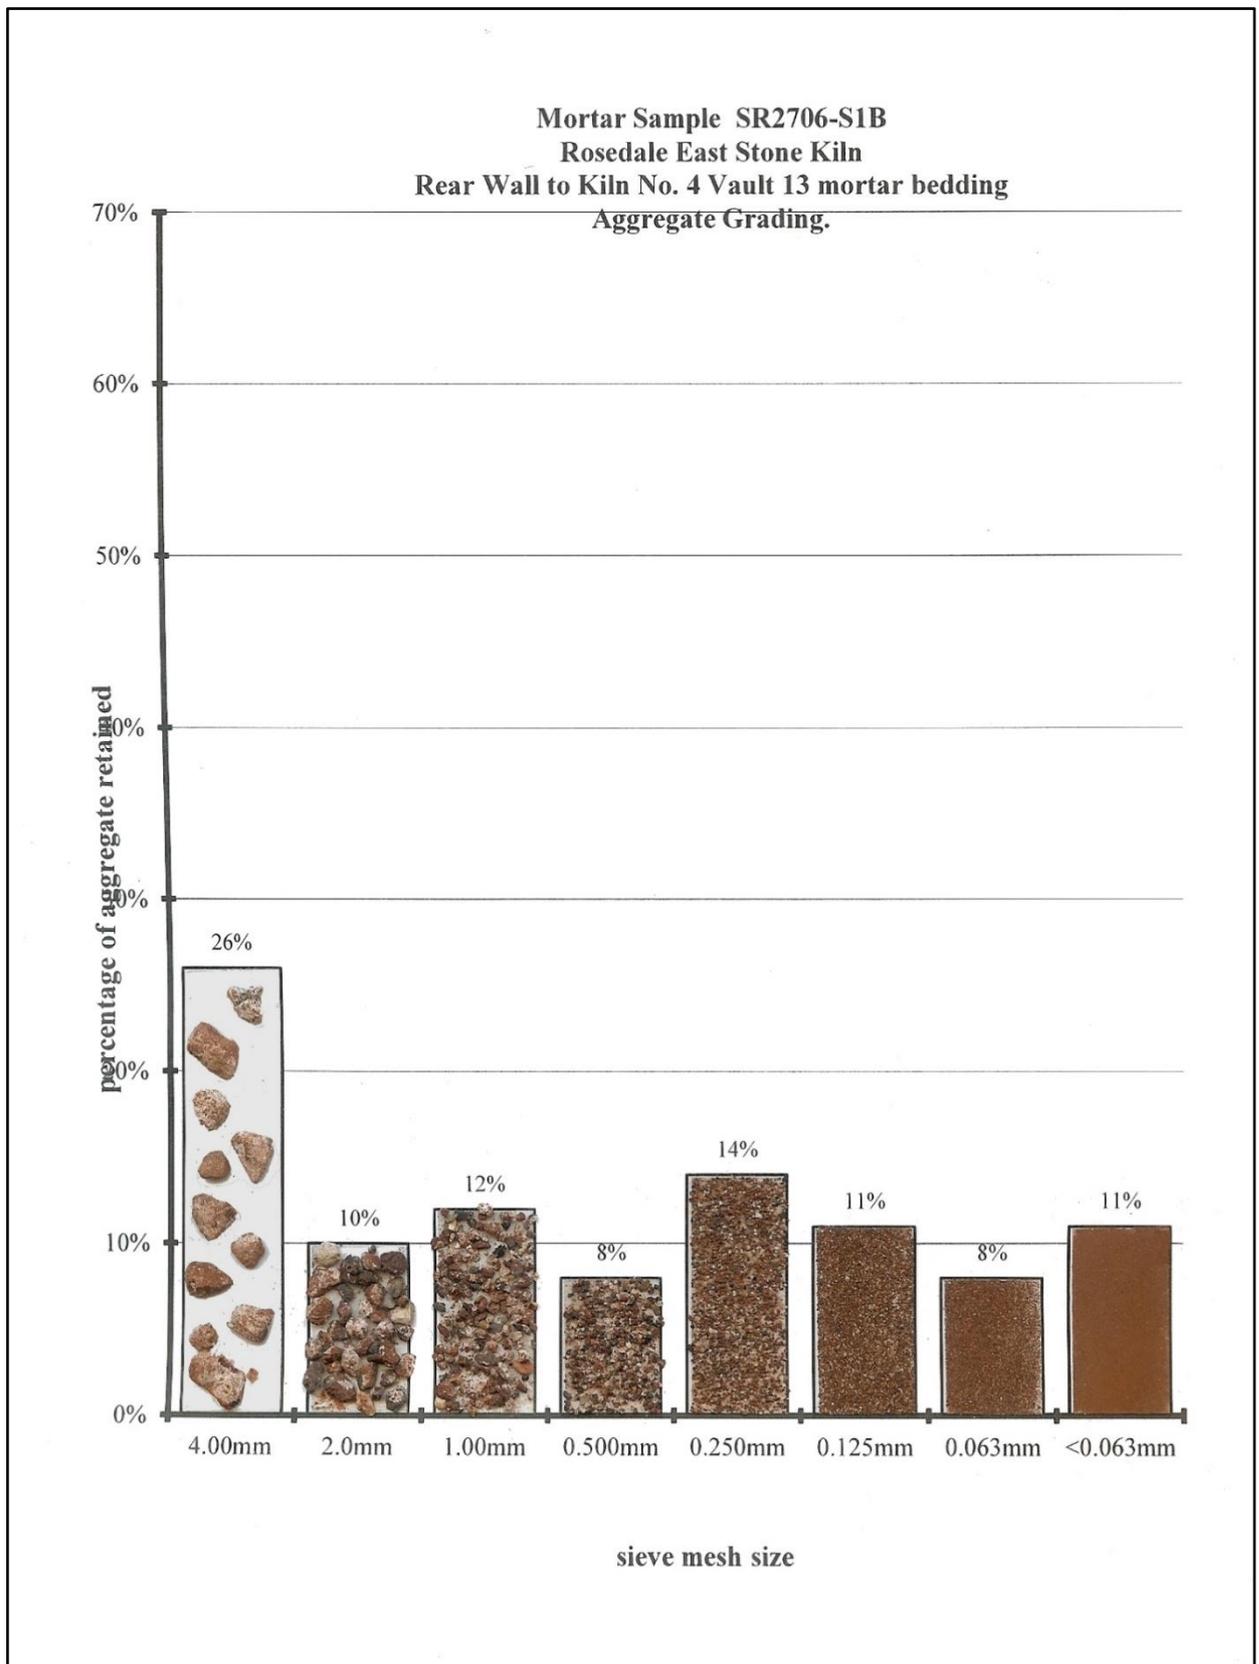
Figure No. 1: Aggregate Grading on Aggregate recovered from sample RESK1B.

The residue from the acid digestions were recovered by vacuum filtration, washed and dried with their particle size distribution determined. The results obtained are presented in table No. 1 above. With the gradings displayed in the form of aggregate filled histograms in the appended Figures No. 1, 2, and 3, shown at the end of this report.
