**THE INFLUENCE OF CONTAMINATION ON THE FATIGUE
PERFORMANCE OF ELECTROFUSION JOINTS**

A thesis submitted for the degree of Engineering Doctorate of the
University of Sheffield

Department of Mechanical Engineering

December 2014

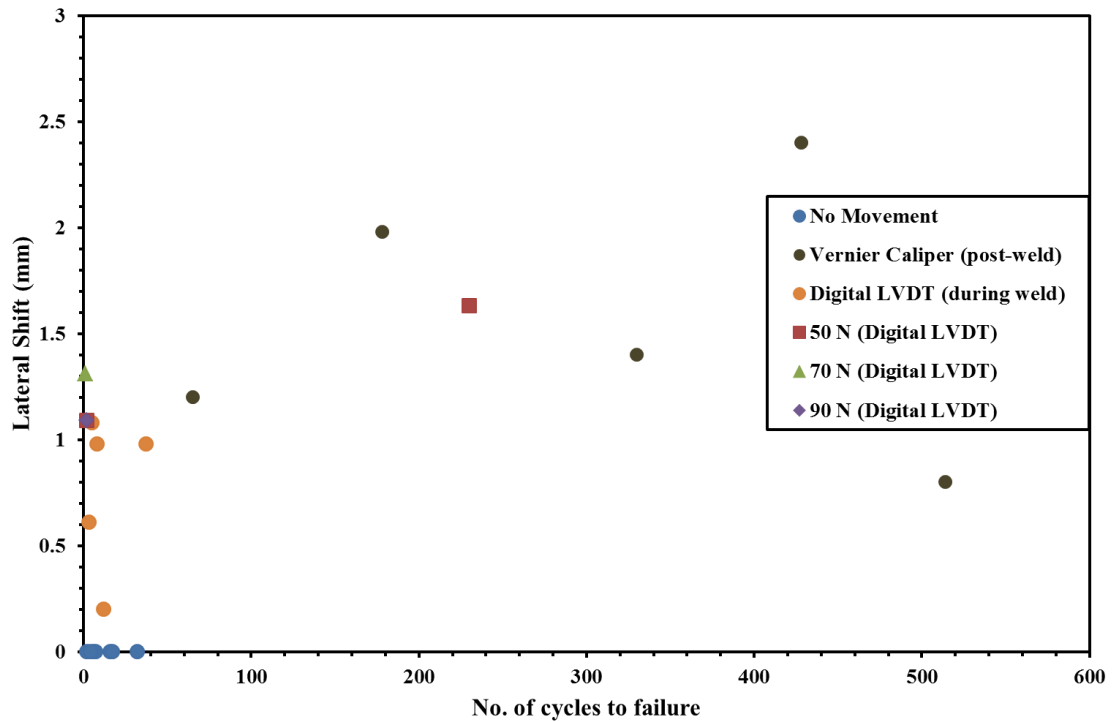
Figure 4-14 Fatigue-life of contaminated joints containing lateral shift during weld process when $P_{MEAN} = 12.50$ bar and $P_{RANGE} = 17.50$ bar

Figure 4-14 illustrates that if below 1.30 mm of lateral shift occurs, there is little or no change to the fatigue performance of a contaminated electrofusion tapping tee. However, there is a single instance whereby the joint moved by 0.80 mm (measured using a Vernier Caliper) and lasted 514 cycles. There was no obvious reason why this particular joint had an increase in fatigue performance.

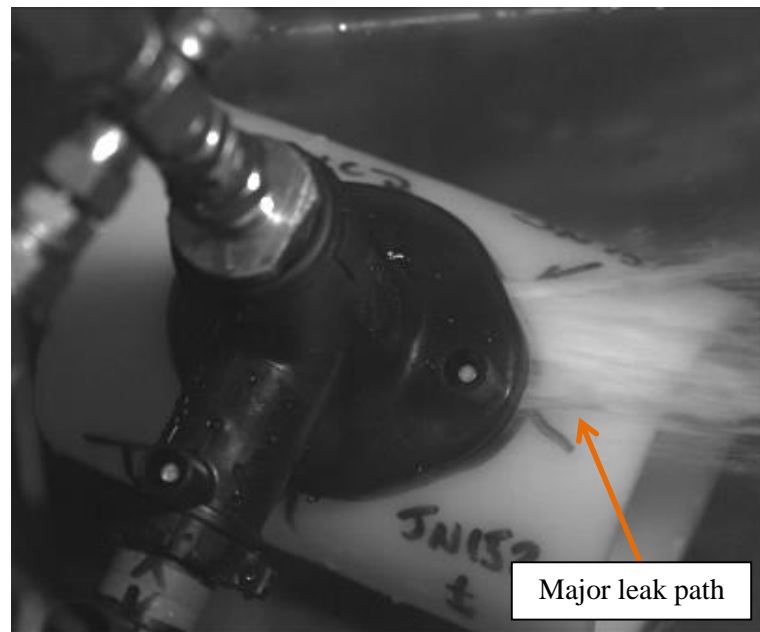
Figure 5-4 Failing tapping tee showing 'major' leak path

When a specimen fails (see Figure 5-4) and a major leak path is formed, it is important to consider that the piston head of the experimental hydraulic rig (previously mentioned in Section 3.2.3) drops instantaneously in an effort to maintain the target pressure of the cycle. In this effort, the water held within the piston cylinder is forced through the leak path until empty. During this process, it is possible that a local force is exhibited as the volume of water dissipates via the leak path. Therefore it is possible that the leak path opens further (increases in size) during this time. As the flow of water stops, the leak path (gap) may close up again; thus making it difficult to observe the leak path post-failure.

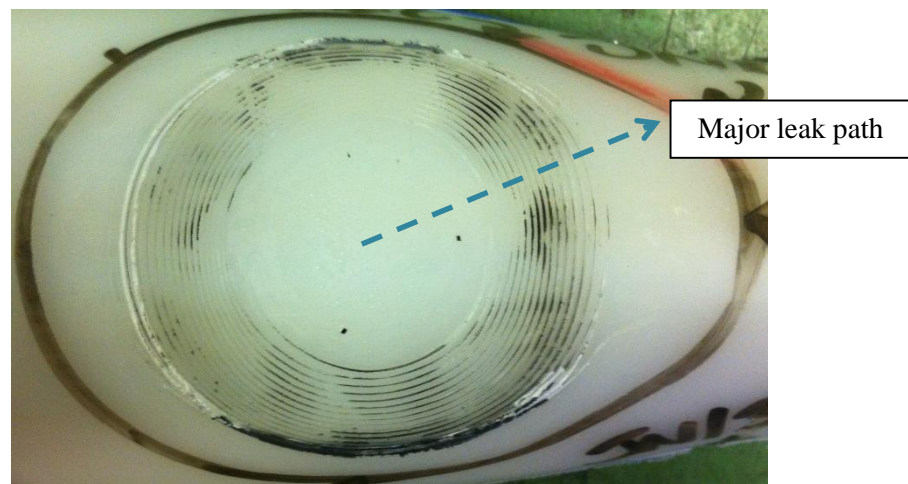
Figure 5-5 Specimen H (90% $P_{MAT, MAX}$)

- Minor leak paths become more predominant as the pressure range is decreased in the fatigue testing regime i.e. Specimen H (90% $P_{MAT, MAX}$) (Figure 5-5) has one clear major leak path that is coincidentally somewhat identical to that shown in Figure 5-4, whereas Specimen CS (40% $P_{MAT, MAX}$) (Figure 5-10) has one major leak path and two minor leak paths. This may suggest that the lower pressure ranges promote crack growth under dynamic loading; potentially in a circular manner.

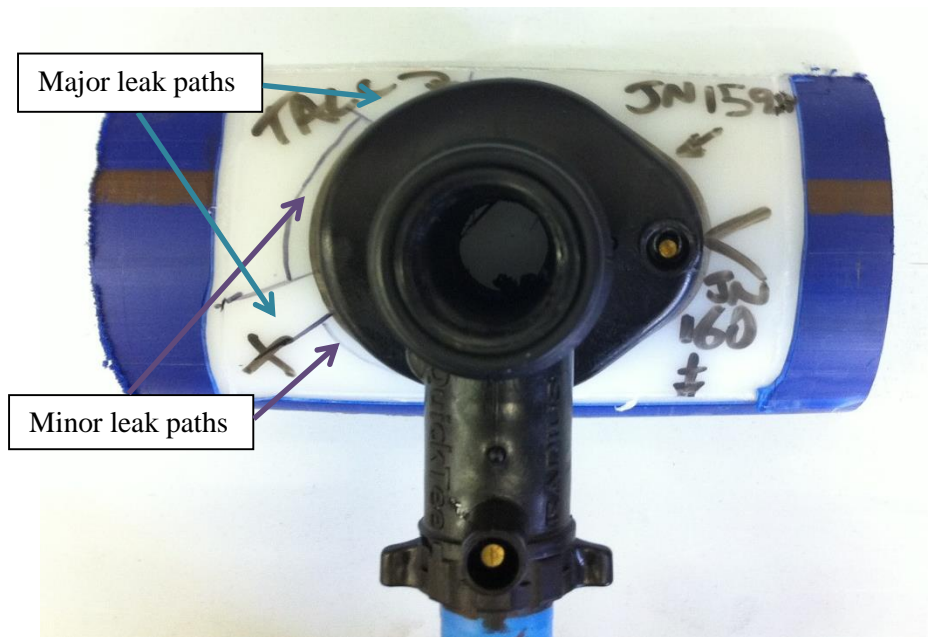
Figure 5-11 Specimen 'X' prior to crush test

Specimen 'X' is a contaminated joint that had previously failed under dynamic load from the fixed mean approach – results shown in Section 4.1. The specimen was tested with parameters $P_{\text{RANGE}} = 20 \text{ bar}$ (2.0 MPa), $P_{\text{MEAN}} = 12.5 \text{ bar}$ (1.25 MPa) and held a fatigue-life of 2 cycles. An aerial perspective of the specimen is illustrated in Figure 5-11.

Prior to the destructive test of specimen X, a hand pump was used to produce a flow of water through the fitting in order to observe the leak path(s) – it was thought it may be visually clear where some 'good' adhesion took place if the leak path was known. The leak paths are illustrated as to their severity. There was a large and obvious (major) leak path at the top of the Figure 5-11 as well as a large but narrow leak path at the bottom-left of the photo. Smaller leak paths are also noted in Figure 5-11 at the left and bottom of the photograph.

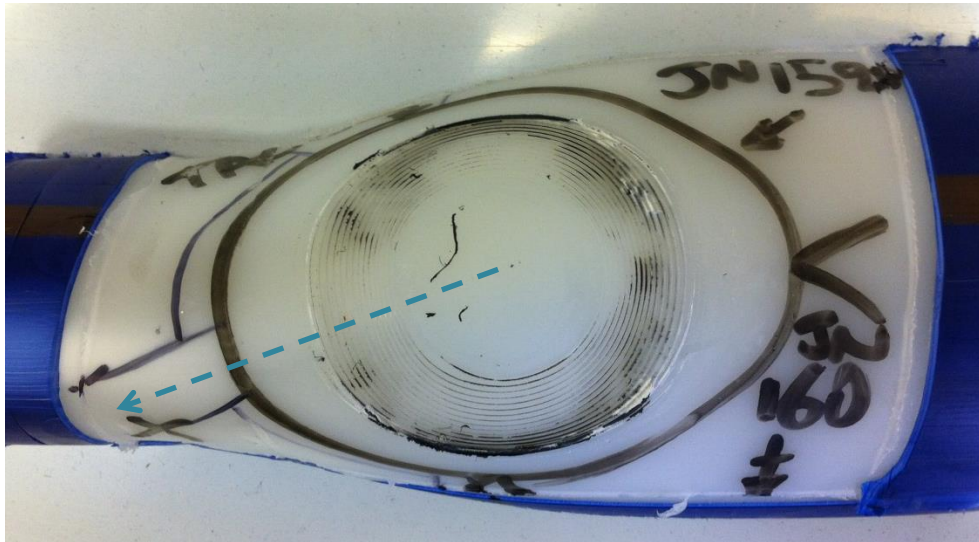
Figure 5-13 Specimen X parent pipe

Figure 5-13 and Figure 5-14 show the parent pipe and the fitting respectively. It can be seen that there is little or no bonding at the bottom-left of the fusion zone which corresponds to the leak path observation defined in Figure 5-11. However, specimen X was subject to a dynamic load (fatigue) and then was further analysed using destructive methods, i.e. the crush test. Therefore, observing the fusion zone on the parent pipe as well as the tapping tee after the crush test does not give an indication of the mechanism of failure of the fitting when it is under dynamic load. However, it does give an idea of the quantity (and quality) of adhesion that took place during the welding process.

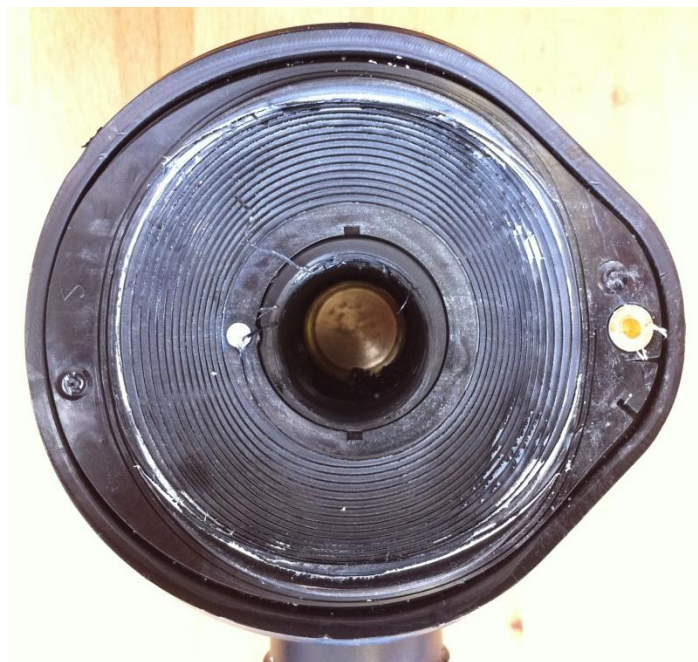
Figure 5-14 Specimen X tapping tee (removed)

Figure 5-14 shows the underside of the electrofusion tapping tee of specimen X. It is also key to note that the filament wires were carefully removed from both the parent pipe and the fitting once they were separated from one another.

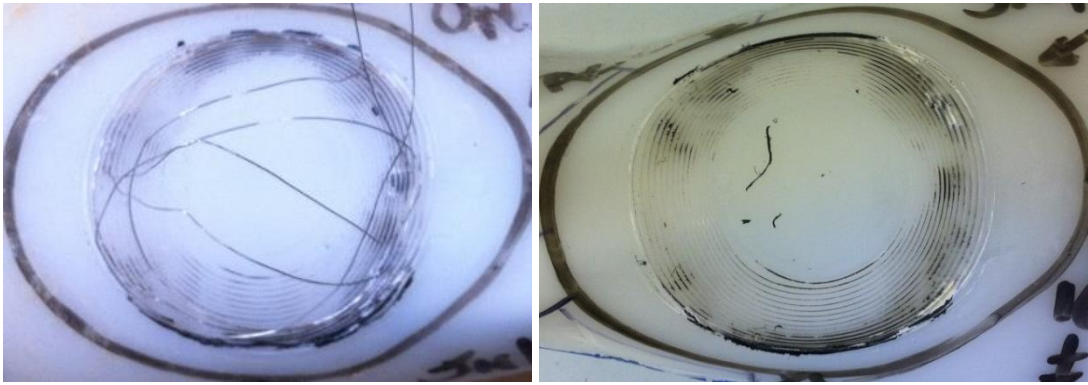
Figure 5-15 Fusion zones on parent pipe of specimen L (a) and specimen X (b)

By observing the fusion zone of specimen L (from Section 5.1) and specimen X (see Figure 5-15), similarities become more evident. Both specimens appear to have some remains of the tapping tee (black polymer) on the surface of the pipe. Both specimens show a very small amount of ductility to the bottom right and top right of each specimen. This is also consistent with the findings of the comparison of adhesion with respect to the fatigue testing pressure range stated in Section 5.2 whereby a small amount of localised ductility is observed either side of the indentations made when the filament wires are heated during the welding process.

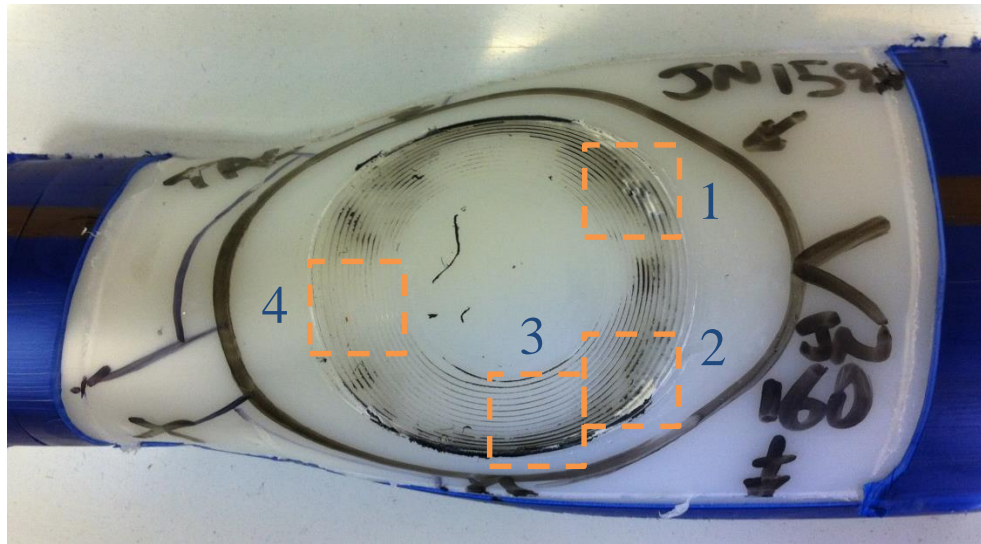
Figure 5-16 Approximate location of SEM samples – specimen X

Four pieces approximately 15 x 15 mm were carefully cut from the parent pipe using a junior hack saw. Figure 5-16 shows the approximate locations of samples 1 to 4. A summary of the observations made can be found in Table 5-2.

<i>Sample</i>	<i>Visual observations/comments</i>
1	There appeared to be a small amount of ductile failure throughout the area on close inspection (to the naked-eye); located where the filament wires were embedded into the parent pipe.
2	Same as sample 1 except to a greater extent but only in an area approximately 2 mm ² .
3	Very little bonding. Some black polymer remained on the outer section of the fusion zone. Again, located where the filament wires appeared to have sat.
4	Almost no black polymer remains on the parent pipe. Note: area is in line with the observed leak path.

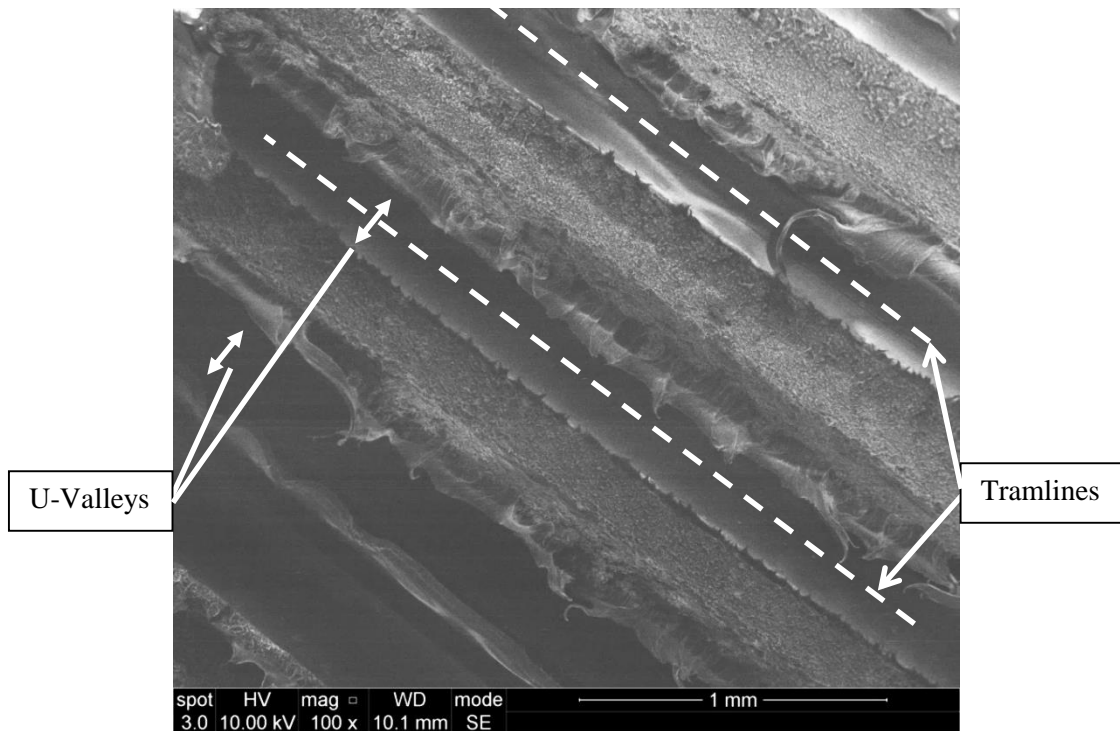
Figure 5-18 Sample 1 (x100 magnification)

Figure 5-18 shows Sample 1 at x100 magnification. There are three very distinct ‘tram lines’ moving from the top-left to the bottom-right of Figure 5-18. These are the indentations caused by the filament wire during the heating process of the electrofusion welding cycle. It would appear that the heat produced by the filament wires, in combination with the vertical force applied as a result of the top-loading clamp, forces the filament wires to embed into the parent pipe during the heating cycle, thus leaving indentations in the form of ‘U-shaped’ valleys on the parent pipe and perhaps giving the joint some structural strength.

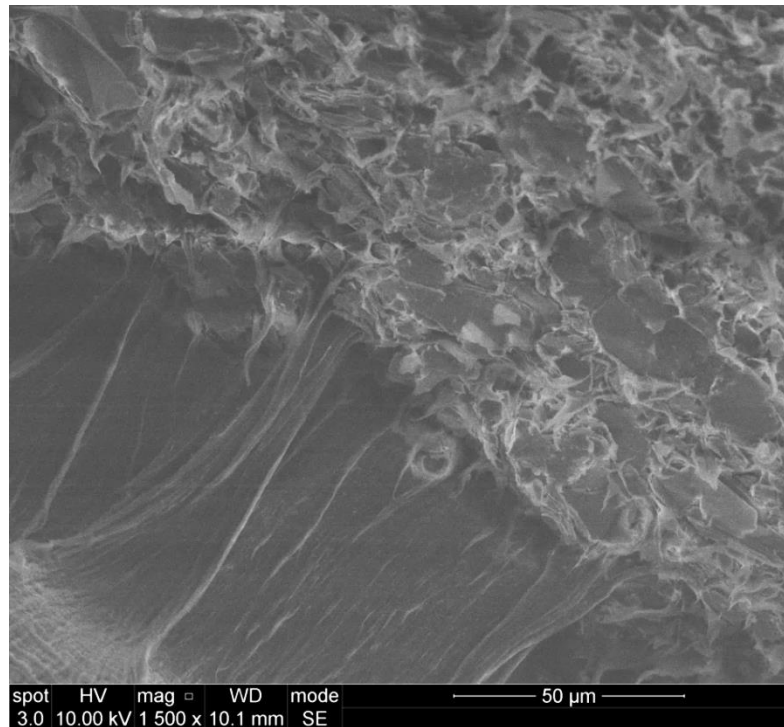
Figure 5-22 Sample 1 (x1500 magnification)

Moving away from the extreme end of the ductile failure (i.e. the threshold of the U-valley), to the start of the ductile elongation; a transition from brittle to ductile failure is observed. This is illustrated in Figure 5-22 at 1500 times magnification.

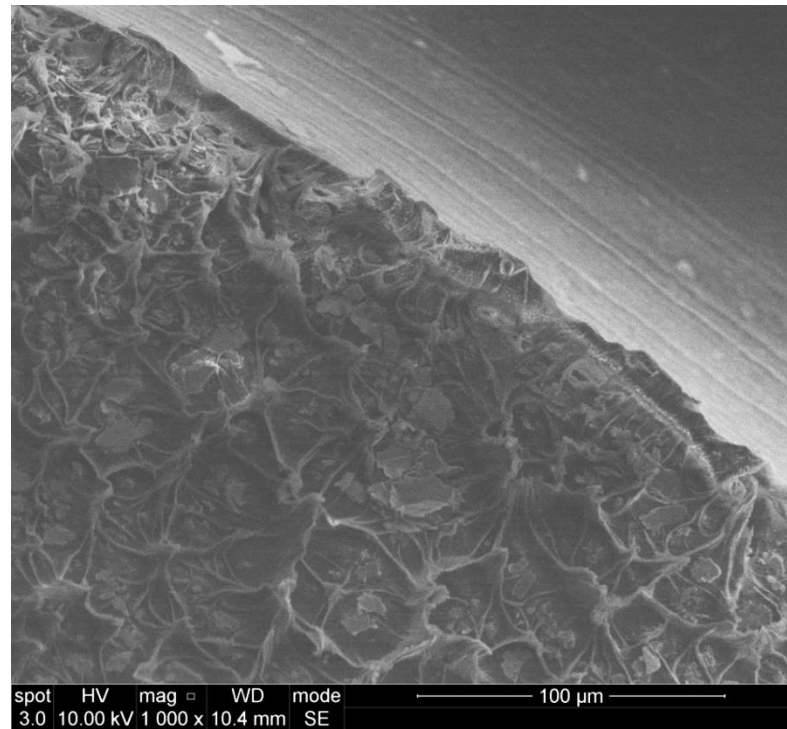
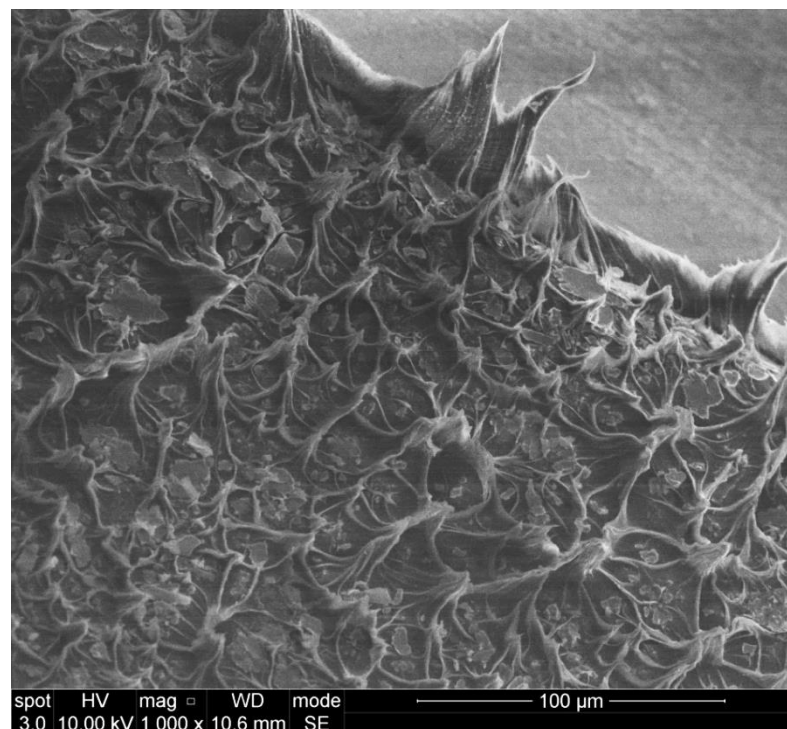
Figure 5-23 and Figure 5-24 both show the brink of two U-valleys at slightly different locations but on the same filament wire line at 1000 time magnification. Here, the failure surface shows some attempt at bonding to the fitting with some short polymer elongations throughout the surface. It is interesting to note that in the centre of each 'dark' region (between elongations on the pipe surface), there appears to be lighter coloured patches. This may be the remains of the talc contamination. However, this is only an assumption and would require a further chemical analysis of the failure surface to take place to determine the makeup of the fracture surface.

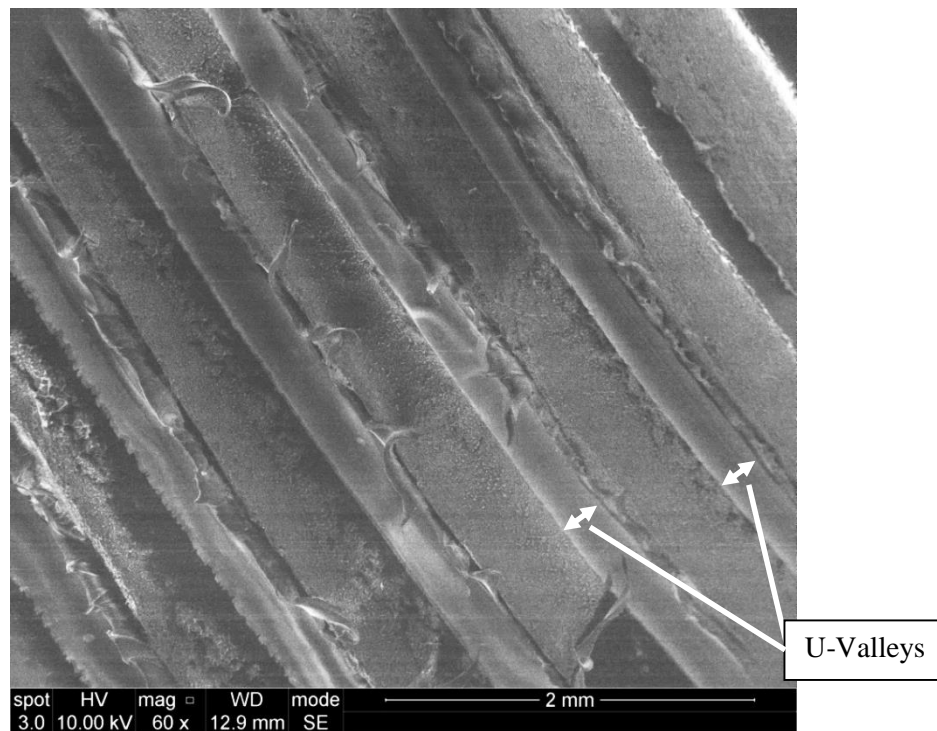
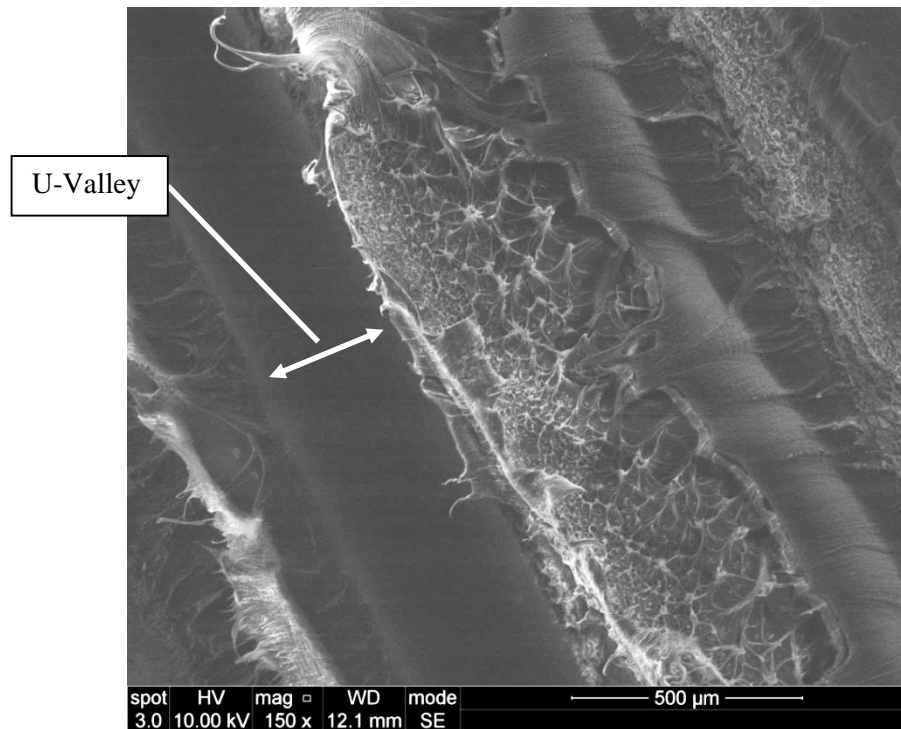
Figure 5-25 and Figure 5-26 show SEM analysis of U-valleys for sample 2 at 60 and 150 times magnification respectively. Like sample 1, there appears to be a difference in failure surface between the threshold of the U-valley in comparison to between the valleys themselves.

Much like Sample 2, Figure 5-26 shows some ductile elongations are at the threshold of the U-valleys.

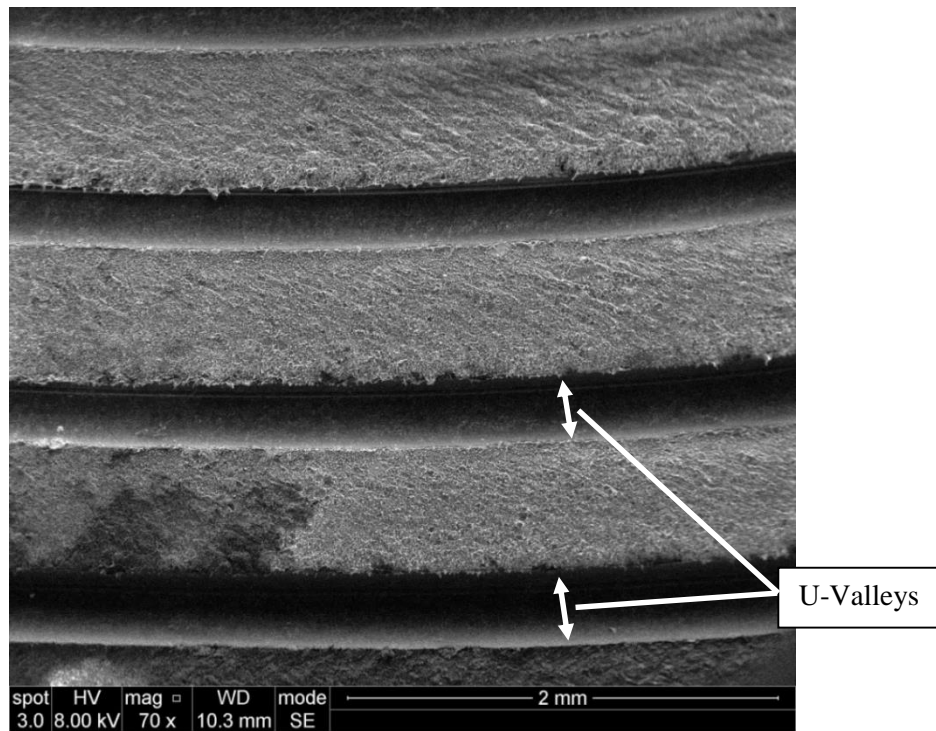
Figure 5-27 sample 3 (x70 magnification)

The third sample showed little bonding present via inspection by eye. Figure 5-27 shows the failure surface of sample 3 showing the U-valleys running left to right in the picture.

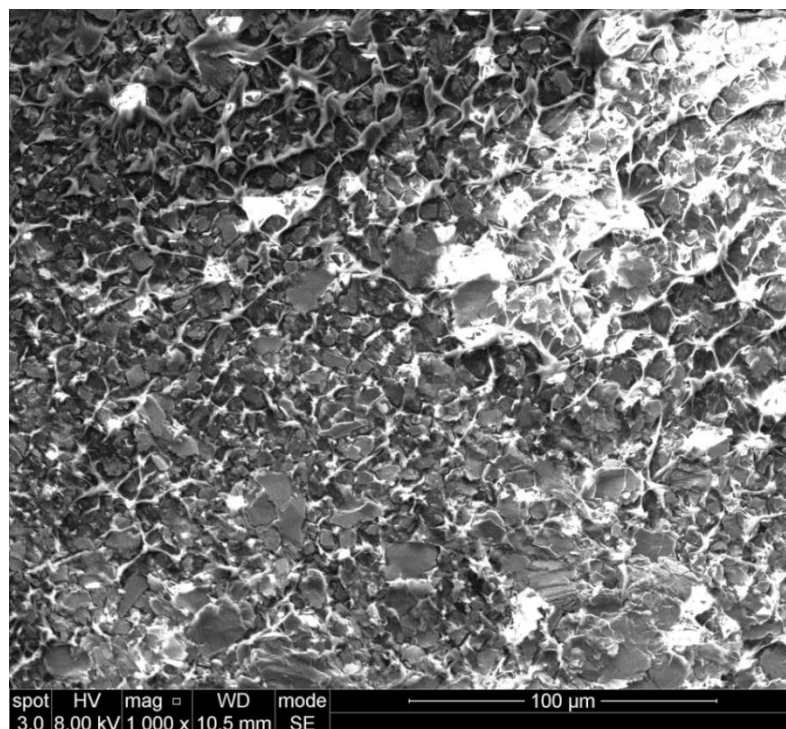
Figure 5-28 Sample 3 (x1000 magnification)

Figure 5-28 illustrates the failure surface of the parent pipe between the U-valleys. Much like the failure surface between valleys observed in sample 1 and 2, there appears to be a mainly brittle failure.

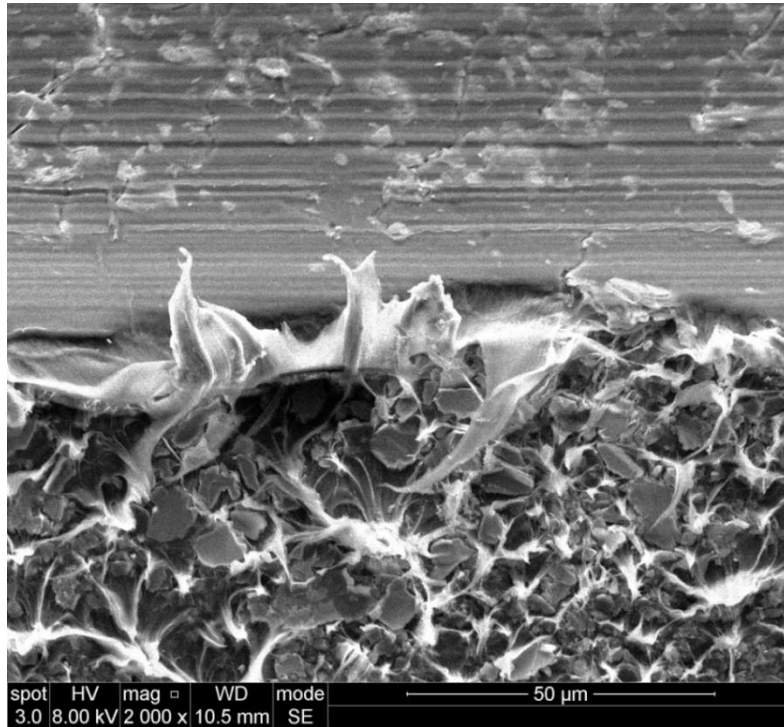
Figure 5-30 Sample 3 (x2000 magnification)

Figure 5-30 illustrates the U-valley at the top of the photograph and the brittle failure surface at the bottom. Note that in the middle of the photograph there are elongations that show a small amount of bonding has taken place.

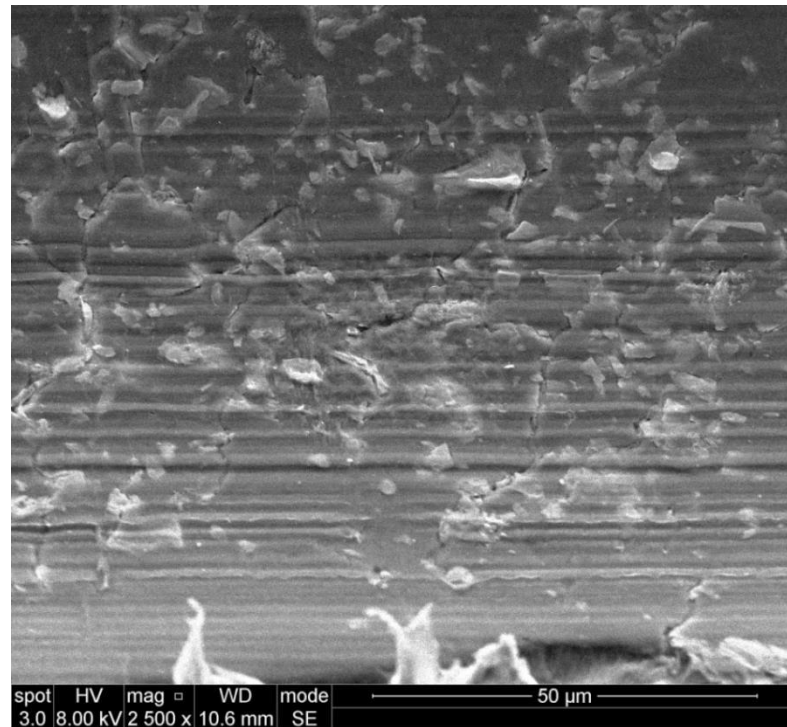
Figure 5-31 Sample 3 (x2500 magnification)

Figure 5-31 (below) shows the full extent of the U-valley. The channel appears to have small white particles that vary in size ranging from $\approx 0.5 \mu\text{m}$ to $\approx 6 \mu\text{m}$. Five particles were picked at random and the size was estimated using the '50 μm ' scale at the bottom of the photograph. These white particles (areas) correspond to the particle sizes and distribution that is expected from the talc contamination of the pipe surface prior to welding (see Appendix A for Contamination Experiment for distribution and size particulate contaminant using talcum powder). However, there is no evidence that upholds this without providing a chemical analysis of this surface. Unfortunately, the analysis was unable to be performed during the SEM analysis in this project.

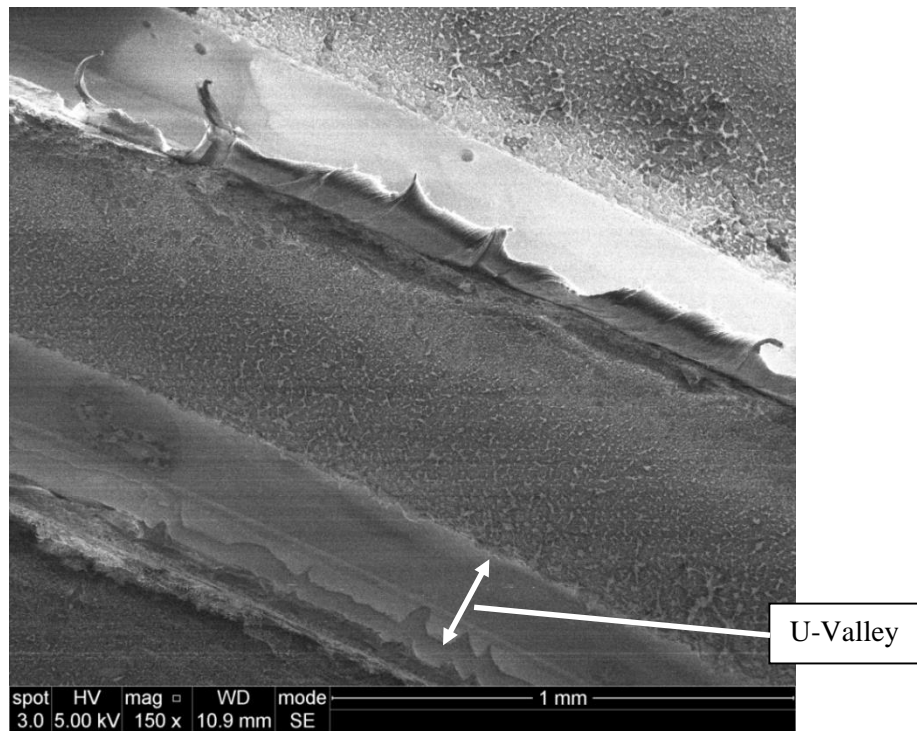
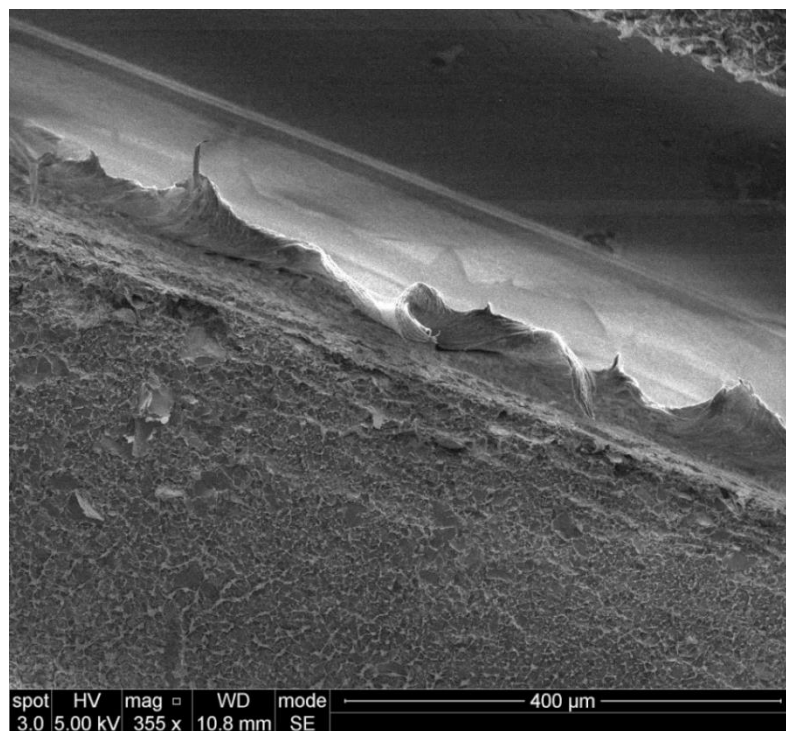
Sample 4 was observed visually to have no remains of black polymer from the fitting. It was also highlighted as this was the area that had the most prolific leak path when water flow was applied using a hand pump.

Under the SEM analysis, like the previous samples, there appeared to be a distinct difference in the failure surface at the threshold of the U-valley in comparison to between the valleys. This is further evident in Figure 5-32 and Figure 5-33.

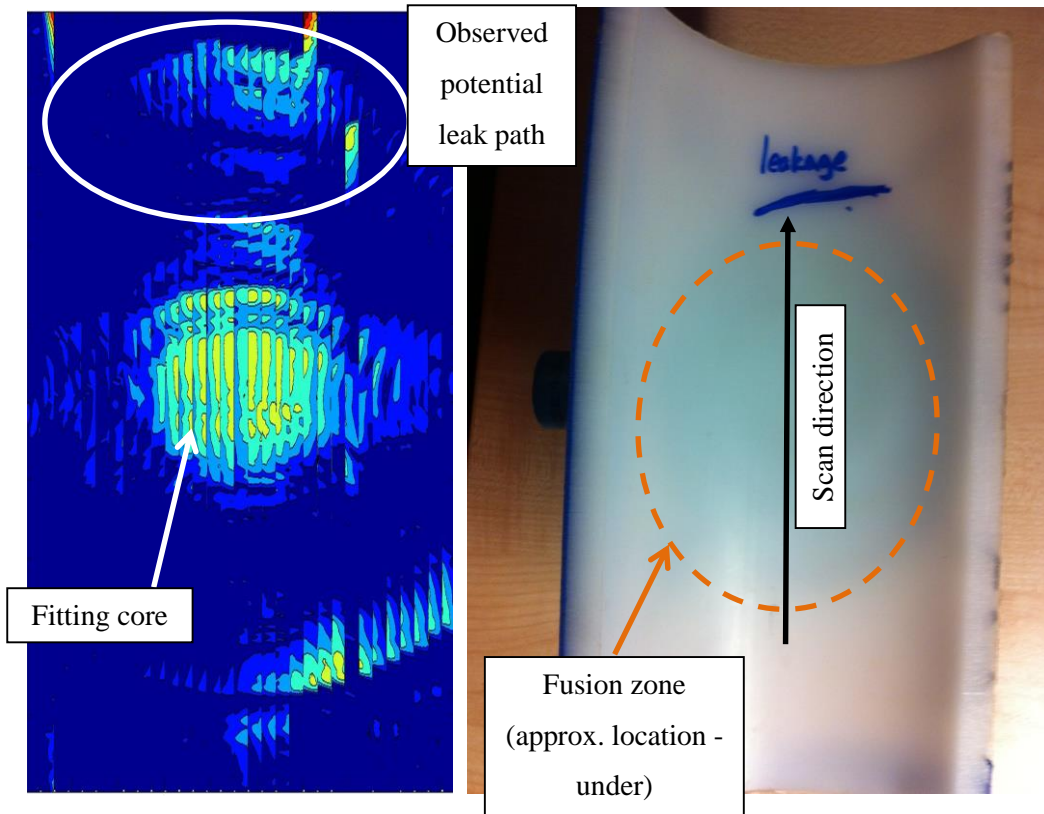
Figure 6-3 Preliminary line scan results showing leak path (a) and scan direction (b) [74]

Preliminary line scans were conducted on the bore of the pipe to observe any delamination about the fusion interface of three contaminated electrofusion tapping tees after they were previously failed via the ramp to burst test. The data obtained from the line scans were processed using MATLAB. The data were arranged to create an intensity map by knitting together the individual line scan data; thus showing the fusion zone. Intensity in this case is expressed as the magnitude of reflected signal received by the ultrasonic transducer. In theory, once intensity is plotted with respect to line scan position, a leak path should be observed. Figure 6-3 shows the intensity map (Figure 6-3a) and the specimen scanned (Figure 6-3b).

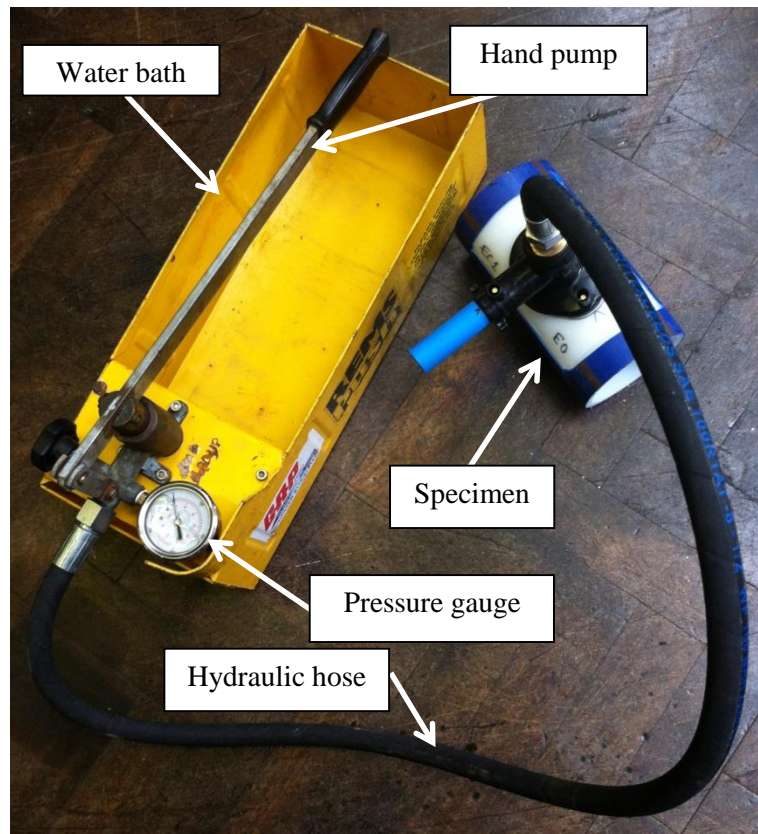
Figure 6-4 Hand pump and fitting (attached)

Once the map was created and analysed, the leak path hypothesis could be confirmed by applying a flow of water through the tapping tee fitting. This was achieved using a basic hand pump that was attached to the stem of the fitting (Figure 6-4). For this particular specimen, the leak path has been highlighted to be at the same location as found from the ultrasonic line scan experiment.

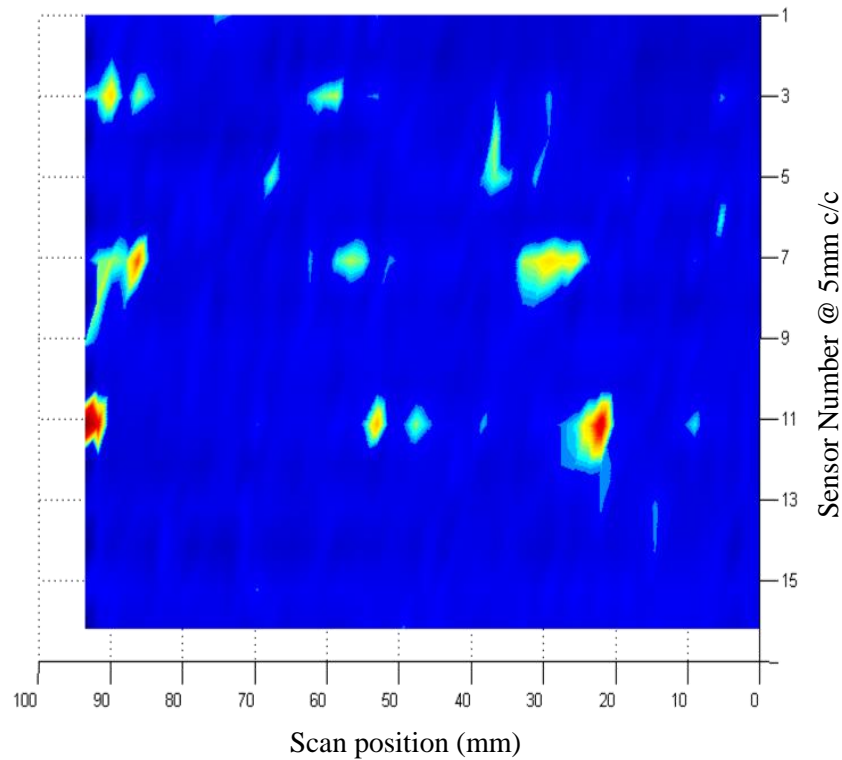
Figure 6-30 shows the results from the ultrasonic data which observed the holes in the pipe. The colour map is created using arbitrary units based on the signal intensity during the scan.

The results are successful in that they show the accurate locations of the holes in the pipe. However, it was noted that the sensors only picked up the holes that were directly opposite the sensor. Although this seems obvious, sensor 3 failed to accurately pick up the top three holes as the sensor must not have been directly over the centre of the holes. This may explain why the data is inconsistent at this point. The bottom holes shown in Figure 6-29 are not shown in Figure 6-30 as sensor 15 was dead, as mentioned in Section 6.3.2.

Figure 6-30 Data from ultrasound scan of holes in pipe

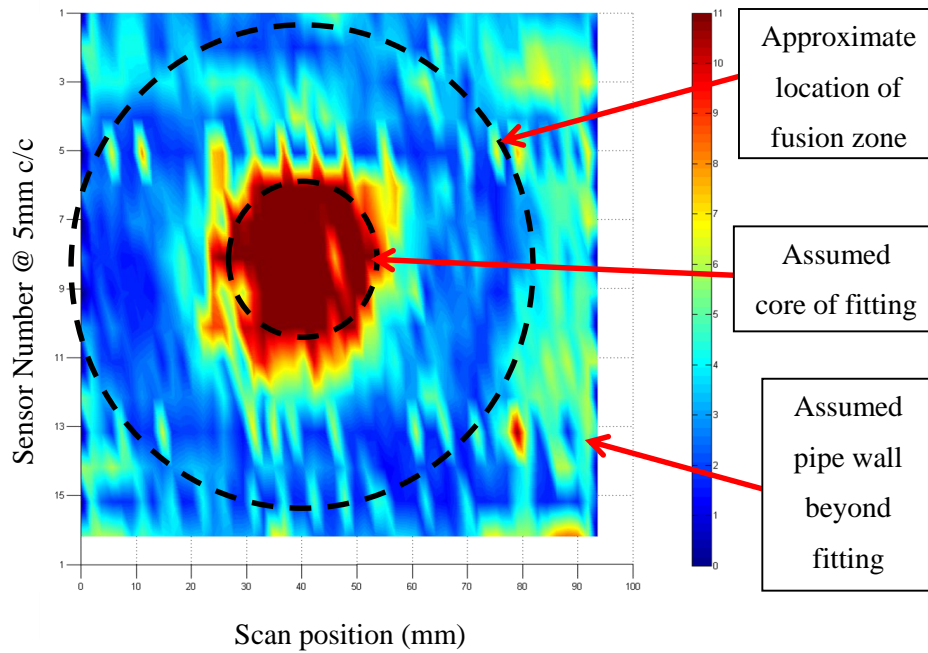
Figure 6-31 Scan of a perfect joint

Figure 6-31 shows the 82nd scan of the perfect joint. The fatigue test was performed for 192 cycles of which no failure occurred. The 82nd scan was selected to represent the approximate middle in the number of cycles conducted. The results depicted clearly show the centre of the fitting. The circumference of the fusion zone can almost be fully observed as well as pipe wall beyond the fitting. However, the results are arguably subjective as they may be seen as ‘open to interpretation’. Accurately positioning the probe before commencing a test to ensure the apparatus effectively scanned the entire fusion zone proved difficult. It was noted that the probe may scan beyond the fitting. Therefore it was expected to observe the pipe beyond the fitting but potentially only on one side of the results.

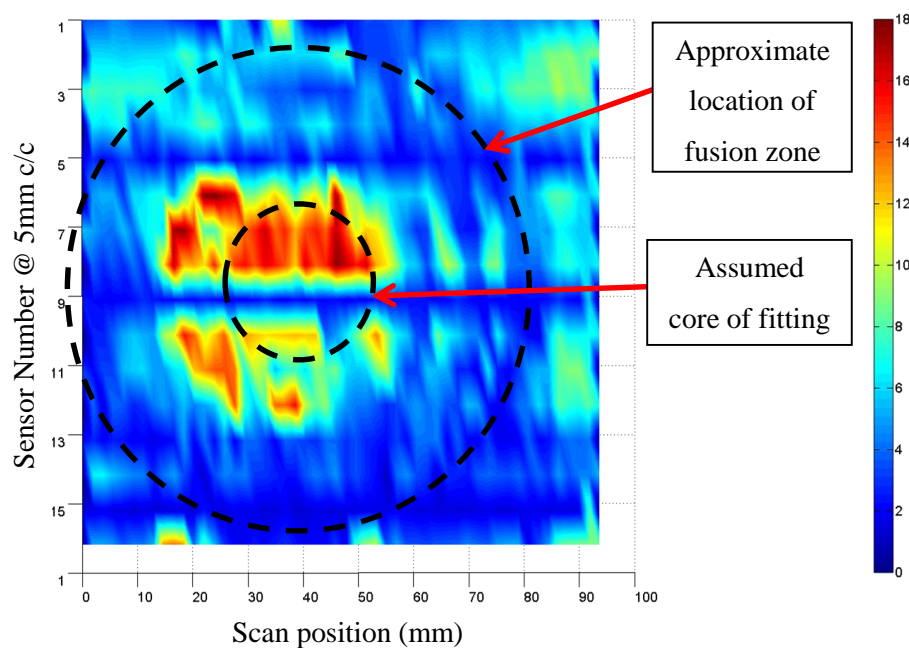
Prior to commencing the fatigue test, an initial scan was performed when no pressure was present in the system. The results of this scan are illustrated in Figure 6-32 where the centre of the tapping tee fitting is easily observed. However, it is clear that for reason unknown by the author, no results were obtained by sensor 9. Here, an outline of the tapping tee can also almost be seen.

Figure 6-32 Initial scan – No pressure – specimen ES

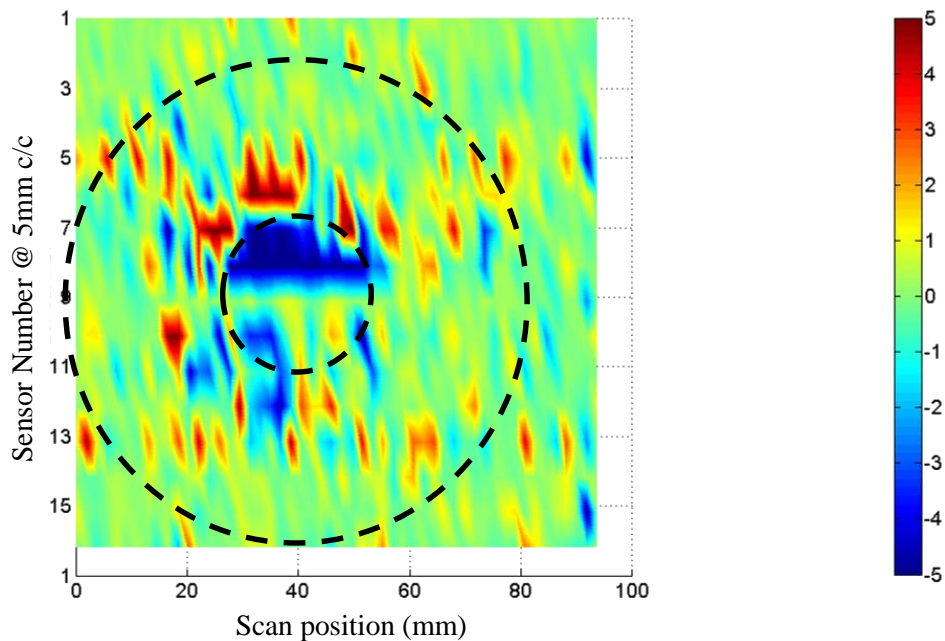
Figure 6-34 Difference in results with respect to starting pressure – specimen ES

As can be seen in Figure 6-34, there is little change in magnitude of signal received about the fusion zone. However, there appears to be a slight change around the centre of the fitting where the signal has intensified. This may be due to pressurisation of the tapping tee potentially initiating a crack mechanism.

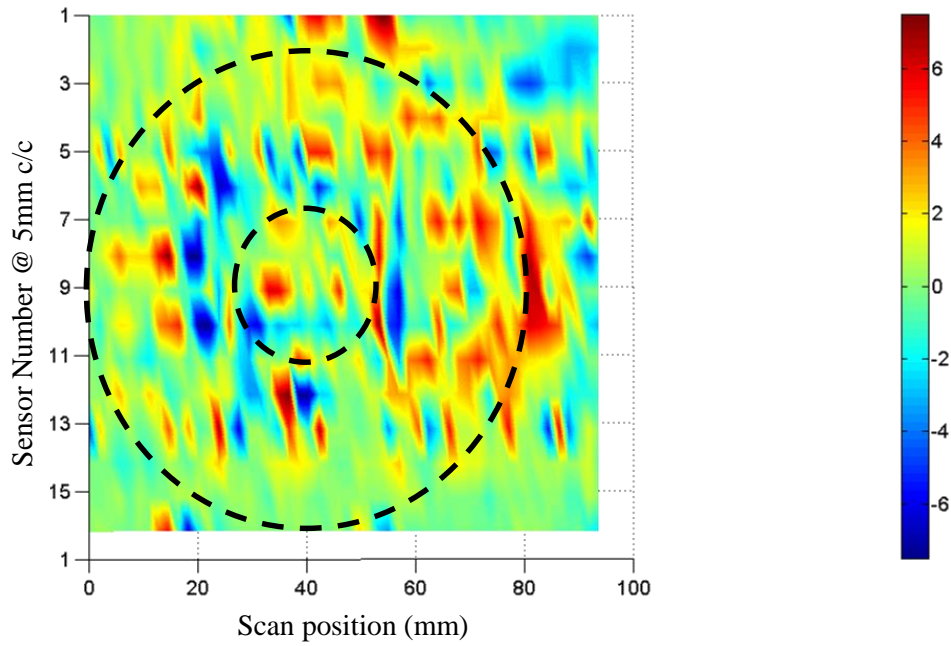
Figure 6-36 Cycle 2 – showing difference from first cycle – specimen ES

The second scan shows a change in signal amplitude between approximate scan positions 60 mm to 90 mm.

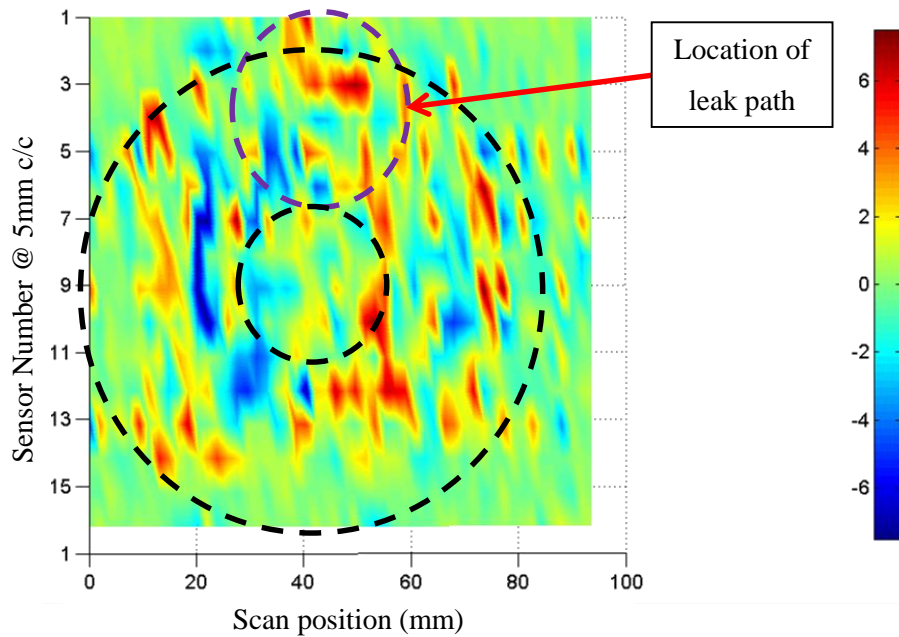
Figure 6-39 Final (7th) cycle – showing difference from first cycle and approximate leak path – specimen ES

It would appear that there was a noticeable change in the signal amplitude between positions 50 mm and 80 mm which suggests that some delamination may have taken place. However, as the scanning probe mechanically failed during the 3rd cycle and required resetting, the results may not give an accurate representation of the failure mechanism. Figure 6-40 shows the major leak path of specimen ES. With respect to the location of failure on the final scan (Figure 6-39), the area of the fusion zone (scanned) that corresponds to the major leak path has been highlighted in Figure 6-39.

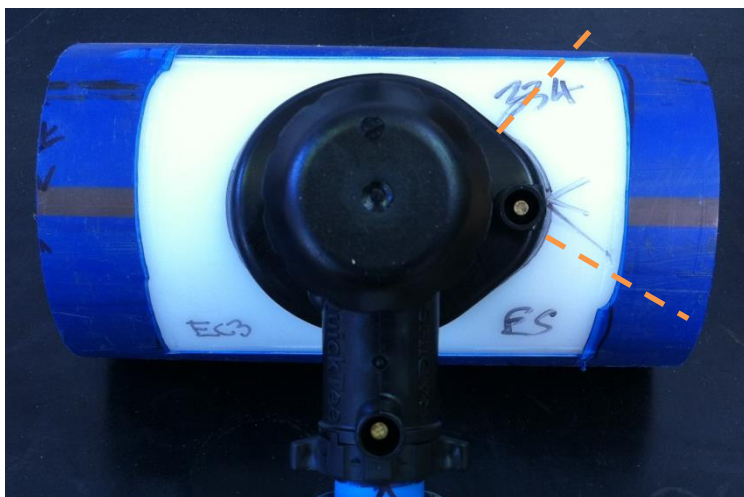
Figure 6-40 Specimen ES showing major leak path

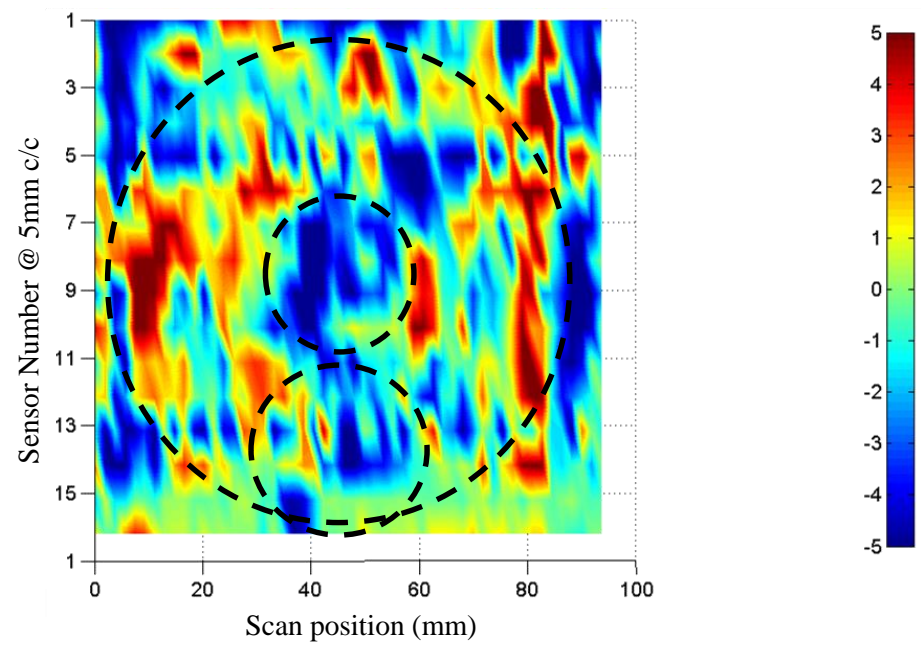
Figure 6-46 Cycle 6 – showing difference from first cycle and approximate leak path – specimen ET

The results suggest the difference in amplitude of the signal increases around the approximate location of the centre of the tapping tee in the final two cycles in the fatigue test. This could be the propagation of a crack(s) about the jointing interface. In contrast, the first three cycles of the test show an abundance of 'green' which represents no change in the difference in signal amplitude in comparison to the first scan of the fatigue test.

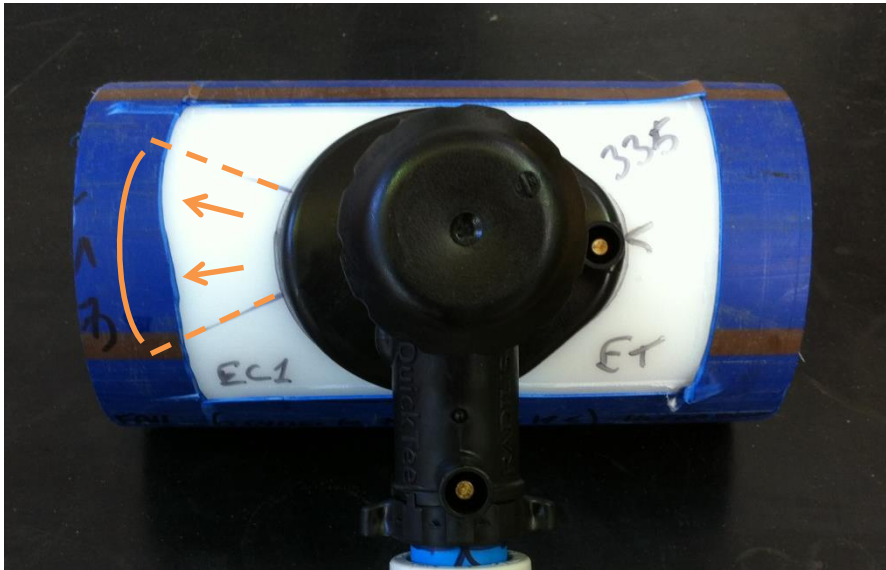
Figure 6-47 Specimen ET showing major leak path

Figure 6-47 shows the major leak path of specimen ET; this has also been highlighted in Figure 6-46 at the approximate location in the fusion zone. It becomes clear that the results obtained for specimen ET may not show the failure mechanism of a contaminated electrofusion tapping tee. Interestingly, the signal amplitude appears to increase in the last two cycles which may indicate rapid crack growth. However, it was later discovered by analysing a video of the mechanical scanning of the tapping tee - taken using a static webcam - that the entire probe rotated its 'home' position very slightly after each scan. Thus the home position was not consistent throughout the fatigue test. Although, there was very little difference from the home position on the first scan compared to the last scan; the results obtained from the fatigue test are arguably flawed in that the scan position was not consistent. Therefore the difference in signal amplitudes with respect to the first scan of the fatigue test are also inconsistent, giving an incorrect representation of data.
