**THE INFLUENCE OF CONTAMINATION ON THE FATIGUE
PERFORMANCE OF ELECTROFUSION JOINTS**

A thesis submitted for the degree of Engineering Doctorate of the
University of Sheffield

Department of Mechanical Engineering

December 2014

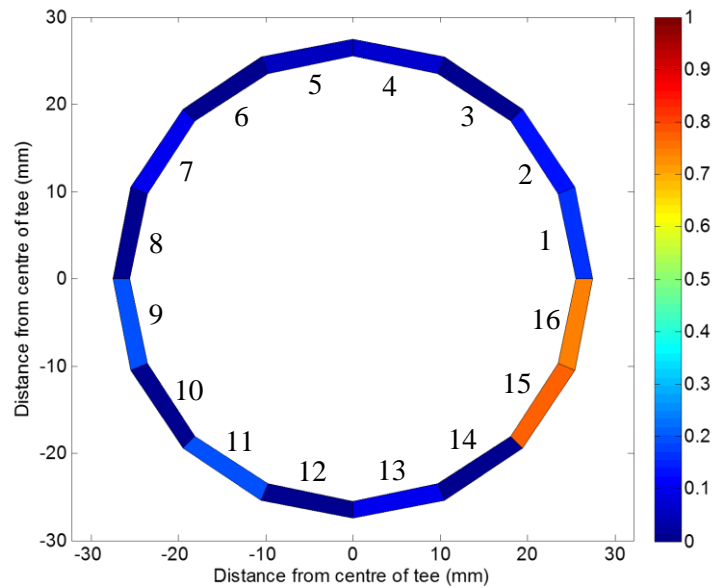
Figure 6-53 Difference at starting pressure – 12.5 bar

The results highlighted in Figure 6-53 suggest there has been an increase in signal strength about sensors 15 and 16. This may indicate that a crack may have developed as a result of pressurising the contaminated electrofusion tapping tee.

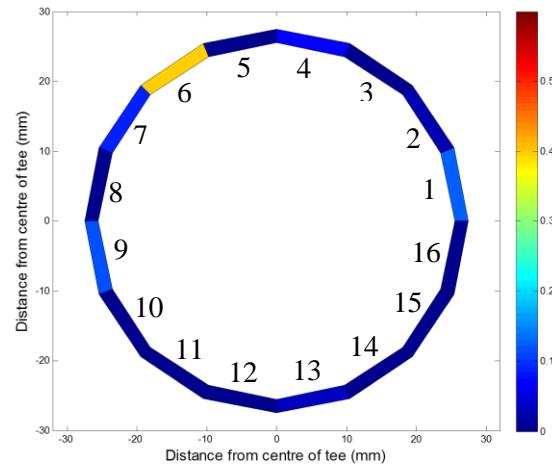
Figure 6-60 Cycle 12 (failure cycle)

The specimen failed on the 12th cycle during the rest time at the top of the cycle, i.e. at maximum pressure. It was also here where the scan commenced as the trigger pressure was active at the top of each cycle. Therefore, it is assumed that the sensors captured the failure as it occurred. Post-experiment, water was pumped through the failed specimen in order to observe the leak path. Figure 6-61 shows the leak path of the failed specimen; a major leak path was observed over sensors 1 to 6.

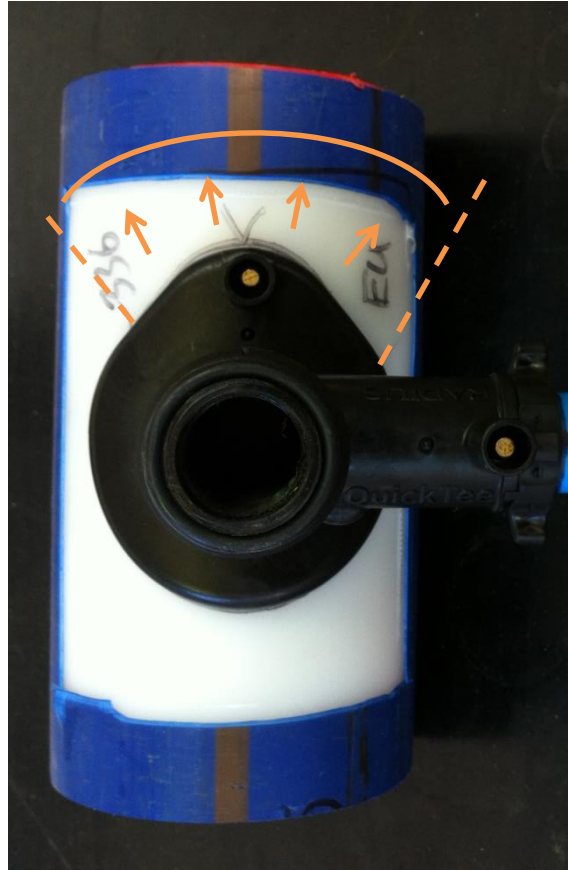
Figure 6-61 Specimen EU showing leak path area and direction

The pad sensor arrangement seemed promising in showing the development of cracks through the jointing interface but again limitations within its design meant that solid conclusions could not be drawn. The position of the sensors with respect to the fusion zone meant that delamination would only be observed local to where the sensors were placed. Therefore, an analysis of crack initiation and propagation would be near impossible to observe. The analysis did show some change in the signal amplitude but on most sensors. The most obvious and largest amplitude change was at sensor 6. However, the specimen showed a predominant leak path between sensors 1 to 5; therefore again, the analysis being inconclusive.
