## Chapter 3 : Stainless Steel

In this chapter stainless steel 316L will be examined, due to its widespread availability and low cost. The composition was determined via ICP-OES and combustion methods and is given in Table 3.1.

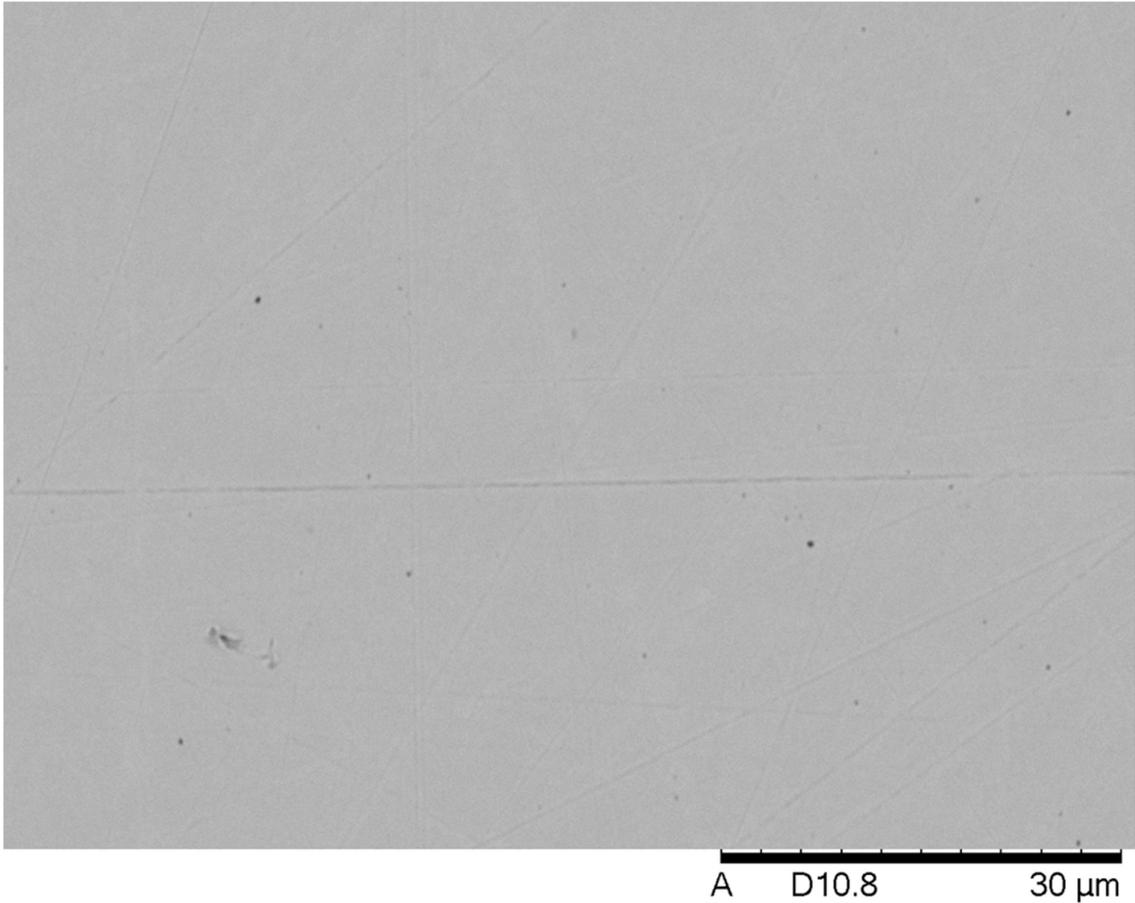
Figure 3.1 gives a SEM image of the stainless steel before immersion into the molten salt, the surface is clean with some scratches present due to polishing.

Figure 3.1: SEM image of stainless steel 316L before immersion in the molten salt.

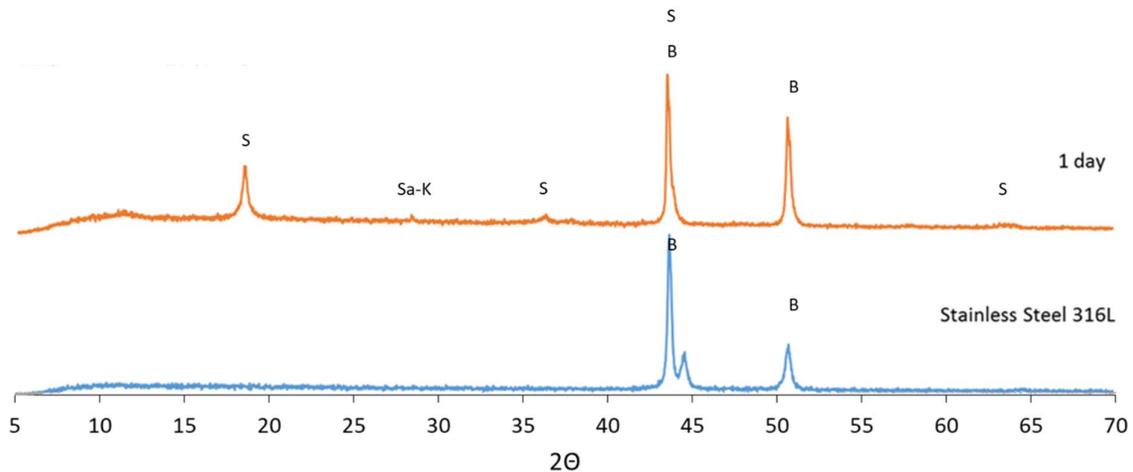
The XRD pattern for the one day test, along with a sample of stainless steel 316L, are shown in Figure 3.3. Peaks at approximately 44 and 51° 2θ are assigned to stainless steel 316L. The peak at ~18° 2θ is due to the presence of lithium in the form of a spinel on the surface.

It appears that the steel sample in the one day test utilised lithium to form a protective layer over the surface of the sample. It is difficult to ascribe the peak to a particular spinel, as lithium chromium oxide, lithium manganese oxide and lithium chromium manganese oxide all give similar diffraction patterns, this is shown in Figure 3.4, and is further exaggerated by the presence of stainless steel giving a somewhat noisy pattern, which subsequently causes some broad peaks.

Figure 3.3: XRD patterns for the baseline stainless steel 316L tests. Here S corresponds to a spinel (shown in Figure 3.4), B is the bulk and Sa-K is the potassium salt.

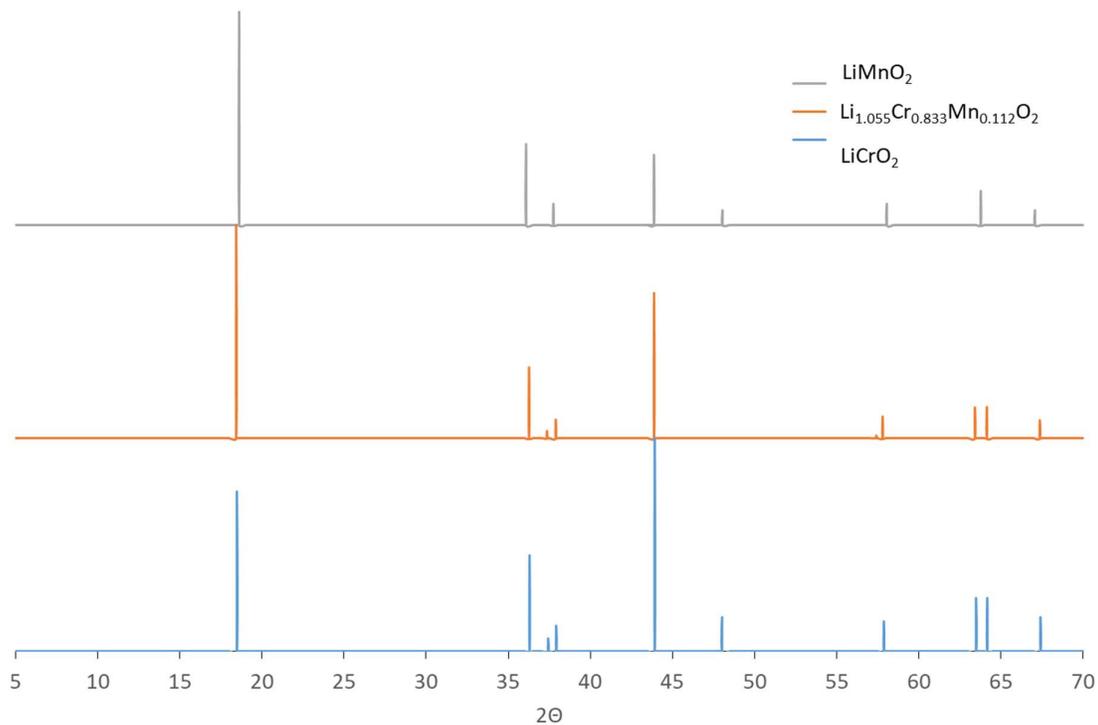
Figure 3.4: Diffraction patterns for possible spinels observed in this work.

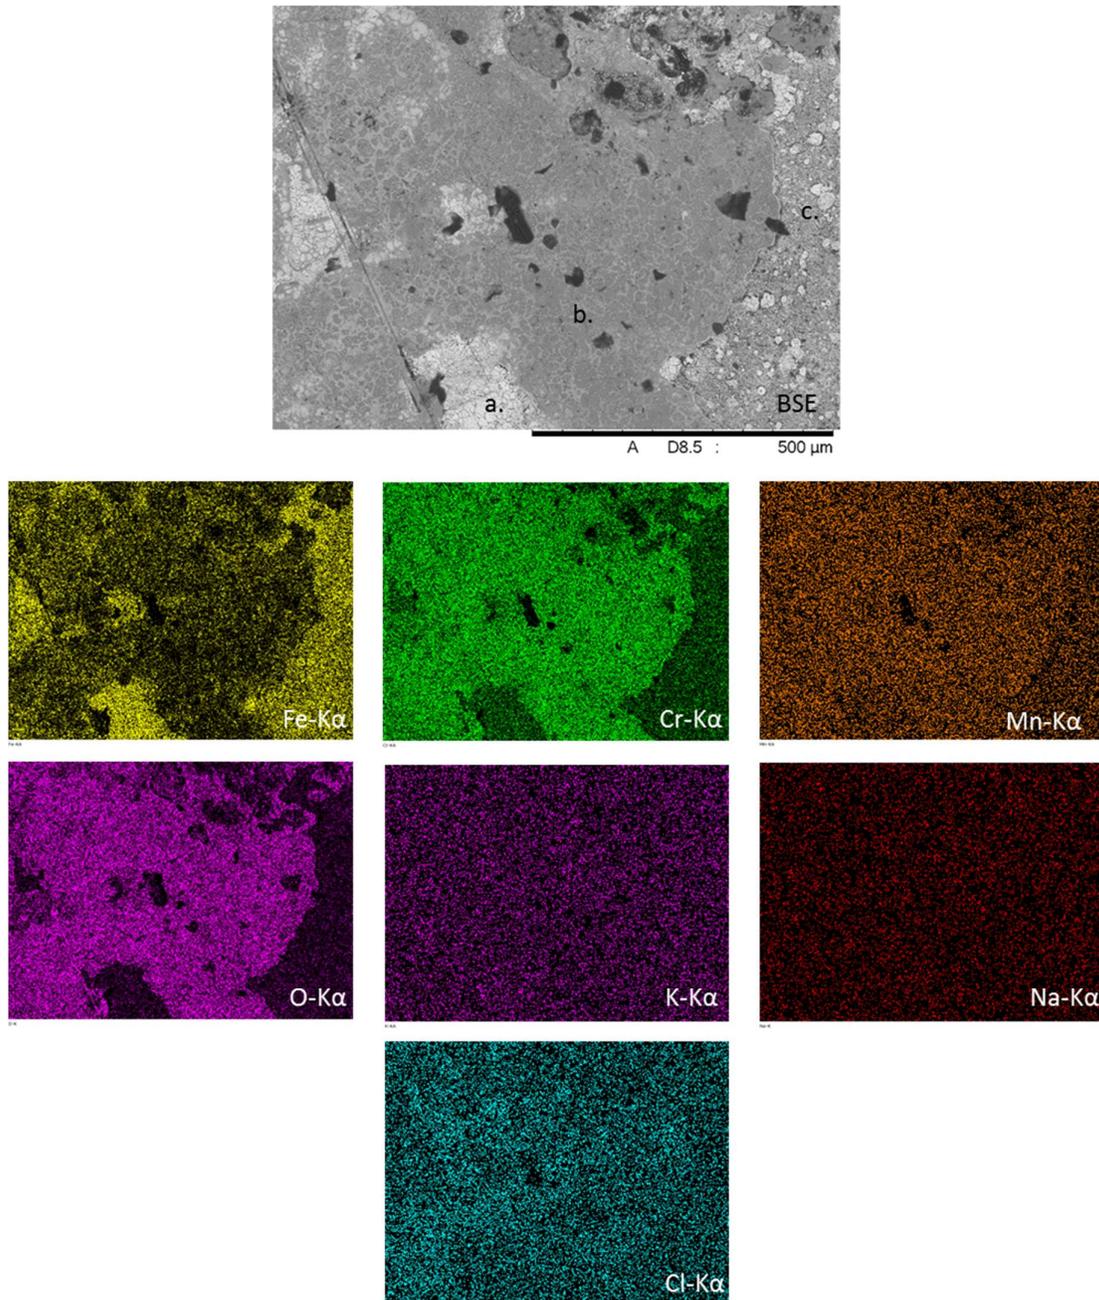
Three different regions are observed in the one day baseline results, and these are denoted (a), (b) and (c). Figure 3.5 shows a surface SEM image for the one day test; contrast can be seen between the three regions, which are present in conjunction with one another. The EDX analysis for region (a) indicates that it is iron rich and is likely the stainless steel bulk. Grain boundary attack was stated by Richardson et al. [1] to be the predominant form of corrosive attack in Inconels by fluorides [1] and this type of mechanism is visible in area (a). Region (b), also showcased in Figure 3.5, shows a chromium/oxygen corrosion layer. The preferential leaching of chromium has been widely reported in this field, with Richardson et al. [1] reporting that voids are formed due to the depletion of chromium, this has also been observed by Shankar and Mudali, and by Olson et al. [1, 2, 6]. The experiment was run in atmospheric conditions and it was therefore possible for oxygen to aid in the formation of the corrosion layer, whereas work by other authors has generally been conducted in a controlled environment and the effect of oxygen has been minimal [2, 6, 7]. The corrosion layer does not cover the full sample, but where the corrosion product is present the bulk Figure 3.5 is not observable. This suggests that the corrosion product is relatively thick and while it does not cover the full sample, it is envisaged that as the immersion time increases so will the surface coverage. The

Figure 3.5 shows a textured surface denoted as region (c), the EDX analysis shows that iron is the main element present, and it is believed that the stainless steel bulk (a) was attacked. This is further proven by the difference in the microstructure of area (a) and (c): (a) appears smooth, whereas (c) is more textured. This textured surface suggests that the bulk has been attacked, and it is believed that the alloying elements have been sacrificially removed from the stainless steel bulk (a) to form (c) before the corrosion layer, (b).

Sodium and potassium are shown in the EDX data to represent alkali metals from the eutectic salt; lithium cannot be observed in the EDX data as it has a low atomic number and cannot be detected, but when analysed together with the XRD data it is likely that a lithium chromium oxide layer has formed.

Figure 3.5: BSE image and corresponding EDX elemental maps for stainless steel 316L coupon immersed in an alkali eutectic chloride salt for one day. Regions (a), (b) and (c) are discussed in the text.

On a first viewing, Figure 3.5 suggests that manganese is present within the corrosion layer, as contrast can clearly be seen in the EDX data for manganese. However, the preferential leaching of manganese has not been observed in the literature and therefore further investigation was required. Figure 3.6 shows the EDX spectrum between 5-6.6 keV. The  $K_{\beta}$  peak for chromium is observed at 5.95 keV, whereas the  $K_{\alpha}$  peak for manganese is observed at 5.9 keV, and as broad peaks are obtained for this sample, it is easy for the two elements to be present within the EDX data, but further investigation

EDX can also be used to give an estimation of the composition of the layer, this is given in Table 3.2. This reiterates the results that have already been observed, with an increase in the relative composition of the chromium and oxygen in area (b), when compared to area (a) and (c). The point analysis gave no indication that manganese was present within area (b).

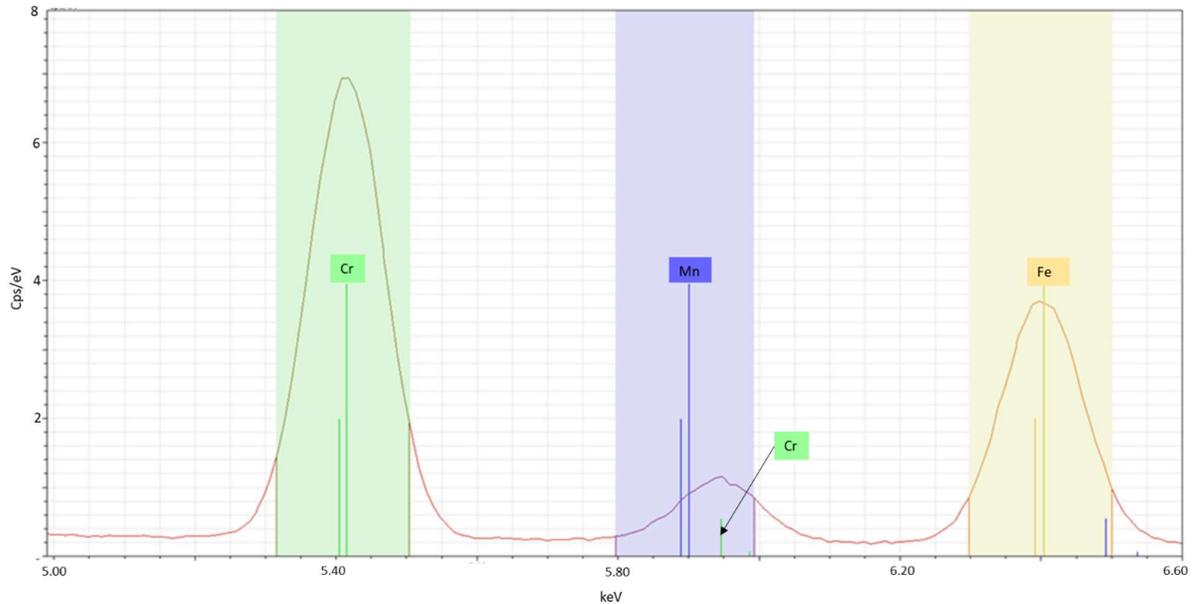
does suggest that only chromium is present [9]. It is therefore highly likely that manganese present in EDX data has been incorrectly quantified by the software.

Figure 3.6: EDX spectral peak positions and integration regions for chromium, manganese and iron between 5-6.6 keV, along with an example spectrum obtained for the sample.

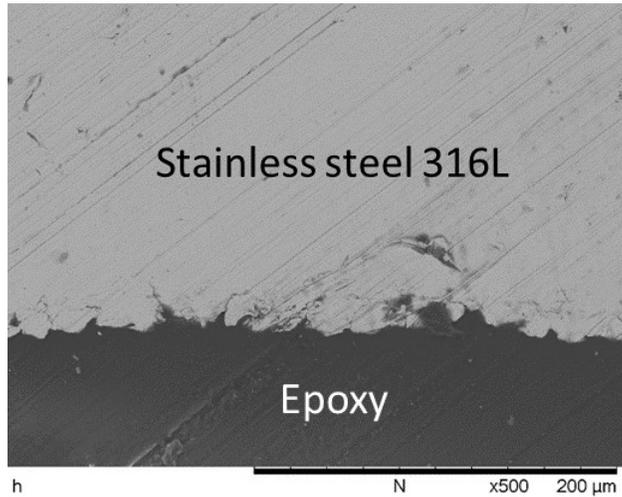
The cross sectional image, Figure 3.7, does not give much insight into the corrosion layer. This is seen throughout this work, and is to be expected as the layer appears sporadically on the surface. Although the layer appears thick in Figure 3.5, it is relatively thin when compared with the bulk and is difficult to observe. Images were taken at a higher magnification, but have a low resolution and any corrosion

product is difficult to distinguish. It is also possible that due to the sporadic nature of the layer there is no corrosion product present within the analysed area.

Figure 3.7: Cross-sectional BSE image for a stainless steel 316L coupon immersed in a molten alkali chloride eutectic for one day.

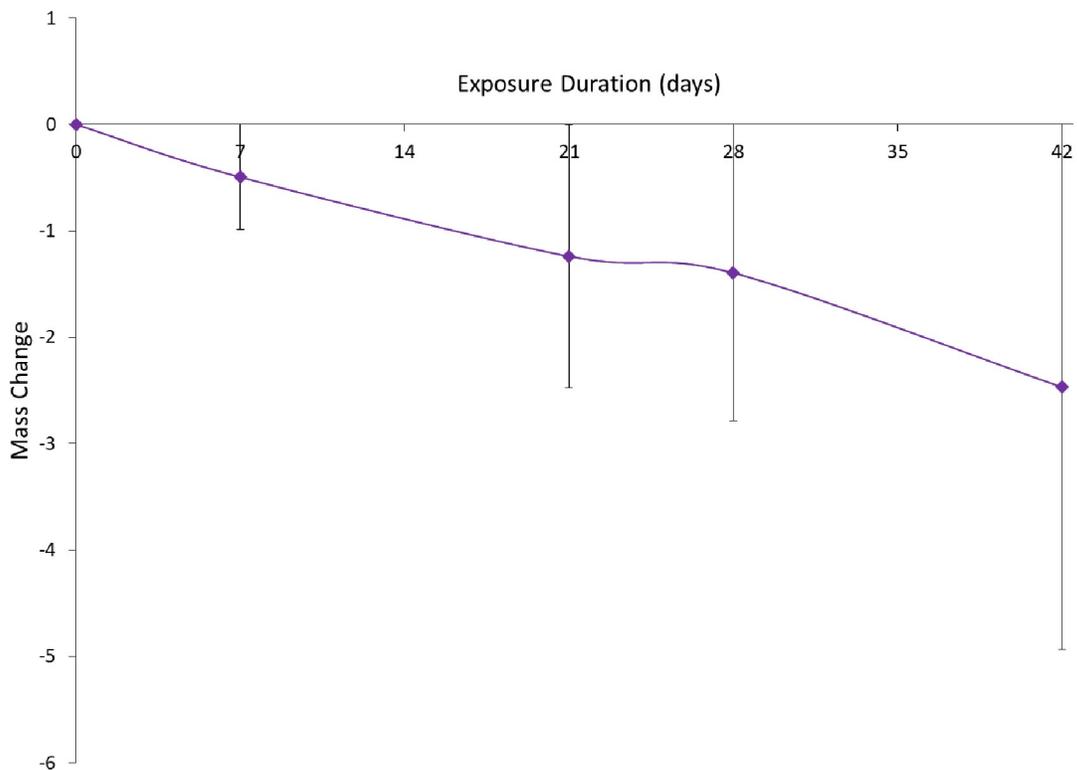
Figure 3.9 shows that the mass loss is close to linear for the samples. It should be noted that the mass change of the specimen is due to loss of initial material and formation of corrosion product. Mass change measurements were not taken for the original three week test.

Figure 3.9: Mass loss of the stainless steel samples during corrosion, as a percentage of initial coupon mass; the original three week test is not shown.

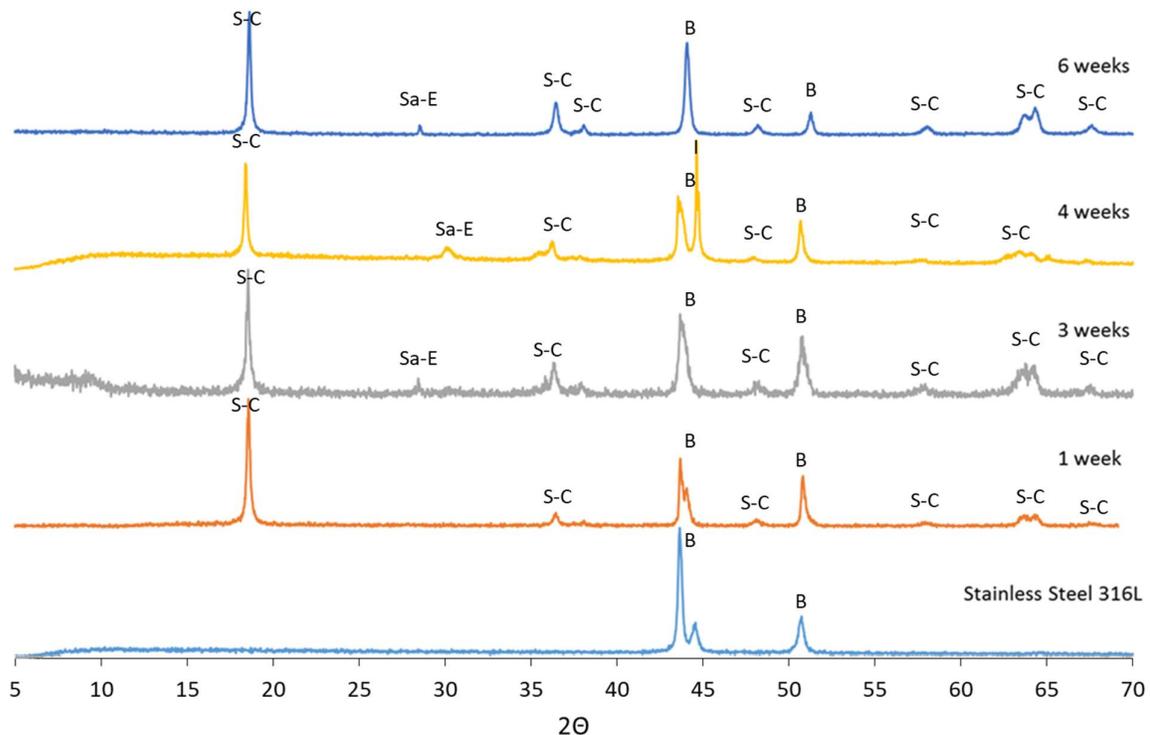
The diffraction patterns for the studied samples can be seen in Figure 3.10; the peaks at approximately 44 and 51° 2θ are assigned to stainless steel 316L. These peaks are present in all the samples but have a significantly lower intensity as immersion time increases, which is attributed to the thicker corrosion layer. Four of the five patterns show the presence of a lithium-containing product at approximately

The lithium-containing spinel peak at approximately 18° 2θ is not present in the three week test. In addition to the two peaks assigned to stainless steel 316L there are numerous oxides including those of iron (Fe<sub>3</sub>O<sub>4</sub>, FeO), chromium (Cr<sub>2</sub>O<sub>3</sub>), and iron and chromium (Cr<sub>0.75</sub>Fe<sub>1.25</sub>O<sub>3</sub>). It is also possible that KCrO<sub>2</sub> and FeCl<sub>2</sub> are present, but with peak broadening, this is difficult to confirm.

The diffraction pattern also indicates that salt is present in the sample, but due to the highly textured surface and inefficient packing of the corrosion product there is a likelihood that it is trapped within the system. This is also possible within the repeated three week test along with the four and six week test, where it is envisaged that a thicker corrosion product will be formed due to longer immersion time.

Figure 3.10: XRD patterns for the stainless steel 316L reruns, where S-C corresponds to the spinel LiCrO<sub>2</sub>, Sa-K is KCl, B is the bulk, Sa-Eu is the eutectic salt, IO is iron (III) oxide and Sa-Na is NaCl.

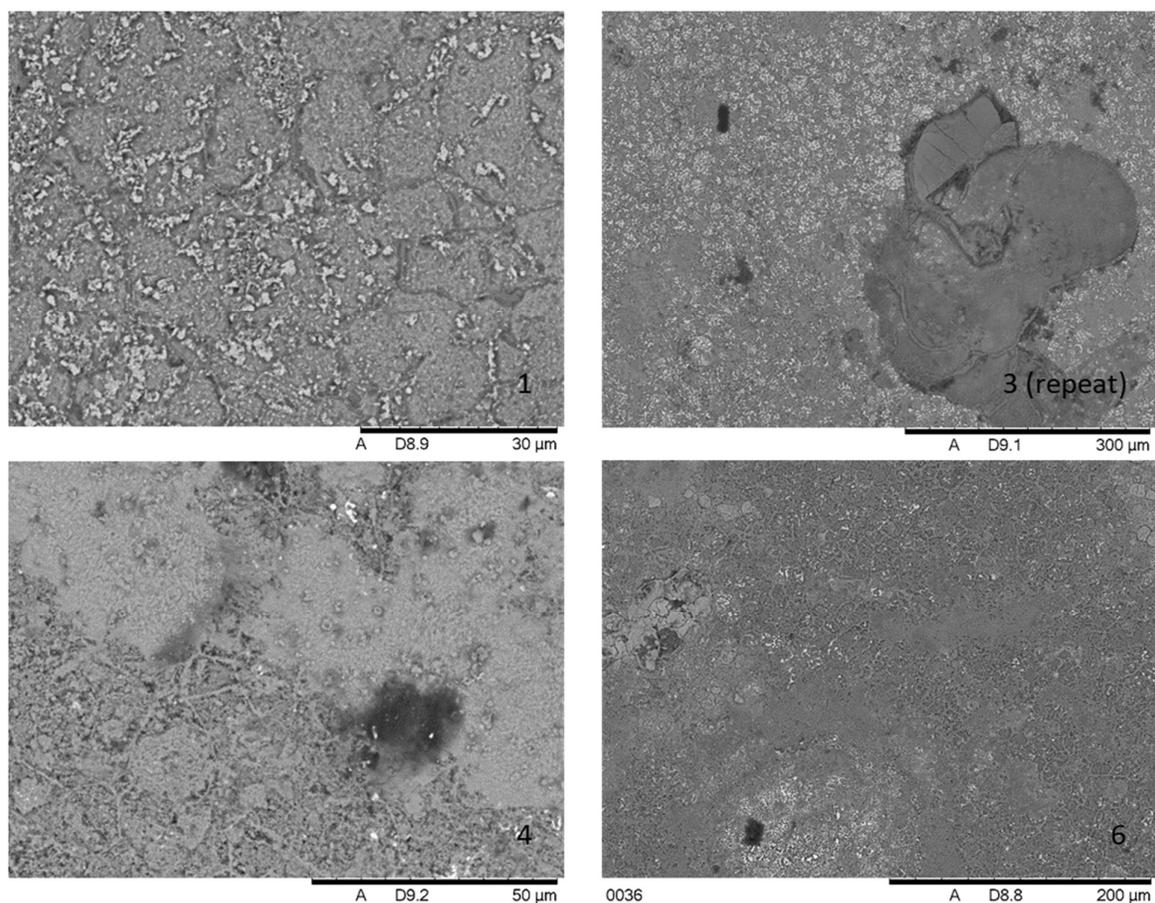
The SEM images obtained in the stainless steel tests show similar results to one another and to the baseline tests, if the three week test is omitted. Therefore the one, three week (repeat), four and six week samples will be reported together, and the three week tests will be reported in Section 3.2.2.3 and 3.2.2.4. Figure 3.11 shows the four BSE images obtained for each of the stainless steel samples held in the molten chloride for a predetermined length of time. Their EDX data is very similar and therefore only the six week test will be shown, Figure 3.12.

Figure 3.11: BSE images of stainless steel 316L held in a molten alkali chloride salt for a predetermined length of time (stated in the bottom right of each image).

The corrosion layers cover the majority of the sample, and the attacked stainless steel surface (c) that was observed in the one day baseline tests is generally not present. Figure 3.12, which shows the six week tests, suggests that chromium and oxygen are present along with iron from the stainless steel, and it is therefore likely that this phase is  $\text{LiCrO}_2$  denoted as (b) in the baseline tests. The selective leaching of chromium has previously been seen by Shankar and Mudali [2] as well as Reiser et al. [12].

The presence of chromium, not only in the corrosion layer but also along grain boundaries, can be seen in the one week BSE image in Figure 3.11 and is a common phenomenon known as intergranular corrosion [13].

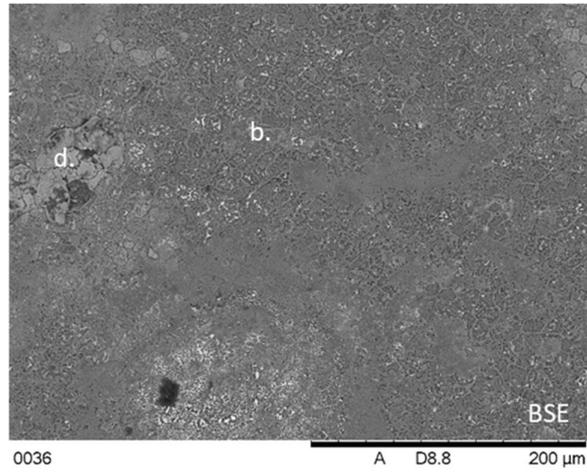
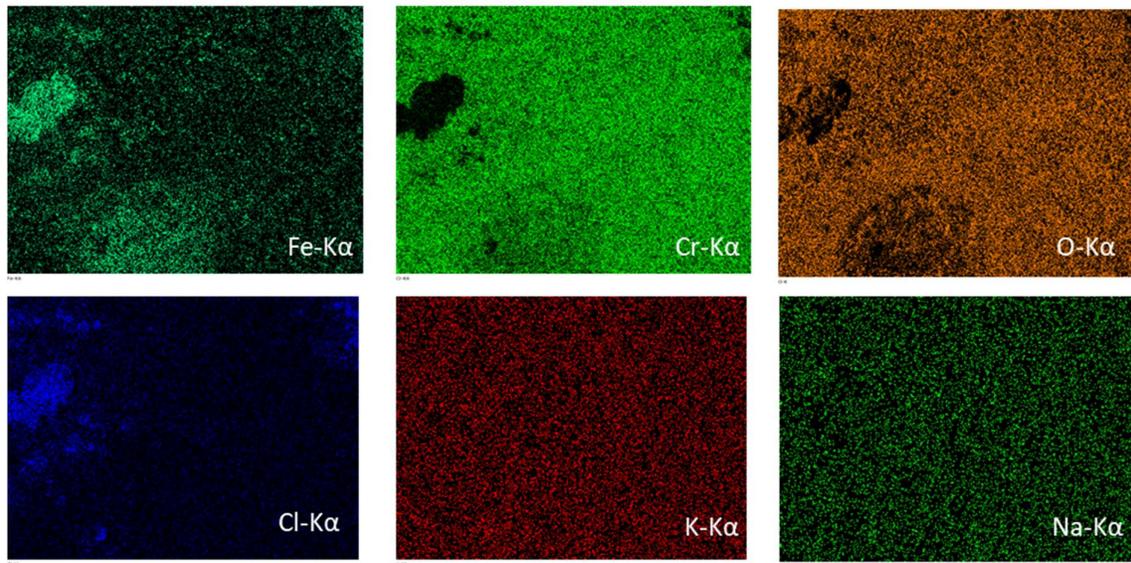
A repeat of the three week test was deemed necessary after the irregular results obtained in the original three week tests. The repeated test resulted in a further area (d) that required further EDX analysis, this is shown in Figure 3.13, and a similar area is observed in the six week tests, Figure 3.12.

The EDX data appear to show that an iron chloride or oxide has formed on both the three week repeat and the six week samples. The XRD patterns for the three (repeat) and six week tests do not show the presence of an iron compound, which has been identified in the EDX data. It is possible that these products are present within the diffraction pattern, but due to disordered phases in the data they are difficult to identify. Furthermore, Table 3.3 also shows an estimate of the elemental composition of (d) obtained via point analysis for both the three week repeat and six week tests and appears to show the formation of an iron oxide. This was difficult to conclude from the EDX due to the lack of contrast within the oxygen data. It is possible that chloride is also present within the sample, but as a trapped inclusion within the disordered matrix.

Figure 3.12: BSE image and corresponding EDX elemental maps for the surface of stainless steel 316L coupon immersed in a molten alkali chloride eutectic for six weeks. Region (d) is discussed in the text.

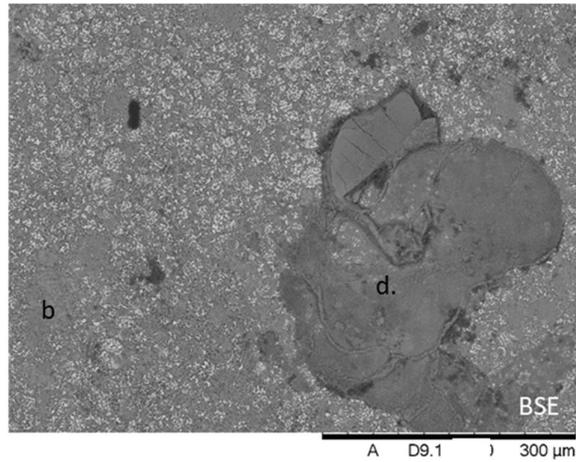
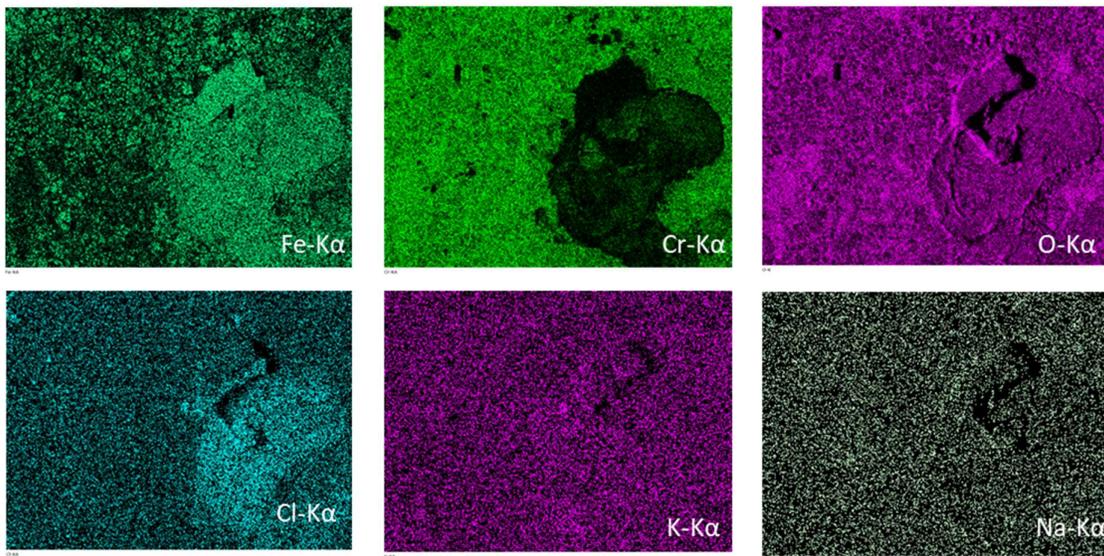
Figure 3.13: BSE image and corresponding EDX elemental maps for the surface of stainless steel 316L coupon immersed in a molten alkali chloride eutectic for three weeks. Region (d) is discussed in the text.

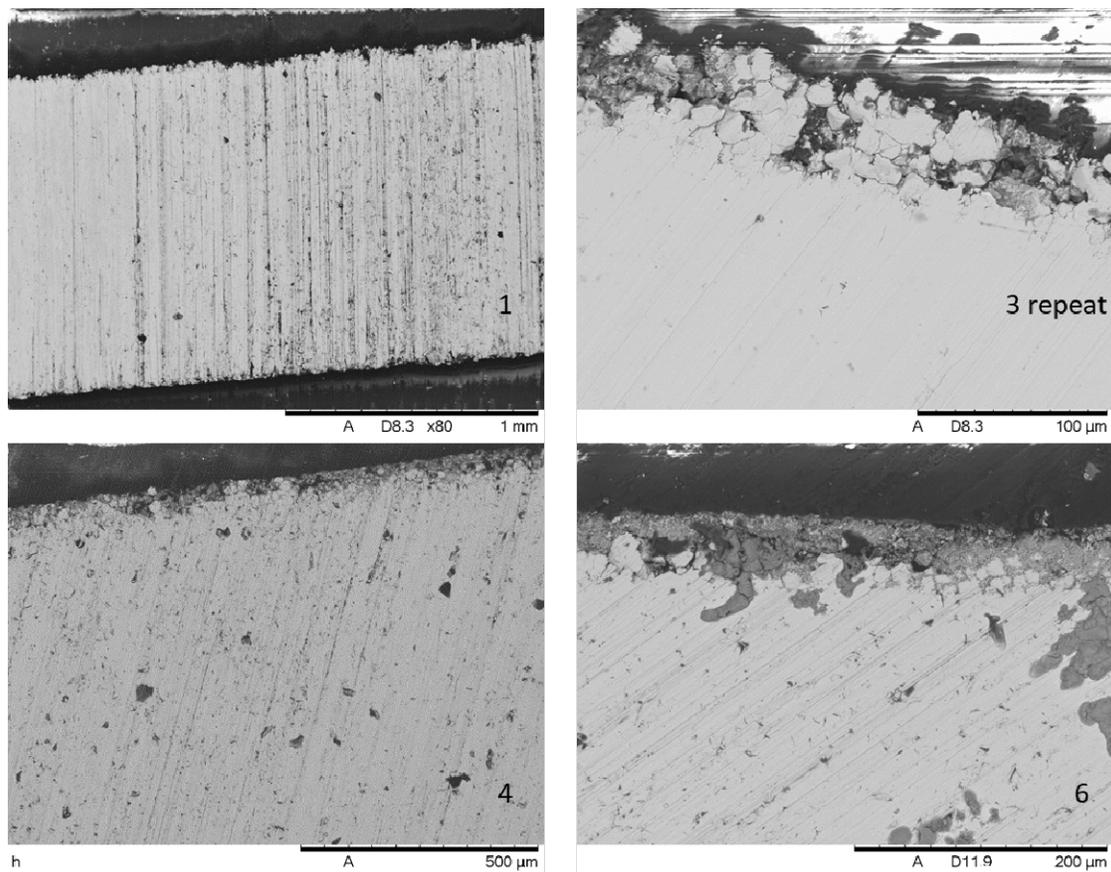
The cross section SEM can be seen for the one week, repeated three week, four and six week samples in Figure 3.14, and as time progresses it becomes clear that the depth of attack has increased, with attack and subsequent formation of lithium chromium oxide on the surface of the sample. The six week results show further penetration and the EDX data are shown in Figure 3.15. The corrosion layer, (b) a chromium-oxygen layer, is similar to the corrosion layer which appears in the four week test, but the six week test also has areas of iron oxide (d) diffusing further into the bulk. Although there was some ambiguity towards area (d) during surface analysis, the cross sectional EDX clearly shows iron oxide.

*Figure 3.14: Cross-section BSE images of stainless steel 316L held in a molten alkali chloride salt for a predetermined length of time (stated in the bottom right of each image).*

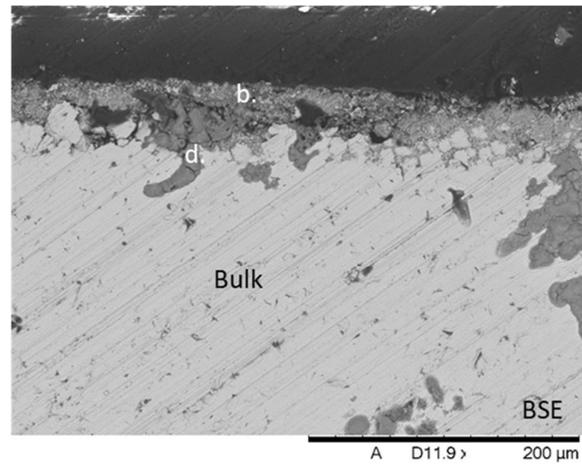
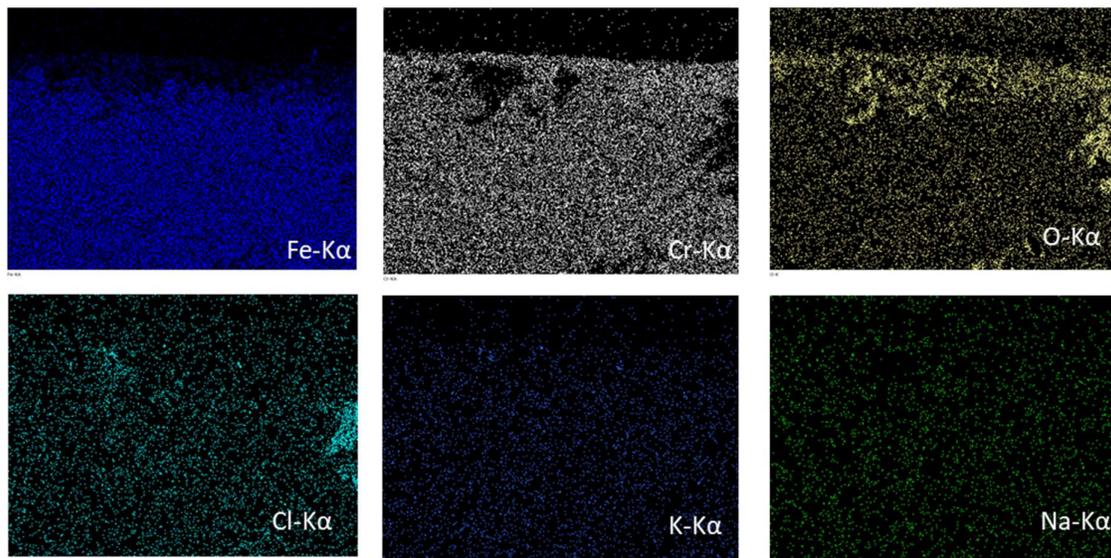
Figure 3.15: cross-sectional BSE image and corresponding EDX elemental maps of the stainless steel 316L coupon immersed in a molten alkali chloride salt for six weeks. Regions (b) and (d) are discussed in the text.

The stainless steel 316L tests showed consistent results, if the three week tests are omitted, with the formation of a lithium chromium oxide layer. The EDX data for the three (repeat) and six week samples showed the formation of iron oxide on the surface and the cross section SEM for the six week test showed the iron oxide diffusing into the bulk.

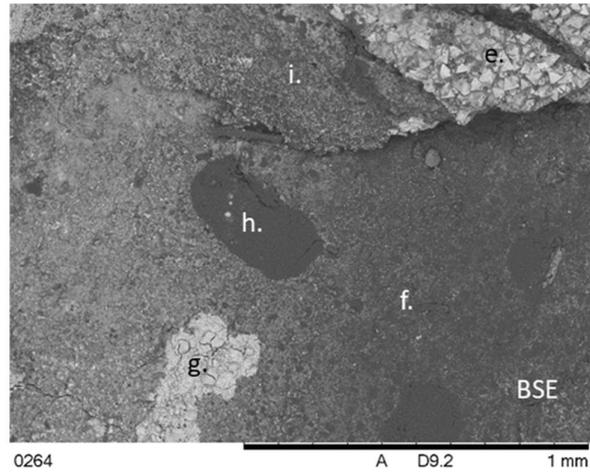
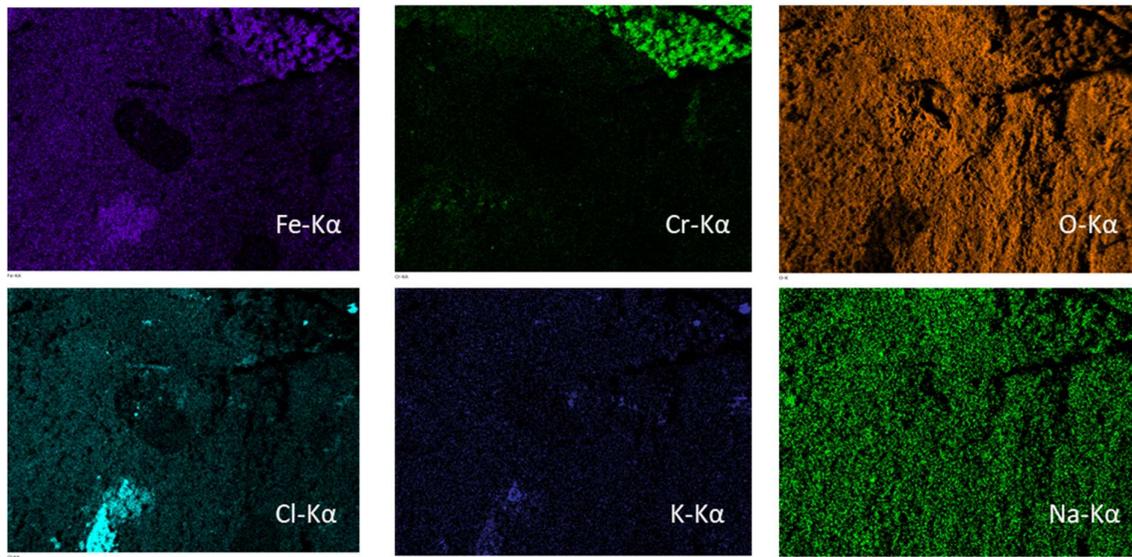
Analysis of the three week samples has proven extremely difficult due to the wide breadth of corrosion products that are present. Currently five different corrosion products (e-i) have been identified in the surface SEM images and are shown in Figure 3.16.

Area (e) in Figure 3.17 shows the formation of a 'blocky' crystal corrosion product, and an additional image, Figure 3.16, suggests that the predominant elements present within region (e) are chromium, oxygen and possibly iron. Further point analysis on this area suggests that chromium oxide has formed on the surface. This coincides with previous work, whereby  $\text{Cr}_2\text{O}_3$  forms a passivating layer over the stainless steel surface [14]. It should be noted that point analysis is an estimate.

Figure 3.16: BSE image and corresponding EDX elemental maps for the surface of a stainless steel 316L coupon immersed in a molten alkali chloride eutectic for three weeks. Regions (e)-(i) are discussed in the text.

Area (f) is a flat corrosion product, and this is shown in Figure 3.16 and Figure 3.18. The EDX data in Figure 3.18 show little contrast between areas (f) and (g), but the images do suggest that iron, chromium, oxygen and chlorine are involved in the formation of corrosion product (f). Figure 3.16 and Figure 3.19 suggest that chromium is not present in the corrosion layer, only iron and oxygen. Although the elemental composition does appear to vary wildly, the microstructure and morphology of corrosion product (f) is consistent. As previously mentioned the EDX data are difficult to analyse fully in these samples due to the highly textured nature of the sample surfaces. It should also be noted that sodium, incorporated from the molten salt bath, appears to be a lot more prominent in corrosion product (f) compared to the other corrosion products formed.

Corrosion area (g) is seen throughout the surface SEM results and initially appears to have a similar microstructure to stainless steel 316L, but Figure 3.16-Figure 3.19 all show that in addition to iron, chlorine is also present. Therefore the molten salt has either chemically altered the bulk resulting in an iron chloride layer, or a corrosion product has formed on the surface containing iron and chlorine. It is the only corrosion product that shows consistent results throughout the three week analysis.

Corrosion product (h) is seen in Figure 3.16 and Figure 3.18. It is more textured compared to corrosion products (f) and (g). Figure 3.18 suggests that iron and oxygen are the main elements, but the nature of these products does make collecting EDX data difficult.

Corrosion product (i) is present in Figure 3.16 and Figure 3.19, and appears to be an intermixing of corrosion products (e) and (f). Figure 3.19 show the formation of blocky crystals similar to (e) embedded into a flat corrosion product similar to (f). These crystals have previously been observed by Shankar and Mudali [2] and by Sellers et al. [3]. Figure 3.19 shows a high level of contrast between areas (h) and (i), and it appears that chromium, and oxygen are present.

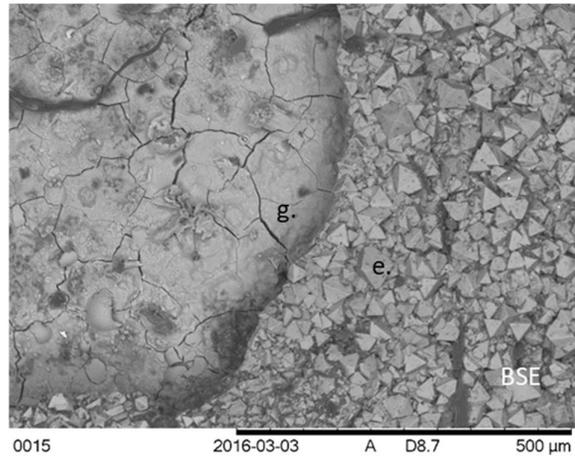
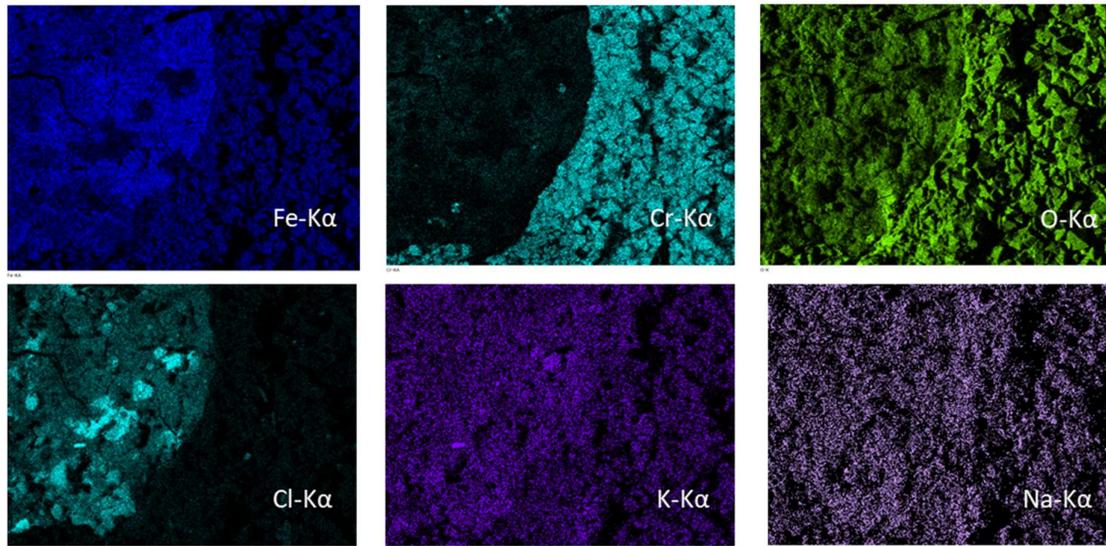
Figure 3.17: BSE image and corresponding EDX elemental maps for the surface of a stainless steel 316L coupon immersed in a molten alkali chloride eutectic for three weeks. Regions (e) and (g) are discussed in the text.

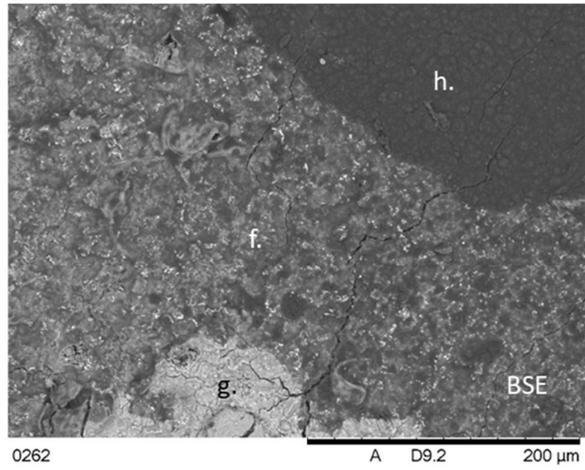
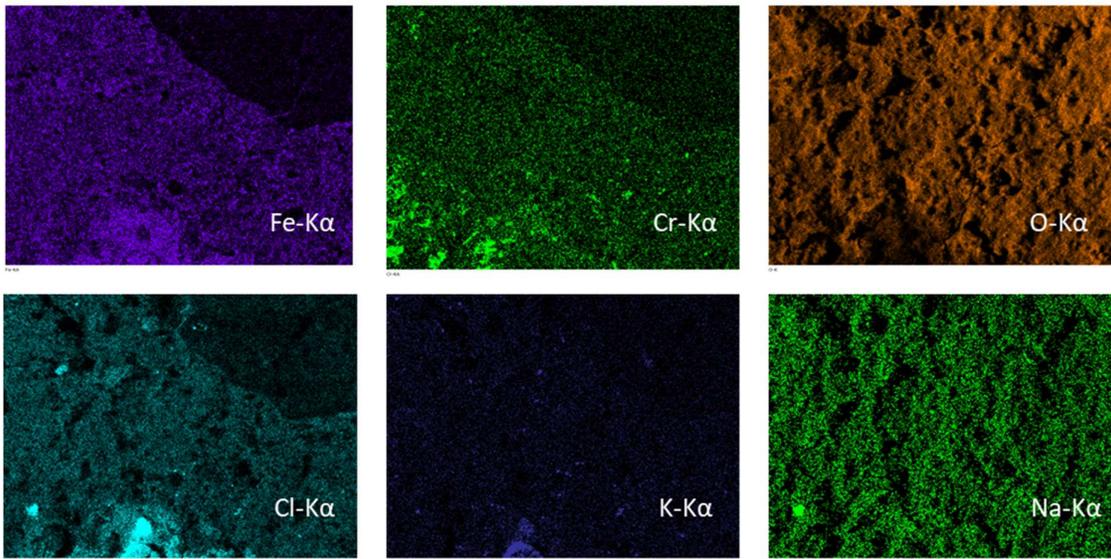
Figure 3.18: BSE image and corresponding EDX elemental maps for the surface of a stainless steel 316L coupon immersed in a molten alkali chloride eutectic for three weeks. Regions (e), (f) and (h) are discussed in the text.

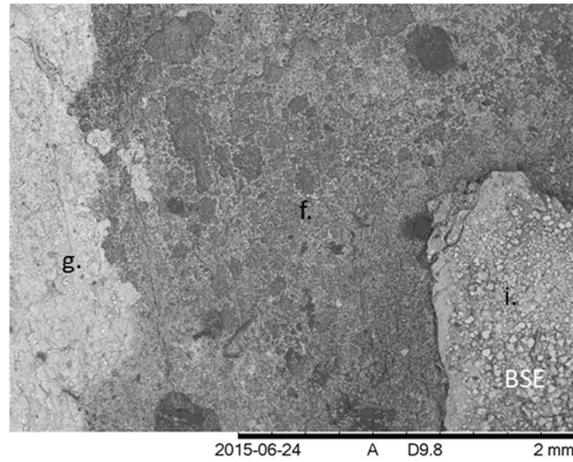
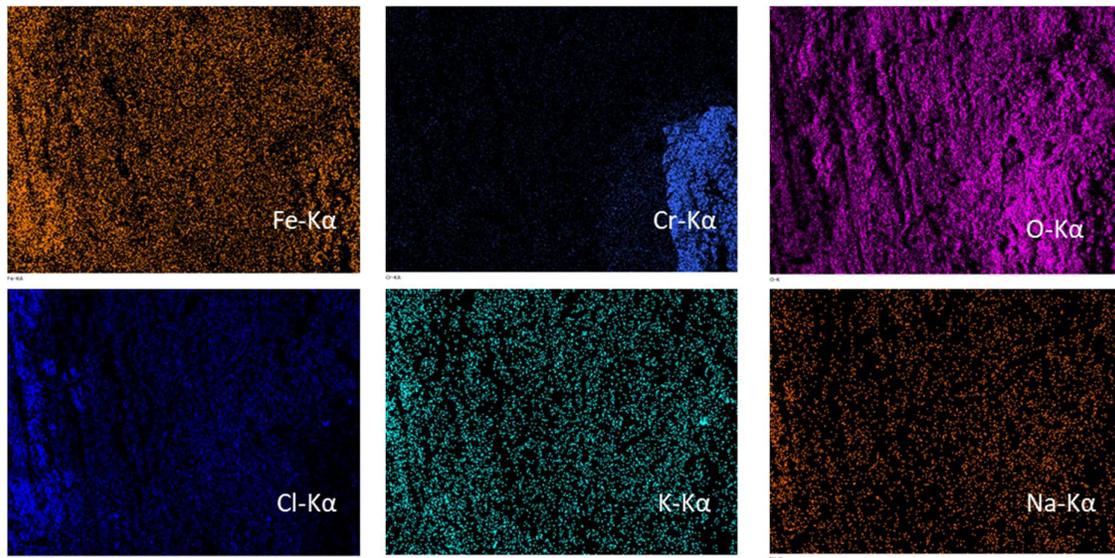
Figure 3.19: BSE image and corresponding EDX elemental maps for the surface of a stainless steel 316L coupon immersed in a molten alkali chloride eutectic for three weeks. Regions (g)-(i) are discussed in the text.

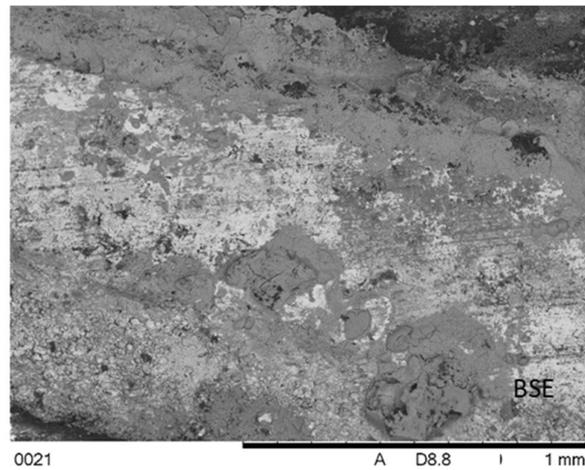
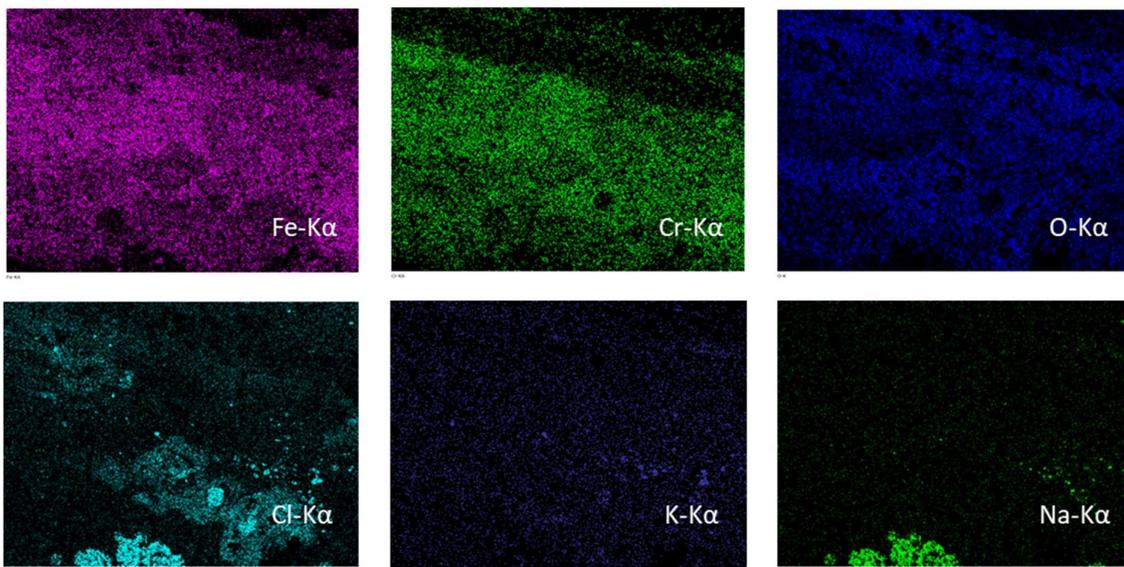
The cross sectional SEM/EDX data after three weeks of exposure are shown in Figure 3.20, a chromium layer has formed on top of a thick iron layer. The cross sectional SEM also appears to show sodium chloride trapped within the porous corrosion layer, and explains the higher than normal concentration of sodium in numerous surface SEM images.

Figure 3.20: Cross-sectional BSE image and corresponding EDX elemental maps for a stainless steel 316L coupon immersed in a molten alkali chloride eutectic for three weeks.
