A Thesis submitted for the degree of Doctor of Philosophy

**The Expansion of Pyritic Mudrocks: A  
consideration and application of physical  
tests for better understanding of the Irish  
pyrite problem.**

University of Sheffield  
Department of Civil and Structural Engineering

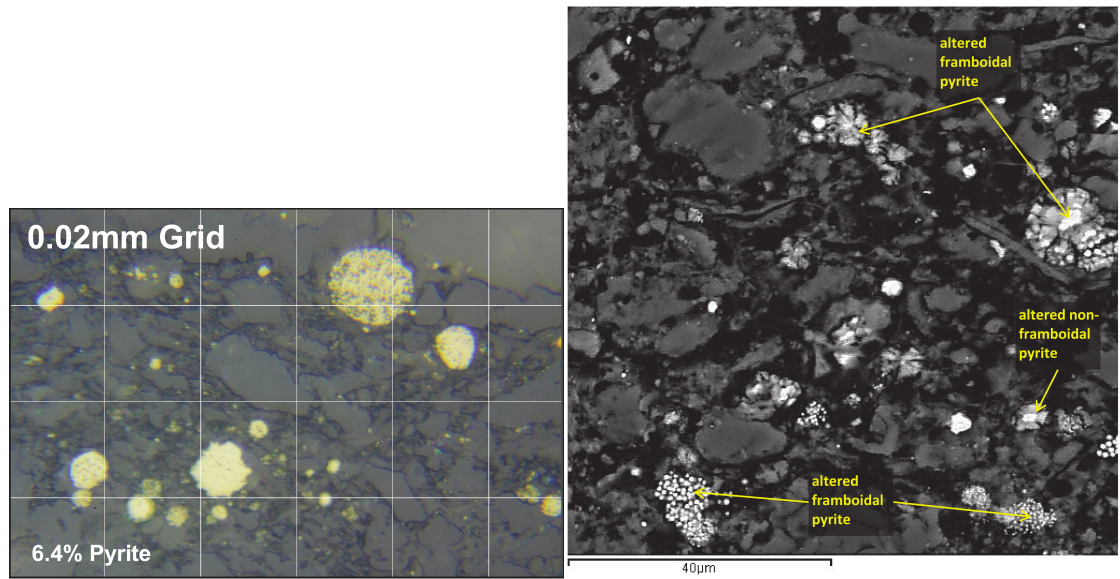
(a) Pyrite crystals under high magnification direct light (with permission from Aidan O'Connell Associates). (b) Pyrite crystals as seen with SEM (with permission from Ground Investigations Ireland).

Figure 2.1: Pyrite crystals as seen in Irish mudrocks.

It is common to find both framboidal, disseminated and cubic pyrite within dark-coloured sedimentary rocks, although the amount of pyrite is not always linked to the reactivity of the material. Rocks with quantities of pyrite as low as 0.1% by weight have been reported to react and cause significant mounts of heave (Penner et al., 1973). Figure 2.1 below shows the main forms of pyrite.

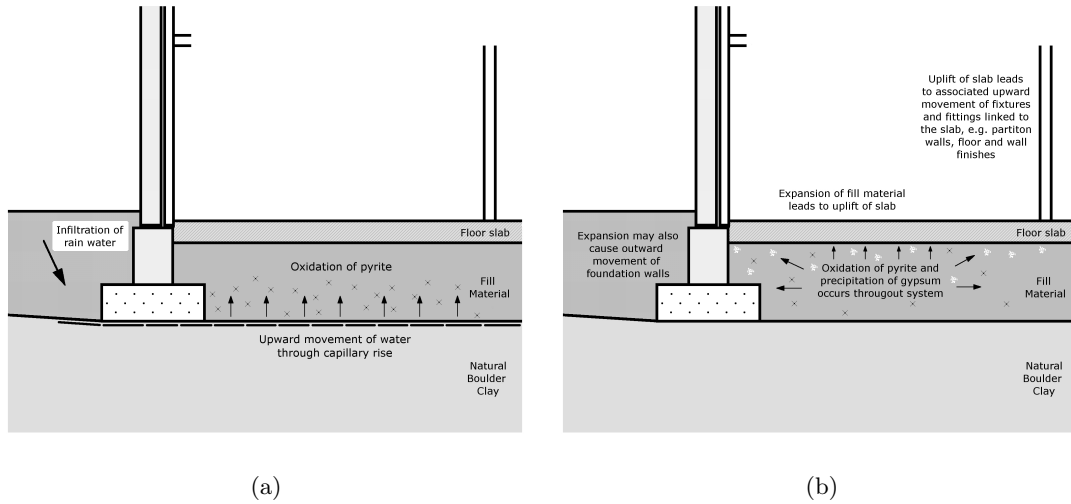
Figure 2.2: The mechanism of the reaction process from initial oxidisation to precipitation.

The stages of the reaction process presented here are taken from the literature currently available and generally represent the processes observed and recorded at different sites globally, all of which have shown expansion of pyrite-rich sedimentary rocks. It should be noted that, depending on individual site conditions, there may be some overlap or absence of the parts of the reaction process outlined in Figure 2.2.

Figure 2.2 shows the method by which water is most likely to be introduced into the below slab environment in the Irish cases (see also Chapter 6). In the Irish cases, the local water table is located within the natural material, in many cases a heavily consolidated boulder clay, and so although the clay is likely to be damp, there will be minimal upward movement of water through this material. Instead, due to the impermeability of the clay, local rainfall and surface water runoff moves through the top soil to pool on the upper surface of the clay. As shown in Figure 2.2a, this water, when sitting on the boundary between the clay and the fill material, moves upward through the fill via capillary rise, providing a water source to support the reaction process, as outline in Equations 2.1 through 2.7 below.

Figure 2.2b shows how precipitation of gypsum within the fill material connects to other parts of the structure and begins to cause damage. The primary result of the precipitation of gypsum, and expansion of the fill, is upward movement of the floor slab. This causes upward movement of parts of the structure that are sitting on the floor slab, including internal partition walls and structures, and fittings attached to the outer walls, such as skirting boards and plasterboard wall finishes. This movement, especially where differential movement is occurring between one section of the wall and another, leads to cracking of the wall finishes. This is shown schematically in Figure 2.3.

This effect of poor construction enhancing the damage caused by pyritic expansion is also seen in Ireland. However, the poor construction there tends to be shown in cases where, for example, instead of sitting on a foundation wall, an internal wall will be offset such that it rests partially on the floor slab. In that case, any uplift of the slab in that area is directly translated into movement of the wall. This is discussed in Section 2.2 and Figure 2.2.

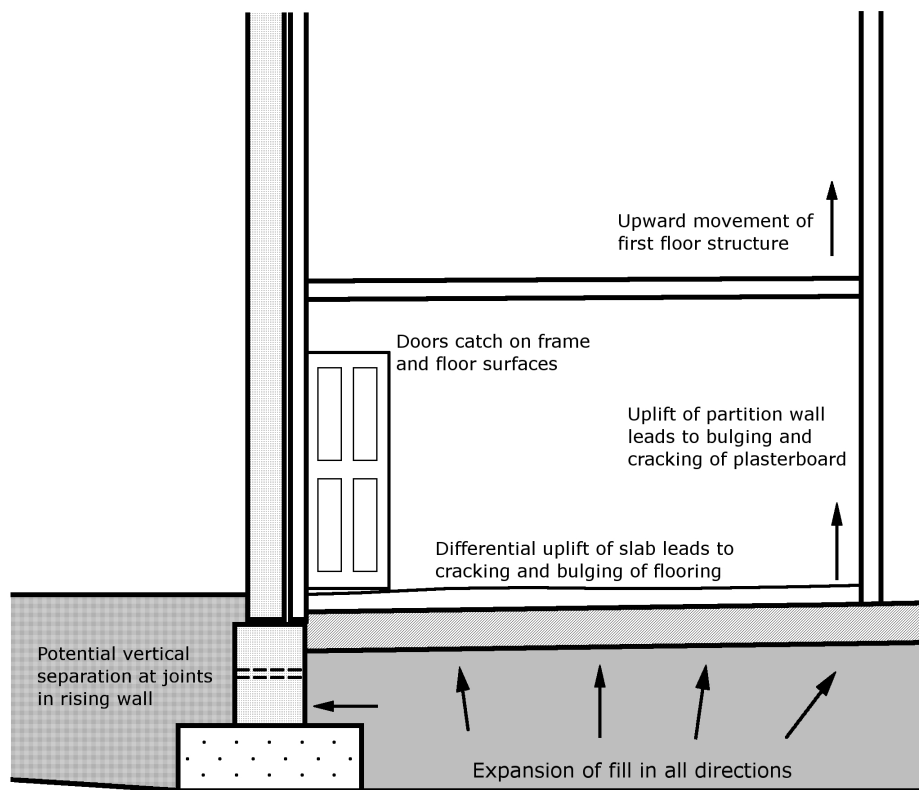
Figure 2.3: Mechanism by which expansion of the fill causes damage to the ground floor of a structure (adapted from Hawkins, 2014a).

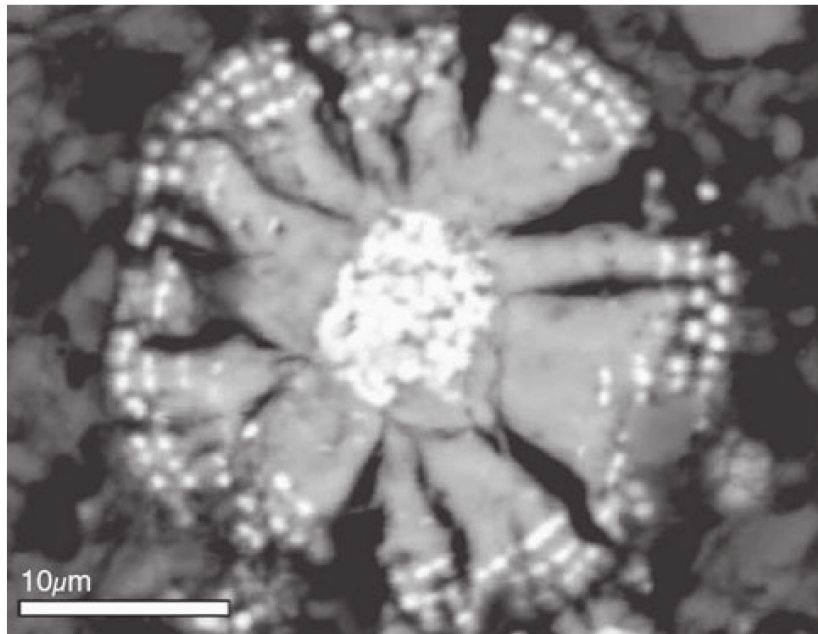
Figure 2.4: A pyrite framboid under SEM showing cracking in the outer material that furthers the reaction in the core material (Hawkins, 2012).

Recent work has suggested that there may be a certain amount of heave caused by the initial breakdown and oxidation of the pyrite framboids (Hawkins, 2012). Due to its low specific surface, cubic pyrite often shows only small alteration rims; however, framboidal pyrite has a much higher specific surface and so is more reactive. This is shown by recent SEM images of partially oxidised framboids, in which cracks have formed during the oxidation process and increased their volume, as shown in Figure 2.4.

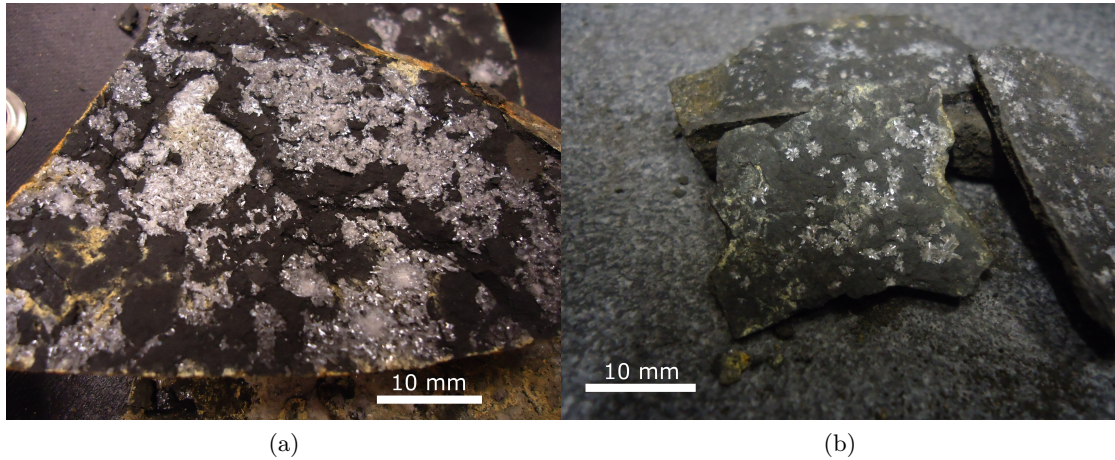
Figure 2.5: Gypsum crystals seen on lamination surfaces of mudrock particles.

In addition, both the location and the crystal habit in which the gypsum precipitates have an impact on the amount of heave. Generally in cases of pyritic heave, gypsum will form in one or both of the following habits: needle-like, acicular crystals or flat, tabular euhedral crystals, shown in Figure 2.5. The acicular crystals (more often found in cracks within mudstone particles) will exert more pressure on the system than larger euhedral crystals (often found in the fine material surrounding larger particles) (Taylor and Cripps, 1984).

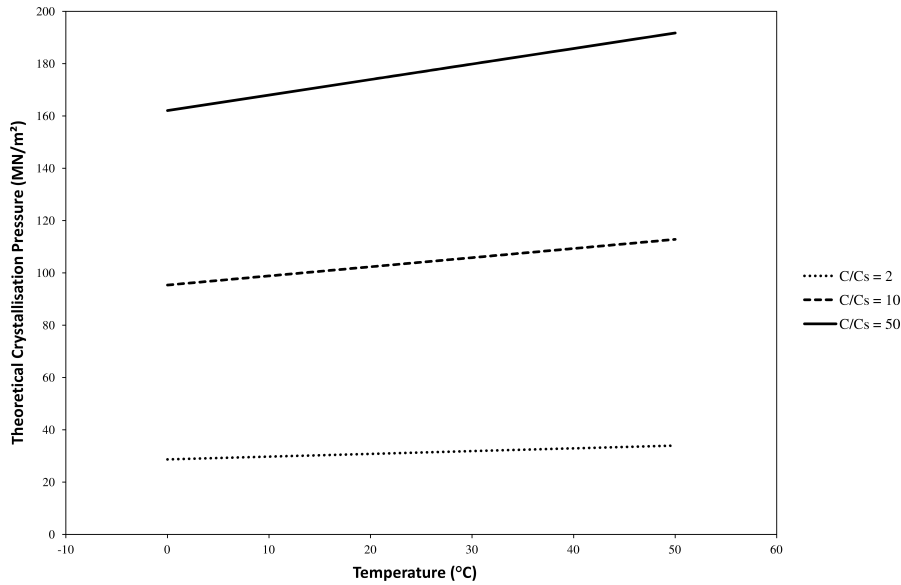
Figure 2.6: Theoretical crystallisation pressures for Gypsum in MN/m<sup>2</sup> (after Taylor and Cripps, 1984).

This gives the theoretical pressure values shown in Figure 2.6, which shows how the potential crystallisation pressure increases with both temperature and the concentration of the solution. It should be noted that these are the maximum values for the given mineral, and so may not necessarily be reached under all possible ground conditions (Taylor & Cripps, 1984).

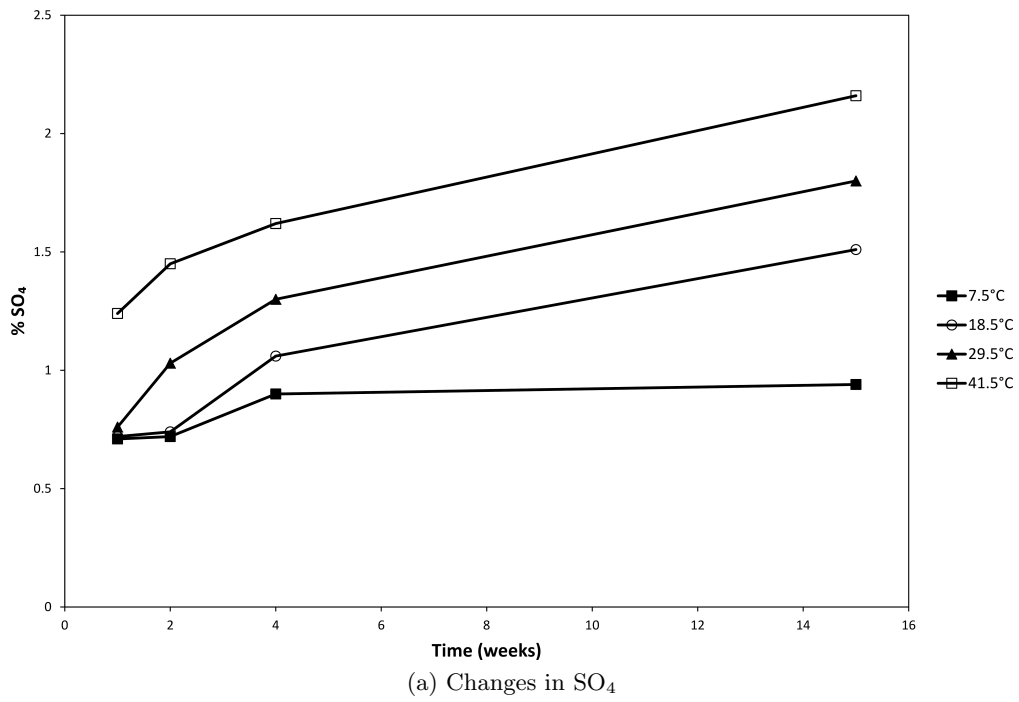
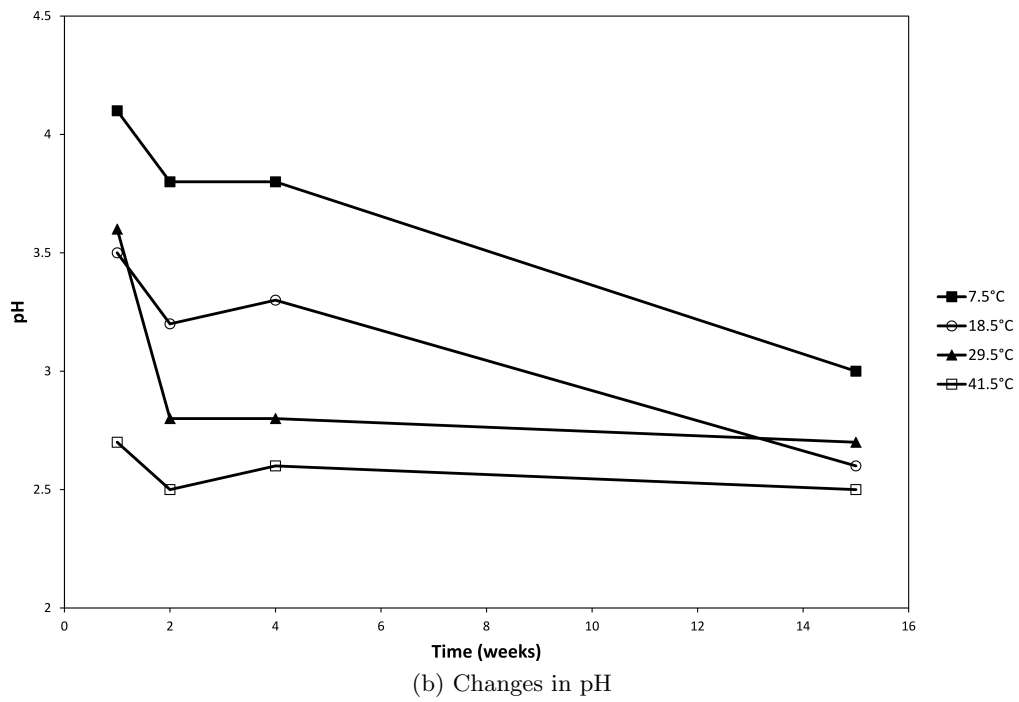
Figure 2.7: Changes in the chemistry of a pyritic mudrock over 15 weeks at varied temperatures (after Hawkins, 2014b).

As shown in Figure 2.7a, the samples kept at the highest temperature (41.5°C) show the highest production of SO<sub>4</sub>, and similarly the lowest pH value (Figure 2.7). Whereas the samples kept at 7.5°C show the lowest rate of production and highest pH values. The low level of activity in the latter case is likely due to a lack of bacterial activity at this temperature (Section 2.2).

Of interest however, is the way in which the samples held at 18.5, 29.5 and 41.5°C all show a similar rate of SO<sub>4</sub> production, at an increase of between 0.056 and 0.074 % SO<sub>4</sub> per week. The sample held at 7.5°C however shows an increase of 0.016 % SO<sub>4</sub> per week.

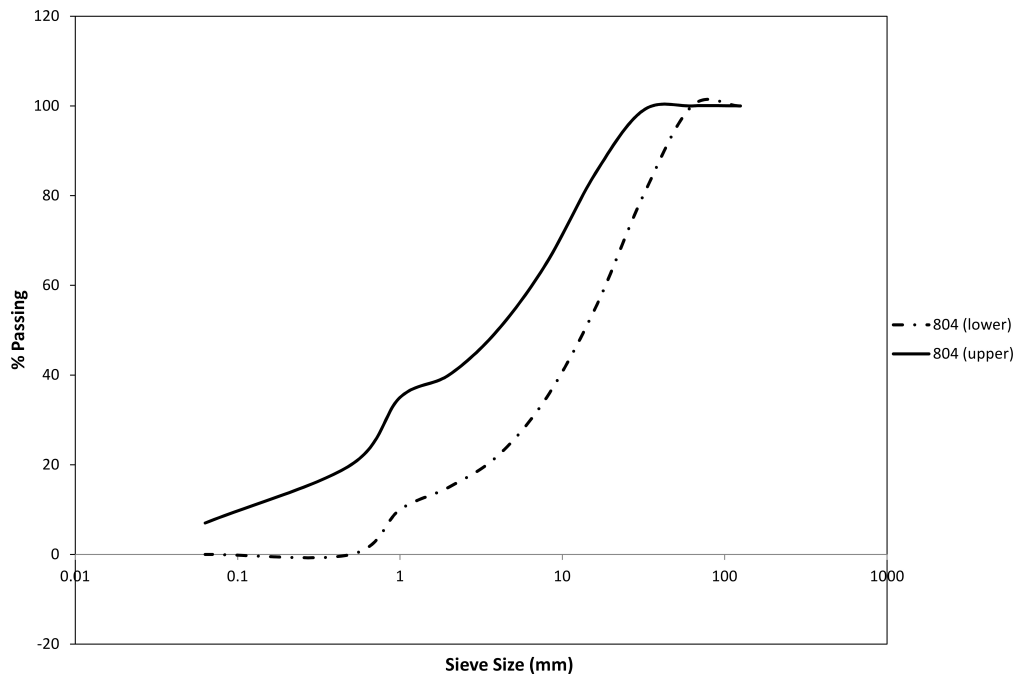
Figure 2.8: PSD limits for Clause 804 material, intended to supply a well graded material for compaction.

Much of the material used in Ireland was likely to have been ordered to Clause 804 standard, which provides an upper and lower limit for particles sizes of material for use in construction. This means the material should be well graded, and can be easily compacted in situ. Figure 2.8 shows the limits, and the effect of grading is discussed further in Section 7.3.

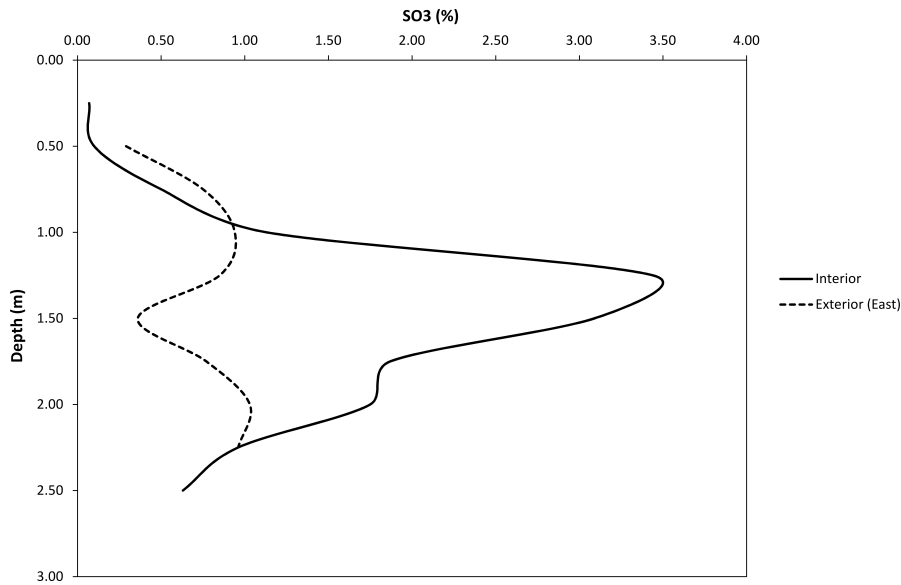
Figure 3.2: Changes in the  $\text{SO}_3$  values with depth in the internal (blue) and external East (red) trial pits at Llandough Hospital (after Hawkins and Pinches, 1987a, 1992).

pit at equal depths) and had higher  $\text{SO}_3$  values, as shown in Figure 3.2.

The increase in  $\text{SO}_3$  values in the upper section of the internal pit corresponds to the oxidation of the material in this area, with material below 2.5 m being un-oxidised and showing pH and  $\text{SO}_3$  values comparative to those at a depth of 1.5 m in the external pits.

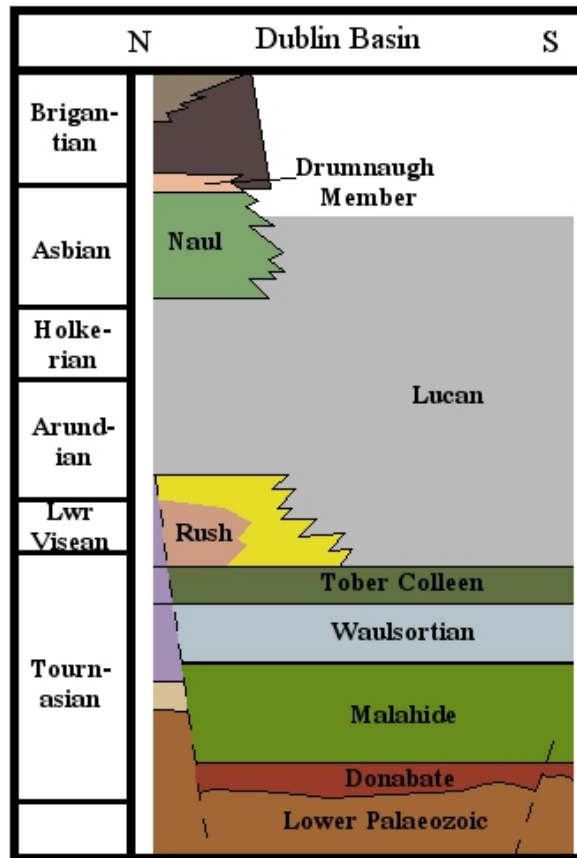
Figure 4.2: Vertical succession of the major rock formations in the Dublin Basin (adapted from Sevastopulo and Jackson, 2009).

Figure 4.2 shows the vertical succession of the rocks within the Dublin basin.

Although Figure 4.2 gives more detail, the stratigraphic succession is simplified when applied for use by the Pyrite Panel (2012). In this case the Geological Survey of Ireland database is used to classify the rock according to their pyritic content. This database contains 7,362 mineral entries, of which 327 (some 4%) are pyrite and 9 are pyrrhotite.

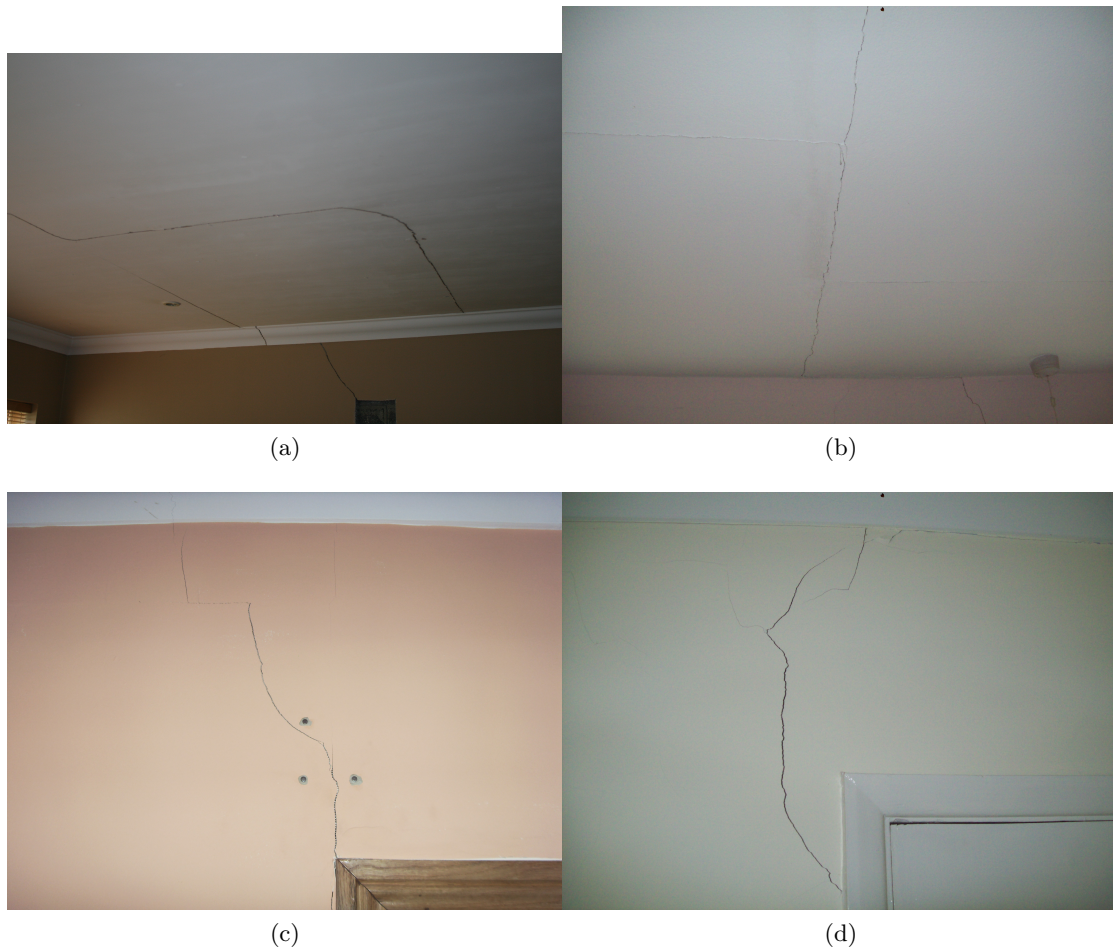
Figure 4.4: Damage to residential properties caused by pyritic heave (a & c) and foundation settlement (b & d). Images a & c used with permission of Taylor Tuxford Associates, images b & d used with permission of Aidan O'Connell Associates.

It is easy to see how the heave cases were mistaken for foundation settlement in the early stages of the problem becoming apparent. Figure 4.4 shows how similar some of the damage seen in cases of pyritic heave is to that seen with differential settlement of a foundation.

This structural inspection, both within the remit of IS 398-1 and for those tests carried out before its introduction, focuses on key types of damage that are solely linked to pyritic heave. Figure 4.4 shows how the cracking that is seen in many cases is not always a reliable indicator of pyritic heave. Other signs such as sticking doors and cracking on/around door frames is cautioned within IS 398-1 that it could be a sign of drying out of the wood rather than pyritic heave.

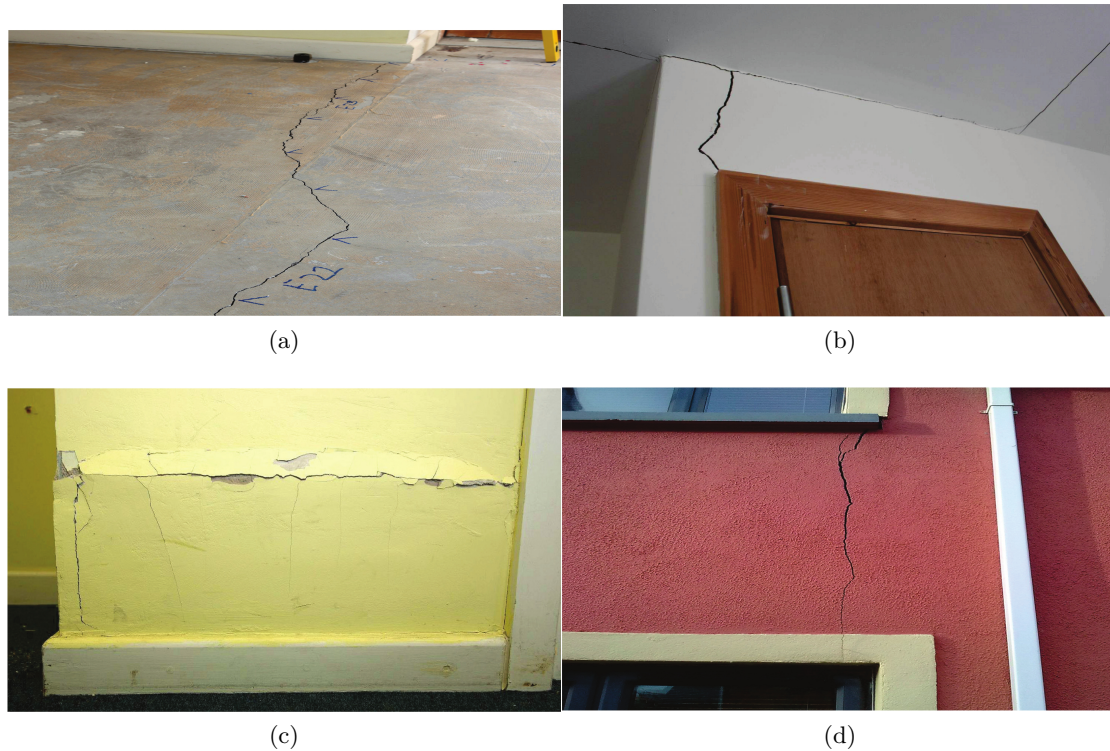
Figure 4.6: Collection of images showing the damage recorded at the facility (after Hawkins and Stevens, 2014).

Between September and November 2006, repairs were carried out to the facility, covering the items listed in table 4.2 as well as to displaced plasterboard that had caused gapping around plug sockets and to a crack on the ceiling of the gym. By October 2007, with problems still occurring, an independent assessment was commissioned. Some images of the damage present at this time are contained in Figure 4.6.

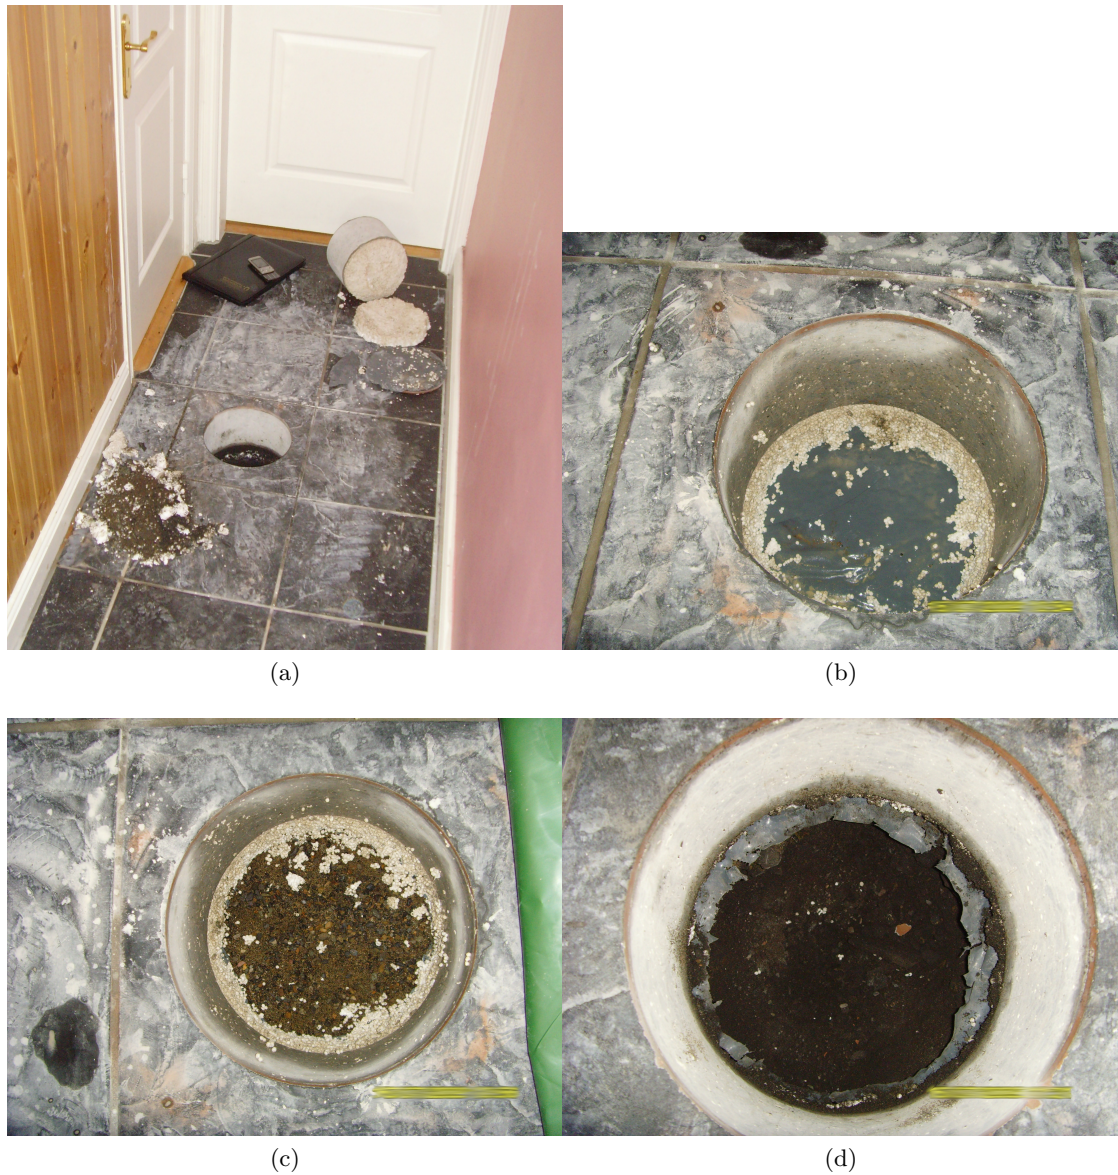
Figure 4.9: The process of coring through the floor slab and taking samples for geotechnical testing.

If the damage is such that it points towards the cause being expansion of the fill material, then geotechnical sampling is carried out, Figure 4.9 shows this process as used to take samples from a property tested in 2009. Since that time the sampling process has been modified and improved, with a larger area of the slab removed and the damp proof membrane cut and peeled back to the sides of the hole rather than removed as shown in Figure 4.9.

The geotechnical sampling first involves coring a hole through the floor slab and any fixed floor finishes in an area of the property indicated by the floor level survey to be undergoing uplift (Figure 4.9a). Once the hole has been cored, the section of floor slab is removed, along with the insulation such that the damp proof membrane is revealed (Figure 4.9b).

At this stage, as stated above, the damp proof membrane is cut and peeled back to sides of the hole such that the sand blinding (Figure 4.9c) and fill material (Figure 4.9d) can be accessed and sampled. Factors such as the thickness of the concrete slab, the presence of sand blinding and the depth of the fill are then recorded, the sample of fill is removed and sent for testing.

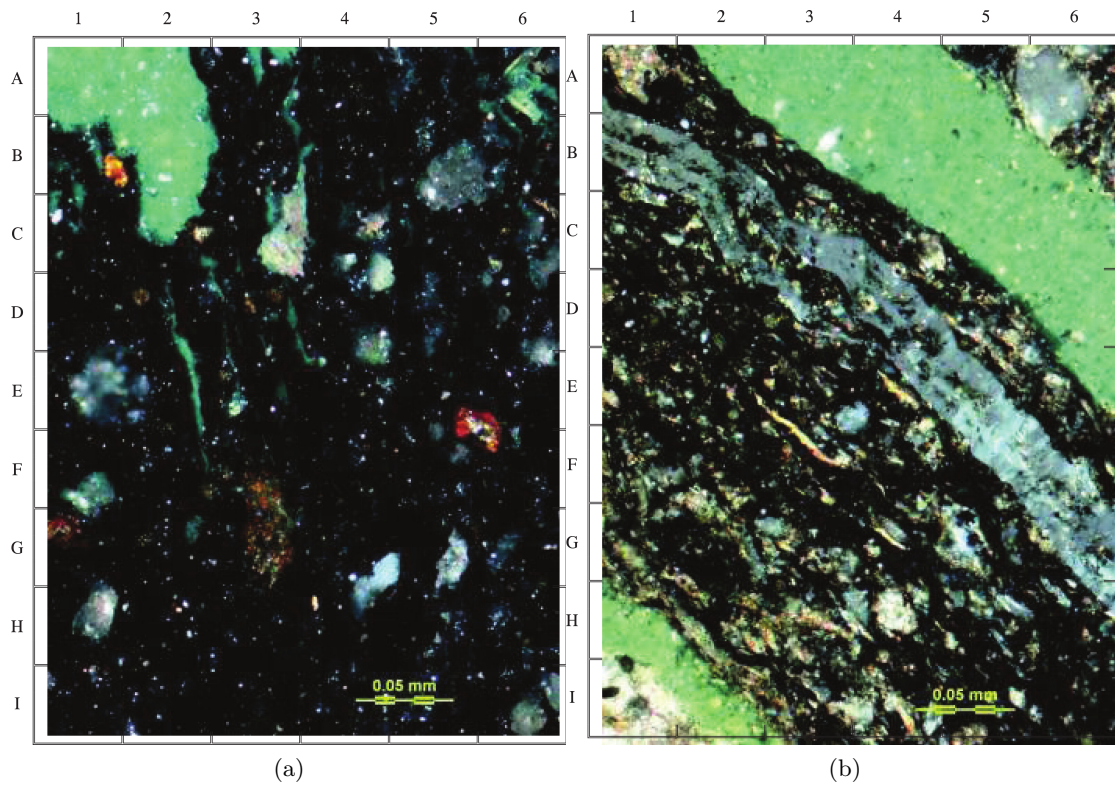
Figure 4.10: Example thin sections of pyritic mudrock, the green material is the resin used in the preparation of the samples (used with permission of Aidan O’Connell associates).

Figure 4.10 shows example thin sections taken from a sample of fill from an Irish property. Figure 4.10a shows oxidised pyrite crystals, for example those at grid point F/G3 and E5. Figure 4.10b shows a sample from the same property with crystallisation of gypsum (the mottled pale-grey material) along a lamination in a mudrock particle. This lamination runs from grid point B1 to G6.

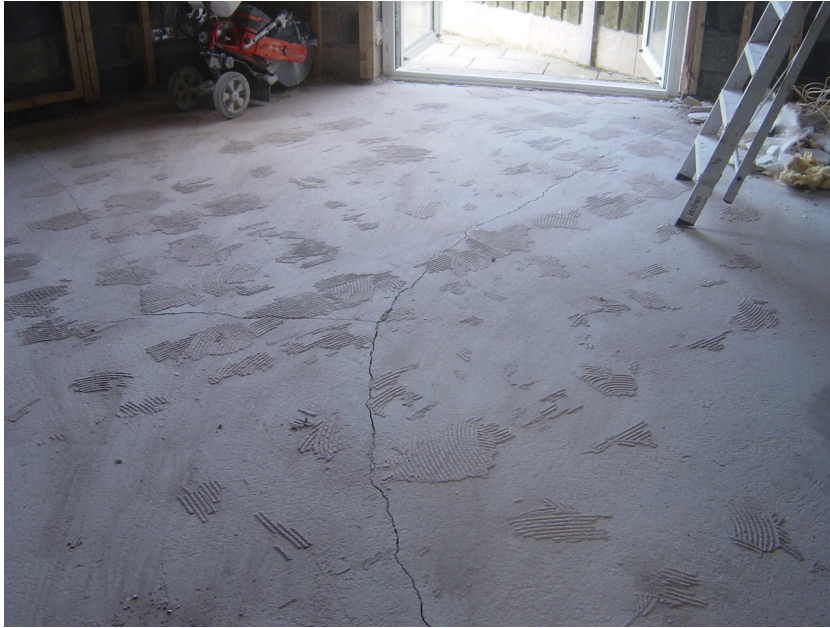
Figure 4.11: Stellate cracking of floor slab recorded during the remediation process (used with permission of Aidan O'Connell associates).

- Services are isolated and the strip out of the ground floor begins. This involves removal of kitchen units, doors, wall finishes and staircases. Any other defects to the ground floor structure, such as construction defects, are also recorded at this time/. Figure 4.11 shows the damage to a floor slab during the strip out process.

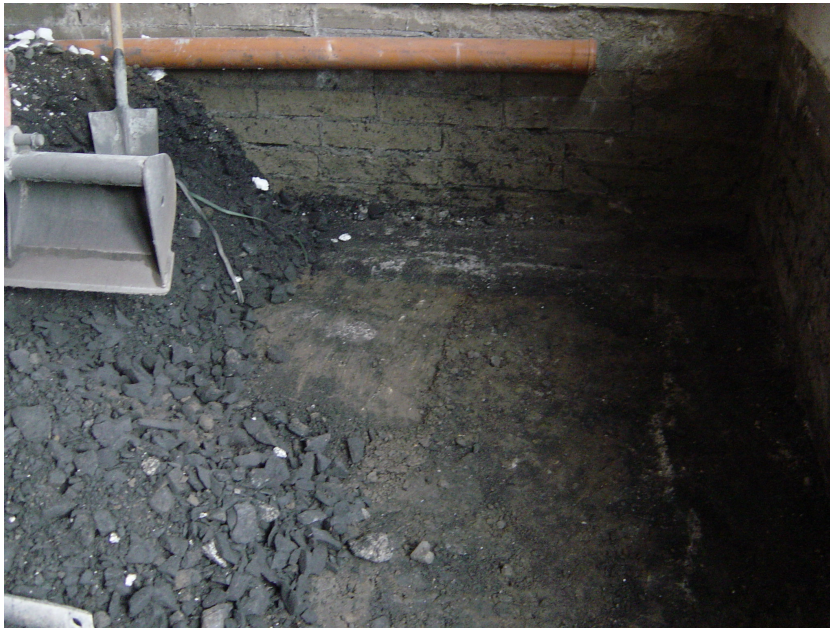
Figure 4.12: Removal of defective fill material from an Irish property, showing the natural material at the base of the foundation (used with permission of Aidan O'Connell associates).

- Internal non-load bearing walls are removed at this stage before the floor slab is cut and removed. The insulation and damp-proof membrane are also removed at this stage, along with service pipes placed below the slab.
- All defective material is removed until the natural bedrock material is uncovered, as shown in Figure 4.12. The material is sampled if necessary before being removed from site and disposed of, and the rising walls are cleaned and inspected for any signs of sulphate attack.

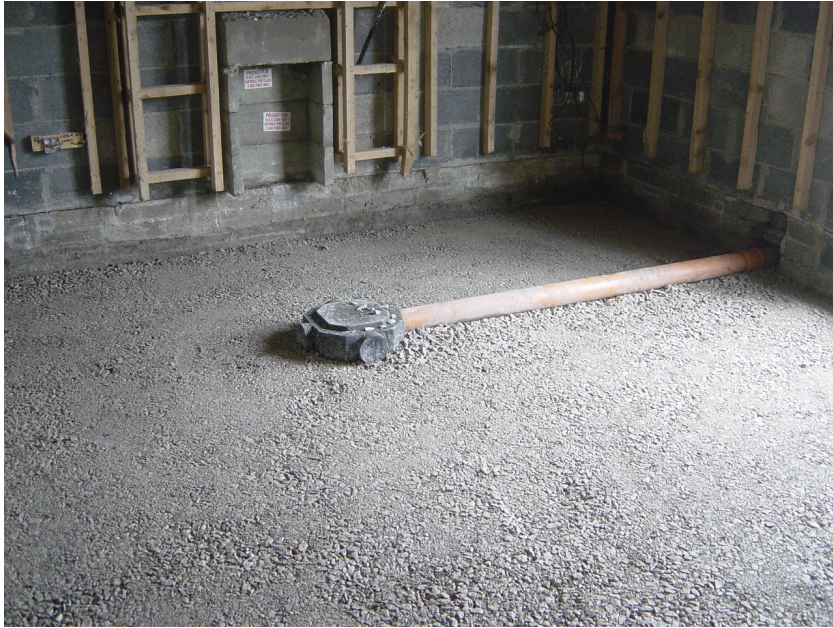
Figure 4.13: Replacement of fill material and radon sump. (used with permission of Aidan O'Connell associates).

- Once all defective fill material has been removed and all surfaces are clean of material that may react in future, tested and certified fill material is placed and compacted, as shown in Figure 4.13. The services such as the radon sump are re-installed and a new damp-proof membrane placed.
- At this point, the steel reinforcement is placed and the concrete for the new floor slab is poured (Figure 4.14). It is worth noting that in many cases, the original ground floor slab did not contain reinforcement, as is revealed when coring through the slab in order to take the samples for the geotechnical tests.

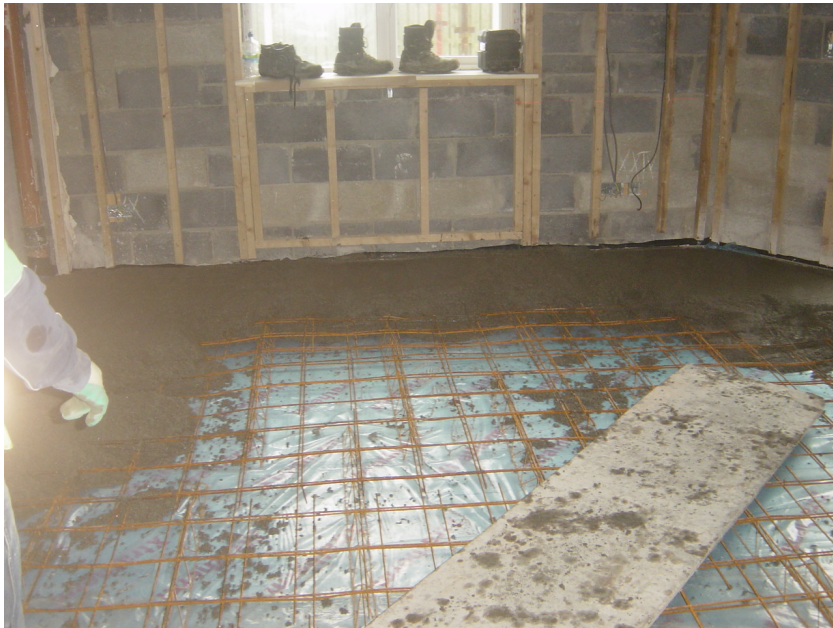
Figure 4.14: Placement of steel reinforcement and pouring of fresh concrete floor slab. (used with permission of Aidan O'Connell associates).

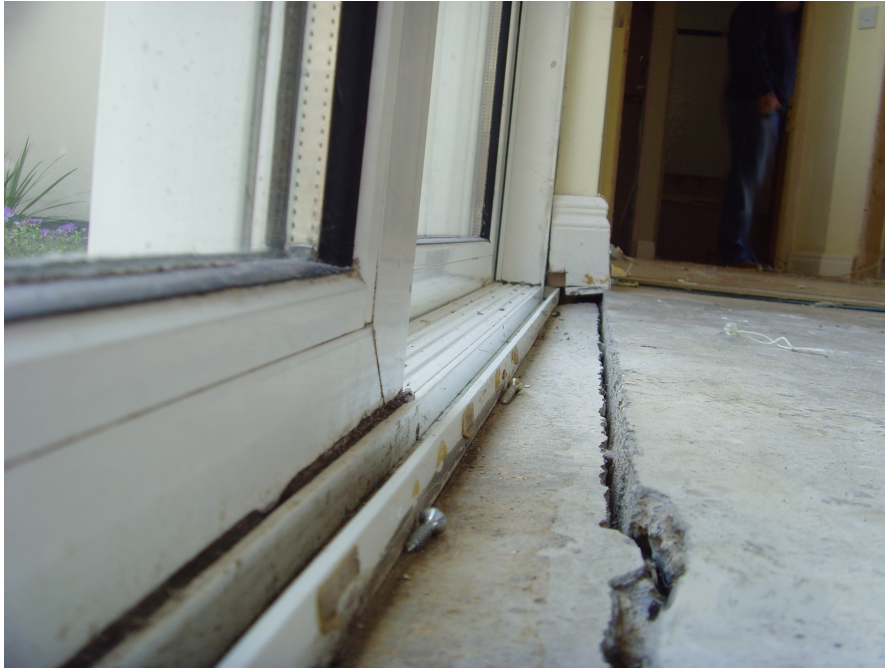
Figure 5.3: Uplift of the floor slab and displacement of skirting boards at Property A, uplift was recorded at around 6 mm in this area (with permission from Aidan O’Connel Associates).

- Radial cracks to the floor slab that are greater than 2 mm in width.
- Upward displacement greater than 5 mm at construction joints in the slab, as shown in as shown in Figure 5.3.

- Upward displacement of skirting boards by up to or more than 5 mm, as shown in Figure 5.3.
- Gaps present around window frames up to 5 mm in width, as shown in Figure 5.4.

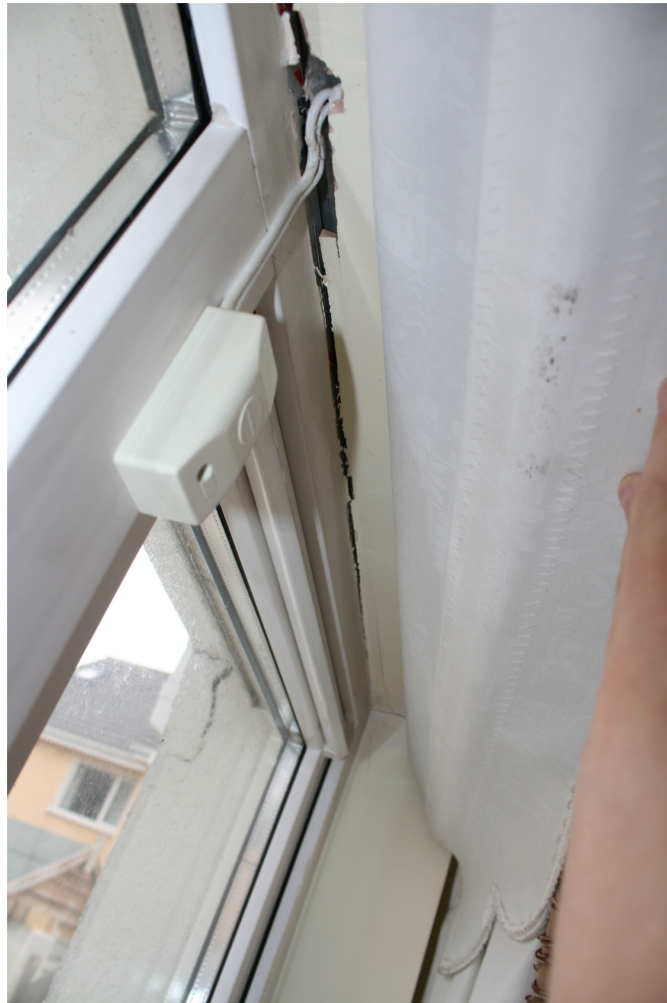
Figure 5.4: Gapping at top of window frame in the living room of Property A (with permission from Aidan O’Connel Associates).

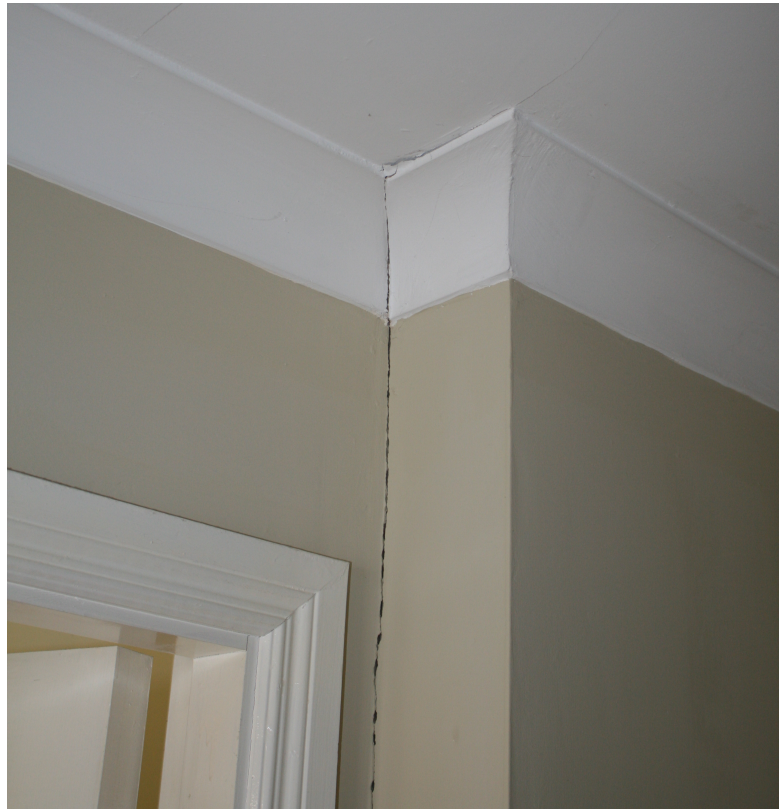
Figure 5.5: Cracking of plasterboard at wall/wall interface in Property A (with permission from Aidan O'Connell Associates).

- Cracking to walls, including cracks above doors and stress cracks at wall junctions, the latter of which is shown in Figure 5.5.

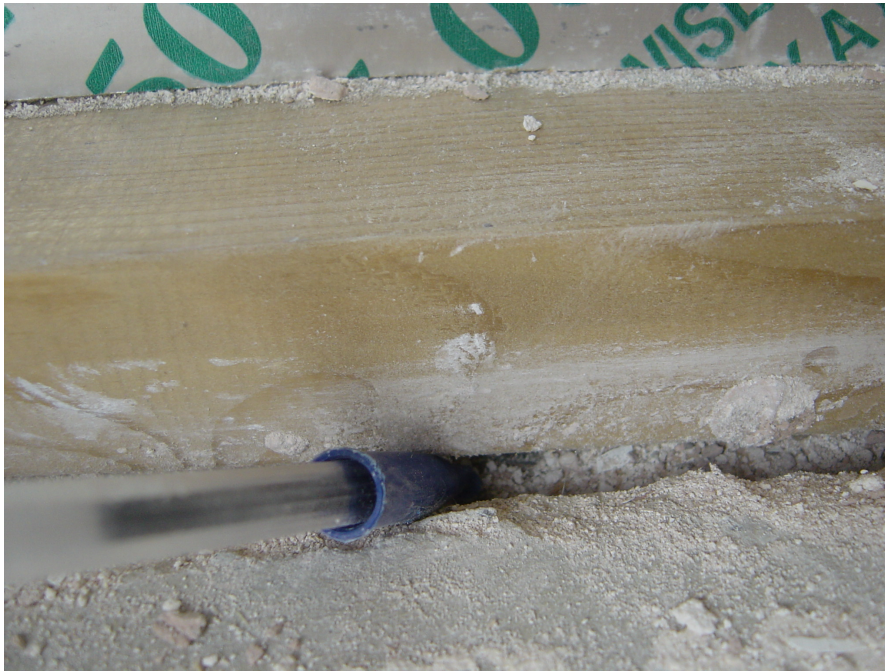
Figure 5.6: Uplift of an internal partition wall at Property A by approximately 5 mm (with permission from Aidan O’Connel Associates).

- Uplift of partition walls was noted during remediation once the plasterboard had been removed, shown in Figure 5.6.

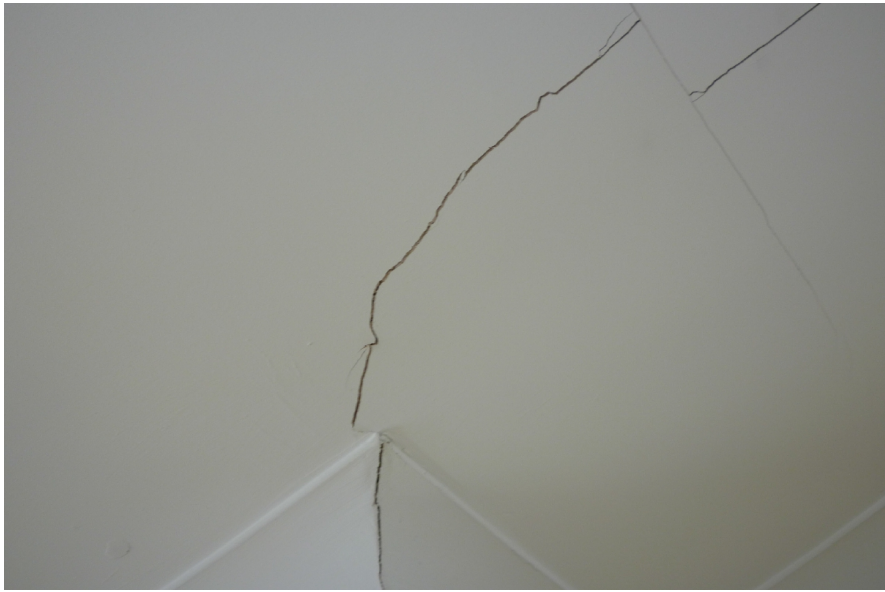
Figure 5.7: Significant cracks to the plasterboard finish of the ground floor ceiling at Property A (with permission from Aidan O’Connel Associates).

This is the other section in which information was limited to that available within the structural report, although this was not necessarily considered to be a reporting priority prior to IS 398-1. However, this does contain pictures of damage to the ground floor ceilings, including Figure 5.7 below showing significant cracking to the ceiling.

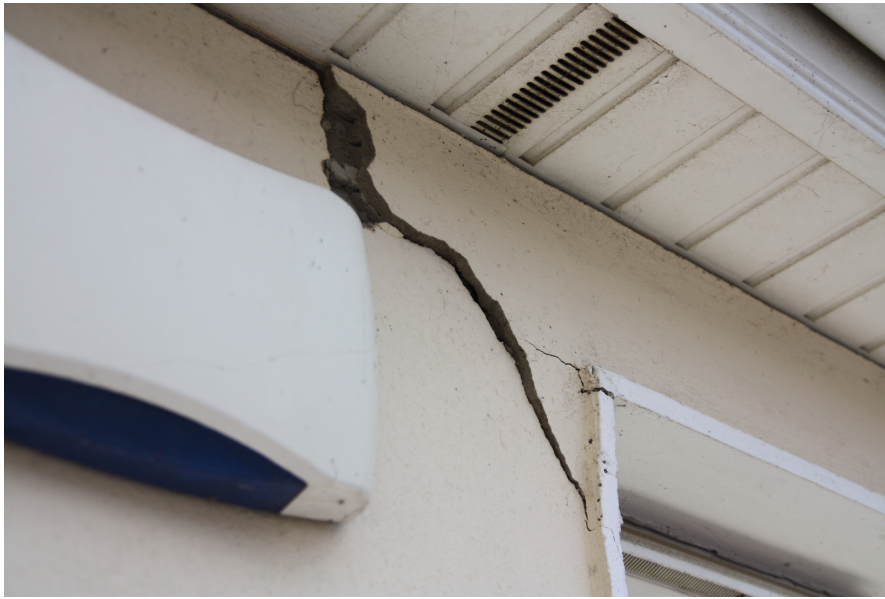
Figure 5.8: Cracking to the render around the living room window at Property A (with permission from Aidan O'Connel Associates).

- Cracking to the external render – in the crack shown in Figure 5.8, the crack is greater than 5 mm in width, and shows more than one axis of movement.

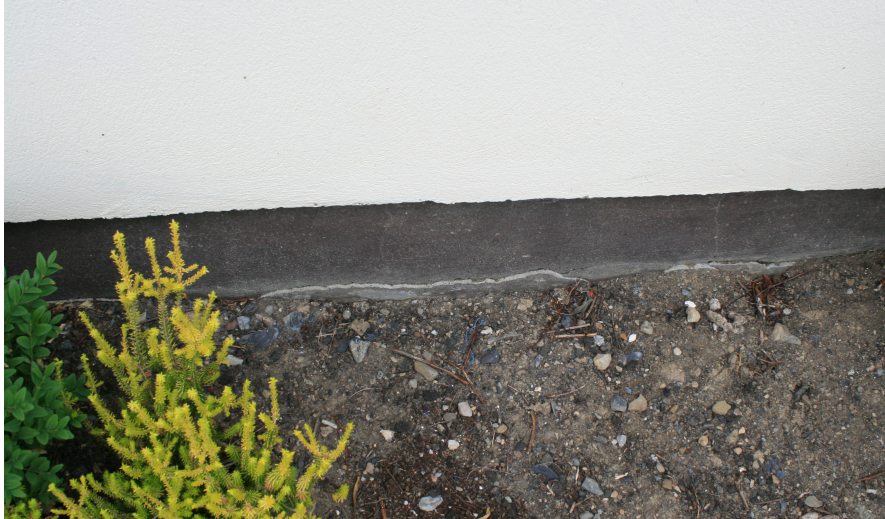
Figure 5.9: Damage to external walls of Property A (with permission from Aidan O'Connel Associates).

- Gapping around window frames and lintels
- Cracking to the plinth around DPC level, as shown in Figure 5.9

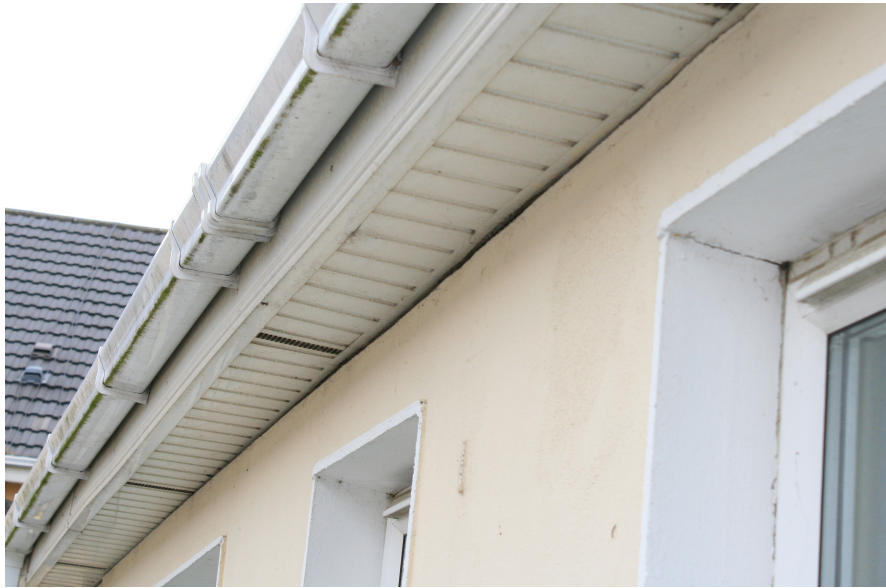
Figure 5.10: Gap at soffit level at Property A (with permission from Aidan O’Connel Associates).

- Gapping at soffit level, greater than 5 mm in places as shown in Figure 5.10

The “score” for this section is 10/10 due to the soffit gap.

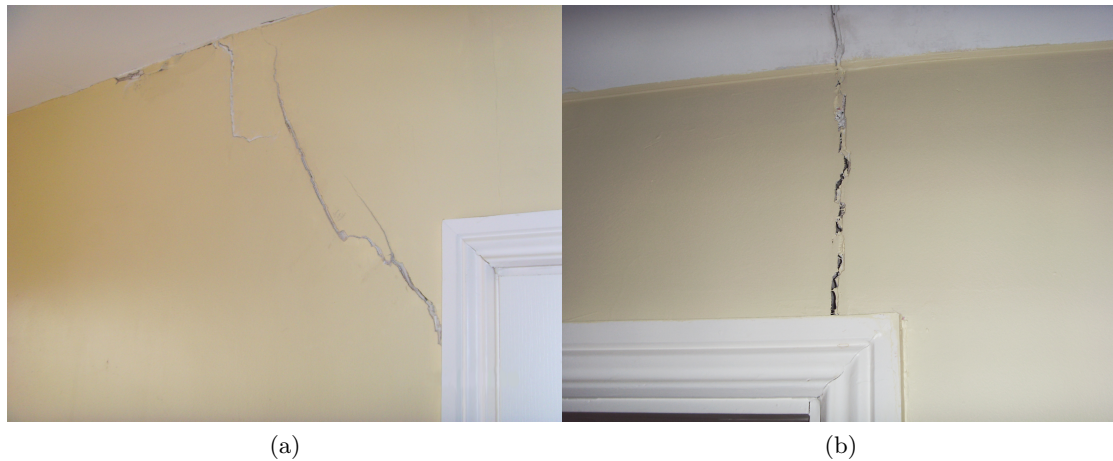
Figure 5.12: Cracking to ground floor walls at Property B (with permission from Aidan O’Connel Associates).

The cracking to the walls within this property was significant. There was cracking to walls on both the ground and first floors, and although the latter is not counted as part of IS 398-1, the level of cracking seen to the first floor landing area can be taken as a sign of upward movement of the stairwell and ground floor partition walls.

Examples of the cracking seen at this property are shown in Figure 5.12.
