A Thesis submitted for the degree of Doctor of Philosophy

**The Expansion of Pyritic Mudrocks: A  
consideration and application of physical  
tests for better understanding of the Irish  
pyrite problem.**

University of Sheffield  
Department of Civil and Structural Engineering

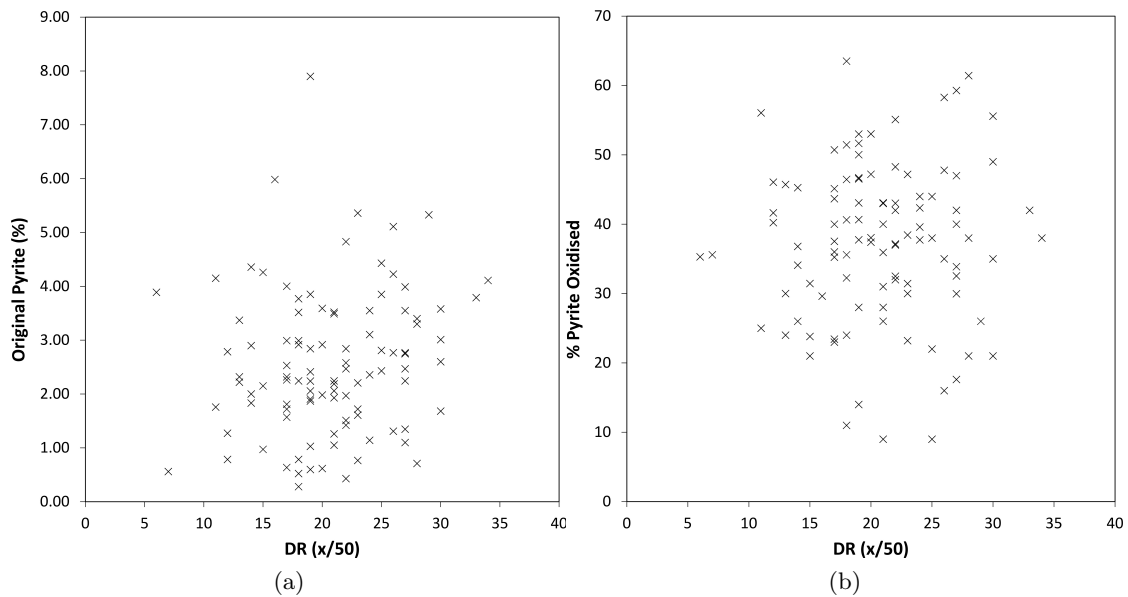
Figure 5.14: Comparison of the damage rating to both the original level of pyrite and the percentage of that pyrite that had oxidised by the time samples were taken.

Where CP = current pyrite (%), and OP = original pyrite (%). These values and their relationship to the damage rating are shown in Figure 5.14.

There are similar hints of correlation in Figure 5.14b, where it would be expected that the more pyrite has been oxidised, the further into the reaction process it is, and so the more damage there should be.

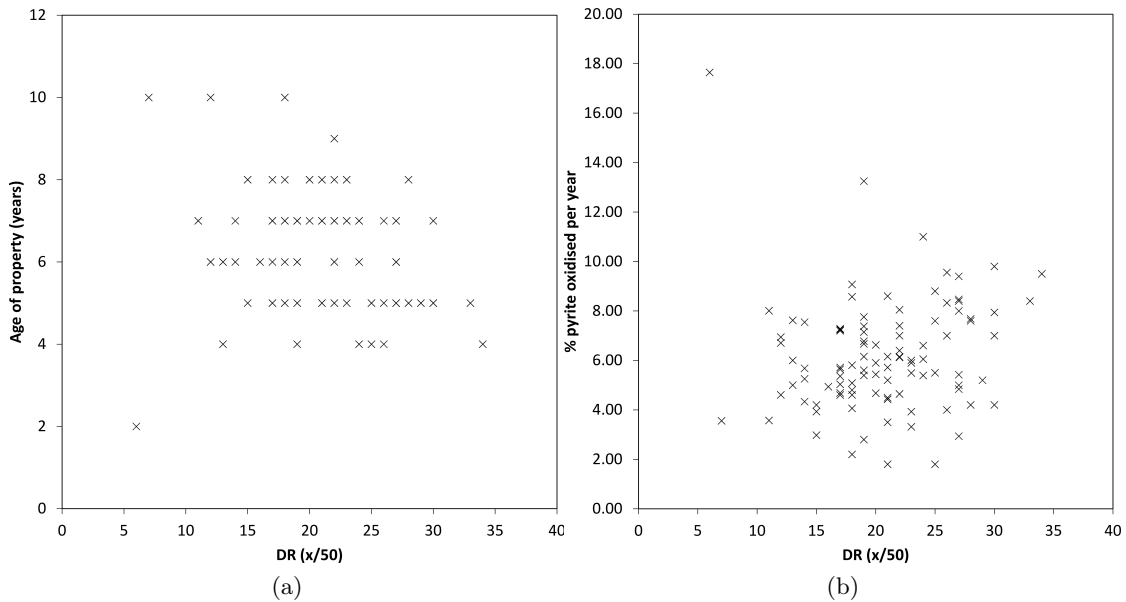
Figure 5.15: Comparison of the damage rating to both the age of the properties and the rate of pyrite oxidation.

As stated above, it is assumed that there is a link between the age of the property and the level of damage – this being based on the idea that as the reaction progresses, more pyrite is oxidised and correspondingly more expansion should occur. However, this is not reflected in Figure 5.15a, although as stated above, there is a lack of precision in this part of the data.

Instead, we can consider the age of the property in terms of the reaction rate – the amount of pyrite that has oxidised per year since construction (Figure 5.15b) and the rate of expansion (Figure 5.17).

Figure 5.15b shows much more correlation than previous graphs, showing the anticipated link that the more pyrite is oxidised per year, the more damage is caused. However, there is still a large amount of scatter in the data.

Figure 5.15b does not represent the amount of pyrite present at either the time of placement of the fill or the time at which it was sampled, it just measures the change between the two over time.

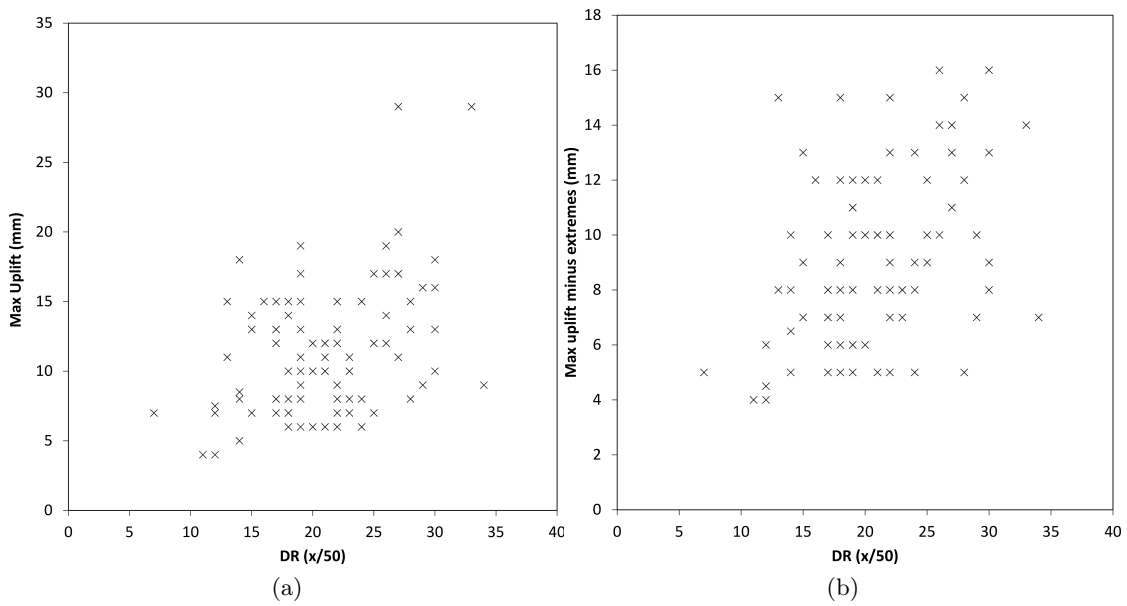
Figure 5.16a shows the amount of damage compared to the largest single point of uplift in each property as shown in the floor level survey.

Figure 5.16: Comparison of the damage rating to both the maximum amount of uplift seen in a property, and the maximum when extreme, one-off values are removed.

In order to reduce this possibility for error, the highest uplift value for each property was taken as the highest value that was recorded at least twice within each property. This is shown in Figure 5.16b.

As anticipated, there is a more obvious correlation between the amount of uplift of the floor slab and the level of damage seen in Figure 5.16. Although scatter is still present, likely caused by the influence of factors as discussed above, there is still a link between the two variables. This is discussed further in Section 5.4 below

The uplift value used for this section of the analysis was the maximum uplift minus any extreme values as depicted in Figure 5.16b. The age of the property is that as described in Figure 5.15a, which is again only accurate to within 6 months.

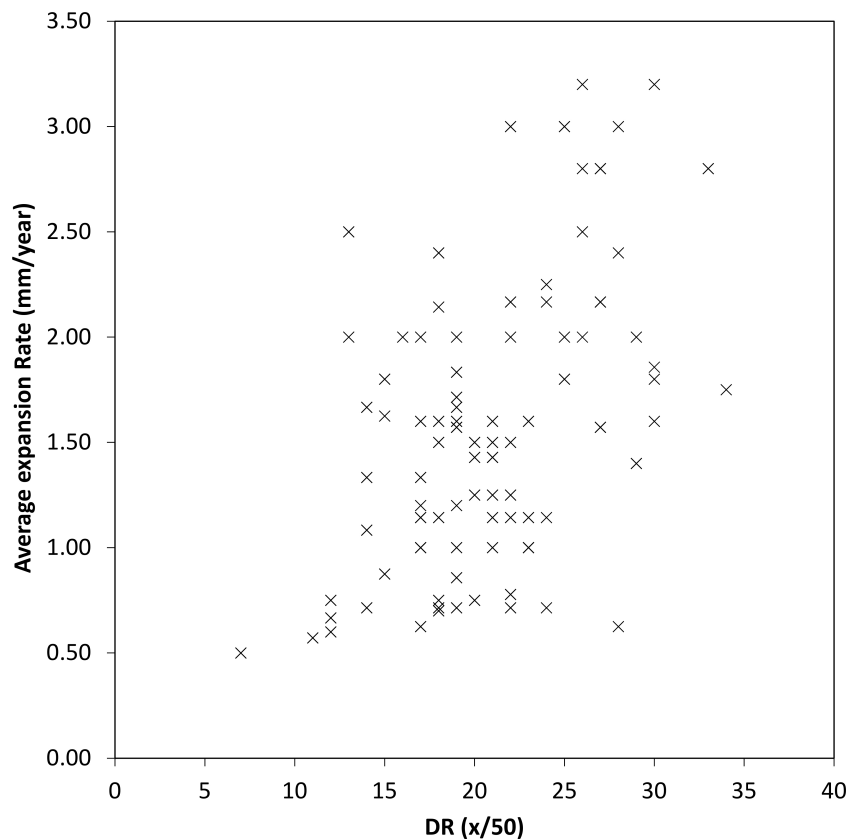
Figure 5.17: Link between the expansion rate and the damage rating.

This again shows correlation between the two values, although there is still a fair amount of scatter seen within the data.

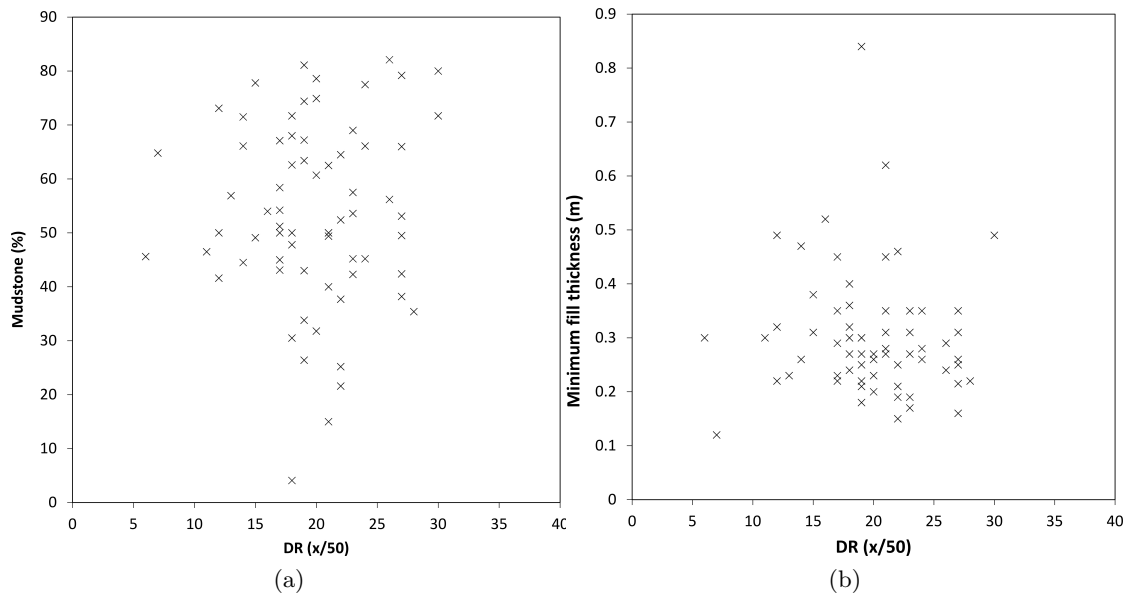
Figure 5.18: Comparison of the damage rating with the amount of mudstone and the depth of the fill.

Figure 5.18 also considers the impact of the fill thickness upon the amount of expansion, a factor that other research has shown to have a possible link (Ballivy et al., 2002. Sutton et al., 2013). The problem with considering the fill thickness in these cases is again a lack of information. For many properties, especially those inspected when the problem was just becoming apparent, the information is either unavailable or incomplete. For the comparison in Figure 5.18b, the fill thickness is that stated in the geological reports that are available. For some properties, the level of the natural material is stated, however, for most the lowest level is where digging stopped due to enough material already having been removed for a sample, or some barrier, such as buried services, was encountered. To that extent, the comparison is only with the minimum possible thickness of the material. The correlation between the damage and the fill thickness is summarised in Table 5.7.

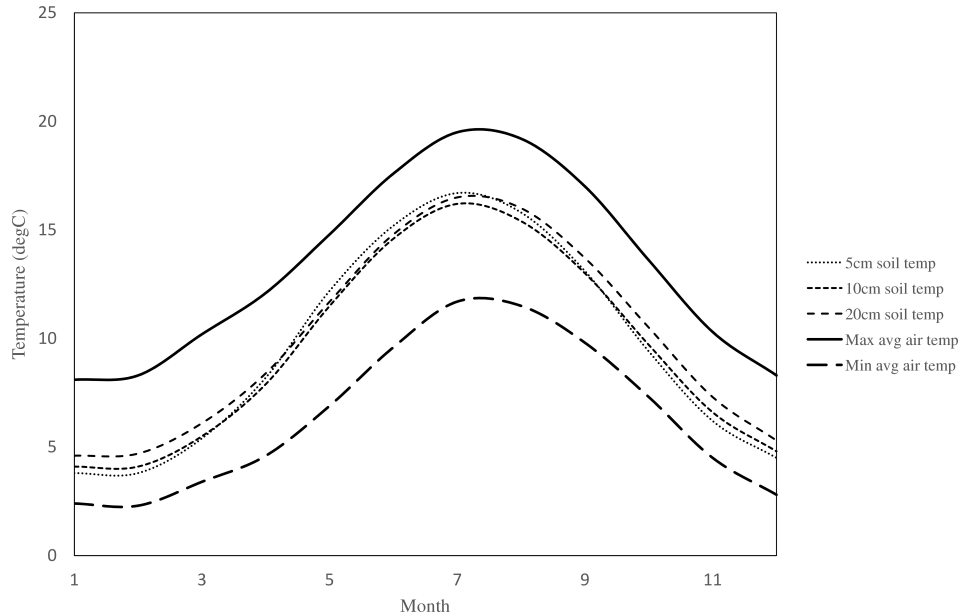
Figure 6.1: Annual air changes in air and soil temperature at Dublin Airport (Met.ie, 2010).

From available air and soil temperature data, Figure 6.1, the insulation effect of the soil can be seen, with the soil temperature changes in air temperature, only slower and to lower extremes.

As shown in Figure 6.1, the average air and soil temperature data for Dublin Airport, located within a few miles of the test property, is available online via the Irish Meteorological Service (Met.ie, 2010). This data shows that in August and September 2015, the monitoring period described herein, the average soil temperature at 10 cm depth was 15.9 and 13.2°C respectively. Therefore, the sensor seems to be recording a higher reading, indicating the warming from the home.

Considering that the annual average soil temperatures at 10 cm depth shown in Figure 6.1 vary between a minimum of 4°C and a maximum of 16°C, the fact that the temperature of the fill is already above this maximum heading into the colder months suggests both a heating effect of the foundation and house structure, and an impact by the human habitation in the property. Based on the current temperature data, it is unclear whether the house is insulating the fill from the cold or is actively heating it. It is anticipated that as more data is retrieved during the winter period, it will be possible to answer this question.

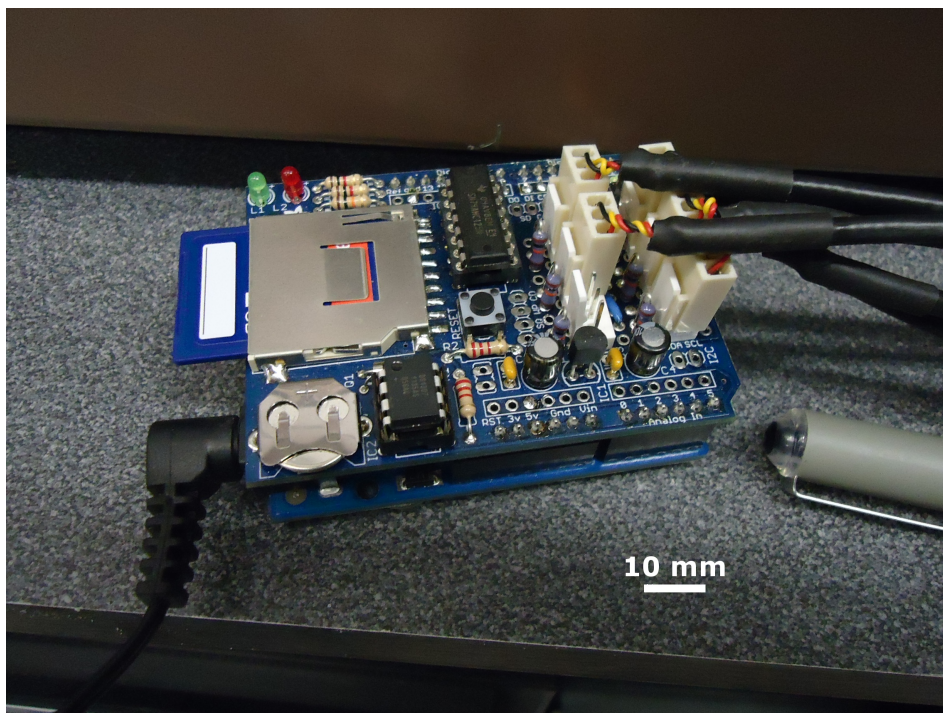
Figure 6.2: Image of the Arduino used in the first round of testing

In order to study the below-slab environment, a system was needed that would be small, low cost and would allow for modifications depending on the number of sensors required. For the prototype system, it was decided to use an Arduino Uno<sup>TM</sup> – this is compatible with a large range of sensors, is reasonably priced and the code is open source meaning that a good support base is available. Figure 6.2 shows the Arduino Uno<sup>TM</sup> used in the laboratory testing.

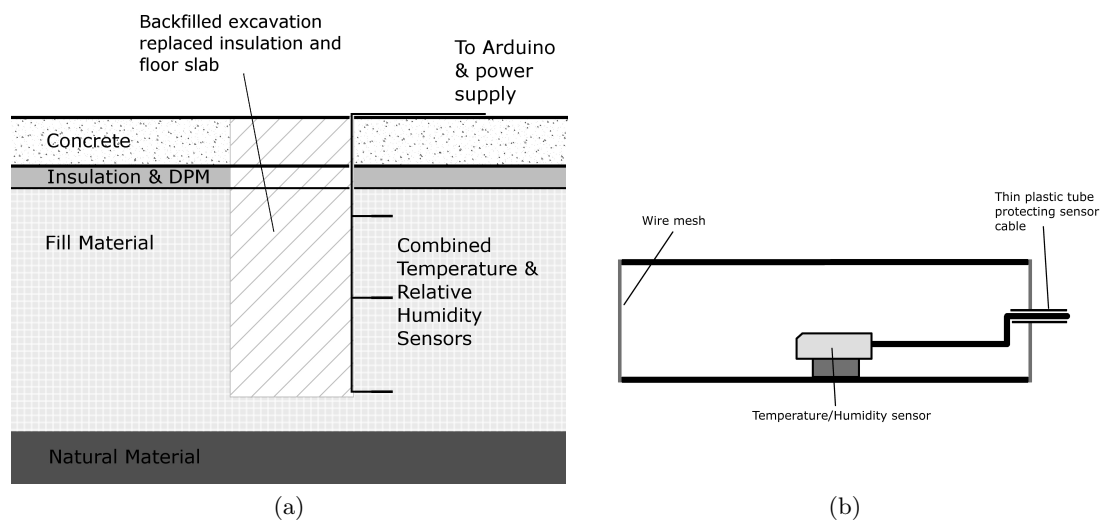
Figure 6.3: Planned method of installing the combined sensors in situ and the shield designed to protect the temperature and humidity sensors.

in order to determine any changes with depth through the fill. The reason being that any major temperature changes were likely to be induced from the direction of the floor slab, and any moisture changes from the direction of the natural material. Figure 6.3a shows the intended layout of the sensors in situ, in order to get the maximum amount of information. Three sensors was determined to give the most data while still allowing for space between the points, especially since the depth of fill would be unknown until installation.

Figure 6.3b shows the design for the housing for the sensors, with a larger tube housing the sensor itself to allow air to circulate which would be restricted were the sensor in contact with the fill.

For this purpose, a system was designed using combined temperature and relative humidity sensors to measure the air within the fill. This could then be calibrated to give a reading of the moisture content of the fill after calibration in the laboratory. Additionally, the sensors were housed within a 50 mm diameter PVC tube covered at both ends by wire mesh – this was intended both to aid placement within the fill material, and to allow air to circulate over the sensors. Figure 6.3b shows this schematically.

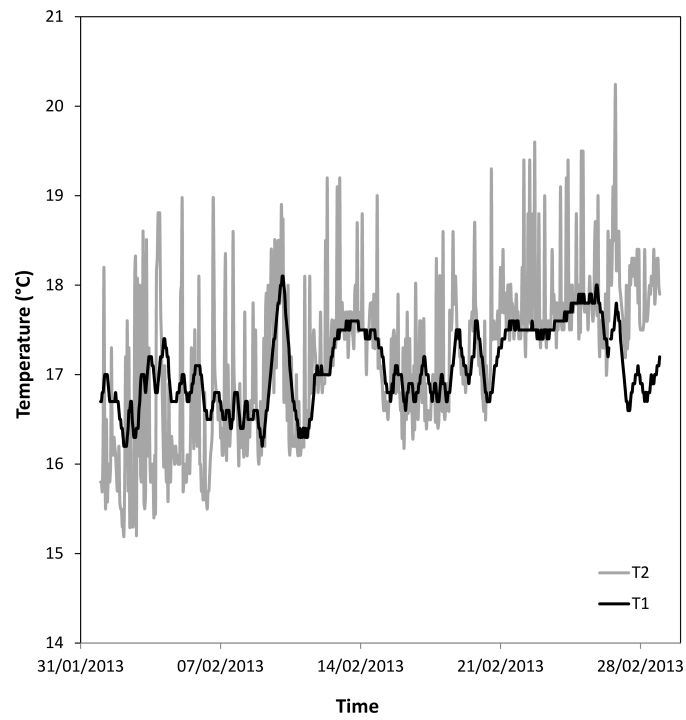
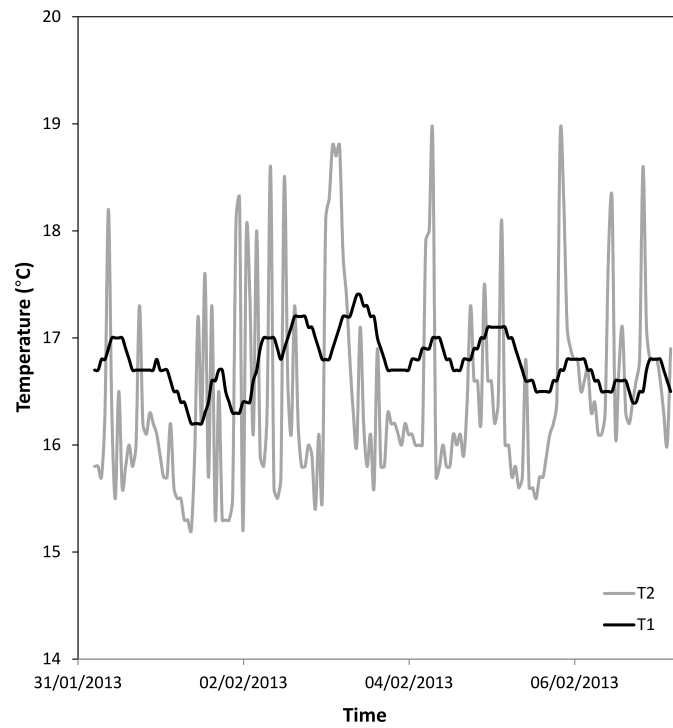
(a) Temperature changes over 31 days.

(b) Temperature changes over 7 days.

Figure 6.4: Mirroring of laboratory air temperature changes (T2) by the soil temperature (T1)..

Figure 6.4 shows the temperature data obtained from one of the buried sensors (T1) compared to one of the sensors situated in the air on top of the tube (T2). Figure 6.4a shows a full month of data from the tube, with recordings taken once per hour, Figure 6.4b shows an expanded view of the data from the first week. Both graphs show that the temperature within the material reflects the changes in the laboratory air temperature, although there is a distinct insulation effect in the sensor variations compared to the laboratory sensors. This insulation effect also causes a lag in the mirroring of the temperatures – high points in the material temperature occur slightly after the corresponding peak in the air temperature. This difference is generally on the scale of 3 to 4 hours, depending on the swing from one extreme to another.

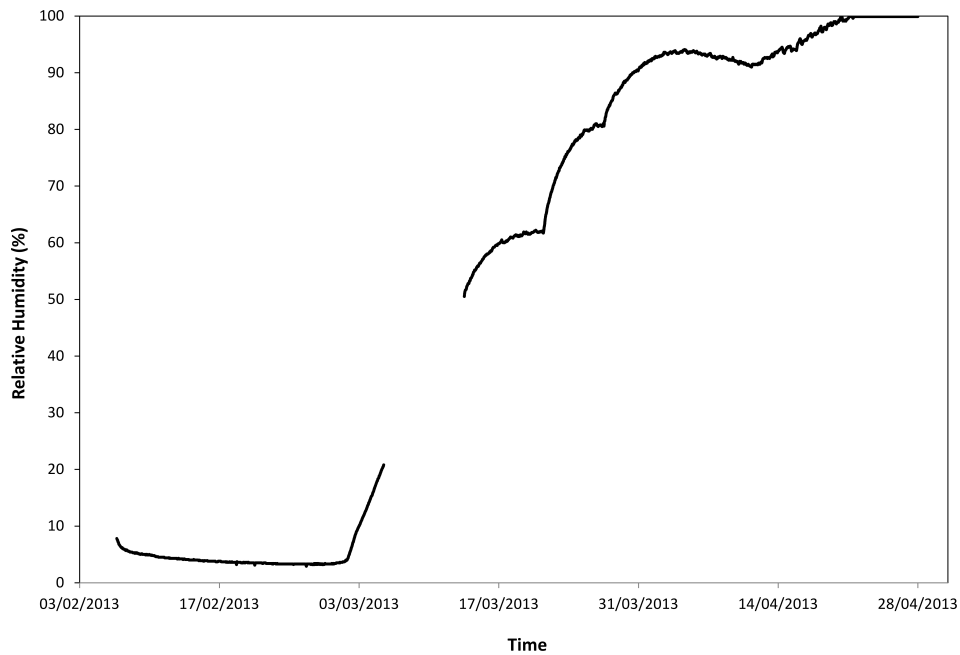
Figure 6.5: Addition of water to the sample containing the relative humidity sensor.

Within 2 hours of being removed from the material, the humidity readings matched those of the sensors that had been left outside the tube to monitor the laboratory conditions. It was then decided to place one of the sensors into a box containing dry material to which water would be added until the sensors read 100% humidity, at this point the moisture content would be measured in order to determine the functional range of the sensors. The material used was the same as the material in the tube, although in this case it was not compacted around the sensors. Apart from the times at which water was added, the box was sealed to maintain it's own environment. Figure 6.5 shows the progress as the water was added, there is a gap in the data due to operator error in which the connector for the sensor was not seated correctly in the Arduino<sup>TM</sup>. The potential for this happening was taken into account when designing for the other sensors as detailed below.

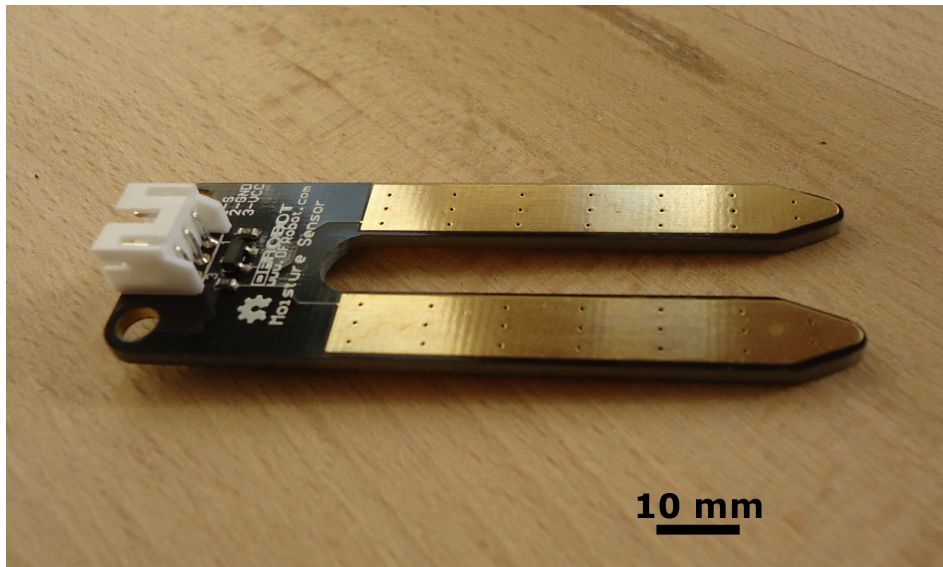
Figure 6.6: Dielectric sensor used with the Arduino to measure the soil moisture.

After looking at alternative sensors, it was decided to use dielectric probes – these could also be used with the Arduino<sup>TM</sup>, would be easier to install (as they do not require a separate housing), and ideally would give a quicker response to any moisture changes than the relative humidity sensors. Figure 6.6a shows one of the dielectric sensors used with the Arduino<sup>TM</sup> system. These are DFRobot moisture sensors (SKU:SEN0114), circuit diagrams and appropriate code are located in Appendix A.

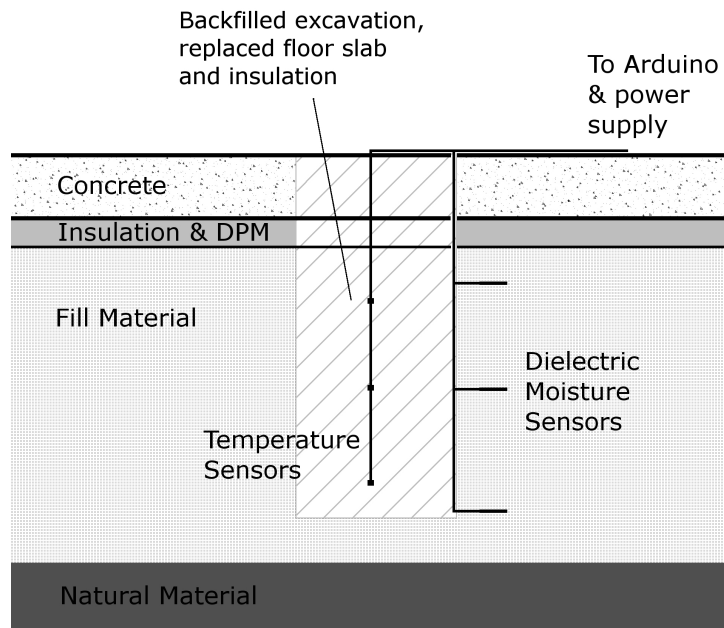
Figure 6.7: Planned method of installing the sensors in situ using the separate dielectric and temperature sensors.

In addition to this, a separate system of monitoring the temperature would be needed, as the sensors no longer combined both functions. This actually made the design somewhat simpler, as smaller, digital temperature sensors could be used – these could be wired in sequence and simply placed along the edge of the excavation, and held in place by the backfill. The sensors used here were the Dallas One Wire digital temperature sensor (DS18B20), which had the benefit of having a reference library for the digital readings, meaning that calibration was unnecessary. The circuit diagram and relevant code for these sensors is contained within Appendix A. Figure 6.7 shows this new layout schematically.

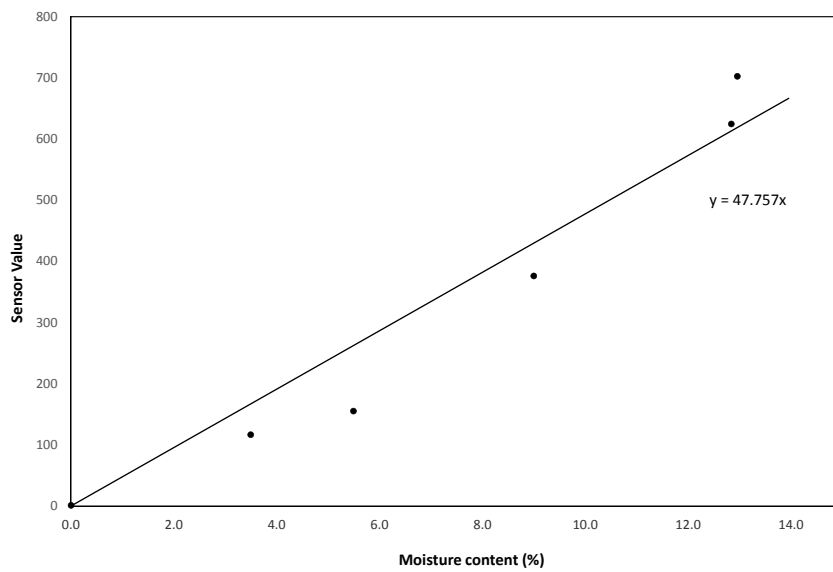
Figure 6.8: Calibration chart as used for determining the relationship between sensor reading and moisture content in the laboratory.

Figure 6.8 shows the relationship between the sensor readings and the moisture content for the material used in the laboratory. This relationship was assumed, based upon the clustering of points, to be linear, and so was calculated as such.

The relationship between the sensor readings and the moisture content, for the material in the laboratory tests, is shown in Equation 6.3, which was used to convert the sensor readings into moisture content values as shown in Figure 6.9.

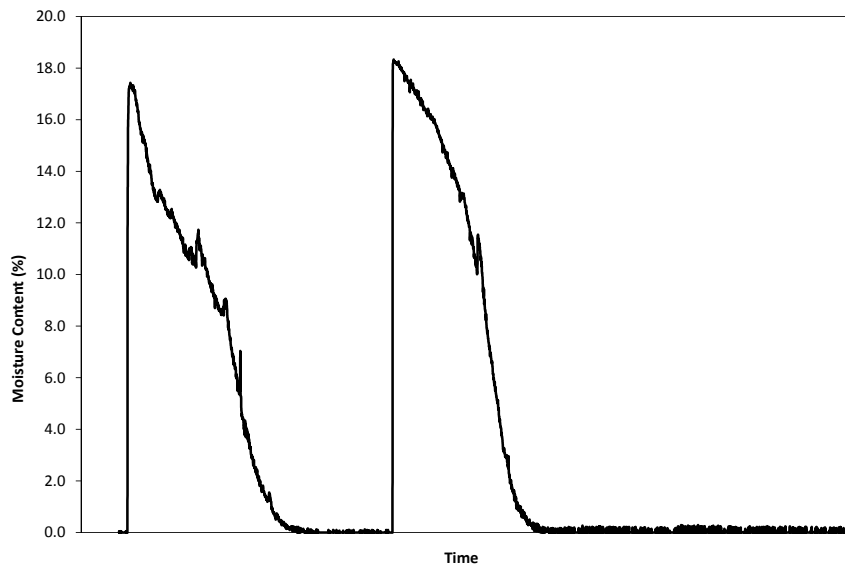
Figure 6.9: Variation of the moisture content as water was added to the soil sample in the laboratory.

Figure 6.9 shows the moisture content variations in the material as water was added. Since the box was not sealed, the water was allowed to evaporate and the material to dry out in order to see how variations occurred.

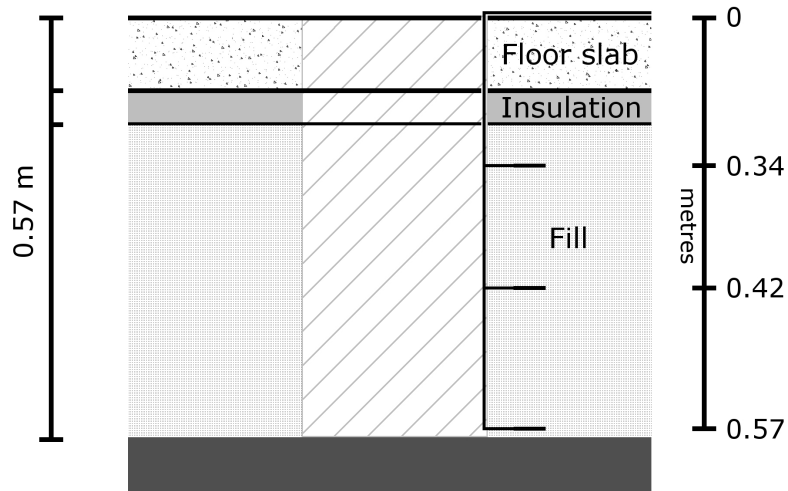
Figure 6.11: Layout of the dielectric sensors, including their depths, in the test property.

The trial pit was 0.57 m deep, this being the level at which the natural, clay material was encountered. The dielectric sensors were placed within the fill material on the side of the pit. The lowest was placed in the fill just above the natural material, the second placed roughly halfway down the side of the pit and the third into the fill just below the blinding beneath the damp proof membrane. This is shown schematically in Figure 6.11.

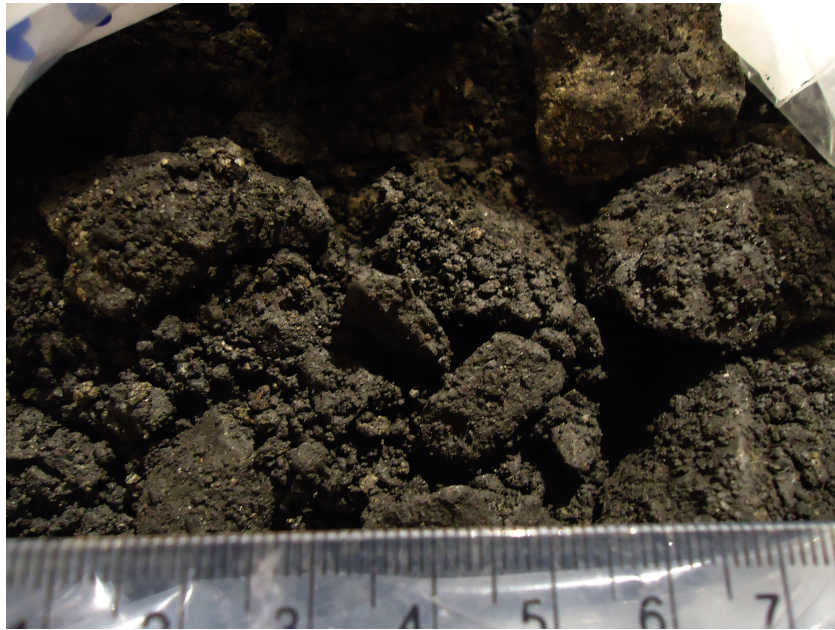
Figure 6.12: Material taken from the pit in which the sensors were installed, shown at its natural moisture content.

The material that was removed from the pit was taken away for testing as per the pyrite protocol, the information from which is not yet available. However, Figure 6.12 shows the sample that was brought back to the laboratory for calibration of the dielectric sensors.

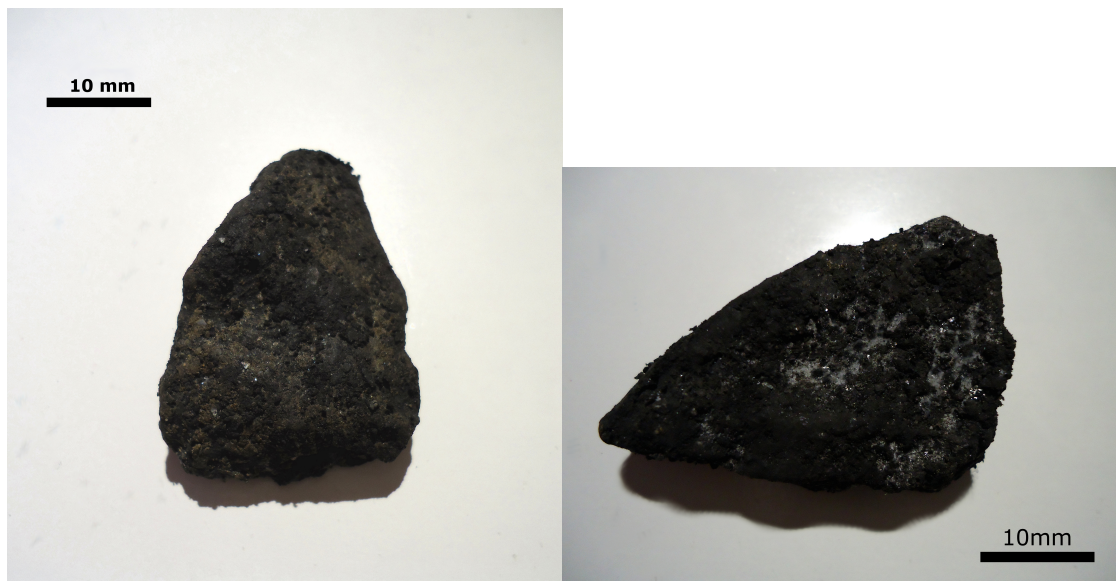
(a) Mudstone fragment showing areas of orange-brown staining – to the right of the image. (b) Mudstone fragment showing areas of gypsum precipitation – silvery grey patches to the right of the fragment.

Figure 6.13: Images of opposite sides of a mudstone fragment taken from the sample shown in Figure 6.12.

The fill material had an in situ moisture content of 6.4% and is generally comprised of mudstone and siltstone, with a large proportion of fine material. The surfaces of the larger particles are frequently stained a brownish colour (Figure 6.13a) and are covered with small white or clear crystals (Figure 6.13b). Based upon visual inspection, these crystals are similar in habit and appearance to the gypsum crystals seen in hand specimens from multiple other locations.

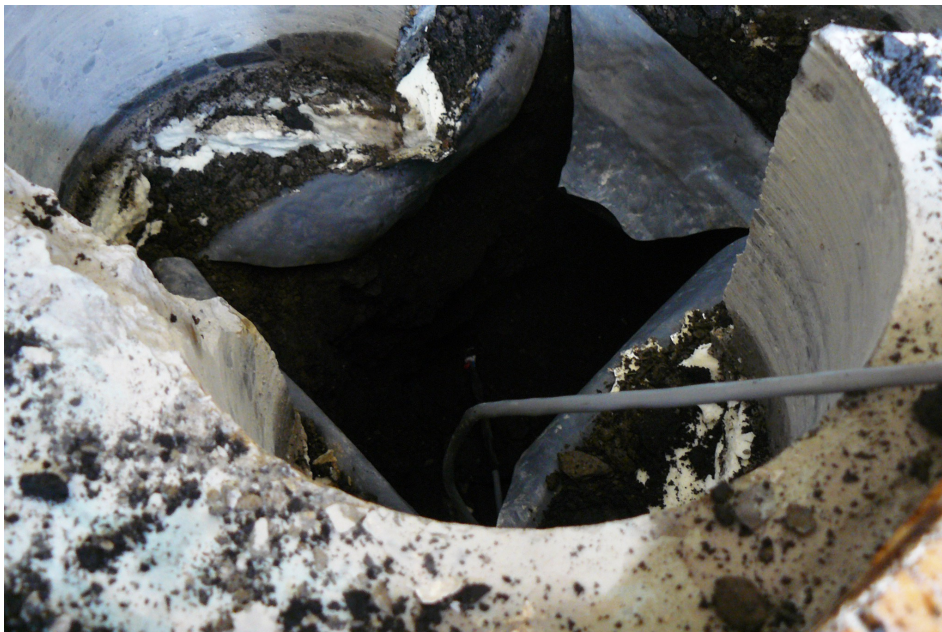
Figure 6.14 below shows the installation of the dielectric sensors in the sample pit at the property. The dielectric sensors were seated into the fill material in the side of the pit with the full length of the pins inserted into the material. The cable containing the temperature sensors was held in place in the middle of the pit as the hole was back filled in order that the cable stayed vertical.

Figure 6.14: Installation of sensors at the test property.

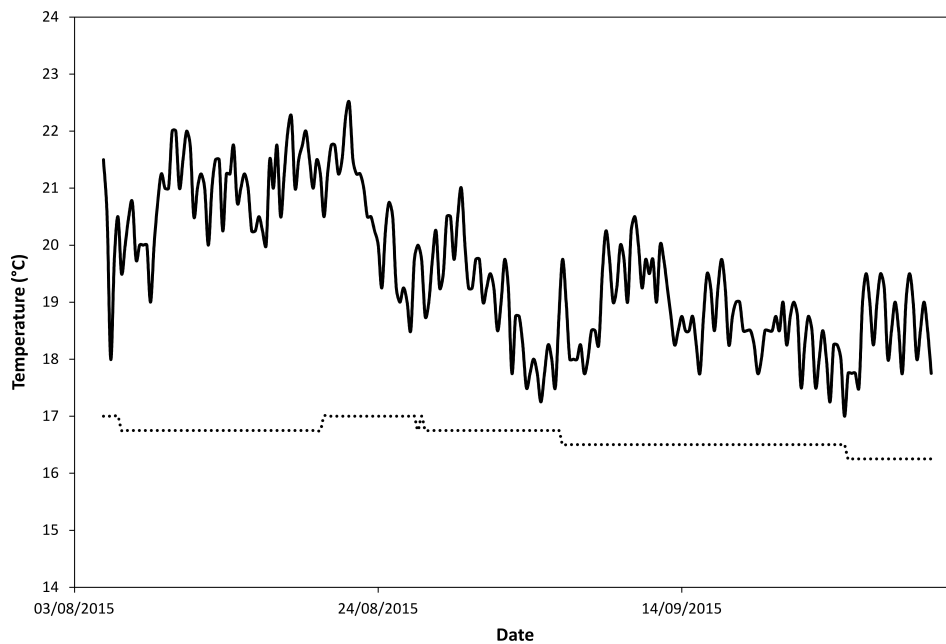
Figure 6.16: Modified data from the internal and middle temperature sensors, reflecting the gradual temperature decreases.

As the figure shows, although a general decrease with time of both temperatures can be seen more clearly than in Figure 6.15, at present there is not enough data to confirm

In order to determine whether there was a reflection of the temperatures, the temperature data for the internal and middle sensors was plotted with data points every 6 hours instead of every 15 minutes as in Figure 6.15. This was intended to remove the smaller temperature fluctuations in order that a better comparison of the temperatures could be made, and is shown in Figure 6.16.

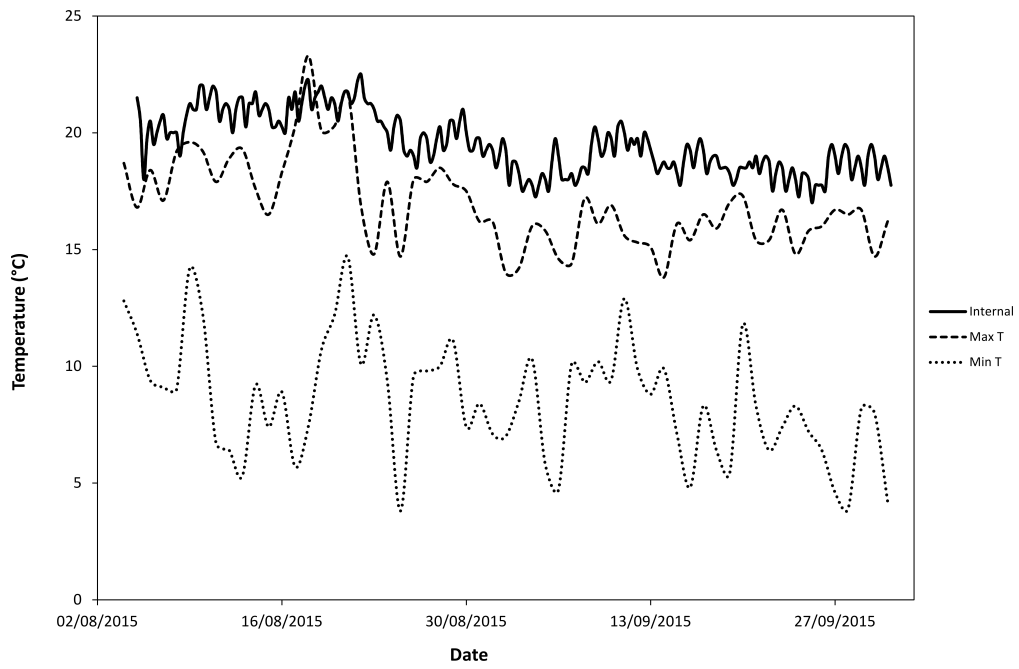
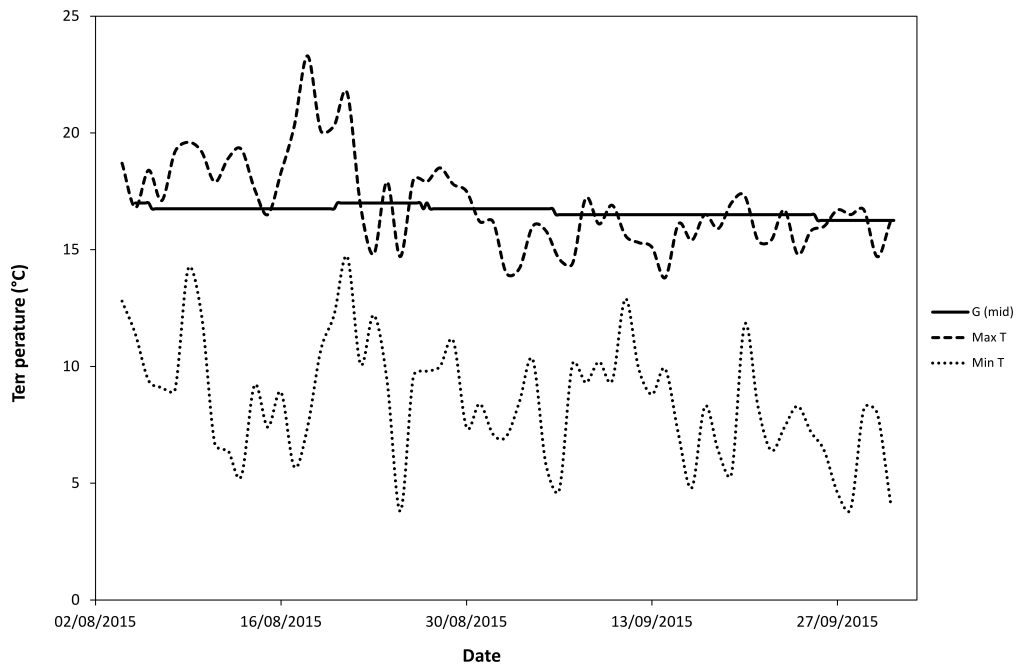
(a)

(b)

Figure 6.17: Variations in external and internal measured temperatures over the monitoring period.

To consider this further, the air temperatures for Dublin Airport during these months was accessed. Figure 6.17 shows the maximum and minimum air temperatures for August and September 2015 as compared to the values obtained from the internal sensor placed near the Arduino<sup>TM</sup> (Figure 6.17a) and the middle of the three buried sensors (Figure 6.17b).

Figure 6.17b, seems to show that the temperature in the fill during the monitoring period is following the internal room temperature, which in turn is following the external air temperature. Monitoring is ongoing to determine if this will remain true during the colder months when the building is heated on a regular basis. More importantly, in the colder months the data should give a better idea as to which temperature has the greatest influence on the fill temperature – the internal room temperature or the external air temperature.

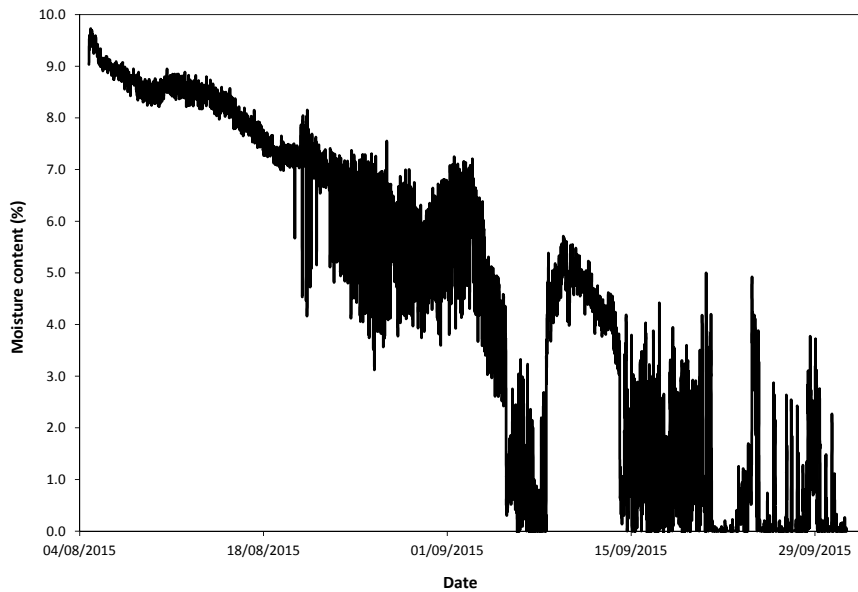
Figure 6.18: Initial data recorded with the uppermost dielectric sensor.

Figure 6.18 shows the raw data obtained from the uppermost dielectric sensor, converted to show the moisture content value, but with no data processing. Although the graph shows an overall decrease in the moisture content of the material, there is a lot of noise present obscuring the data.

Equation 6.4 shows the coefficient obtained from measuring the fill material obtained from the test property, whilst Figure 6.18 shows the initial values obtained from the dielectric sensors.

The cause of this noise is unclear at the time of writing, as the sudden changes in moisture content were not seen in the laboratory experiments that were carried out to

test the system. Considering that in some cases, the moisture content can change from a value of 7.3 to 0.5 and back again within the space of 30 minutes, it is likely that the cause of these anomalies lies with the sensors or Arduino<sup>TM</sup> system, rather than with the fill itself. It is more likely that these anomalies are caused by a problem with the sensors or due to some sort of signal interference.

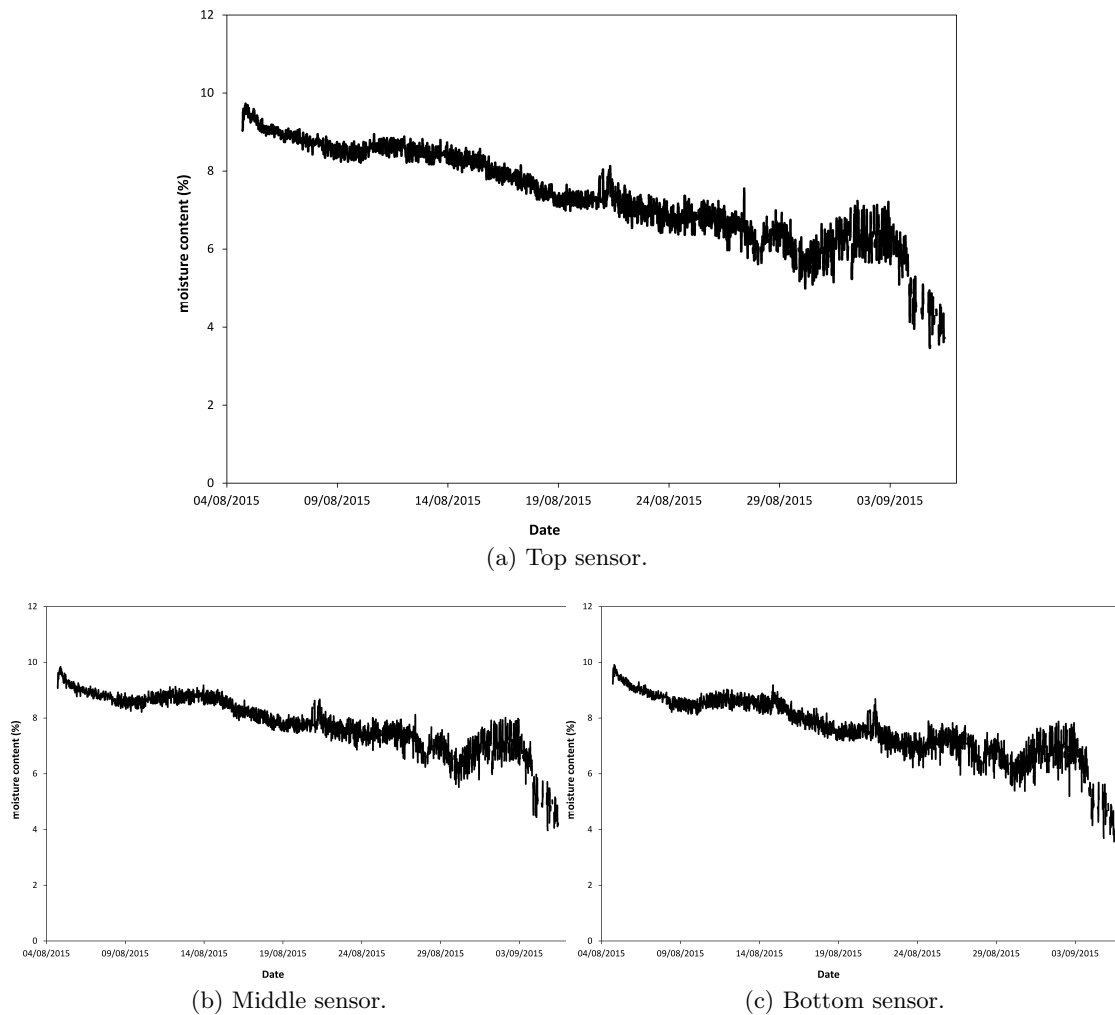
Figure 6.19: Moisture content data retrieved between 4th August and 5th September 2015.

Despite the analysis carried out to remove the worst of the anomalies, there is still a large amount of noise seen in Figure 6.19, and as mentioned above, there is an increase of this noise with time. Still, it can be seen that over time there is a gradual decrease in the moisture content of the material.

In order to better analyse the initial data, the points registering as an anomaly in the ‘if’ analysis were removed, and all data up until the 5th September was plotted as shown in Figure 6.19 below.

This is thought to be due to the moisture level in the material around the sides of the pit equilibrating to match that of the backfill that was placed after excavation. Although the backfill material was not completely dry, it did have a very low moisture content. As this was the only material that was available when installing the sensors, and the natural moisture content was not known such that water could be added to the material, it was decided to go ahead with placement and monitor the situation to see what occurred.

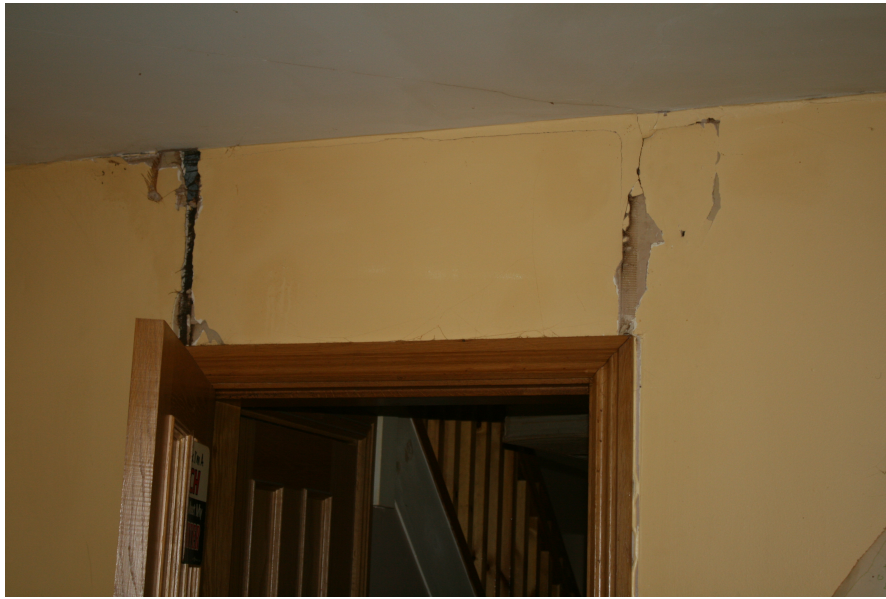
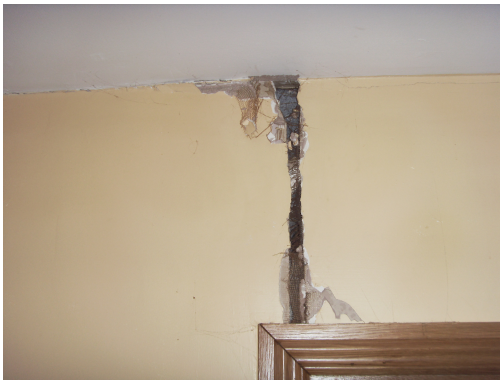
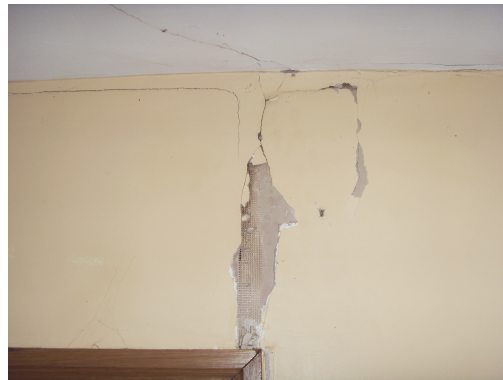
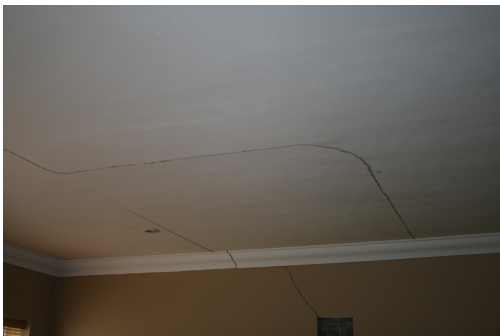
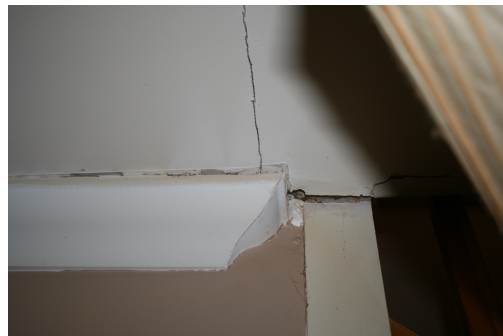
(a) Cracking to the plasterboard above the living room door. Images b) and c) show the cracks in more detail

(b) 10 mm crack to upper left of living room doorway

(c) Cracking and spalling plaster to upper right of living room doorway

(d) Cracking to kitchen wall and ceiling, maximum crack width 8 mm

(e) Cracking and upward movement to stairwell, maximum movement 6 mm

Figure 7.2: Damage seen at the property from which material was removed for testing in the laboratory (Used with permission from Aidan O'Connell Associates).

The analysis gave a minimum value of 30/50 for the amount of damage seen. This is stated as a minimum value since from the limited data available, it is unclear whether other damage might have been present that was not included in either the site photographs or the engineering reports. When compared to the properties that were analysed as part of the work detailed in Chapter 5, this is a relatively high value signifying significant damage, as is highlighted in Figure 7.2.

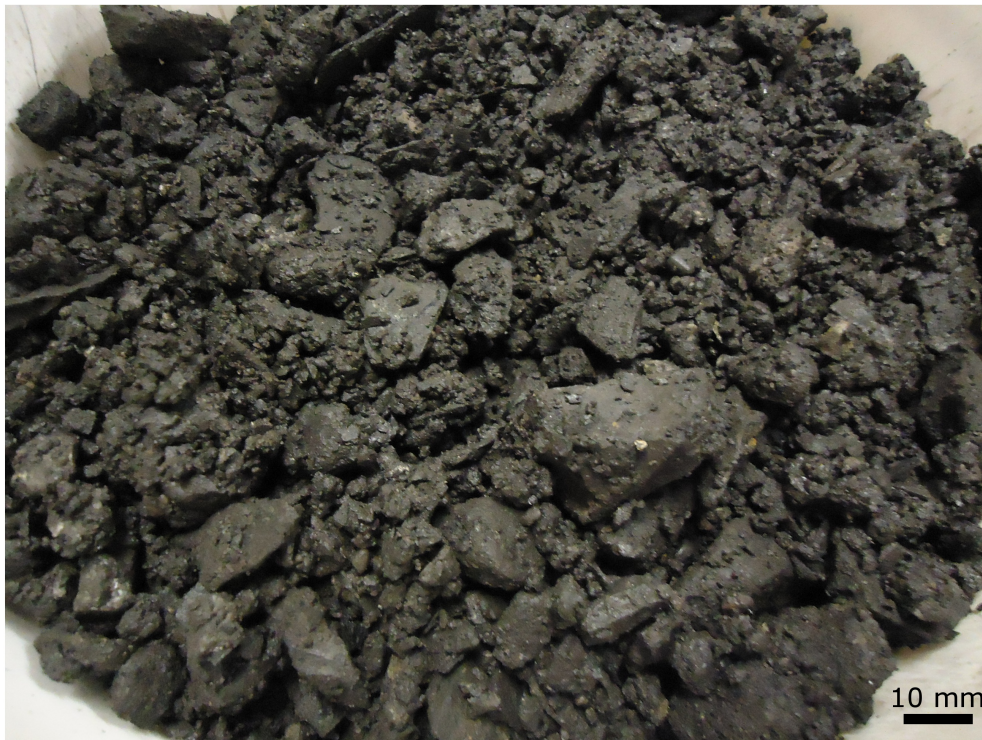
Figure 7.3: Mudrock fill material used in the laboratory testing in its damp state.

The surfaces of the mudstone were noted to contain clear and white crystals and orange-red deposits. It is unclear from the documentation available whether these were also present on the siltstone particles, although some cross-contamination can be assumed.

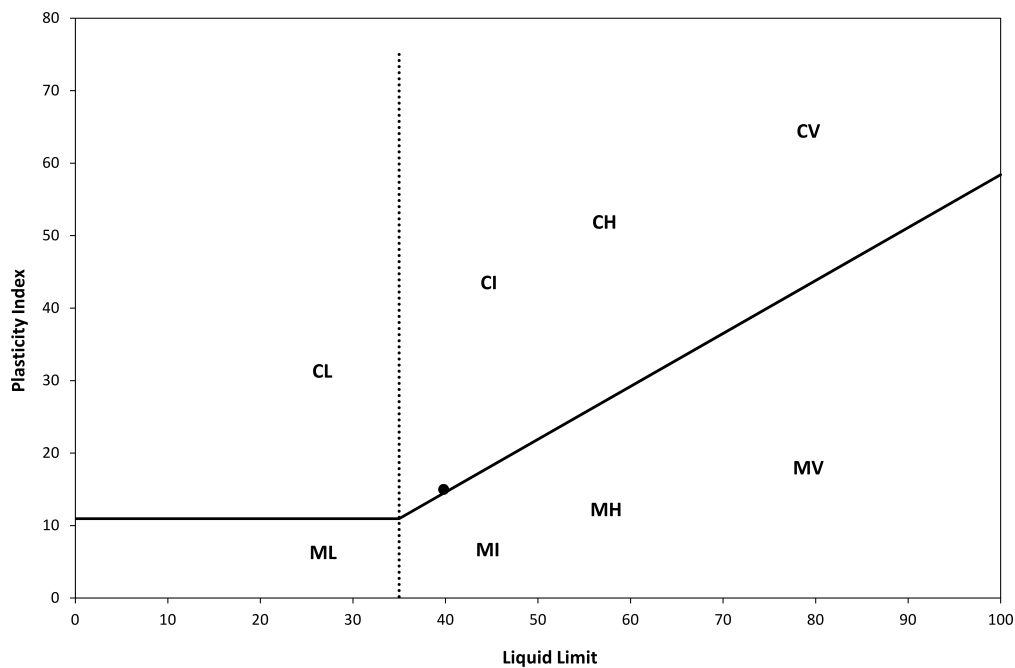
Figure 7.4: Position on the Casagrande chart of the material as tested in the laboratory.  
M: Silt, C: Clay. L: low plasticity, I: intermediate plasticity, H: high plasticity,  
V: very high plasticity.

Table 7.3 shows the summarised values for the material and Figure 7.4 shows the position of the material on the plasticity chart.
