A Thesis submitted for the degree of Doctor of Philosophy

**The Expansion of Pyritic Mudrocks: A  
consideration and application of physical  
tests for better understanding of the Irish  
pyrite problem.**

University of Sheffield  
Department of Civil and Structural Engineering

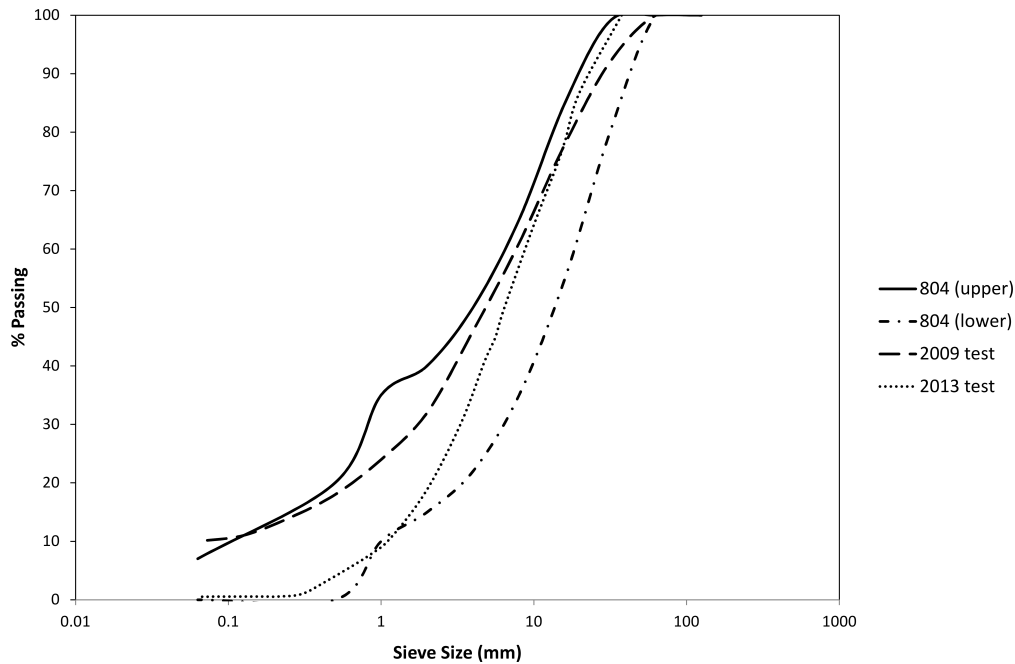
Figure 7.5 shows the PSD for the material obtained as part of the initial testing in 2009 as well as the retest when it arrived in the laboratory after remediation, as compared to the Clause 804 upper and lower limits.

Figure 7.5: PSD for the material used in the laboratory testing from the 2009 geotechnical tests and as received in the laboratory.

As discussed in Section 4.2, when many of the damaged properties were constructed, it was common practice to simply specify Clause 804 material for use as fill beneath the ground floor slab, and the specification comes with upper and lower bounds for the particle size distribution, as shown in Figure 7.5. These bounds are intended to provide a

There is a noticeable difference in the distribution between the 2009 and 2013 tests, with the 2013 test apparently containing less fine material than that in 2009. This is likely due to natural variations in the fill material – although Figure 7.1 shows the location that the sample was taken from, no such information was available as to which bags of material were taken from which location during the remediation process.

However, one thing that is immediately noticeable from Figure 7.5 is the fact that the material largely falls within the limits assigned to Clause 804 material, the main exception being that the 2009 test exceeds the upper limit in the very fine material present.

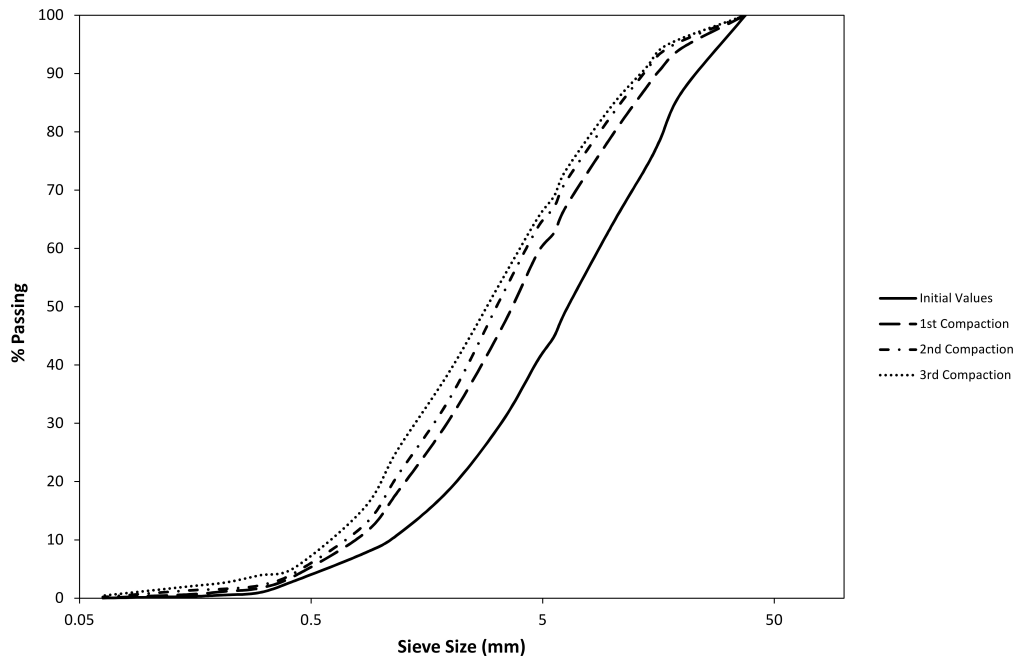
Figure 7.6: Fine-ward progression of the PSD curve with repeated compaction.

There is a general fine-ward movement of the PSD, showing the overall breakdown of the material with each subsequent round of compaction. Considering this breakdown of the material, it would seem that the initial grading of the material before placement as fill at a property would have met the limits of Clause 804.

Compaction was carried out in a 100 mm diameter mould, with a 2.5 kg compaction hammer as detailed in the Manual of Soil Laboratory Testing (Head, 1992) and BS 1377 Part 2 (BSI, 1990). Material for this part of the test was compacted at its natural moisture content, i.e. the moisture content when it was in situ, in this case a value of 7.8%. Figure 7.6 shows the PSD curves for the initial values of the material, and for the tests carried out after each compaction test.

Secondly, part of the specification for Clause 804 material is that it should not contain rock that easily breaks down under compaction. Considering the breakdown of the material shown in Figure 7.6, even if the grading would appear suitable before placement, the strength of the particles would not be.

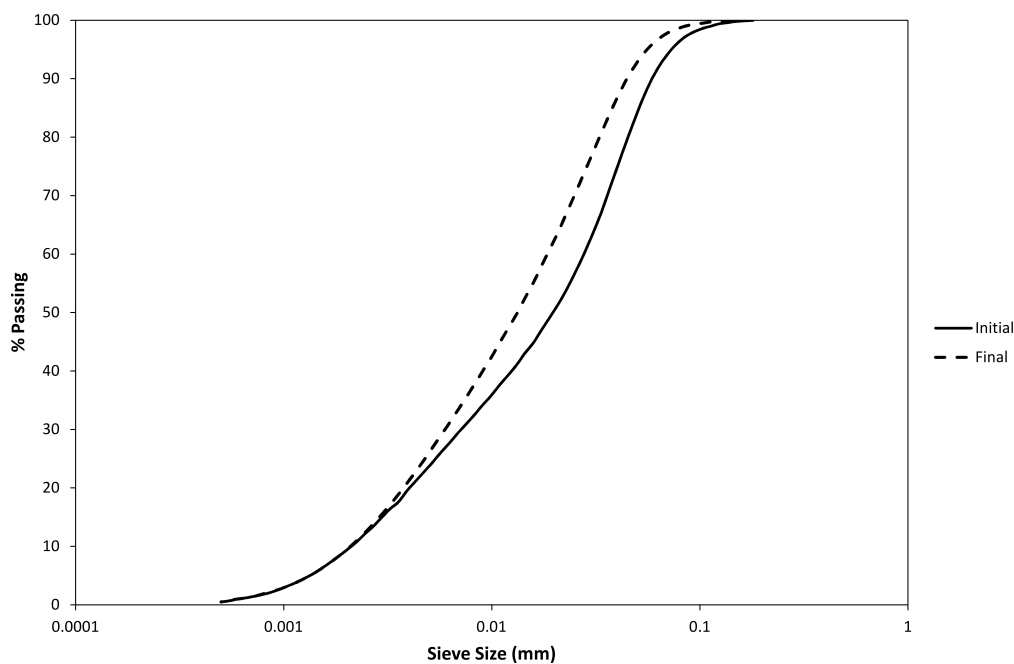
Figure 7.7: Change in the very fine content of the material between the initial test (as received in the laboratory) and after the third and final cycle of compaction, values as determined by the Mastersizer.

Figure 7.7 shows the change in the fine fraction from the initial laboratory tests to after the third compaction. No deliberate drying out of the material took place during these tests, and all material was stored in airtight containers in a cool location between testing phases, however, it is likely that a small amount of drying out occurred due to the nature of both the compaction and sieving tests.

There is a more pronounced increase in the material above 0.01 mm than there is below, which is likely due to the material below this size being too small to be broken down by

the compaction process. Material above this point and below 1 mm or so is also unlikely to be overly affected by the compaction process, but material of this size is produced due to the breakdown of the larger particles.

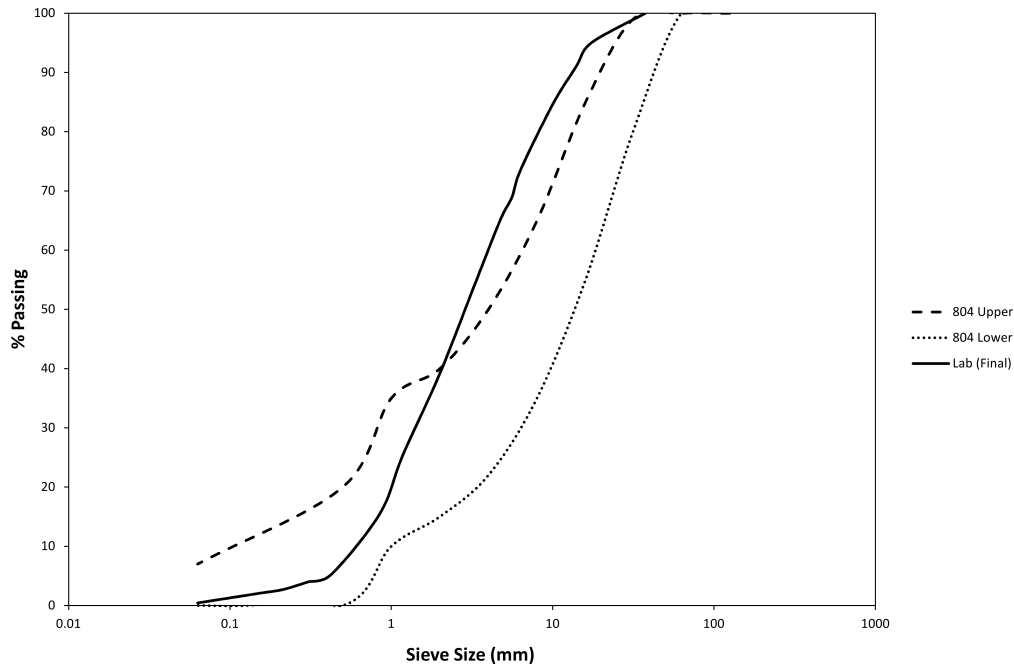
This breakdown of the larger rock fragments is shown in Figure 7.8, which shows the difference between the Clause 804 limits and the PSD of the material after the compaction tests. This material had by this stage undergone 3 stages of compaction in the laboratory in addition to the initial compaction when placed in situ at the property.

Figure 7.8: Comparison of the PSD for the material with the Clause 804 limits after the third round of compaction.

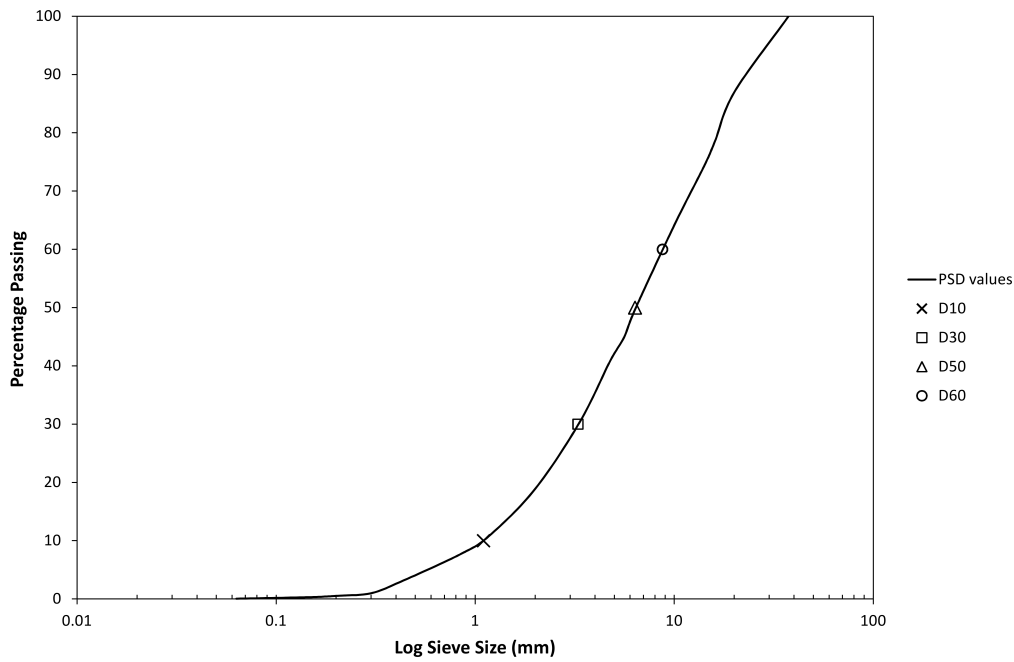
Figure 7.9 shows the PSD curve for the material with the different percentage passing values marked, these values are summarised in Table 7.5.

Figure 7.9: PSD chart showing the key percentage passing values.

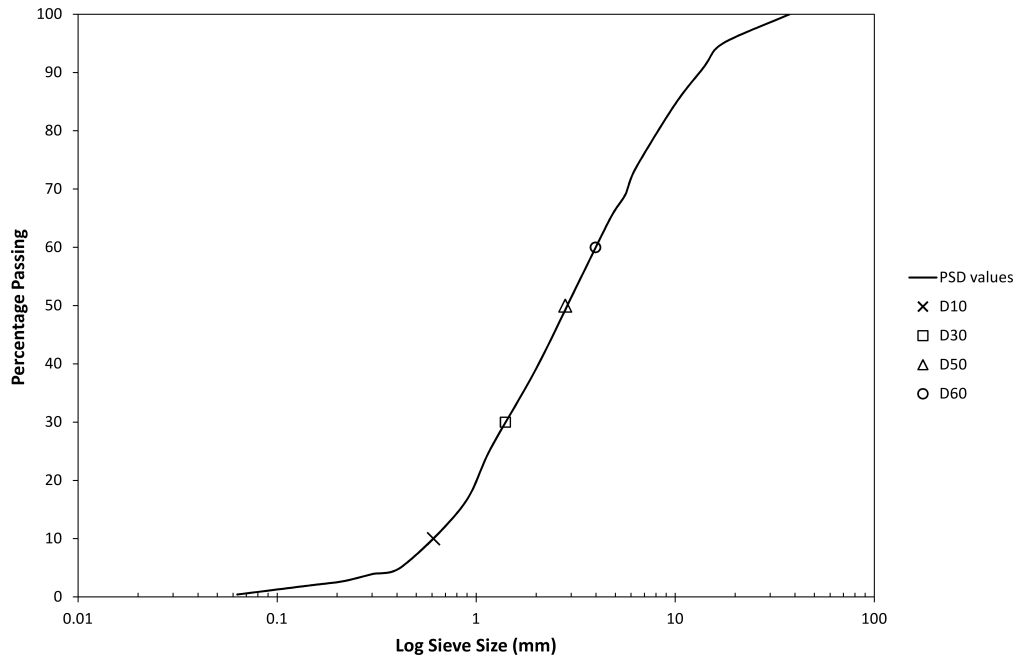
The same analyses were performed on the PSD obtained after the three rounds of compaction, in order to determine how the compaction and break-down process affected the specific surface. Figure 7.10 shows the PSD curve for this analysis.

Figure 7.10: PSD chart showing the key percentage passing values after three rounds of compaction.

Equation 7.1 gives a specific surface of **2.38 m<sup>2</sup>/kg** and Equation 7.2 gives a value of **2.34 m<sup>2</sup>/kg** for the material after the third round of compaction, showing again the increase in fine material.

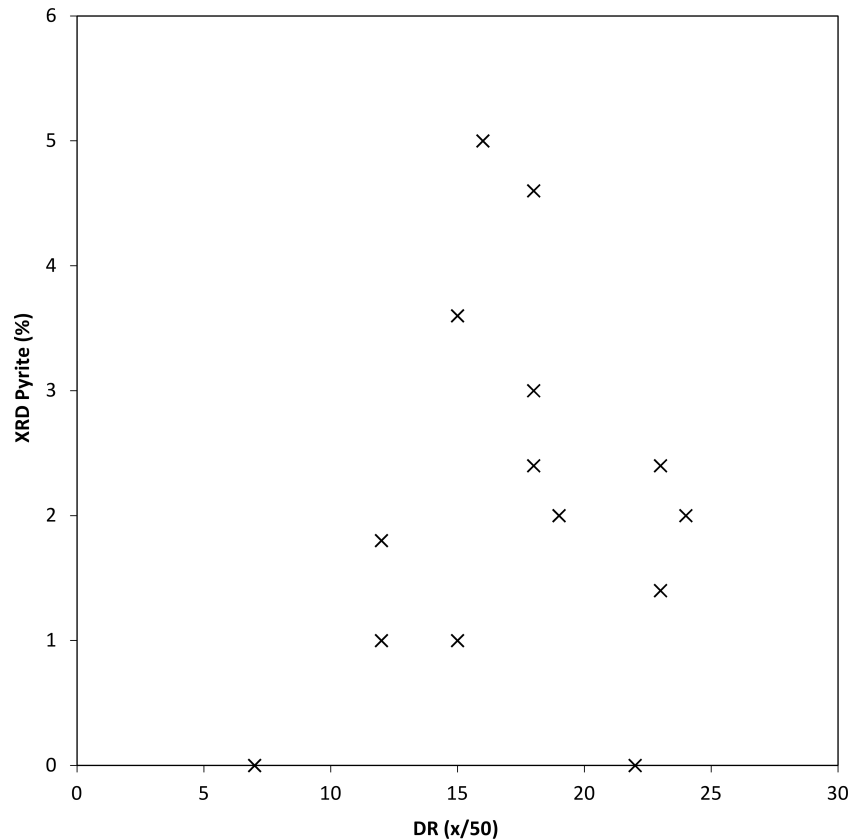
Figure 7.11: XRD pyrite values as linked to the Damage Rating for properties of Development Alpha

The correlation between the XRD pyrite value and the damage rating was calculated to be -0.011, meaning that there is no correlation seen between the data that is available. This would seem to suggest that there is no link between the two values, however, two factors need to be taken into account:

- The XRD value represents the amount of pyrite present in the material at the time of testing, i.e. after the damage seen at the properties had already occurred.
- The correlation between the calculated current value of pyrite (calculated from the chemical tests) and the damage rating was 0.096.

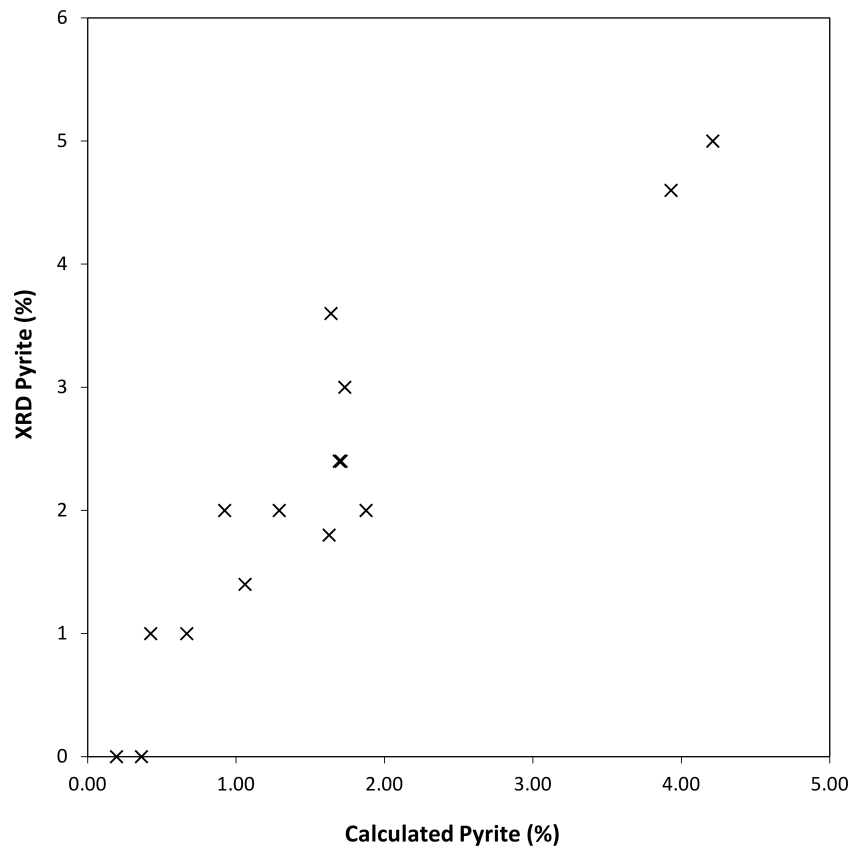
Figure 7.12: Link between the XRD and calculated current pyrite values for Development Alpha.

These values can be seen plotted against one another in Figure 7.12, and shows a Pearson correlation coefficient of 0.92, which indicates that as one increases so does the other, confirming that there is a linear correlation between the two sets of results when using either one to consider the amount of pyrite present in the material as it is examined.

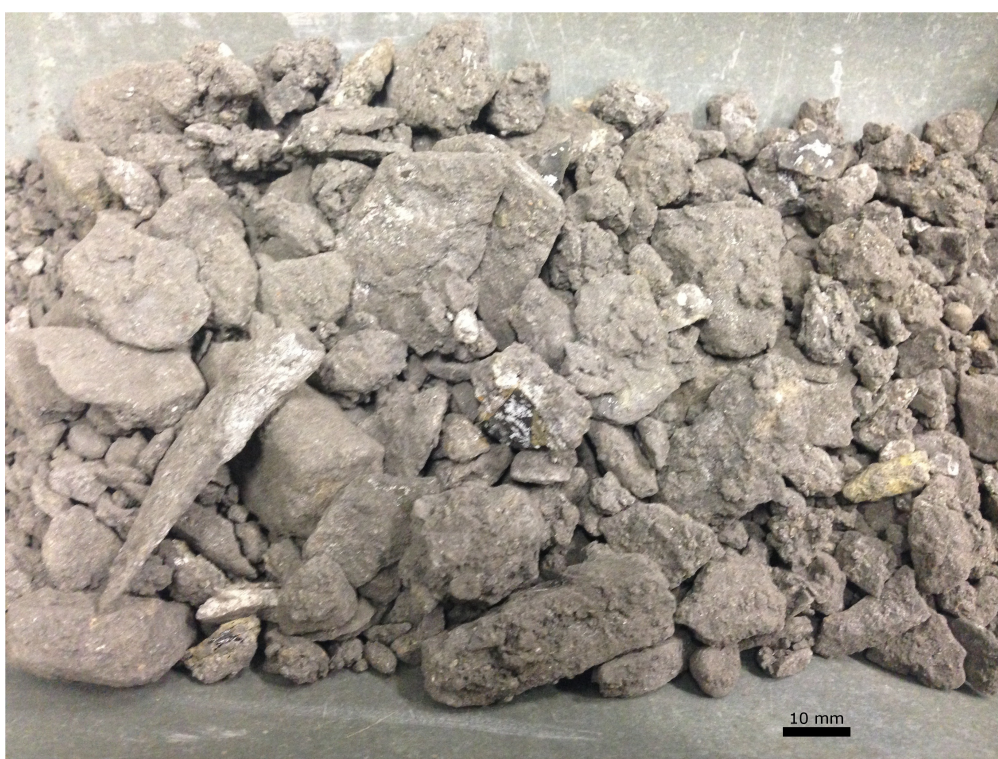
Figure 7.13: Mudrock fill material used in the laboratory testing in its dry state as used for the Comparison Testing

Figure 7.13 shows the material as prepared and shipped out for testing. Prior to shipping the material was passed through a 20 mm sieve and was dried in the oven at 70°C. Prior to sieving the material had been stored in a cool, dry location, and after sieving and drying, before shipping, it was stored in the refrigerator.

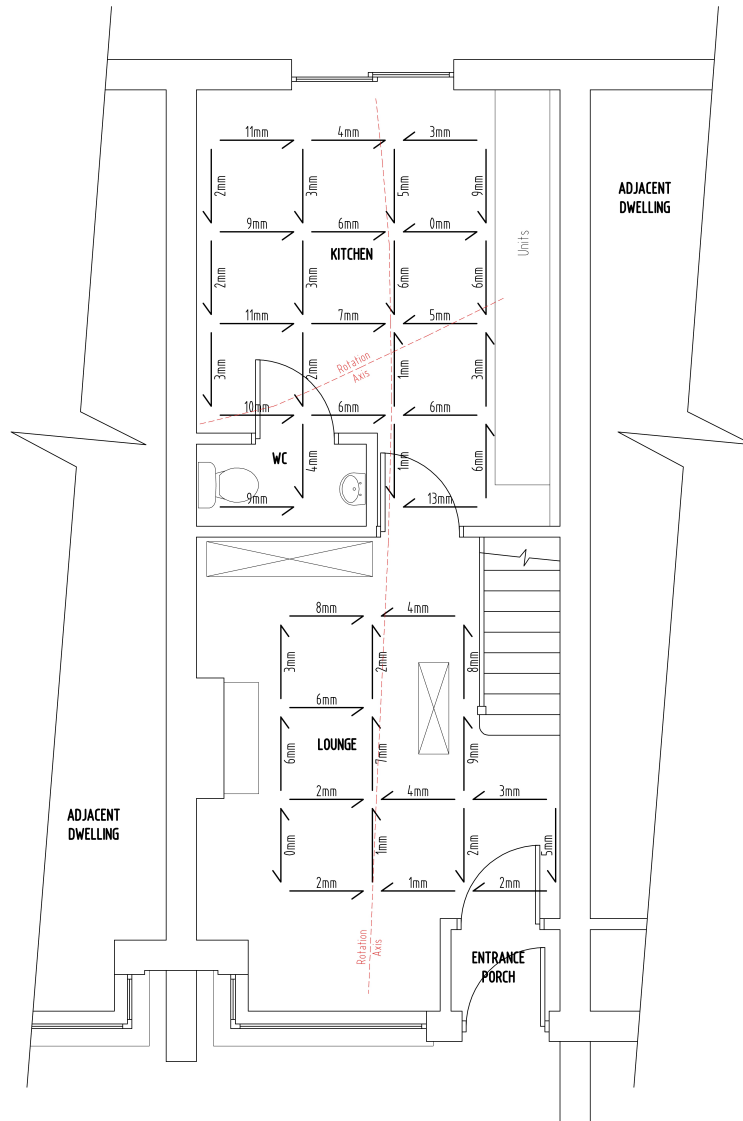
Figure 7.14: Floor level survey for the property from which the samples were taken (used with permission of Aidan O’Connell Associates). All marked lines showing changes in floor level are 1 metre in length.

remediation beginning in summer 2015. Analysis of the structural report with the IS 398-1 framework (as detailed in Chapter 5) gives a damage rating of 23 out of 50, with Figure 7.14 showing the initial floor level survey for the property from which the samples were taken.

This process highlights the ridge in the centre of the kitchen floor slab that was shown in the floor level survey (Figure 7.14), with the majority of the uplift occurring in this

The limestone material was predominant in the lounge area of the property, with only small amounts in the kitchen area where sampling occurred. It should be noted that a large area of limestone was present close to the front wall of the property, where uplift amounts were low (Figure 7.14), but in areas where smaller amounts of limestone were present, such as in the doorway area between the lounge and kitchen, uplift rates were consistent with those in areas containing only mudstone.

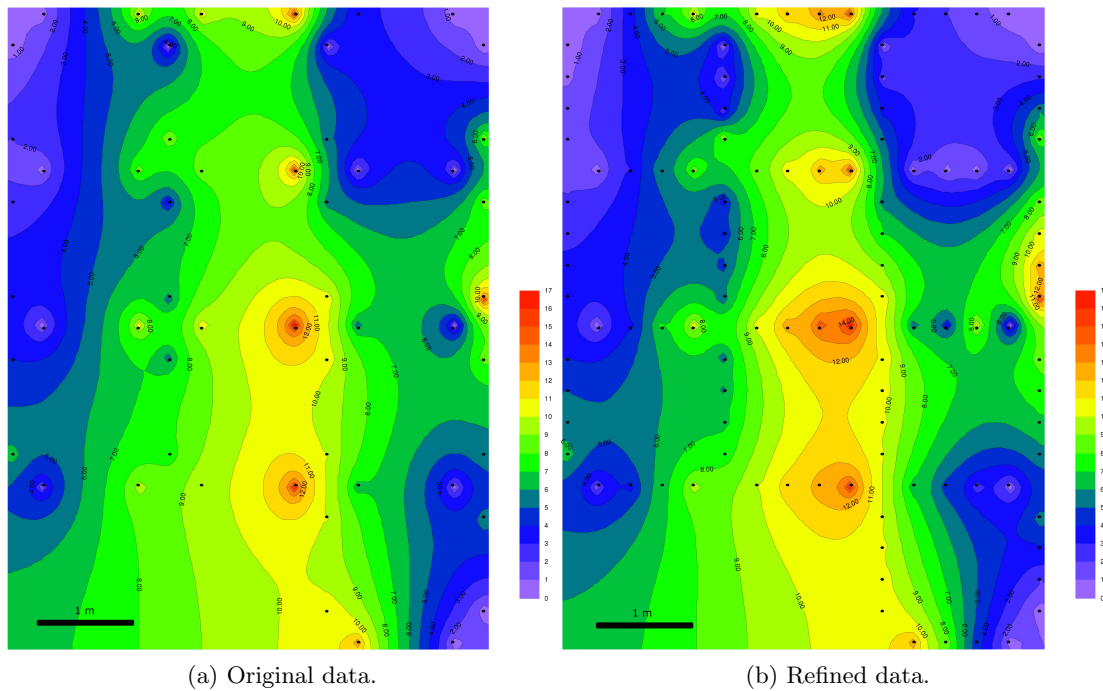
Figure 7.15: Contouring of floor slab levels in the kitchen of the property from which samples were collected. All contours given in mm above zero, grid values taken from the floor level data are shown as black dots.

Taking these assumptions into account, it is possible to create a grid of points across the section of the slab in question in order to obtain a series of contours for the height at each point on the grid. This is shown in Figure 7.15a.

With the assumption that the uplift occurs evenly along each line of measurement, it is possible to add additional values for each line that was used for Figure 7.15a. This was used in order to attempt to refine the data to provide more information. However, as can be seen in Figure 7.15b, the improvement to the image is limited and it would require the addition of a large amount of data to smooth the contours enough to aid analysis.

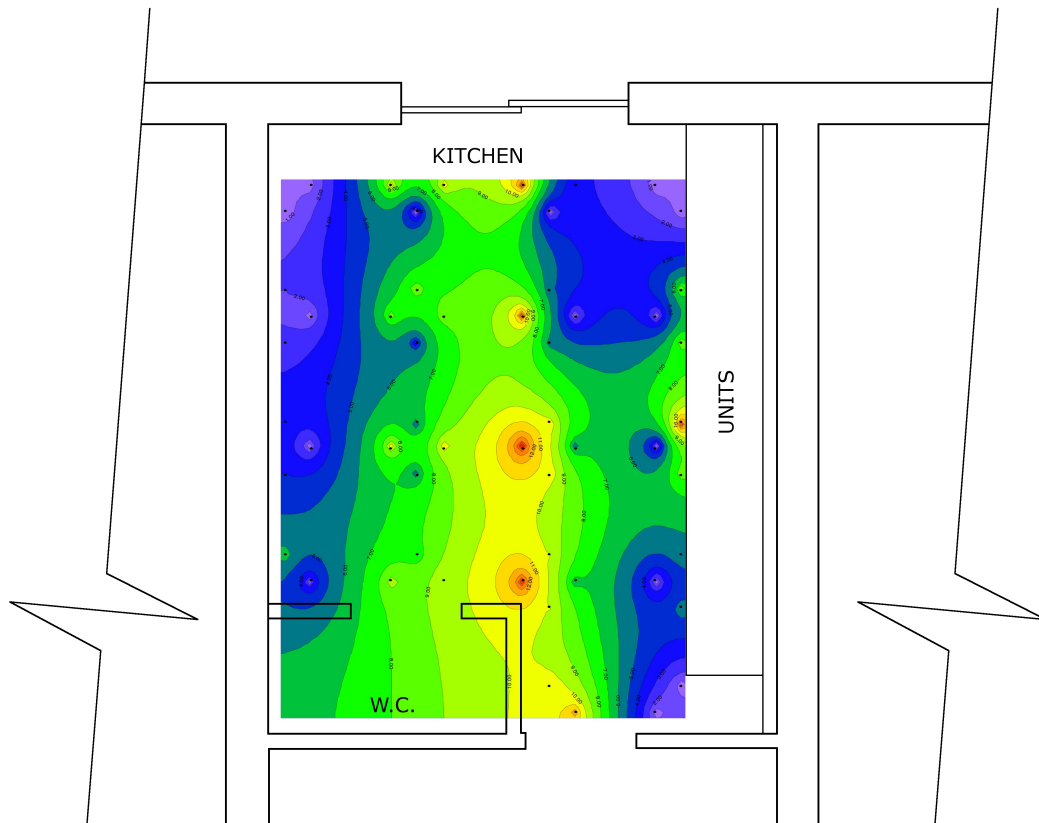
Figure 7.16: Uplift of the floor slab as relative to the structure, all contours given in mm above zero.

area and to the right hand side of the slab near the units.

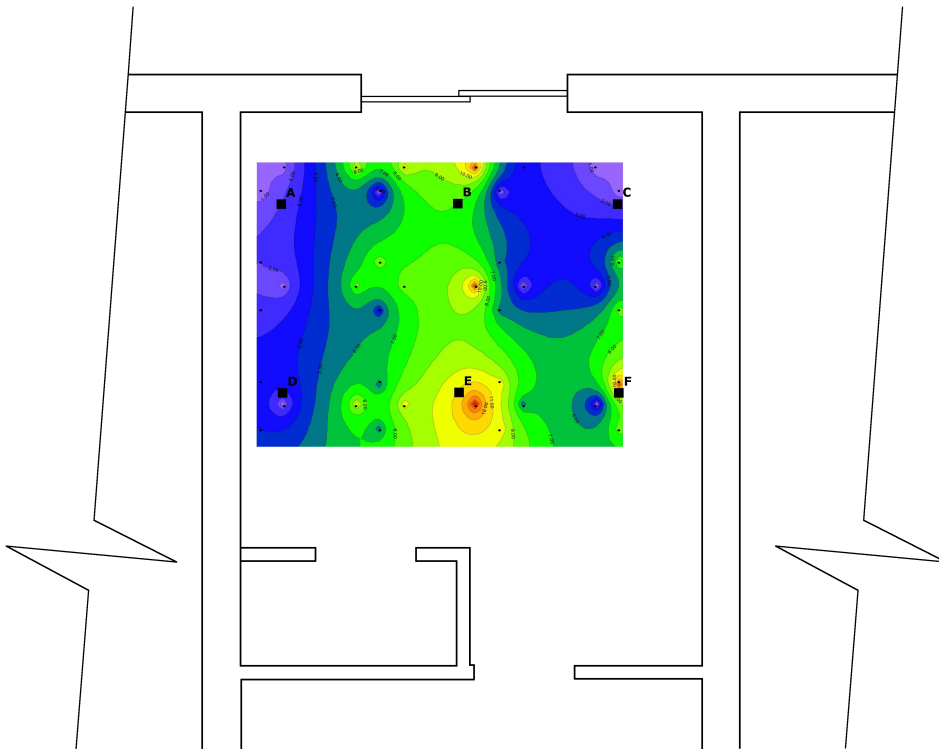
Figure 7.17: Sampling locations at the property relative to the uplift of the floor slab.

Samples were collected from the property during remediation, once the floor slab, insulation and DPC had been removed. They were taken on a grid as shown in Figure 7.17, measured relative to the external walls. At that time the analysis discussed above had not been completed, so the samples were taken based upon the floor level survey in order to have samples relative to areas that showed both large and small amounts of uplift.

When comparing these values to that of the ground floor uplift in Figure 7.17, it can be seen that the chemical data does not clearly reflect the ridge seen in the floor level survey. There is a mirroring of the chemical data around point C which also shows a lower level of uplift in the floor level survey, with all of the chemical values as well as the current and original levels of pyrite showing lower values in this area.

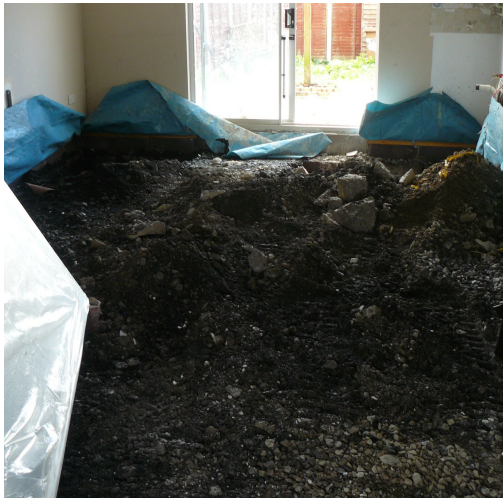
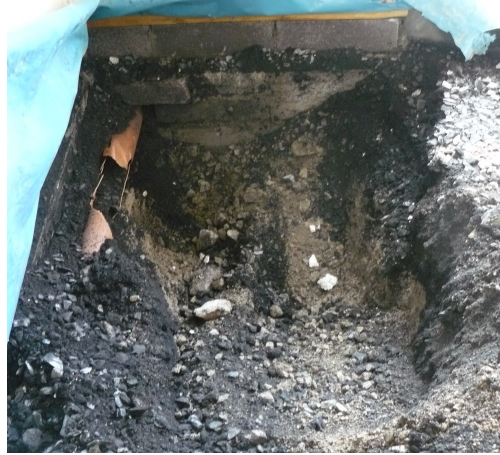
(a) Fill material below the kitchen area, with the double doors at the rear of the property.

(b) Limestone material (pale brown) mixed in with the mudstone (dark grey) fill material.

Figure 7.18: Images of the sampling location and the fill material.

Figure 7.18 shows the sampling location and the material as seen in situ. In particular, Figure 7.18b shows the variation of the material that was seen on site.

The paler material was similar in colour and appearance to the clean limestone material used to replace the defective fill material after remediation. It is likely that a combination of the limestone and mudstone fill materials were used at the time of construction, with one replacing the other after the initial material had run out.

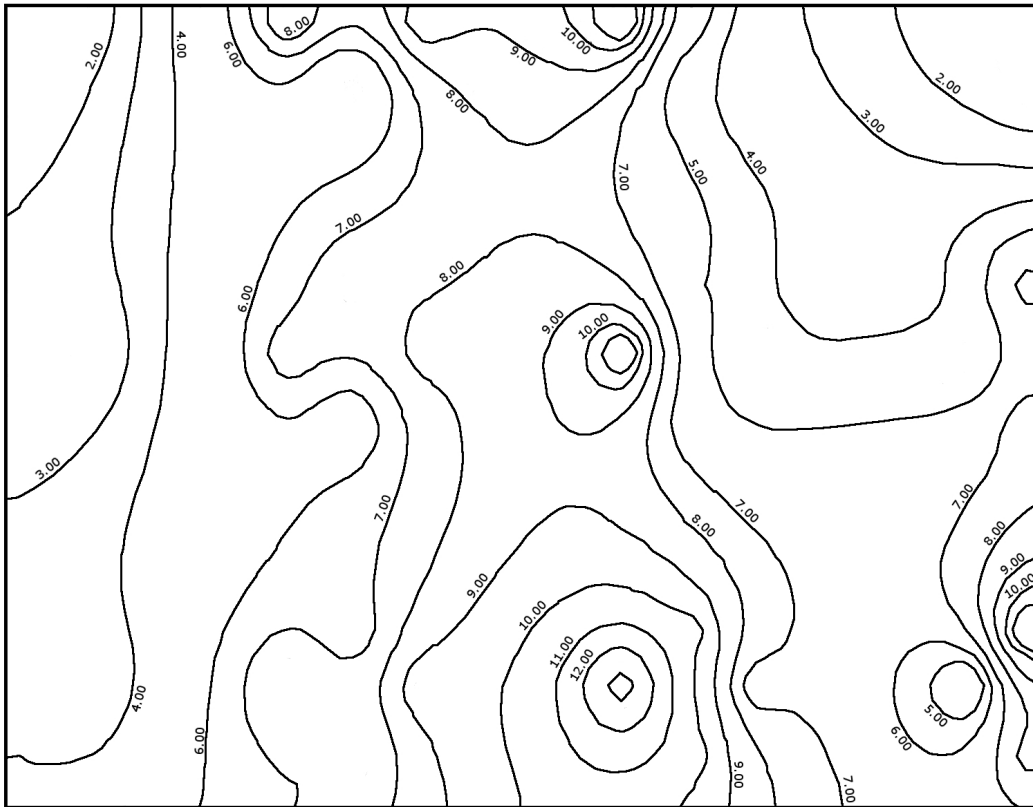
Figure 7.19: Simplified topography of the ground floor slab uplift. All line measurements in mm above zero.

Figure 7.19 shows the simplified topography of the floor slab adapted from Figure 7.17. In this simplified topography some of the contours have been removed in order to allow a clearer view of any intersections between the uplift and the chemical data. All contours shown in Figure 7.19 are in mm above zero – the level at which the floor slab would reside if no uplift had occurred.

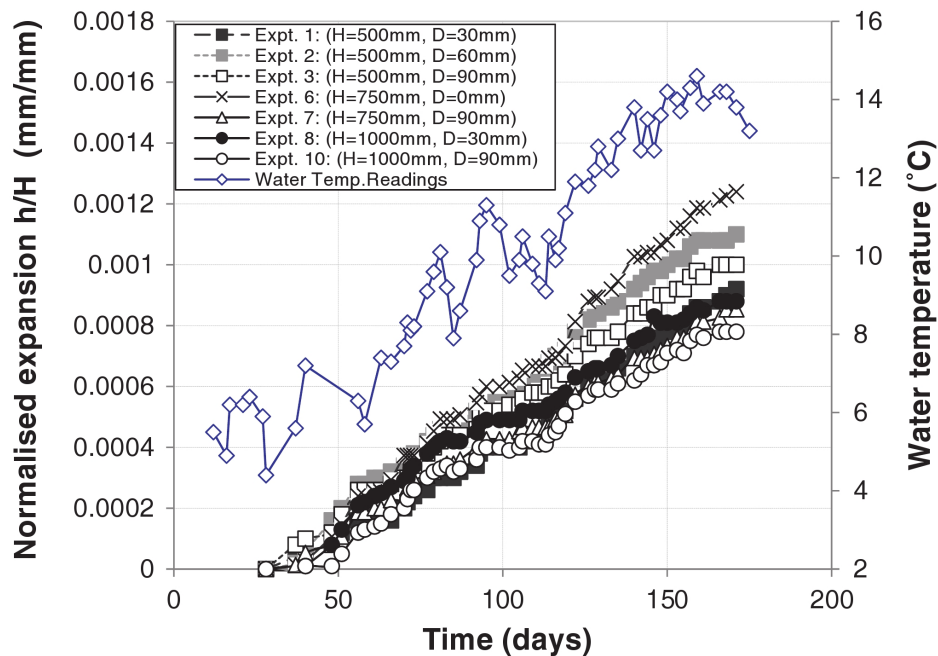
Figure 8.1: Normalised expansion rate of samples in the first round of Galway tests (Sutton et al., 2013).

reflected that of the surrounding environment. Figure 8.1 shows the expansion of some of these tests over a 175 day period.

The temperature of the water is also shown in Figure 8.1, and it was noted that when there was a sizeable drop in temperature, there was an associated reduction in expansion rate. This was thought to be due to a reduction in bacterial activity as the temperature moved below their active range, and less water evaporation leading to less precipitation of gypsum (Sutton et al., 2013). The effect of temperature was followed up on in the second set of Galway tests, as discussed in Section 8.2.3.

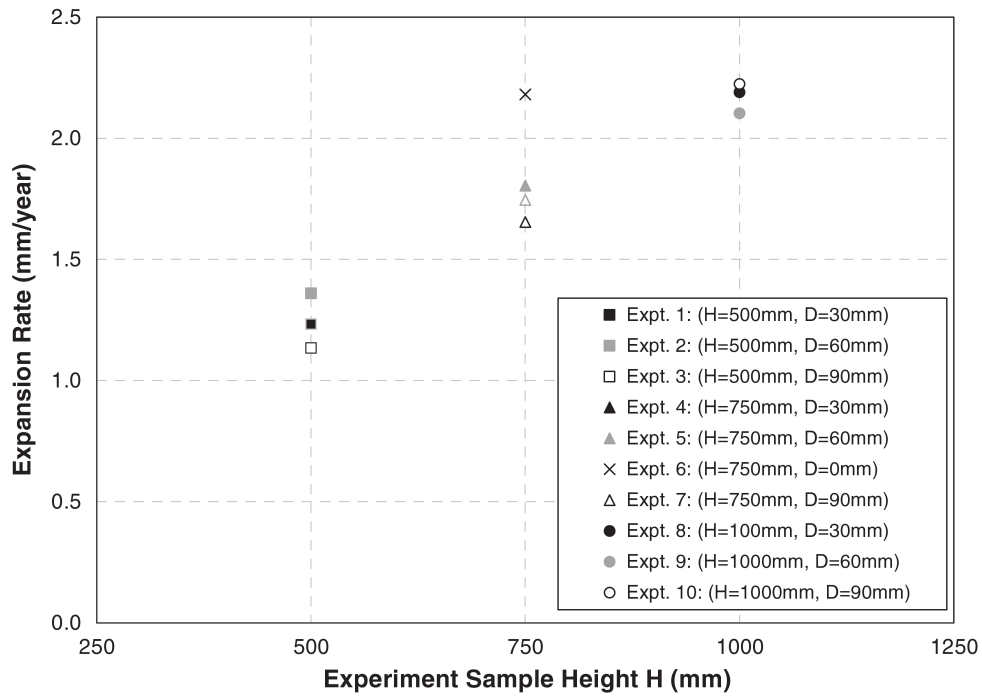
Figure 8.2: The effect of sample height on expansion rate (Sutton et al., 2013).

For the samples with an external water supply, the expansion rate was roughly proportional to the fill height, with an average expansion rate of 2 – 3 mm/year/mm of fill. When considering the Irish properties with between 500 and 750 mm fill thickness and an age of around 5 years, this would lead a maximum expansion of between 6 – 9 mm, which corresponds to the ranges seen in the floor level surveys (Sutton et al., 2013).

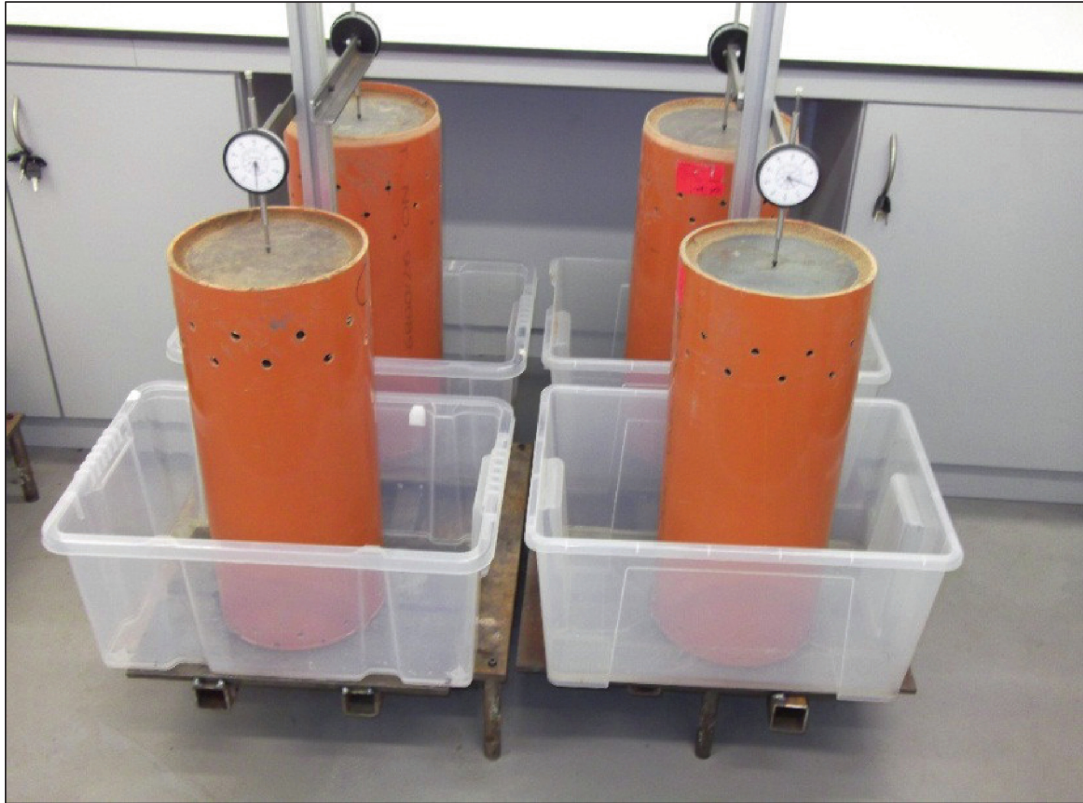
Figure 8.3: Design of the swell from the second series of tests at the University of Galway (McCabe et al., 2015).

Following on from the Sutton et al. (2013) tests, a second series of tests was planned at Galway, this time considering the effect of fill density and temperature upon the rate of expansion. The design of the tubes was the same as in the previous tests, as shown in Figure 8.3, although the height of all samples was kept at 500 mm and water levels maintained at either 10 or 30 mm. The full set of test variables are summarised in Table 8.5.

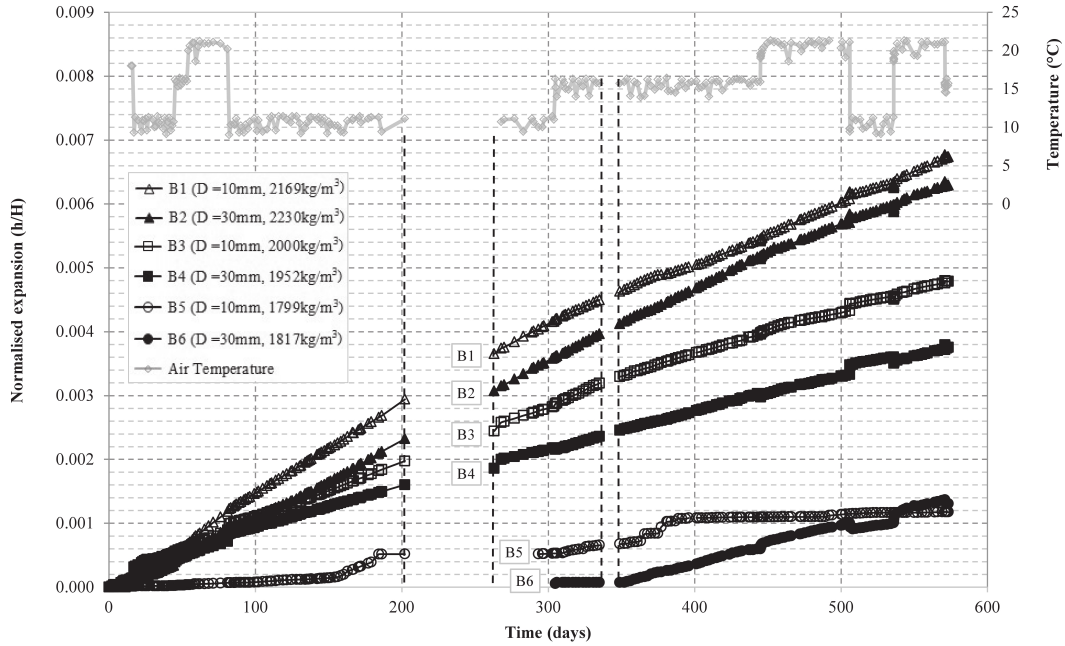
Figure 8.4: Expansion rates of the second series of Galway tests, with variations in temperature and material density (McCabe et al., 2015).

Although some variation can be seen in the expansion rates with the change in temperature, it is the effect of density that is the obvious factor when considering the expansion rates, with the higher density tests showing more expansion at a faster rate. This was expected, since a higher density material will have less void space into which the gypsum can precipitate before precipitating into locations that lead to expansion of the rock.

As shown in Figure 8.4, tests B1-4 generally show a constant rate of expansion, whereas the lower density tests behave differently. Test B6 shows a fairly constant expansion rate, although it did not register any expansion until the test had been running for 300 days. Similarly test B5 shows long periods with no expansion followed by shorter periods where the expansion rate seems to be greater than that of tests B1-4. Figure 8.5 shows the expansion rates compared to the density for the periods the test spent at 20°C (McCabe et al., 2015).

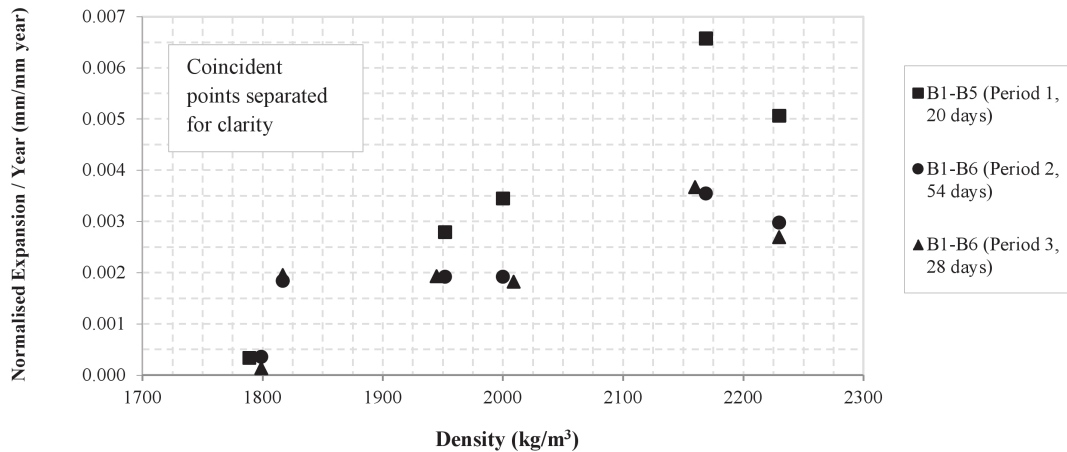
Figure 8.5: Effect of density on the average expansion rate for tests B1-6 at 20°C (McCabe et al., 2015).

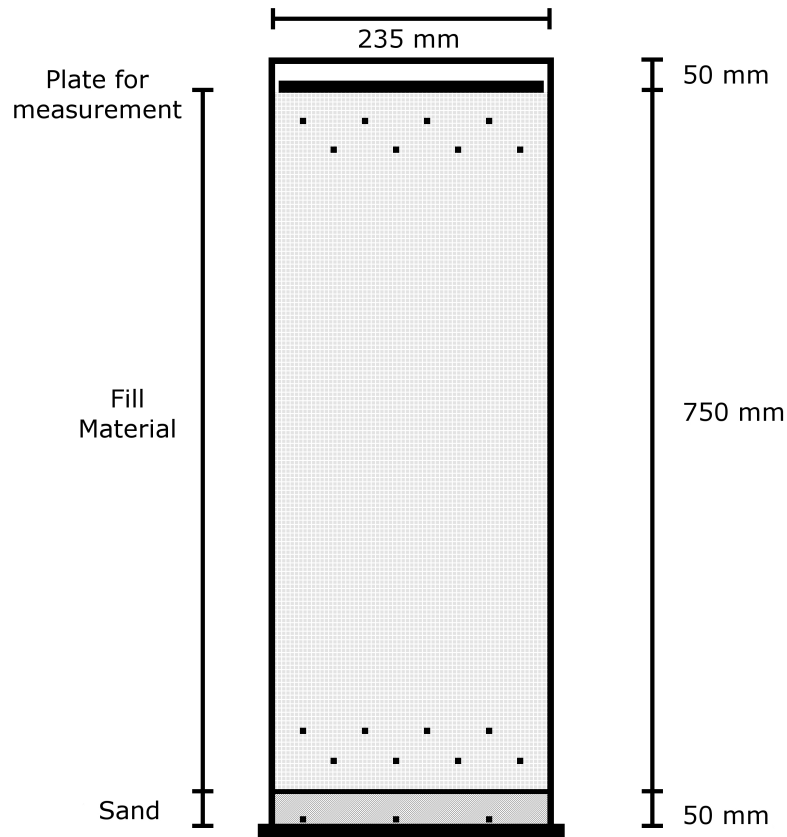
Figure 8.6: Design of the swell test tubes used at Sheffield.

The design of the swell tests carried out at Sheffield was based upon that used by Sutton et al. (2013) and McCabe et al. (2015), as shown in Figure 8.6.

The tubes are made, as with the Galway tests, from polyethylene, with a 235 mm internal diameter and a wall thickness of 12 mm, with a fixed 300 mm square and 20mm thick polyethylene base. 10 mm diameter ventilation holes are located immediately above the base, to allow water ingress, and beginning at 100 mm from both base and top to allow air to move through the material.

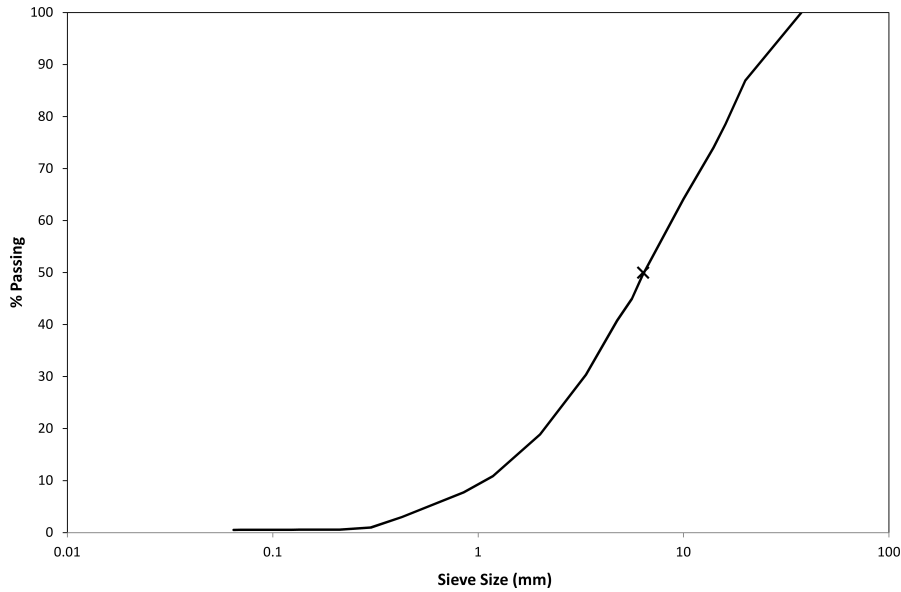
Figure 8.7: PSD chart for the material used in the swell tests with the  $D_{50}$  value marked.

For tests 2 – 9 the grading of the material was determined around the  $D_{50}$  point, with material above this size being considered coarse and that below being considered fine. Figure 8.7 shows the PSD curve for the material, with the  $D_{50}$  point marked. This point corresponds to a particle size of 6.35 mm, and so material was divided into fine/coarse by passing it through a 6.3 mm sieve.

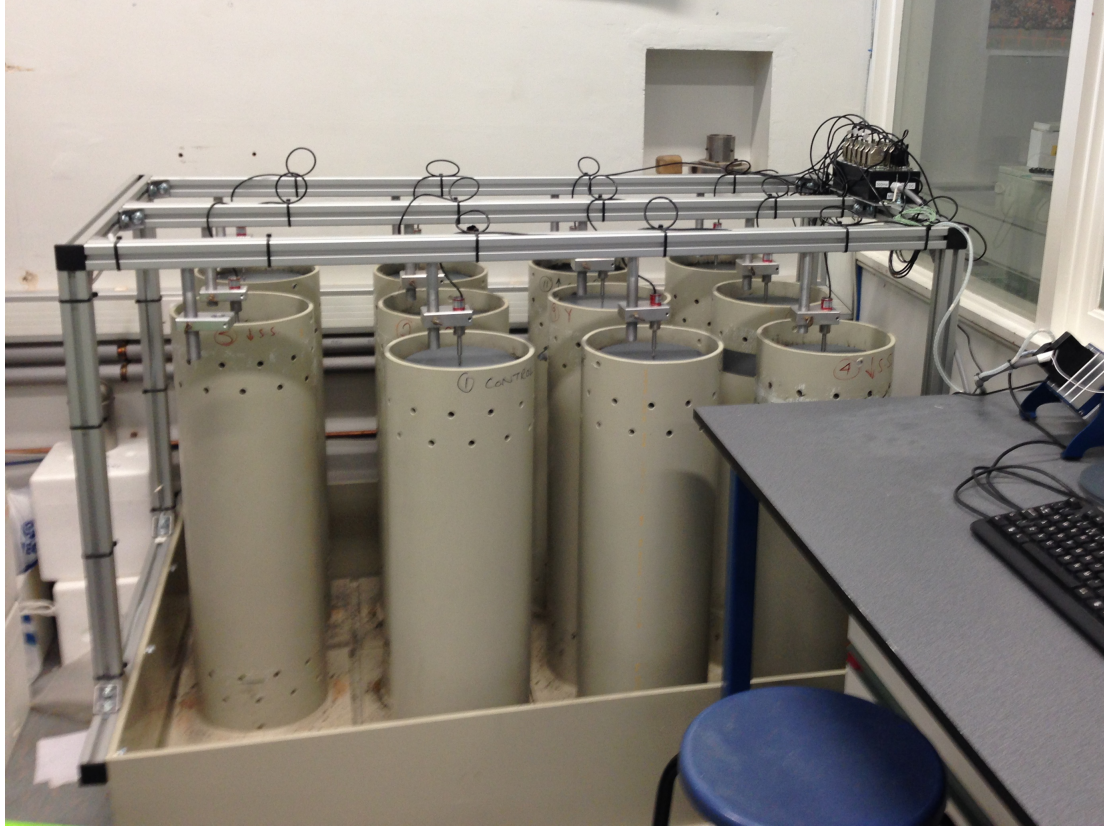
Figure 8.8: Set up of the swell test tubes in the laboratory before the addition of water. Note that the tube used for the initial Arduino system testing (Chapter 6) is missing in this photograph.

As shown in Figure 8.8, the tubes were housed within a polyethylene tank so that the water supply was continuous across all tests. This would ensure that all tests had the same depth of water, even in cases such as over holiday periods when the water would not be topped up as frequently. The exception to this was the control, test 1, which did not have the ventilation holes immediately above the base and so had restricted access to water. The tank itself was seated upon a 50 mm thick layer of polystyrene insulation so that the heat from the underfloor heating did not affect the water temperature.

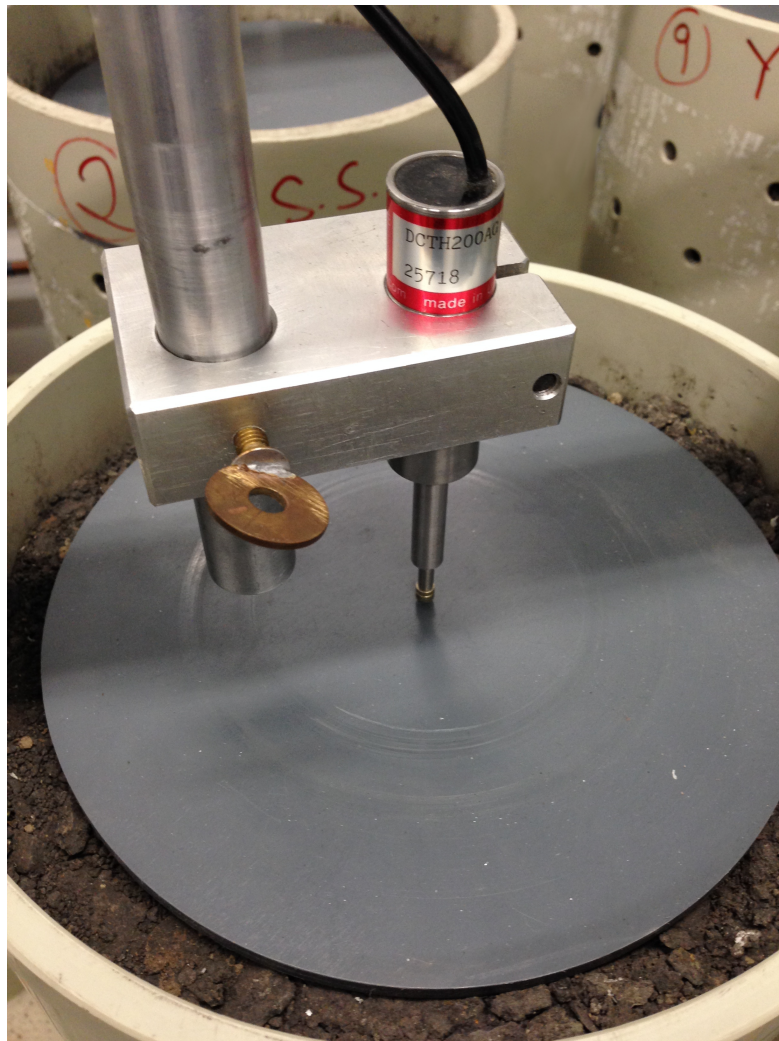
The expansion of the material was monitored via a series of LVDT's (linear variable differential transformers) that were recorded electronically. These LVDT's measured the movement of a polyethylene plate that sat on top of the material in order that any uneven expansion would still be recorded. Figure 8.9 shows the RDP LVDT (DCTH 200AG) sensor that was used for all of the swell tests.

Figure 8.9: LVDT in use monitoring the swell tests.

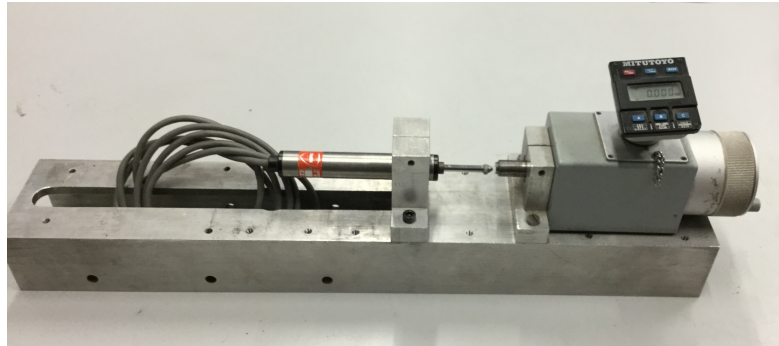
The LVDT's were calibrated using a Mututoyo LVDT calibration rig, shown in Figure 8.10, in which each LVDT was monitored with the LabView software whilst being moved by measured amounts. Any difference between the amount moved on the calibration device and that recorded by the software allows for a calibration factor to be calculated for each LVDT. This is then used by the LabView software to correct the values obtained from the LVDT's before writing the data to file.

Figure 8.10: Mututoyo calibration device in use in the laboratory.
