A Thesis submitted for the degree of Doctor of Philosophy

**The Expansion of Pyritic Mudrocks: A  
consideration and application of physical  
tests for better understanding of the Irish  
pyrite problem.**

University of Sheffield  
Department of Civil and Structural Engineering

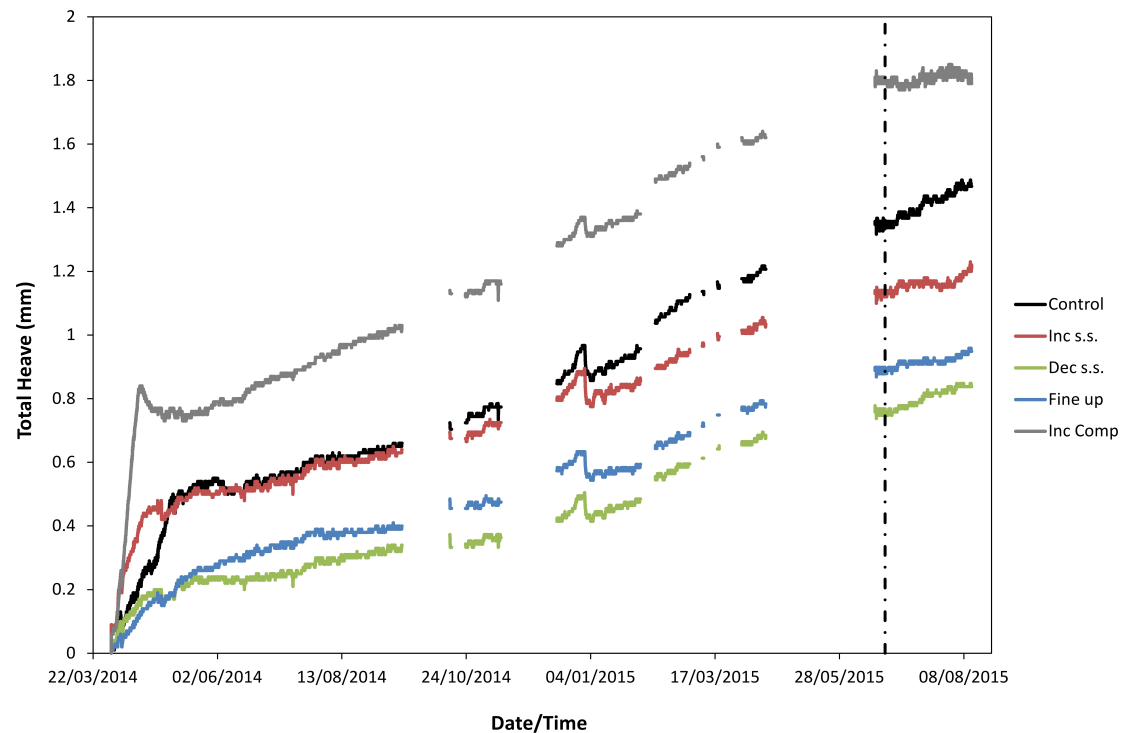
It is also noted across most of the datasets, that there was an initial period of very rapid movement after which the measurement settled into a more steady state of expansion.

Figure 8.11 shows selected data from these initial tests, along with the point at which the test was modified by removing the water in June 2015 (Section 8.5.1). Full results of each of the pairs of tests are discussed later.

Figure 8.11: Expansion of selected swell tests from April 2014 to August 2015. The dashed black line indicates the point at which the water was removed from the tests.

Figure 8.11 shows the swell tests results from April 2014 to August 2015.

The anomaly in the data around the 29th of December 2014 is thought to be caused by the air conditioning in the lab being turned down over the holiday period. This would explain the gradual increase in temperature from around the 21st December to a peak on the 2nd January, with a decrease after this point as people returned to work. The temperature increases from an average of 19.5°C at noon on the 21 December to an average of 21°C on the 2nd January before decreasing again at the start of the working week from the 5 January.

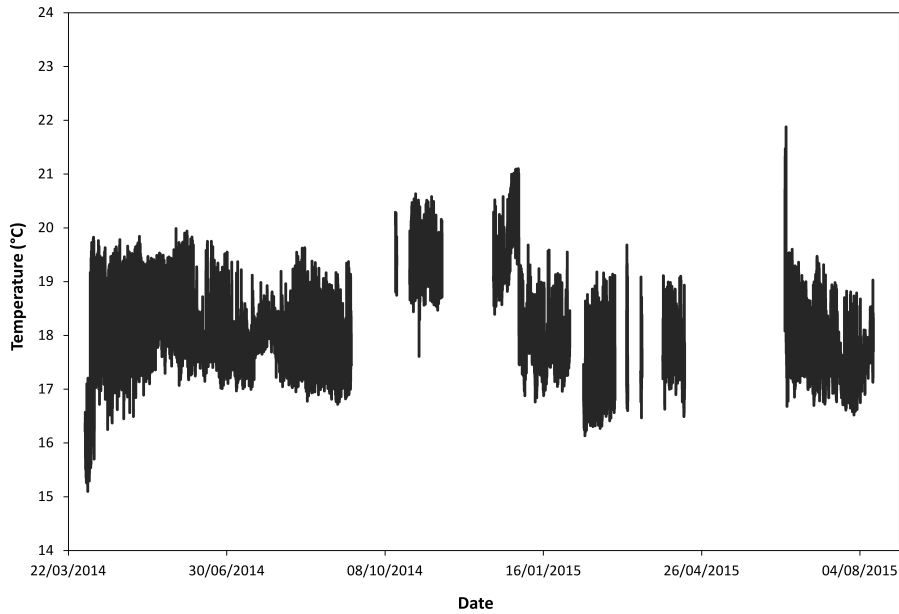
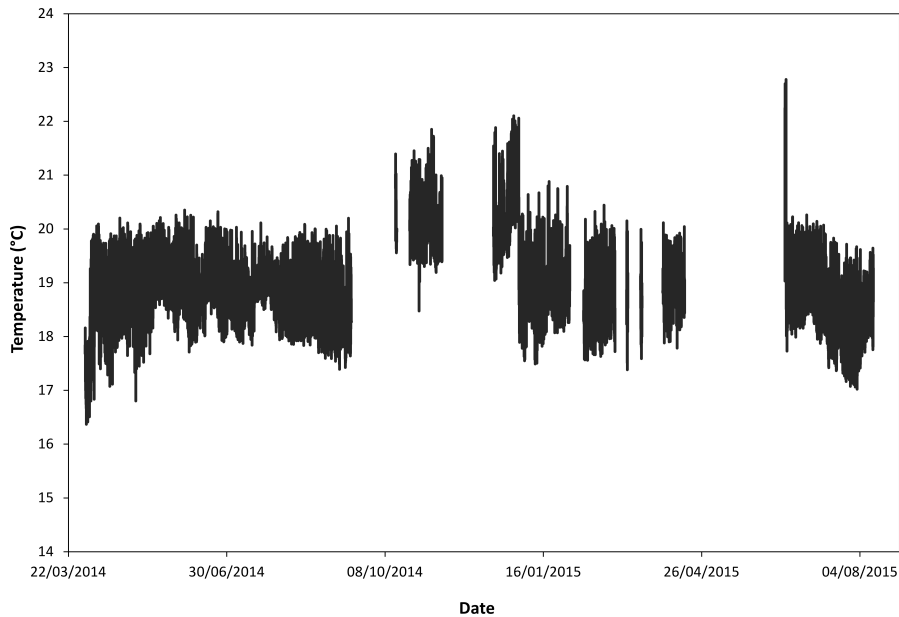
(a) Temperature in the upper section of the test frame.

(b) Temperature in the lower section of the test frame.

Figure 8.12: Changes in laboratory temperature over the test period.

The values recorded at the top and bottom of the frame show changes in temperature at the same time, although that is to be expected, since the sampling rate at this time was once per hour. Temperatures are also similar between the two points, with the upper sensor recording temperatures, on average, half a degree cooler than the lower sensor.

The changes in laboratory temperature alluded to above are shown in Figure 8.12, which shows the variation in temperature over the testing period.

the data for that time period is incomplete, the average temperature in the laboratory was higher in the winter months when the underfloor heating has an effect. Despite occasional variations, the average temperature however, is reasonably consistent, meaning that apart from anomalies such as mentioned above, there should be little effect upon the tests and the data retrieved.

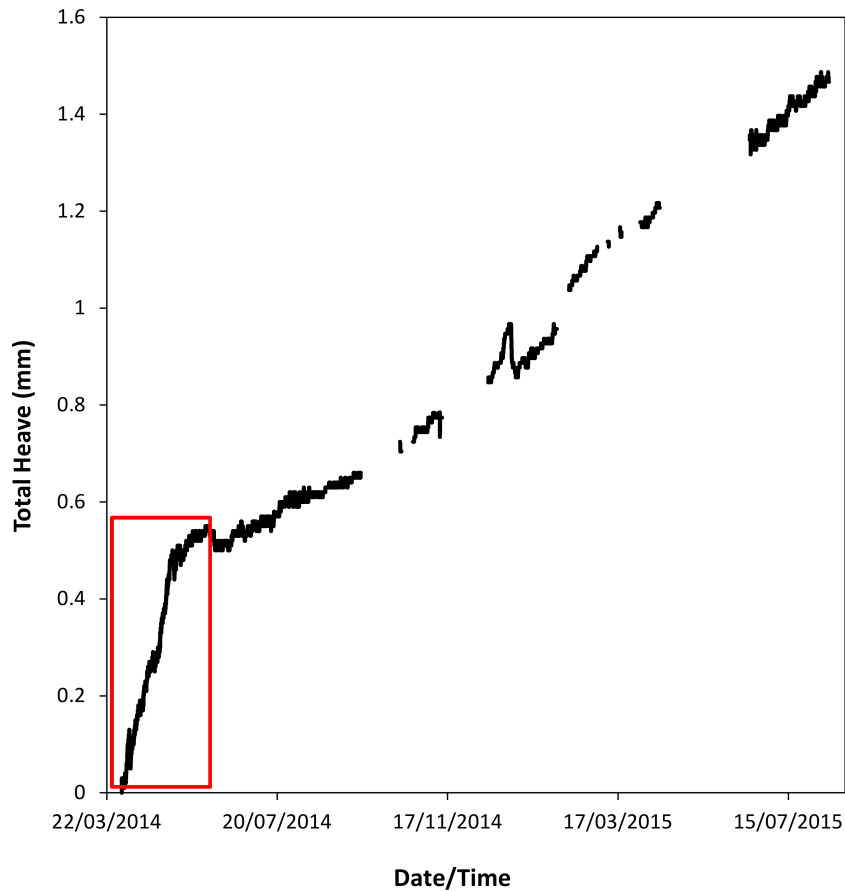
Figure 8.13: Expansion of the control sample over the testing period.

Figure 8.13 shows the expansion of the control sample over the testing period, with the initial rapid period of expansion that was seen in several of the tests highlighted in red.

This increased period of activity was seen to one extent or another in the control (Figure 8.13), increased compaction (Figure 8.14) and increased specific surface tests (Figure 8.15a), and to a lesser extent in the decreased specific surface tests (Figure 8.15b).

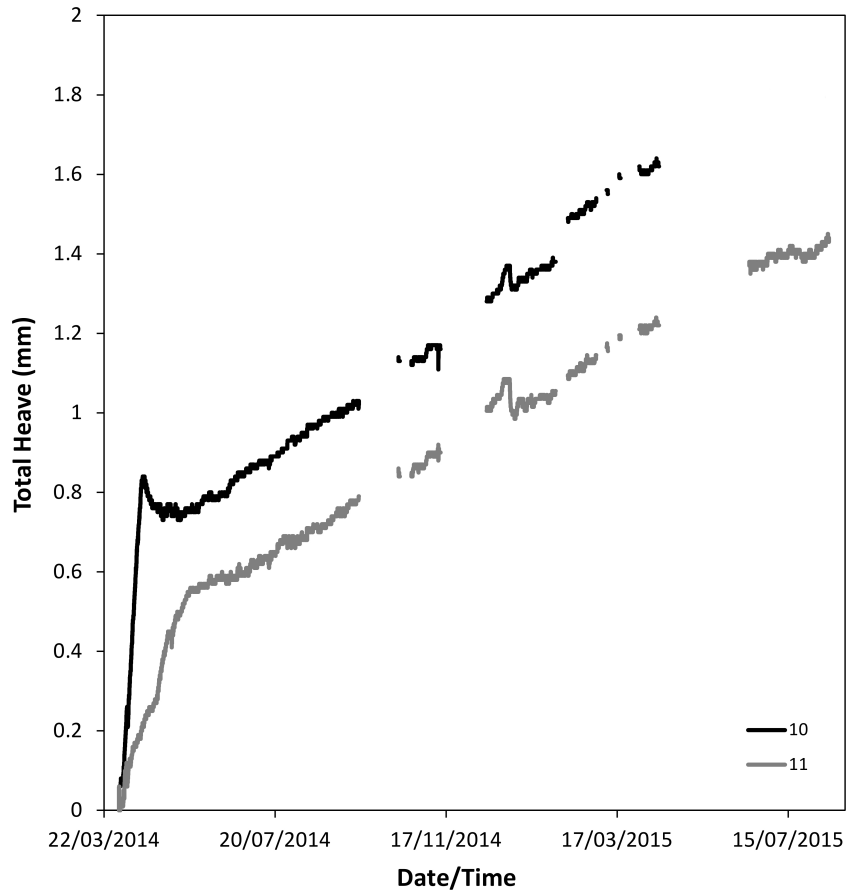
Figure 8.14: Expansion of the samples with increased compaction over the test period. Note that Test 10 was removed in April 2015 as discussed in Section 8.5.2.

Figure 8.14 shows the expansion of the tubes intended to be compacted at a higher bulk density than the other tubes. Results similar to those shown by McCabe et al. (2015) wherein the tests they compacted at a higher density showed a greater expansion rate and subsequently showed a higher level of total heave were expected.

These two tests can also be compared to the control, which had a bulk compaction density of  $1950.7 \text{ kg/m}^3$ , sitting between the densities achieved in the two increased

compaction tests. However, the amount of expansion seen in the Control test is slightly less than that of Test 11, with the expansion rate of the Control only progressing faster than that of Test 11 after more than 12 months into the test period.

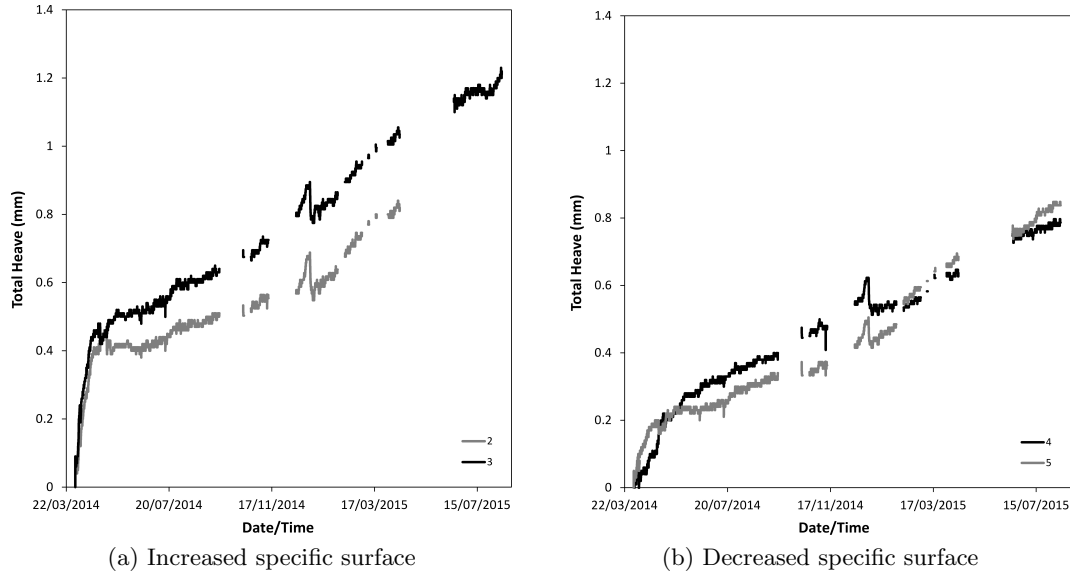
Figure 8.15: Expansion of the samples with both increased and decreased specific surface over the test period. Note that Test 2 was removed in April 2015 as discussed in Section 8.5.2.

Figure 8.15 shows the difference between the increased and decreased specific surface tests. At first glance the expansion rates of all four tests seem similar, however, the test containing the material with an increased specific surface shows considerably more expansion with Test 3 reaching a peak value of 1.22 mm total heave. By comparison, Test 5 only reaches a peak total heave of 0.84 mm.

It should be noted, that in contrast to the control and increased compaction tests, the test showing more expansion in this pair, Test 3, actually has the lower bulk density: 1876.6 kg/m<sup>3</sup> compared to Test 2 which is 1907.9 kg/m<sup>3</sup>. As stated above, the expansion rates beyond the initial rapid expansion phase are comparable suggesting that it is the initial rapid expansion period that had the most influence upon the difference in total heave seen between these two tests.

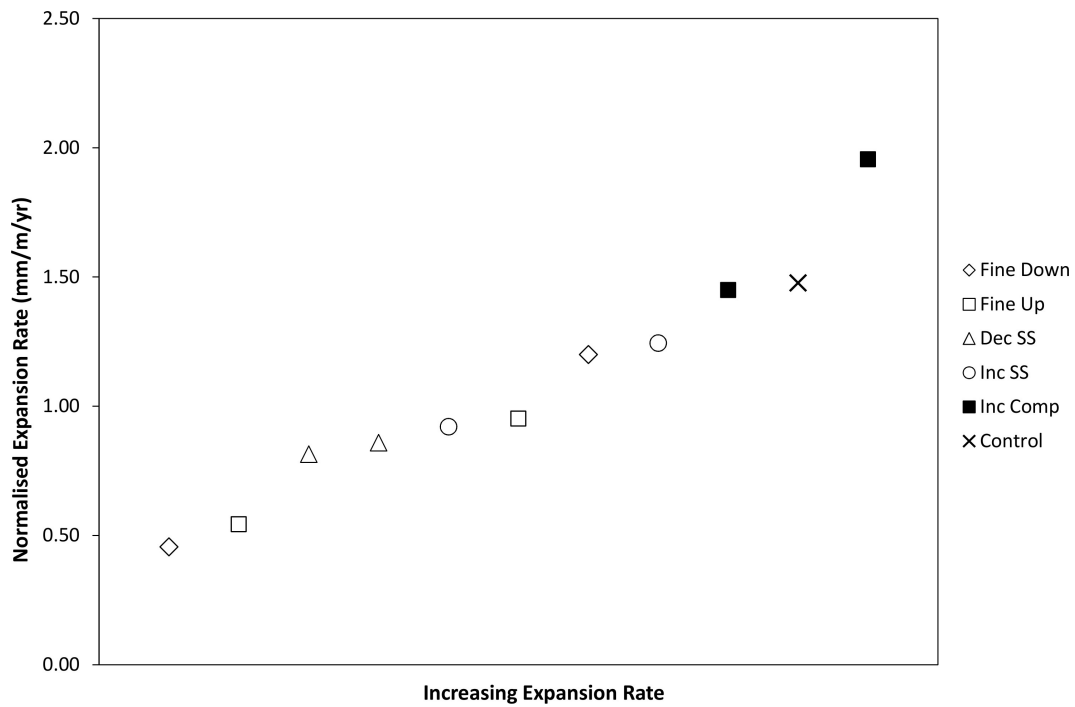
Figure 8.17: Variation of the normalised expansion rate of the Sheffield tests according to test type.

Throughout much of the literature, it is common to see reference to ‘normalised’ data, in which the rate is shown as either the percentage of the fill that oxidises per year (% fill/year) or as the amount of expansion that is seen per year for every metre of fill present (mm/m/year). Both of these methods account for the fill thickness in a given situation, and allow that rate to be compared to fill thicknesses at other locations. Both values for the Sheffield swell tests are shown in Table 8.9, while Figure 8.17 shows graphically how the normalised expansion rate varies according to the variable considered in each test.

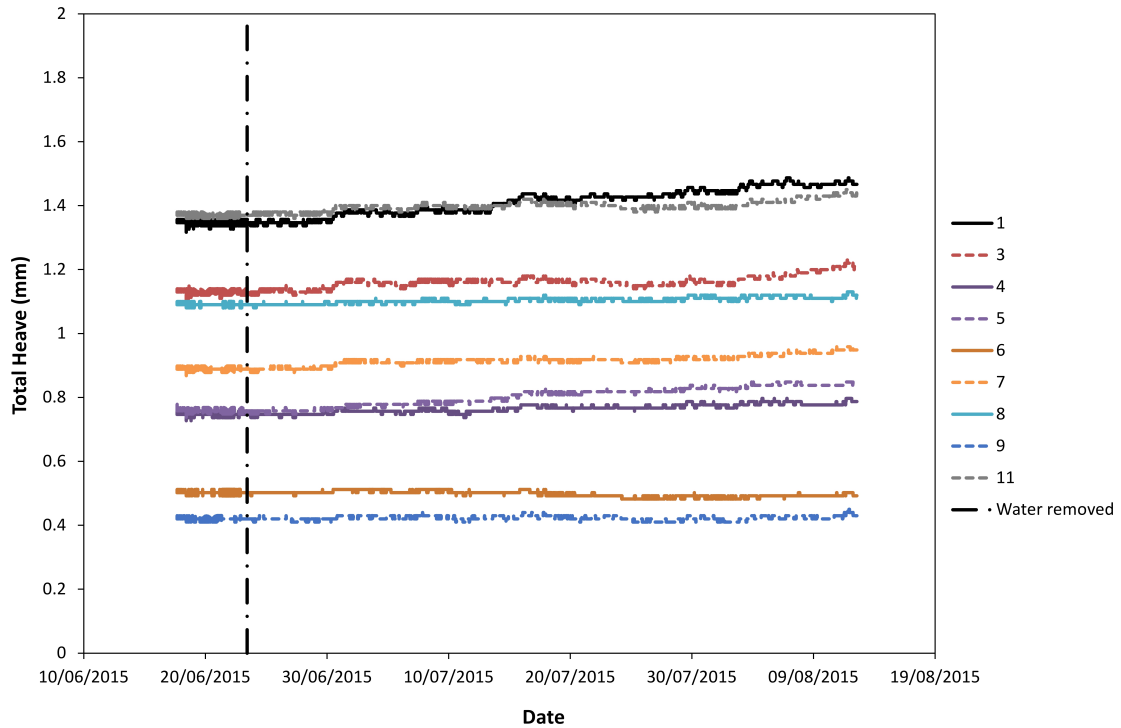
Figure 8.18: Expansion of the swell tests immediately after the water was removed.

Figure 8.18 shows the readings from the tube just before and for 6 weeks after the water was removed. At this point the data was being recorded every 15 minutes in order to better determine any changes to the rate of expansion.

As can be seen from both Figure 8.18 and Table 8.11, although there was continued expansion in the majority of the tests, the rate decreased significantly once the water had been removed. The control test carried out by Sutton et al. (2013) actually showed more expansion than some of the tests containing water, so this decrease in reaction in the Sheffield tests was unexpected.

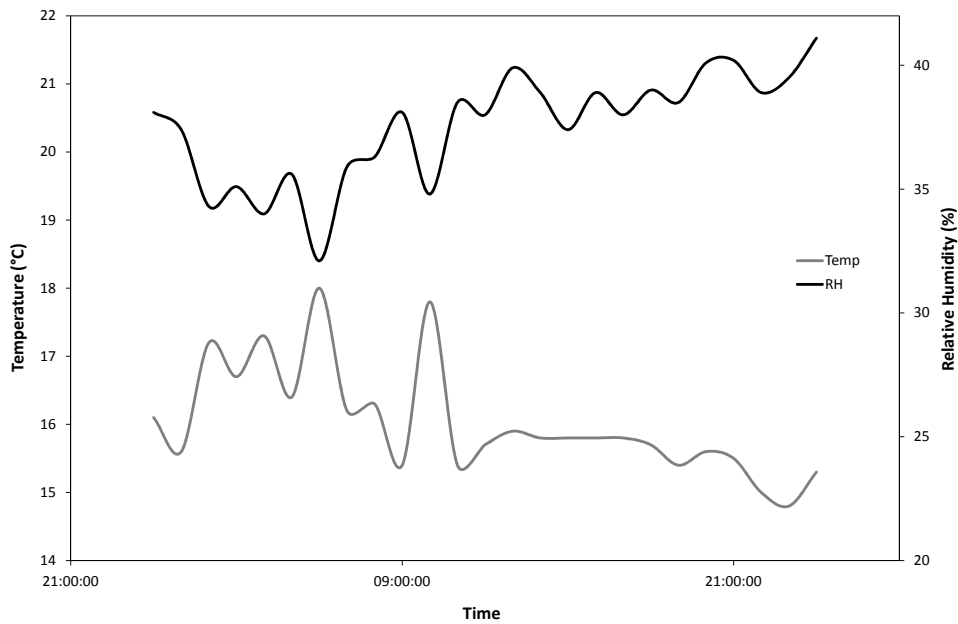
Figure 8.19: Variation of the laboratory temperature and relative humidity over a 24 hour period.

The relative humidity in the laboratory over the time shown in Figure 8.19 goes from a low of 32.1% to a peak of 41.1%, with these low points corresponding to times at which the temperature was increased by movement of people in and out of the laboratory.

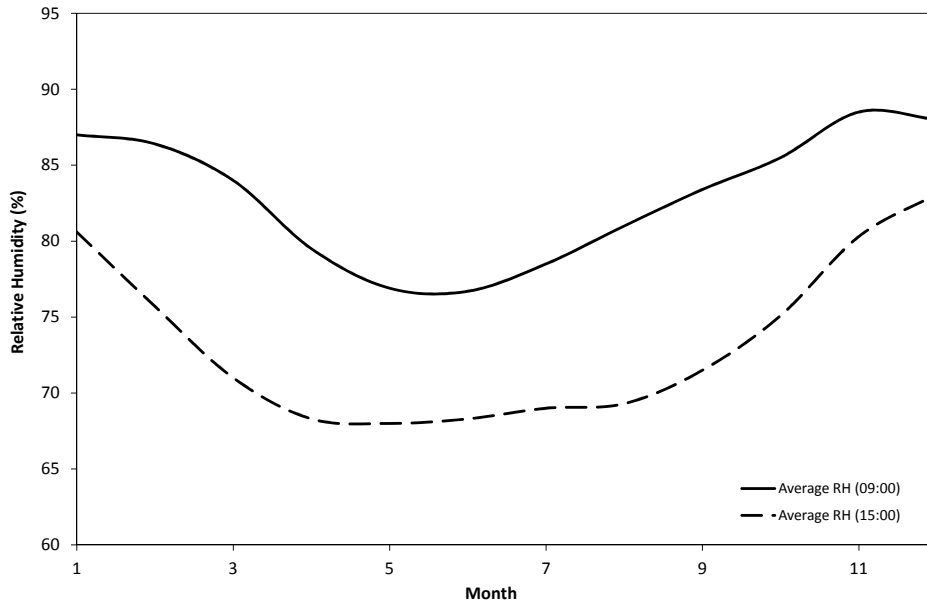
Figure 8.20: Variation of the average relative humidity in Dublin over the course of a year (Met.ie, 2010).

The peak average humidity shown in this data is 88.5% whilst the minimum is 68%. Both of these values are larger than the peak value of 56% obtained from readings in the laboratory, and the lowest site value is almost double the laboratory average value.

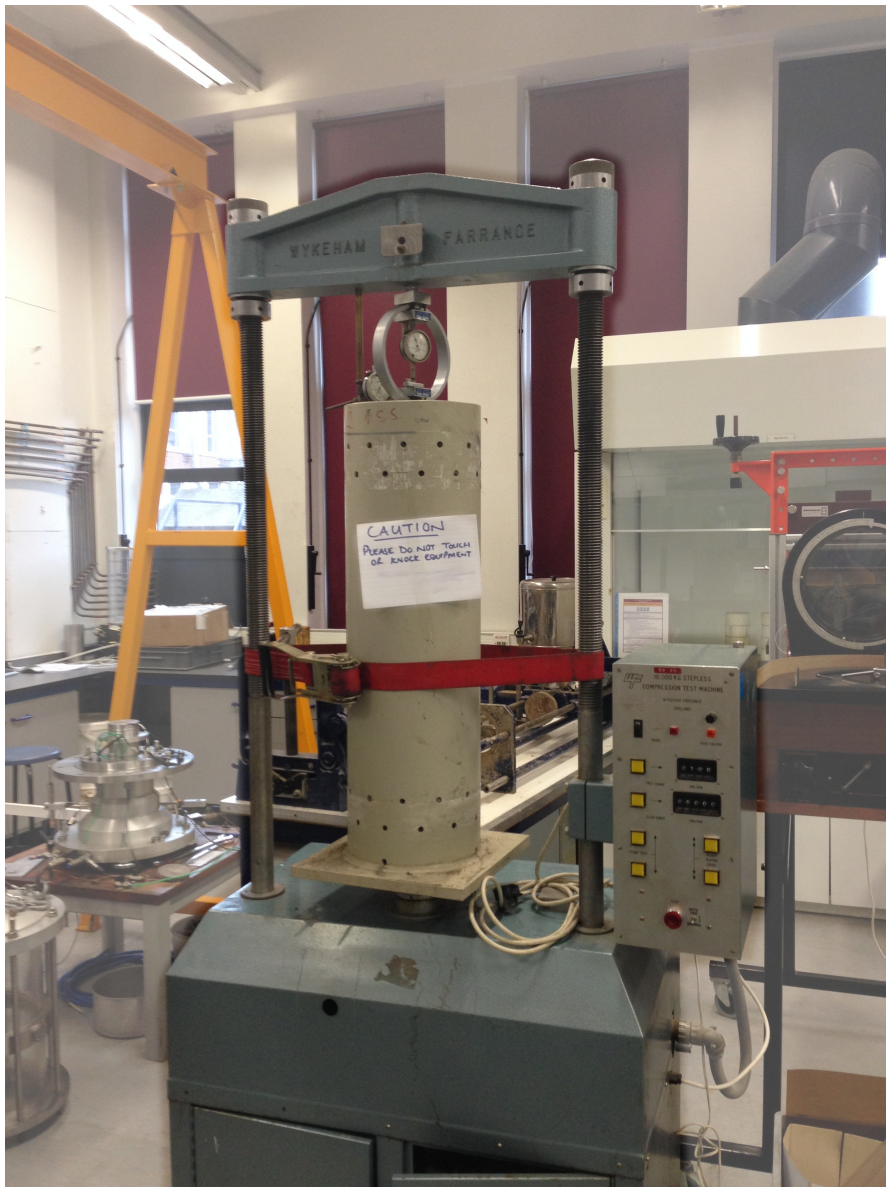
To this extent, two of the swell tests were removed from the tub of water and placed into triaxial frames, with the upper surface restrained by the frame and any movement registered by a proving ring, as shown in Figure 8.21.

Figure 8.21: Placement of swell test 10 within the triaxial frame.

The two swell tests that were used were one with increased specific surface and one with increased compaction. These were chosen as they had previously been showing a relatively high expansion rate and as such were anticipated to continue expanding once restrained in the triaxial frame. The proving rings used initially were 5 kN and 10 kN rings, with the 5 kN ring on test 2 with increased specific surface, and the 10 kN ring on test 10 with increased compaction, with 0.002 mm scale dial gauges on both the proving ring and the surface of the material in order to measure both movement of the ring and

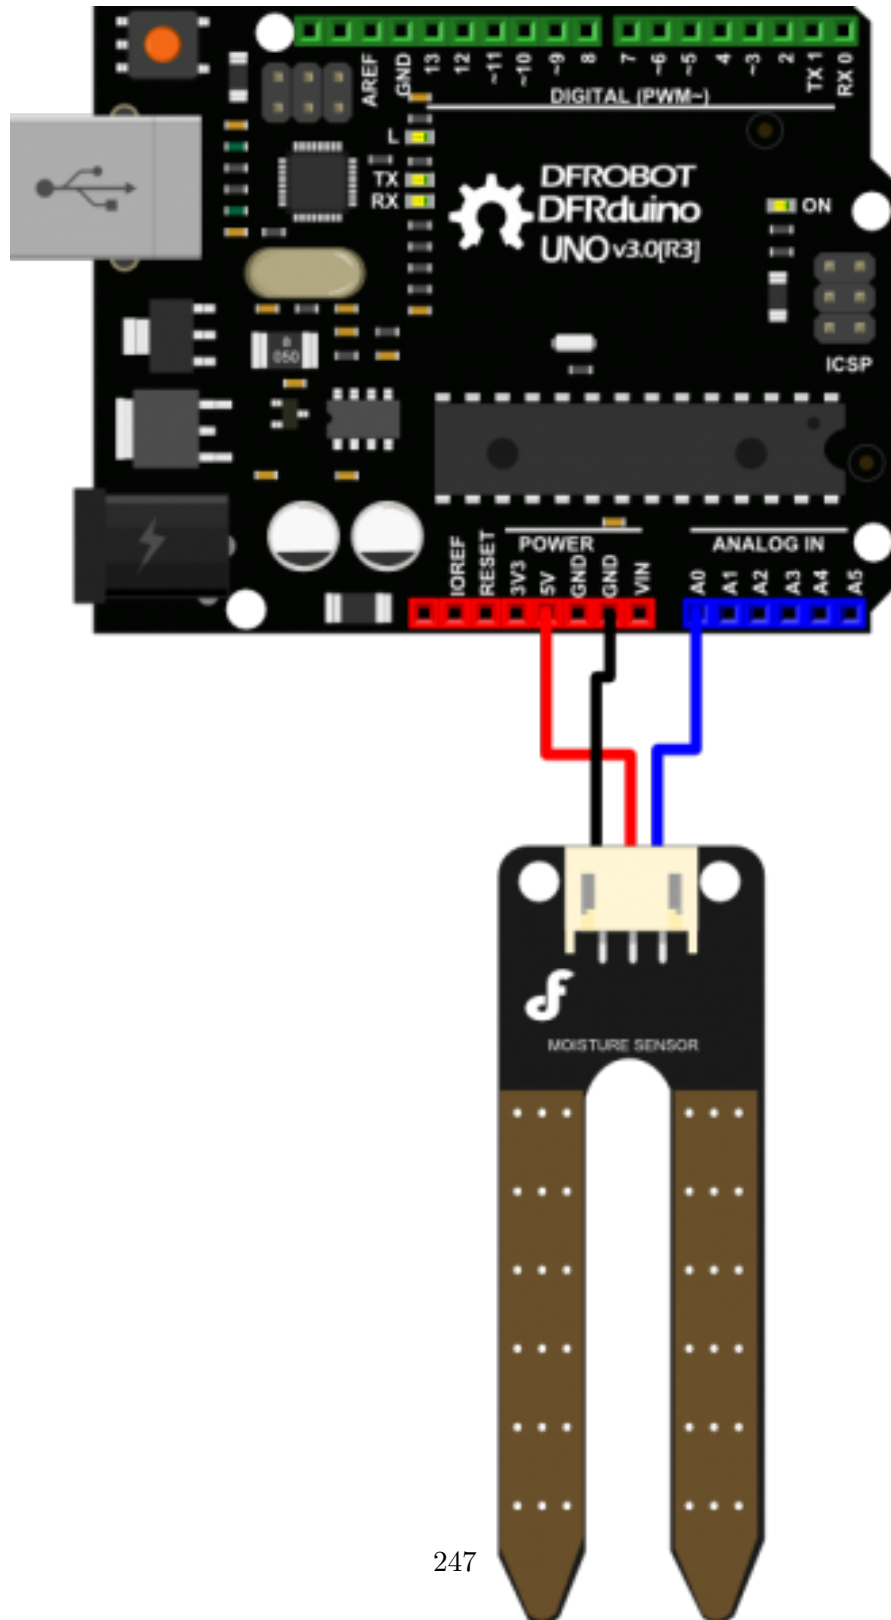
Figure 1: Circuit layout for the dielectric sensors used for the Arduino in Chapter 6 (SKU:SEN0114).
