SCALING-UP THE TRIBOLOGICAL ASSESSMENT OF LASER CLAD RAIL TO BUILD THE CASE FOR FIELD IMPLEMENTATION

Thesis submitted for the degree of Doctor of Philosophy

THE UNIVERSITY OF SHEFFIELD
FACULTY OF ENGINEERING
DEPARTMENT OF MECHANICAL ENGINEERING

July 2024

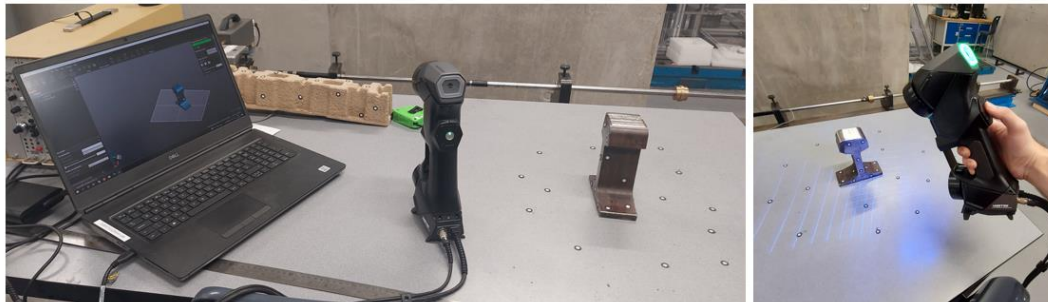
Figure 3.10: HandScan Creaform laser 3D scanner for profiles (Creaform3D, n.d.)

A laser scanner by Creaform was used for profile measurements (see Fig.3.10). It allows 3D and 2D profile measurements. Magnetic bands were put near the desired area around the sample for surface measurements and those bands were put over the sample except the desired surface region. When all magnetic parts were put around the area, the laser scanner was ready to measure and the software was opened on the laptop.

In the software, the surface scan was chosen first then surface magnetic bands were chosen on the software for the start point of the scan. After that sample scans were chosen and the sample scan started. When finishing the part scan all connected parts were chosen on the surface and other scans were deleted and the good parts were saved. After finishing all steps 2D and 3D analyses were made with the same software and the results were saved.

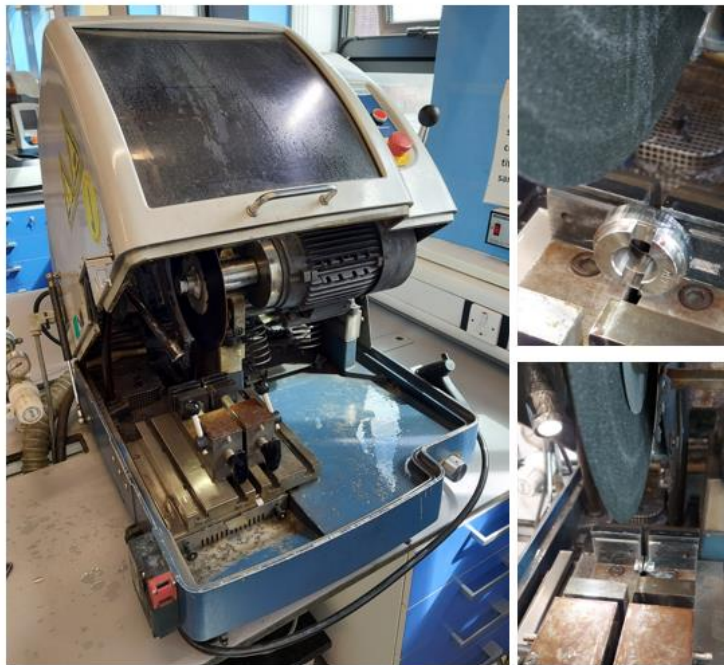
Figure 3.12: Abrasimet sectioning machine

An Abrasimet is a sectioning machine for samples (see Fig. 3.12) (AbrasiMet 250). The blade was chosen depending on the hardness of the steel. The blade was attached to the machine by using a screw and flange. Then samples were inserted by using clamps. After ensuring the blade screw was tightened, the light was turned on, the cooling water worked properly, and the cage was closed machine could be started. The sectioning process starts with adding cooling water over the blade. The machine was controlled by hand and the sample was sectioned.

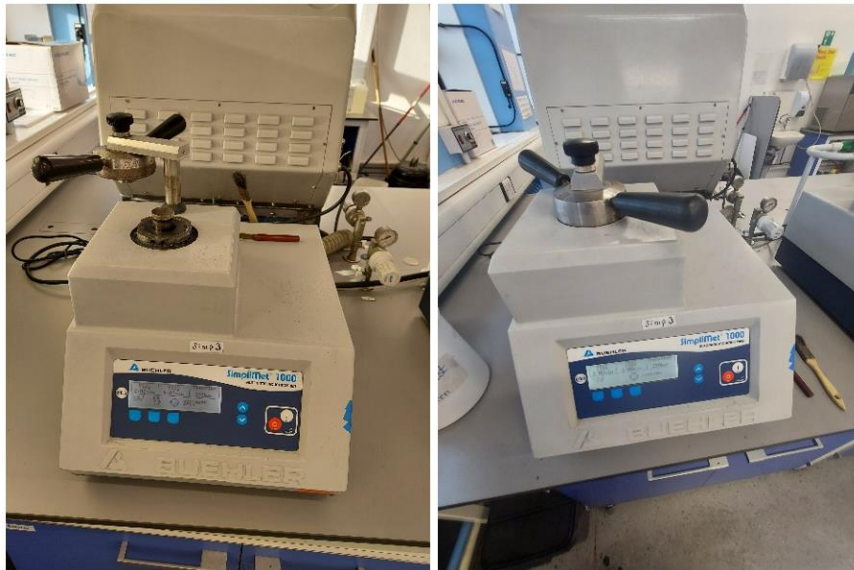
Figure 3.13: Simplimet 1000 mounting machine

Sectioned samples were mounted by using a Simplimet 1000 machine (see Fig. 3.13) (SimpliMet 1000). Samples were sectioned depending on the size of the mounting surface. Mounting samples were chosen for allowing use in the SEM machine. When the mounting space was lowered down, the sample mounting powders were poured over the sample and the sample was lowered down all the way through and the cap was closed to allow pressurization. The machine starts with preheating and then it starts to mount the sample. When the mounting

was finished, the machine stops and the cap can be opened and the sample was ready to grind and polish.

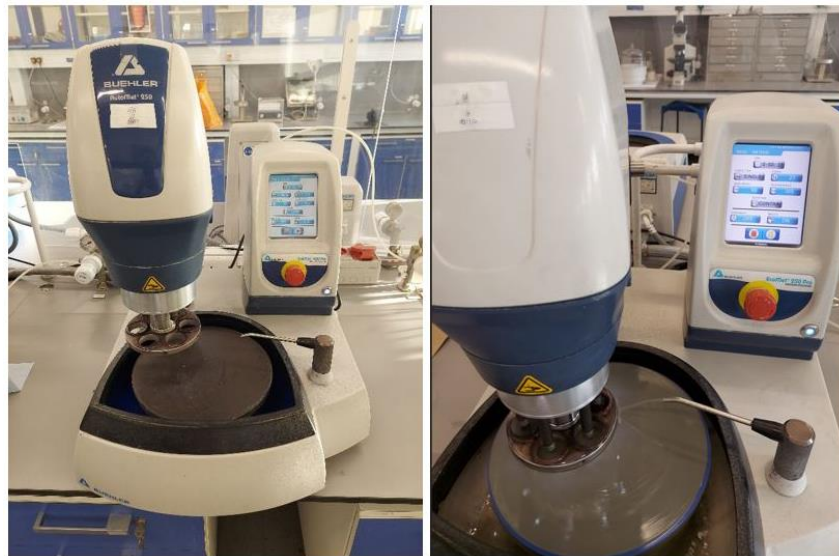
Figure 3.14: Automet 250 Pro grinding and polishing machine

Grinding and polishing were carried out using the Buehler Automet 250 Pro machine in the micro preparation lab (EcoMet 250) (see Fig.3.14). After mounting the samples grinding was done first with 400 μm , 800 μm and 1200 μm grinding papers respectively. Those numbers means that when there is a higher sandpaper number the paper has a finer abrasive and it creates smoother surface finish, but when the number is lower, it represents coarser abrasives which

Polishing was carried out with different polishing consumables. Generally, it was done with 9 μm , 3 μm and 1 μm polishing papers. Depending on the end polishing, Silica was used in some of the samples as well. For the polishing duration, it was longer than grinding as it took almost 10 minutes total time for all polishing steps.

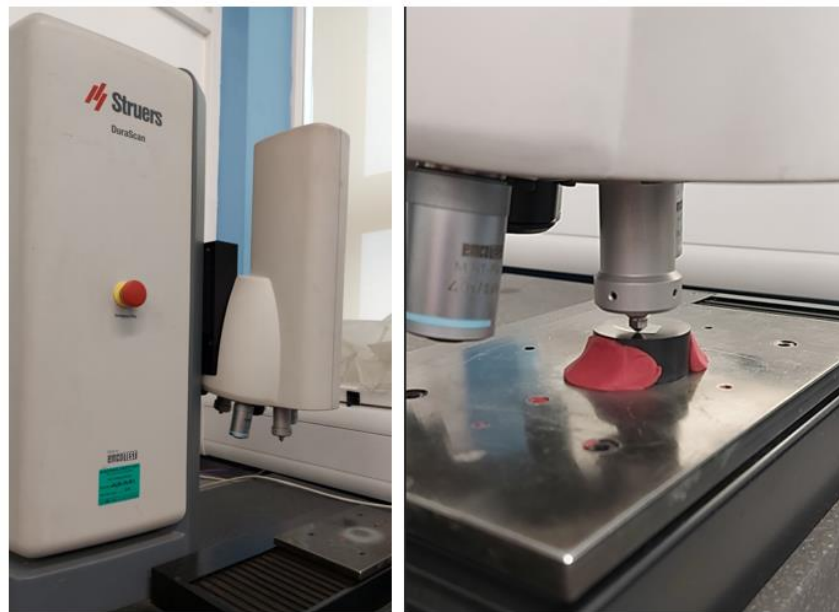
Figure 3.15: DuraScan micro-hardness machine

Micro-hardness measurements were made using a microhardness tester (DuraScan) (see Fig. 3.15). The Vickers hardness method was used. After finishing the 1 μm or silica polishing stage on the sample, it was put under the indentation stage. When the machine was turned on and the set-up load was chosen as HV 1, the location was then chosen over the steel part from the surface to the bulk part. Depending on the desired measurement area indent numbers and distance between two indentation points was set-up. The machine started and micro-indent hardness measurements were taken. At the end, all indentation points were checked and if it did not choose the correct points, a measurement was made manually at that point. When finished and the results were all clear, they were saved as an Excel file and hardness data were saved.

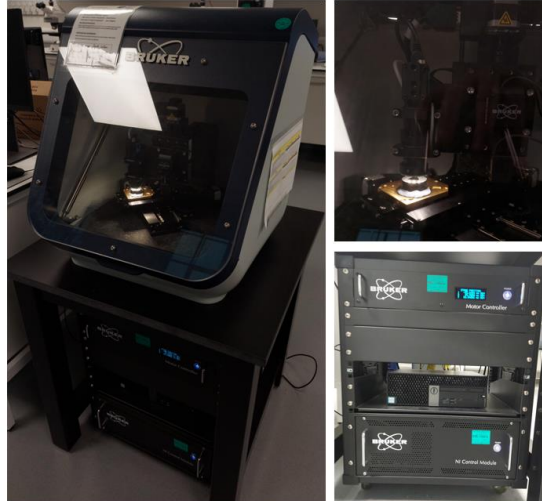
Figure 3.16: Bruker nano-hardness machine

Nano-hardness measurements were taken using a Bruker nano-hardness machine (see Fig. 3.16) and it was mainly used for examining the surface point hardness values on the samples (Hysitron.). After the micro-hardness measurements were finished, if the surface needed examining more closely, the nano-indenter was used.

Measurements were done in 10×10 matrix of indentation points on a sample and the load was chosen depending on the material. The loads that were mainly used $5000 \mu\text{N}$ or $3000 \mu\text{N}$ depending on the hardness of the sample. Before starting measurements, a calibration was made. After that indentation numbers were chosen with load and then desired measurement areas were chosen. Then the start indentation points were chosen and the machine was started with auto focus. After the machine analysed the height of the sample, the desired hardness area was chosen and measurements started. At the end of the test, the data were collected as a nano-hardness map and csv files.

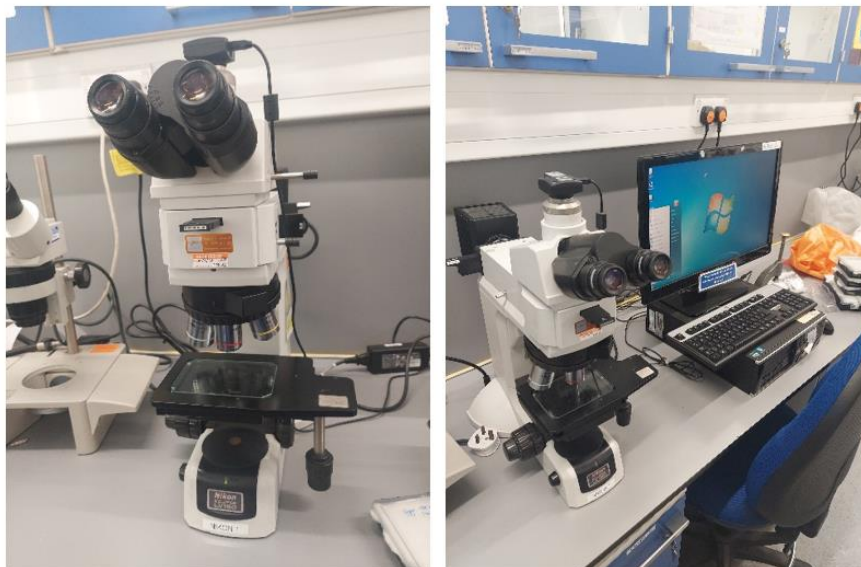
Figure 3.18: Nikon Eclipse LV 150 optical Microscope

A Nikon Eclipse LV 150 optical microscope (see Fig. 3.18) was used for the microstructure analysis (Nikon) . After preparation, the sample was put on the stage in the microscope and software was opened on the computer. When the software was opened, required settings were chosen for the best image quality and magnification was chosen. Images were collected with higher magnifications and images were saved.

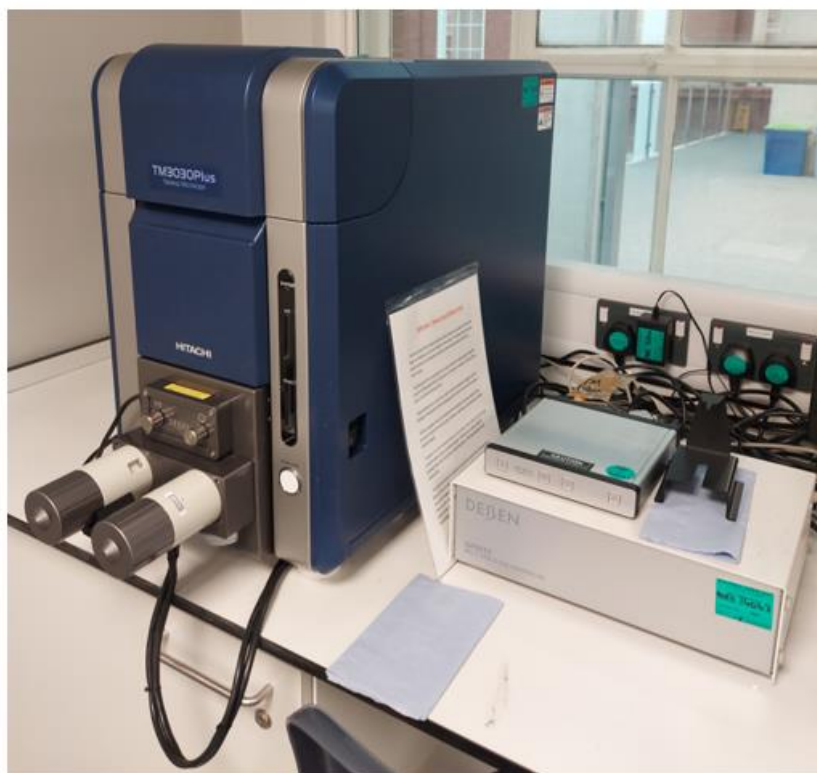
Figure 3.19: TM3030 tabletop SEM machine

SEM images were taken using a tabletop Hitachi TM3030 SEM machine (see Fig. 3.19) (Hitachi). The table-top SEM allowed imaging of the microstructure with higher magnifications. First the machine and the computer were turned on and the machine vacuum was released to insert the sample inside. After that the software was opened and the sample was prepared depending on the height of the machine. The sample was inserted inside and the vacuum was turned on again. After the vacuum finished, the software allowed visualisation of microstructure. Brightness, contrast, and focus were set-up and images were taken with different magnifications. When all images were saved, the machine vacuum was released again and the sample was taken off.

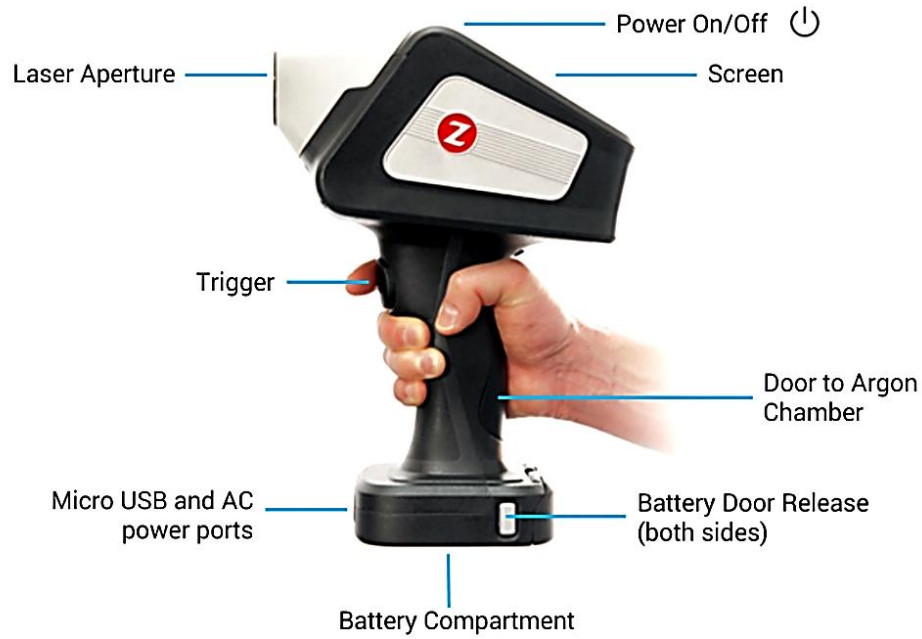
Figure 3.20: LIBS chemical analyses portable tool (SciAps, n.d.)

LIBS (Laser Induced Breakdown Spectroscopy) is a hand held portable chemical analyses tool (see Fig. 3.20) (SciAps, n.d.). It was used in the laser cladding repair tests. It was expected to measure the chemical compositions of the clad parts and they were compared with other similar materials.

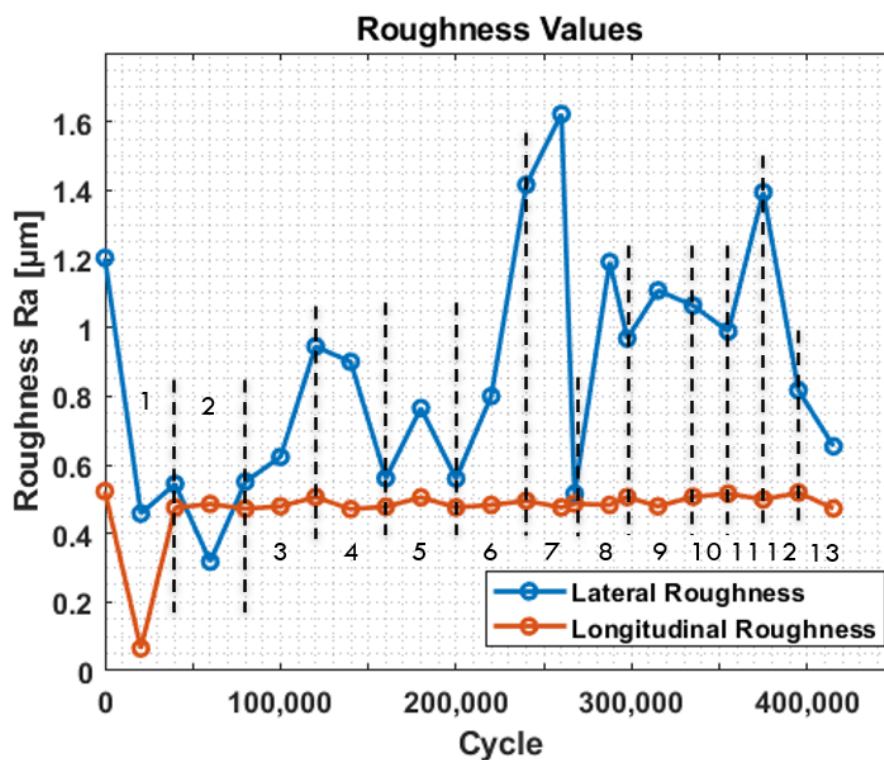
Figure 4.3: Roughness measurements of the laser clad coating during the longevity tests: (a) direction of measurements; (b) Ra roughness values.

The arithmetic average roughness (Ra) measurements in Figure 4.3(b) show that after an initial reduction after 20,000 cycles the longitudinal roughness remains at a steady state. The lateral roughness shows variation throughout testing with the evolution of the surface. The Ra roughness value increases between 200,000 and 260,000 cycles peaking at $1.65\text{ }\mu\text{m}$. It can be also from previous wear scratch images in Figure 4.3, after 200,000 cycles wear scratches are seen more on the images of the surface. 13 different sections are shown and they were the wheel change points Lu et al. (2018) shows that unclad R260 roughness values are higher than $6\text{ }\mu\text{m}$ after 30,000 cycles of a test so these values are relatively very low.

Roughness was measured after each block of cycles and the value of roughness was recorded and the data extracted from the profilometer. The whole length of the lateral roughness in disc was measured with around 10 mm. The longitudinal part of the disc was measured around 6-10 mm for roughness. The surface roughness was monitored with the Alicona throughout the longevity tests in both the longitudinal and lateral directions on the rail disc, as shown in Figure 4.3(a).

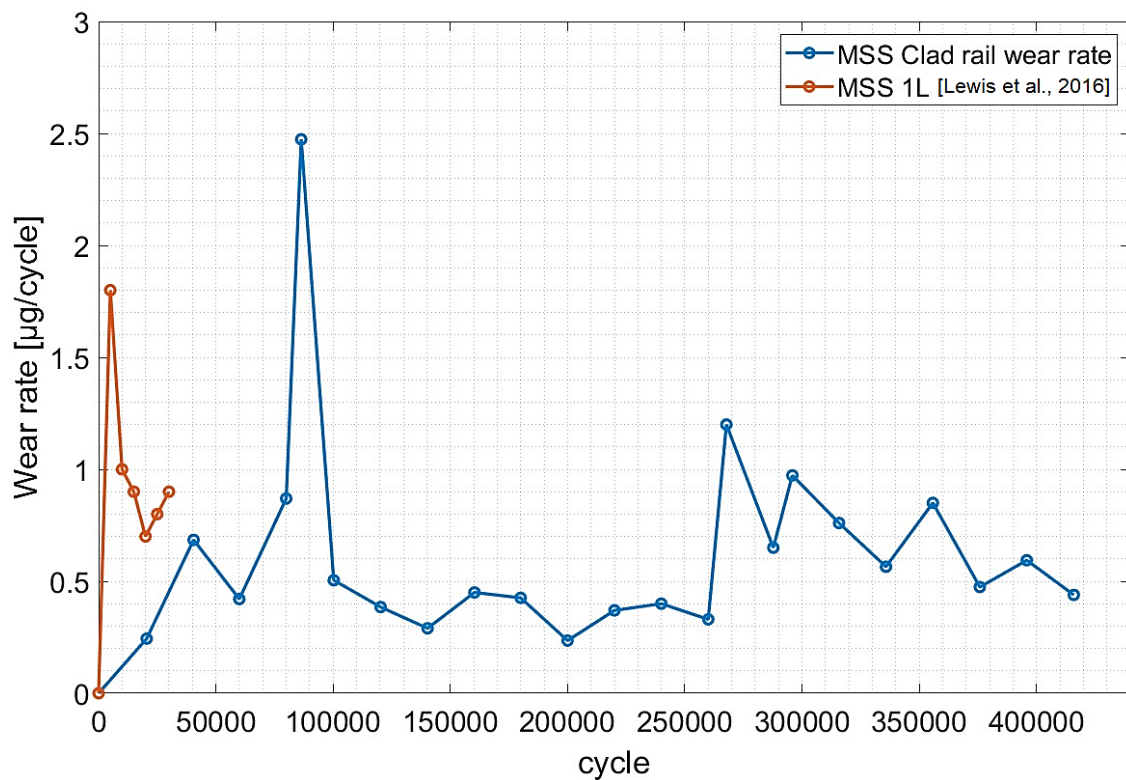
Figure 4.5: Wear rate during the longevity test: (a) Laser clad rail disc; (b) R8 wheel disc

The laser clad rail disc experienced a peak in wear rate of almost 2.5 $\mu\text{g}/\text{cycle}$ after 80,000 cycles before settling below 0.5 $\mu\text{g}/\text{cycle}$ until a second lower maintained rise occurred at 280,000 cycles. This coincides with visible wear appearing on the rail disc surface around 300,000 cycles. The peak points also occurred because of the worn wheel discs and needed change the wheel discs. It is because wheel disc dimensions change after long number of cycles. This could be because the clad layer is starting to break down more, but the wear rate is still much lower than would be seen in unclad materials where wear rates of 13 $\mu\text{g}/\text{cycle}$ would be expected for R260 after 30,000 cycles (Lewis et al., 2016). The exceptional peak at 80,000 cycles could have been due to an effect from the wheel disc deterioration.

The wear rate of the wheel disc similarly peaked after 280,000 cycles, reaching 520 $\mu\text{g}/\text{cycle}$ having remained below 50 $\mu\text{g}/\text{cycle}$ up to that point. The peaks occurred as the fatigue life of the wheel material was exhausted and gross flaking occurred.

Rail disc and wheel disc wear rates can be seen on the graphs shown in Figures 4.5a and 4.5b.

To put this data into context, in a shorter test for an MSS clad layer on R260 rail for another project, the wear rate experienced a similar peak at 5,000 cycles and then the wear rate reached a steady state during the rest of the test until the end at 30,000 cycles, as can be seen in Figure 4.5(a) (Lewis et al., 2016).

test wear rate is around 1 $\mu\text{g}/\text{cycle}$. On this research it is found around 0.5 $\mu\text{g}/\text{cycle}$ and the maximum wear rate was 2.5 $\mu\text{g}/\text{cycle}$ there see (Fig 4.5(a)). When compared to the two data points, it showed a bigger difference on wear rates for R260 and MSS clad rail. MSS clad showed better wear resistance.

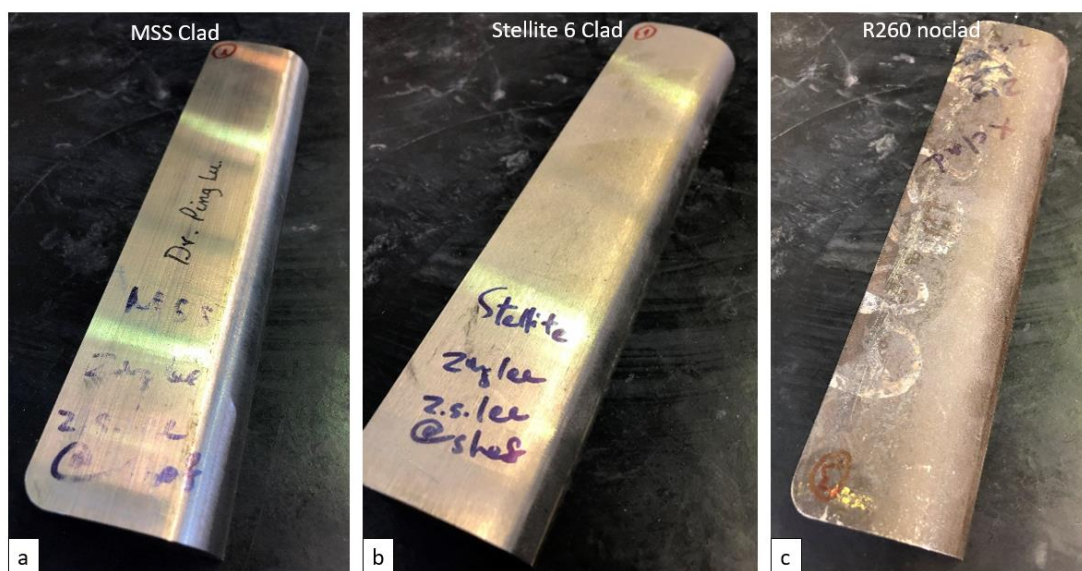
Figure 6.2(a) shows the rail and pocket sample with the pocket sample dimensions. Figure 6.2(b) shows how the pocket sample is inserted in the rail. The pocket samples were inserted into the rail with three bolts from the back face of the pocket sample and one from underneath the pocket sample. Figure 6.3 shows the pocket specimen images from before the experiments.

Figure 6.2: Full scale test pockets before tests: a) MSS Clad; b) Stellite 6; c) un-clad R260 un-clad

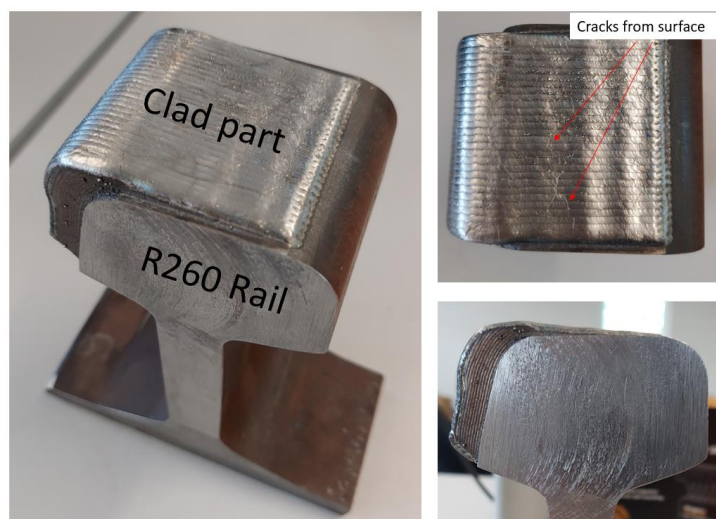
For the full-scale test repair specimen, post machining, the rail section was rebuilt to its original shape using many layers of T400 clad over standard R260 grade rail (see Figure 6.3). T400 has high wear and corrosion resistance and it is cobalt based alloys. In the other tests, the clad repair surfaces were ground to give a smoother surface, but here beading texture were used directly without any grinding step. Some cracks can be seen already over surface of the clad part.

Figure 6.3: T400 Clad over R260 full scale rail with many clad layers

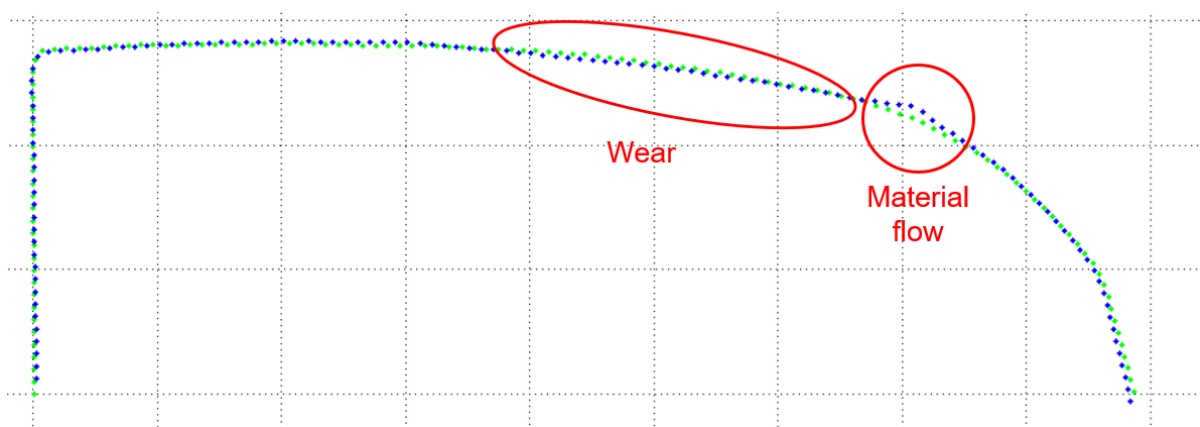
Figure 6.8: Un-clad R260 pocket surface profile measurements: a) profile measurements by 3D laser scanner; b) profile measurement by Calipri before and after 5,000 cycles (green line refers to before test and blue colour to after test).

2D profiles of the un-clad R260 pocket specimen were taken close to the middle part of the specimens. The location of the section is shown Figure 6.4(c). The un-clad R260 pocket specimen profiles showed far more deformation than the clad materials after 5,000 cycles. Wear region can be seen in Figure 6.8(b) with material flow.

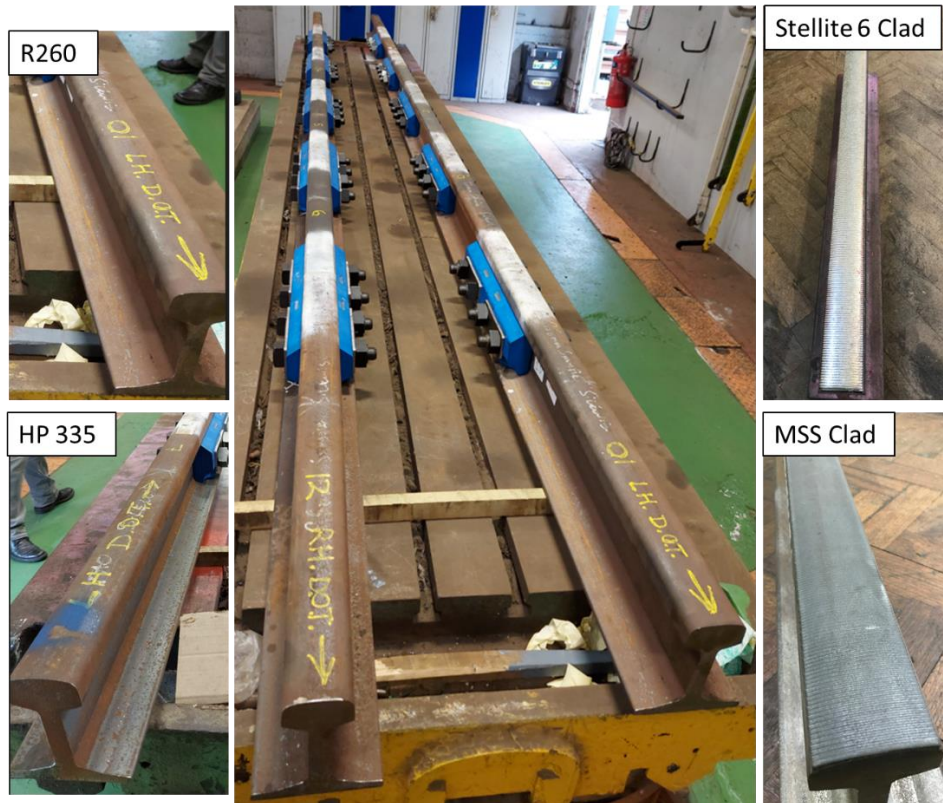
Figure 9.1: Field test plan of rail and IBJ sets: (a) Plan of the rails and IBJ sets for assembly; (b) Assembled rails and IBJ sets.

Figure 9.1 (b) shows the assembled parts of the rails based on the plan in Figure 9.1 (a). The assembly process was done in Progress Rail, UK. There were standard R260 rails, premium rails, MSS clad and Stellite 6 clad rails. The surface of the clad rails can be seen from the images and they were put in track in that conditions.

The field test plans of various rails and IBJ sets is shown in Figure 9.1 (a). The plan includes 4 different types of rails. They are standard rail that is R260 grade and 3 different clad rails. Clad materials are Stellite 6 and Martensitic stainless steel (MSS) with two different thicknesses. Stellite 6 and MSS are used for 3 mm clad, and another MSS is used for 1 mm clad thickness on standard rails. The chemical compositions of the materials are shown in the Table 9.1.

Also, left, and right rails are placed dependent on the direction of the rail. Running bands were shown in Figure 9.1. IBJs can be seen between the rails. The block joints were assembled prior to the string being welded in place in track.

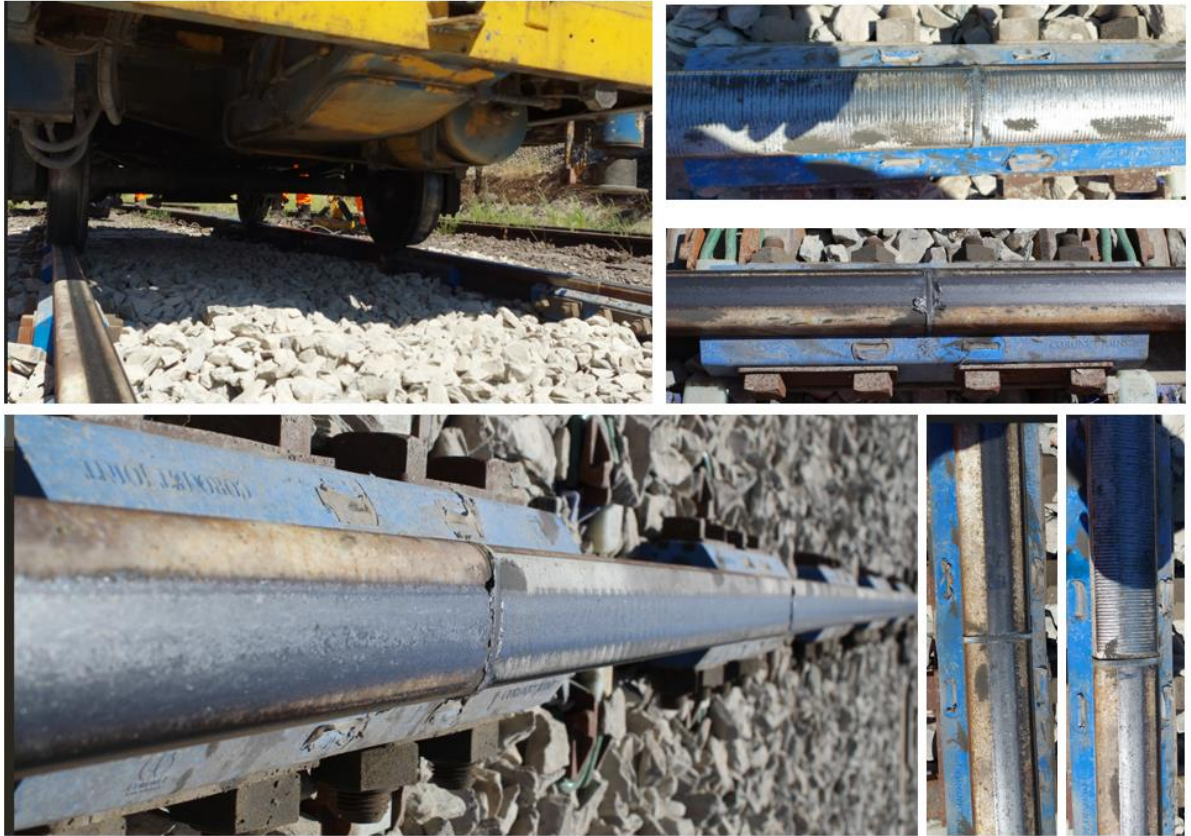
Figure 9.6: Some images after rail traffic over rails and IBJ components

Figure 9.5 shows the some IBJ set surface 3D scans for before and after 1st measurements. In this figure IBJ 6,5 and 4 is showed and there can be visible how IBJ plastic part change and intend to have lipping in the middle of images. For all rails and IBJ parts will be examined with upcoming measurements and analyse as a 2D profile changes as well. Figure 9.6 shows the images after rail traffic over rails and IBJ sets. Wear band got visible over rails.

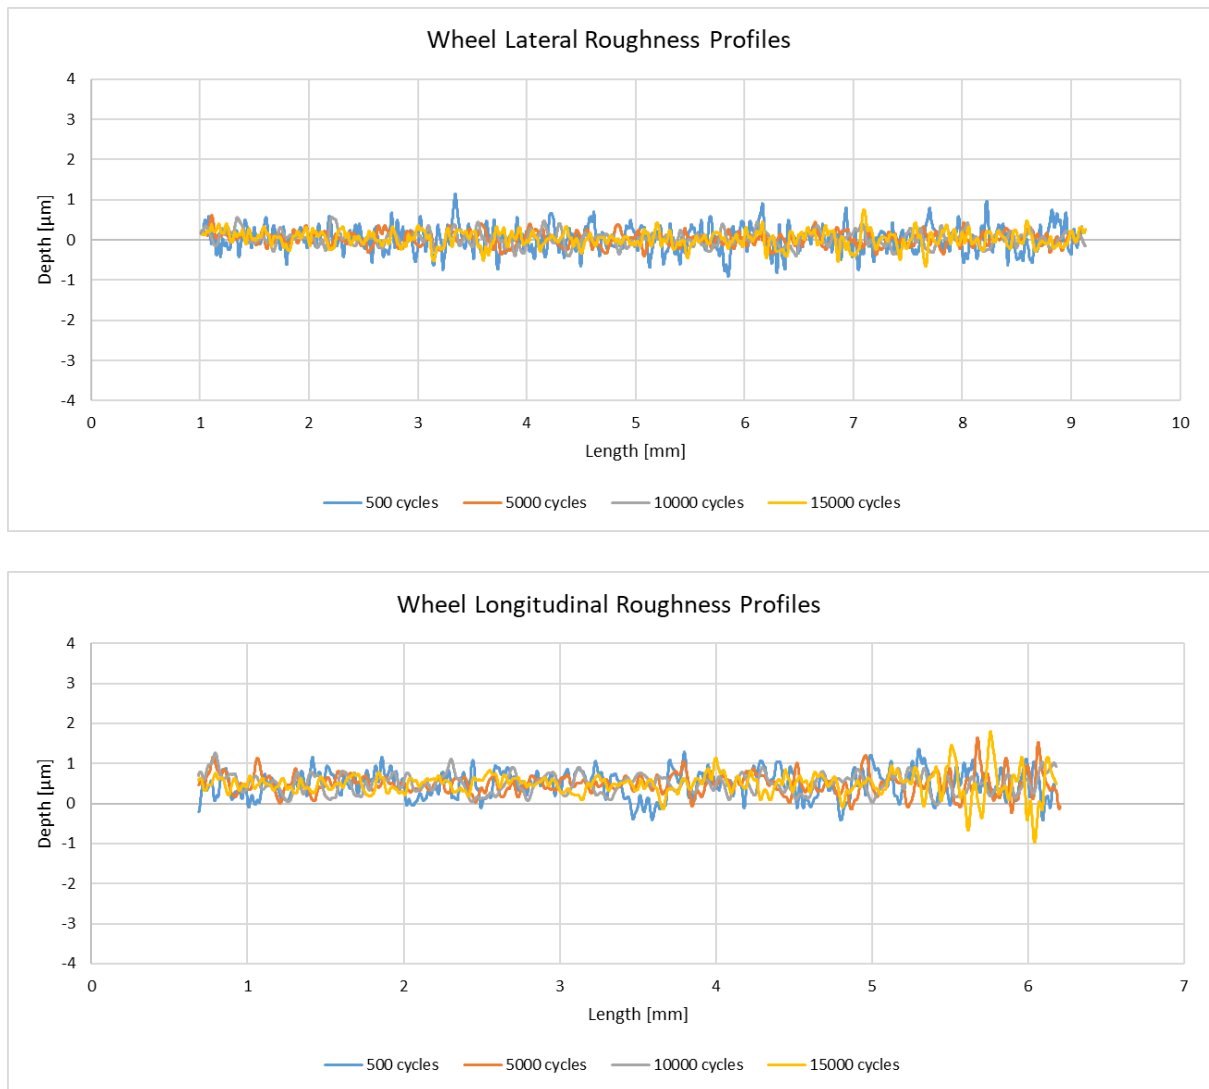
1500 MPa 1% Slip Water Lubricated Tests

Figure 12.6: Small scale repair tests surface evolution roughness graphs from Alicona with 1500 MPa, 1% slip, water-lubricated test condition

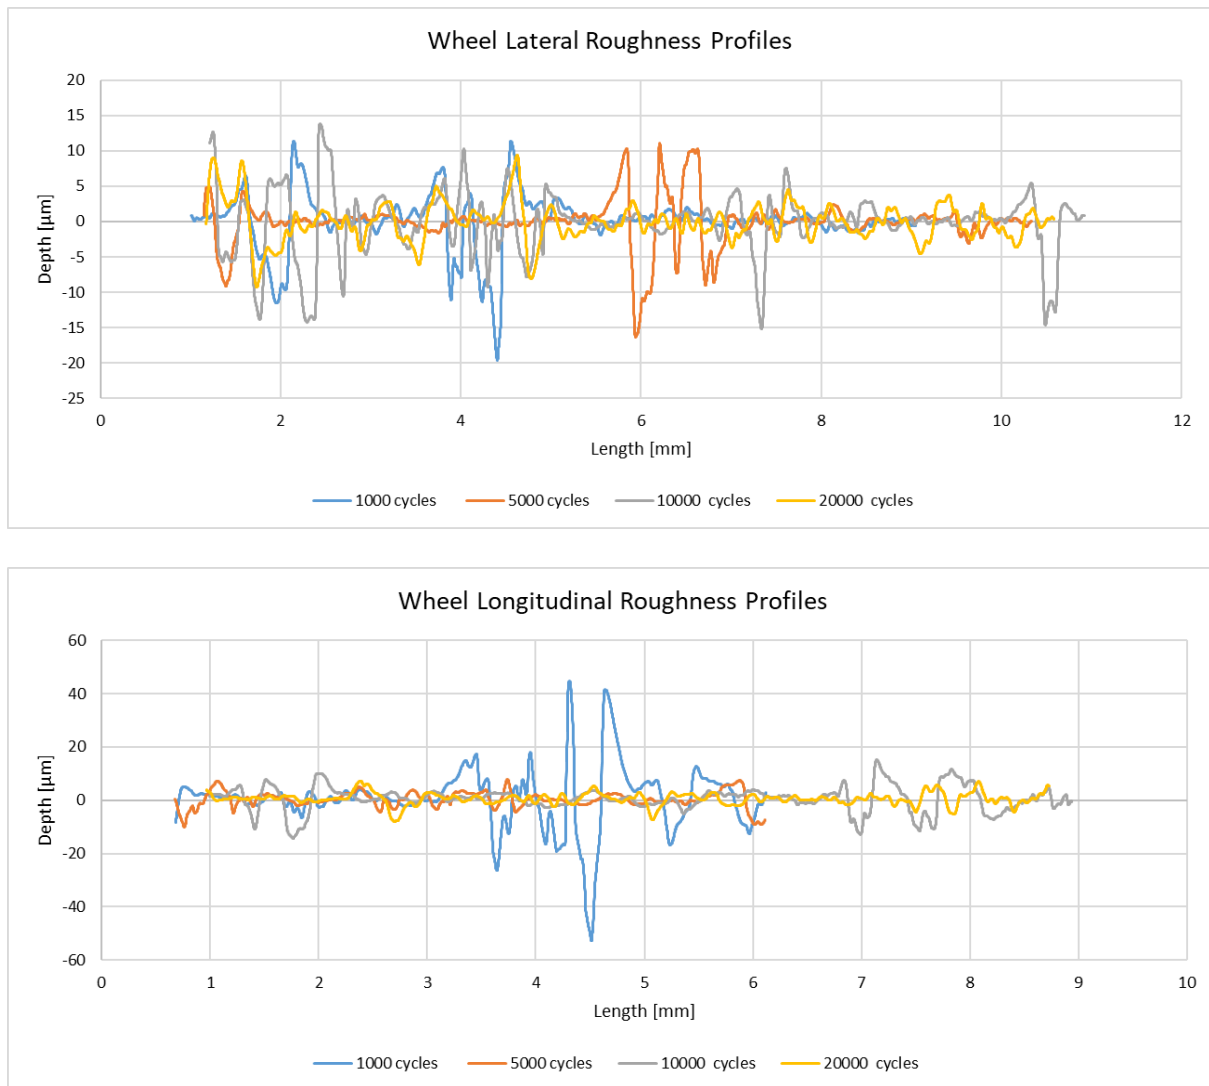
1500 MPa 3% Slip Dry Tests

Figure 12.7: Small scale repair tests surface evolution roughness graphs from Alicona for 1500 MPa, 3% slip, dry test condition

Figure 9.5: Surface 3D scan images of IBJ sets.-----	182
Figure 9.6: Some images after rail traffic over rails and IBJ components -----	183
Figure 12.1: Small scale repair tests clad part images after tests -----	200
Figure 12.2: Small scale repair tests surface images from Alicona after tests-----	201
Figure 12.3: Small scale repair tests surface evolution roughness graphs from Alicona with 900 MPa, 0.5% slip, dry test condition -----	206
Figure 12.4: Small scale repair tests surface evolution roughness graphs from Alicona with 900 MPa, 0.5% slip, water-lubricated test condition -----	211
Figure 12.5: Small scale repair tests surface evolution roughness graphs from Alicona with 1500 MPa, 1% slip dry test condition -----	216
Figure 12.6: Small scale repair tests surface evolution roughness graphs from Alicona with 1500 MPa, 1% slip, water-lubricated test condition-----	221
Figure 12.7: Small scale repair tests surface evolution roughness graphs from Alicona for 1500 MPa, 3% slip, dry test condition -----	226
