The Archaeology and Conservation
of the
East Front of York Minster

Volume 2 of 2
Figures, Drawings and Appendices

Alexander B Holton

University of York

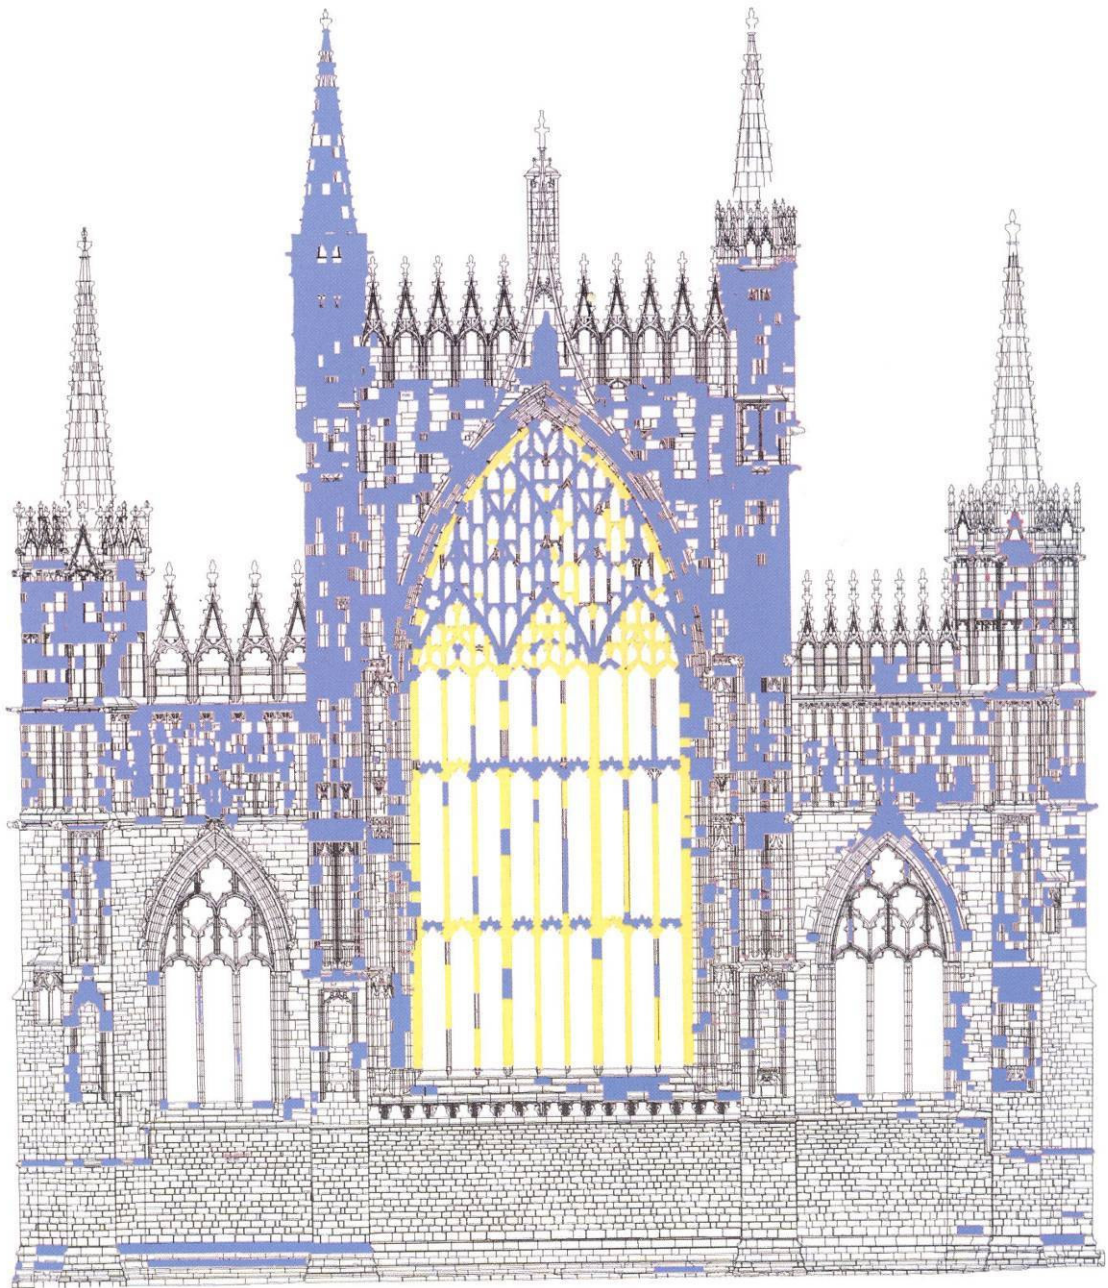
Figure 8: East Front repair proposals as at 12 February 2005 (York Minster 2005, 9)

- Stone for probable renewal or partial renewal
- Stone which can be re-used in Great East Window

At full scale this working drawing shows all areas of damage, the types of probable repair required and stonework requiring further inspection.

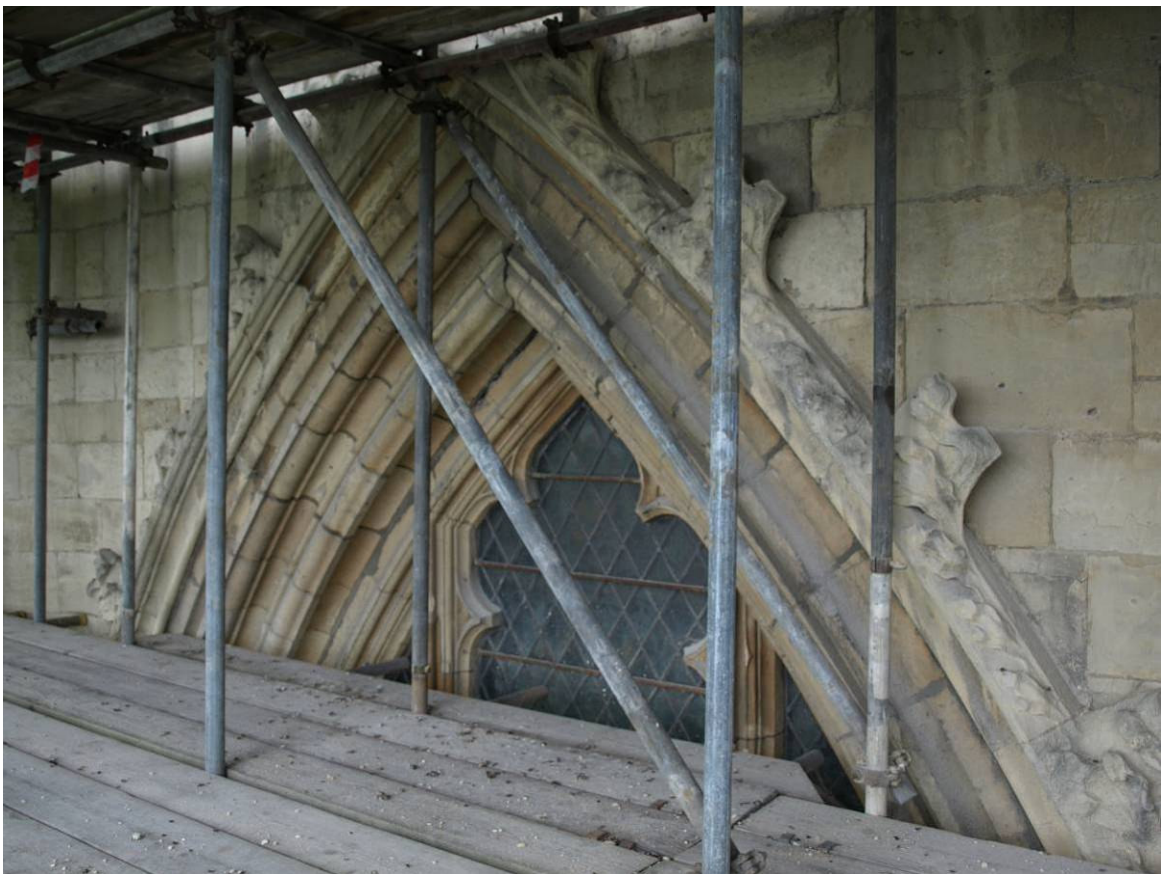
Figure 166: South aisle, 1950s; detail shows mis-coursing in easternmost bay (YML/Acc2002/66/1/21-40)

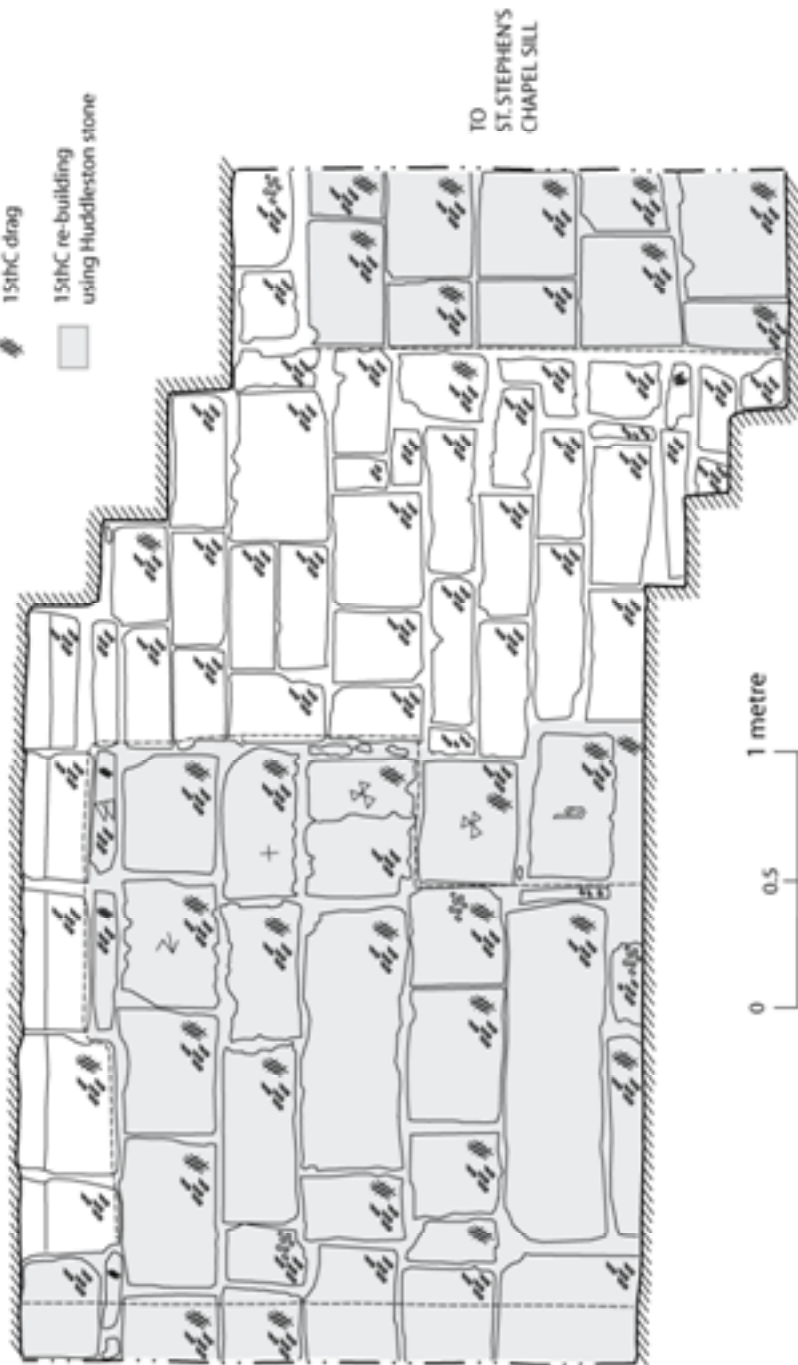
Figure 181: East Front interior, north passage at sill level, west wall, showing rear faces of reconstructed masonry

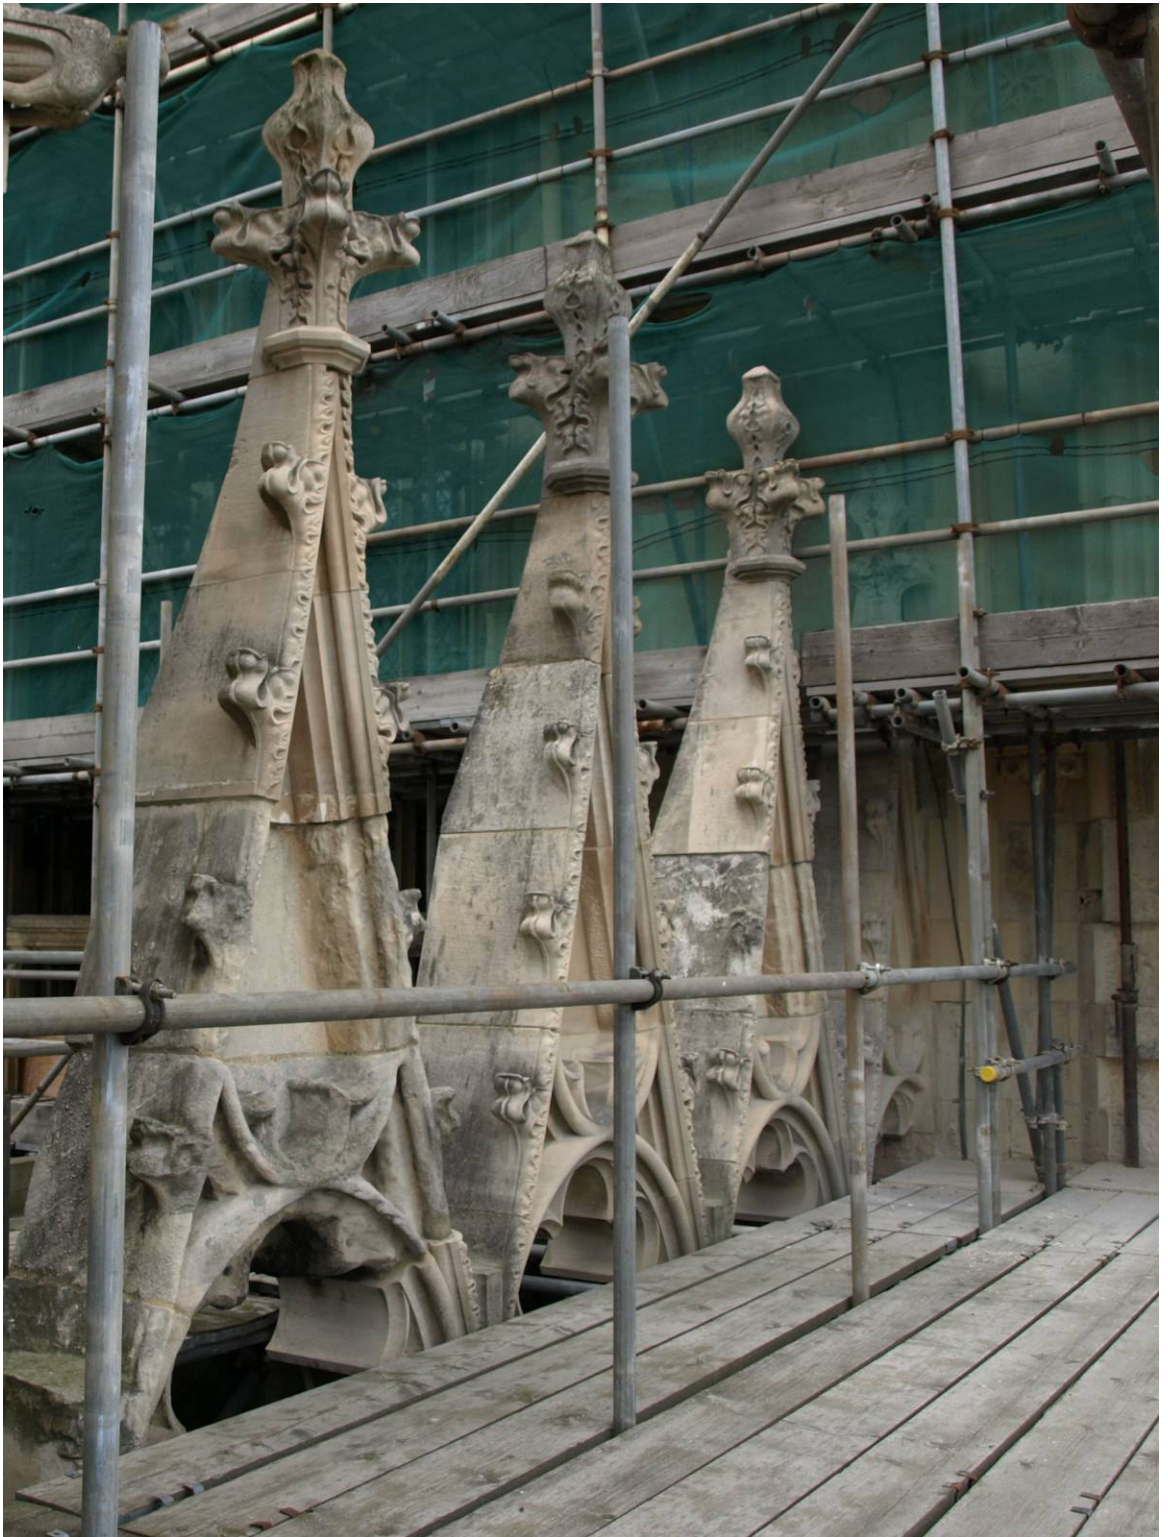
Figure 241: East Front, parapet gablets above south aisle, Level D

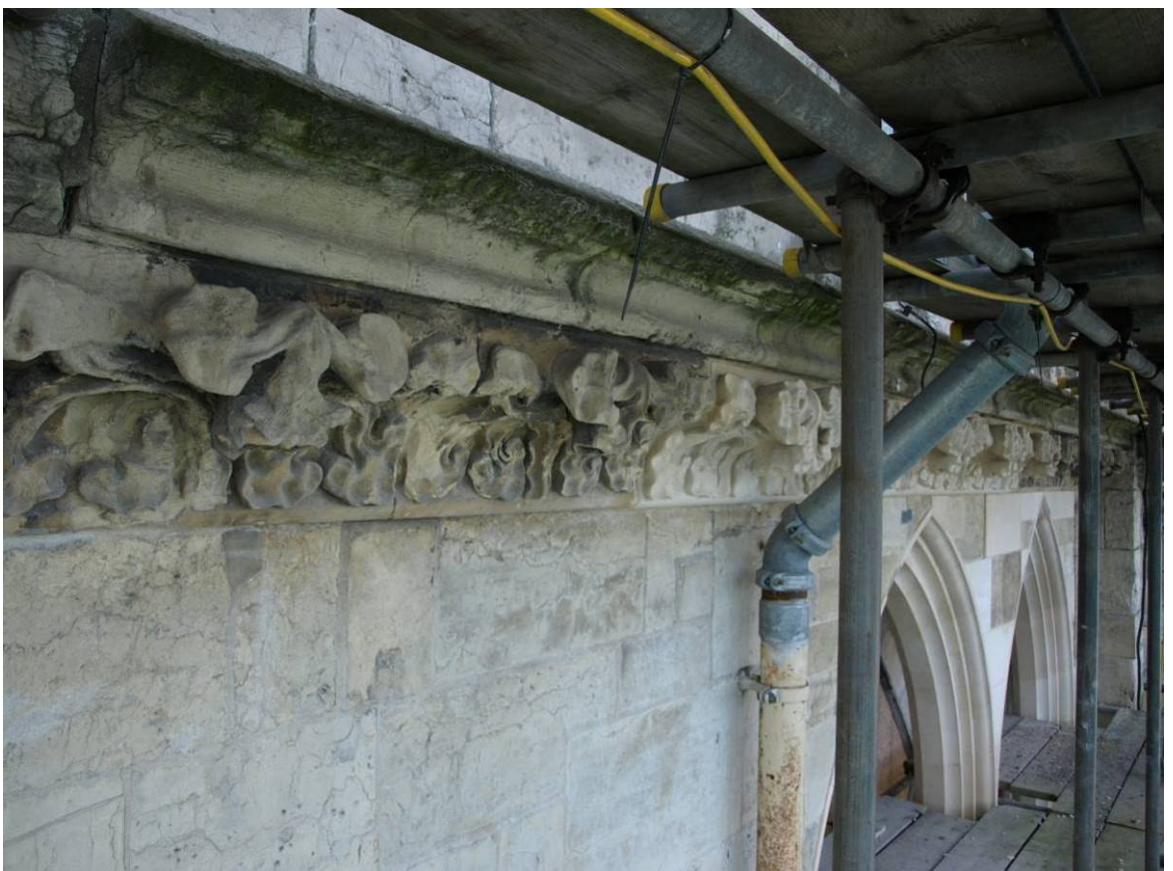
Figure 273: Thoresby's east end, north-clerestory cornice, 1830s with recent replacements (2006)

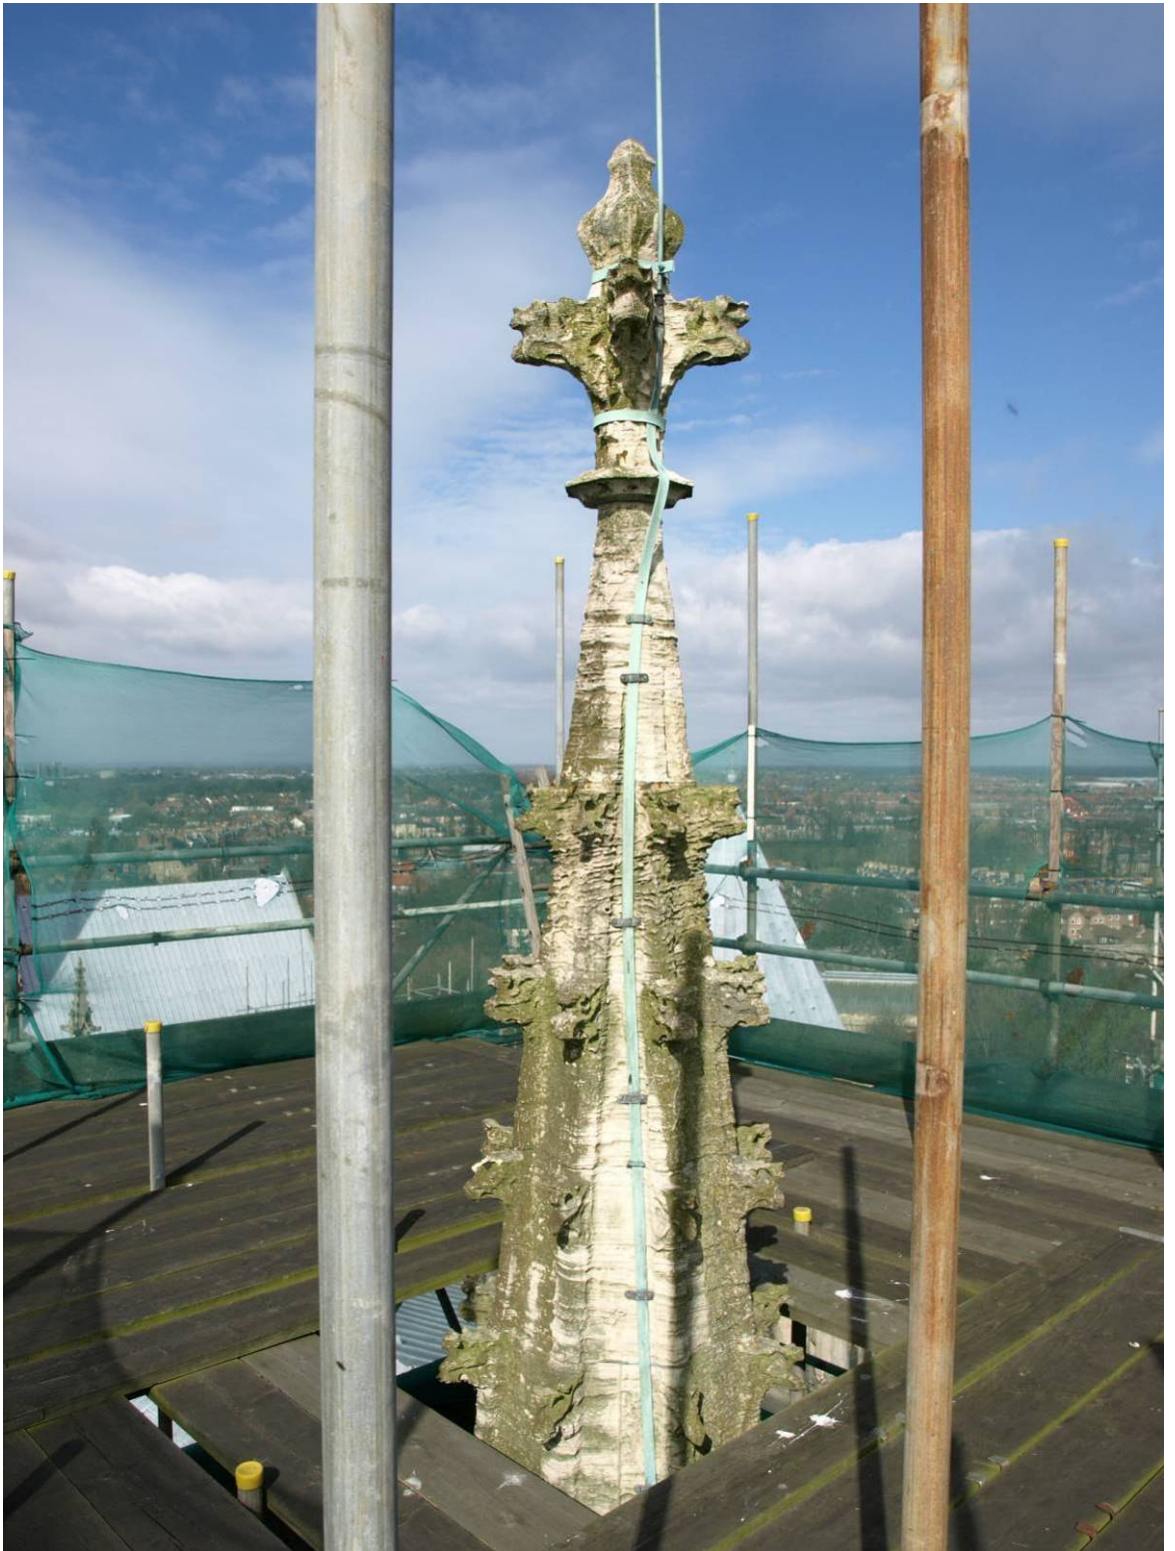
Figure 280: East Front, south-buttress spirelet, Level I

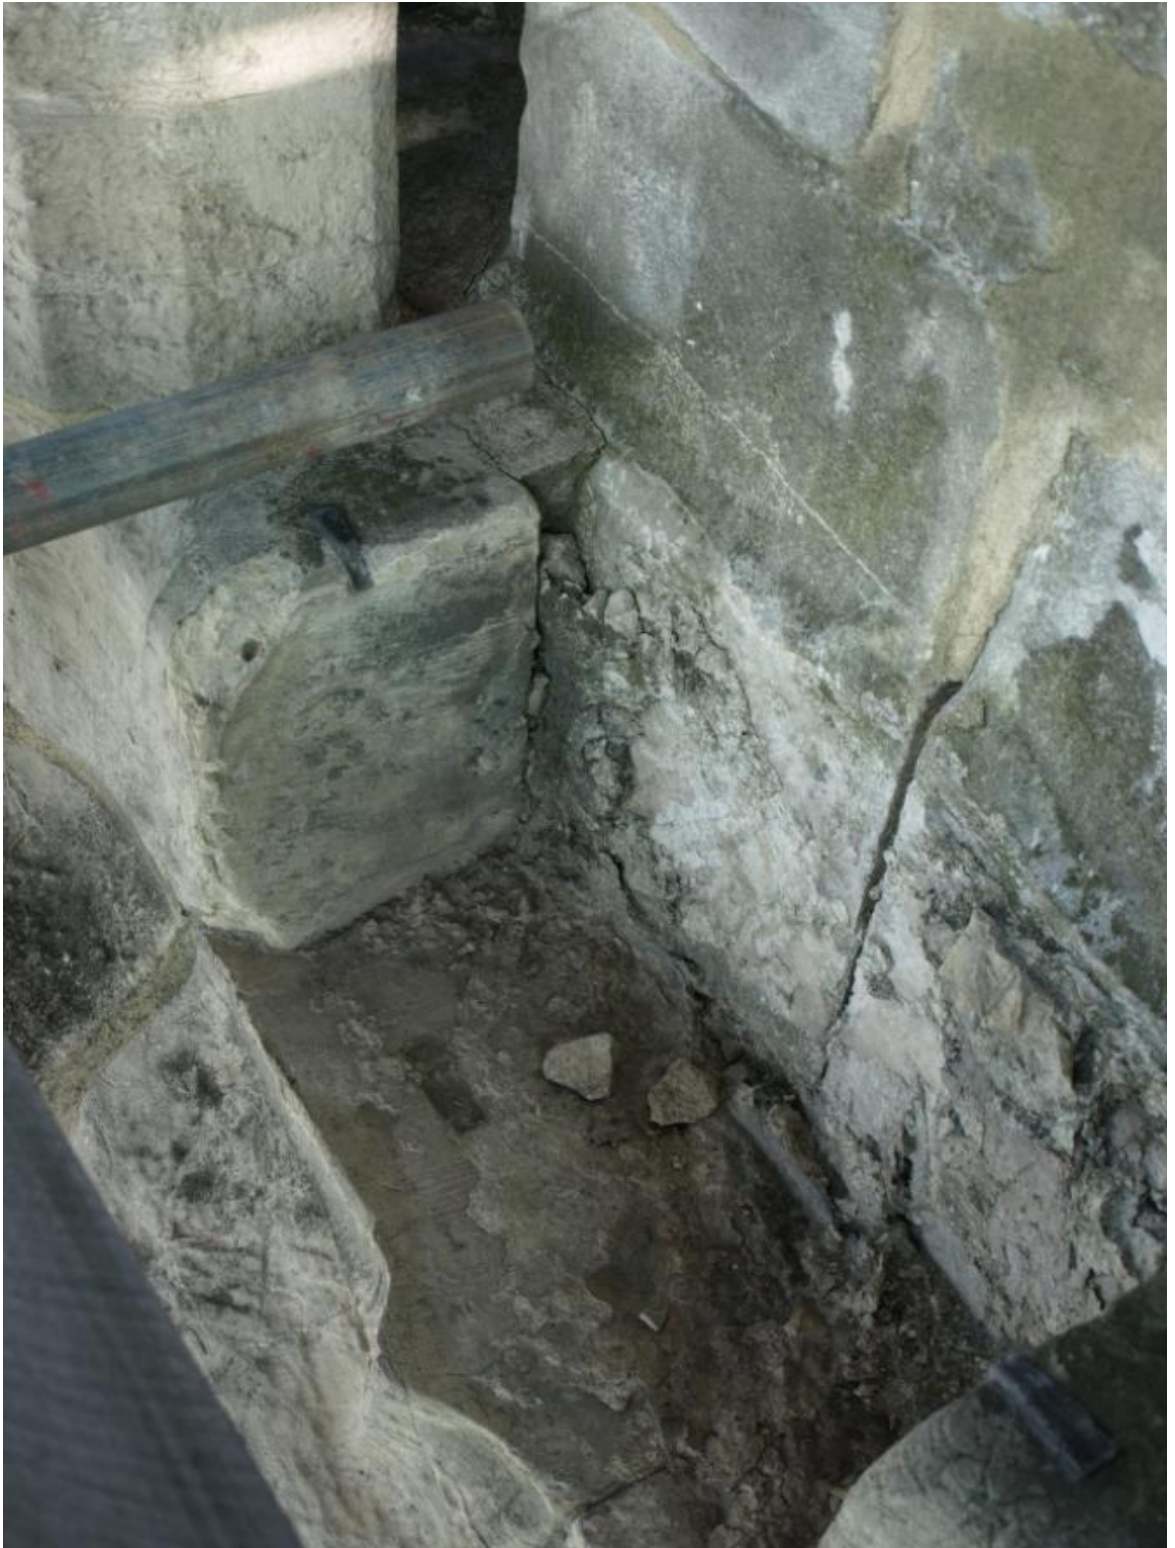
Figure 289: East Front, south buttress Level G/H, straight-joint between corona and broach

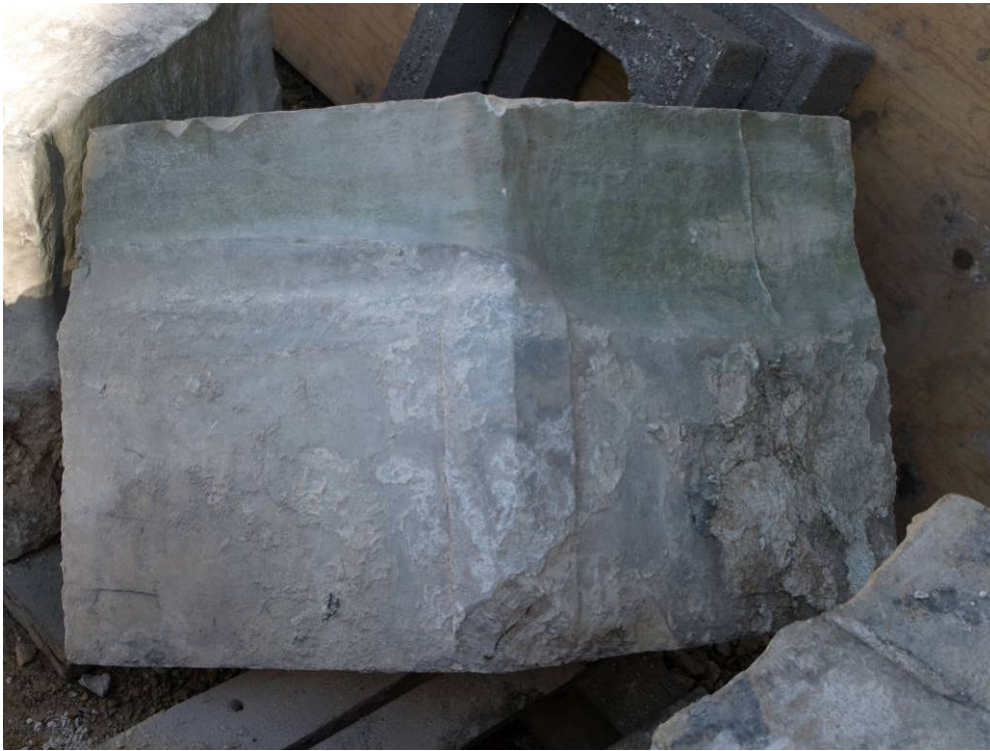
Figure 290: Removed broach-stone from below spirelet, south buttress, showing concealed and damaged moulding

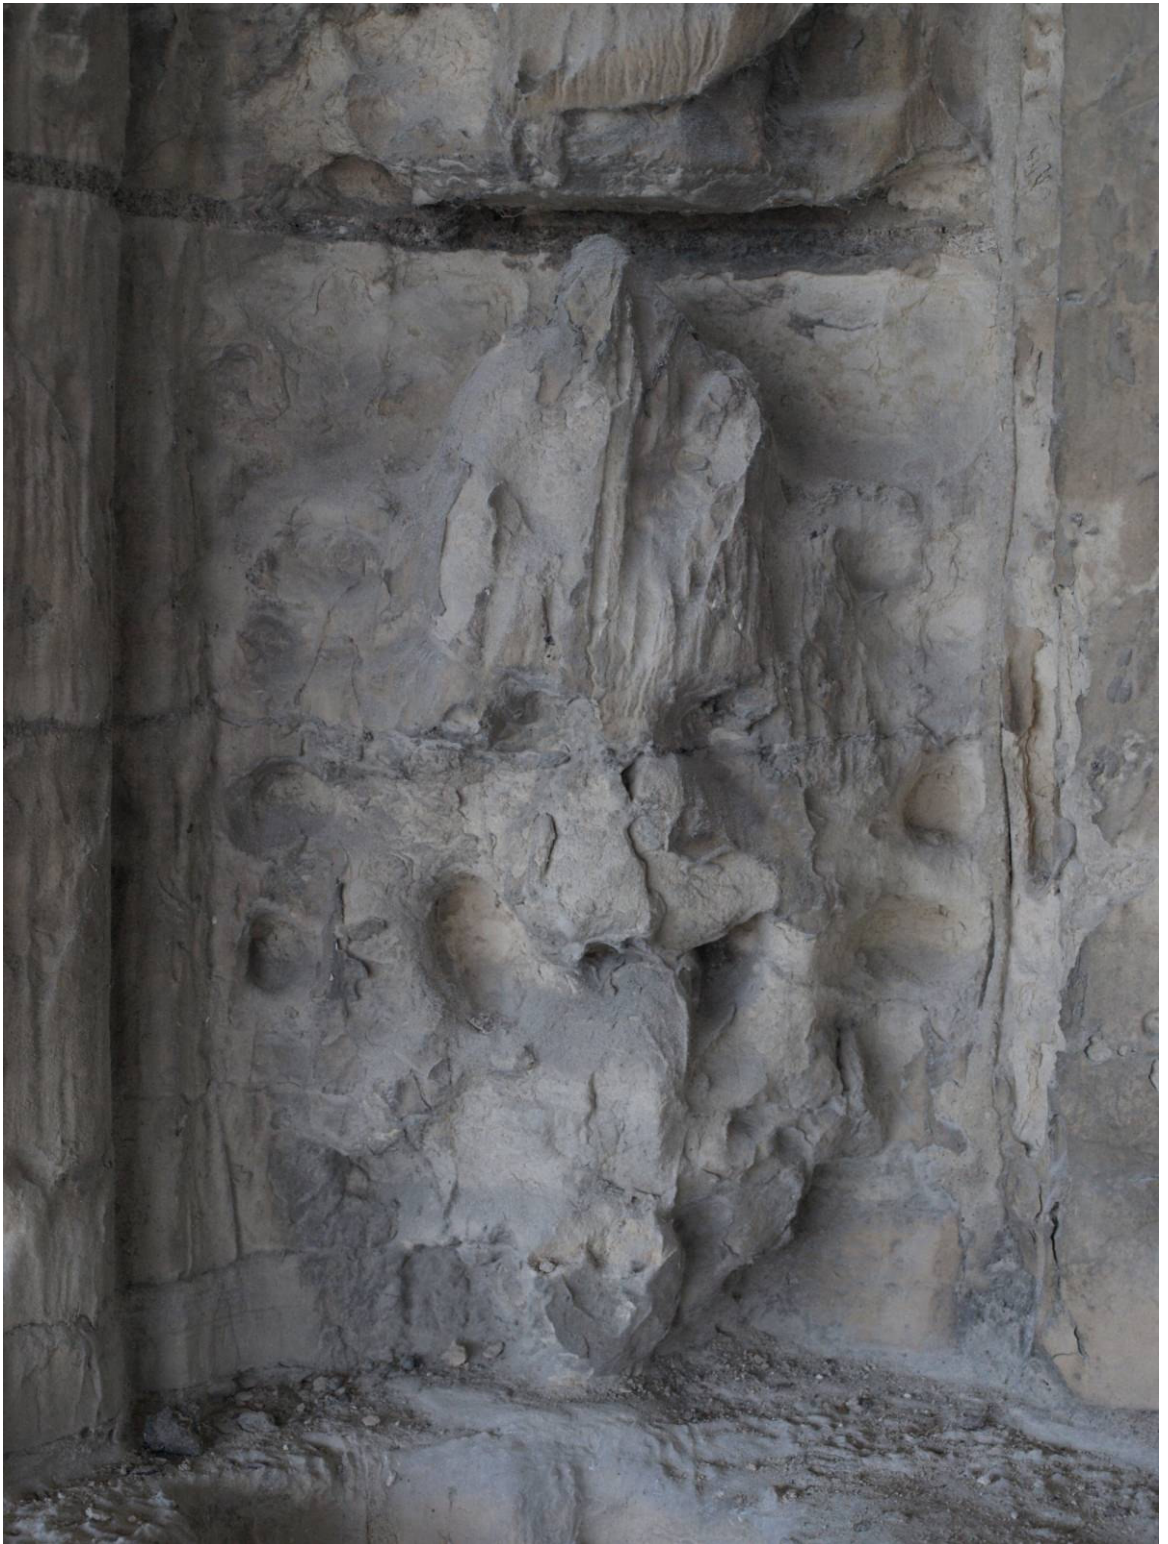
Figure 357: Great East Window, b1 illustrating typical decay patterns

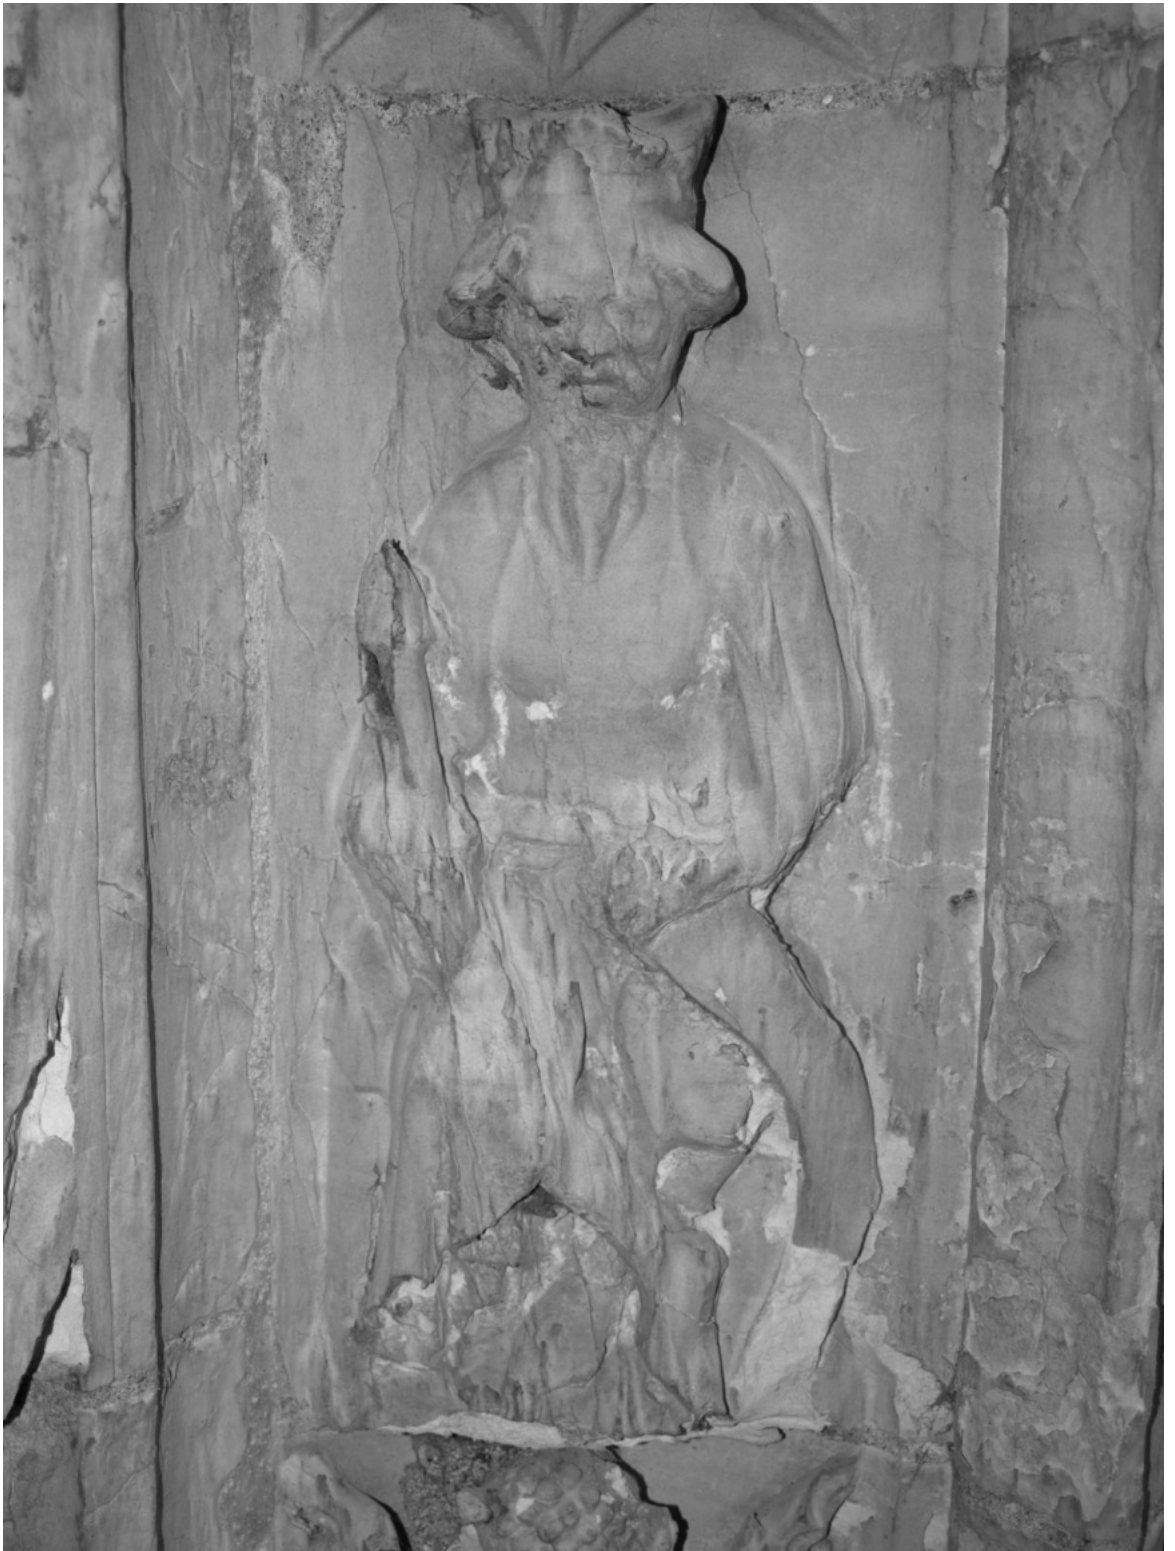
Figure 360: Voussoir b34, December 2008

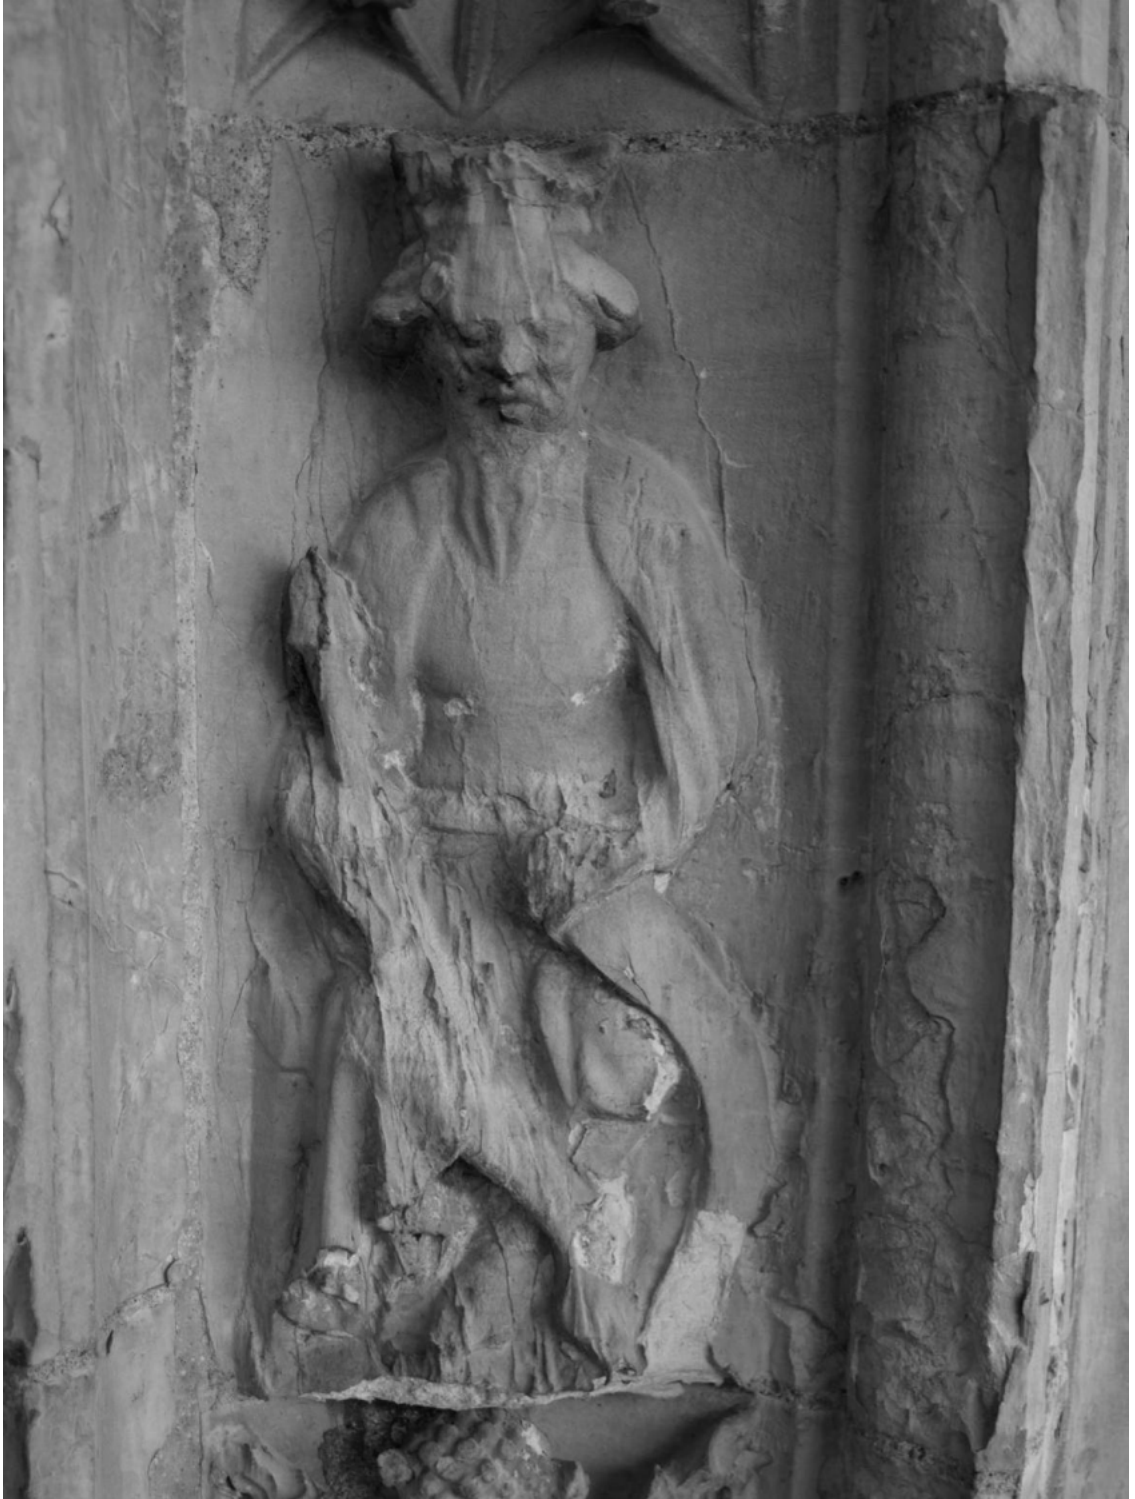
Figure 361: Voussoir b34, April 2009

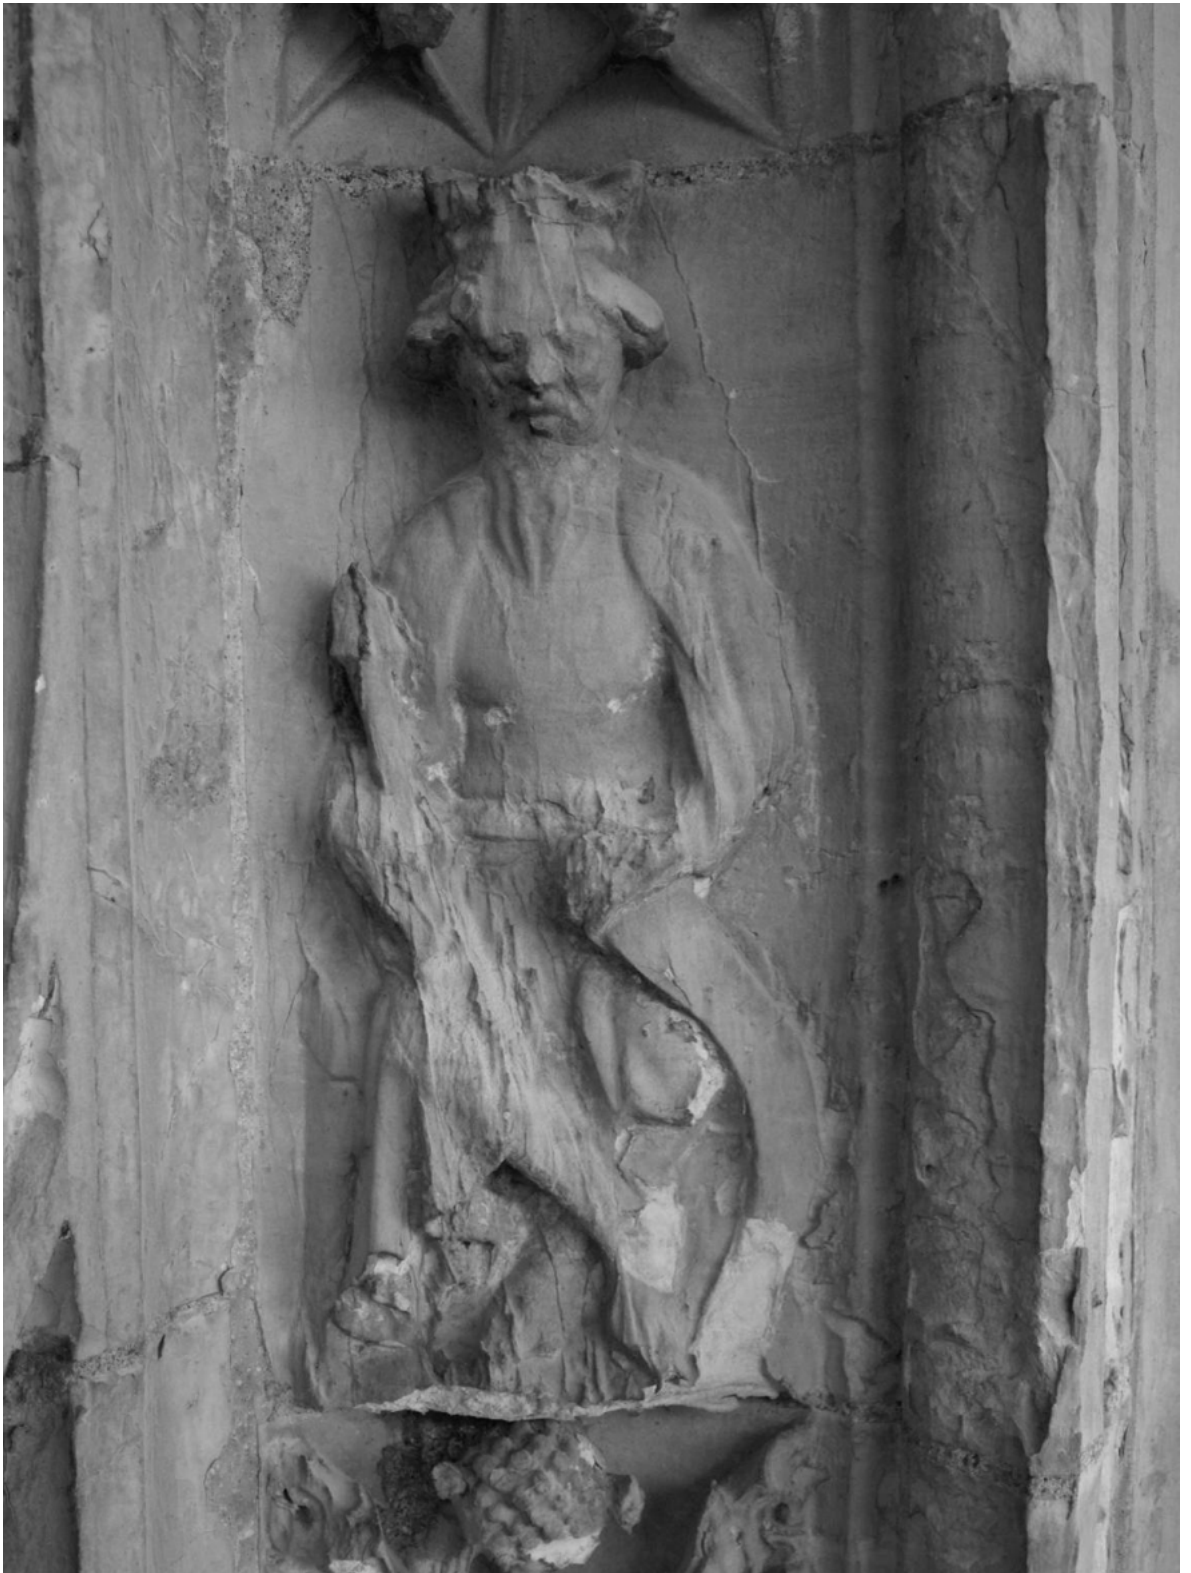
Figure 362: Voussoir b34, September 2009

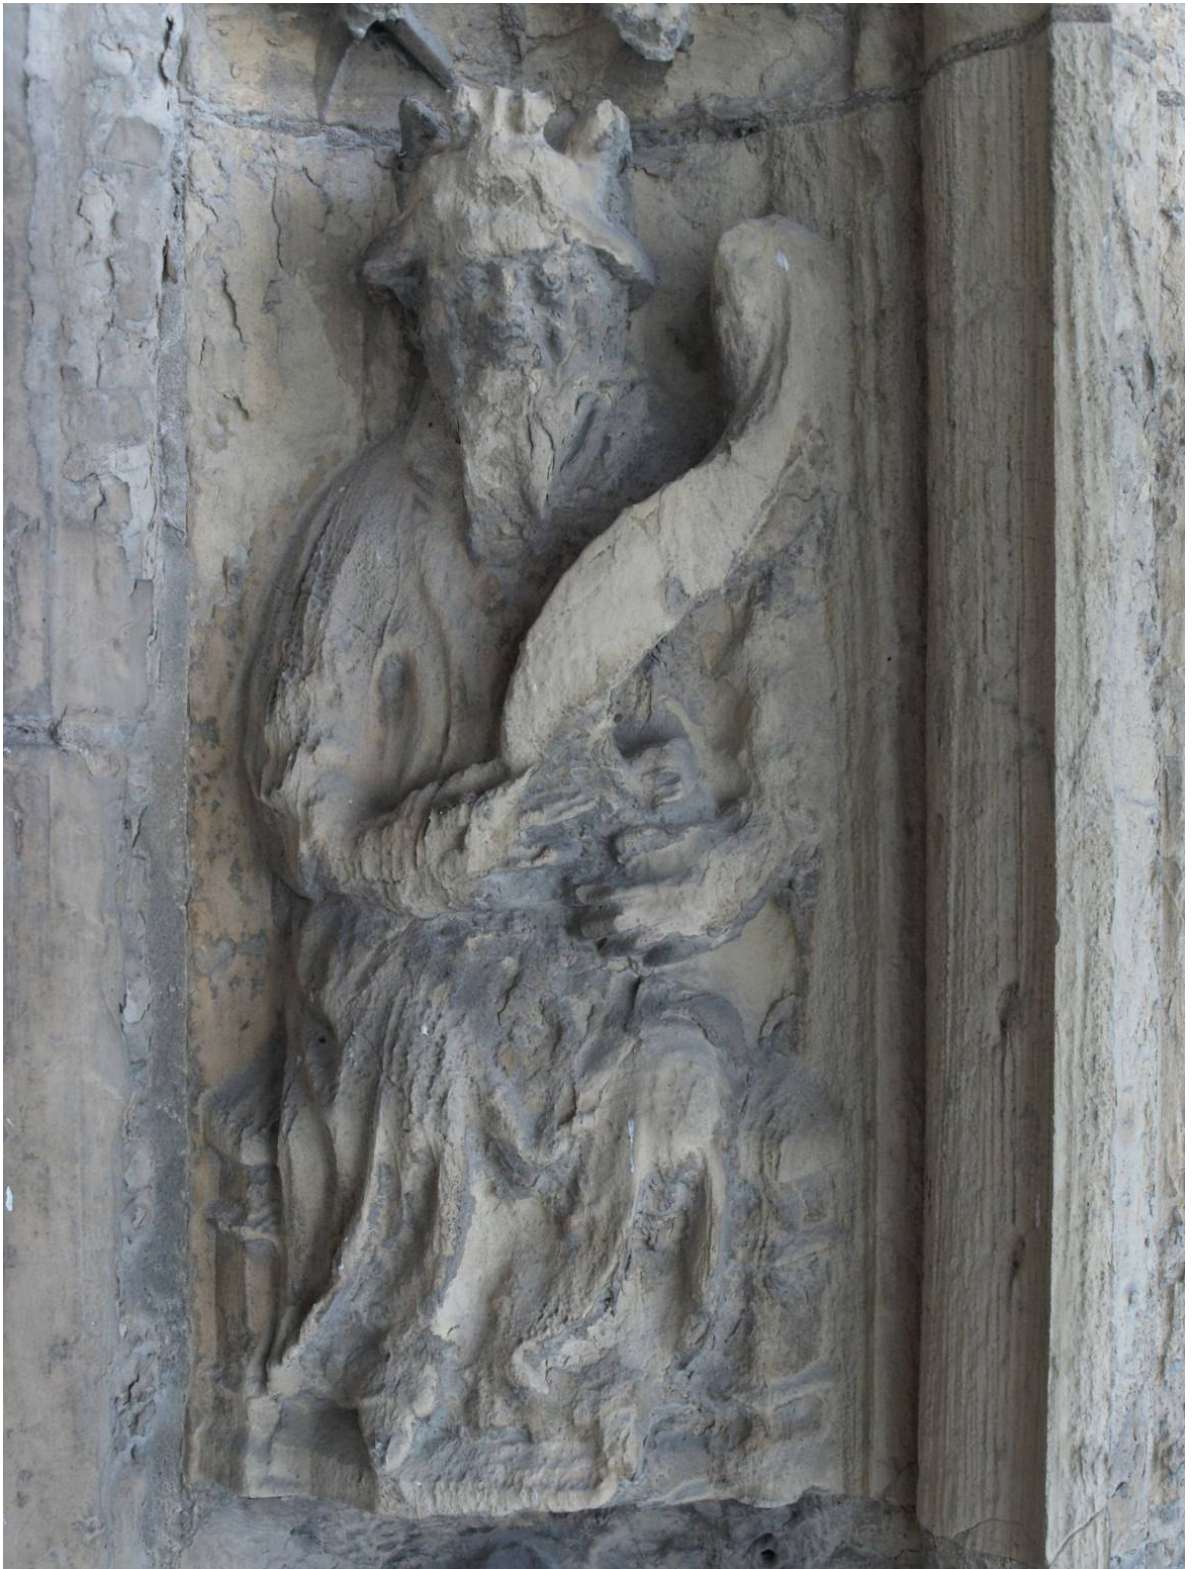
Figure 363: Voussoir b4, nineteenth-century replacement ?based on b46 (overleaf)

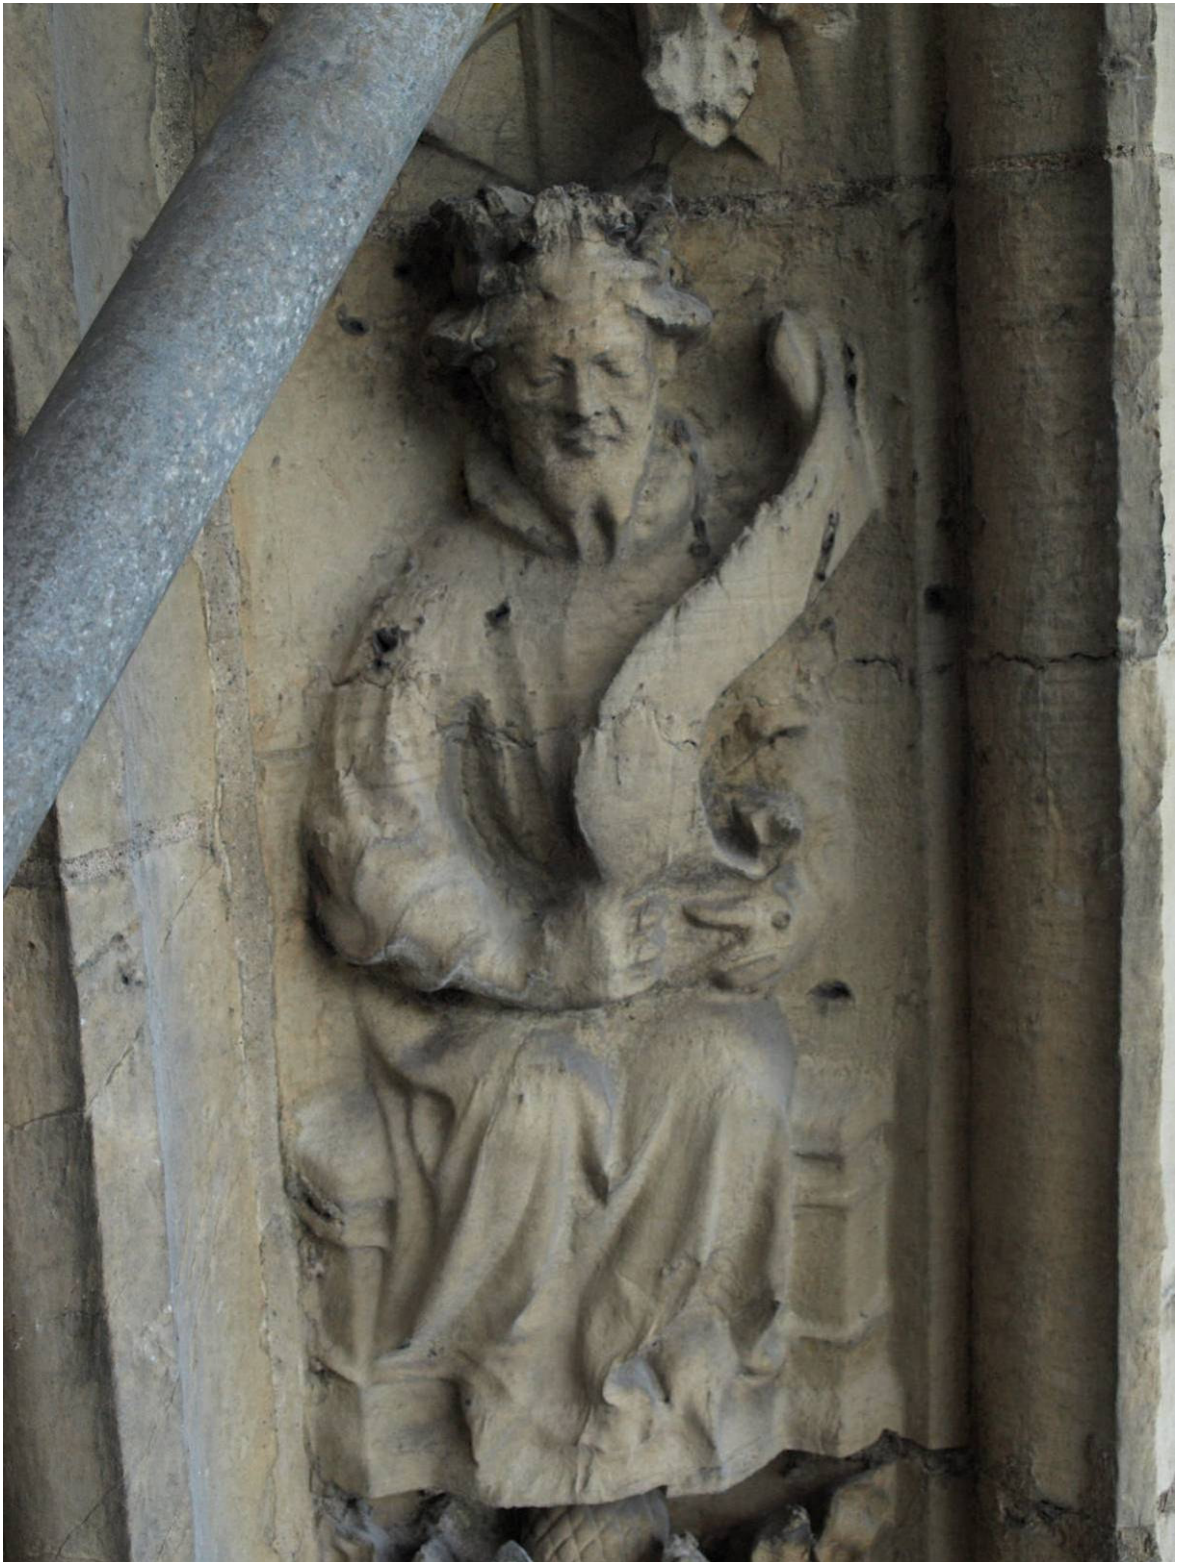
Figure 364: Voussoir b46, medieval

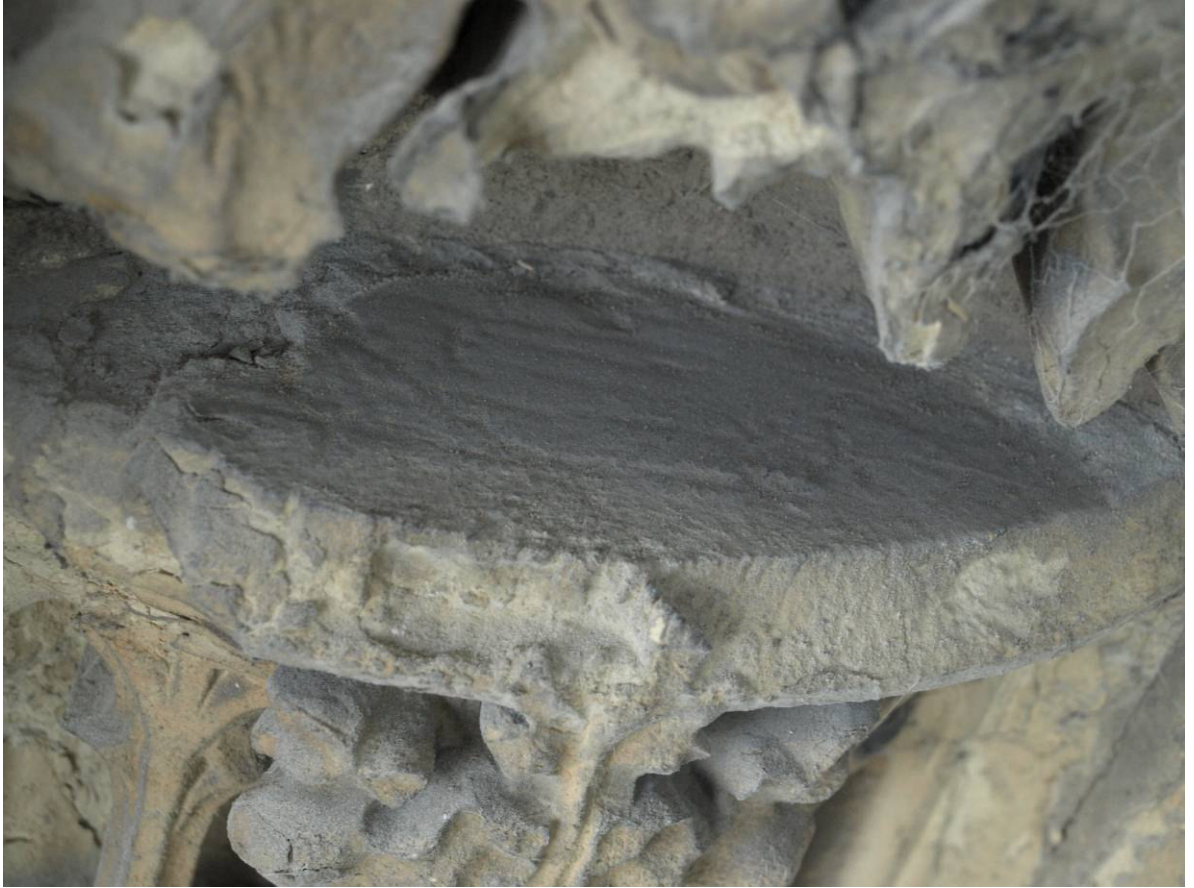
Figure 366: Example of replacement canopy showing lack of piercing and nineteenth-century tooling
