The Archaeology and Conservation
of the
East Front of York Minster

Volume 2 of 2
Figures, Drawings and Appendices

Alexander B Holton

University of York

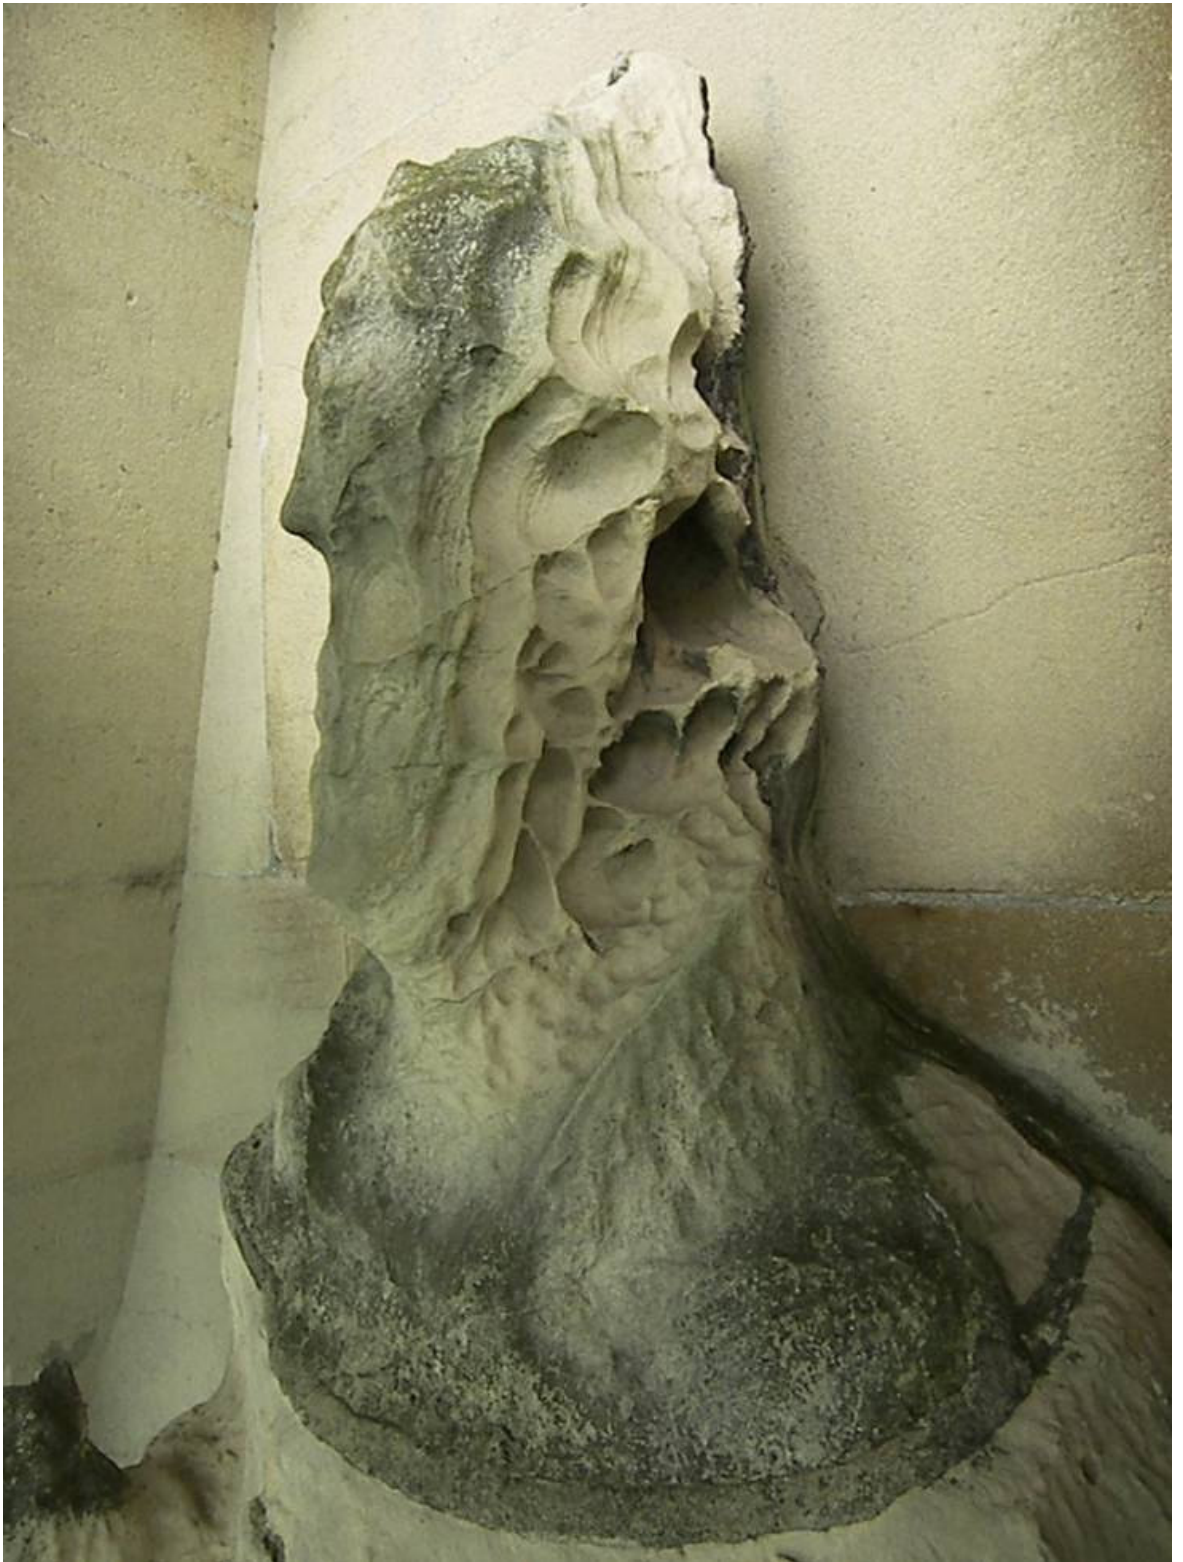
Figure 378: Seated figure, cement/New Ketton pointing between torso and head section

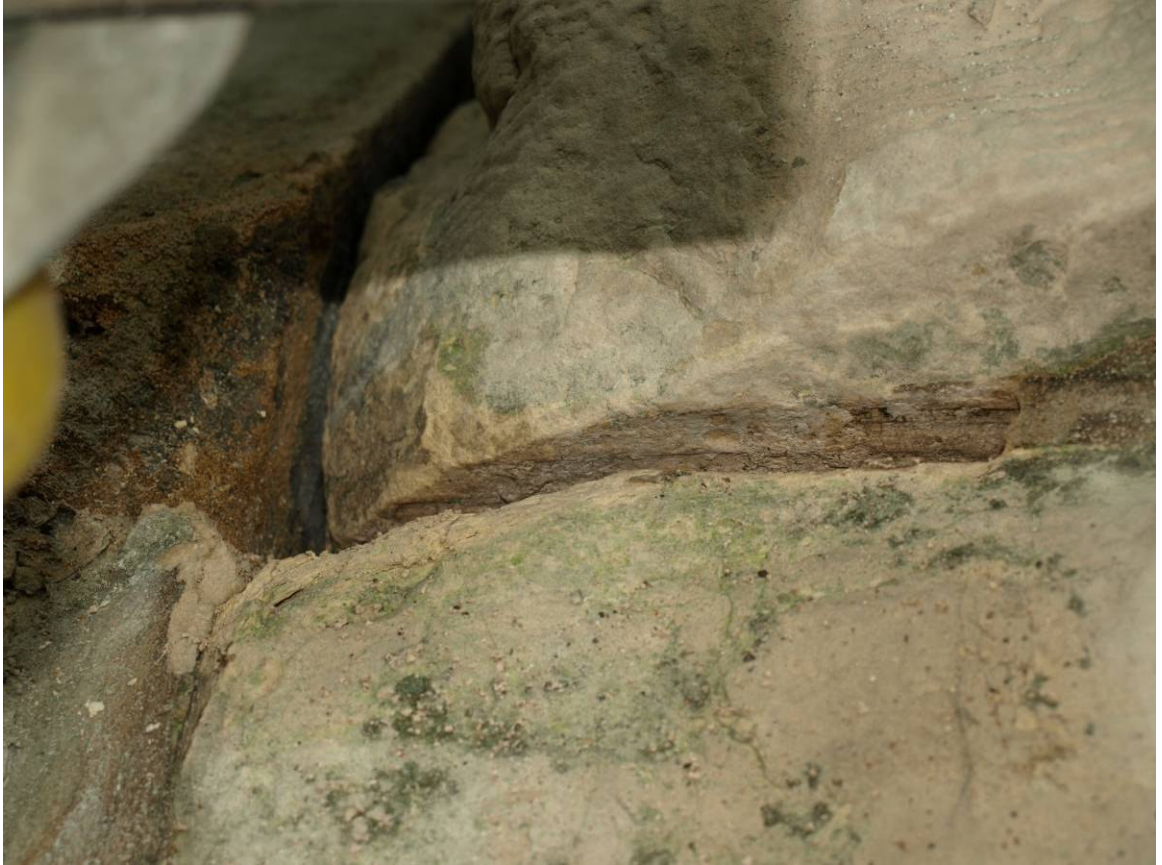
Figure 381: Seated figure, right-hand side of base showing exposed armature linking base with parapet

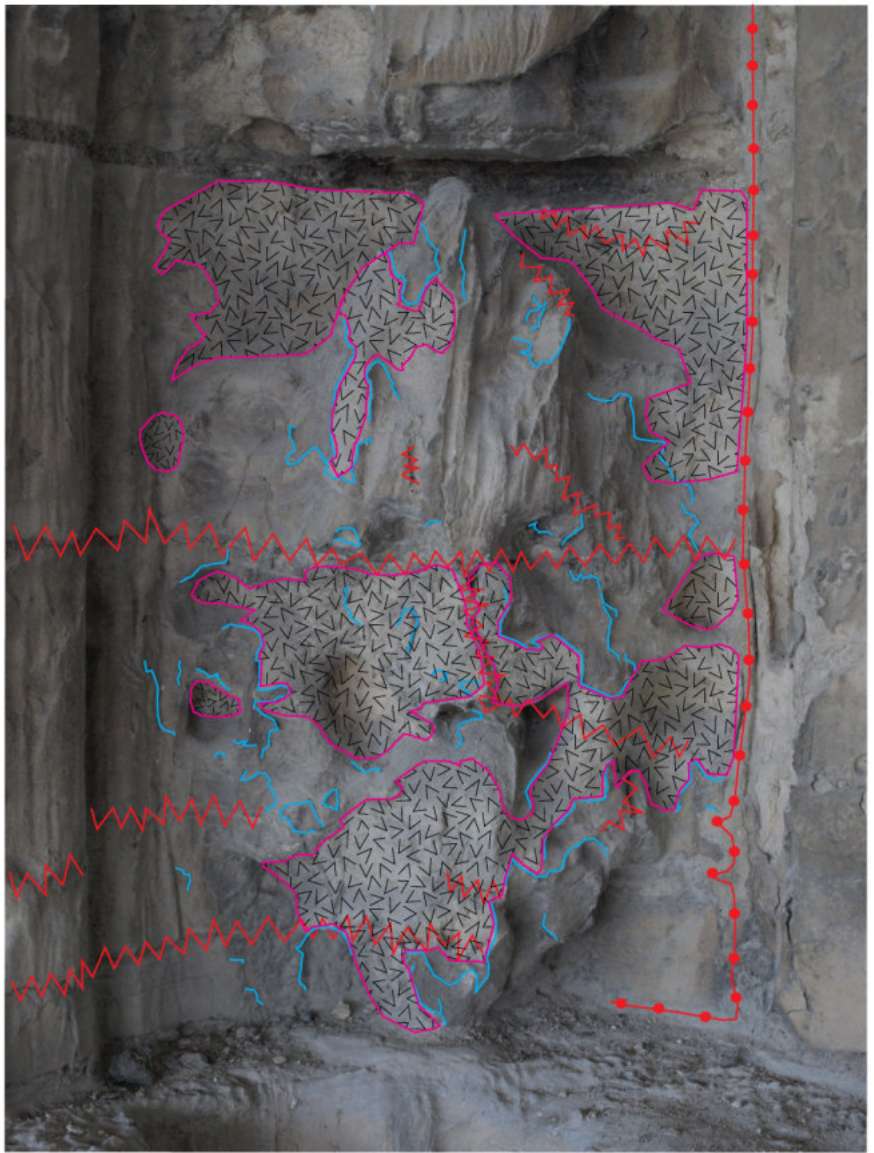
Brown staining to surface skins

Note decay debris below mask on East Window capitals

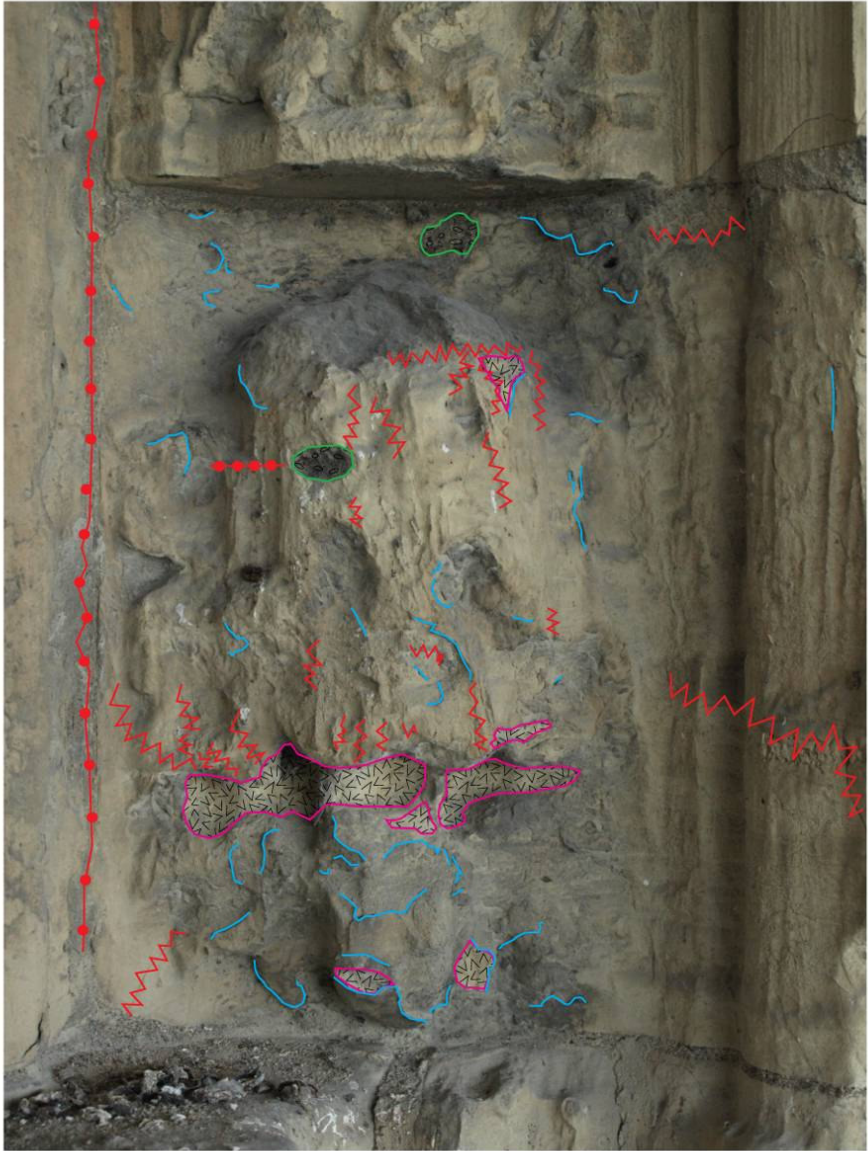
LOCATION :
 YM/East Front/Area 4/GEW voussoirs
 STONE ID:
 b2
 RECORDED BY/DATE:
 AH Photo Apr 09; Condition Survey AH Apr 09

Extant sound surfaces harmoniously weathered

Brown staining to surface skins

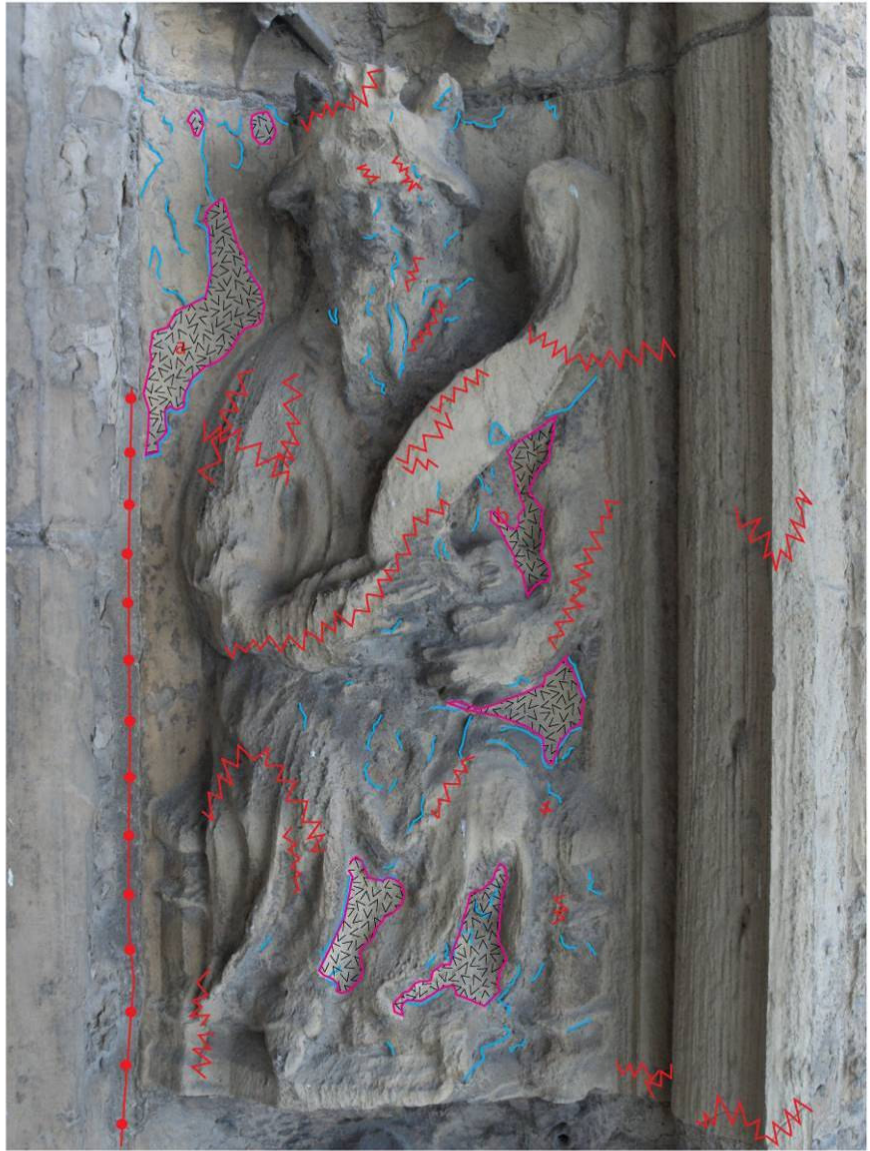
Brown-yellow staining to surface skins

Aggregate residues noted on surface - part of earlier coating application or residue from 'sponging-off' after re-pointing?

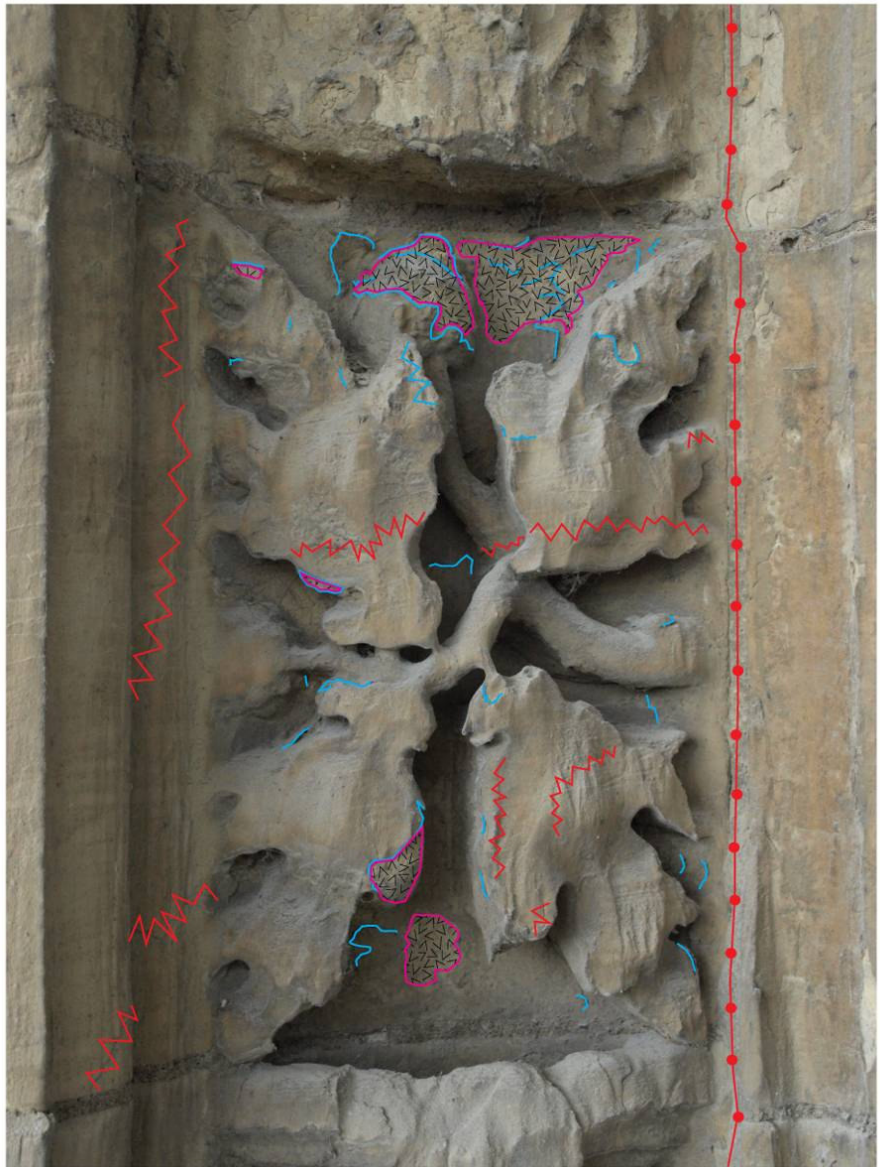
brown staining to sound surfaces

harmonious weathering to sound surfaces, softening of carved details

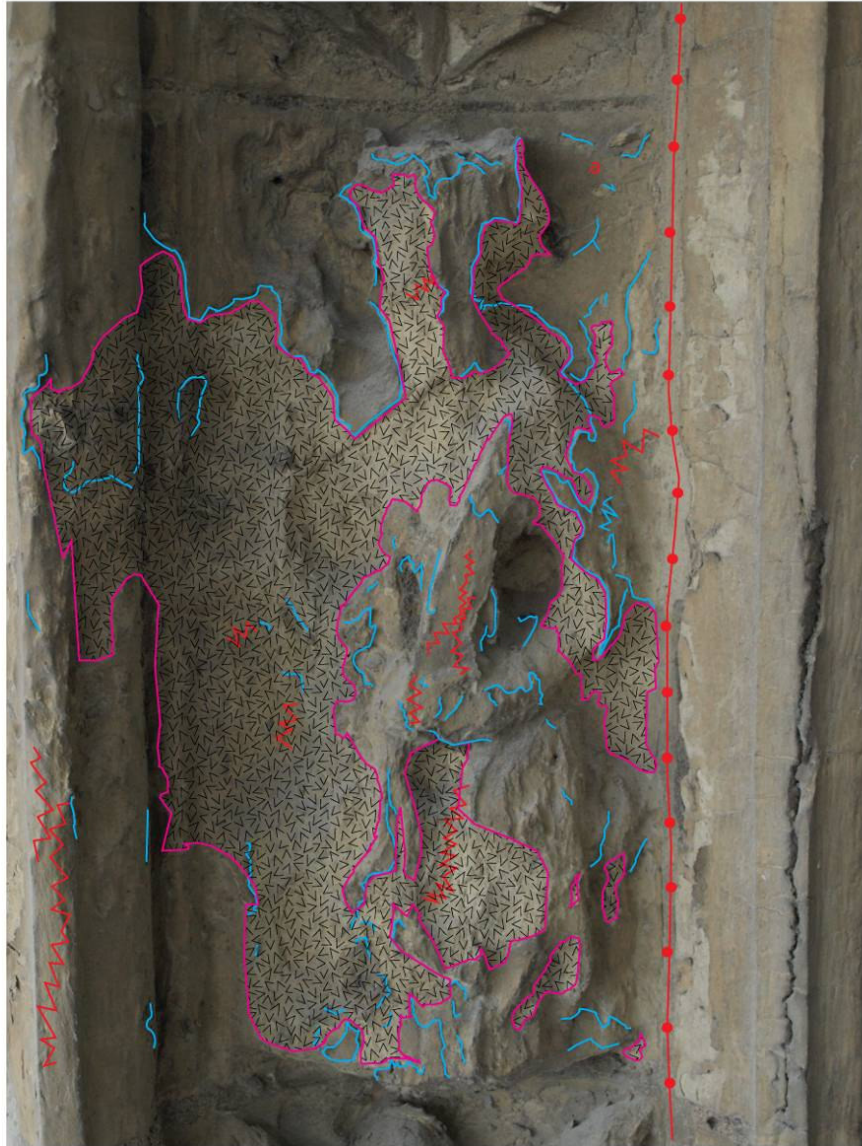
LOCATION :
 YM/East Front/Area 4/GEW voussoirs
 STONE ID:
 b9
 RECORDED BY/DATE:
 AH Photo Apr 09; Condition Survey AH Apr 09

substantial decay, with some significant losses of surfaces and detail since survey by Godfrey (2005). These include the uppermost section of the scroll [a]

voussoirs immediately above and below remain sound; considerable loss of adjacent masonry of EW arch to L/H side

brown staining to surface skin

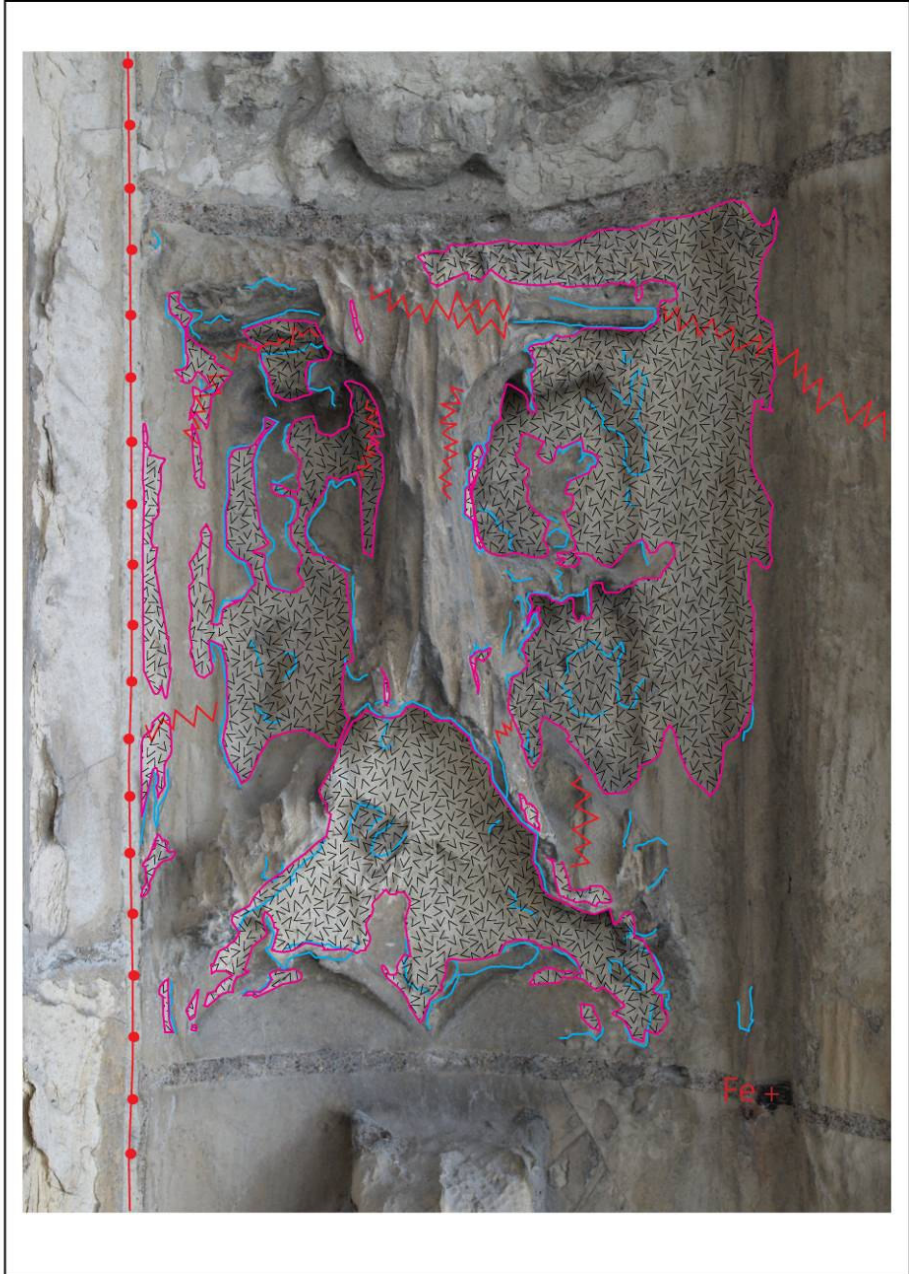
poor condition

brown staining to surface skins

some harmonious weathering to extant sound surfaces

multiple vertical faults running through central section

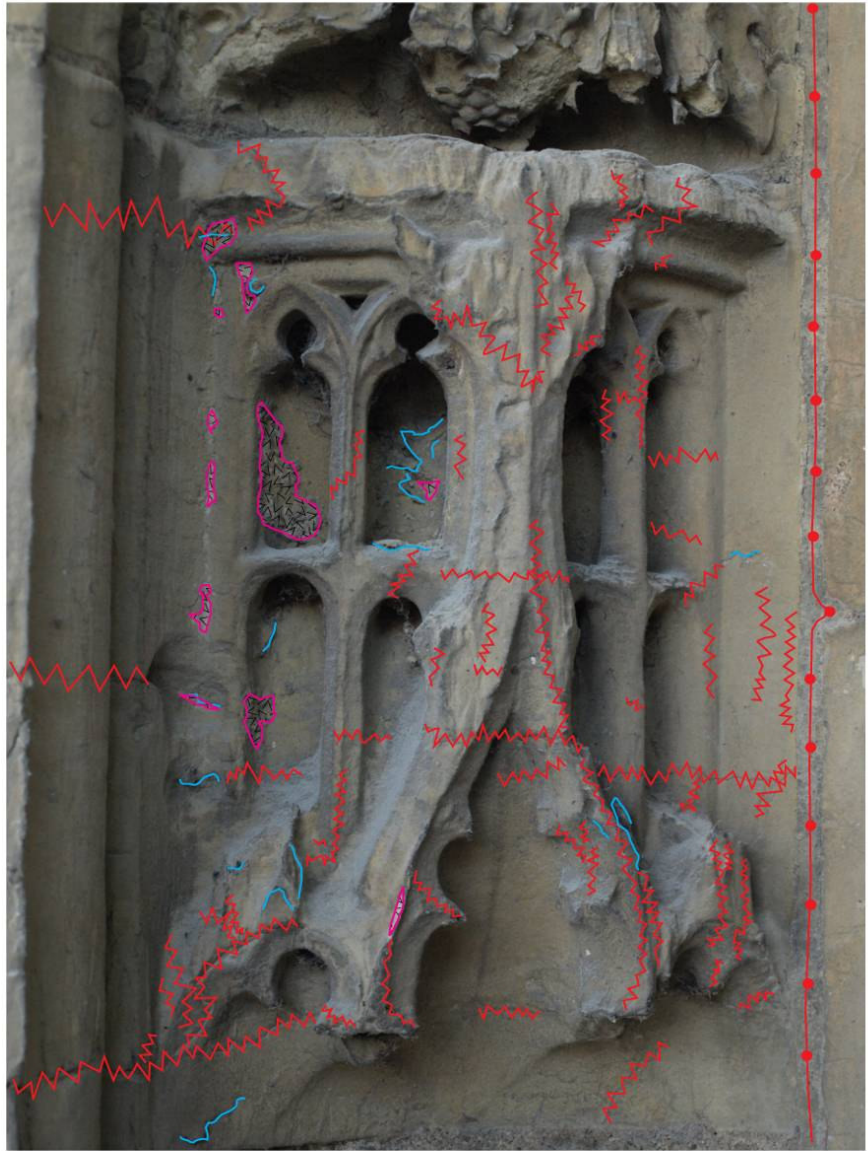
brown staining to surface

pockets of earlier decay subsequently consolidated and inhibited to lower L/H side

outermost details softened by harmonious weathering

zone of micro-blisters behind leftmost upper canopy light

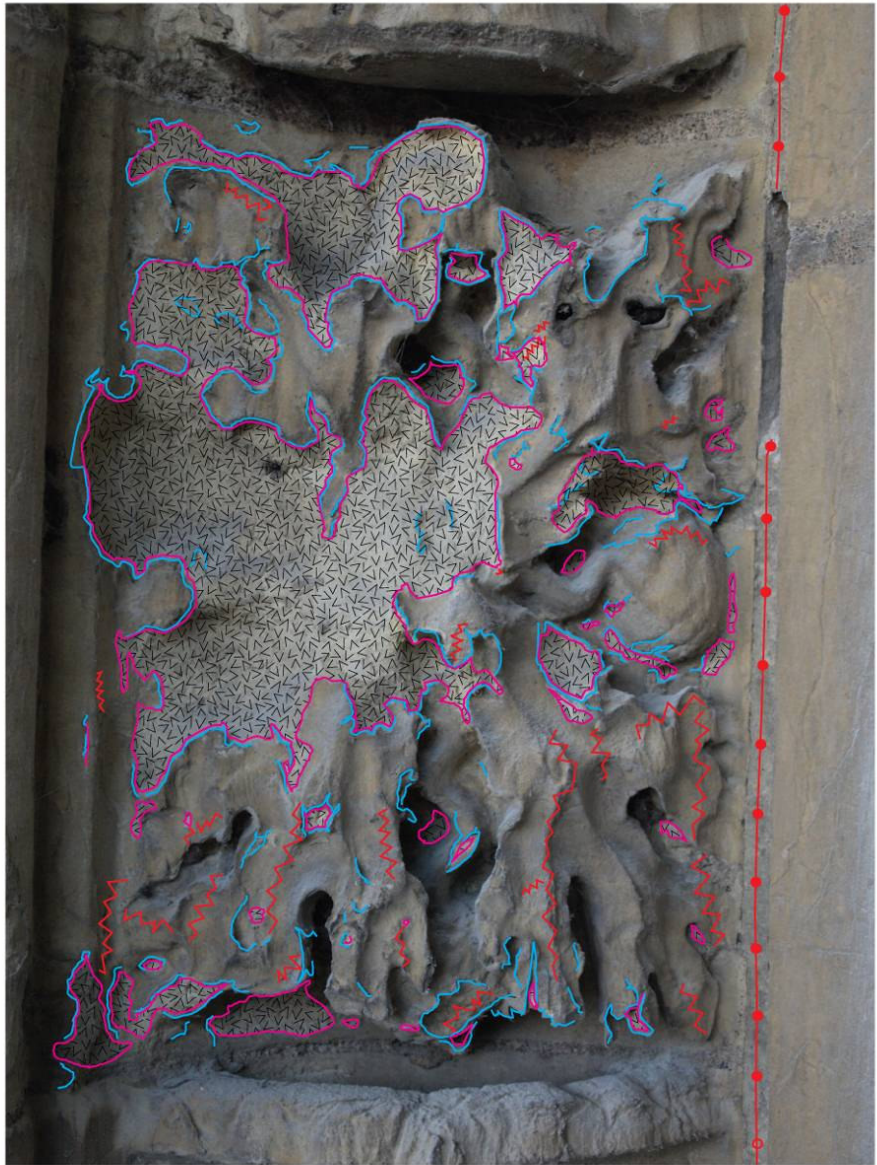
14thC original foliage
 four main leaves and
 four flowers originally
 brown staining to
 surface skins
 extant surface details
 softened by
 weathering
 claw tooling observed
 on R/H bed where
 mortar has previously
 been removed

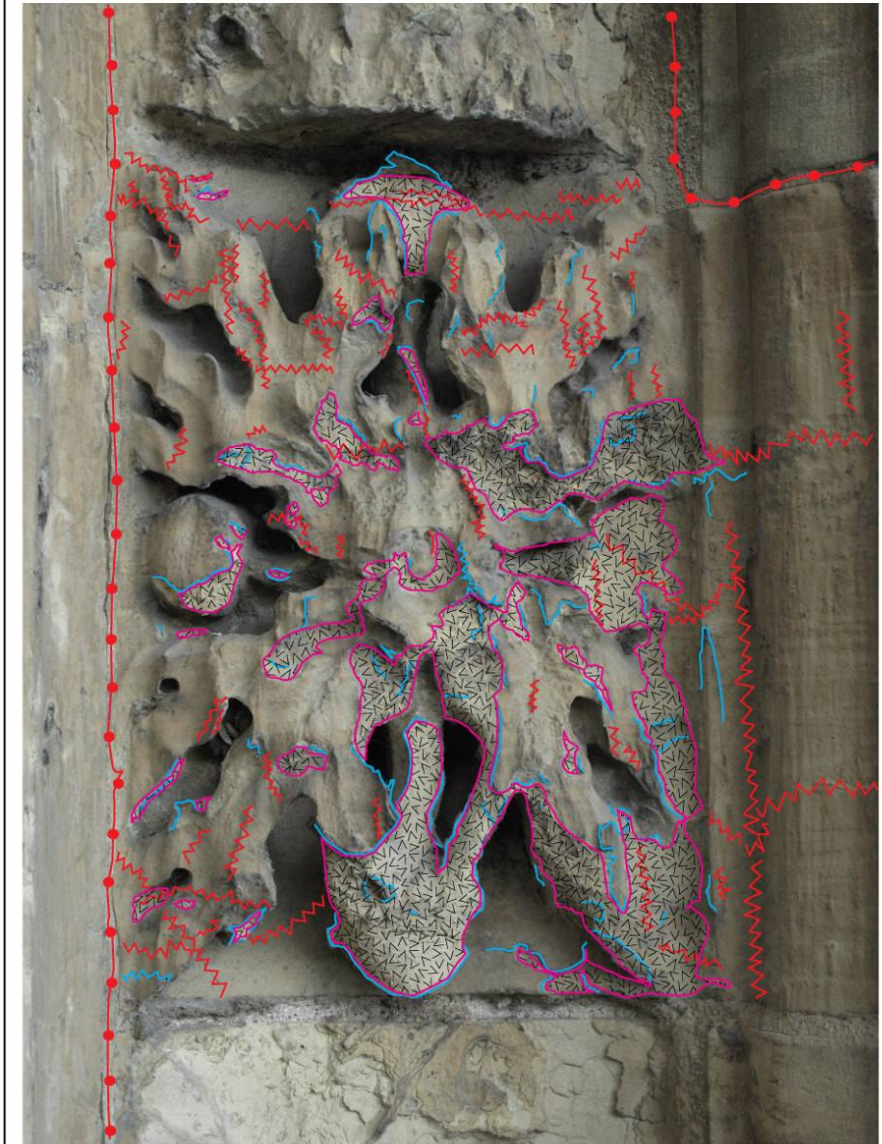
brown staining to sound surfaces

dark sulphation residues behind lower flower

further decay likely to be concealed beneath surface soiling

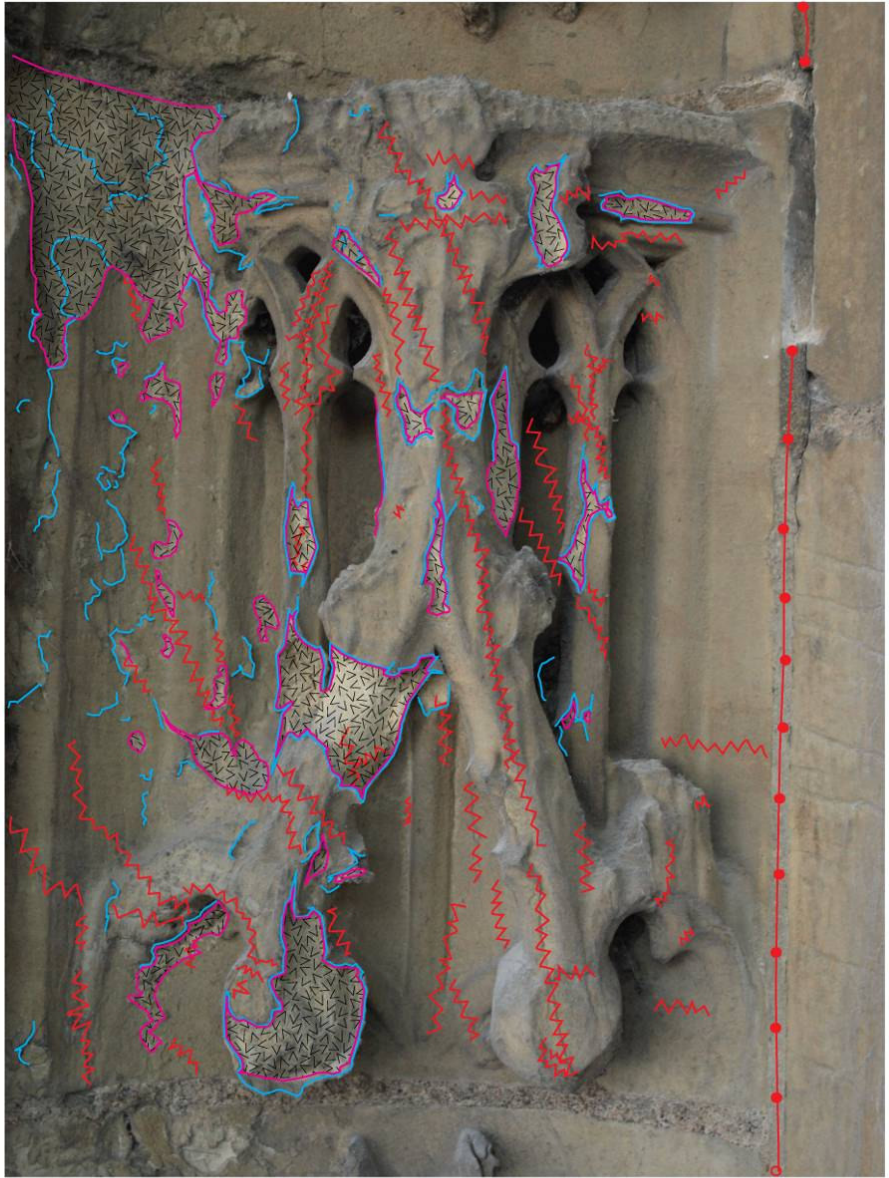
claw tooling observed in previously exposed R/H joint

canopy lobes originally formed two beasts; heads now missing

brown staining to sound surfaces

details softened by harmonious weathering

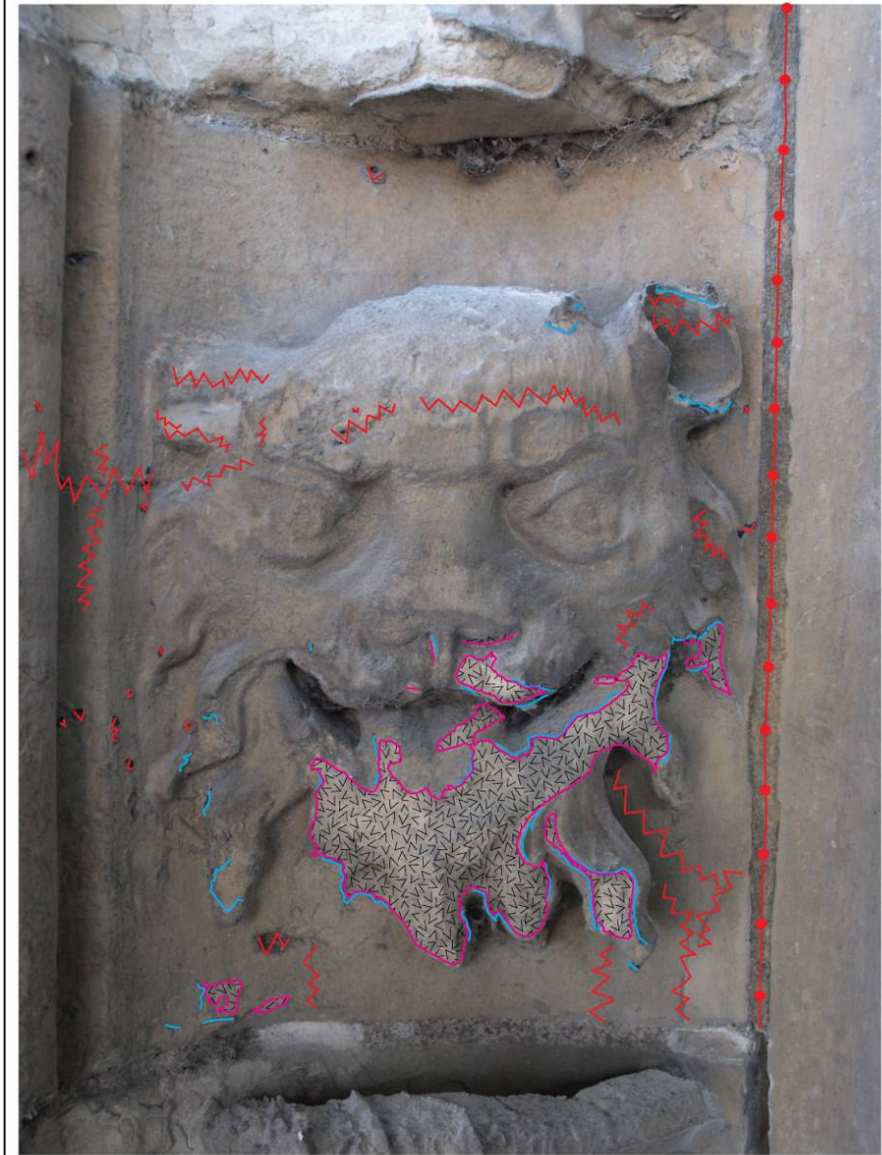
claw tooling observed in previously exposed joint

brown staining to sound surfaces

softening of details through weathering

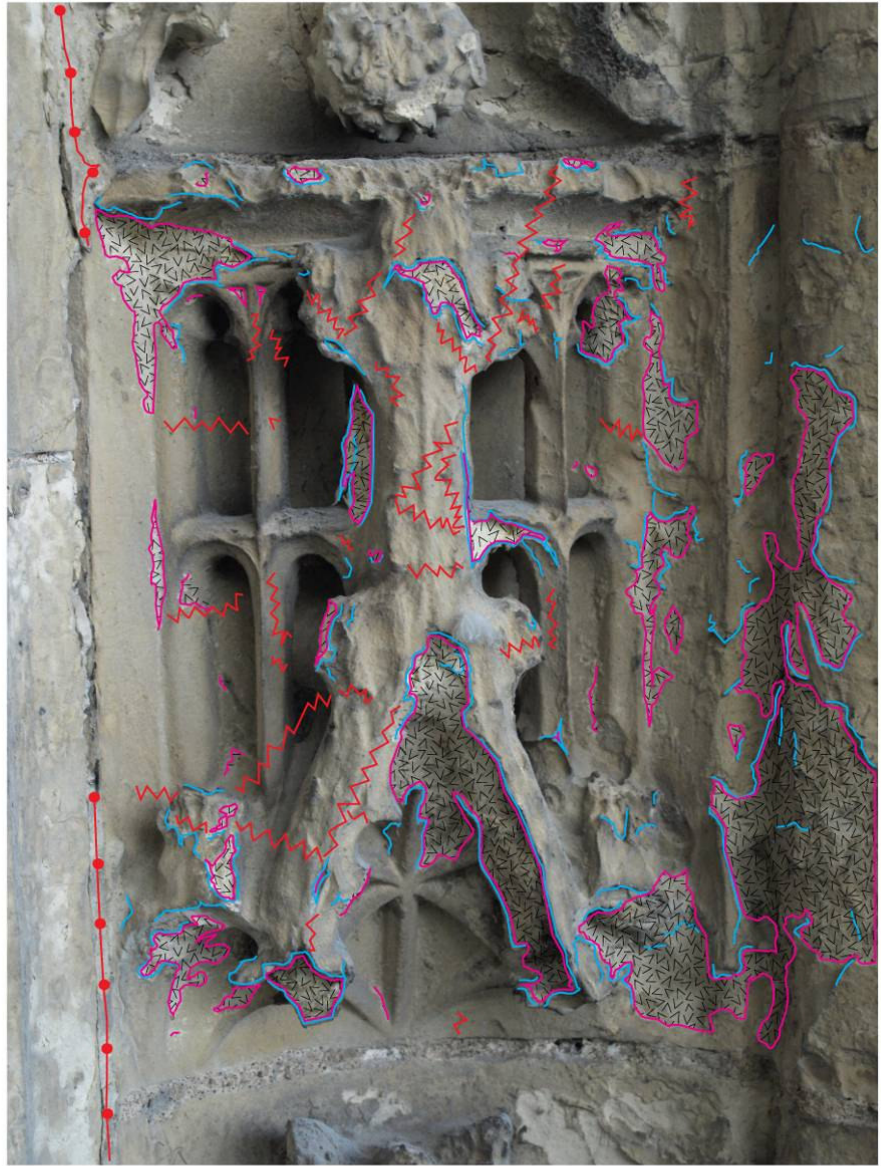
brown staining to sound surfaces

extant details softened by weathering

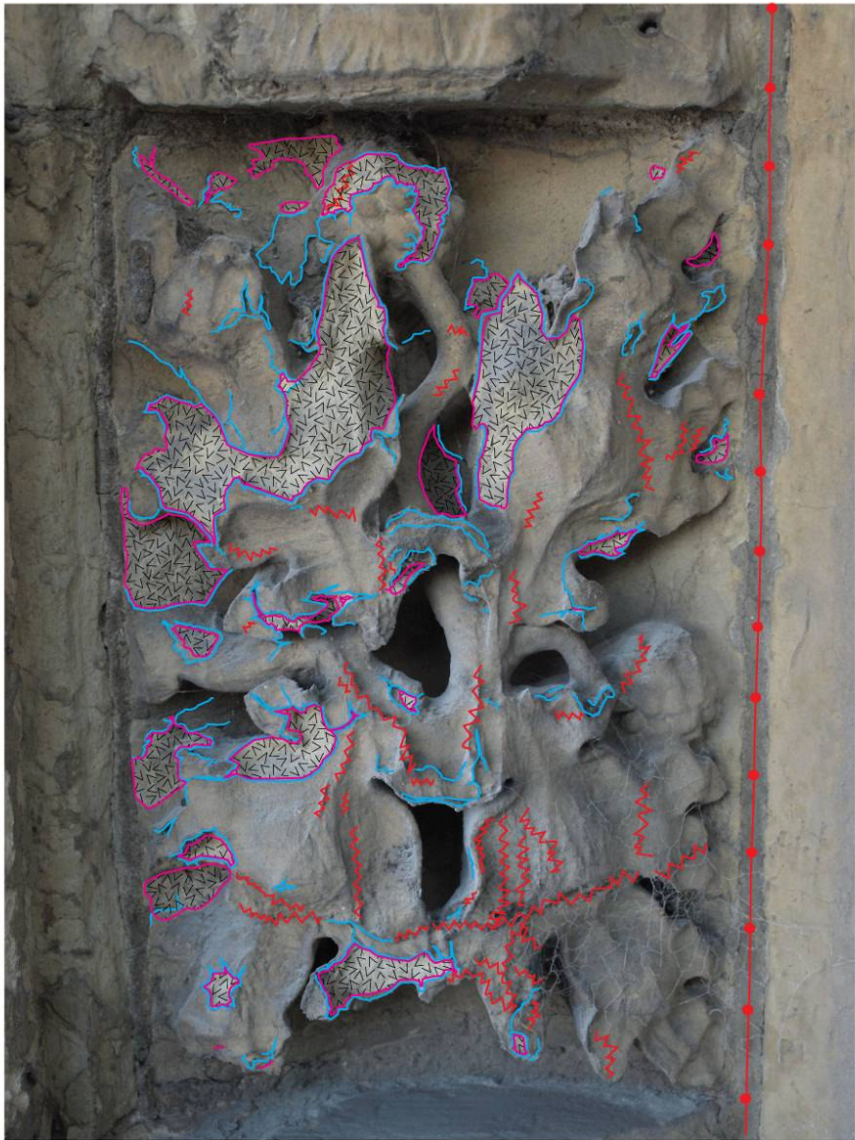
details softened by weathering

brown staining to sound surfaces

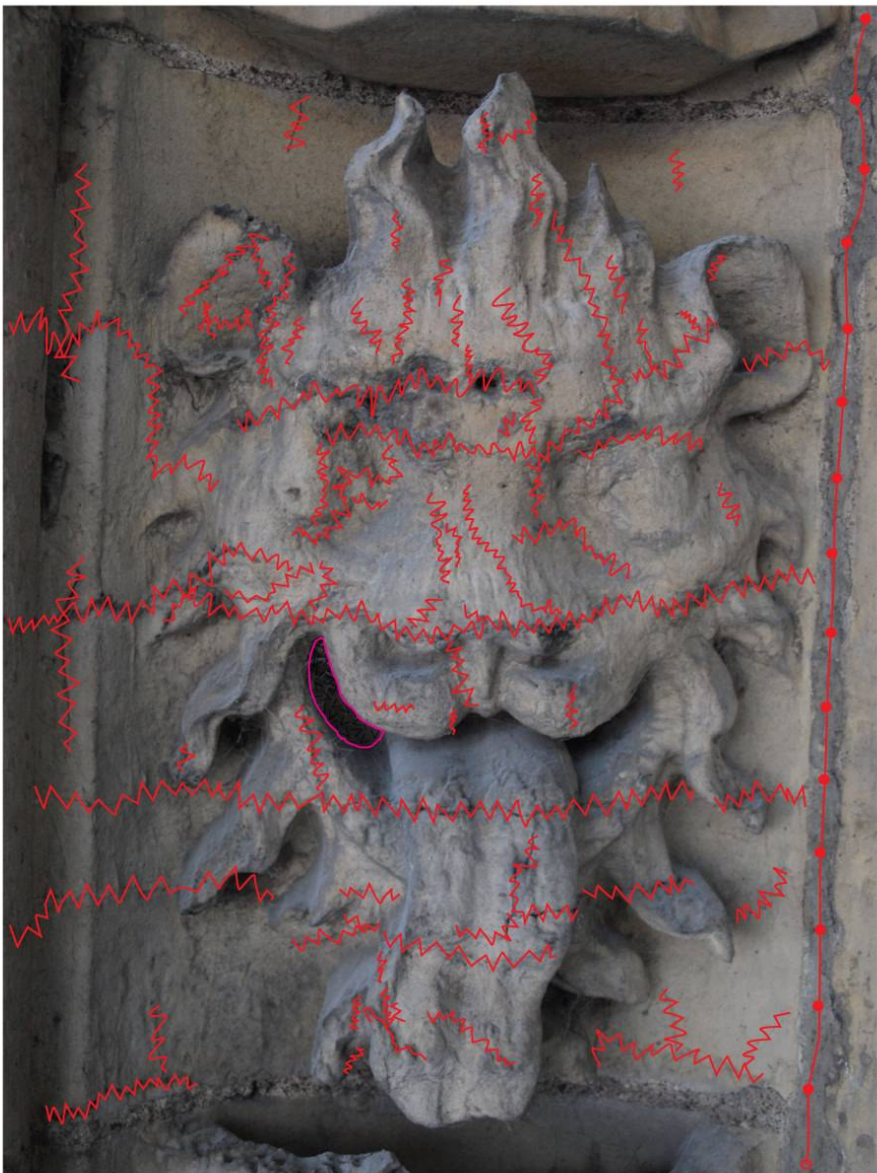
details softened by weathering

brown staining to surface

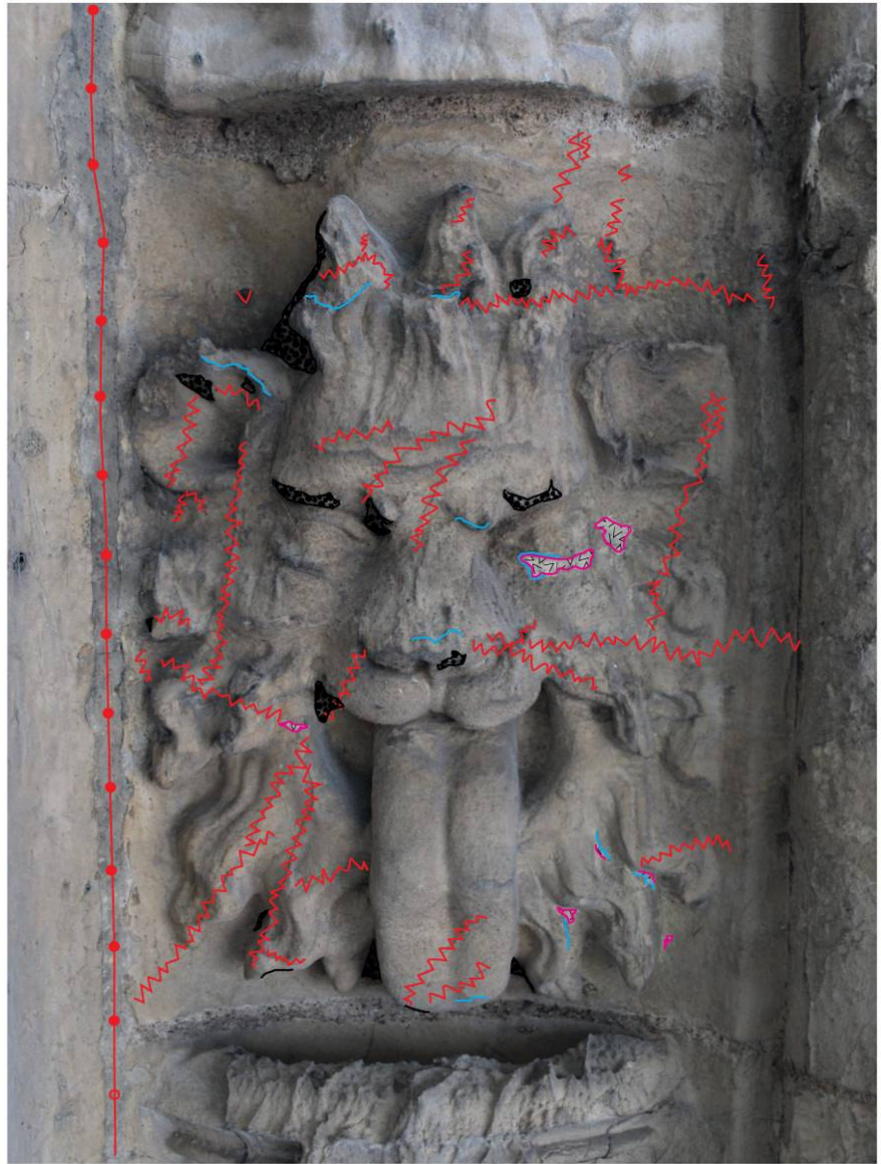
softening of details caused by weathering

brown staining to surface

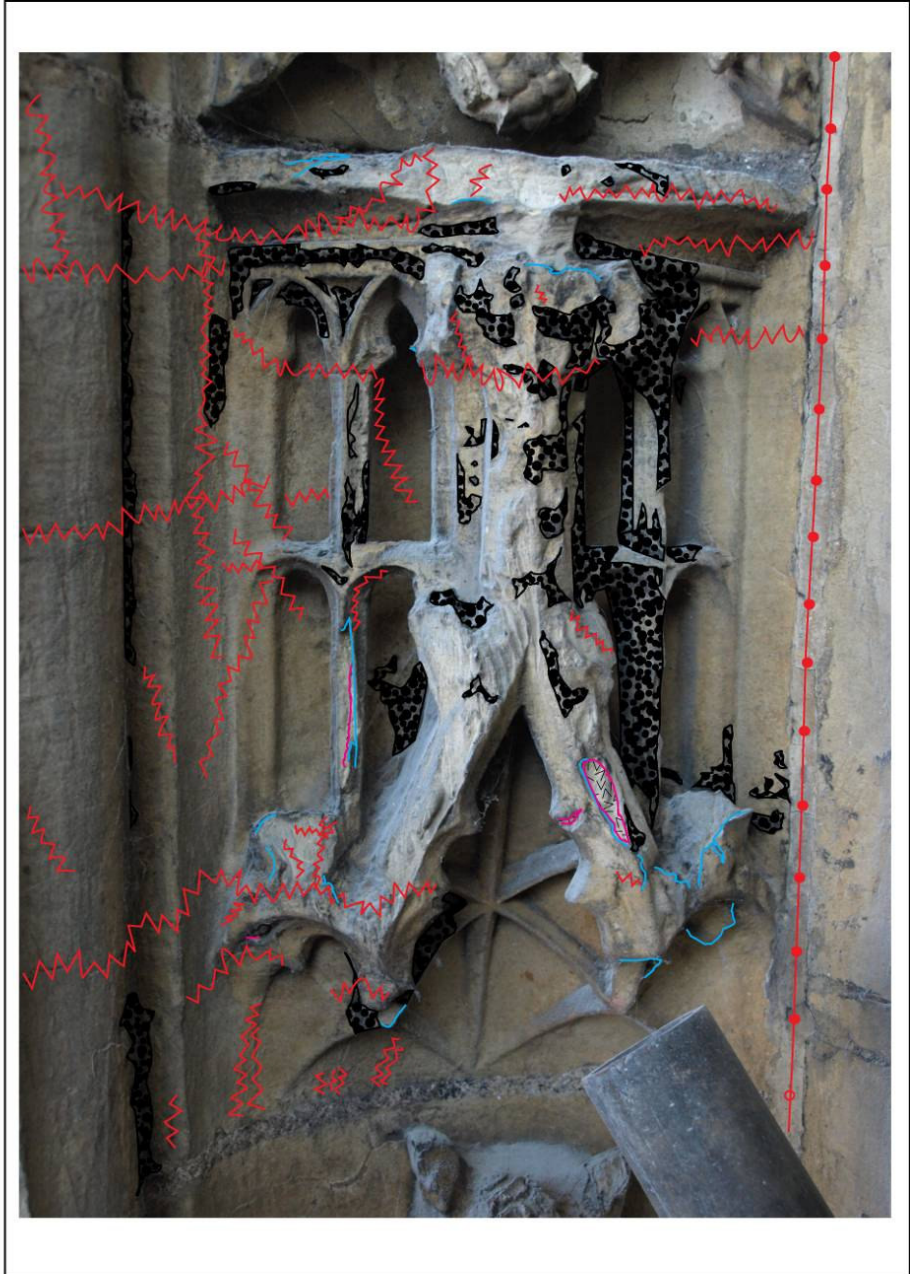
details softened by weathering

brown staining to surface

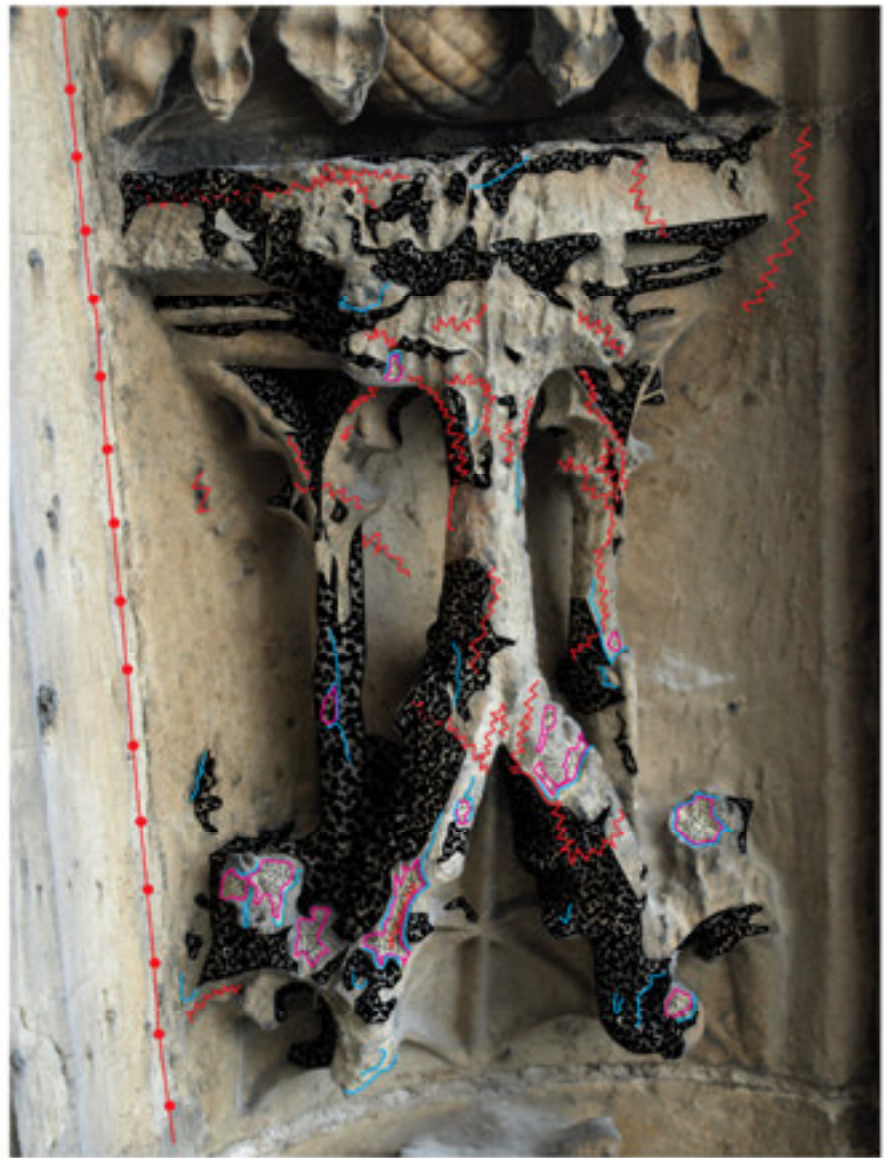
14thC original canopy
 evidence of previous black sulphation
 surface scored by previous wire brushing
 sound condition, but much detail now lost
 extant details softened by weathering
 brown staining to surface

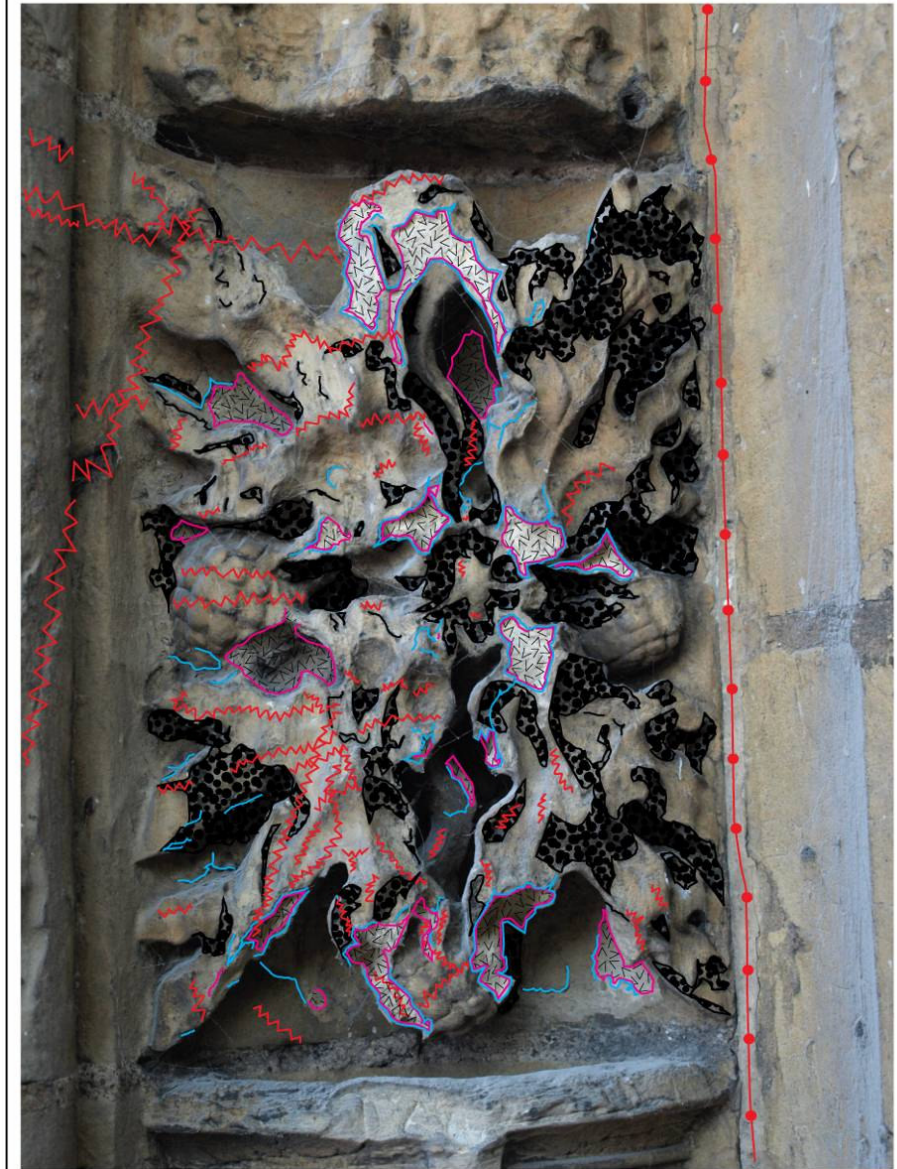
some softening of details caused by weathering

brown staining to surface

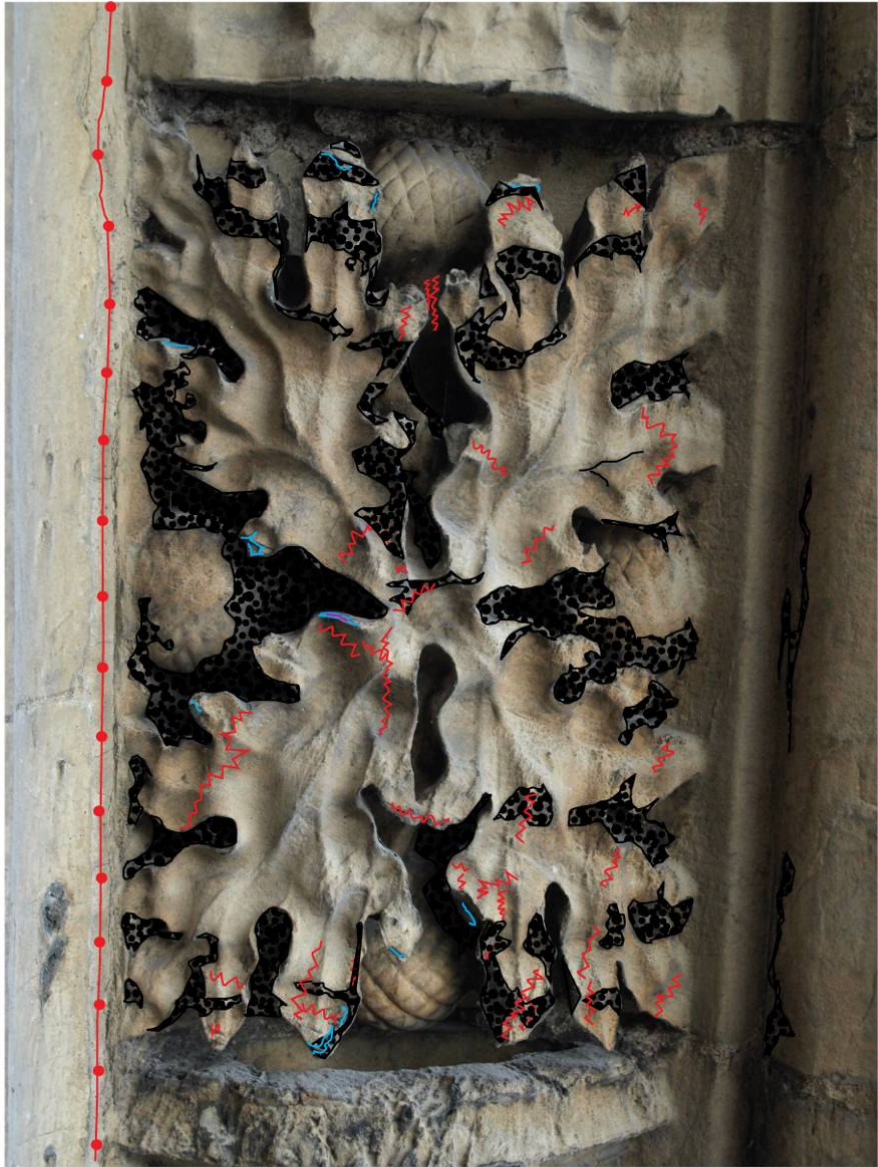
slight softening of details caused by weathering

brown staining to surface
