The Archaeology and Conservation
of the
East Front of York Minster

Volume 2 of 2
Figures, Drawings and Appendices

Alexander B Holton

University of York

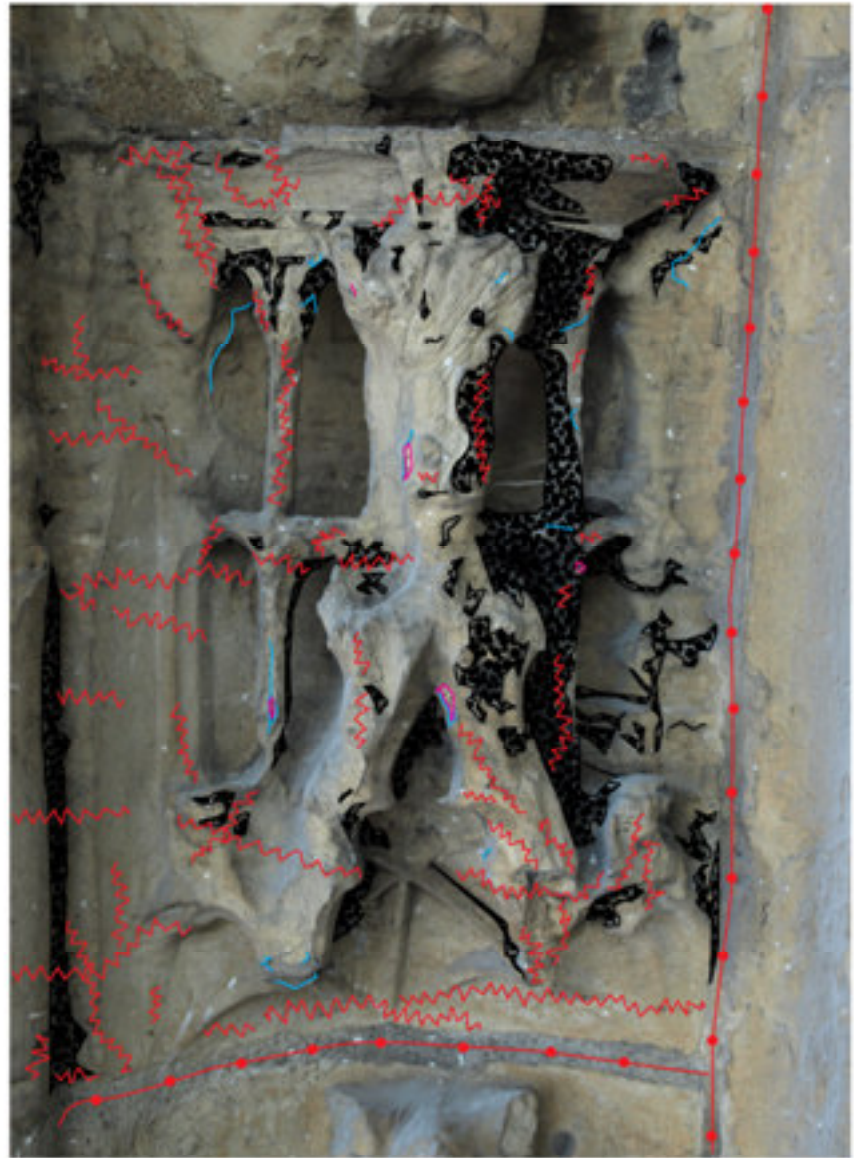
14thC original canopy
 extant details softened by weathering
 previous decay subsequently consolidated in some areas
 evidence of previous dark sulphation
 some scoring from previous wire brush cleaning
 brown staining to surface

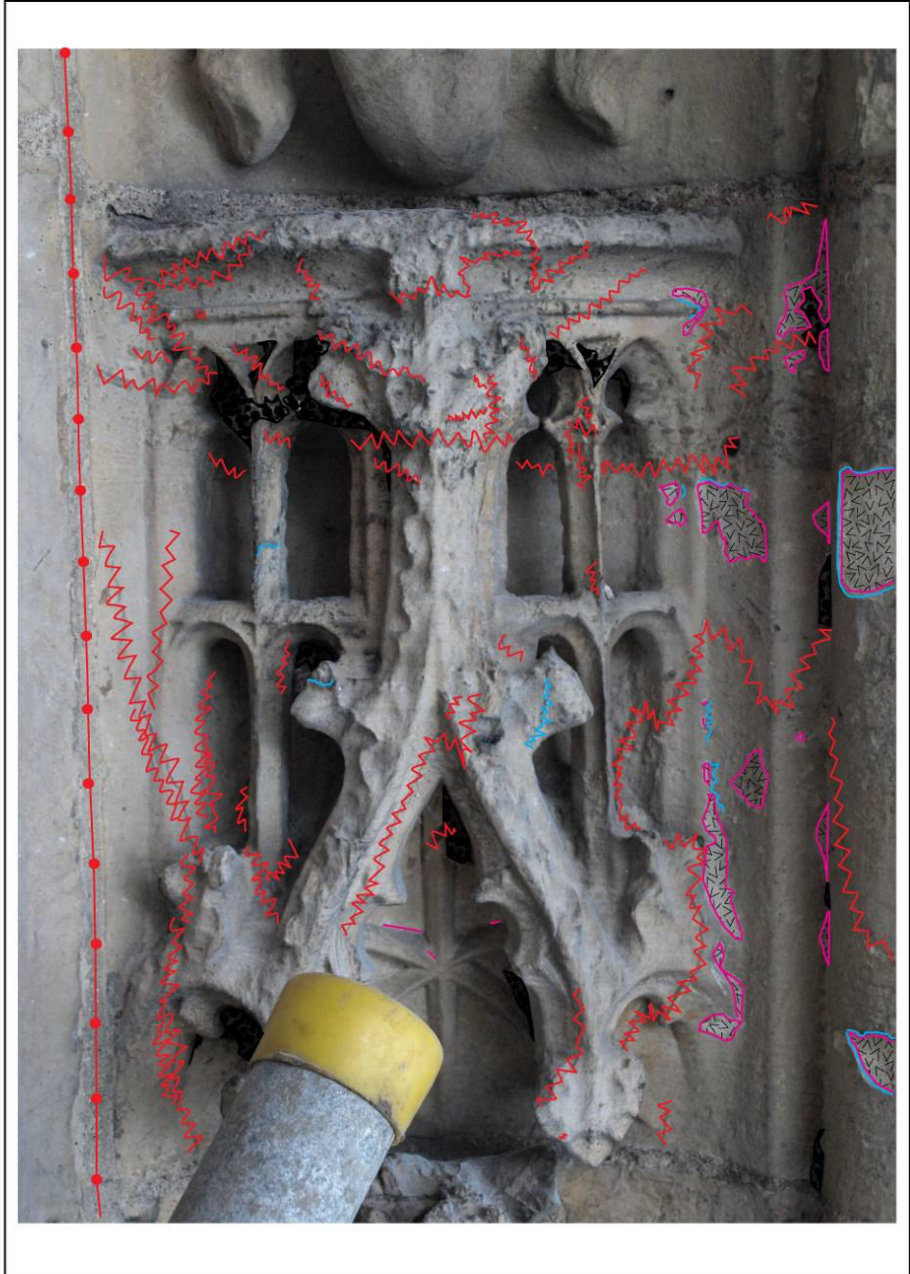
evidence of previous dark sulphation

brown staining to surface

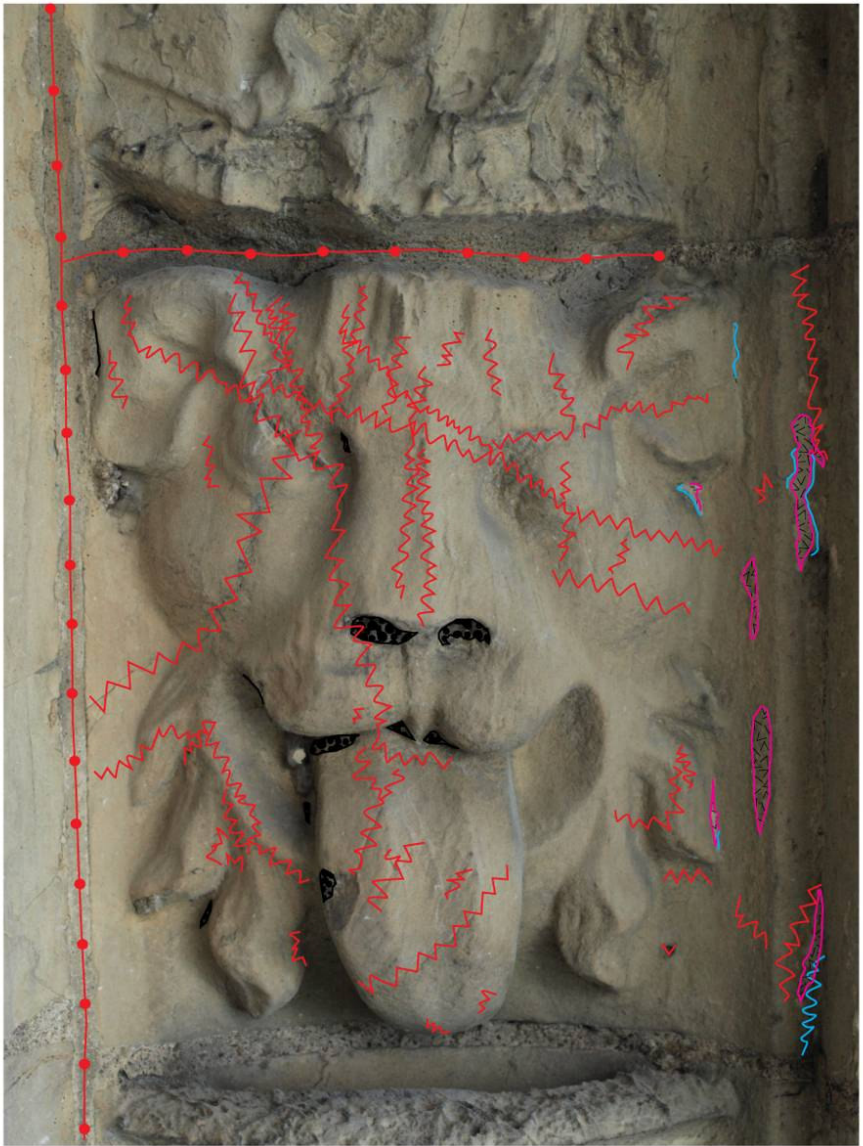
softening of details by weathering

brown staining to surface

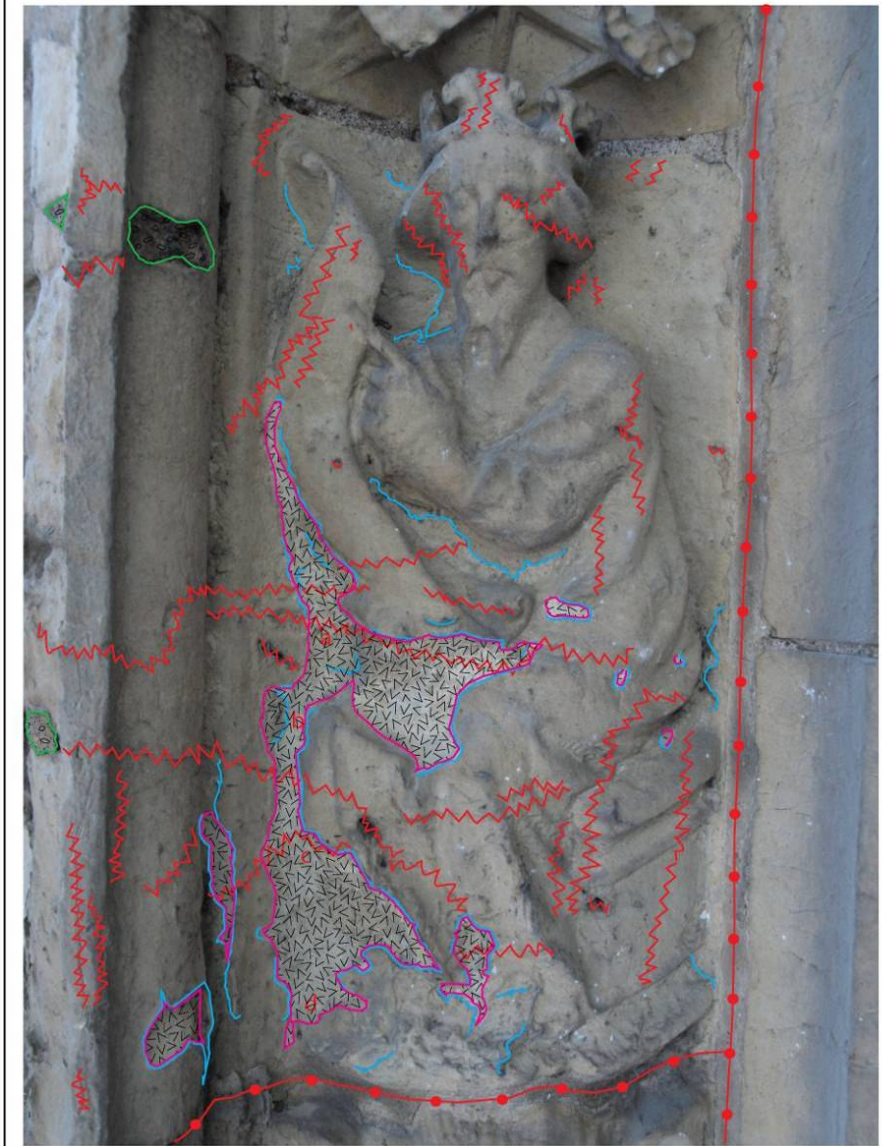
softening of details by
weathering

yellow-brown staining
to surface

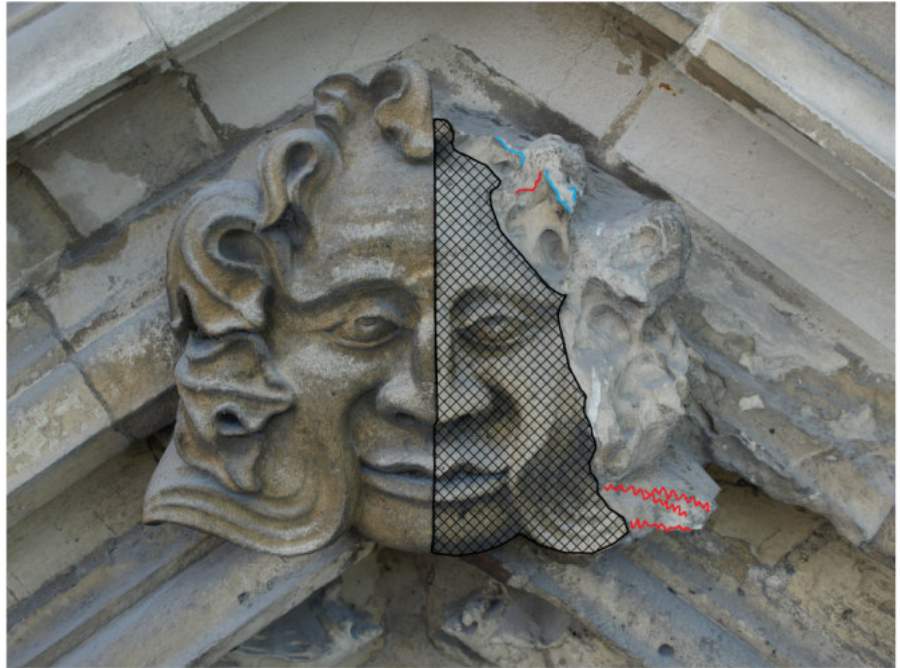
L/H side renewed in 1915 in Ketton oolitic limestone; carved by Sam Monk. R/H side original 14thC with mortar repair over, also by Monk. repair composed of cement with crushed Ketton as aggregate

brown staining to Ketton stone and mortar repair

decay ongoing beneath original stone
